**HERITAGE SURVEY OF THE HLULEKA ROAD, WILD  
COAST, EASTERN CAPE**

**EIA REFERENCE: 15/2/1/1/NEMA/50/09-025:  
DEDEA MTHATHA**

**FOR COASTAL & ENVIRONMENTAL SERVICES**

**DATE: 6 April 2009**

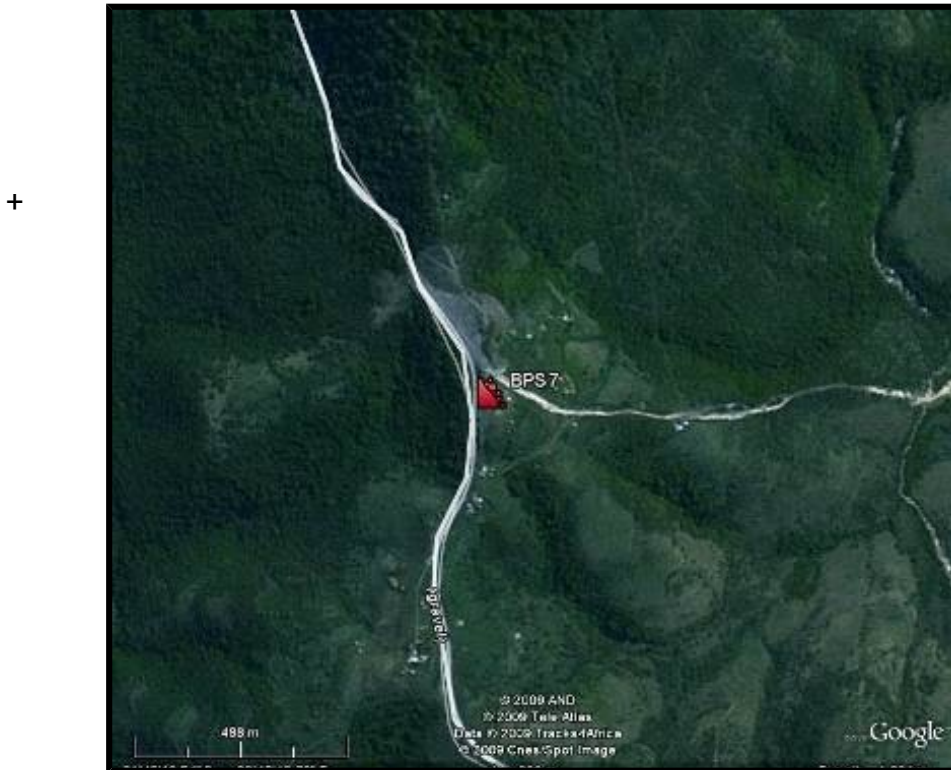
FIGURE 6: LOCATION OF BP7

BP7 is located near the 30.0km mark (fig. 6). There is an existing borrow pit to the northwest of BP7. The borrow pit is in a small hill with a shale deposit. No artefacts were observed.

Mitigation: No further mitigation is required. Palaeontological assessment will be required.

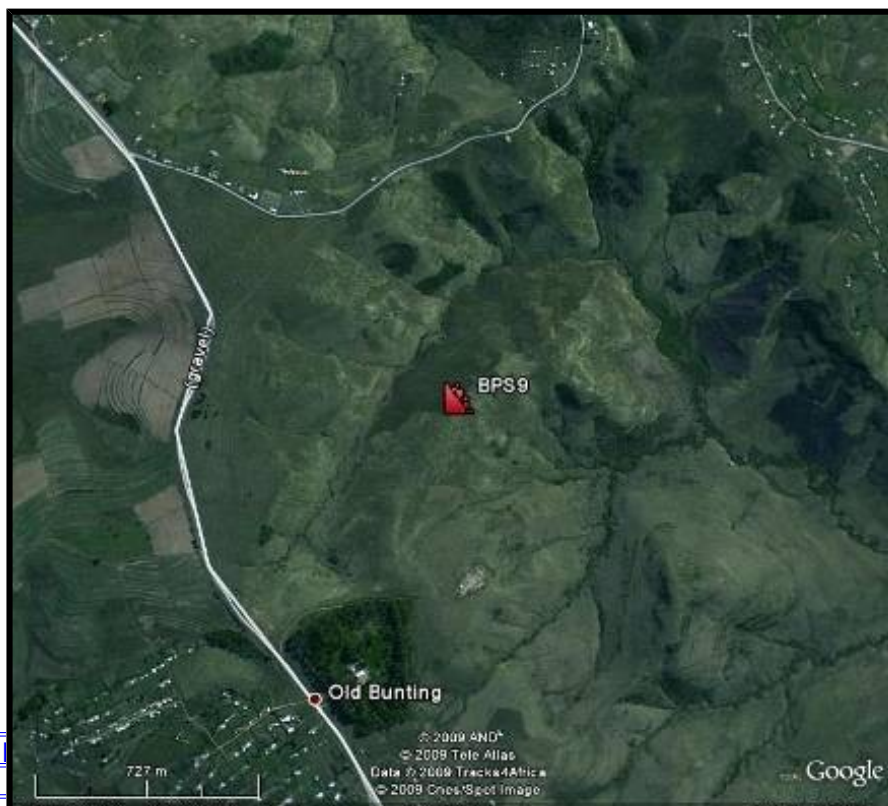
FIGURE 7: LOCATION OF BP9

BP9 is located near the 17.8km mark, and about 1km from the road (fig. 7). The borrow pit is on a large hill. The Old Bunting Mission is located near the entrance to the borrow pit. There appears to have been agricultural activity on the land suggesting that homesteads may have occurred here as well. I did not observe any old homesteads.

Significance: The site is of low significance. The mission may be of high significance.

Mitigation: No further mitigation is required. The mission should not be affected.

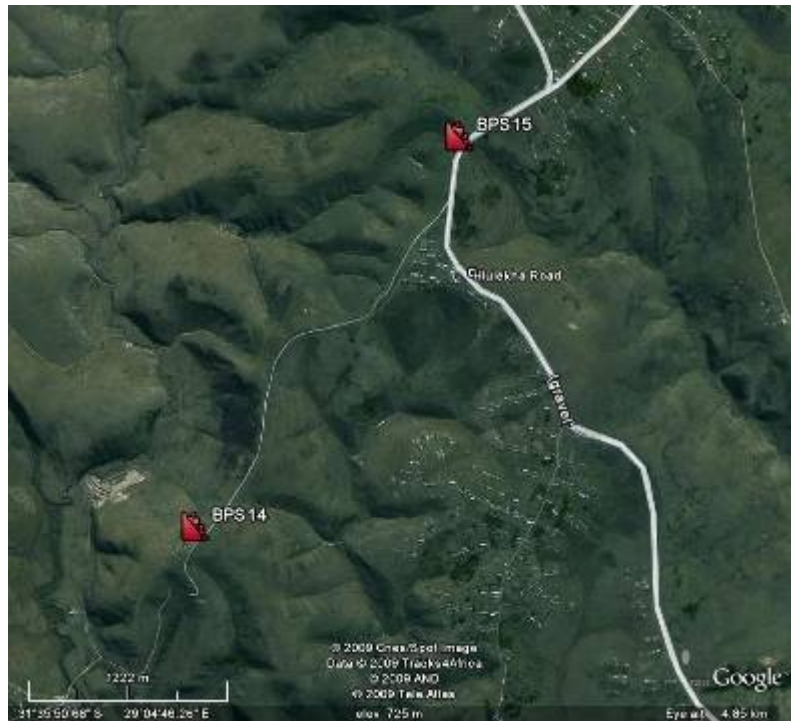
FIGURE 8: LOCATION OF BP14 - 15

BP14 is supposed to be located 2.7km from the 3.2m mark (fig. 8). The site is next to an existing borrow pit that has sandstone, dolerite and shale layers. These layers may be palaeontologically significant.

BP15 is located near the 3.0km mark (fig. 8). The site consists of a few MSA tools. There are shale and dolerite layers in the borrow pit as well.

Mitigation: Palaeontological assessment will be required.

Mitigation: No further mitigation is required. Palaeontological assessment will be required.
