**HERITAGE IMPACT ASSESSMENT:
PROPOSED HYPERION SOLAR DEVELOPMENT 1,
LYNDOCH 432/REM, KURUMAN MAGISTERIAL
DISTRICT, NORTHERN CAPE**

Required under Section 38(8) of the National Heritage Resources Act (No. 25 of 1999).

SAHRA Case No.: 12965

27 March 2019

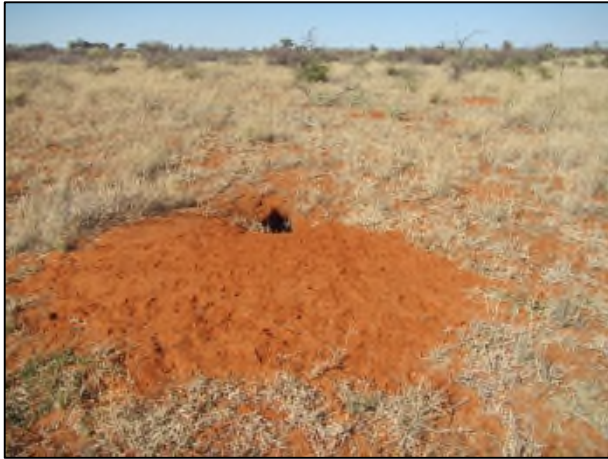
Figure 9: View of a burrow showing the clean red sand that occurs beneath the grass.

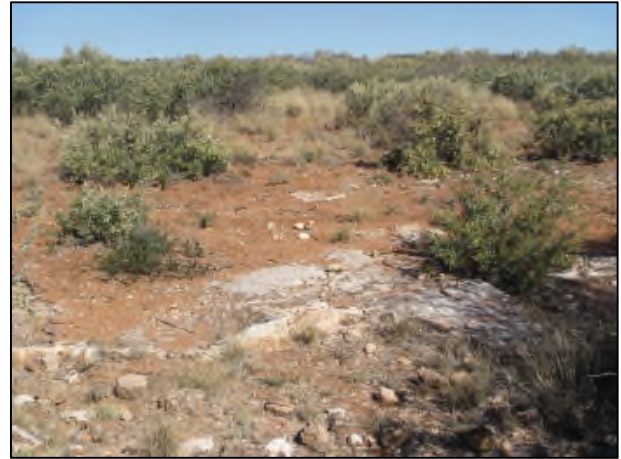
Figure 10: Calcrete exposed beneath the red sand close to the Vlermuisleegte.

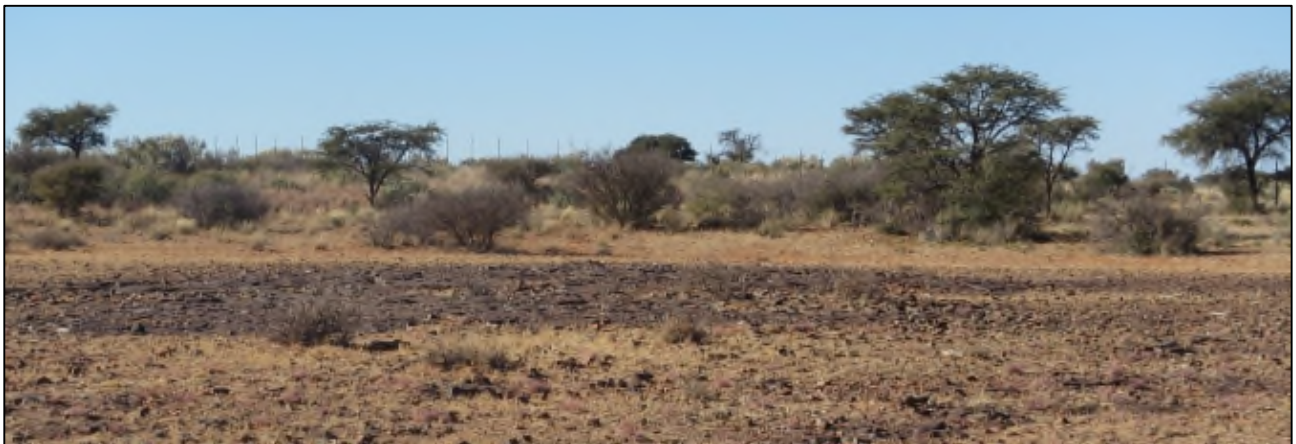
Figure 11: View across the only bedrock exposure on site. It lies within the channel of the Vlermuisleegte whose depth below the plains is evident here.

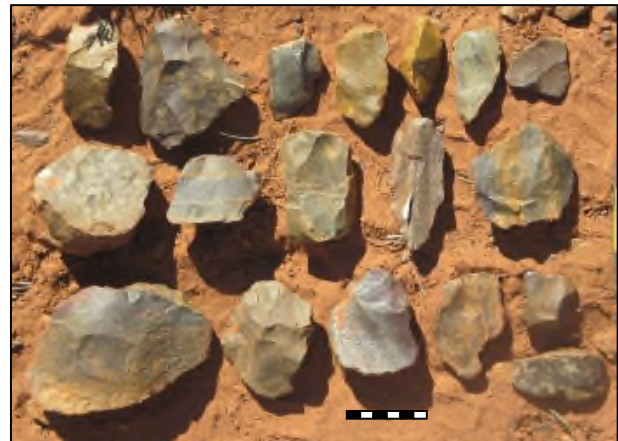
Figure 35: Artefacts from waypoint 1216 on the gravel hill south of the project site. Scale in cm intervals.

The only variation from the flat sandy plains on either side of the Vlermuisleegte was the low gravel hill just mentioned (Figure 34). As expected, this gravel area also contained stone artefacts (Figure 35).

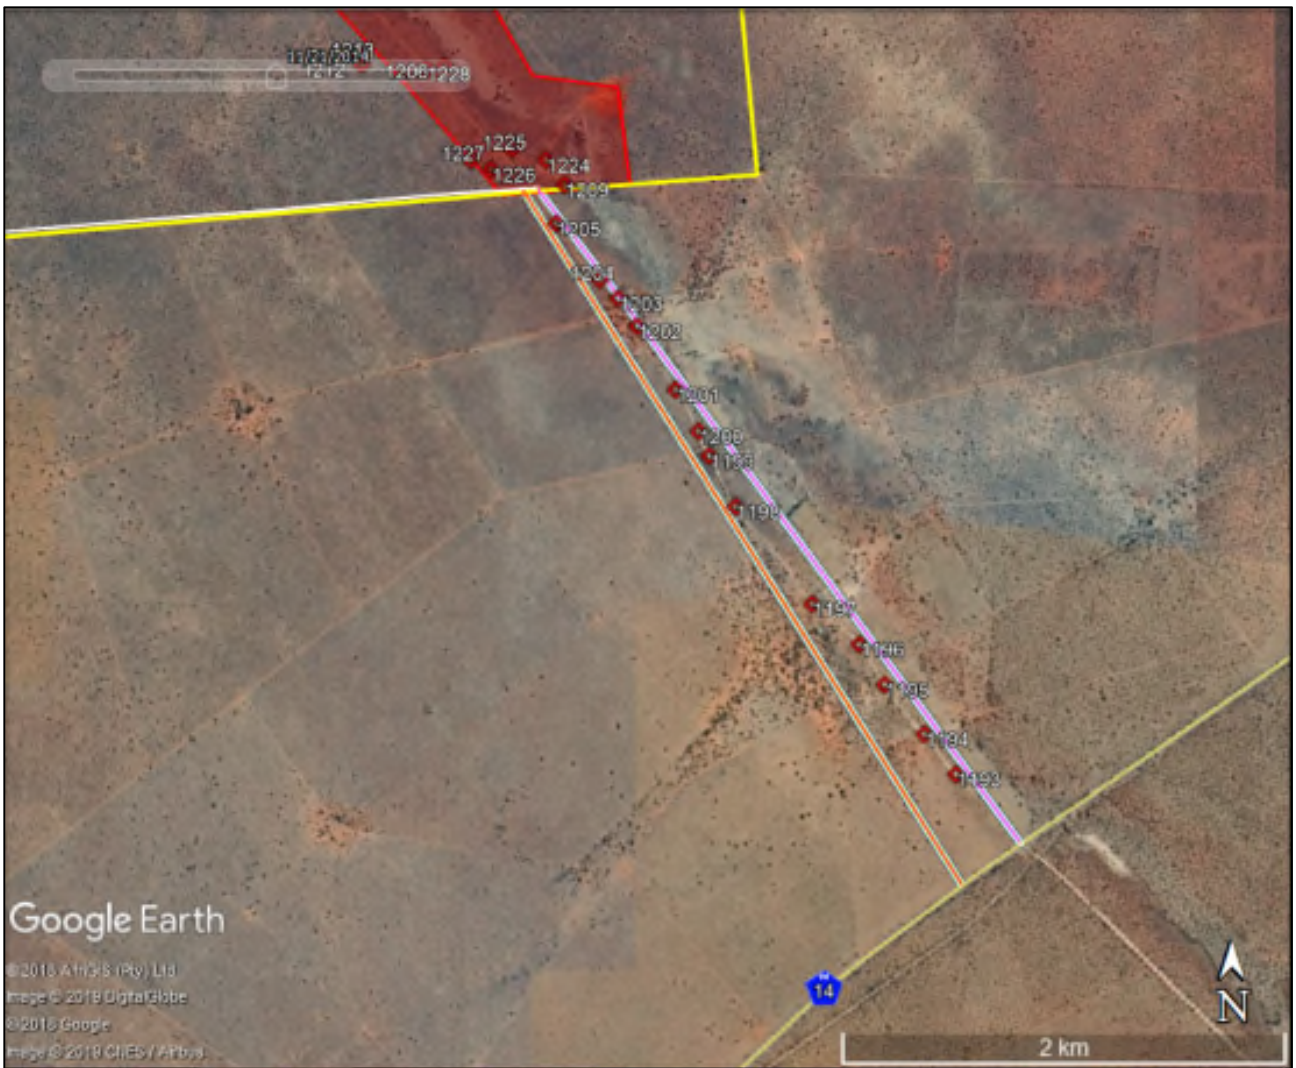
Figure A3.2: Aerial view of the Alternative 1 and 2 access roads (purple and orange lines respectively) showing the heritage finds (numbered red symbols) and heritage no-go area for PV development (red shaded area).
