**PROPOSED IBISI INFILL HOUSING PROJECT,
UMZIMKHULU LOCAL MUNICIPALITY
KWAZULU-NATAL**

Phase 1 Heritage Assessment

December 2019

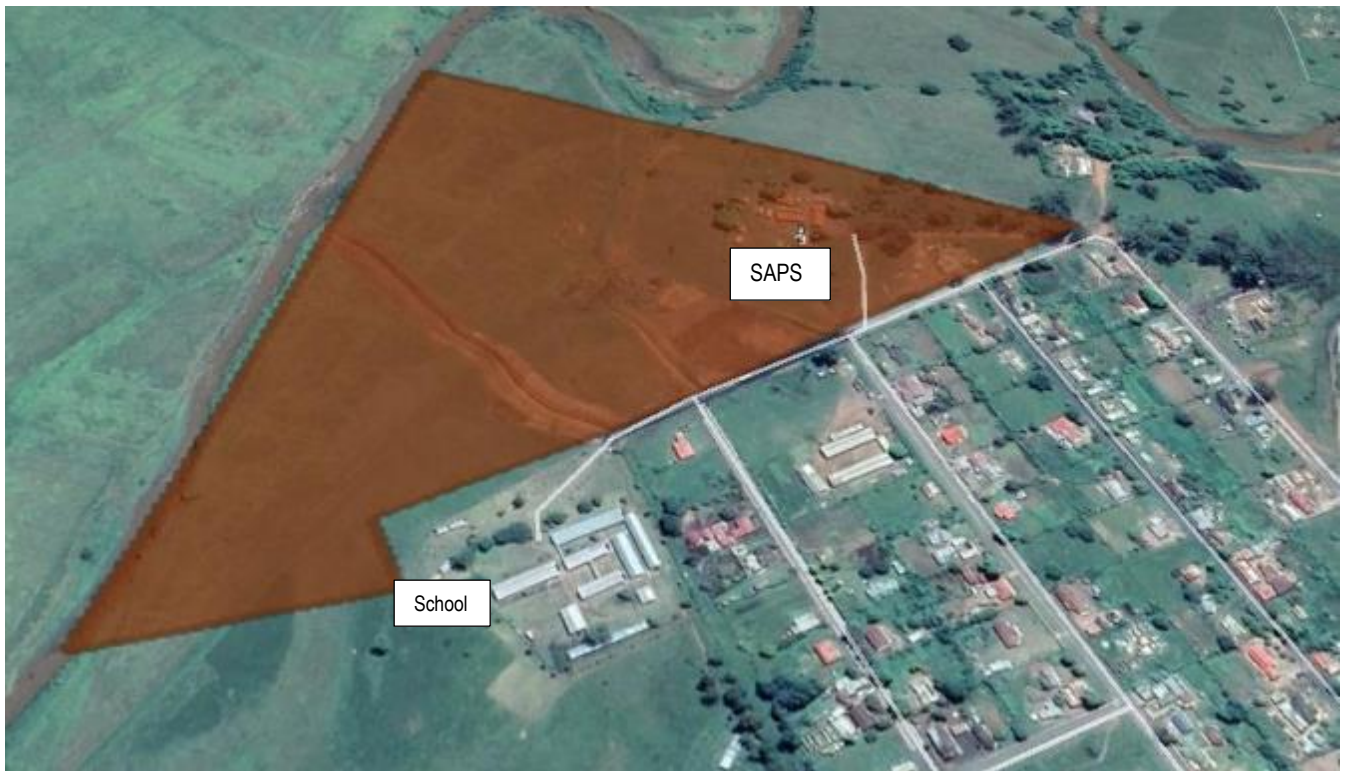
Figure 3: Northern infill housing site

Northern infill site (Figure 3):

The rest of the northern site was inspected and no heritage sites were found. Two trenches that have been dug from the tar road going towards the Ibisi River, cross the project area. These trenches are clearly visible on **Figure 3** above. Some dumping of rubbish and building rubble is taking place in this area. The areas below or north of the school and close to the river (see **Figure 3**) have also previously been cultivated and are now lying fallow. No heritage sites were found in these areas.

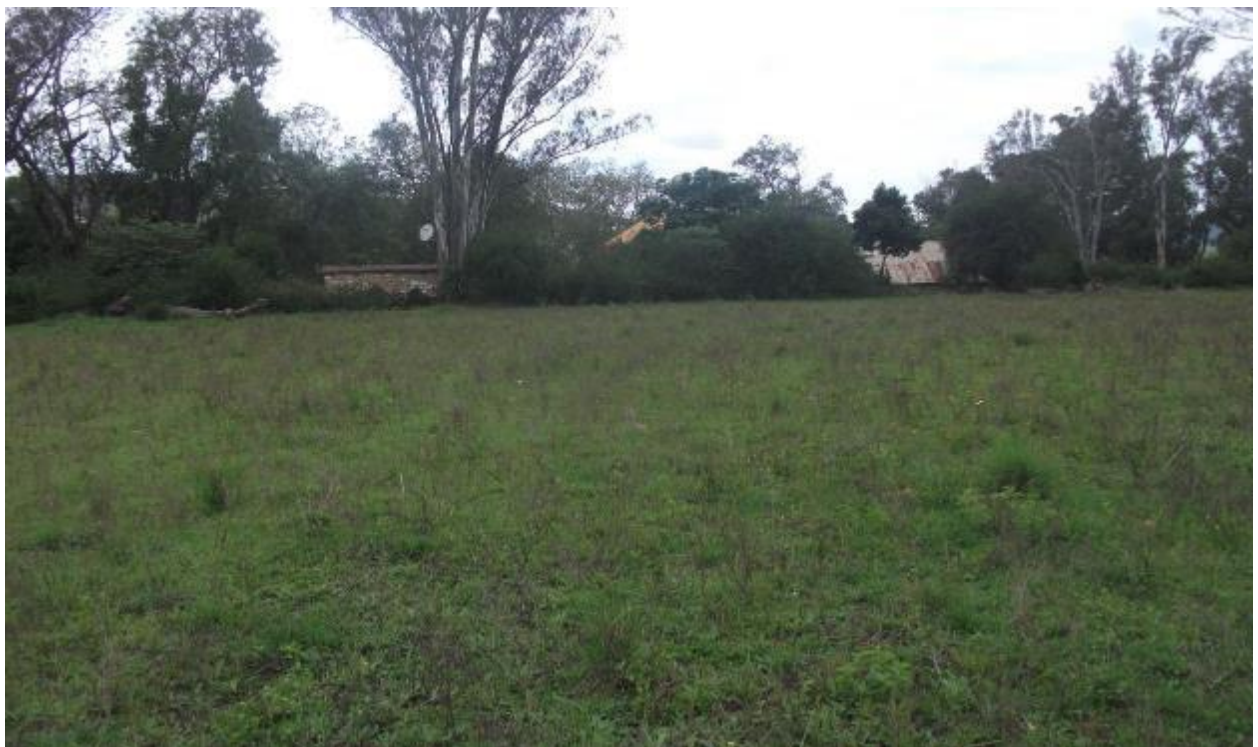
Figure 4: Fallow land with structures on eastern boundary

This area was inspected on foot. The area to the east and north-east of the police station was previously cultivated and which is presently lying fallow. Several structures were observed on the eastern boundary of the infill site (see **Figures 4 and 5** below). No heritage sites were found which was unsurprising due to the disturbed nature of this area.

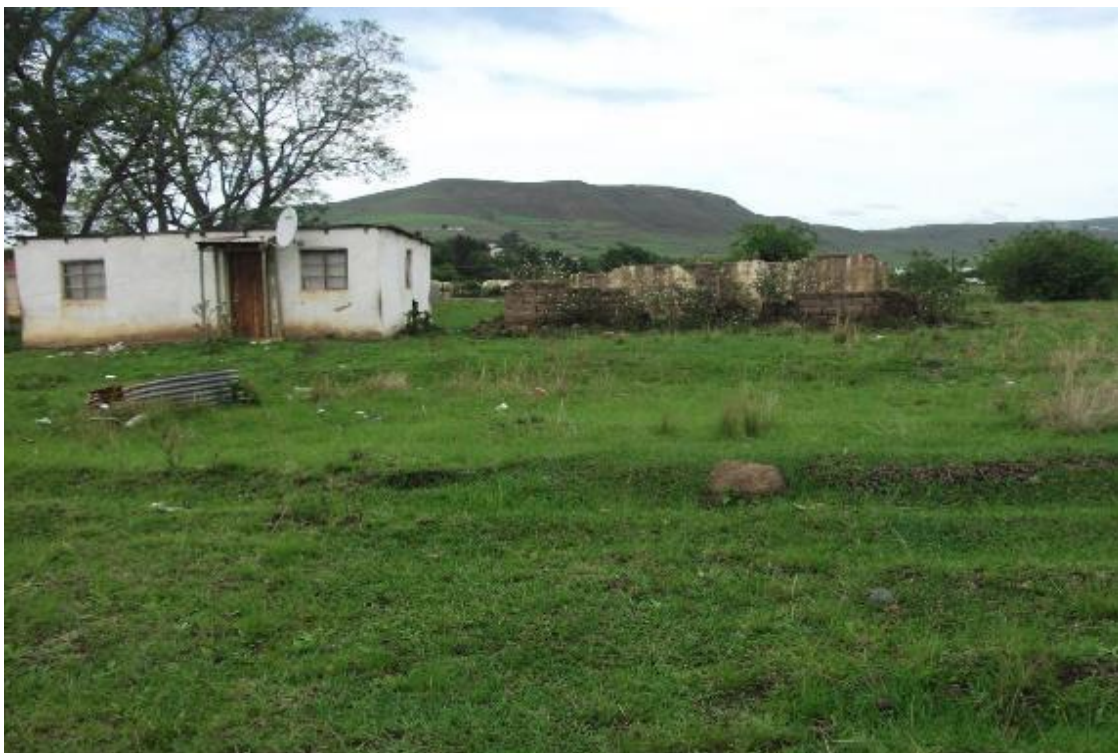
Figure 6: Dwelling and remains of dwelling

Immediately behind and west of the police station (which is situated in the infill site), one intact structure and the remains of several other structures were found. The intact dwelling is currently occupied. The remains of walls and floors of two structures are still visible and outlines in the ground and associated rubble of at least three additional structures can be seen.

The remains of the structures indicate that they were made of mud bricks held together with 'daga' (dagha) and then plastered. The remains of square structure dug into the ground were found that could have been the outside toilet / long-drop. The surrounding area was inspected for graves but none were found.

COORDINATES	DESCRIPTION	Significance	MITIGATION
NORTHERN INFILL SITE			
30°24'16.8" S 29°53'14.3" E	Remains of mud brick structure including walls and floor	Probably > 60 years; low heritage significance as such structures are fairly common in KZN; however, the remains are protected by legislation	If the remains are to be removed/destroyed, then application must be made to the Institute to obtain permission to do so
30°24'16.9" S 29°53'14.6" E	Intact structure that is currently occupied	Possibly > 60 years; low heritage significance; however, high social significance as it is someone's home	As the structure houses people, it is recommended that it remains <i>in situ</i> ; if it is to be destroyed, a built heritage specialist must be asked to determine the age of the structure; if >60 years then application must be made to the Institute to obtain permission to do so; if <60 years the structure can be demolished

The date of the topographical map indicates that at least one of the structures found in the northern infill site is older than 60 years of age. If the remains are to be destroyed to make way for the proposed housing development, then application must be made to the KwaZulu-Natal Amafa and Research Institute for permission to destroy all the associated structures as structures older than 60 years are protected in terms of the section 37 (1)(a) of the KwaZulu-Natal Amafa and Research Institute Act, 2018 which states that no structure which is, or which may reasonably be expected to be older than 60 years, may be demolished, altered or added to without the prior written approval of the Institute having been obtained on written application to the Institute.

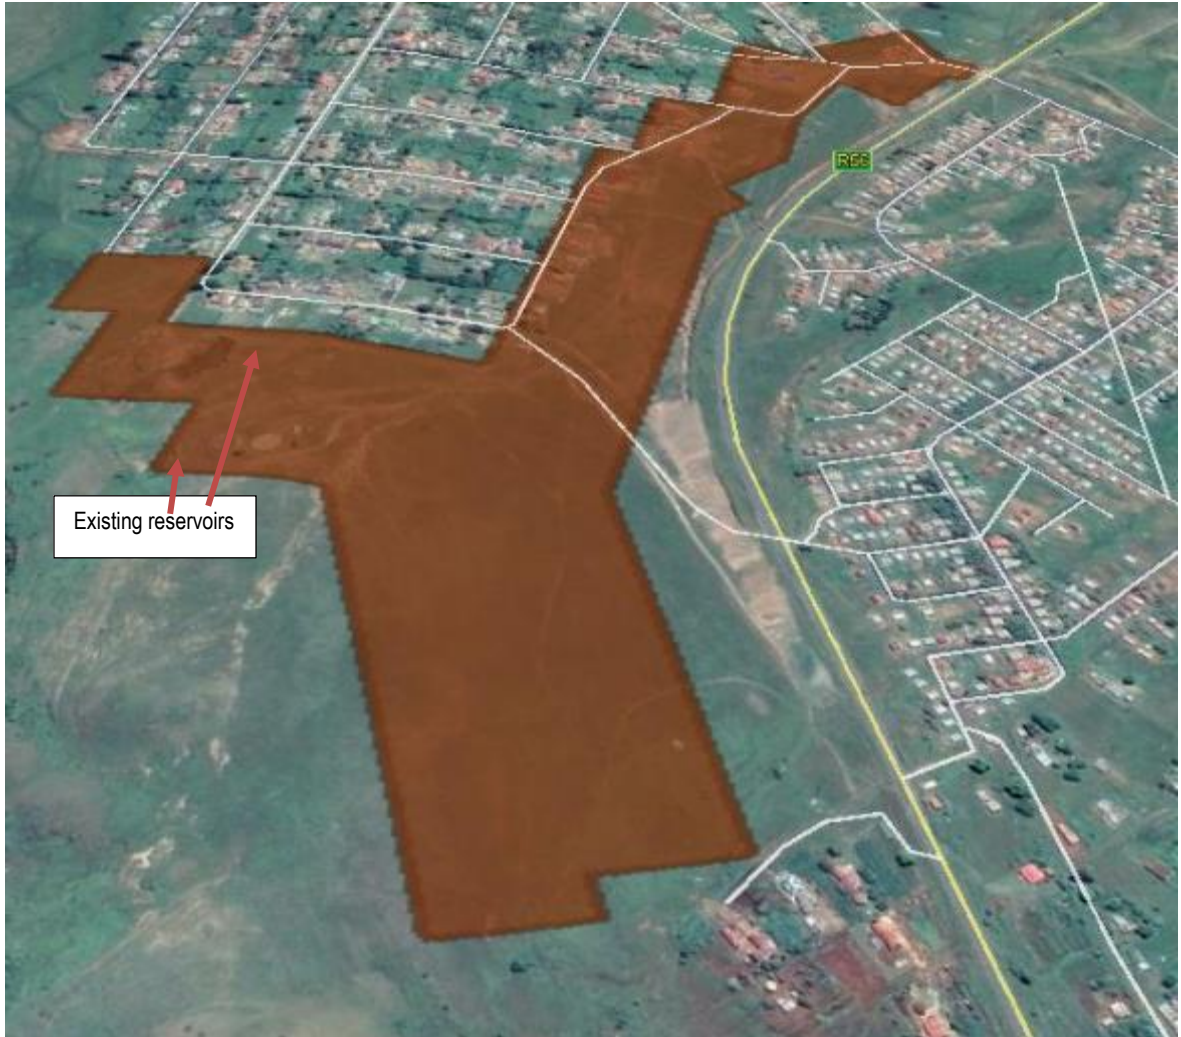
Figure 10: Southern infill site

Southern infill site (Figure 10)

This area was inspected on foot. The northern area closest to houses has existing reservoirs and associated water infrastructure on it as well as an existing borrow pit below which extensive dumping of waste and rubble is taking place. The topography is steep and erosion is taking place close to the water infrastructure (reservoirs, etc.) and below the borrow pit.

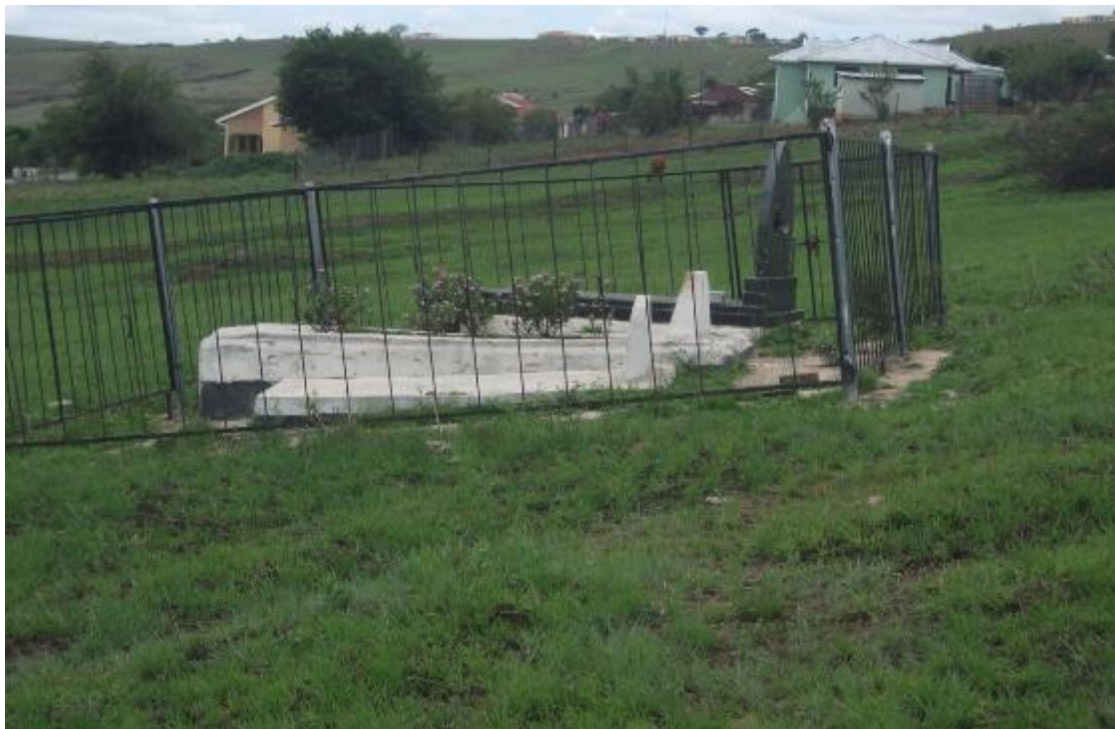
Figure 16: Fenced graves

A small family grave site is located within the proposed infill site. The graves have headstones and the site is fenced. No other heritage sites were found during the site inspection.

30°25'24.7" S 29°53'19.1" E	Stone outline of circular structure	Low heritage significance; however, remains are most probably >60 years hence protected by legislation	The complex of remains must be fenced with a buffer of 10 m between them and any construction activity
30°25'21.5" S 29°53'27.4" E	Fenced grave site	High heritage significance, graves protected by legislation	The grave site must be left <i>in situ</i> and must not be damaged during construction of the houses; family must be allowed access to the grave site at all times.

The grave site that falls within the southern infill area is protected by section 39 (1) of the above Act. This section states that no grave or burial ground older than 60 years or deemed to be of heritage significance by a heritage authority – (a) not otherwise protected by this Act or (b) not located in a formal cemetery managed or administered by a local authority may be damaged, altered, exhumed, inundated, removed from its original position or otherwise disturbed without the prior written approval of the Institute having been obtained on written application to the Institute. It is recommended that the graves are left *in situ* and clearly marked so that they are not damaged during the construction of houses. The disinterment of graves is not recommended. In addition, as recommended in **Table 1** above, access to the graves by family must be allowed at all times including during the construction of the proposed housing development.
