**INTEGRATED HERITAGE IMPACT ASSESSMENT IN TERMS OF SECTION 38(8)
OF THE NATIONAL HERITAGE RESOURCES ACT, 1999 (ACT 25 OF 1999)**

**PROPOSED DEVELOPMENT OF HUMANSRUS SOLAR PV ENERGY FACILITY 1 ON
A PORTION OF THE FARM HUMANSRUS 147/ REMAINDER, PRIESKA DISTRICT,
NORTHERN CAPE**

November 2014

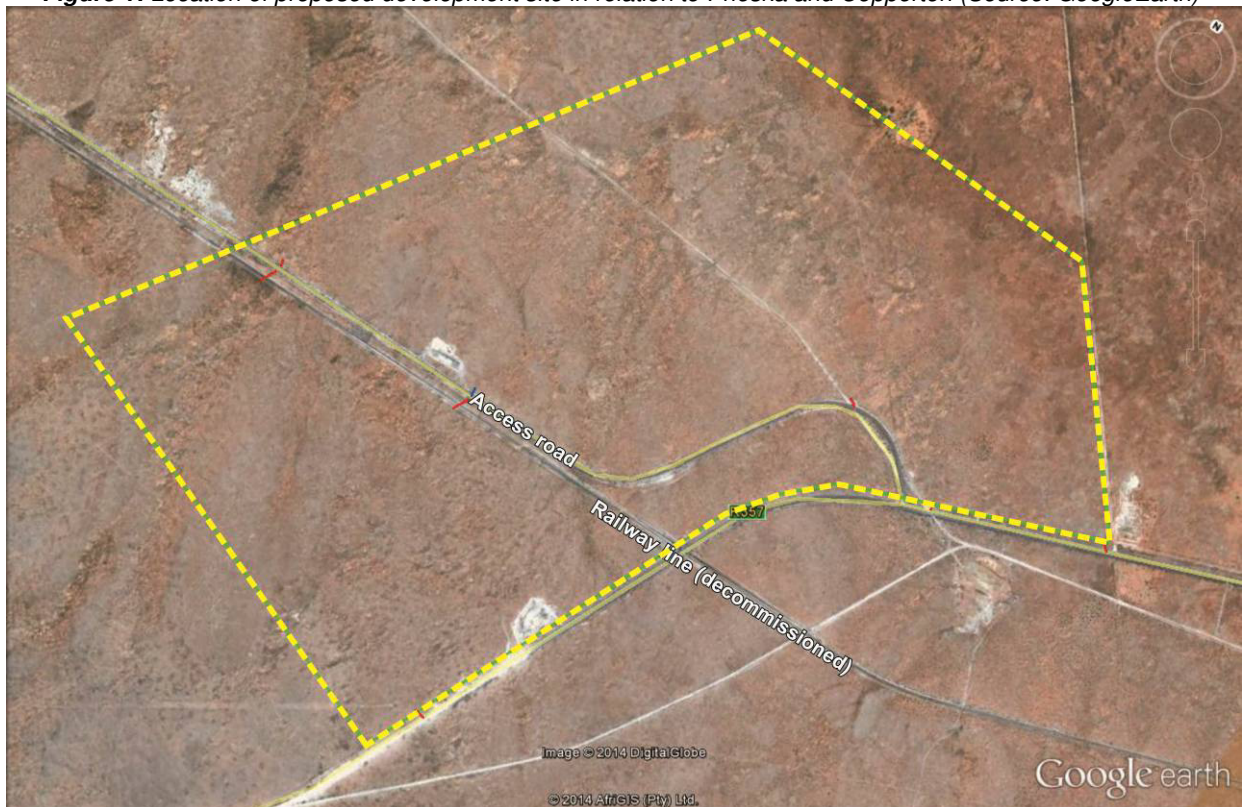
Figure 2: Proposed site boundaries transposed onto recent aerial imagery (Source: GoogleEarth)

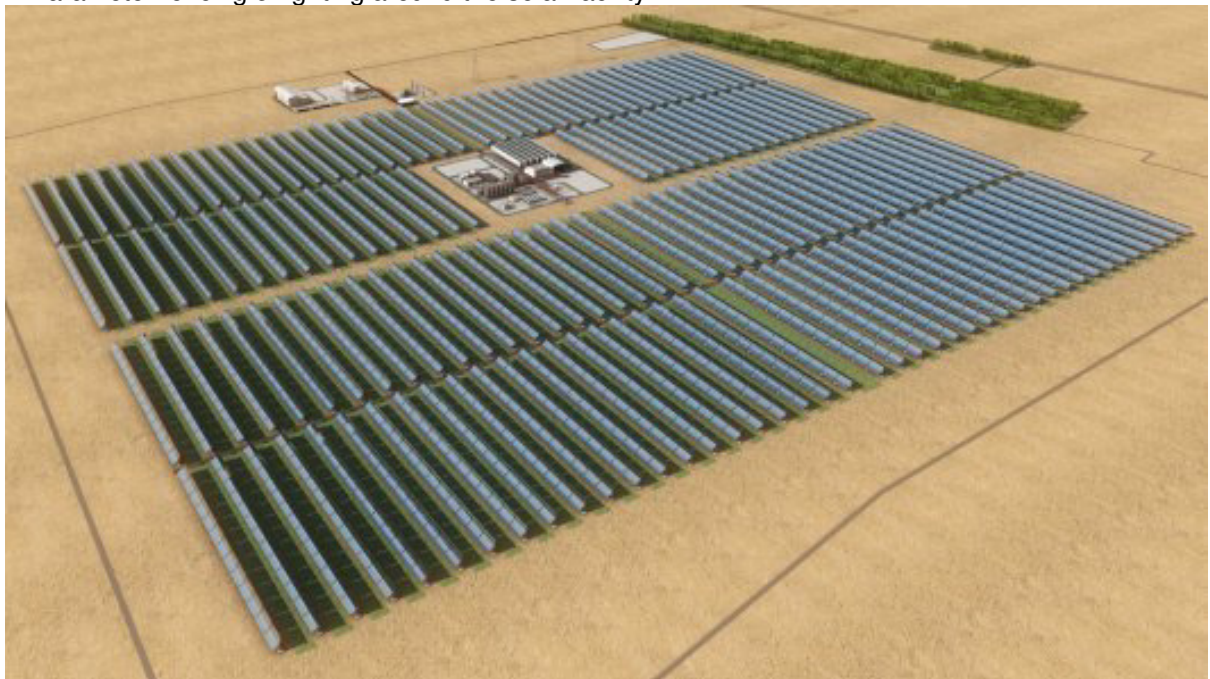
Figure 3: Typical layout of the components of a Solar PV facility (Source: CapeEAPrac, October 2014)

While the study area includes an area of 475ha, the proposed solar photovoltaic panels will not exceed an area of 200 - 275ha. The facility will have a generation capacity of 75MWAC (MegaWatts - Alternating Current) (86.25MW Direct Current). The PV technology will be either fixed-tilt PV, single-tracking/axis PV or double-tracking/axis PV. The infrastructure associated with this PV development will include the following:

- Solar field of PV modules/panel arrays with maximum structure height of ± 3.5 metres;
- Maximum of 60 x inverter stations / mini-substations (including MV distribution transformers) at a height of 3m;

- On-site Switching Station / Substation of approx. 120m x 70m in size (including a transformer to allow the generated power to be connected to Eskom's electricity grid);
