Environmental Impact Assessment for the Proposed St Helena Community Wind Farm Development, Western Cape Province

HERITAGE IMPACT ASSESSMENT

LITA WEBLEY, TIM HART & LIESBET SCHIETECATTE Archaeology Contracts Office University of Cape Town Private Bag X3 Rondebosch 7700 Tel: 021 650 2357

9 September 2011 Revised 10 February 2012

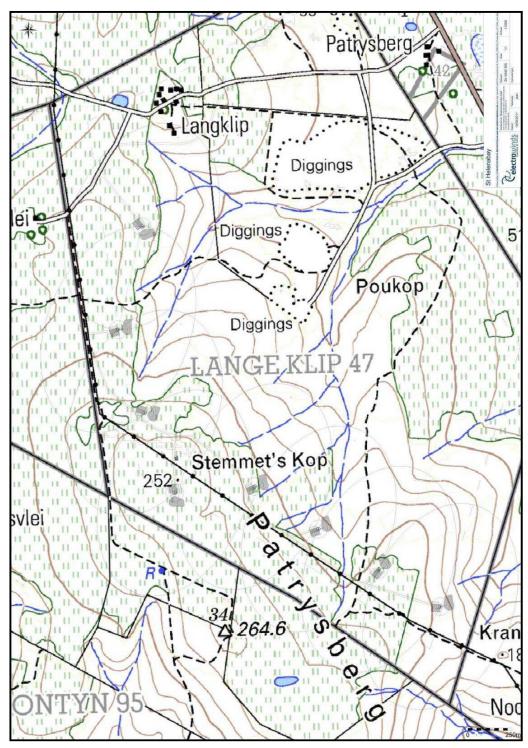
Figure 2: The location of the 8 turbines (and associated infrastructure) as well as internal access roads in light grey (Graphic supplied by client)

The Visual Impact Assessment¹ describes the turbines as being linearly located on a ridgeline towards the prevailing wind direction, with gaps ranging from 400m to almost 700m.

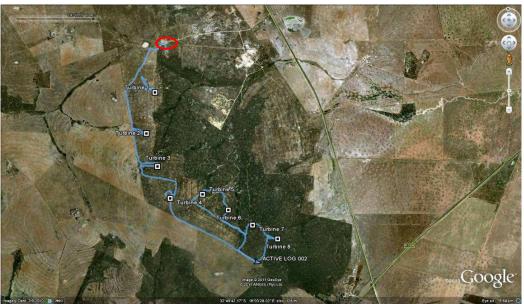
Figure 3: The locations of farm buildings at Langeklip (within the red circle), the distribution of the turbine positions and the GPS tracks recorded during the survey.

The turbine locations, access roads and underground cable positions were surveyed during the fieldwork (Figure 3).

Prior to the field survey, it was anticipated that scatters of archaeological material (possibly even shell middens) would be found around granite koppies on the top of the Patrysberg (Figure 3).

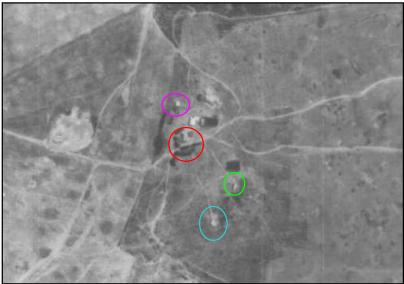
Figure 4: An extract from the 1938 aerial photograph showing the Langklip farmhouse. The circled buildings are still standing.

The house can be identified in a grove of Eucalyptus trees on the 1938 aerial photograph of the farm (Figure 4) and is circled in red. It is a single-storey, L-shaped house with modern steel windows under a pitched roof of corrugated iron. There is a verandah, but only at the front of the building and this has been enclosed. It too contains steel window frames and a modern door. There are outside steps leading up to a loft door, located on the short leg of the L-shape (Plate 6 & 9). The house is connected to a kitchen area at the back of the building by a flat-roofed link (Plate 7).

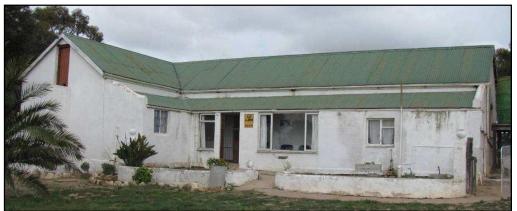
Plate 6: The original farmhouse of Langeklip which is now used as offices by the Seeland Community Trust.

The current farm complex consists of a cluster of buildings, including the main house which has been significantly modified (Plate 6). There are some modern sheds behind the house, a shed with a date of 1948 (Plate 9), a modern house occupied by the previous owner Mr J Laubscher, a number of worker's cottages (Plate 10) and one ruined stone building (Plate 11). No family or farm worker graves were recorded.

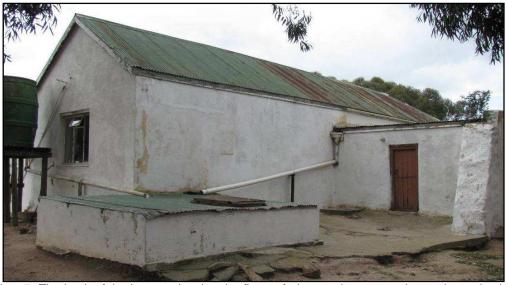
Plate 7: The back of the house, showing the flat-roofed extension connecting to the projecting oven and chimney. Note the buttressing at the back of the house, supporting the chimney.

There are no windows at the back of the house (Plate 7), and the flat-roofed extension has a modern "Bo-en-onder" door but no windows. The projecting hearth and chimney stack at the back of the house is called an "abba vuurherd"²⁸, the southern wall of the vaulted oven contains a small window which provides a little light to the top of the wood burning stove or open hearth.

There is a square, brick-lined reservoir at the back of the house which collects the rainwater from the gutters (Plate 7).

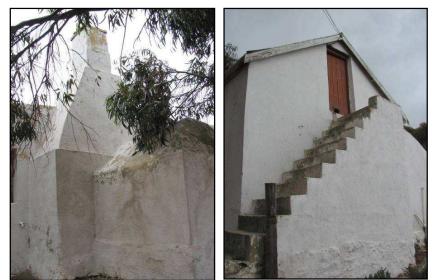
Plate 8: Bakoond at the back of the house. Plate 9: Outside steps leading to the loft door.

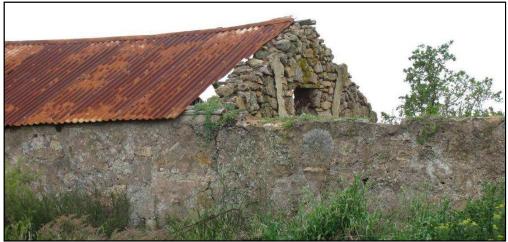
Plate 12: Ruined stone building.

A long, rectangular stone building is located in close proximity to the three worker's cottages. The age and function of the stone building is unclear but it is shown in the 1938 aerial photograph of the farm complex and is circled in green in Figure 4. The structure is walls of rubble plastered with clay and whitewashed. It is a long, narrow structure, divided into two rooms, with a "chimney" added at one end. The core of the building may originally have consisted of only one room, with the southern room added at a later date. There are wooden window frames and a wooden lintel above the interior door. No historical archaeological material was recorded around the building. The main entrance is situated in the east facing façade.

There are two anomalies which suggest a more recent date for the ruin. The chimney is pulling away from the wall, suggesting it may have been added at a later date. Cemented into the chimney is a modern, screw top bottle, which suggests a late 20th century date. There is also a recent concrete floor in the one room. It is possible that this building may have been a shed which was later converted into a dwelling.

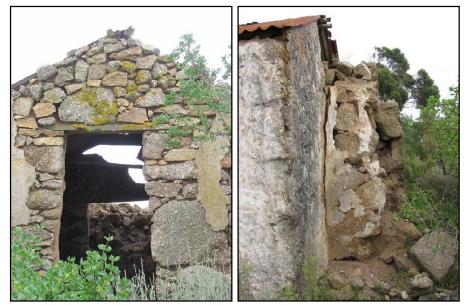
Plate 13: The interior rooms in the stone building. Plate 14: The "bakoond" appears to have been added at the end of the building.

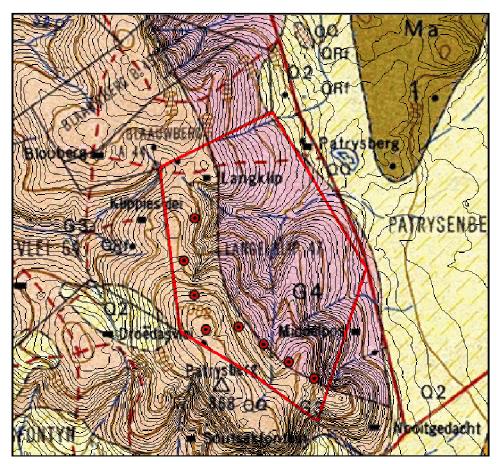
Figure 2. Geology of the study area. From Visser & Schoch (1972). Contours at 5 m intervals added.

The project area is situated on the slopes and crest of an elevated ridge, the Patrysberg. The provisional positions of the wind turbines are near or on the crest of the ridge, at elevations ranging between ~170 to ~250 m asl. The main information for the area is Visser & Schoch (1972, 1973) and the accompanying geological map, the relevant part of which is reproduced as Figure 2.

The entire property is underlain by granite rocks of the Vredenburg Batholith. These are labelled G3 (Saldanha Granite) and G4 (Cape Columbine Granite) (Figure 2). Subsequently, the granites have been re-examined and renamed. The G3 granite is now called the Vredenburg Granite while the G4 granite is comprised of the Patrysberg Biotite Granite and the Slippers Bay Granite (Siegfried, 2006). Diggings on the flanks of the drainage in the northern portion of the area (Figures 1 & 3) relate to quarrying of kaolin clay formed by the deep weathering of the granites.

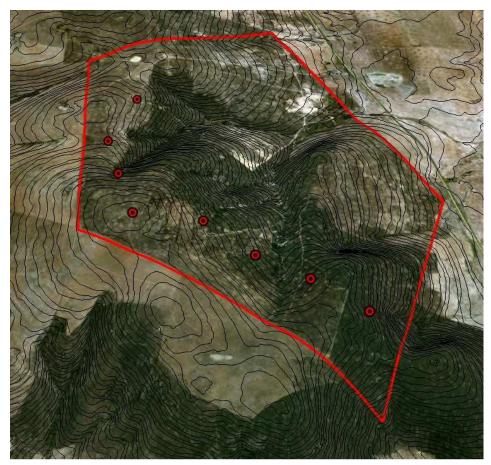
Figure 3. Simulated oblique view of the project area, looking north. From Google Earth.

The soil cover is generally thin and numerous outcrops of the granite bedrock can be seen in aerial images (Figure 3). The less steep parts of the property have been cultivated. The dot-patterned nature of the soil cover is evident (Figure 3) and is typical of "heuweltjiesveld", the low hillocks being termitaria. The "heuweltjiesveld" is an old soil cover depicted as Q2 on the geological map (Figure 2), but it is only mapped where thicker and for mapping purposes is ignored where thinly developed on bedrock.
