**HERITAGE SURVEY OF THE UPGRADING OF THE  
D2286, P372, L1190, P148, L1333, L1351, D897,  
AND D30**

**FOR AFZELIA ENVIRONMENTAL CONSULTANTS**

**DATE: 7 NOVEMBER 2022**

**Umlando: Archaeological Surveys and Heritage  
Management**

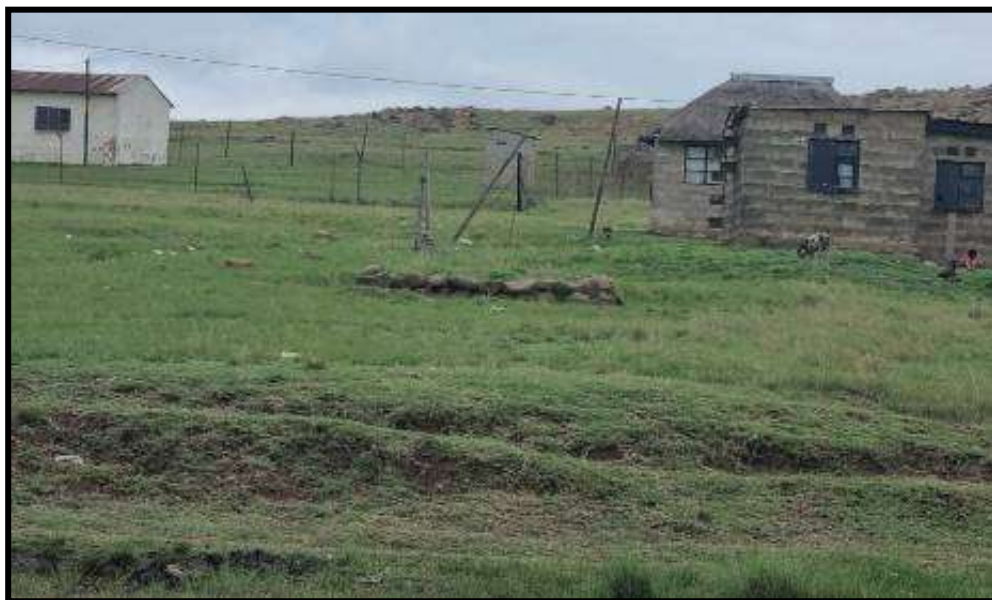
**FIG. 9: GRAVE 1**

Grave 1 consists of a stone cairn ~15m east from the edge of the road (fig. 9).

**Mitigation:** The grave needs to be clearly demarcated before construction begins along this section of the road. At least 10m buffer needs to occur between the grave and any roadworks.

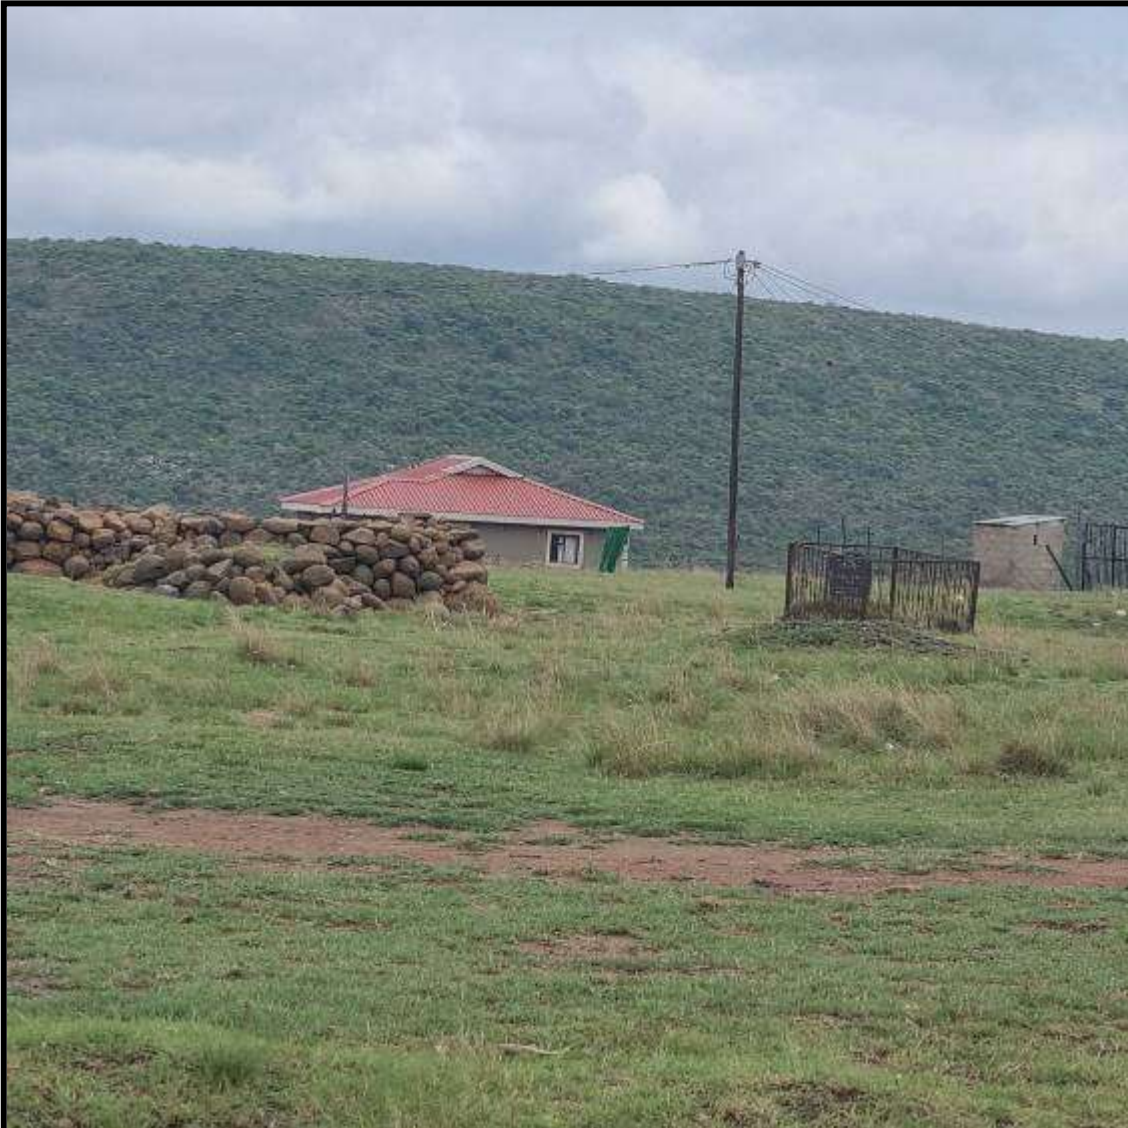
**FIG. 10: GRAVE 2**

Grave 2 consists of two graves: a stone cairn and a tombstone. These are ~15m southeast from the edge of the road (fig. 10). The graves occur between a stone walled kraal and the road.

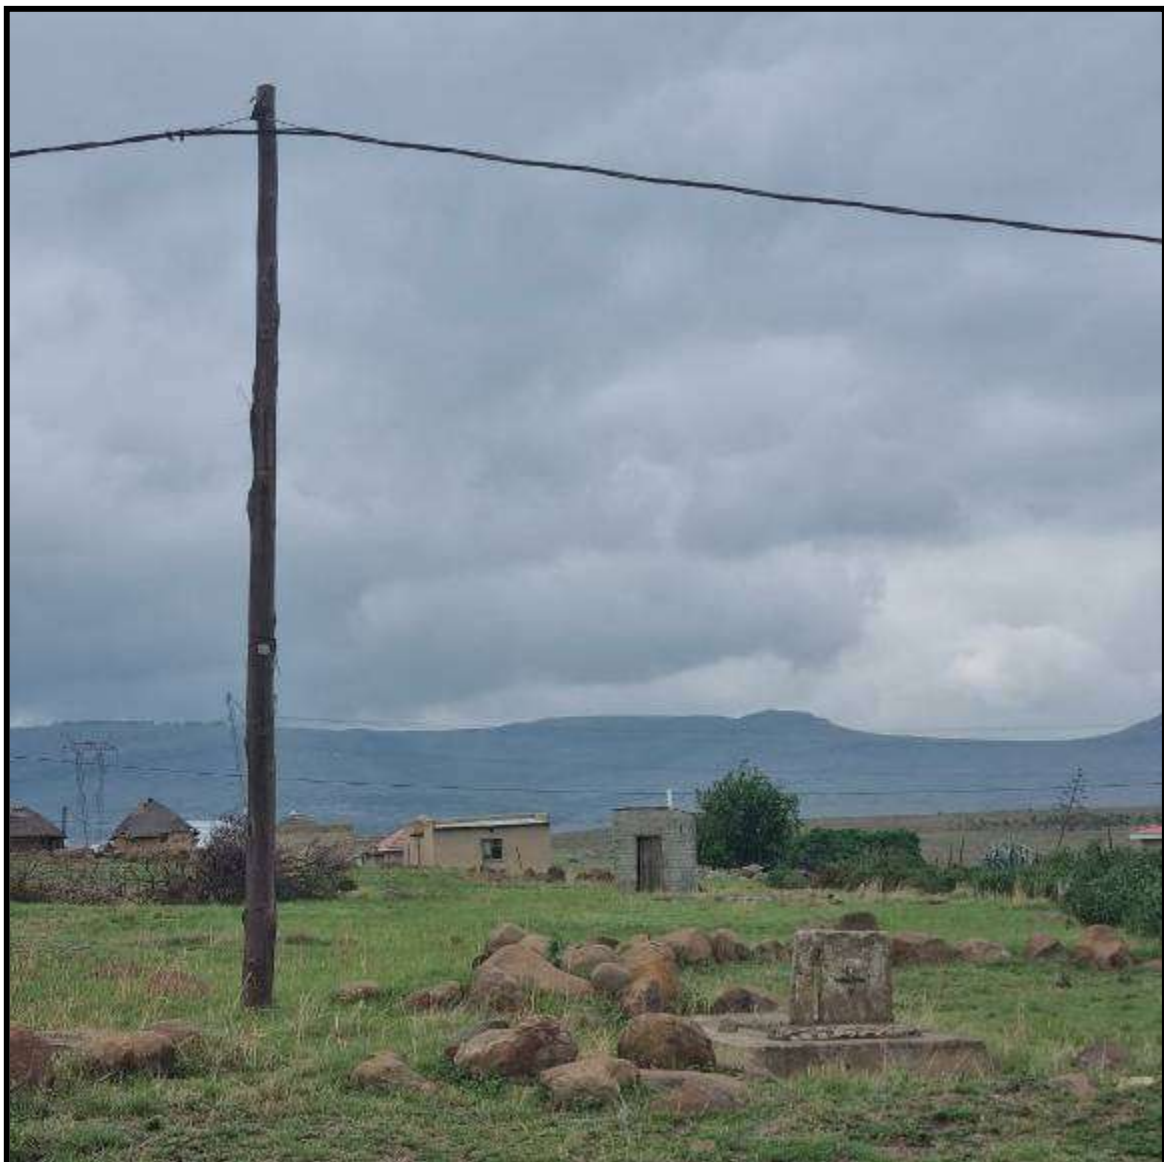
**FIG. 11: GRAVE 3**

Grave 3 consists of a single grave with a cement covering and headstone. Grave 3 is ~15m southeast from the edge of the road (fig. 11).

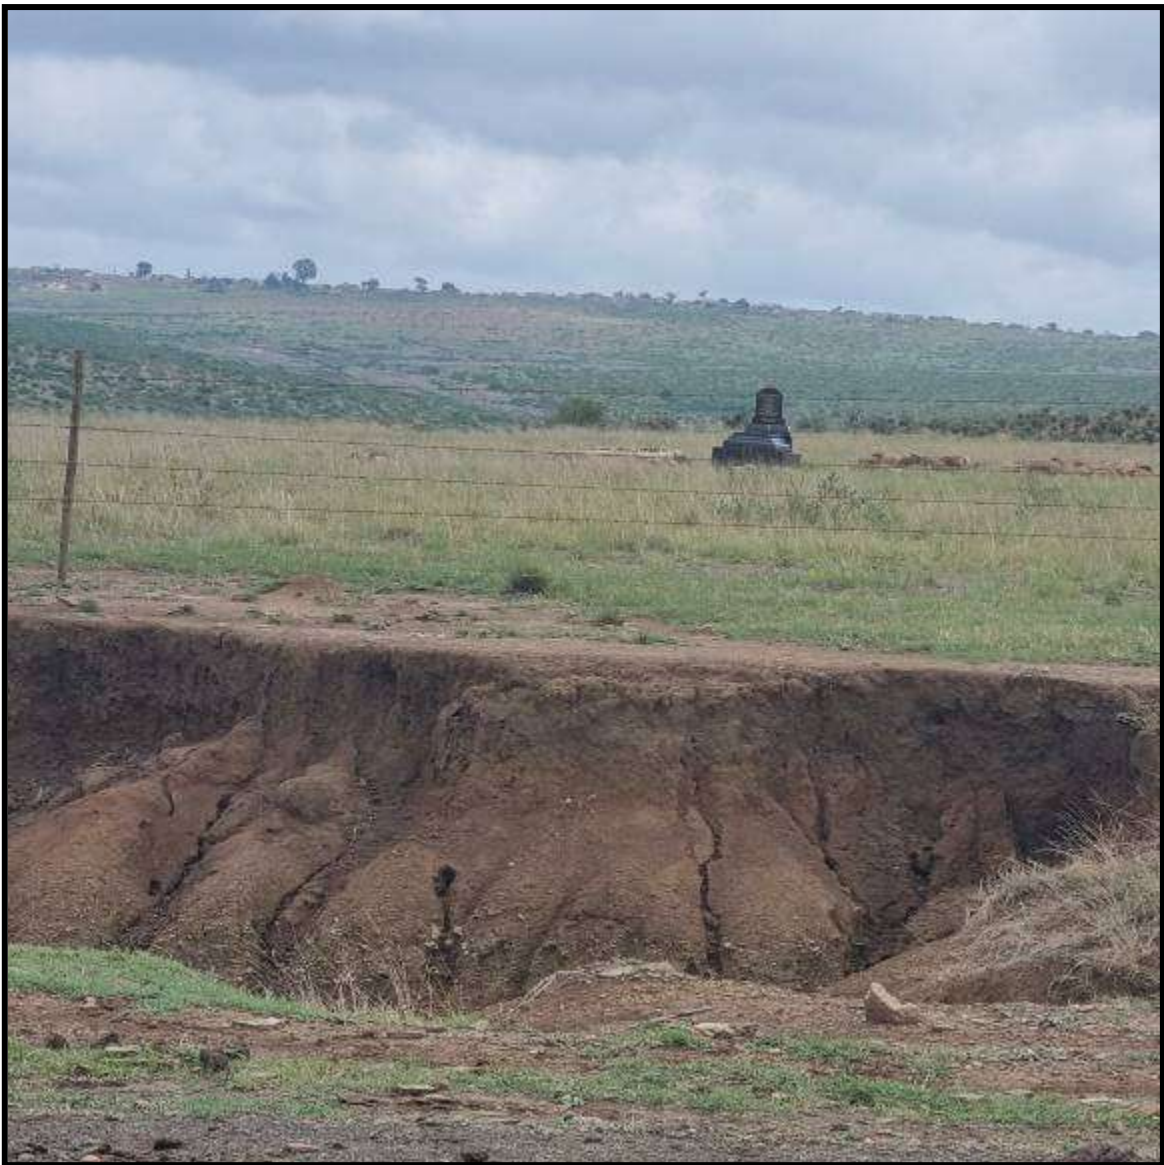
**FIG. 12: GRAVE 4**

Grave 4 consists of three stone cairns and one tombstone. They occur behind a fence and ~30m east from the edge of the road (fig. 12).

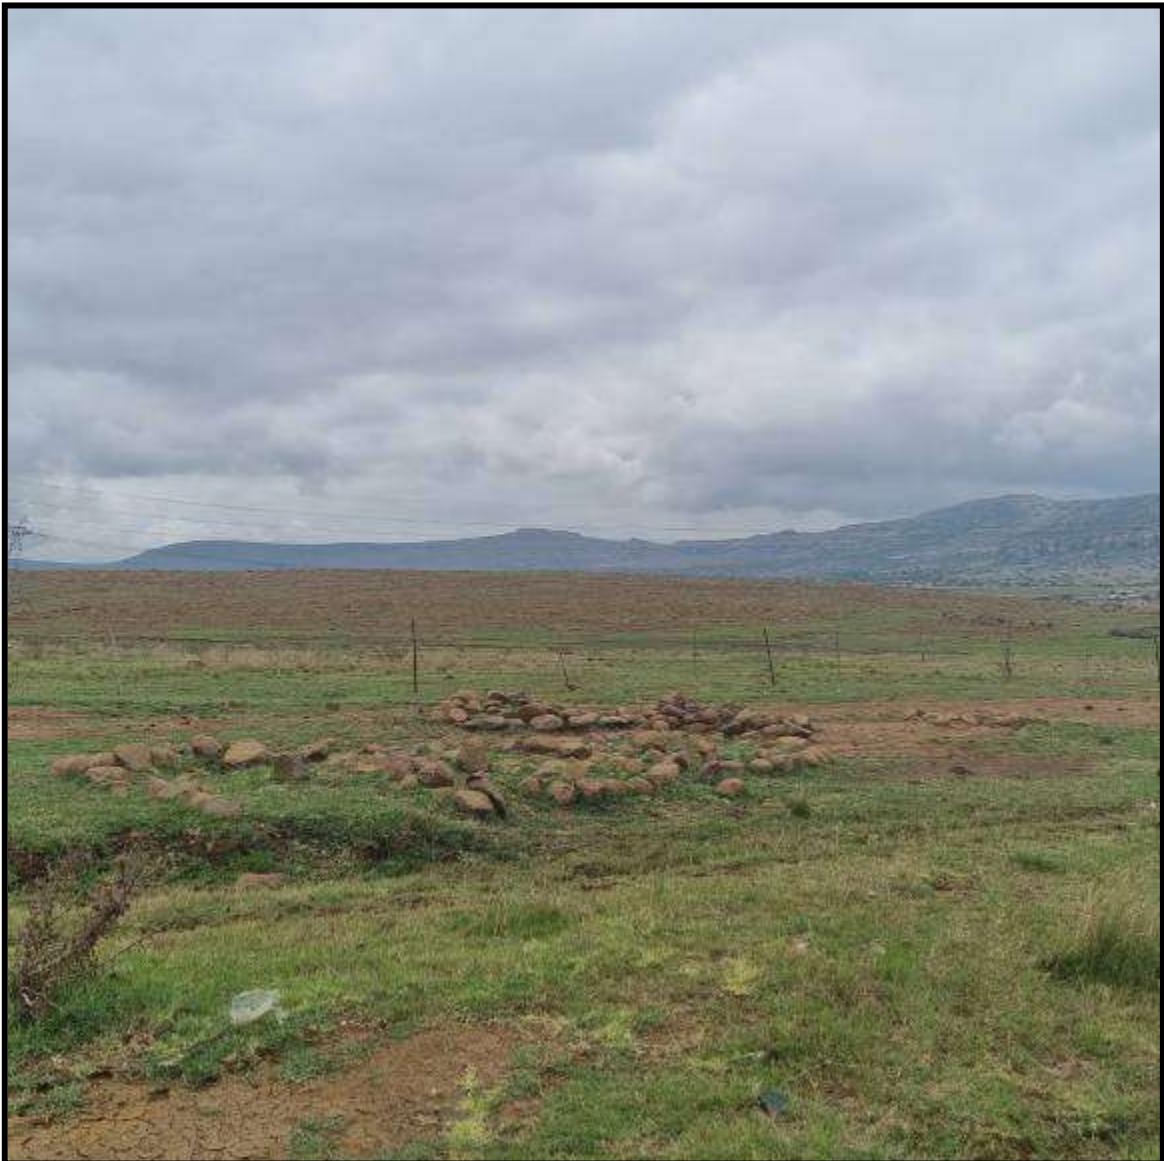
**FIG. 13: CEMETERY 9**

Cemetery 9 (recorded as Grave 5 during the survey) consists of a seven stone cairns ~15m – 20m east from the edge of the road (fig. 13). Two stone cairns are slightly separated from the main group.

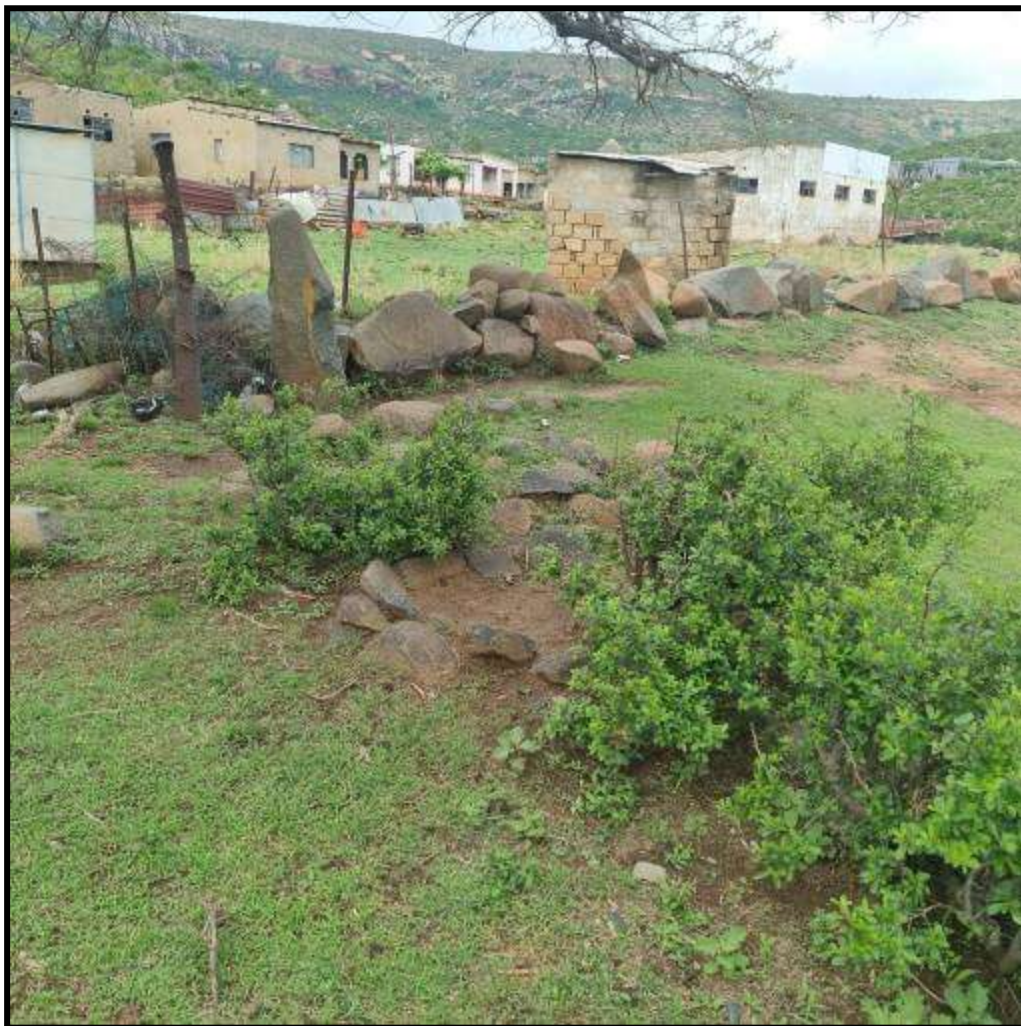
**FIG. 15: GRAVE 6**

Grave 6 consists of a three stone cairns within a stone walled feature (fig. 15). The cairns are graves and are ~3m east from the edge of the road.

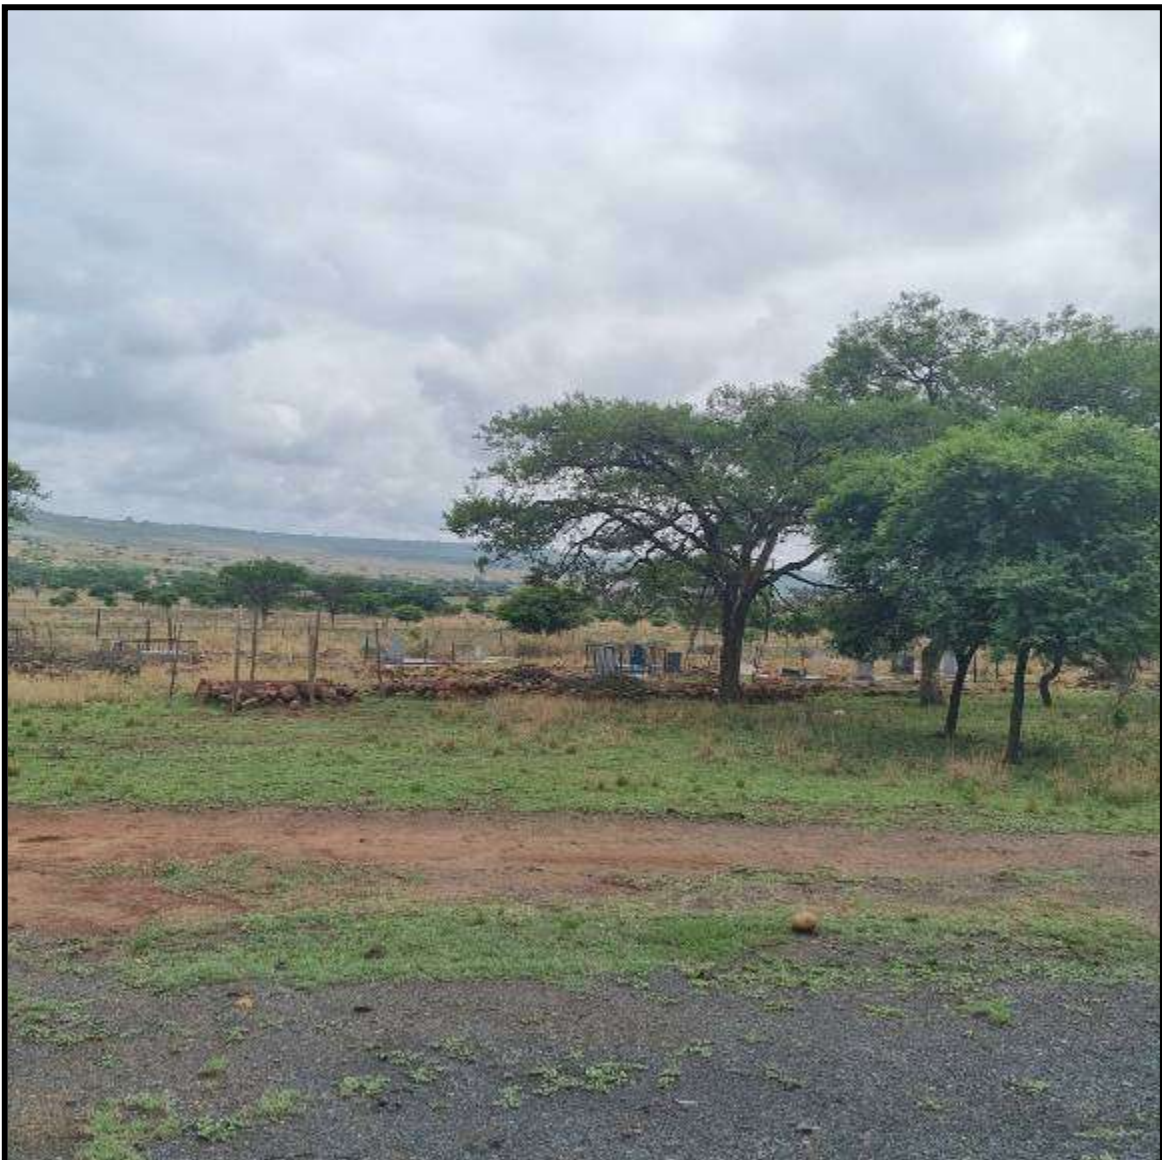
**FIG. 16: CEMETERY 1**

Cemetery 1 occurs ~20m north from the edge of the road (fig. 16). The cemetery is not demarcated with a fence.

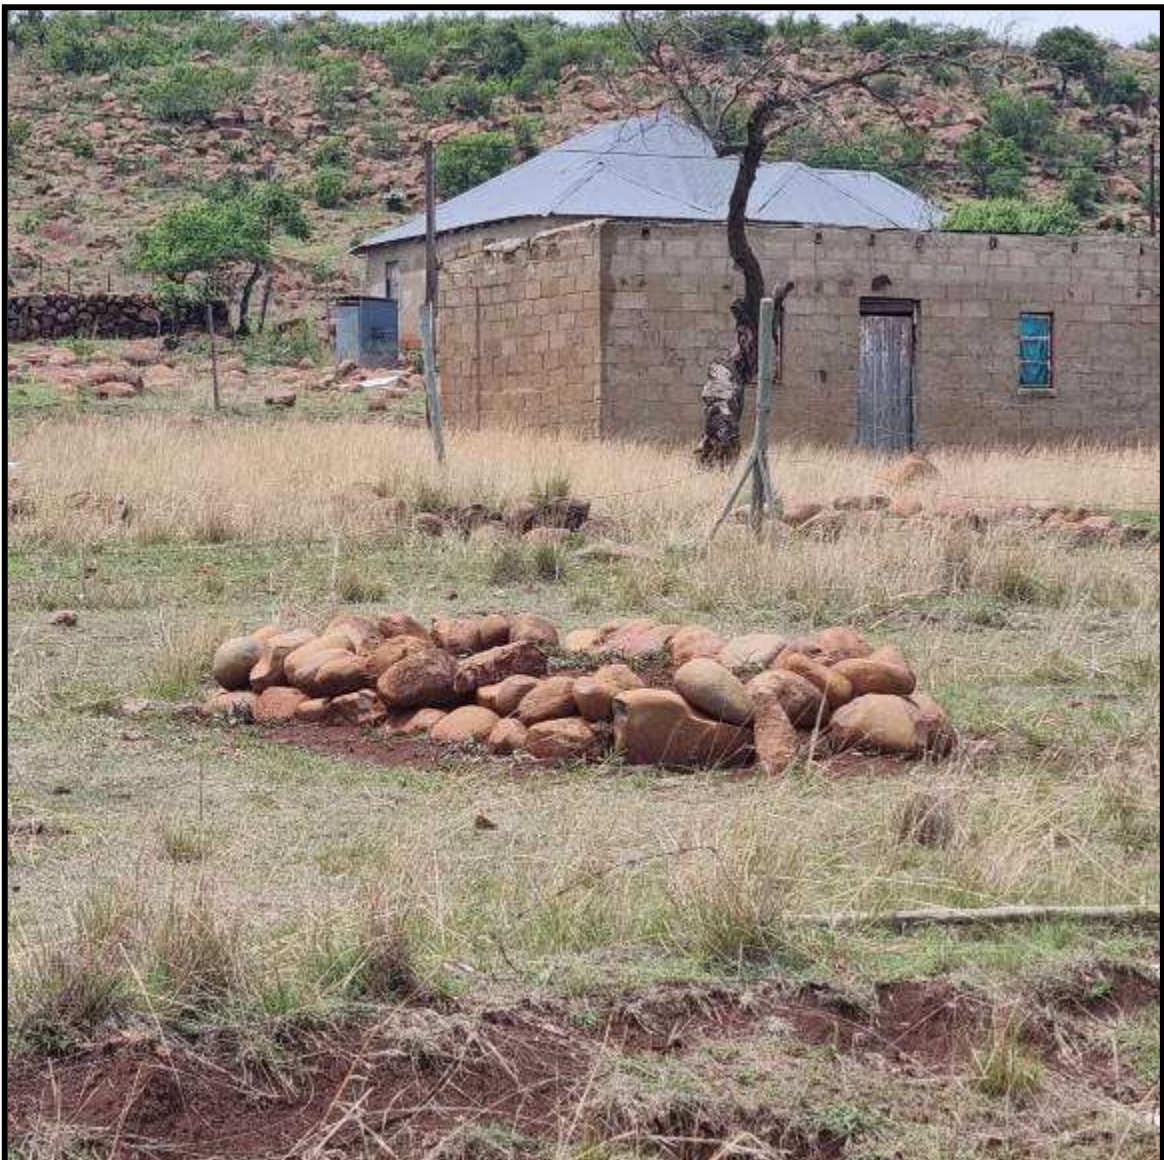
**FIG. 17: GRAVE**

Grave 10 consists of a stone cairn ~13m east from the edge of the road (fig. 17). The grave is not demarcated.

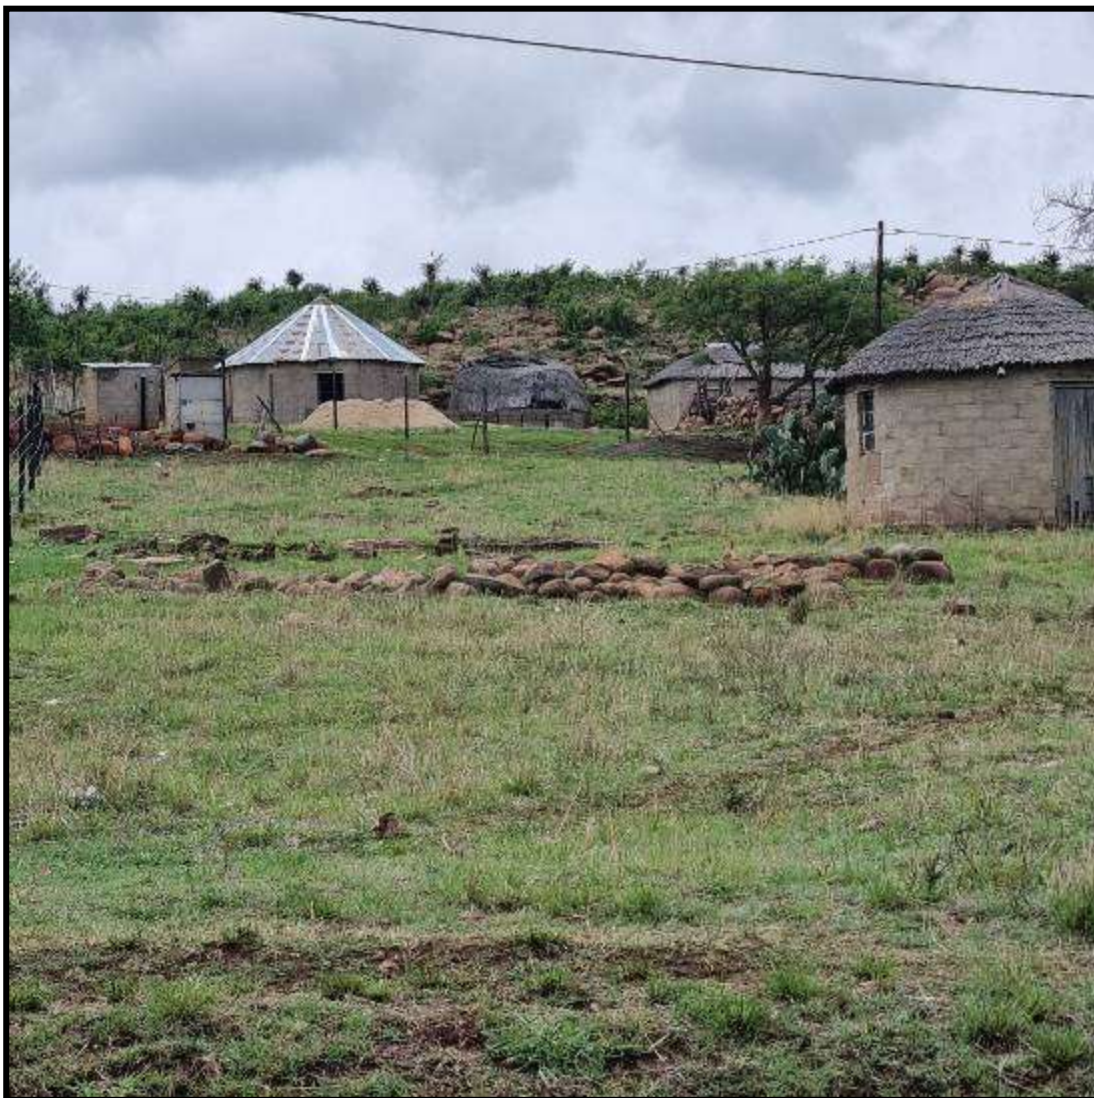
**FIG. 21: GRAVE 14**

Grave 14 consists of 10 graves as stone cairns (fig. 21). Some graves have headstones. It is technically a cemetery, according to my definition; however the graves are directly associated with the house. The graves are not fenced off and occur ~10m from the edge of the road.

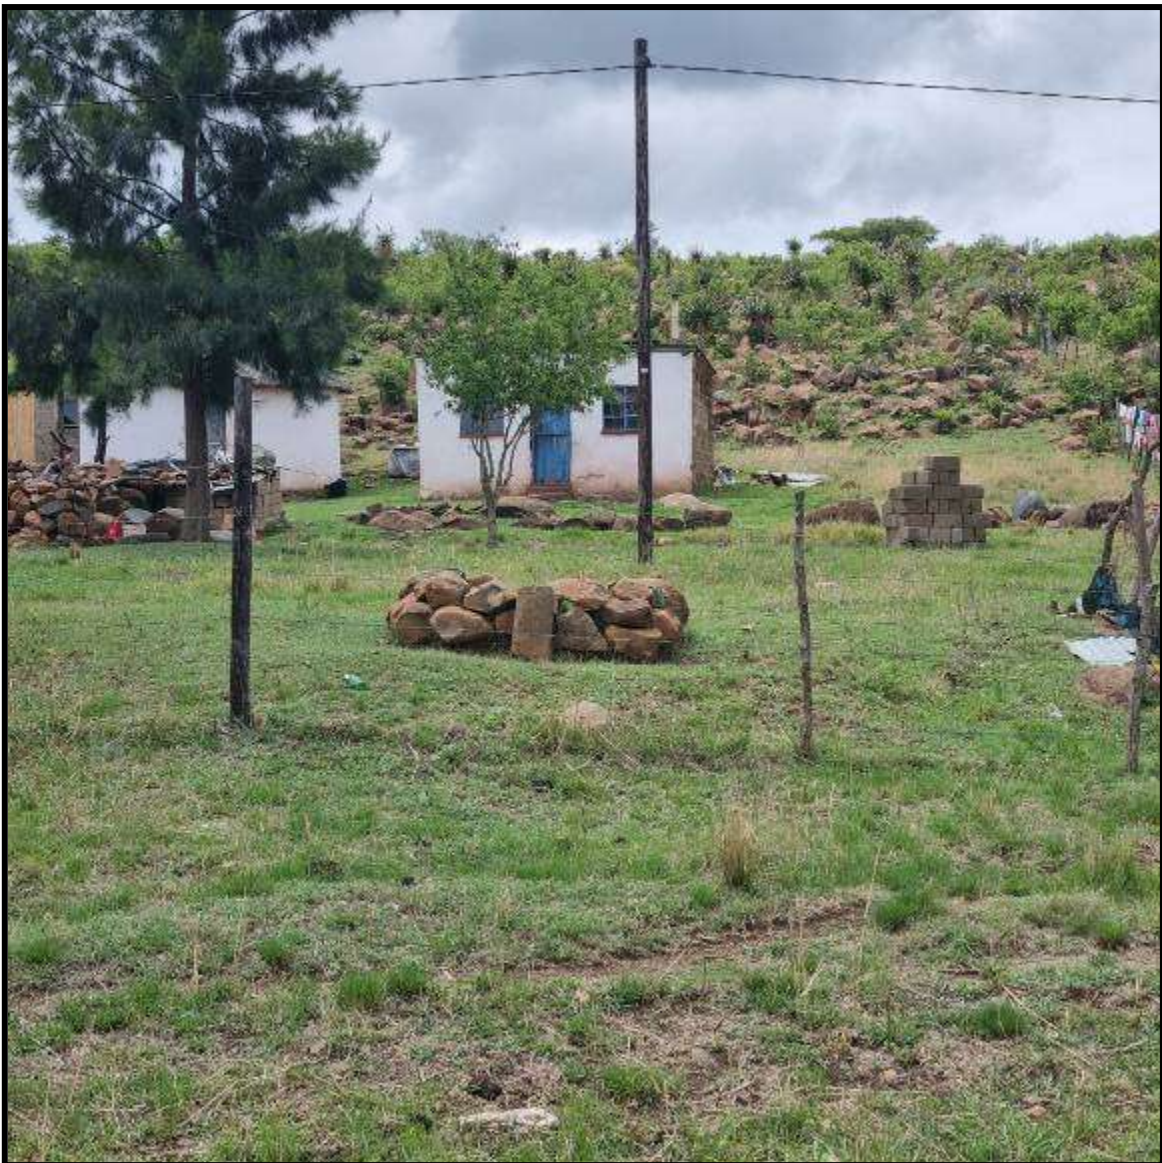
**FIG. 22: GRAVE 15**

Grave 15 consists of a single stone cairn with a headstone. The grave is ~10m northeast from the edge of the road (fig. 22). The grave is in a fenced off area and thus already demarcated.

**Mitigation:** The grave requires no further mitigation.

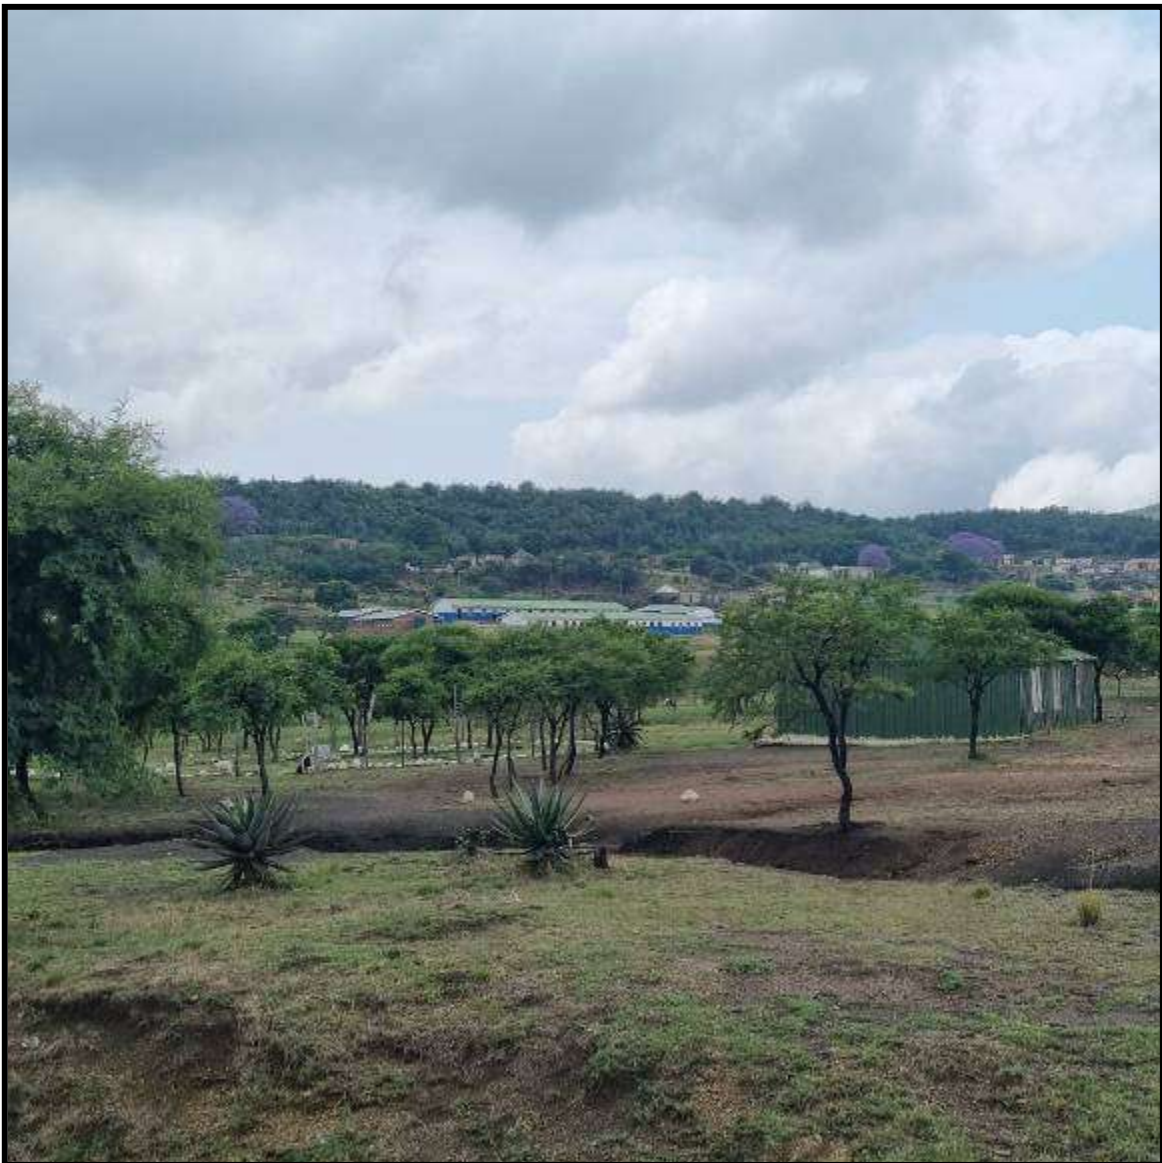
**FIG. 24: SHEMBE TEMPLE**

Shembe 2 consists of a Shembe Temple and church. These occur ~40m north from the edge of the road (fig. 24).

**Mitigation:** No further mitigation is required.

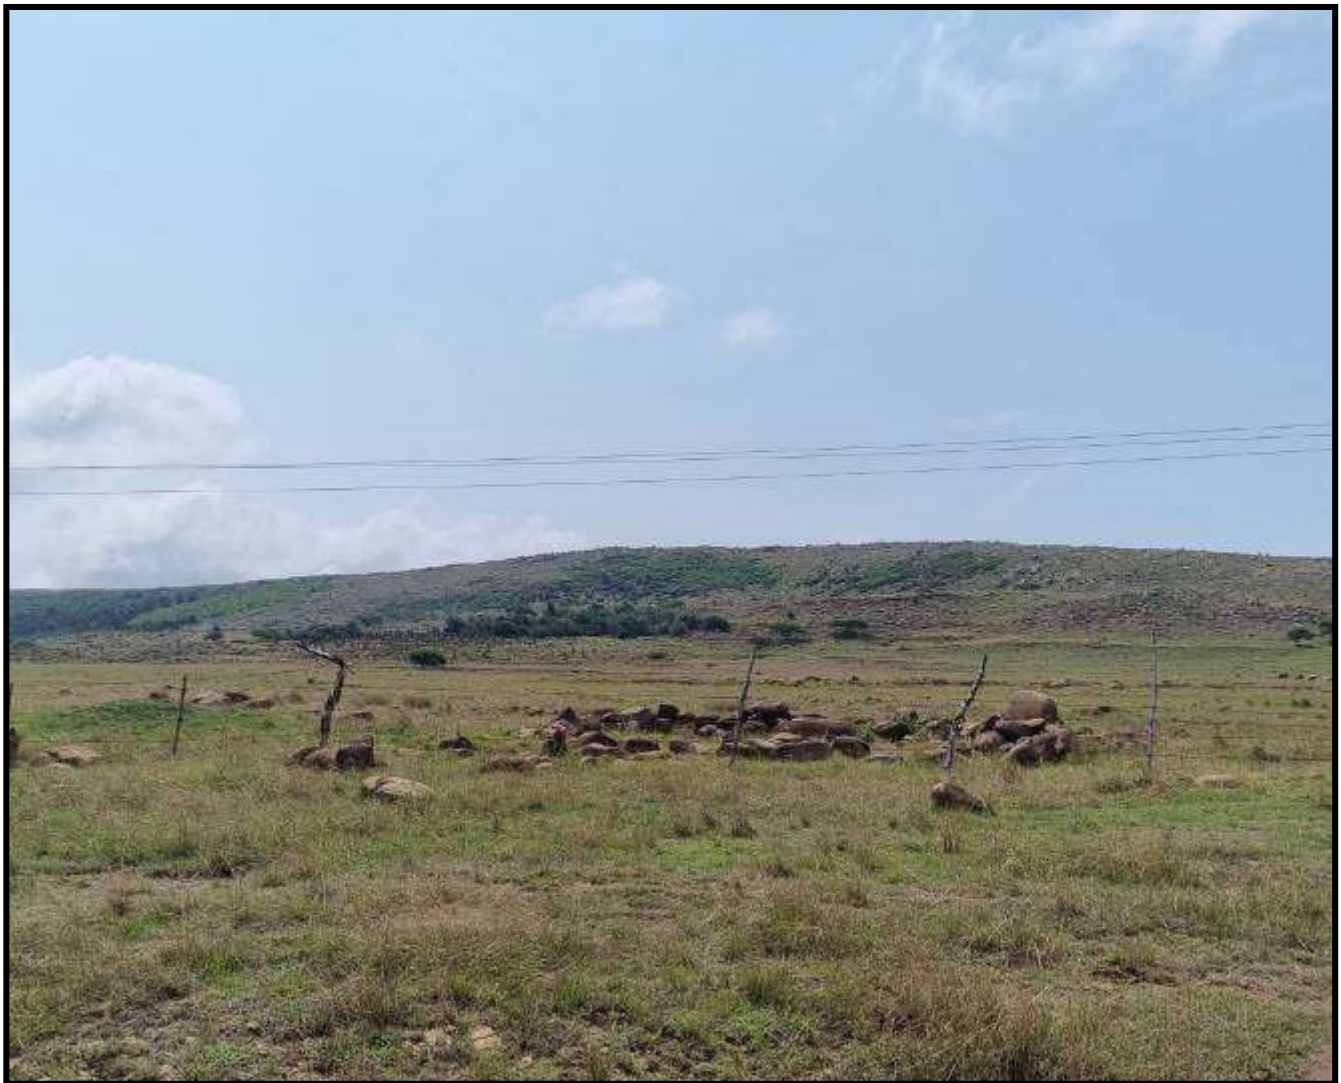
**FIG. 25: KRAAL 1**

Kraal 1 is a stone walled cattle byre or kraal) ~17m c 10m in size. The stone walling occurs ~15m north from the edge of the road and behind a fence (fig. 25).

**Mitigation:** No further mitigation is required.

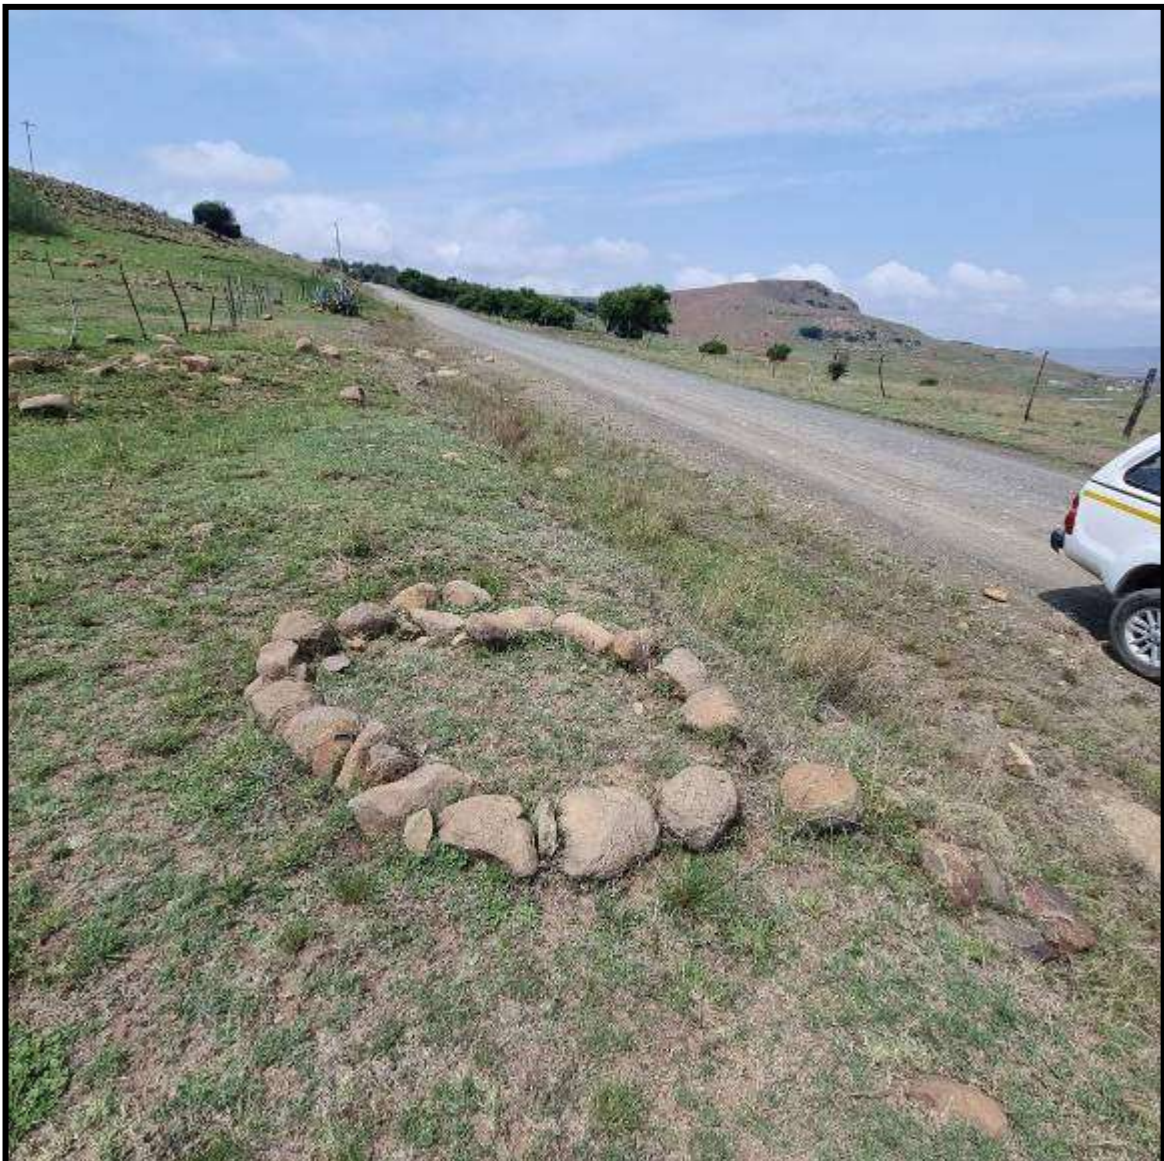
**FIG. 26: GRAVE 22**

Grave 22 consists of a single stone cairn on a raised area on the edge of the road. There are broken stone walled features near the grave and behind the fence. The grave is ~2m from the edge of the road (fig. 26).

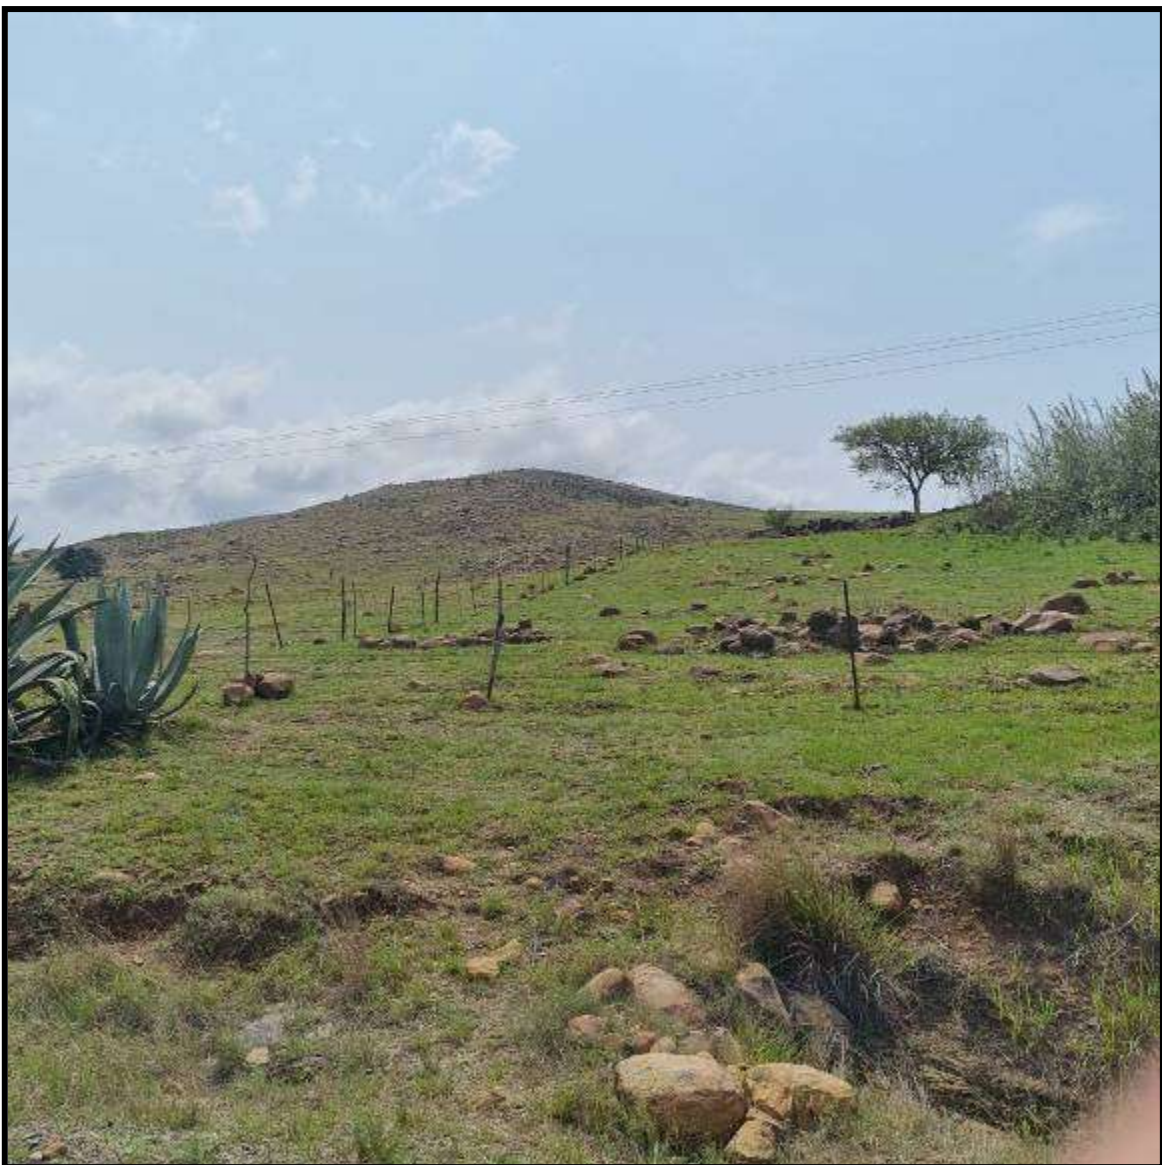
**FIG. 27: GRAVE 21**

Grave 23 consists two or three stone cairns ~15m northwest from the edge of the road (fig. 27). The grave is in a fenced off area and thus already demarcated. There are the foundations of houses further uphill from the graves.

**Mitigation:** The grave requires no further mitigation.

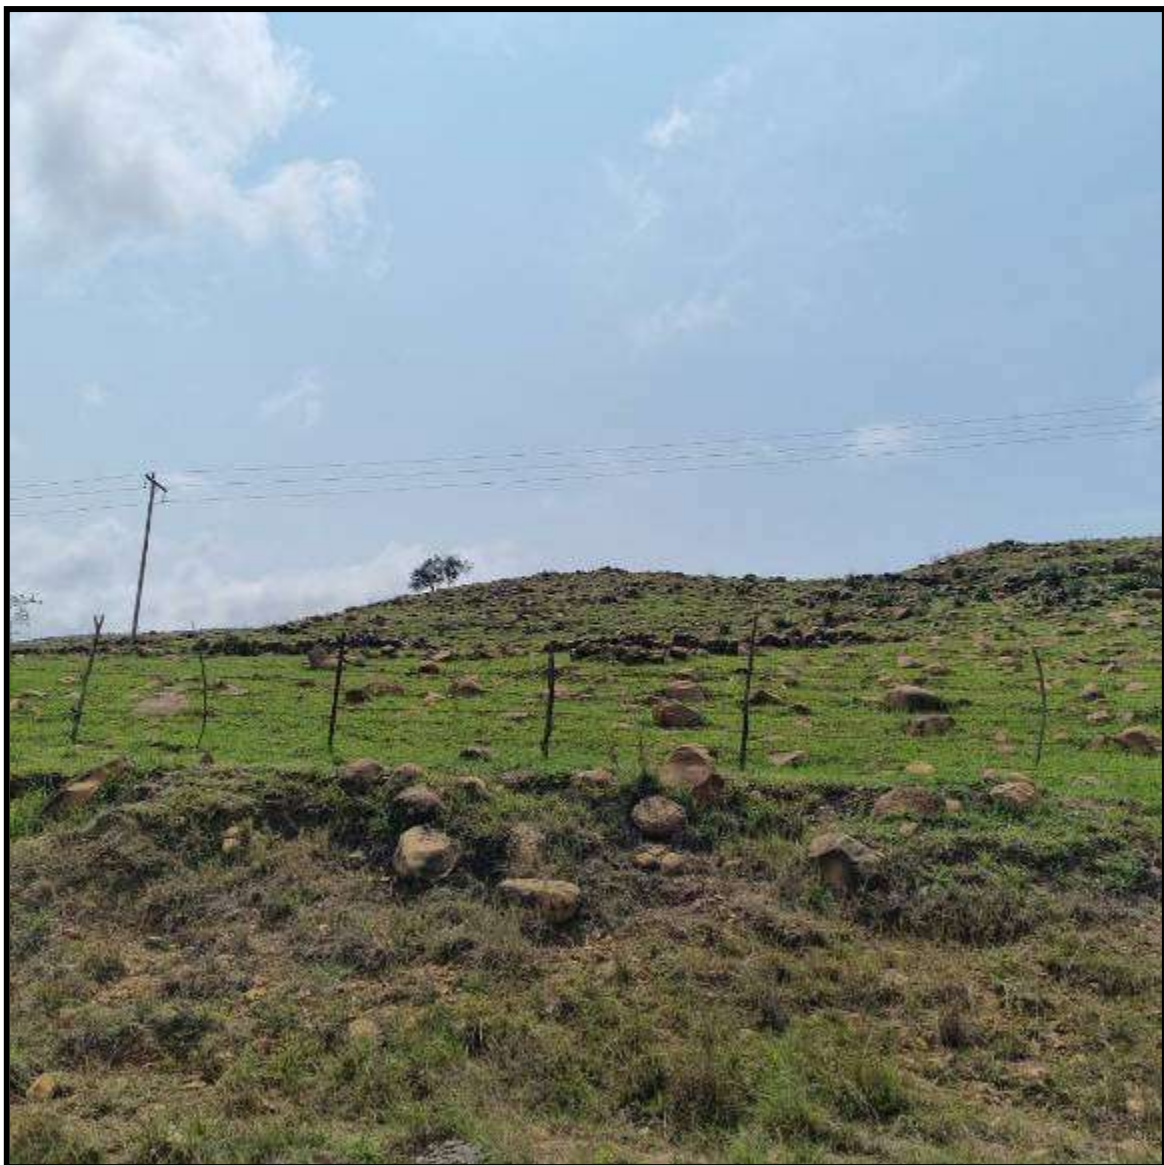
**FIG. 28: CEMETERY**

Cemetery 3 consists of ten+ graves at the base of the hill. The graves are all stone cairns. The cemetery occurs ~13m from the edge of the road (fig. 28).

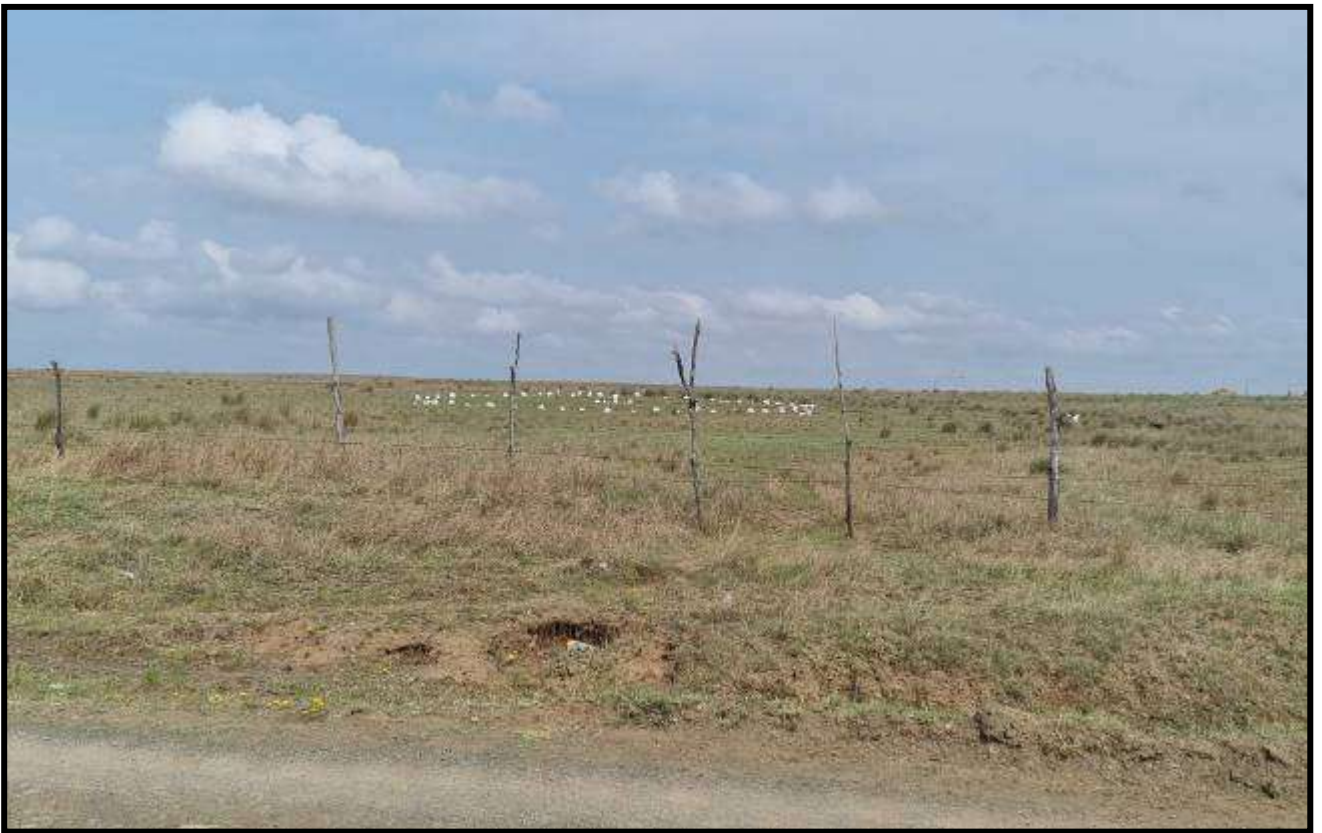
**FIG. 29: SHEMBE TEMPLE 3**

The site consists of a Shembe Temple behind a fence. The temple occurs ~40m from the edge of the road (fig. 29).

**Mitigation:** The site will not be affected..

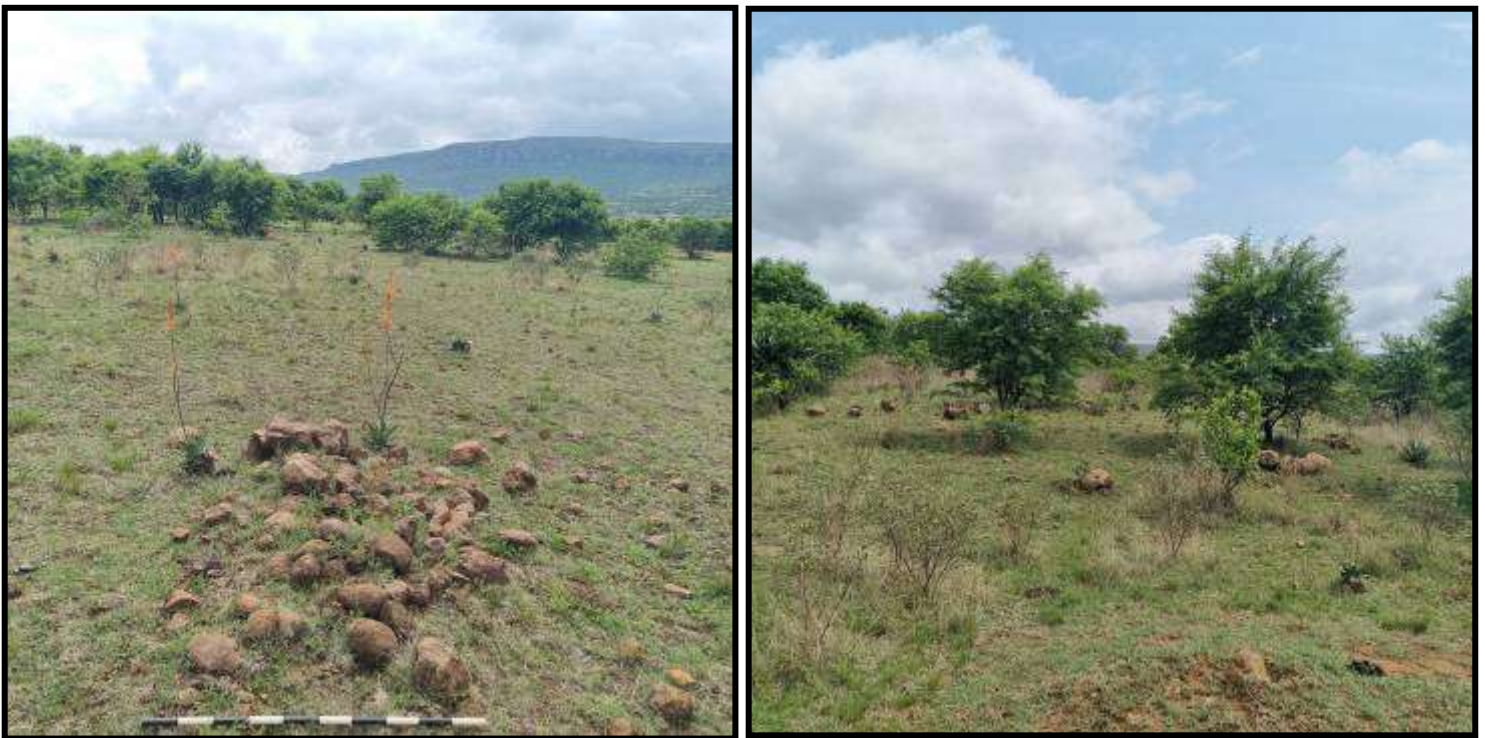
**FIG. 30: GRAVE 7 AND STONE WALLED FOUNDATIONS**

Grave 7 consists of several stone walled foundations and a single grave (fig. 30). The grave is a stone cairn. The site covers an area of ~200m c 90m in size consists of several house floors. The grave is ~305m from the edge of the road. The built features do not occur on the historical maps and could predate them.

**Mitigation:** The grave needs to be clearly demarcated before construction begins along this section of the road. At least 10m buffer needs to occur between the grave and any roadworks. The road upgrade is unlikely to affect any of the stone walled foundations, as they are also ~30m from the road.
