**HERITAGE SURVEY OF THE UPGRADING OF THE  
D2286, P372, L1190, P148, L1333, L1351, D897,  
AND D30**

**FOR AFZELIA ENVIRONMENTAL CONSULTANTS**

**DATE: 7 NOVEMBER 2022**

**Umlando: Archaeological Surveys and Heritage  
Management**

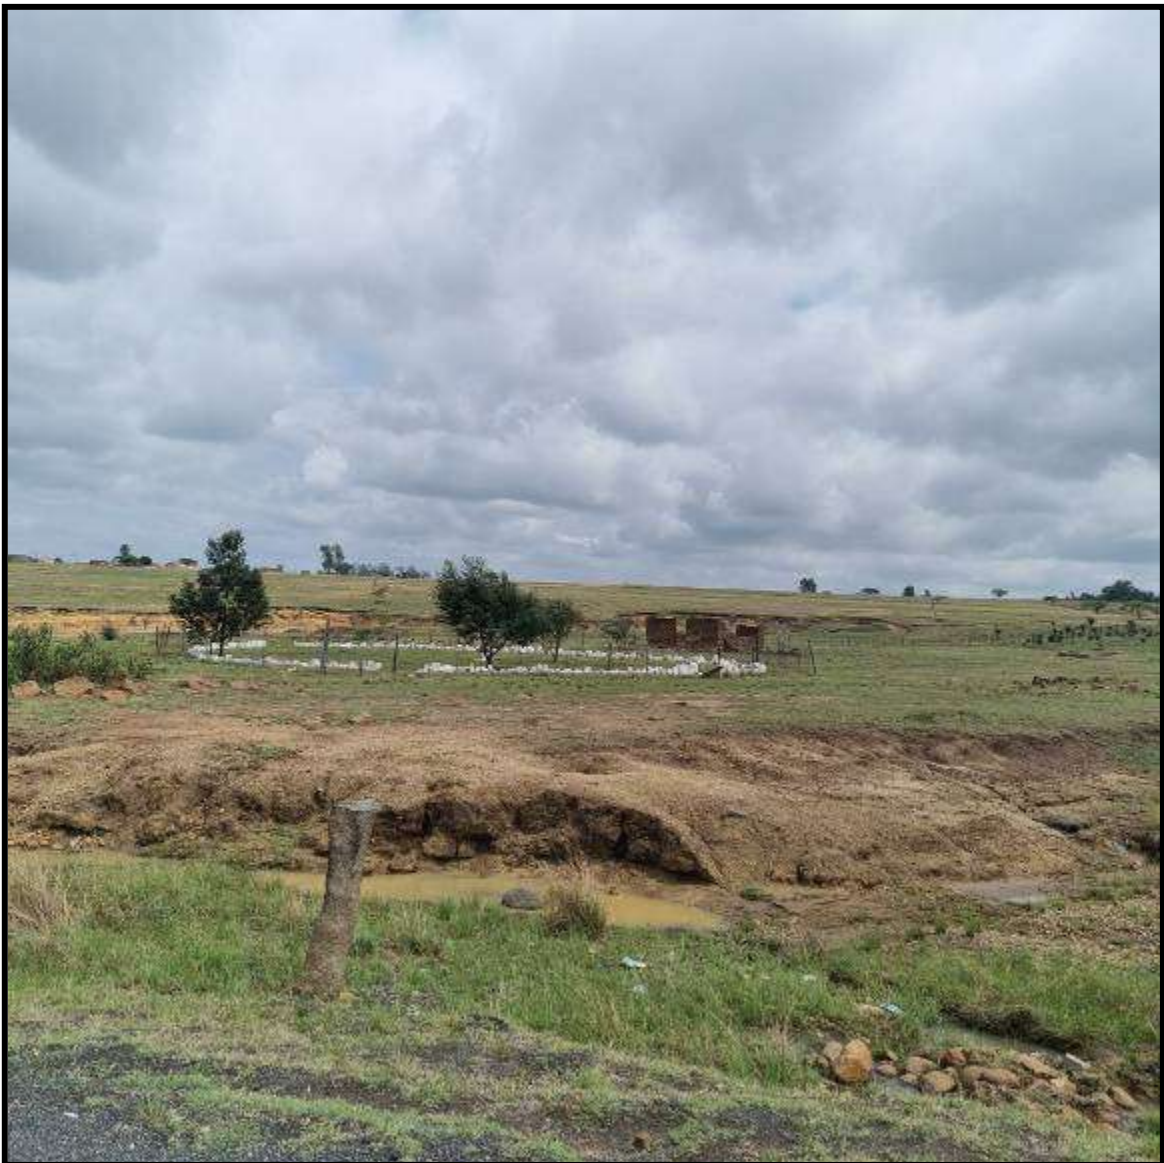
**FIG. 32: SHEMBE TEMPLE 2**

The Shembe Temple occurs ~30m northwest from the edge of the road (fig. 32). It will not be affected.

**Mitigation:** No further mitigation is required

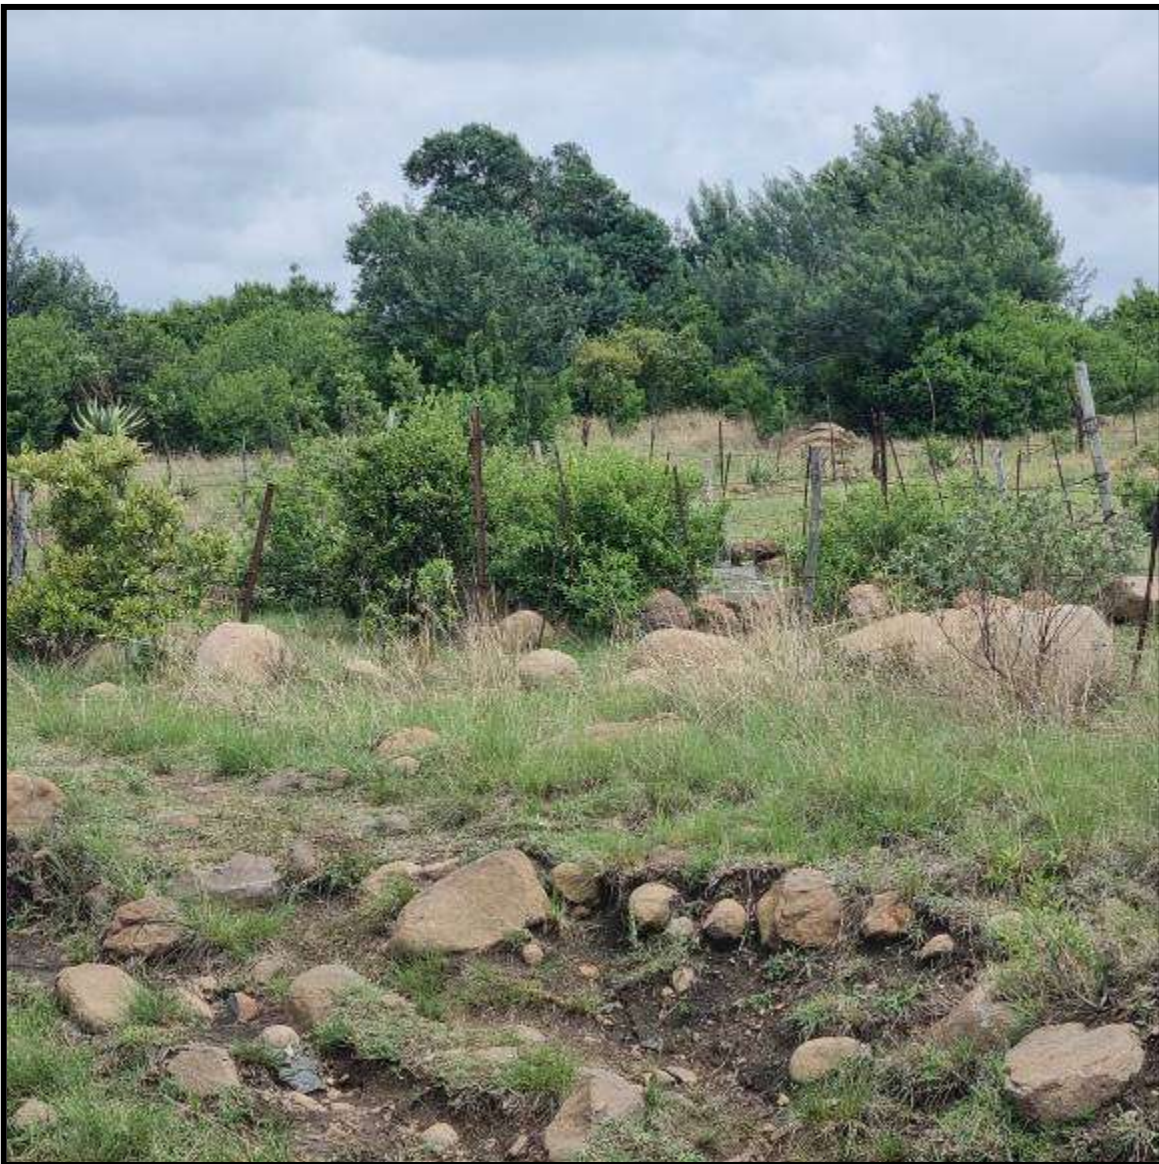
**FIG. 33: GRAVE 8**

Grave 8 consists of a stone cairn ~20m southeast from the edge of the road (fig. 33). The grave is fenced off but does not occur within a yard.

**Mitigation:** The graves need to be clearly demarcated before construction begins along this section of the road. At least 10m buffer needs to occur between the grave and any roadworks.

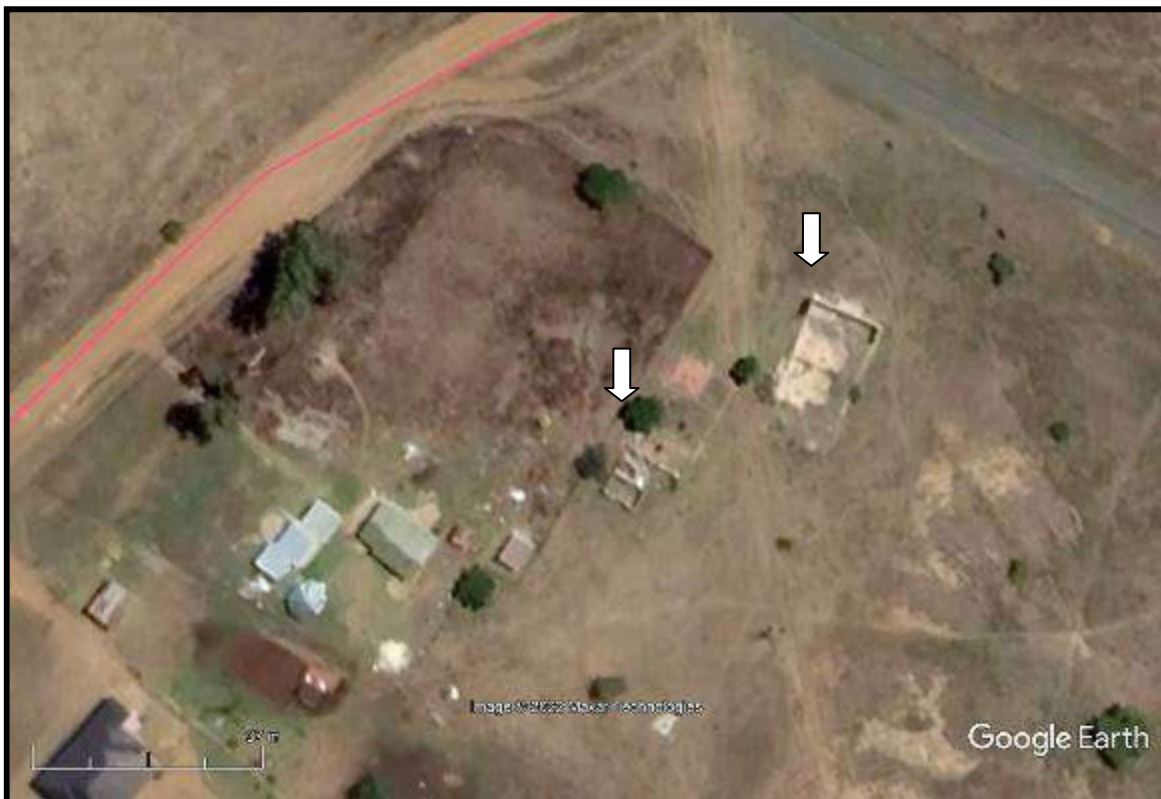
**FIG. 34: HISTORICAL HOUSES**

The historical houses predating 1944 occur along the southern road after the Buffalo River crossing. The houses are in ruin and will not be affected by the road upgrade (fig. 34).

**Mitigation:** No further mitigation is required..

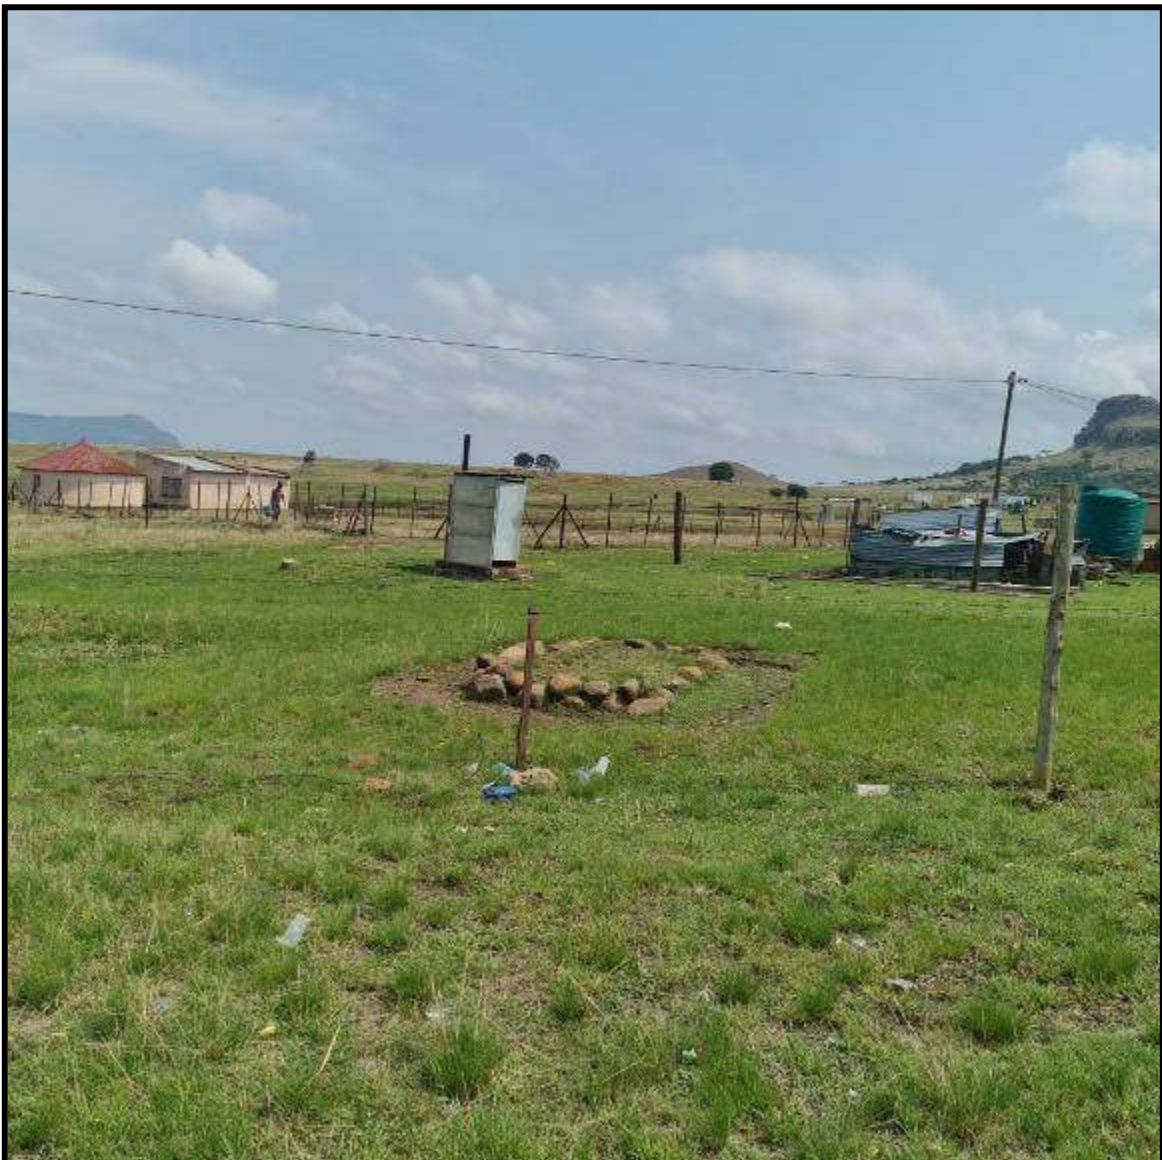
**FIG. 35: GRAVE 23**

Grave 23 consists of a stone cairn within a yard. The yard is demarcated, with poles but there is no fencing. The grave is ~9m from the edge of the road (fig. 35).

**Mitigation:** The graves need to be clearly demarcated before construction begins along this section of the road. At least 10m buffer needs to occur between the grave and any roadworks.

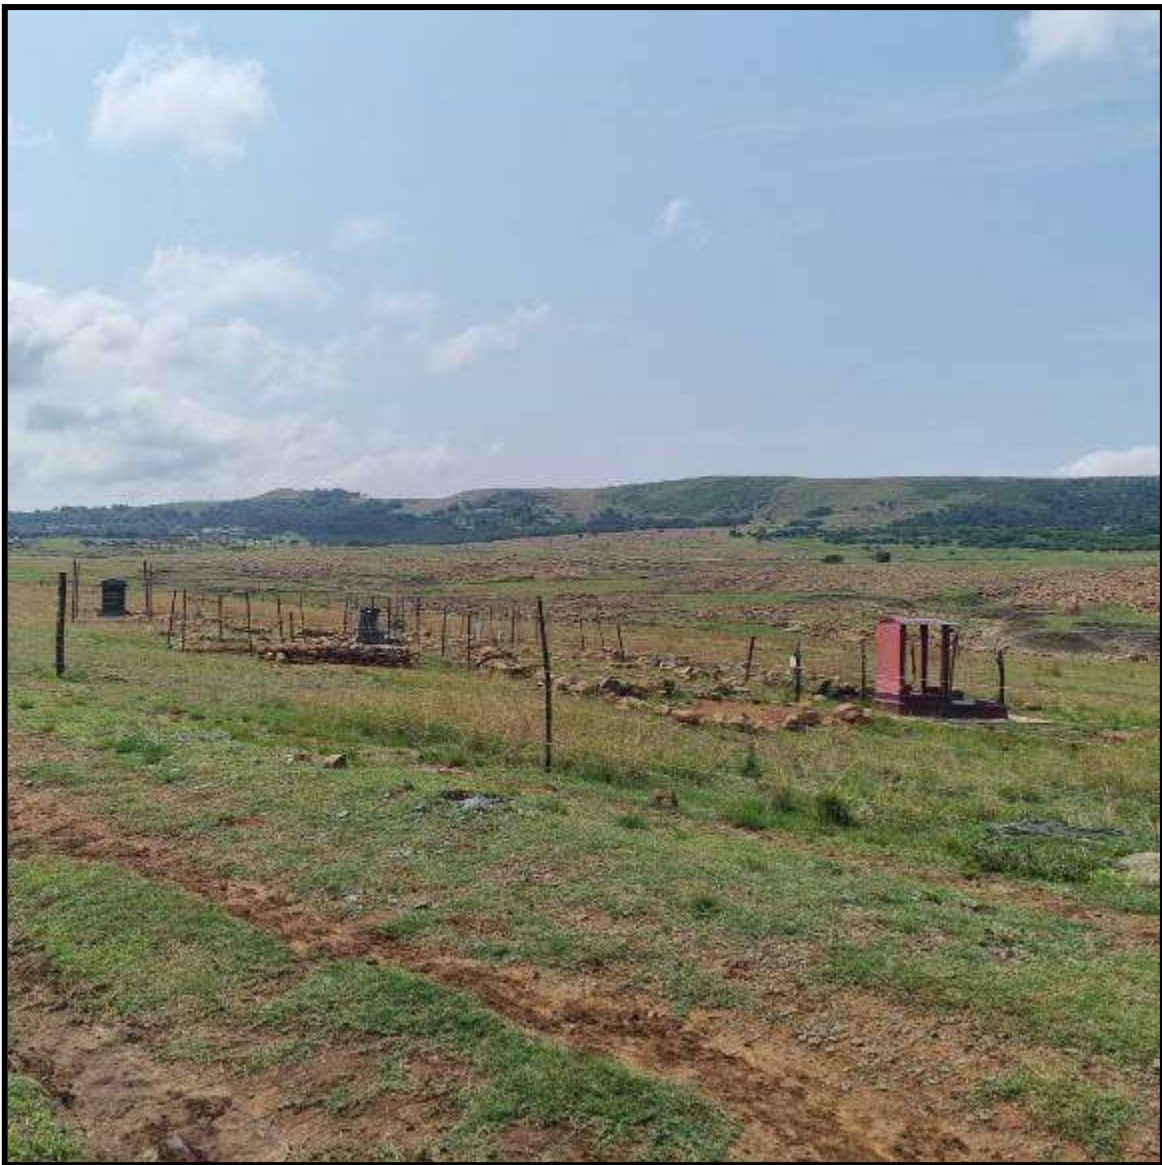
**FIG. 36: CEMETERY 4**

Cemetery 4 occurs ~15m from the edge of the road (fig. 36). It is ~80m x 40m in size and is fenced off.

**Mitigation:** The cemetery should be clearly demarcated before construction begins along this section of the road.

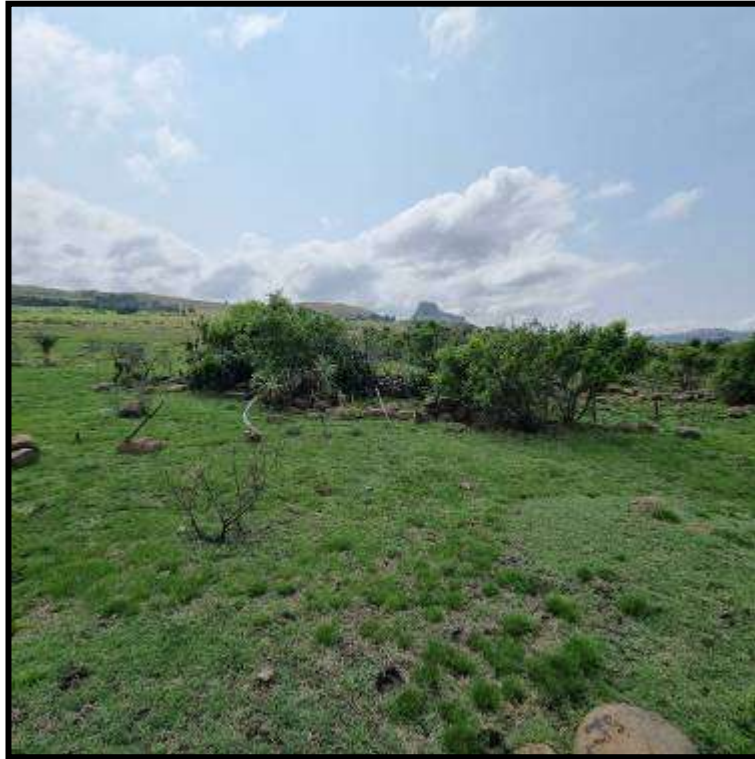
**FIG. 38: STONE WALLING**

The stone walling is part of a kraal with house floors to the northwest (fig. 38). This is probably 'h22' from the 1964 map. No graves were noted, however they could have sunken below the surface. If graves do occur, then they will be between the kraal and the road.

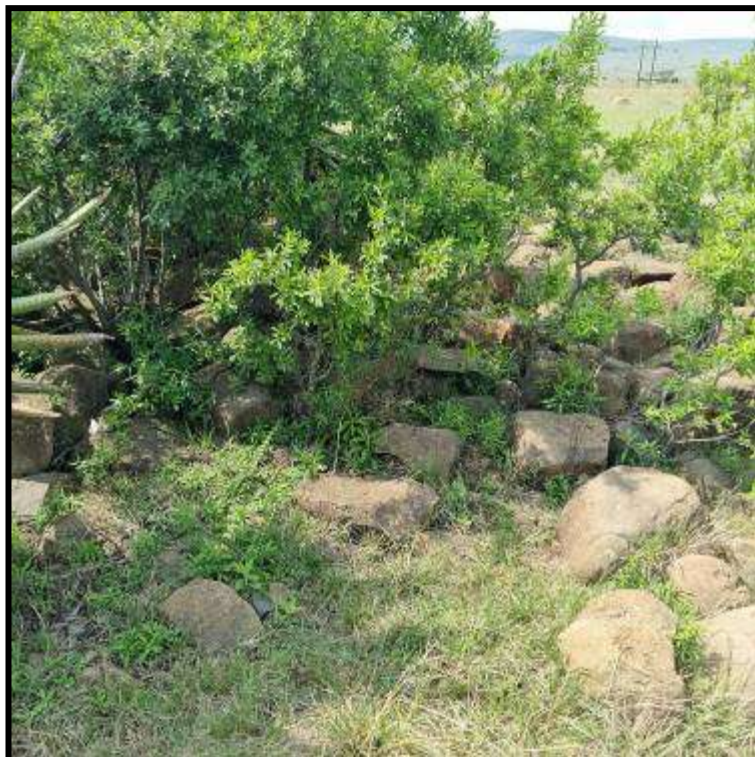
**FIG. 39: KRAAL 4**

Kraal 4 is a small kraal for goats/sheep ~8m from the edge of the road (fig. 39). The kraal might predate 1944.

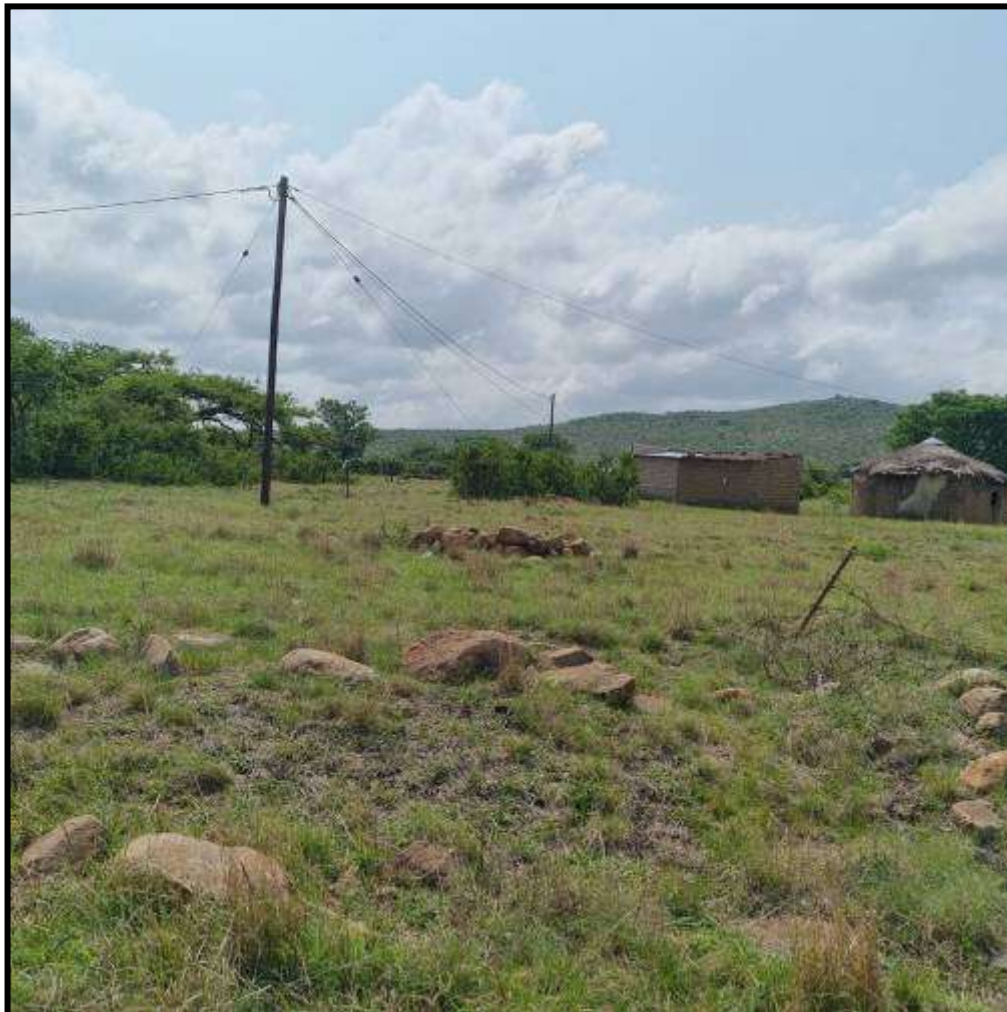
**FIG. 40: GRAVE 26**

Grave 26 consists of a single stone cairn ~10m from the edge of the road (fig. 40).

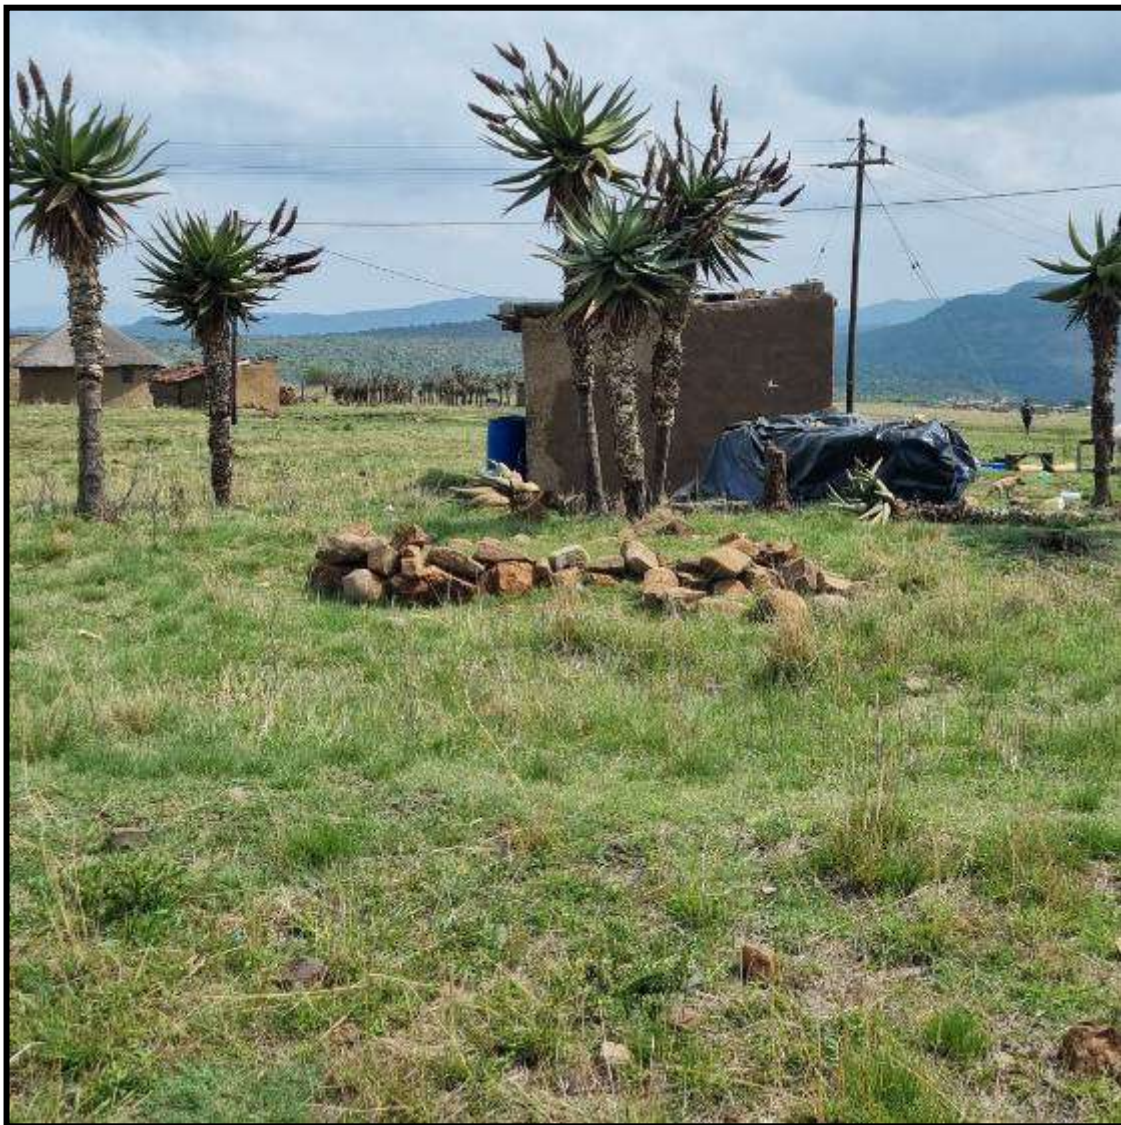
**FIG. 43: GRAVE 29**

Grave 29 consists of a stone cairn within a yard that is not fenced. The grave is ~5m south from the edge of the road (fig. 43).

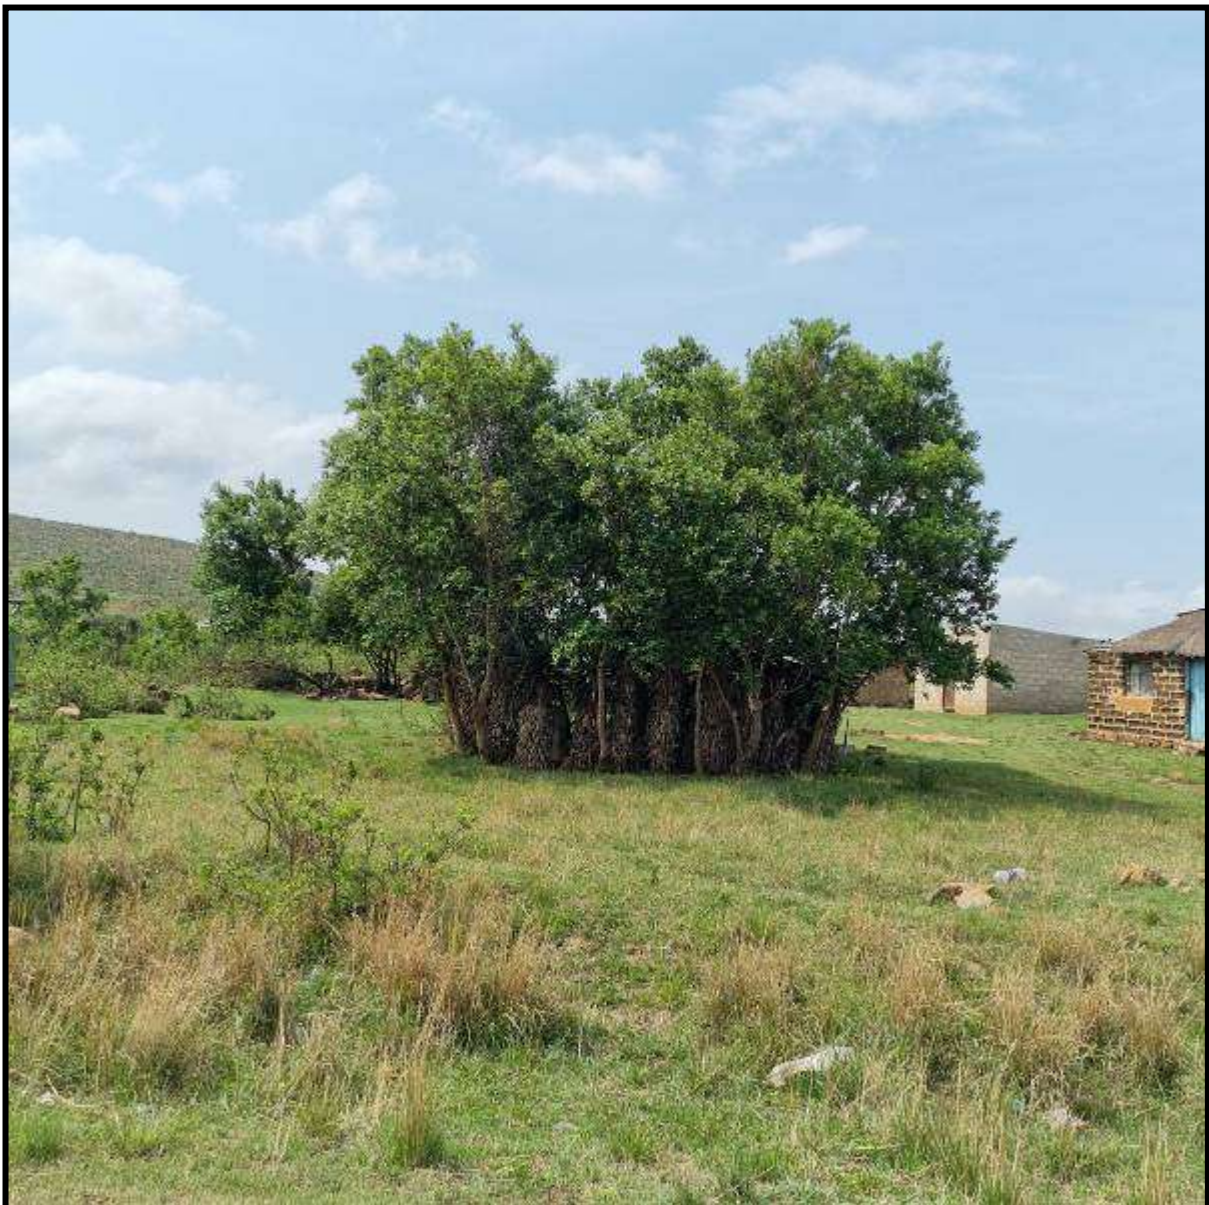
**FIG. 44: GRAVE 30**

Grave 30 consists of a grave with a headstone surrounded by aloes and trees. The vegetation is a natural buffer; however, it still needs to be demarcated. The grave is ~10m from the edge of the road (fig. 44).

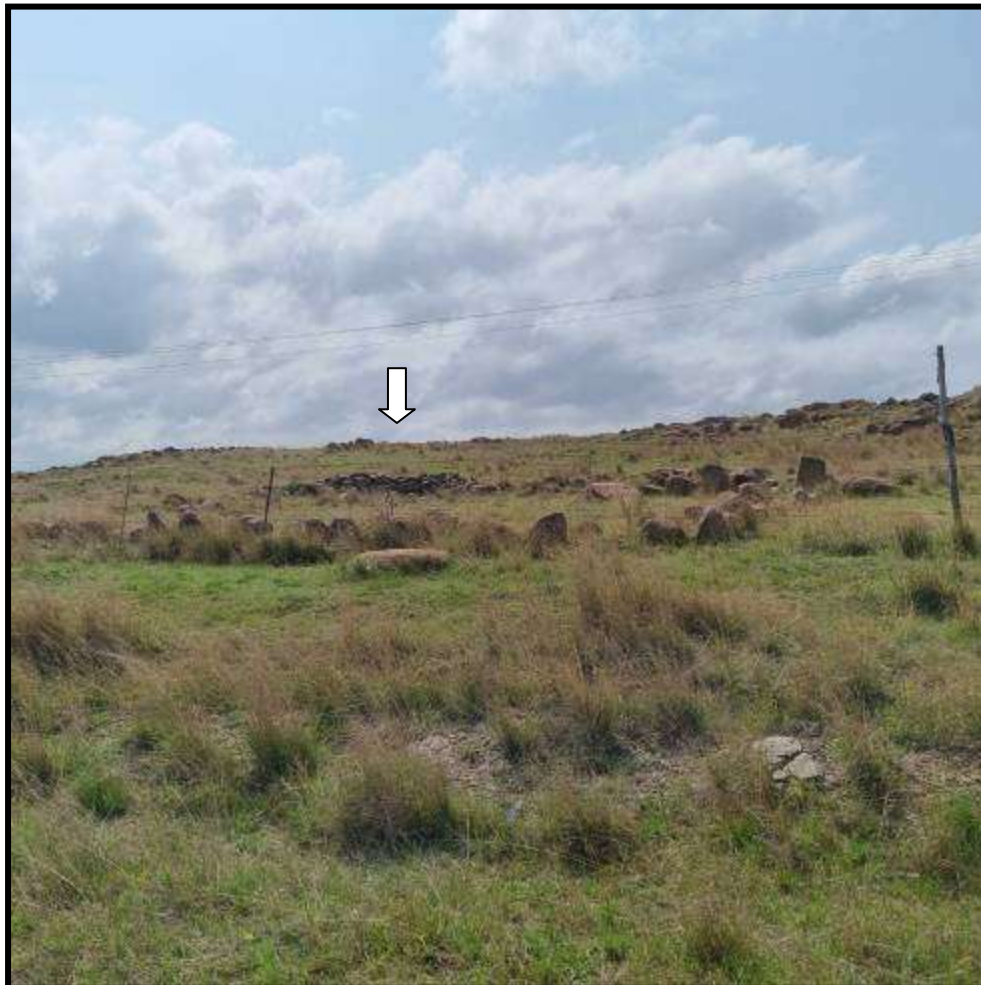
**FIG. 45: KRAAL 5**

Kraal 5 consists of a circular stone walled kraal ~16m in diameter. The cairn occurs within a yard. The yard is demarcated, with poles but there is no fencing. The kraal is ~9m from the edge of the road and behind a fence (fig. 45).

**Mitigation:** No mitigation is required as it is already demarcated.

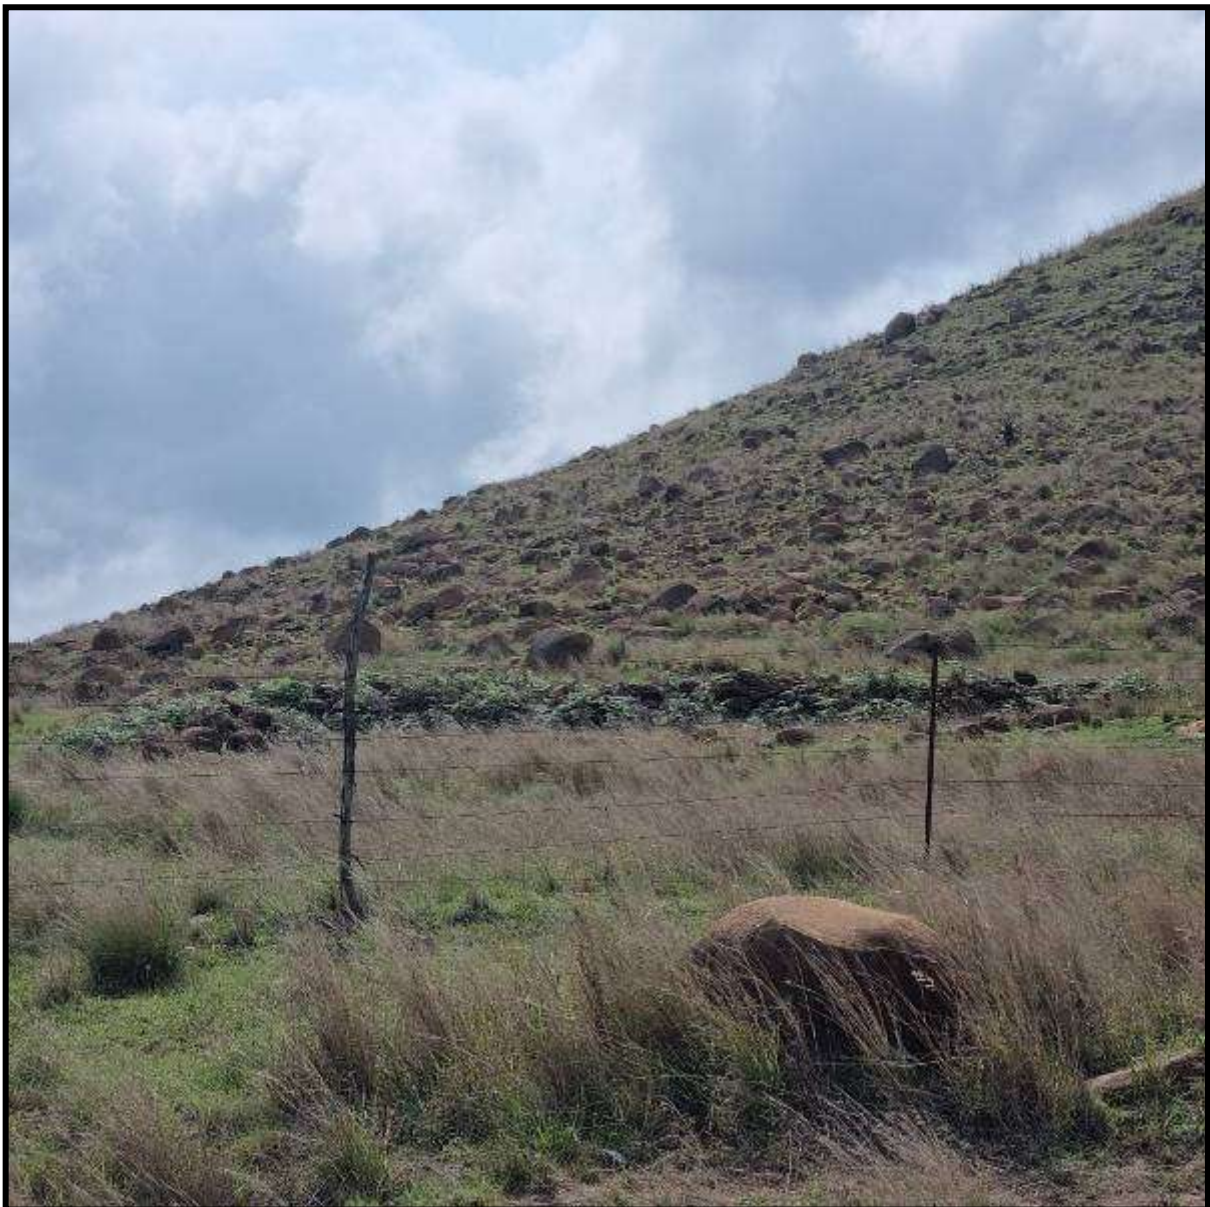
**FIG. 46: GRAVE**

Kraal 2 consists of a square stone walled kraal ~10m wide. The kraal is ~9m from the edge of the road and behind an existing fence (fig. 46).

**Mitigation:** No mitigation is required as it is already demarcated.

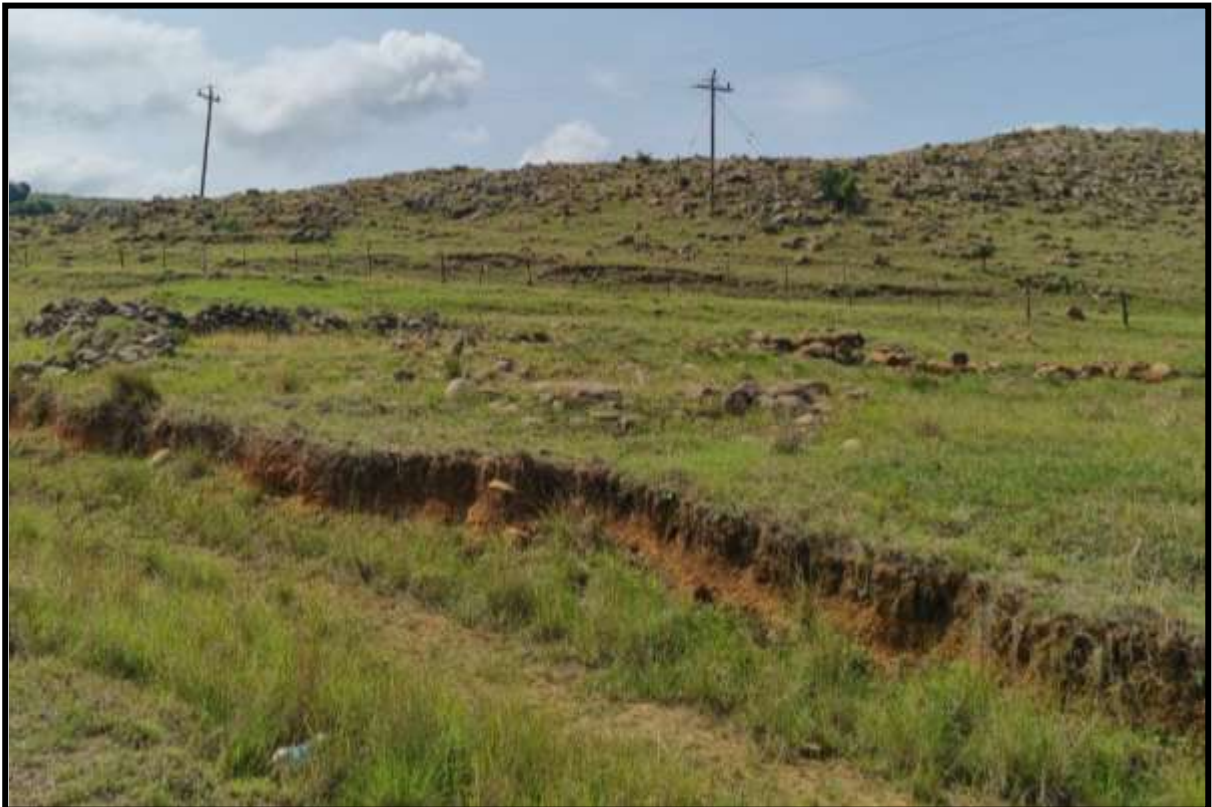
**FIG. 47: CEMETERY 6**

Cemetery 6 is enclosed on the western side by a small wall; while the rest is open (fig. 47). The cemetery is ~4m from the edge of the road

**Mitigation:** The cemetery needs to be clearly demarcated before construction begins along this section of the road. At least a 4m buffer needs to occur between the cemetery and any roadworks. That is, the road cannot extend closer to the cemetery unless there are special reasons/restrictions.

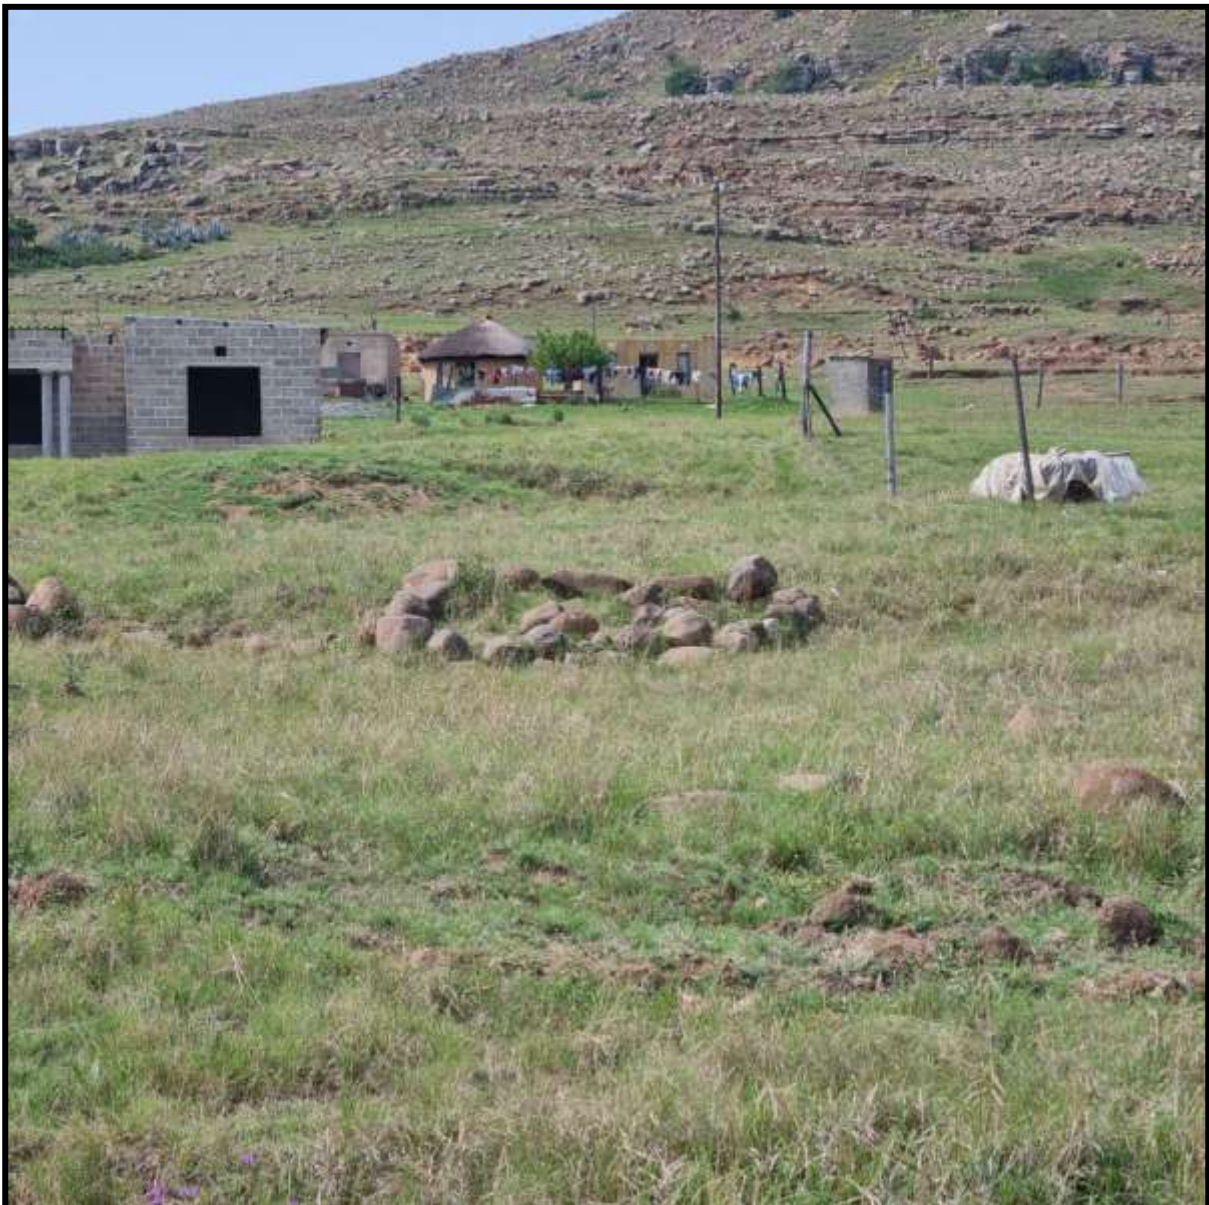
**FIG. 48: GRAVE 30**

Grave 30 is enclosed on the western side by a small wall; while the rest is open (fig. 48). The grave is ~15m from the edge of the road

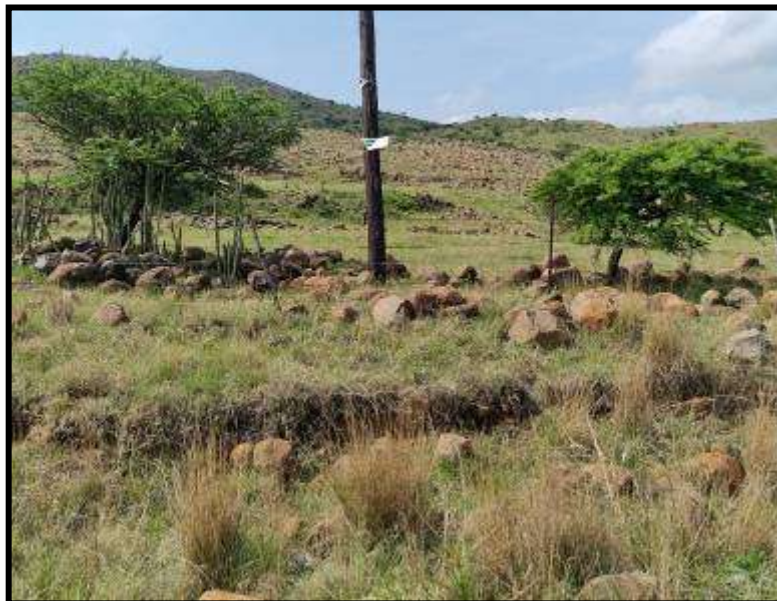
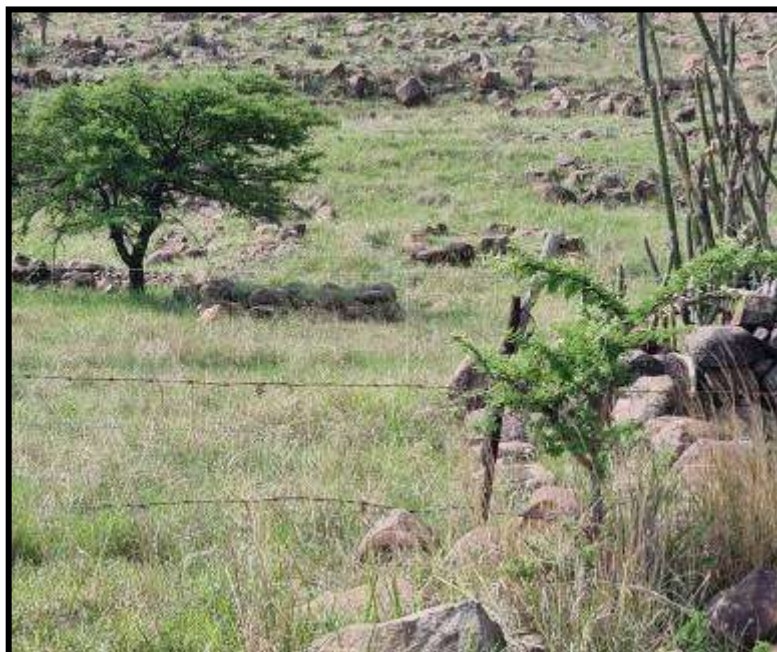
**FIG. 50: GRAVE 31 & KRAAL 3**

Grave 31 consists of a single stone cairn within a partially built stone walled kraal (fig. 50). The kraal is referred to as Kraal 3. These features are behind a fence. The grave is ~20m from the edge of the road, while the walling is ~9m from the road. The sites could relate to sites 29 or 30 from the 1944 map.

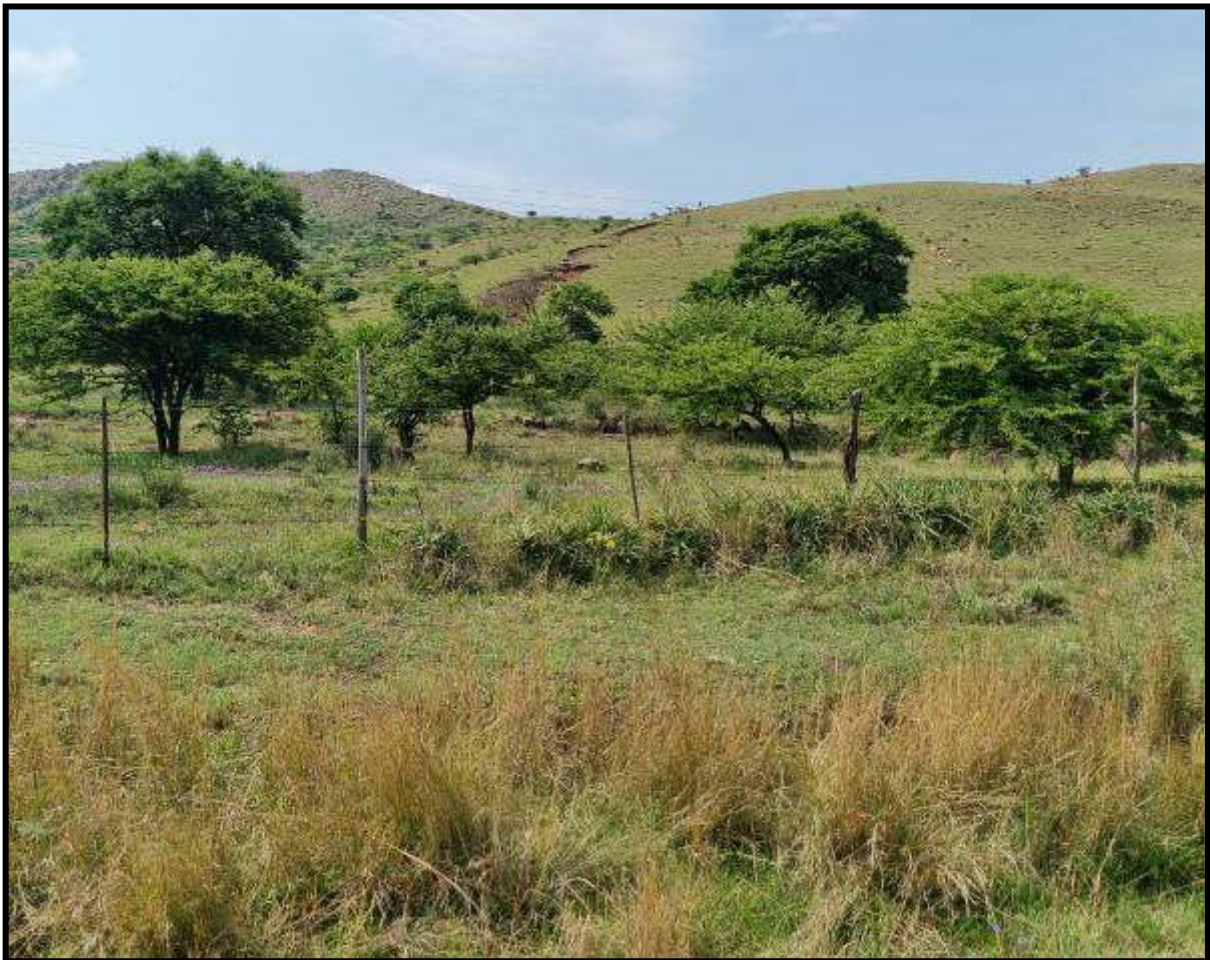
**FIG. 51: HOUSES**

Houses consists of several stone walled features and foundations that relate to '31' and 'h39' from 1944 and 1964, respectively. The features are 15m to 40m from the edge of the road (fig. 51) and are already demarcated by a fence.

**Mitigation:** The site is already demarcated and no further mitigation is required

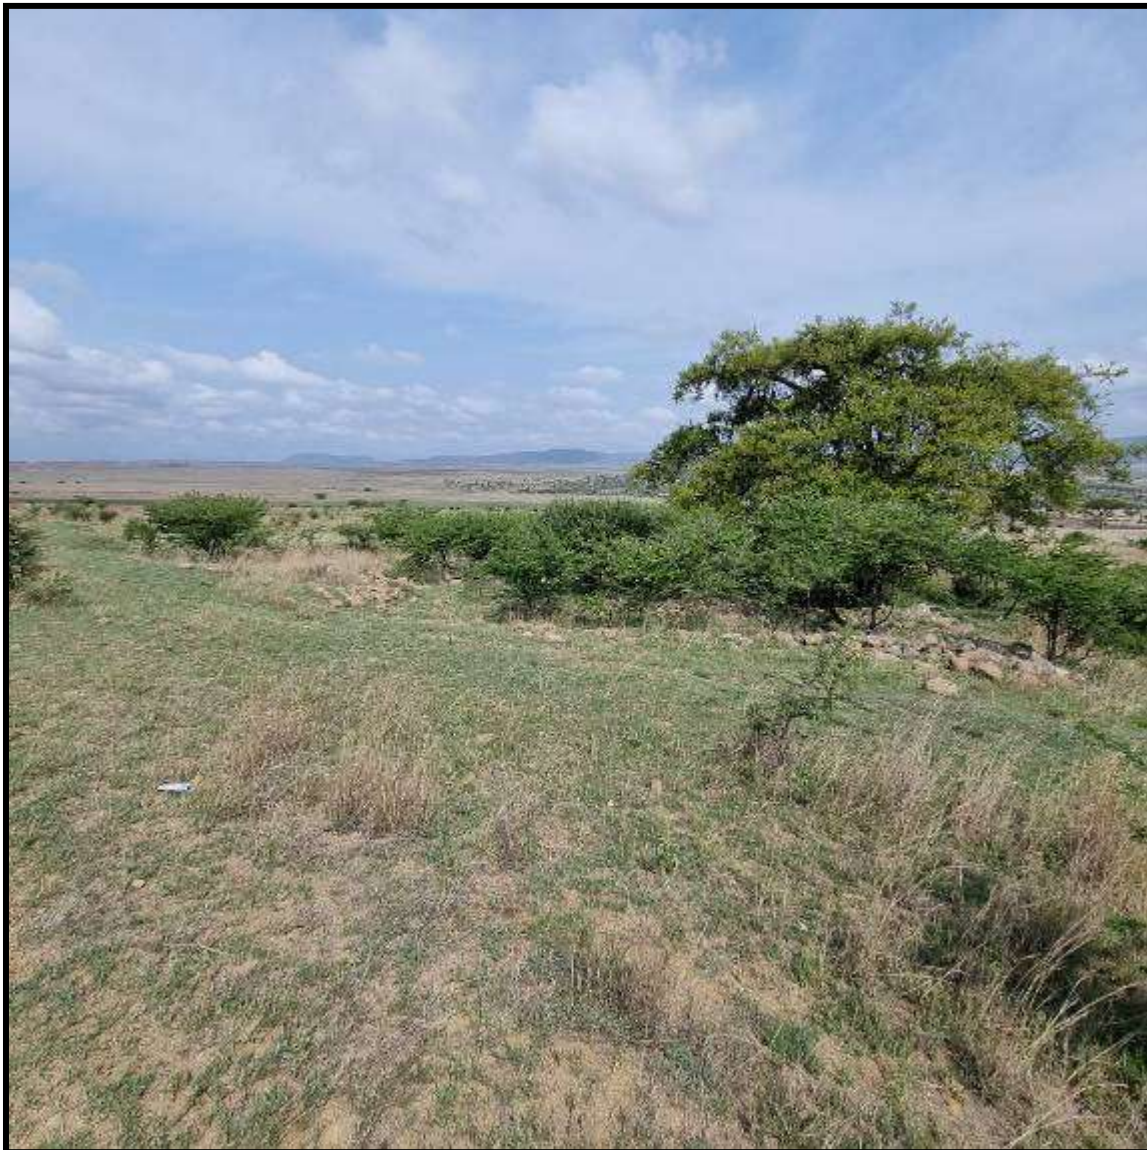
**FIG. 52: CEMETERY 8**

Cemetery 8 consists of several stone cairns under young thorn bush trees. The cairns themselves appear to be old. The cemetery is ~9m from the edge of the road and is not demarcated (fig. 52).

**Mitigation:** The cemetery needs to be clearly demarcated before construction begins along this section of the road. At least 10m buffer needs to occur between the grave and any roadworks. This means the southern edge of the road should not be affected; however given the limited space the 10m buffer could be reduced.

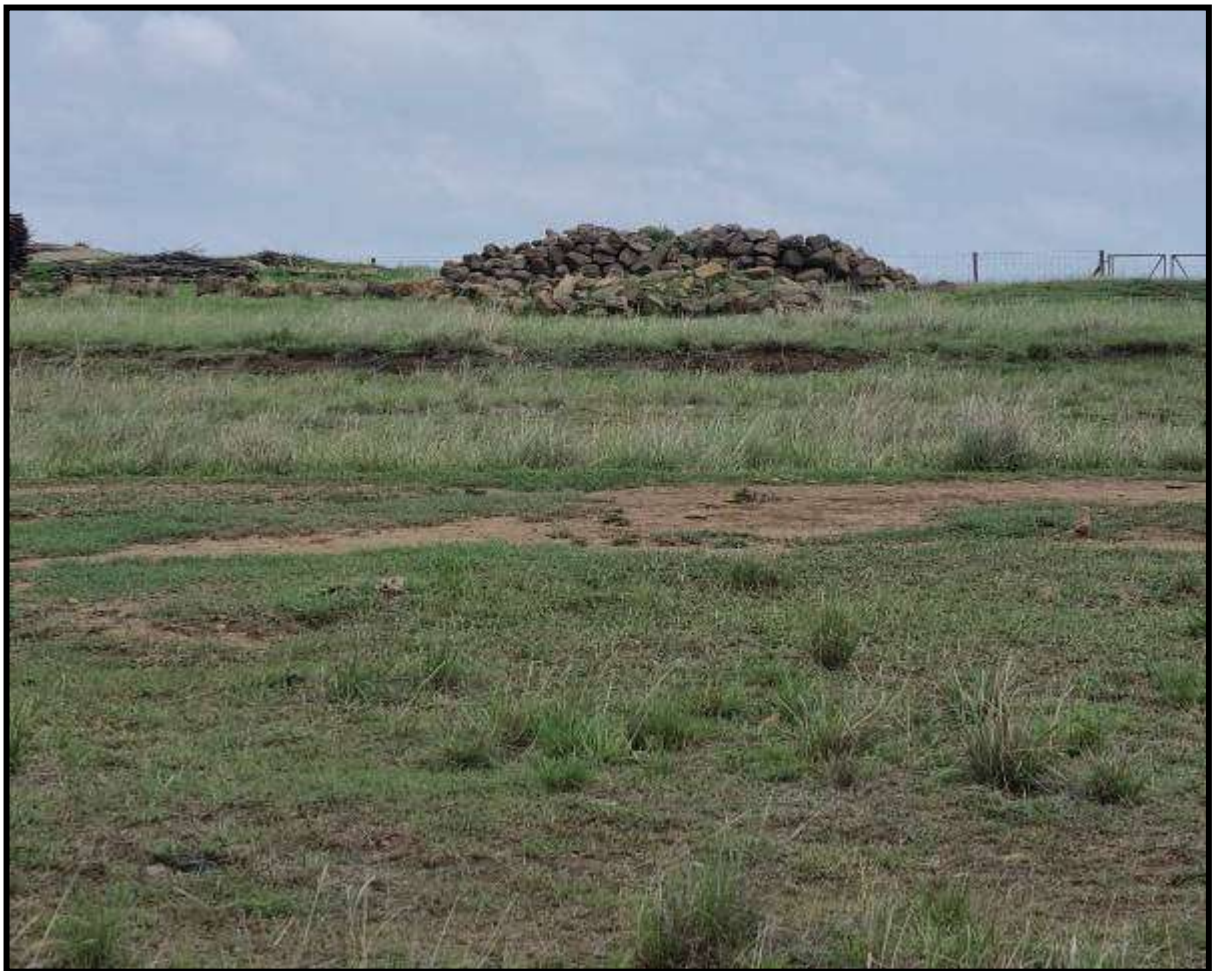
**FIG. 54: GRAVE 5**

Grave 16 consists of three stone cairns just north of a stone walled kraal within a yard. The yard is demarcated, with poles but there is no fencing. The graves are ~25m from the edge of the road (fig. 54).

**Mitigation:** The graves need to be clearly demarcated before construction begins along this section of the road. At least 10m buffer needs to occur between the grave and any roadworks.
