**HERITAGE SURVEY OF THE UPGRADING OF THE  
D2286, P372, L1190, P148, L1333, L1351, D897,  
AND D30**

**FOR AFZELIA ENVIRONMENTAL CONSULTANTS**

**DATE: 7 NOVEMBER 2022**

**Umlando: Archaeological Surveys and Heritage  
Management**

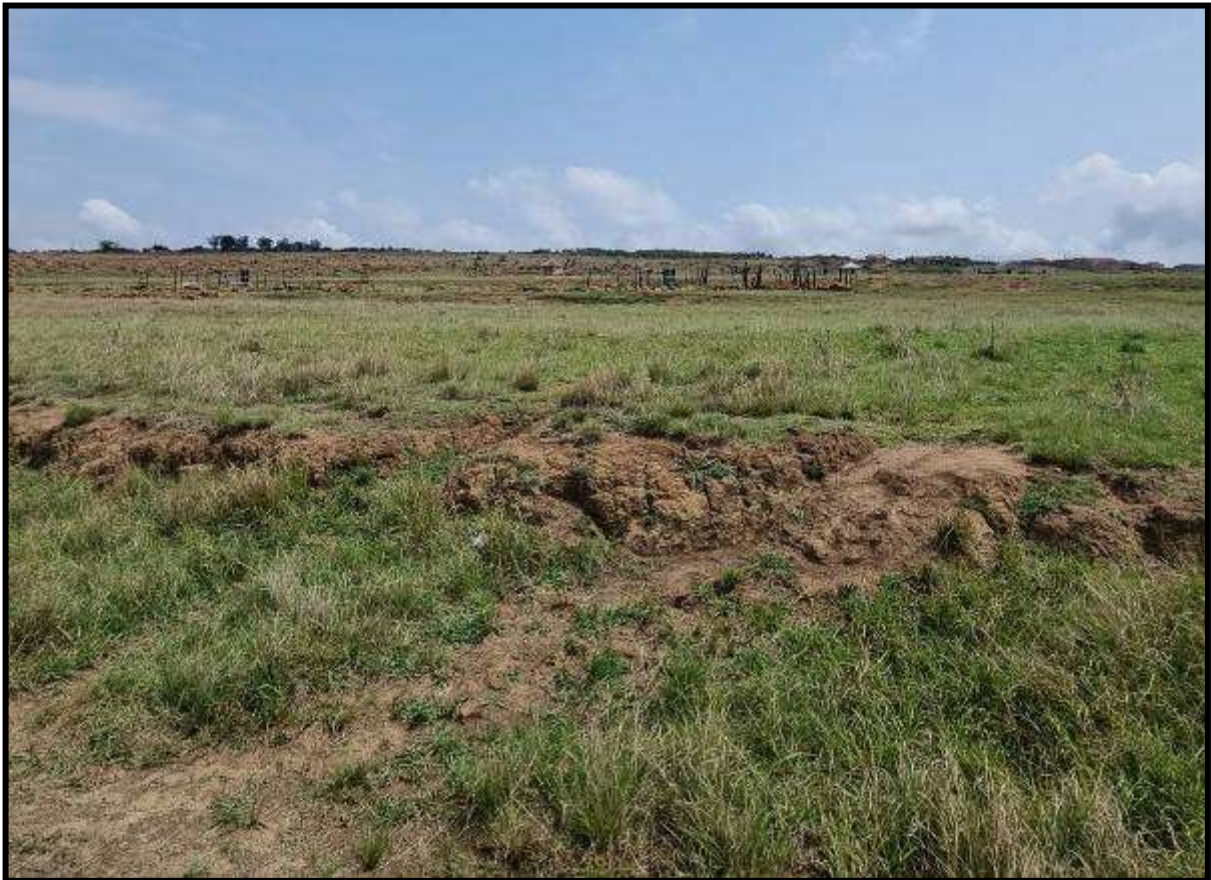
**FIG. 55: CEMETERY 2**

Cemetery 2 consists of a stone cairn and graves with headstones uphill from the road. There is a fence around the cemetery. The yard is demarcated, with poles but there is no fencing. The cemetery is ~20m from the edge of the road (fig. 55).

**Mitigation:** The cemetery will not be affected and no further mitigation is required.

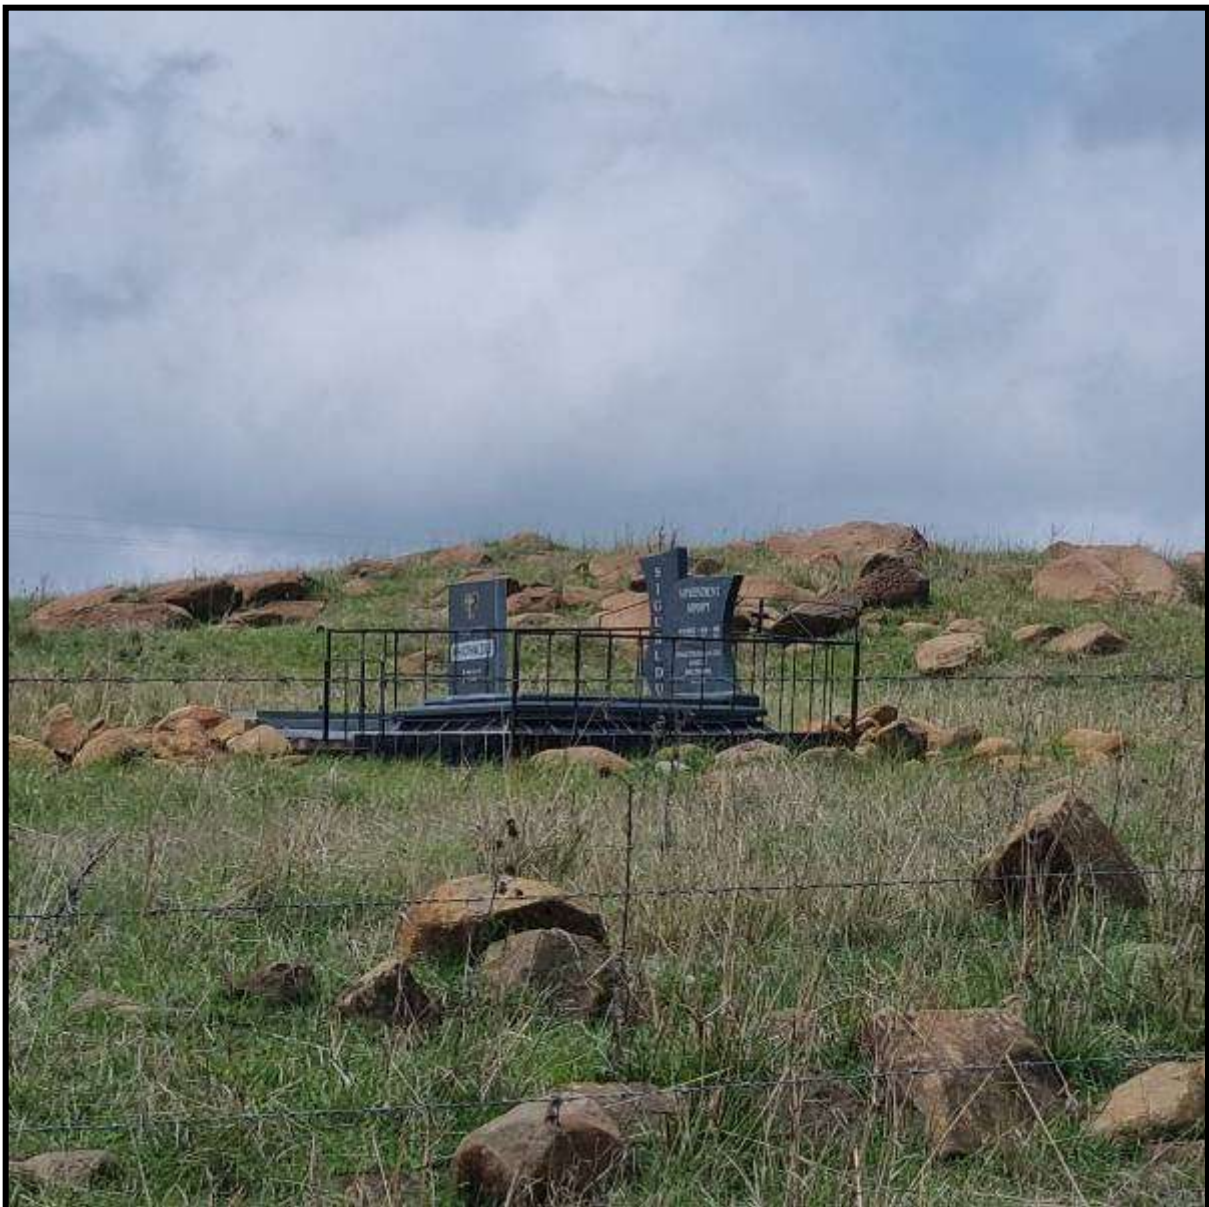
**FIG. 56: GRAVE 17**

Grave 17 consists of a two recent graves with headstones (fig. 56). There is a small fence around the graves, and a fence between the graves and the road. The graves are ~15m from the edge of the road and will not be affected.

**Mitigation:** The graves will not be affected and no further mitigation will be required.

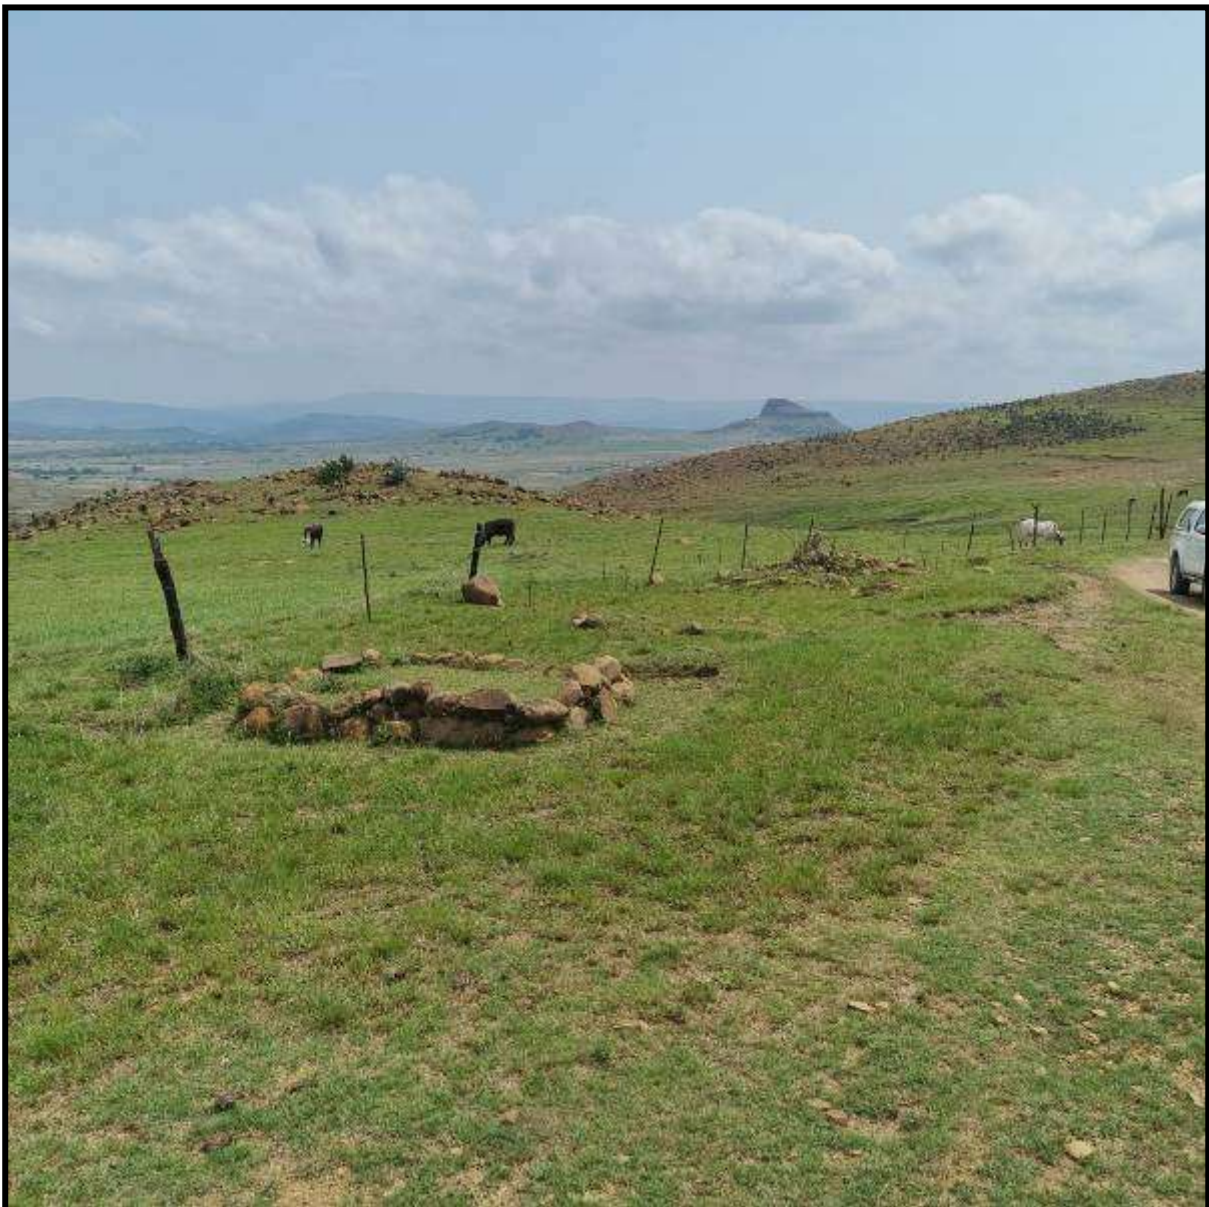
**FIG. 57: GRAVE**

Grave 18 consists of six stone cairns of which some are on the verge of the road (fig. 57). One of the graves appears to have a water culvert excavated onto the cairn itself (fig. 58).

**Mitigation:** The road needs to be realigned and moved away from the graves.

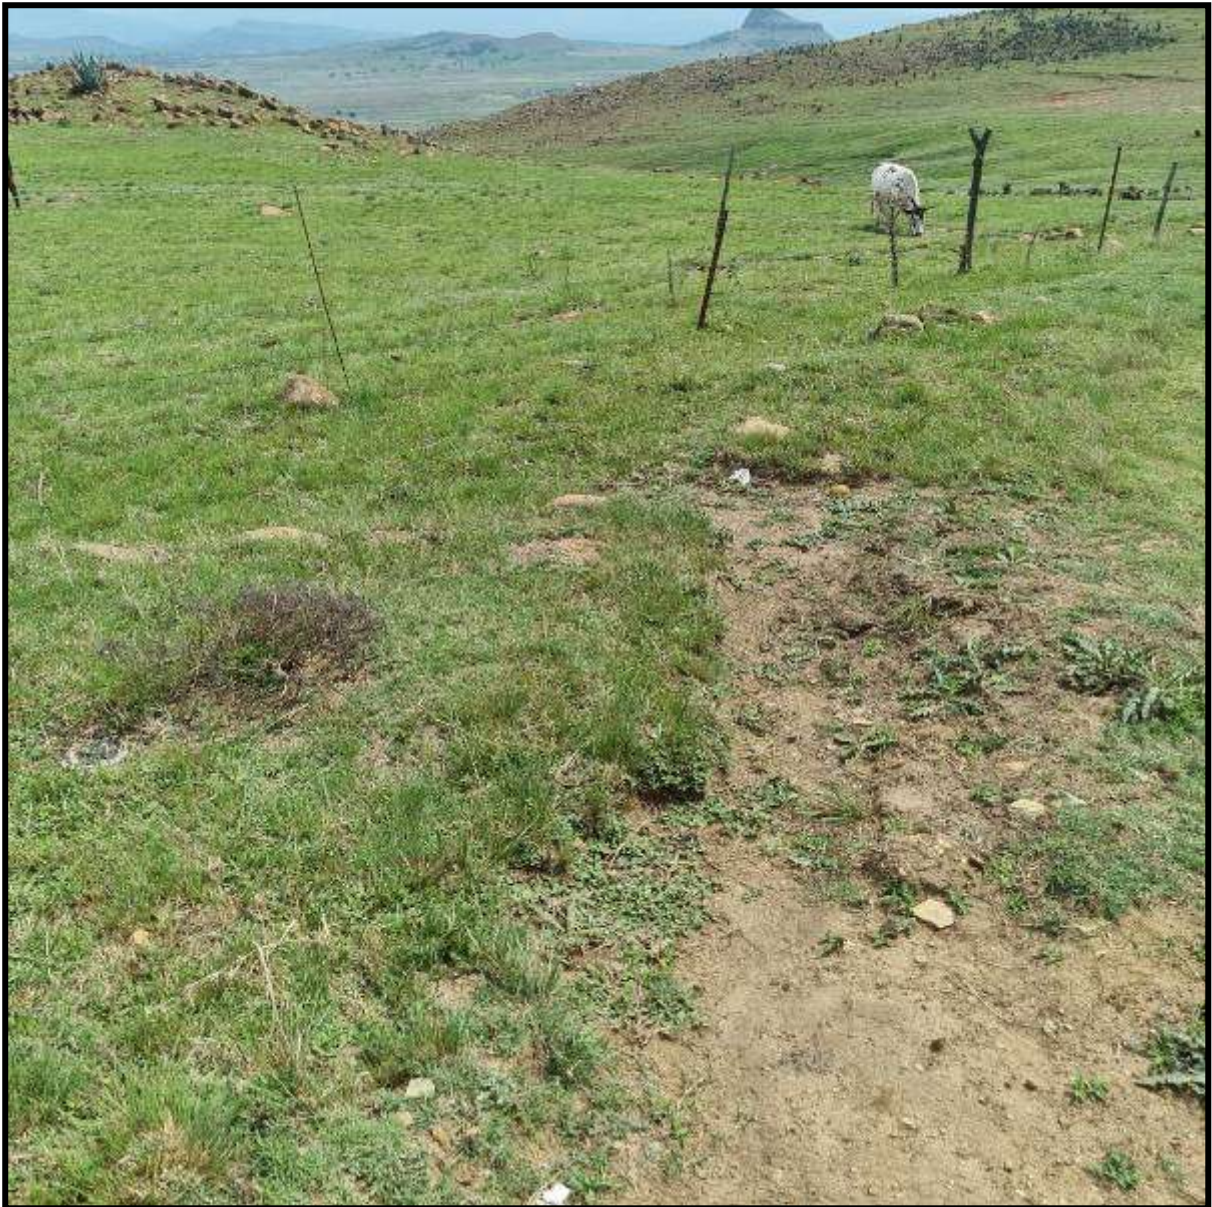
**FIG 58: AFFECTED GRAVE WITH WATER CULVERT**

*One site will require the road to be re-aligned as the existing culvert directly affects a human grave. Another grave needs to be reinforced, as erosion will eventually expose the human remains in the road cutting.*
