# IXOPO CRU HOUSING PROJECT, UBUHLEBEZWE LOCAL MUNICIPALITY, KWAZULU-NATAL

# **Phase 1 Heritage Impact Assessment**

# September 2016

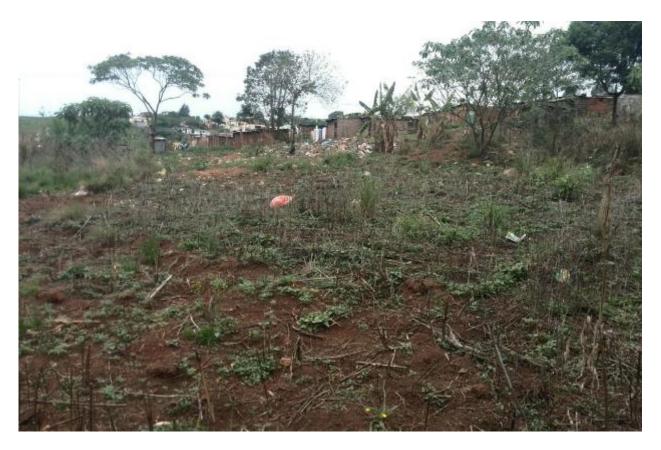
The site of the proposed development includes an informal settlement on the south eastern section of the project area. The area where the informal settlement is situated is highly disturbed by human activity with lots of litter lying around. There are several areas throughout the project area that have been cleared and used for vegetable and maize cultivation (see Figures 3 and 4).

Figure 3: Informal settlement with cultivated area adjacent to shacks

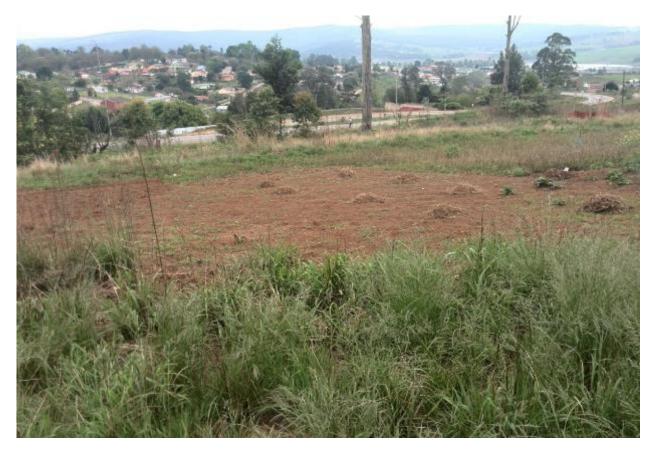
Figure 4: Looking northwards with cleared area in foreground

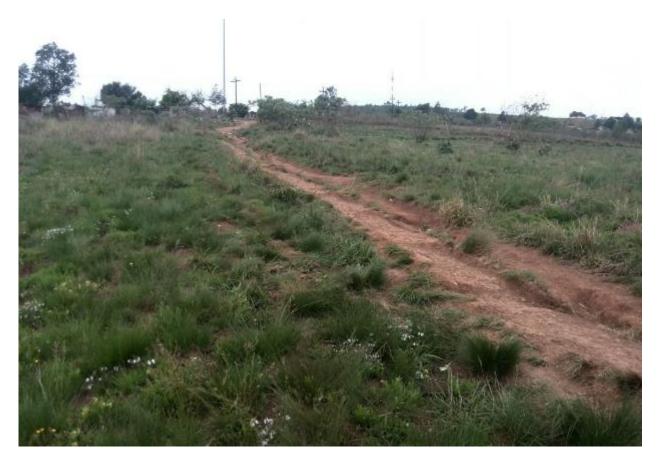
A walk through of the project area was undertaken. The area, apart from the informal settlement, is largely undeveloped but it is disturbed by its close proximity to the informal settlement with the existence of informal roads, paths and rubbish dumps. In addition, several geotechnical test pits had been dug for investigation for the proposed housing development (see Figures 5 and 6). There is also an existing power line that crosses the project area.

Figure 5: Existing road/path and power line looking southwards

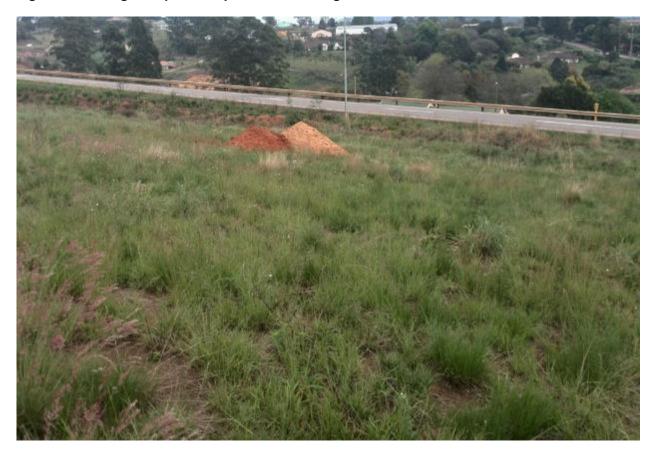
Figure 6: Test pit with R56 road in background

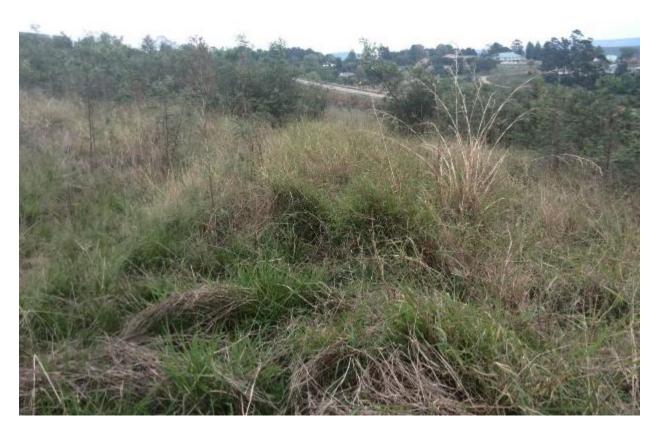
There are thickets of wattle trees and thick undergrowth that are used as informal toilets and access in these areas was limited. (Figure 7). However, visibility was generally good apart from the few areas mentioned.

Figure 7: Overgrown sections of project area

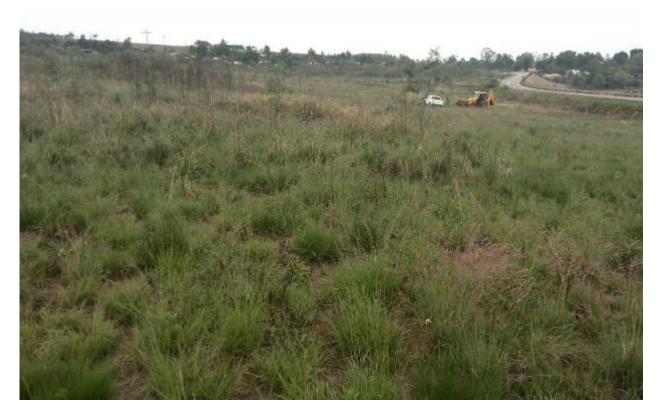
Figure 8: South western section of project area

An area enclosed with wire is situated close to the R56 where either animals are kept or where produce is grown.

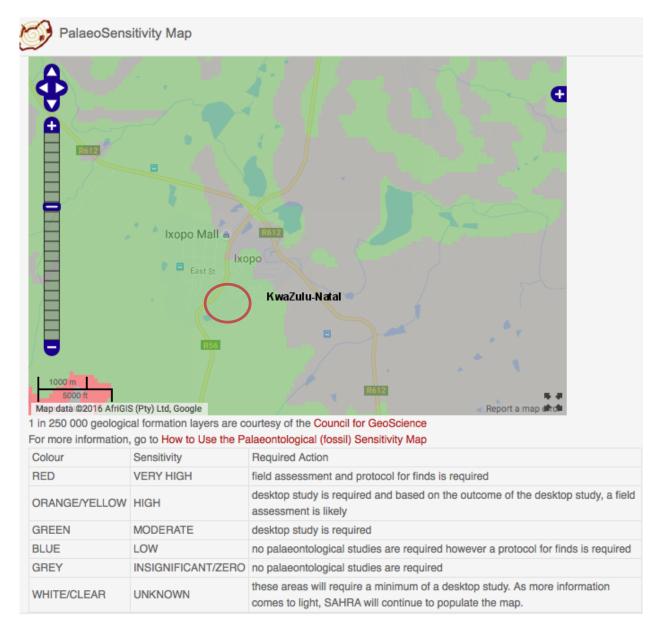
The South African Heritage Resources Agency's Fossil Sensitivity Map indicates that the project area is situated in an area coloured in green that indicates an area of moderate palaeontological / fossil sensitivity (see Figure 8 below). As indicated in Figure 9, an area of moderate sensitivity requires a desktop palaeontological assessment. However, due to the disturbed nature of the project area, it is anticipated that there is a low probability of finding intact and significant fossils therefore it is recommended that no further studies are undertaken in this regard. However, a protocol for fossil finds included in the mitigation measures in section 9 of this report, must be adhered to by the developer.

Figure 9: Fossil sensitivity map with project area indicated by red circle

- All heritage resources found in close proximity to the construction area must be protected by a 3m buffer in which no construction can take place. The buffer material (danger tape, fencing, etc.) must be highly visible to construction crews.
- Under no circumstances may any heritage material be destroyed or removed from site unless under direction of a heritage specialist.
- If there are chance finds of fossils during construction, work in the area of the find must be stopped and a palaeontologist must be called to the site in order to assess the fossils and rescue them if necessary (with an Amafa permit). The fossils must then be housed in a suitable, recognized institute.
