IXOPO HOUSING PROJECT, UBUHLEBEZWE MUNICIPALITY, KWAZULU-NATAL

Phase 1 Heritage Impact Assessment

September 2020

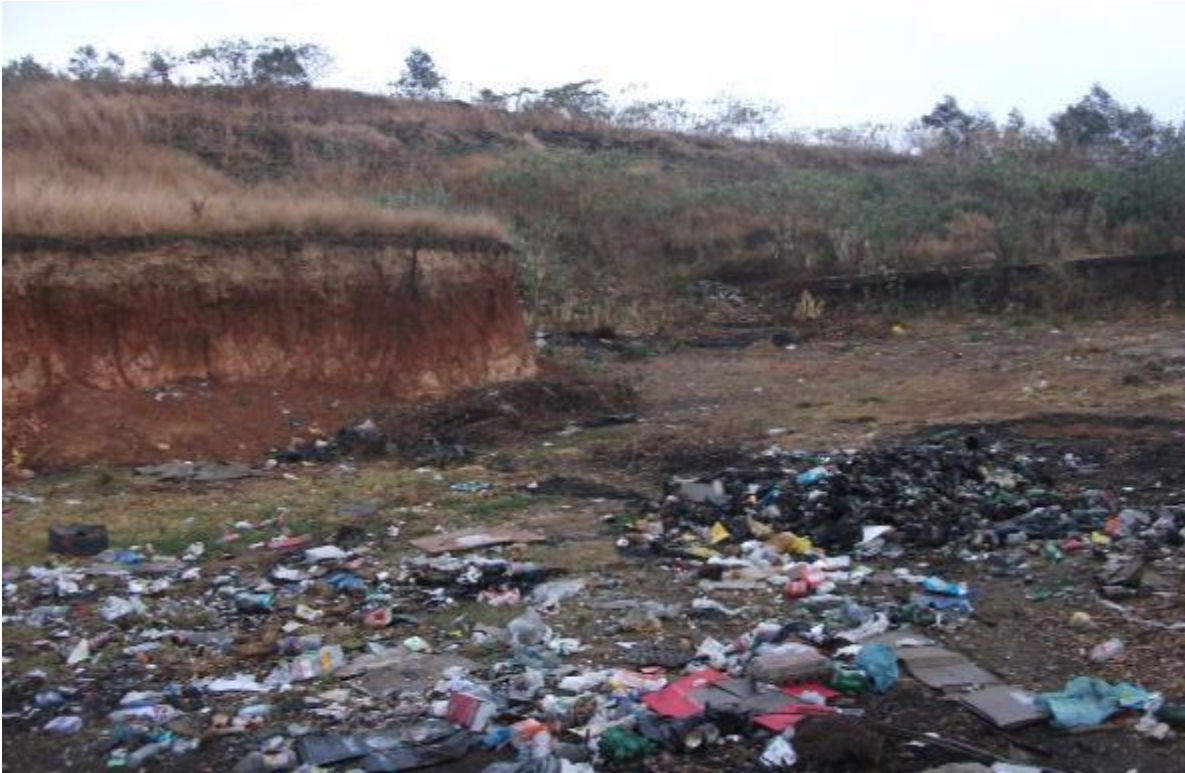
During the site inspection, an area that appears to be an old quarry or borrow pit was found which is used to dump refuse/garbage (**Figure 2**). In this area, the remains of a concrete floor were found. It is unclear whether it was associated with a dwelling or other structure as no other remains were found.

Figure 2: Area used to dump garbage

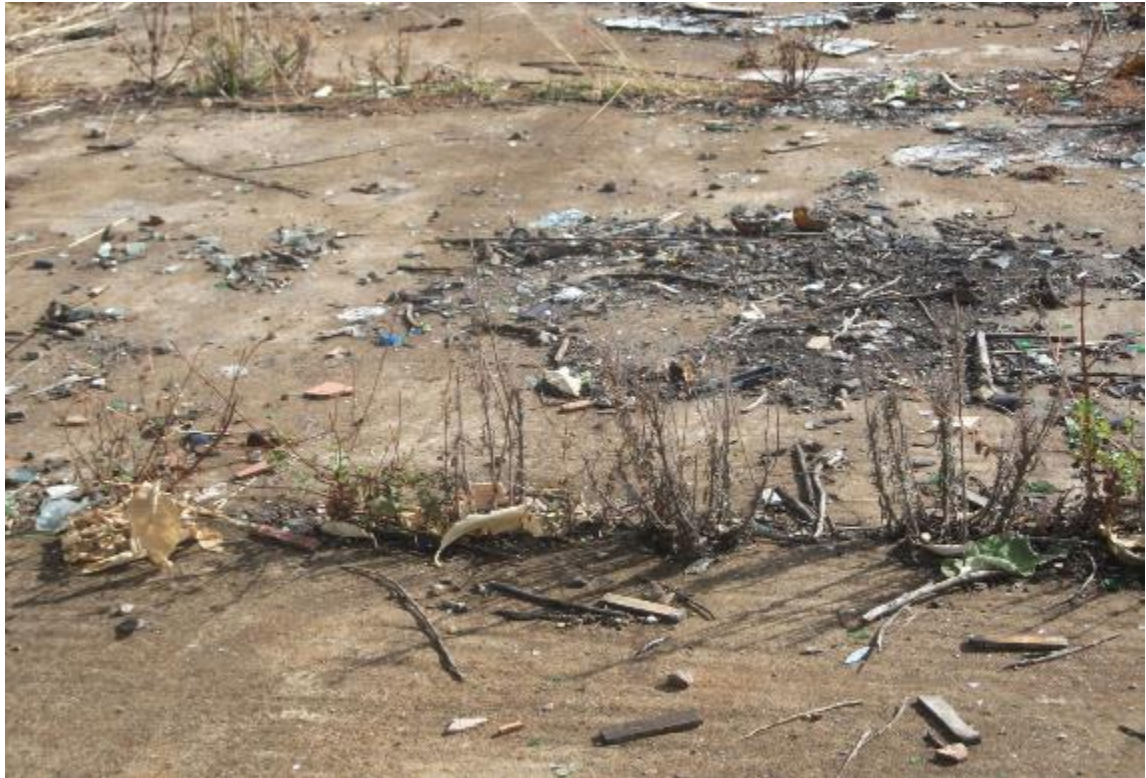
Figure 3: Remains of concrete floor

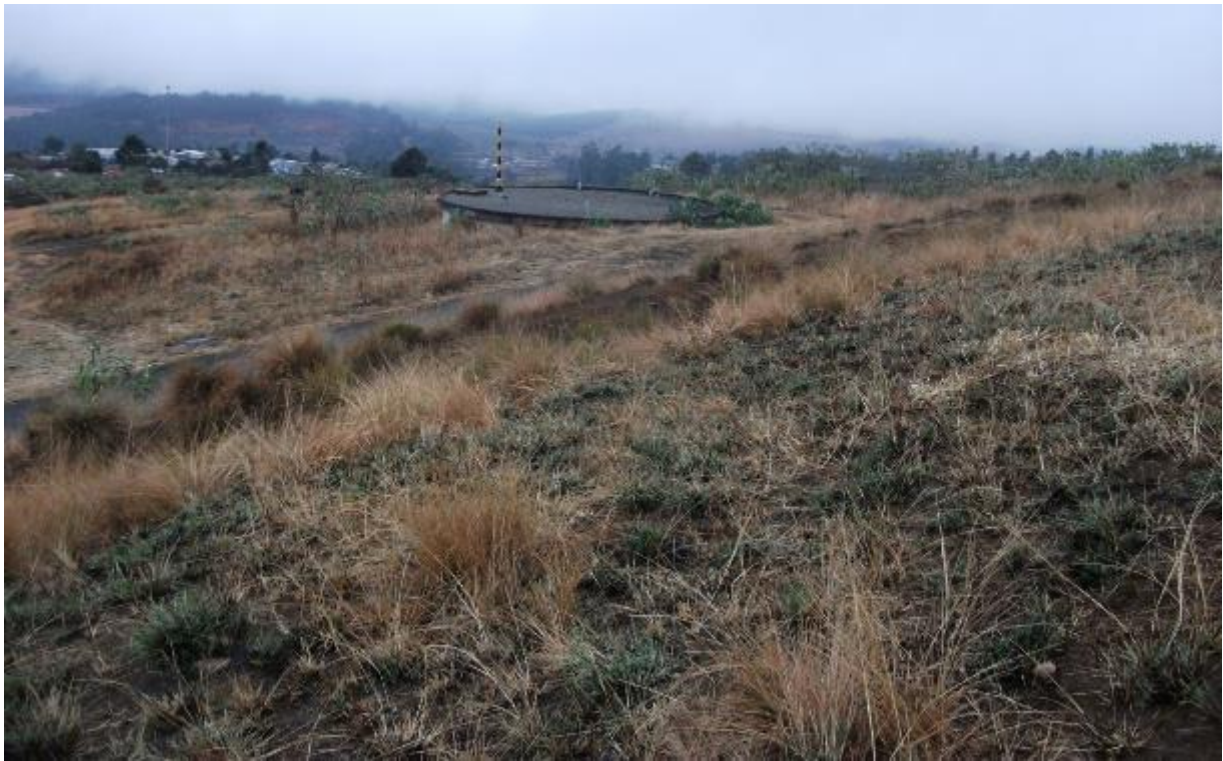
A large cemetery was found below the existing reservoir. Much of the cemetery falls outside the area proposed for the housing development. However, a number of graves (>5) were found within the development area. It is therefore recommended that the area immediately north-east of the road and below the reservoir be left undeveloped due to the presence of graves. The area to be left undeveloped is indicated in **Figure 5** below.

Figure 4: Reservoir and surroundings

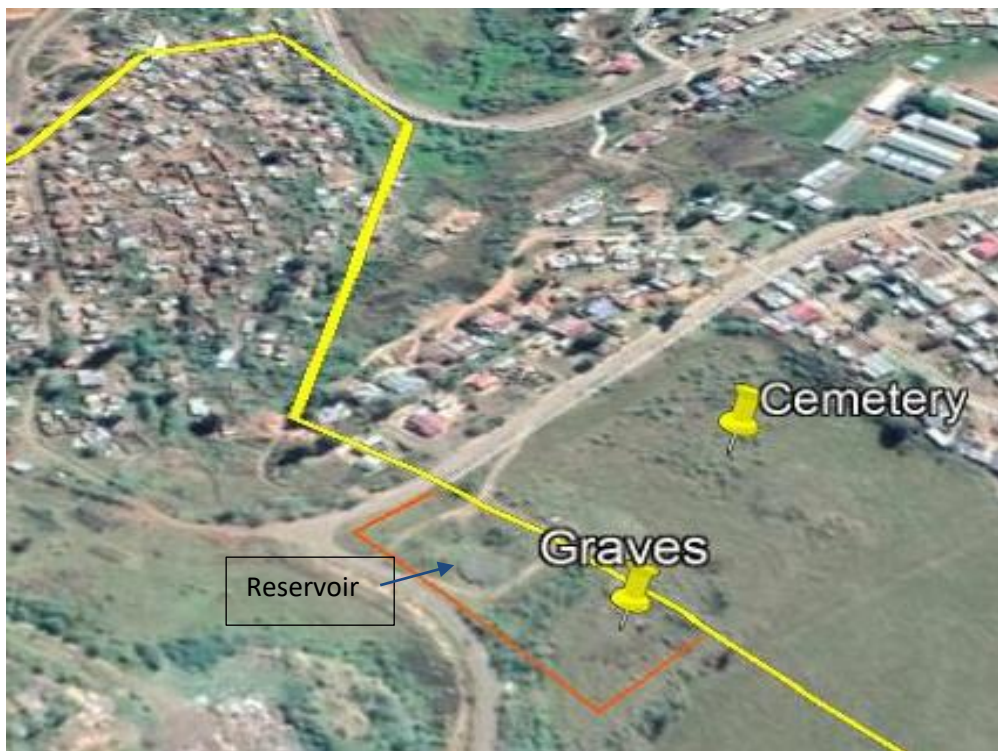
Figure 5: Area to be excluded outlined in orange

It is recommended that an area below the road and incorporating the reservoir be excluded from the housing development due to the presence of graves. It is also recommended that no development take place within 15 m of the cemetery located just outside the development area to ensure that no graves are damaged during construction.

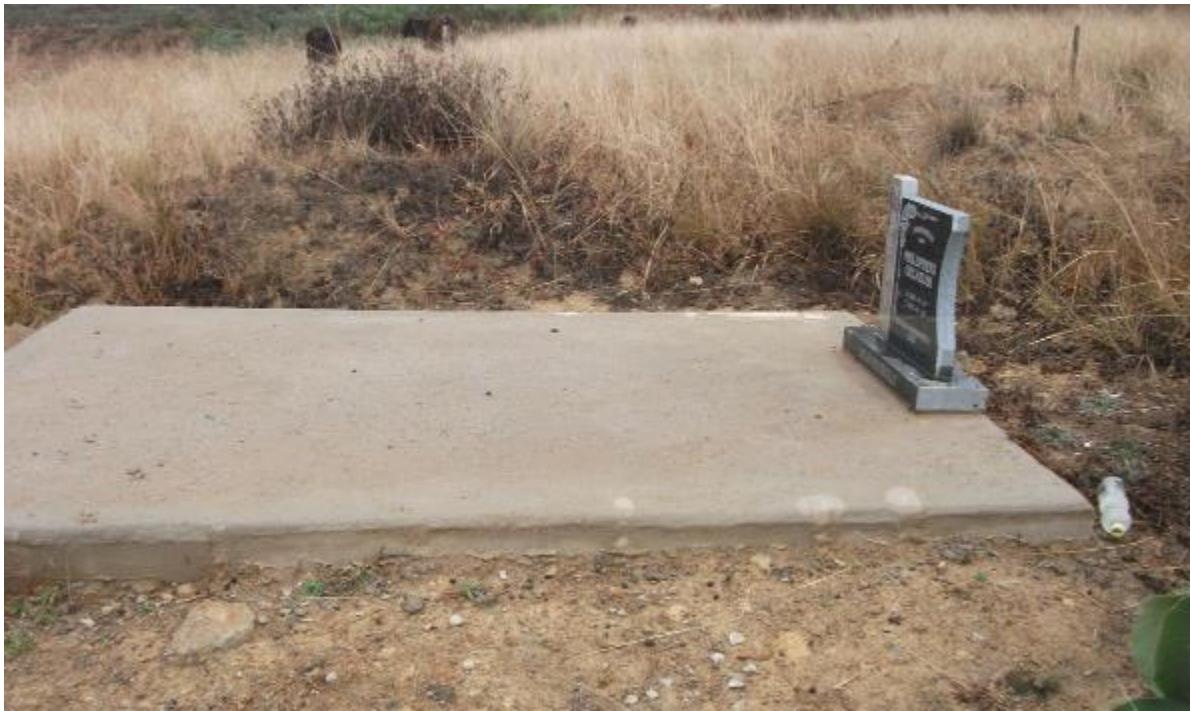
The graves are either marked with headstones, others with headstones and concrete slabs over the grave whilst other graves were mounds of soil, some with wooden crosses and others outlined with bricks (see images below).

Figure 6: Grave with headstone

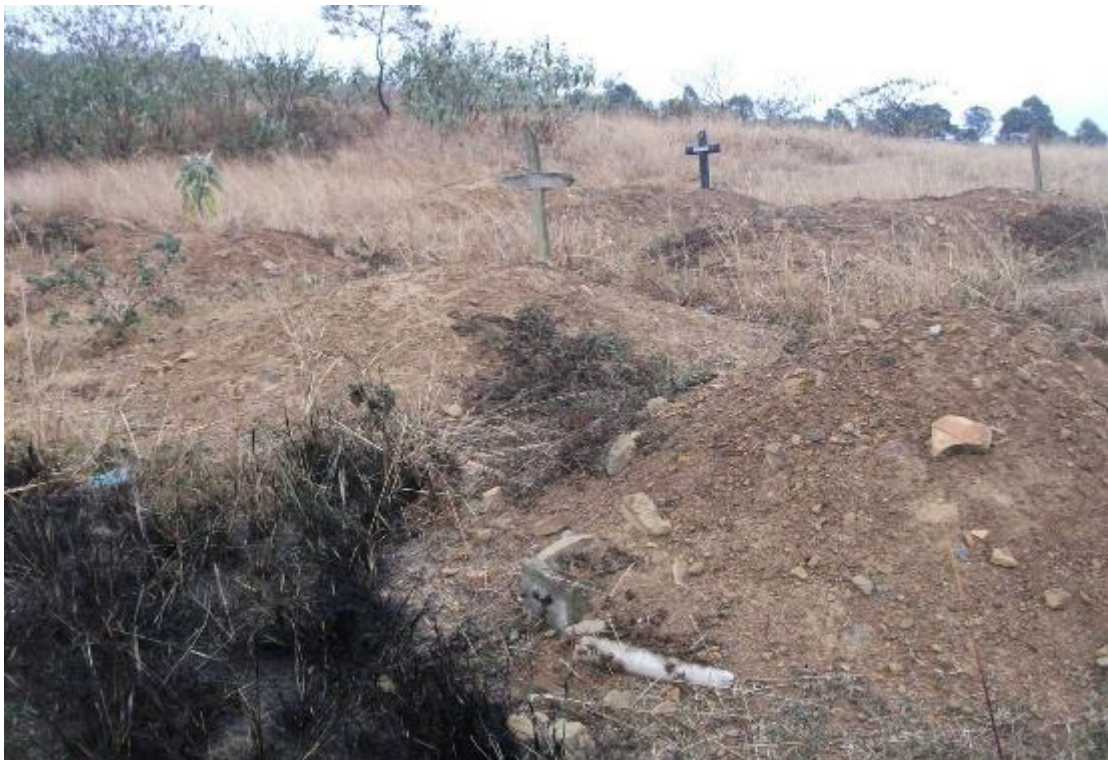
Figure 7: Graves with wooden crosses

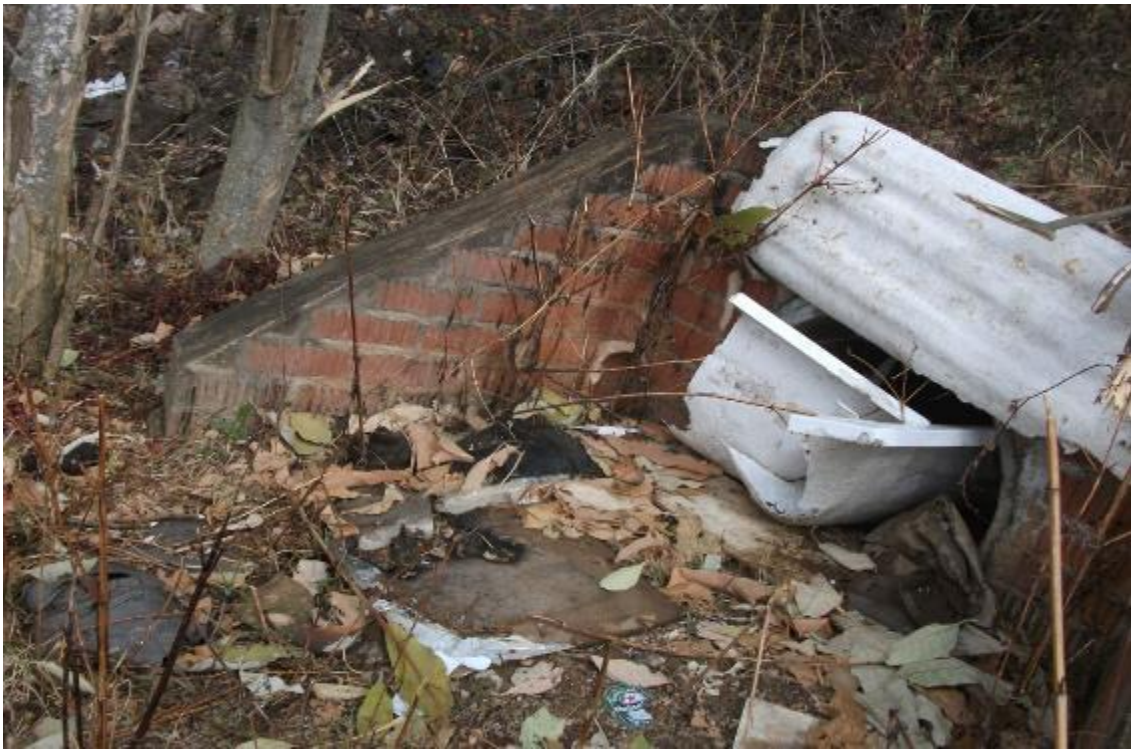
The area east and south of the cemetery towards the watercourse and below the tar road leading from the borrow pit (discussed previously) was inspected. Just below the tar road the remains of what appears to be a stormwater drain were found. It is of low heritage significance as there is no surrounding context to it.

Figure 8: Remains of drain

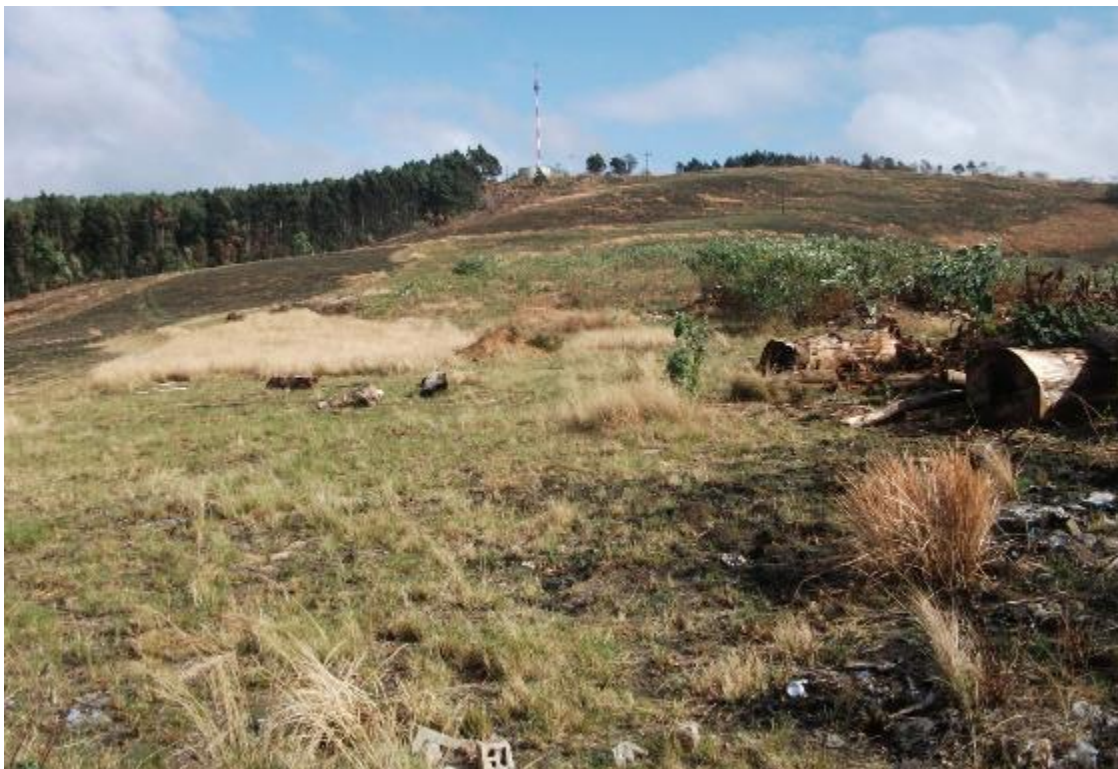
The southern sections of the project area were inspected and no heritage sites were found during the inspection. Dumping of refuse, building rubble, etc., is taking place in parts of this area. There is also existing water conveyance infrastructure and power lines.

Figure 9: Looking south over project area towards cellphone mast

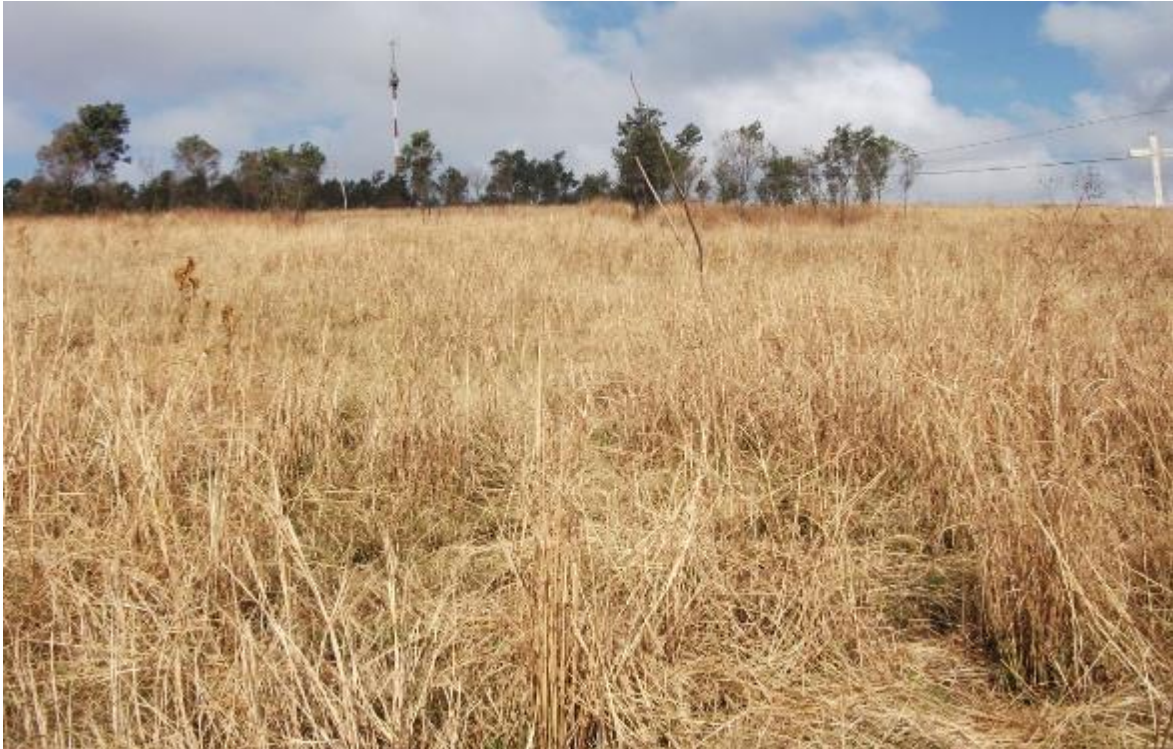
The area immediately south of the informal settlement has many illegal connections crossing it. The specialist inspected an area that was deemed to be safe as there was an existing pathway. No heritage sites were found in this area.

Figure 10: Illegal connections crossing project area

Once the illegal connections are removed from the area immediately south of the informal settlement, it is recommended that a heritage specialist inspect this area prior to development to ensure that no heritage sites are impacted by the construction of the houses.

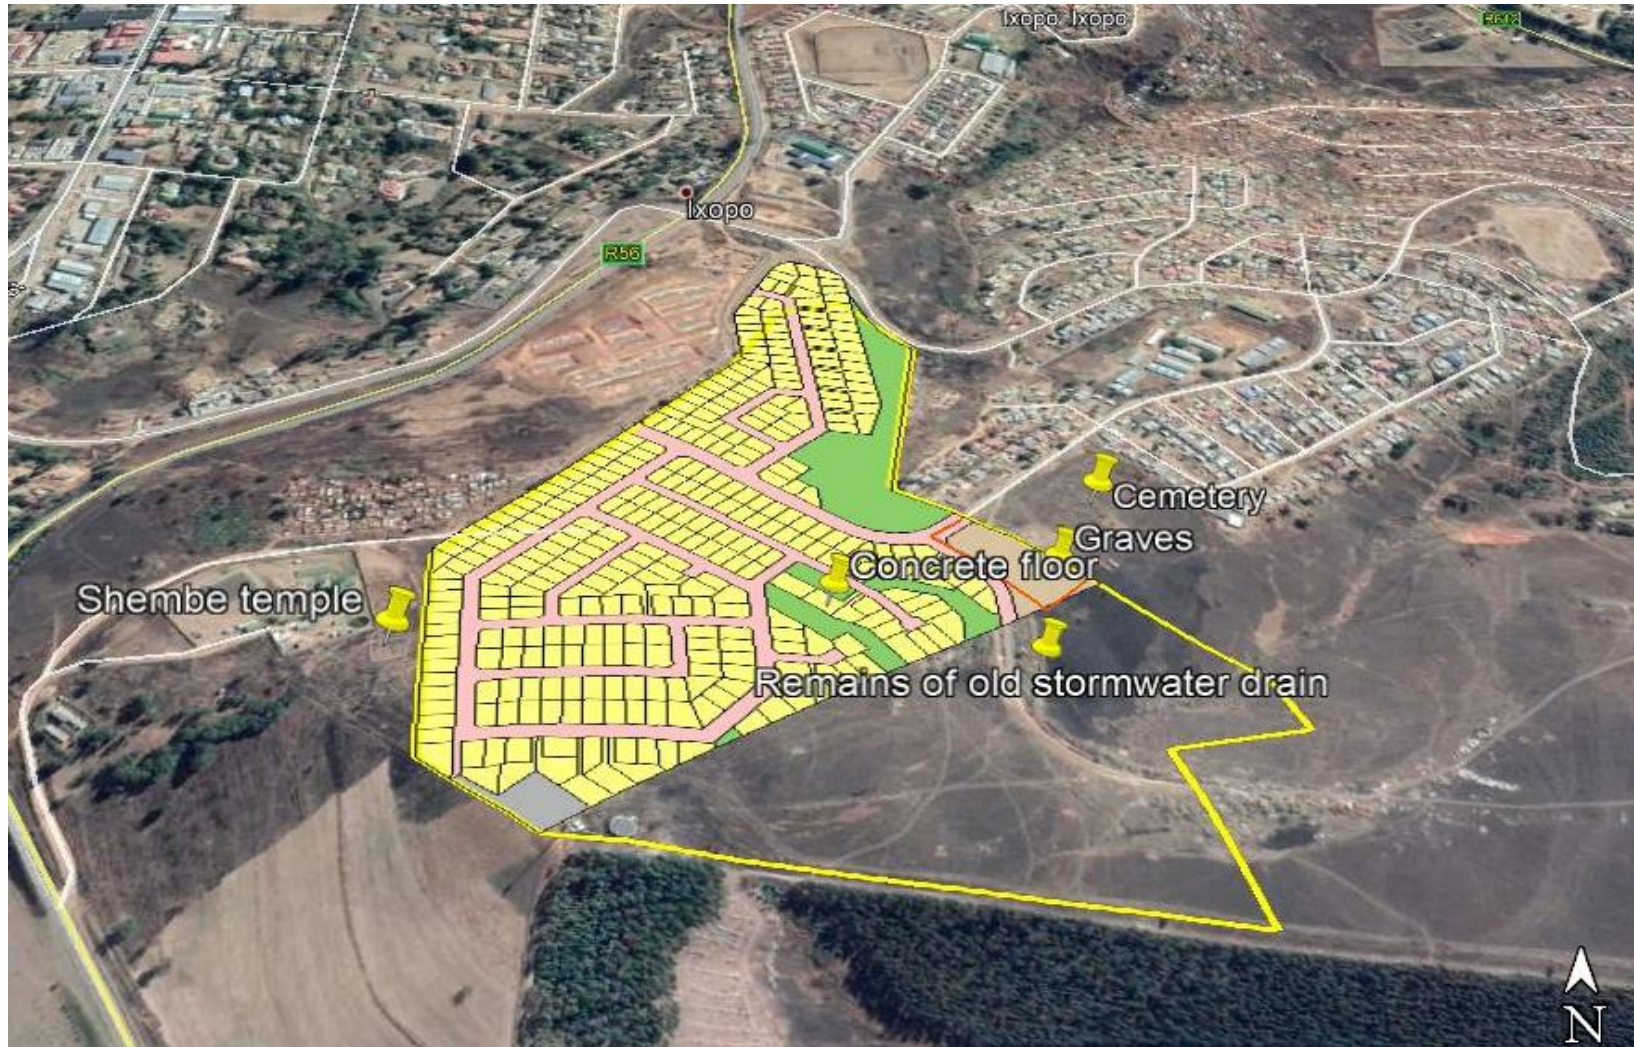
These recommendations were taken into account in the final layout of the housing project as can be seen in **Figures 12 and 13** below. The cemetery identified during the site inspection has been excluded from development.

Figure 12: Amended layout taking into consideration heritage sites
