KOEBERG INTEGRATION PROJECT

Heritage impact assessment of the proposed Acacia 2 x 400 kV
loop in lines to the Omega Substation and Koeberg 2 HV Yard
Western Cape Province

Prepared for

Savannah Environmental (Pty) Ltd

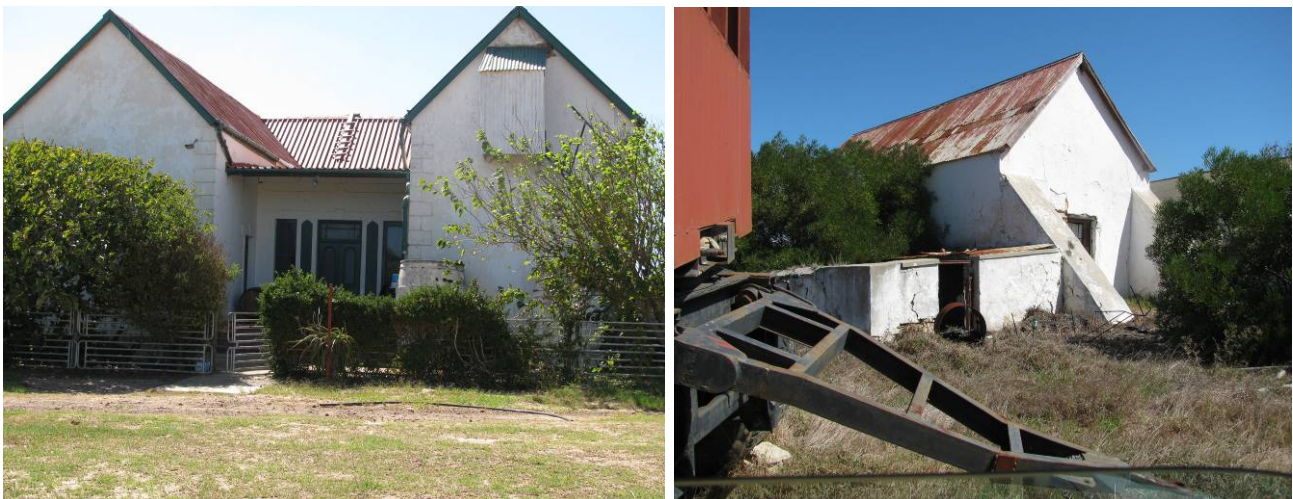
Figure 3 Vaatjie main house (left) and outbuilding (right).

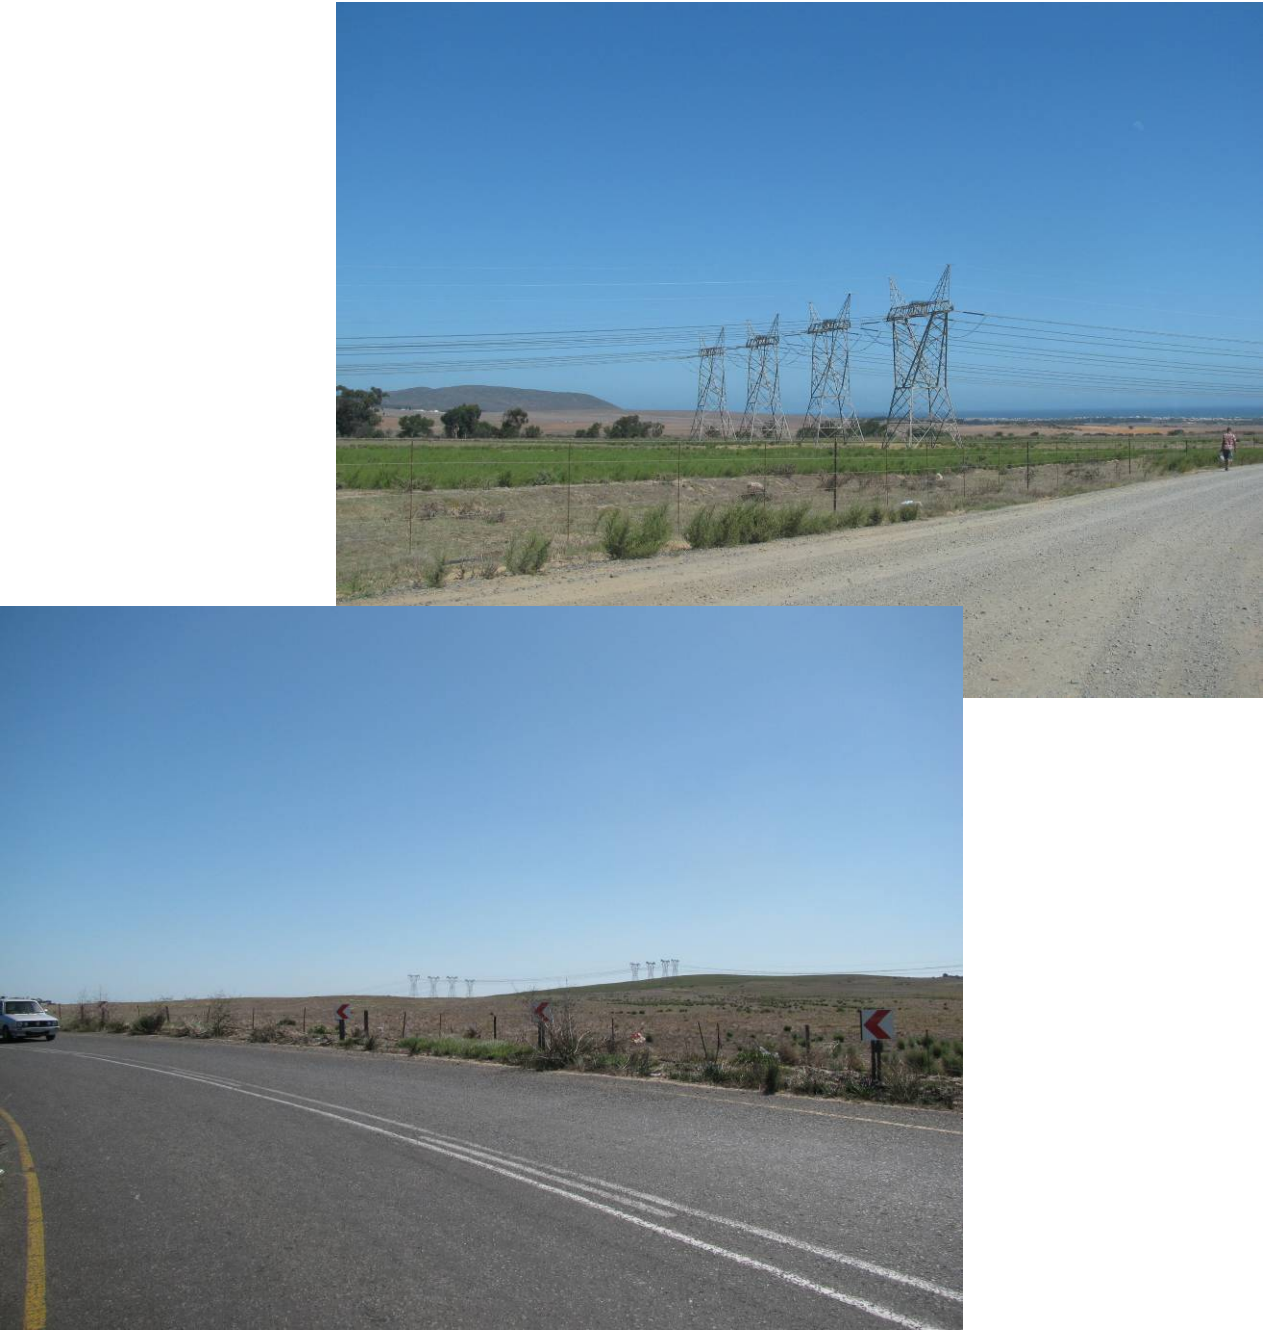
Figure 4 Above: view of existing 400 kV transmission lines from the turnoff to Olifants Kop Farm. Below: View of existing 400 kV transmission lines from a distance of 3 km (R304)

MITIGATION: It is recommended that in the interests of the conservation of landscape, existing corridors are used. Tower designs should be kept consistent within corridors.
CUMULATIVE IMPACTS: The massed transmission lines will be slightly more visible from a distance.
RESIDUAL IMPACTS: N/a

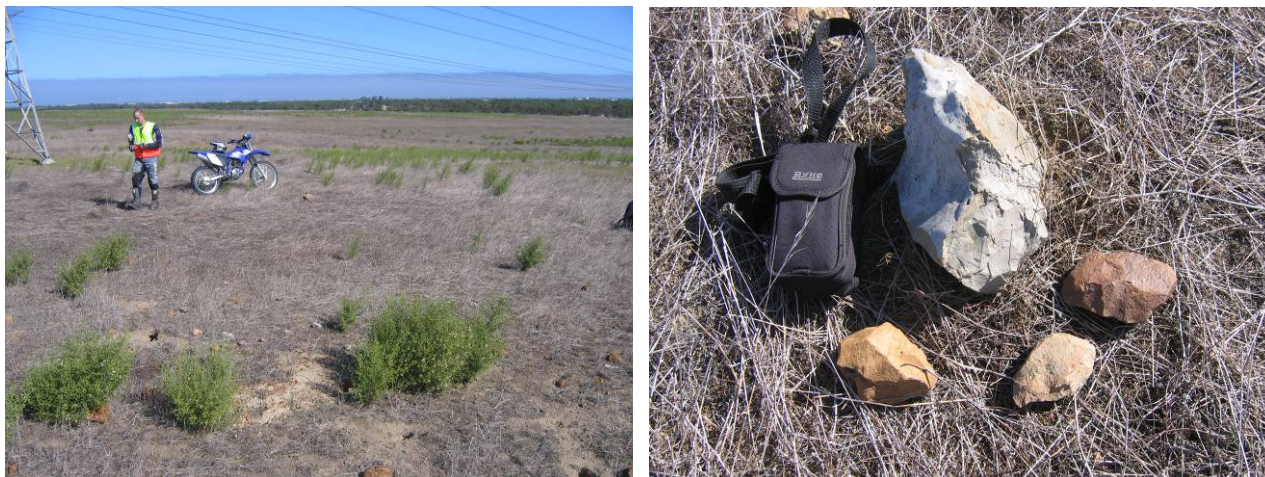
Site 1 (S 33 41 44.1 and E 18 29 26.7).

Figure 3 Site 1 (left), large silcrete chunk and patinated informal ESA material (right)

This is an area of scattered silcrete chunks, varying in size up to 30 to 40cm, irregular cores and a number of flakes and bifaces of later ESA or perhaps MSA age. Conversation with the farmer revealed that it is very likely that the more finely made (and diagnostic) artefacts have been removed or collected some time ago. The silcrete is heavily patinated and iron-stained. There is no silcrete outcrop at this site although larger silcrete boulders up to a meter in diameter have been cleared from the field and piled to the one side, as is the general practice. It is likely that a silcrete raft once existed here, the material having been quarried to a minor extent by prehistoric people. The raft was probably removed by farmers while lands were being prepared. The site lies in a disturbed context and is not considered significant in heritage terms.

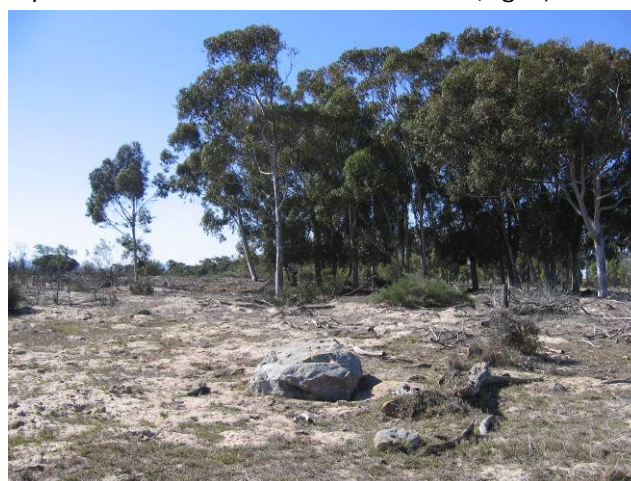
Figure 4 Disturbed area with silcrete boulder at site 2

end, site GO7 (ACO report 2004), intersected by both the R304 and the Atlantis railway line, a distance of nearly 300 m. This area is underlain by "raft silcrete" which is exposed in places, particularly under the gum trees to the west of the railway line. There are some flakes on the surface and evidence of quarrying of the silcrete outcrops. No formal tools were seen but the size and patina of the artefacts suggest at least MSA age. Large silcrete boulders also occur alongside the R304.

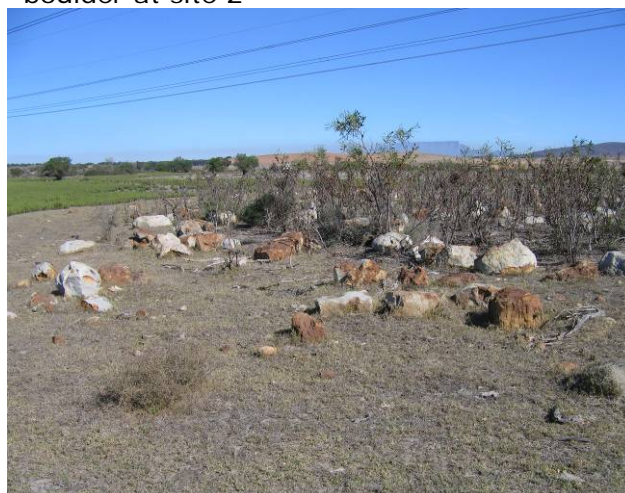
Figure 5 Silcrete boulders at site 3

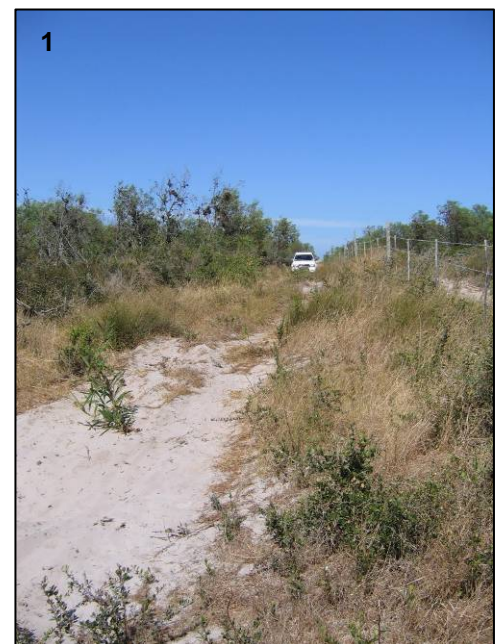
8.2 KZR 2 a&b

These are both highly disturbed Early Stone Age artefact scatters occurring on the lower slopes of a ploughed hill immediately adjacent to the jeep track and Donkergats River (plate 2). The scatter is fairly continuous but slightly denser patches are represented by the GPS co-ordinates. The artefacts originate from the deflation zone above the Malmsbury series and have been brought to the surface by ploughing. None of this material is found in the bed of the Donkergats River, but probably dips

below. We believe that the sands that line the bed of the Donkergats River are a fairly recent phenomenon probably supplemented by aeolian material. The scatter covers a large area (approximately 70x 20 meters). The artefacts consist of flakes, chunks and cores. A single small sub-classic biface (plate 5) was also located. Virtually all the material is made on silcrete and is for the most part heavily patinated and are frequently orange in colour. Fresh scars are likely to be due to plough damage.

Significance: Early Stone Age sites such as these are common and frequently found in cultivated land. Significance is low.

Recommendation: Take the position of the site into account during planning of transport and infrastructure. Although of low significance and disturbed by ploughing, damage to the site should be avoided.

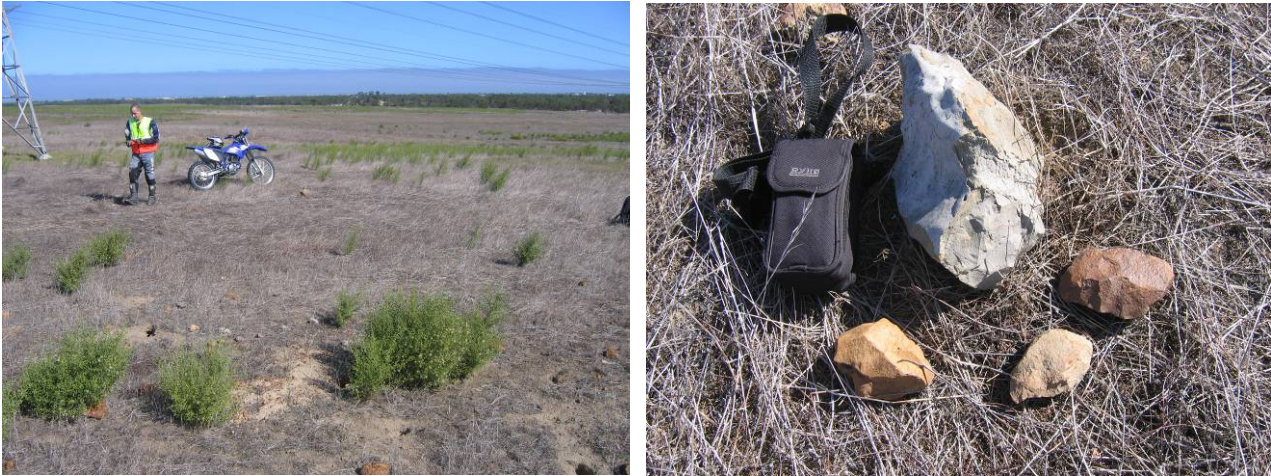
Figure 3 Site 1 (left), large silcrete chunk and patinated informal ESA material (right)

Atlantis. The area between Ankerlig and the entrance to the shooting range, where the lines turn south-west towards Koeberg is already heavily affected by construction of the railway line and station, the shooting range road and development of the industrial area. Site 1 (S 33 41 44.1 and E 18 29 26.7). This is an area of scattered silcrete chunks, varying in size up to 30 to 40cm, irregular cores and a number of flakes and bifaces of later ESA or perhaps MSA age. Conversation with the farmer revealed that it is very likely that the more finely made (and diagnostic) artefacts have been removed or collected some time ago. The silcrete is heavily patinated and iron-stained. There is no silcrete outcrop at this site although larger silcrete boulders up to a meter in diameter have been cleared from the field and piled to the one side, as is the general practice. It is likely that a silcrete raft once existed here, the material having been quarried to a minor extent by prehistoric people. The raft was probably removed by farmers while lands were being prepared. The site lies in a disturbed context and is not considered significant in heritage terms.

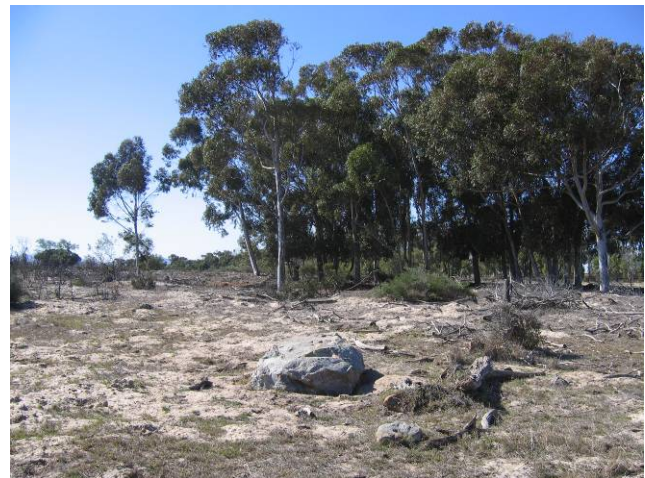
Figure 4 Disturbed area with silcrete boulder at site 2

by both the R304 and the Atlantis railway line, a distance of nearly 300 m. This area is underlain by "raft silcrete" which is exposed in places, particularly under the gum trees to the west of the railway line. There are some flakes on the surface and evidence of quarrying of the silcrete outcrops. No formal tools were seen but the size and patina of the artefacts suggest at least MSA age. Large silcrete boulders also occur alongside the R304.

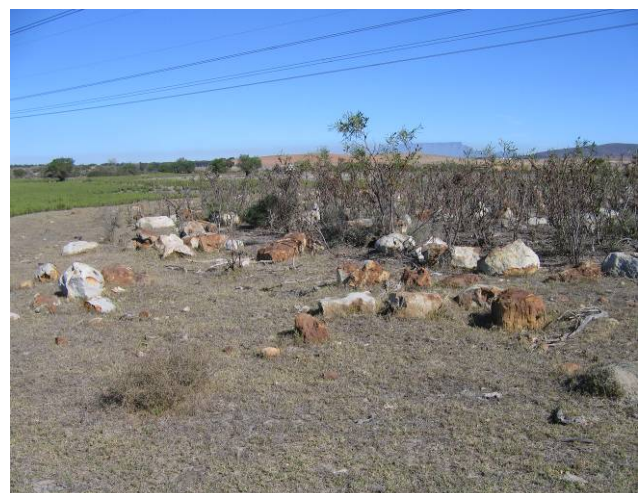
Figure 5 Silcrete boulders at site 3

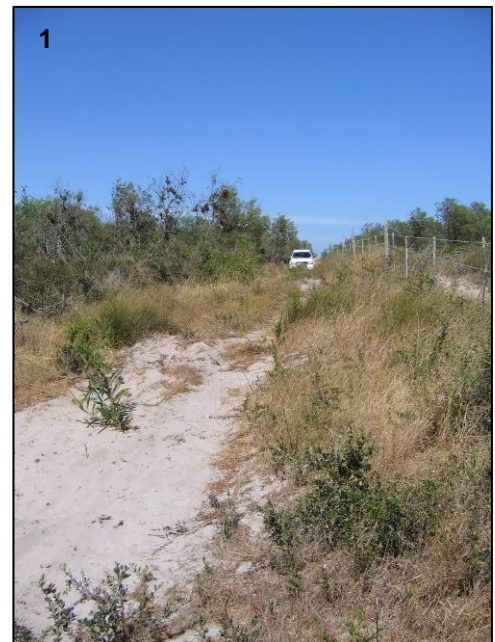
KZR 2 a&b

Significance: Early Stone Age sites such as these are common and frequently found in cultivated land. Significance is low.

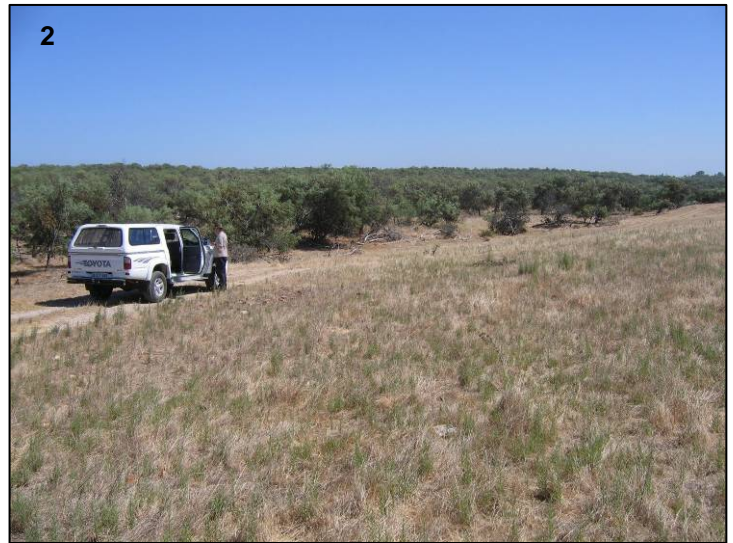
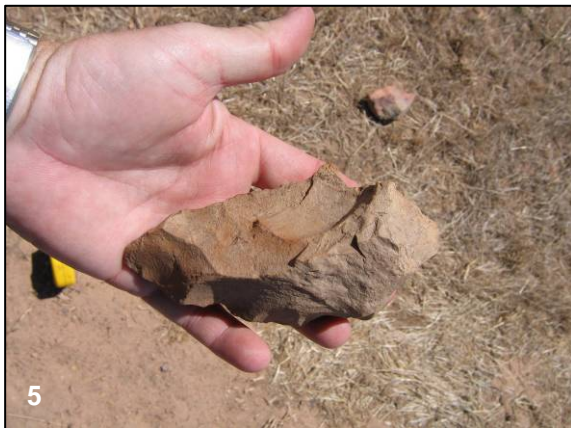
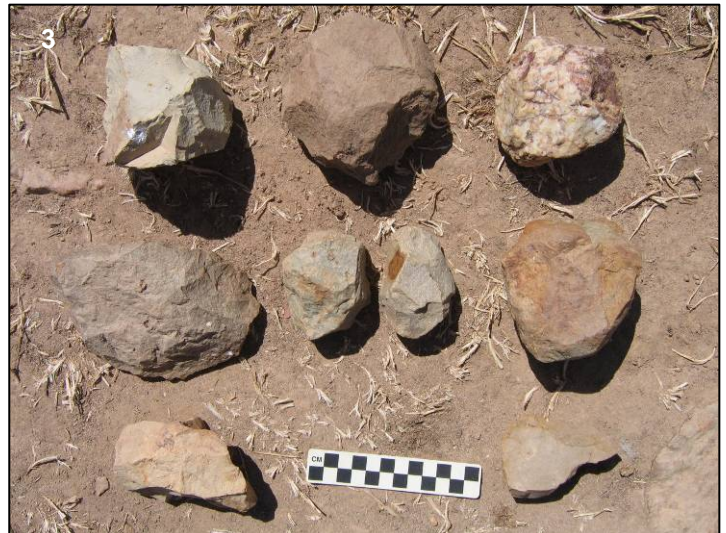
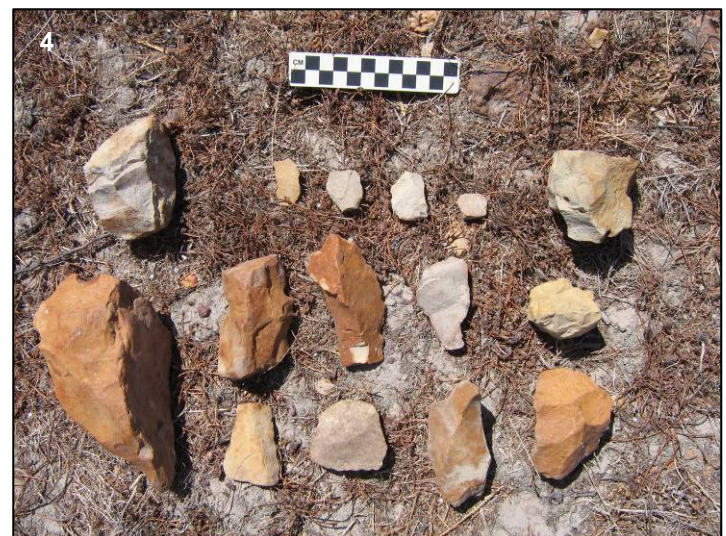
These are both highly disturbed Early Stone Age artefact scatters occurring on the lower slopes of a ploughed hill immediately adjacent to the jeep track and Donkergats River (plate 2). The scatter is fairly continuous but slightly denser patches are represented by the GPS co-ordinates. The artefacts originate from the deflation zone above the Malmsbury series and have been brought to the surface by ploughing. None of this material is found in the bed of the Donkergats River, but probably dips below. We believe that the sands that line the bed of the Donkergats River are a fairly recent phenomenon probably supplemented by aeolian material. The

scatter covers a large area (approximately 70x 20 meters). The artefacts consist of flakes, chunks and cores. A single small sub-classic biface (plate 5) was also located. Virtually all the material is made on silcrete and is for the most part heavily patinated and are frequently orange in colour. Fresh scars are likely to be due to plough damage.

Recommendation: Take the position of the site into account during planning of transport and infrastructure. Although of low significance and disturbed by plowing, damage to the site should be avoided.

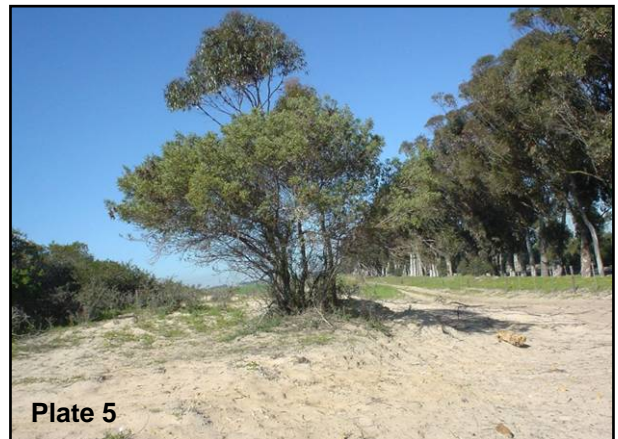
GO7

This site is located on the edge of the field identified as Alternative A (S 33° 42' 13.2" E 18° 30' 24.4"; Plate 5). It consists of a low bushy rise and sandy area (Plate 5) that have escaped ploughing and farming, and on which was found a very small selection of stone artefacts. These artefacts are made on silcrete and probably date to the Middle Stone Age (MSA), although a single ESA core in quartzite was also seen. This site has very low importance and could be assigned a provisional grading of 3b.

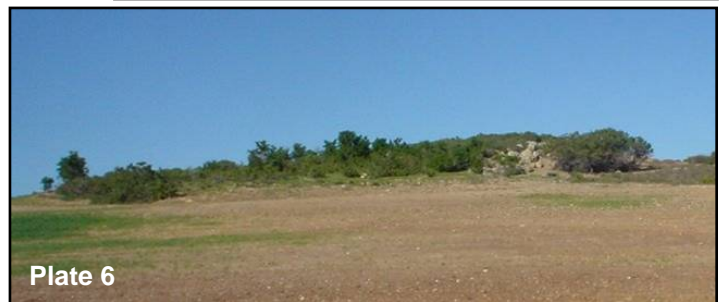
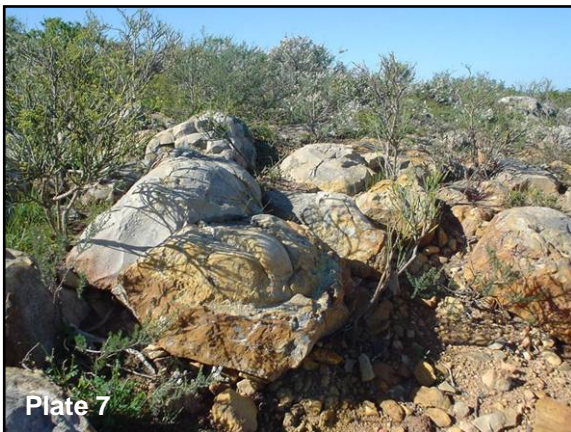
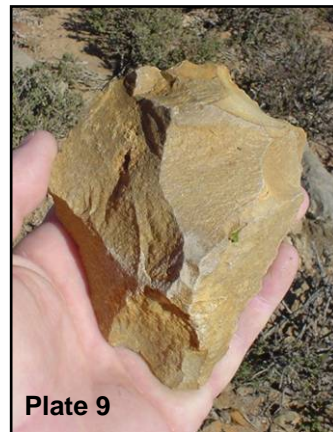
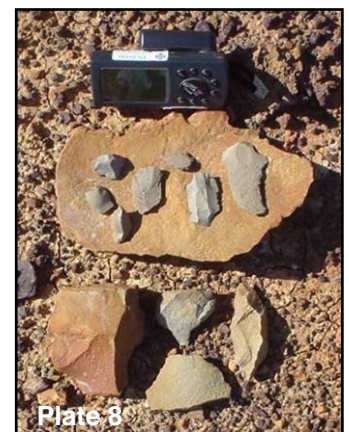
GO3

This site is located just within the southernmost part of the area earmarked as Alternative C (S 33° 42' 49.7" E 18° 29' 43.6"; Plate 6). Should this alternative be chosen the site would be directly impacted. The site is located on a small hill (Plate 6) capped with a layer of silcrete (Plate 7) from which

Age people have obtained raw material for the manufacture of stone artefacts. Numerous flakes, blades, cores and other débitage items are present lying on and around the hill (Plate 8), signifying frequent use of the outcrop as a stone source. Artefacts dating to the MSA and LSA (Later Stone Age) are common, although the former probably dominates. The vast majority of artefacts are on silcrete collected directly from the outcrop, although some quartz pieces are also present. A few silcrete artefacts attributable to the ESA, including one hand-axe (Plate 9), also occur. The deflated area to the northwest of the hill also contains numerous artefacts. This site could be assigned a grade of 3a.

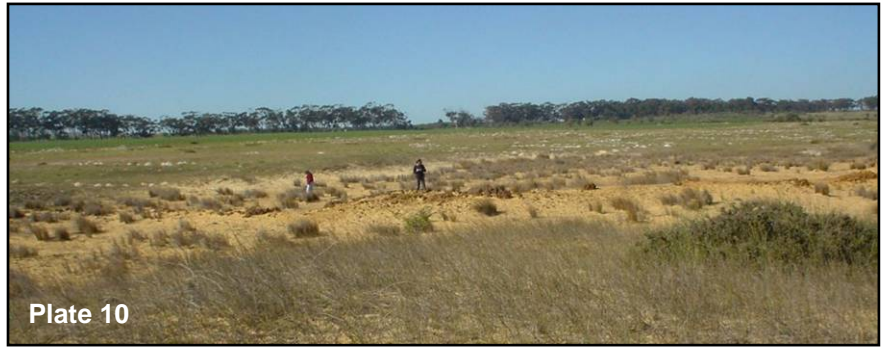
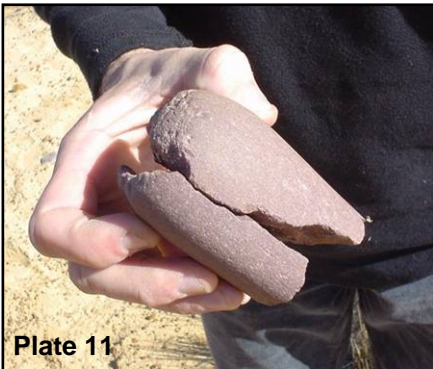
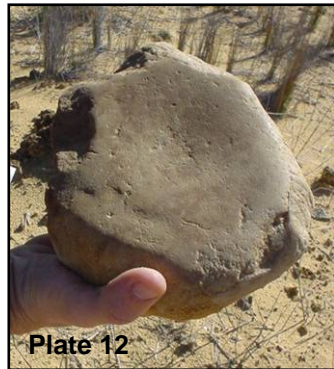
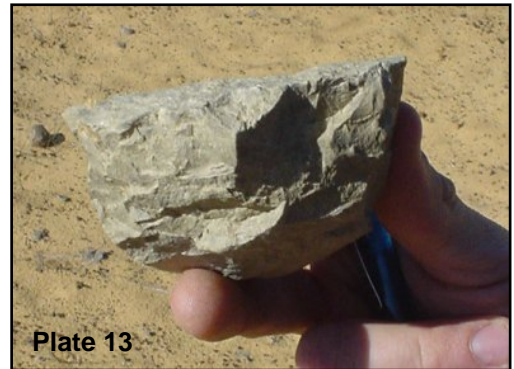
GO2

This site lies just outside the southeastern margin of Alternative C and should not be directly impacted by the erection of the substation here. The site should, however, be incorporated into the management plan for the farm as a whole, both during and after the construction phase. It is

located immediately east of GO3 (S 33° 42' 49.5" E 18° 29' 59.1"; Plate 10) and consists of a sandy deflation containing a scatter of stone artefacts. These seem to be a mixture of MSA and LSA artefacts. Among the latter are three fragments of cobbles, each of which had been used as both a hammerstone and an upper grindstone (e.g. Plate 11), and one larger cobble that had been used as a lower grindstone and anvil (Plate 12). Plate 13 shows a single platform core, possibly of MSA origin. Kaplan (1996) reports that Mr D. Drury of the South African Museum excavated two human skeletons from this site, described as "a large sand dune" (Kaplan 1996: 3), sometime in the mid-20th century. It is interesting to note that the artefacts occur in a deflation which appears to be a relatively recent phenomenon as shown by the blue circles on Figures 4 and 5 (aerial photographs from 1938 and 2001 respectively). The hill (foreground in Plate 10) is currently entirely vegetated and has no archaeological material present on it at all. We are uncertain as to how to reconcile these facts with the site having been recorded as a sand dune in the past. With the current deflation of the site, it is thought that its integrity has been substantially altered by souvenir hunters, with many artefacts probably having been removed over the years. As such, the site could provisionally be graded 3b.

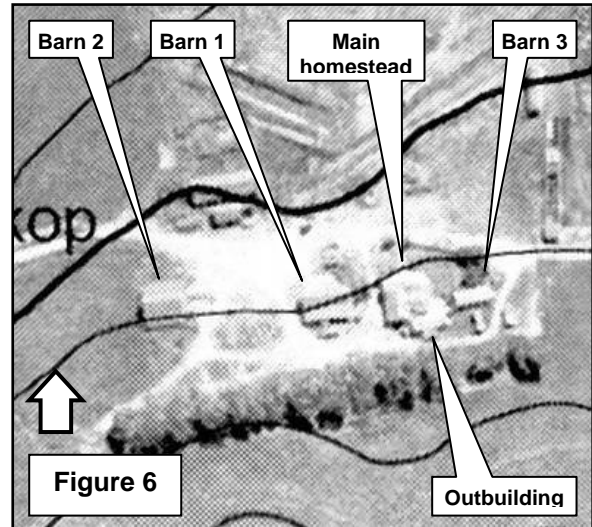
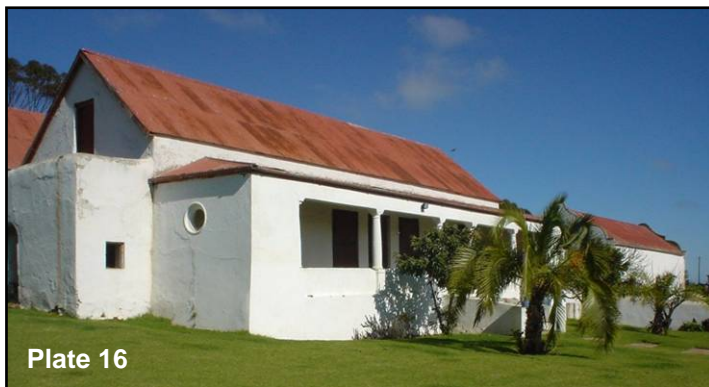
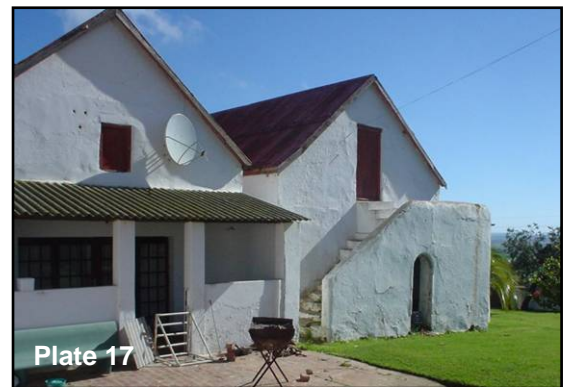
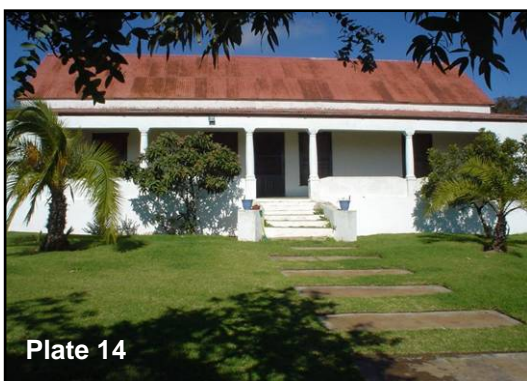
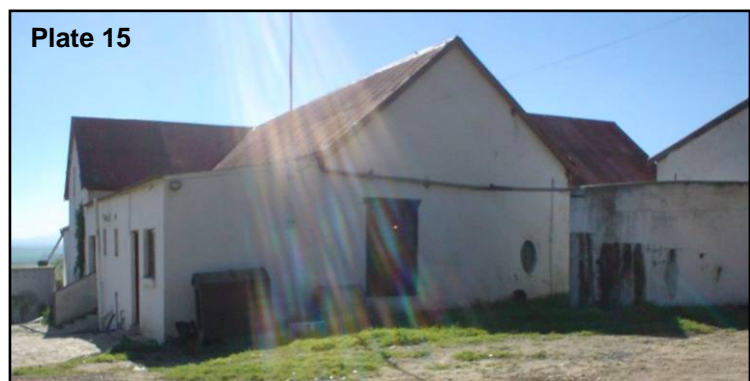
Main homestead

The main dwelling house (Plate 14) is architecturally very interesting. The previous report by Kaplan (1996) identified the building as late 18th or early 19th century, an estimate with which we agree. The essential form of the building is T-shaped indicating that it had its origins in the Dutch occupation period styles of the 18th century. The seemingly organic growth of this building suggests that it may even have originally started out as a longhouse, in the form of the current front portion. Although various additions were made to the building in later years (e.g. small room on the left in Plate 15 and second wing and later stoep on the left in Plate 17), the T-shaped core still exists. The front stoep (Plates

14 & 16) was probably added in the early 20th century and it is quite likely that the original thatched roof was replaced with corrugated iron at the same time. If the building ever had a front gable, it may well have been removed at this time. There is a solder in the roof space which is accessed by an outside staircase built in stone against the eastern end gable (Plates 17 & 18). Most of the openings in the building have 19th century fenestration ranging from Victorian to Georgian apart from the modern additions to the "T" form which contain contemporary joinery. The farm house has a neat garden bounded by a vernacular style yard wall.

This farmhouse is a significant structure protected by section 34 of the National Heritage

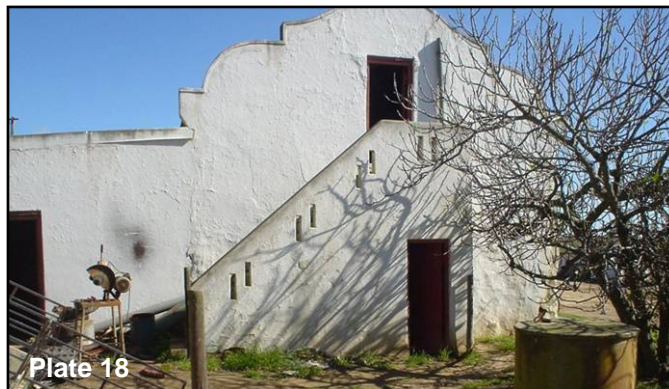
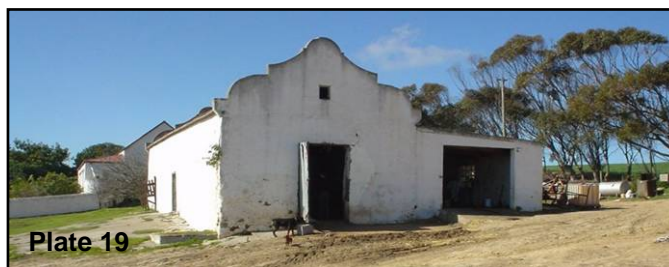
Old outbuildings

At least four of the outbuildings are old. The dates of 1937 on the barn immediately west of the main homestead (Barn 1; Plate 18 & 19) and 1933 on the barn to the southeast of the main dwelling (Barn 3; Plate 20) do not reflect the true age of the buildings. Rather they date the addition of the Cape Dutch revivalist gables to the already existing structures. Some of the joinery and fabric in the barns certainly predates the end of the 19th century and in all likelihood is earlier. Both the original structures were re-roofed when the gables were added resulting in loss of the original roof joinery. The barn dated 1937 has a modern shed added to its southern side. The last and western-most barn (Barn 2; Plate 21) probably also dates to at least the mid- to late 19th century. Its straight gables are quite likely older than the curved gables of the other barns. This barn has had modern sheds attached to either side.

The outbuildings are protected by section 34 of the National Heritage Resources Act as applied by Heritage Western Cape. A permit must be applied for and issued for their alteration or destruction.
