KOEBERG INTEGRATION PROJECT

Heritage Impact Assessment for the construction of two 400kV  
transmission lines between Koeberg 2 NPS, Omega substation,  
Muldervlei substation and the Stikland substation, Cape Town  
Metro, Western Cape Province

April 2010

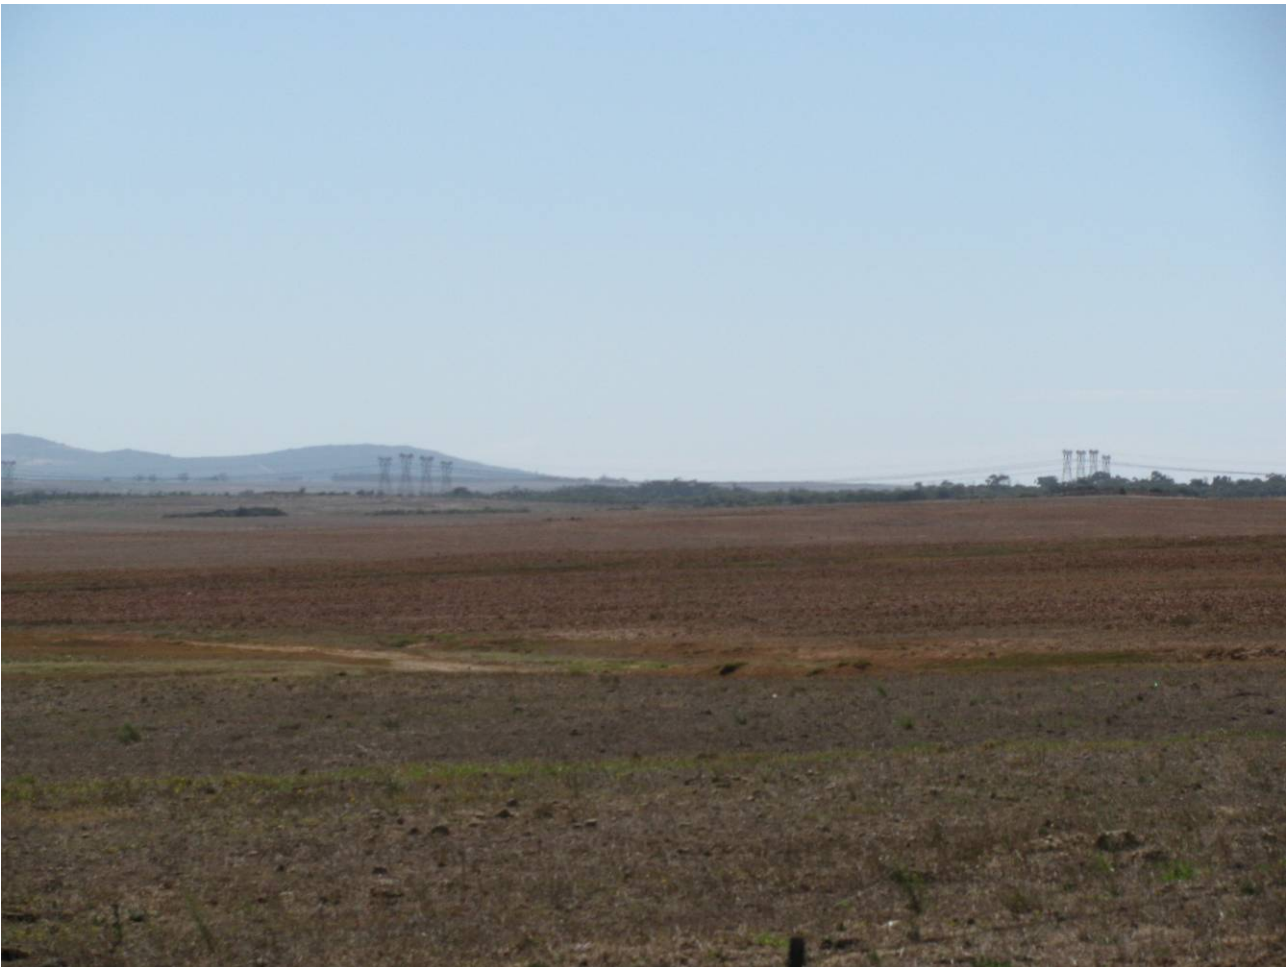
**Figure 2 4x400 kV transmission lines Koeberg – Omega viewed from roughly 2000 m in open landscape.**

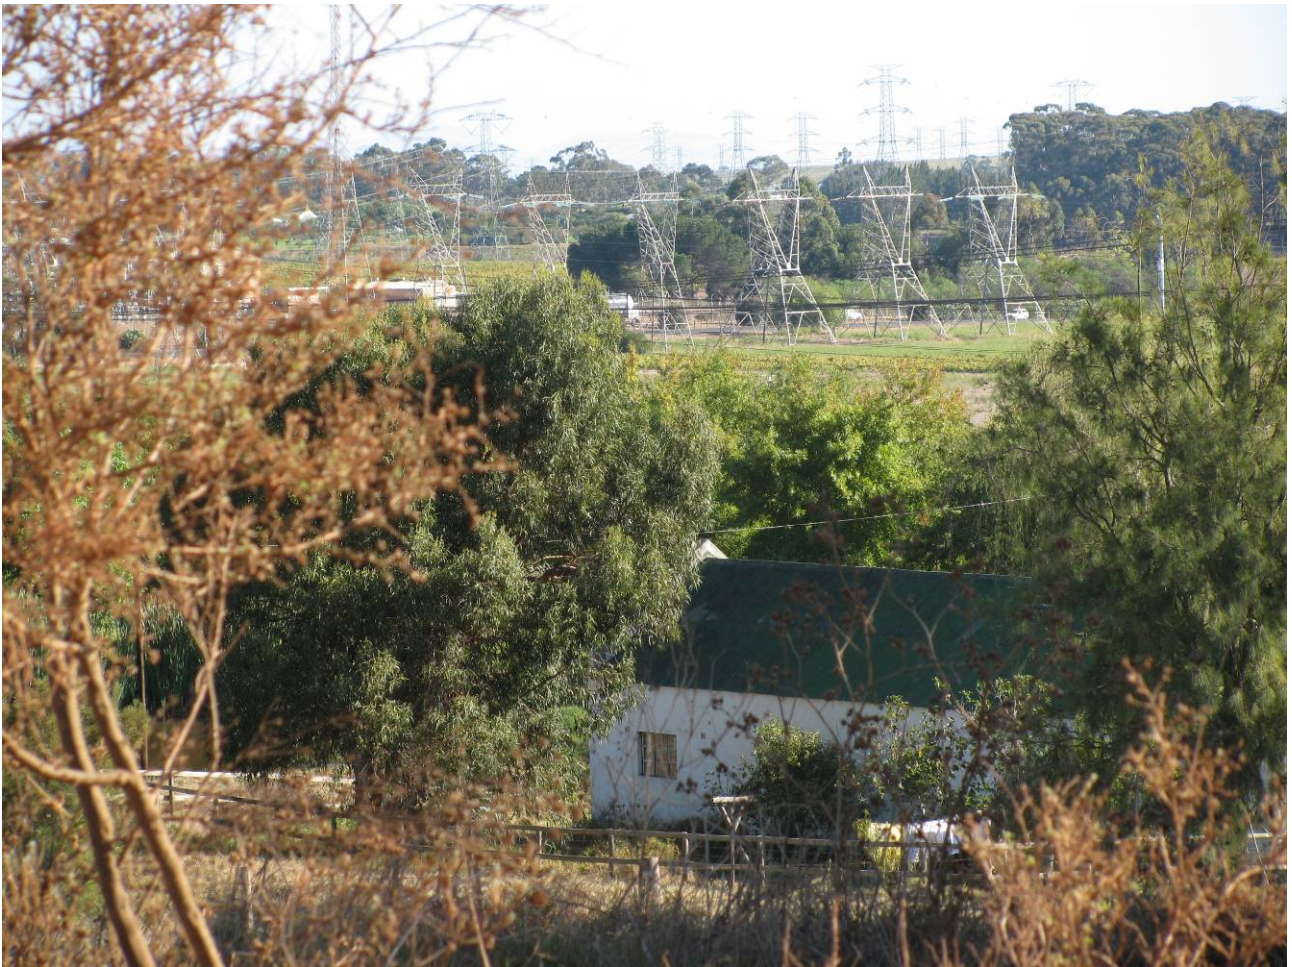
**Figure 3 The heritage site Joostenberg Vlakte (in the fore-ground) has been negatively impacted by transmission lines and other infrastructure within 200 m of the buildings.**

The existing Muldersvlei Stikland corridor passes along the western edge of the Cape Winelands. This incorporates the Joostenberg Vlakte, an area with a long history of small holdings. Halkett & Attwell (2009) have characterised the landscape around Joostenberg Vlakte as unused agricultural lands, an undulating topography with distant views of the mountains. They have described the area as having limited heritage and scenic significance although the landscape currently possesses a sense of openness particularly enhanced by the land slopes towards the south west from the R312. The Muldersvlei substation and existing power line servitudes to Stikland has already resulted in notable impacts to a number of historic Cape farms. The farm Joostenberg Vlakte lies adjacent to a veritable maze of electrical infrastructure. Transmission lines pass through the landscape of the historic farm Bellevue Provincial Heritage Site and are overtly visible as a backdrop to Hazendal, also a Provincial Heritage Site (see figures 3 and 4).

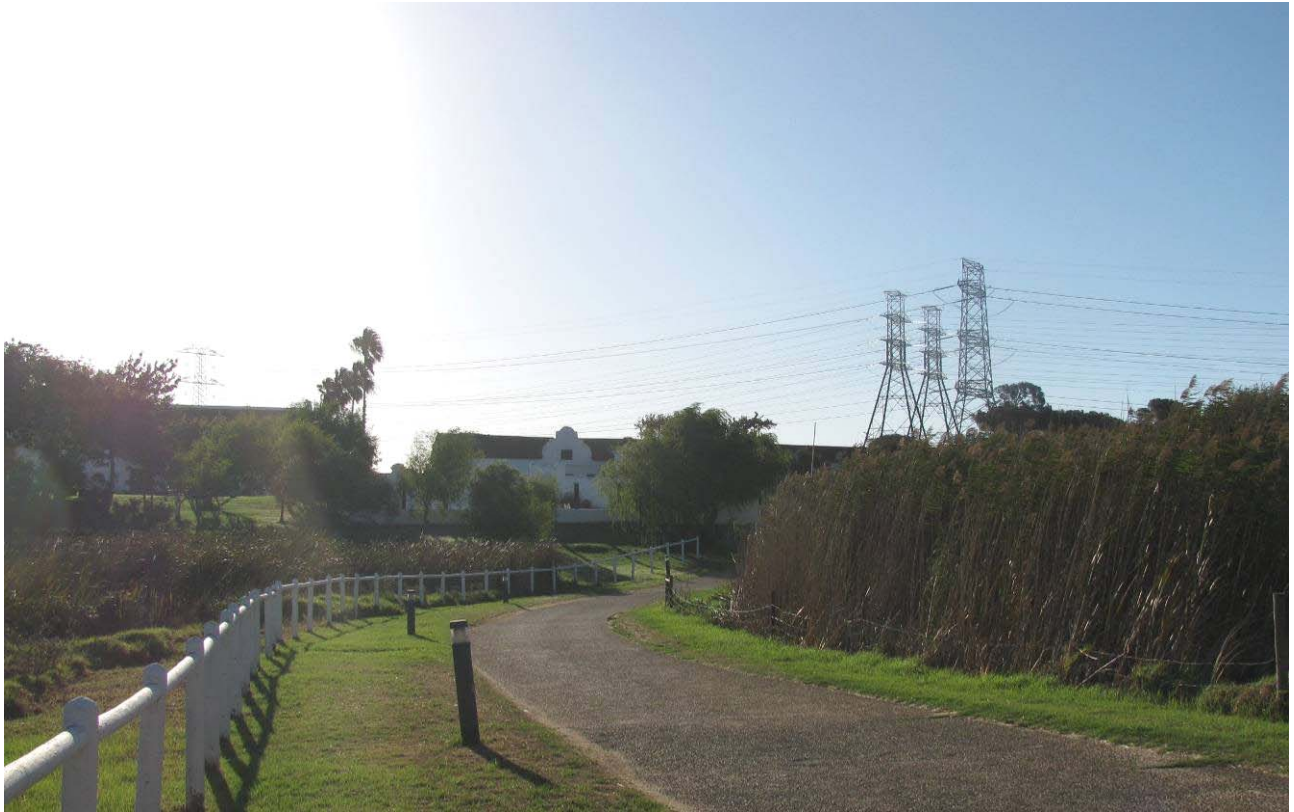
**Figure 4 Transmission lines and towers located some 80 m behind the farm buildings at Hazendal Provincial Heritage Site dominate the view towards the buildings and destroy the sense of history of the place.**

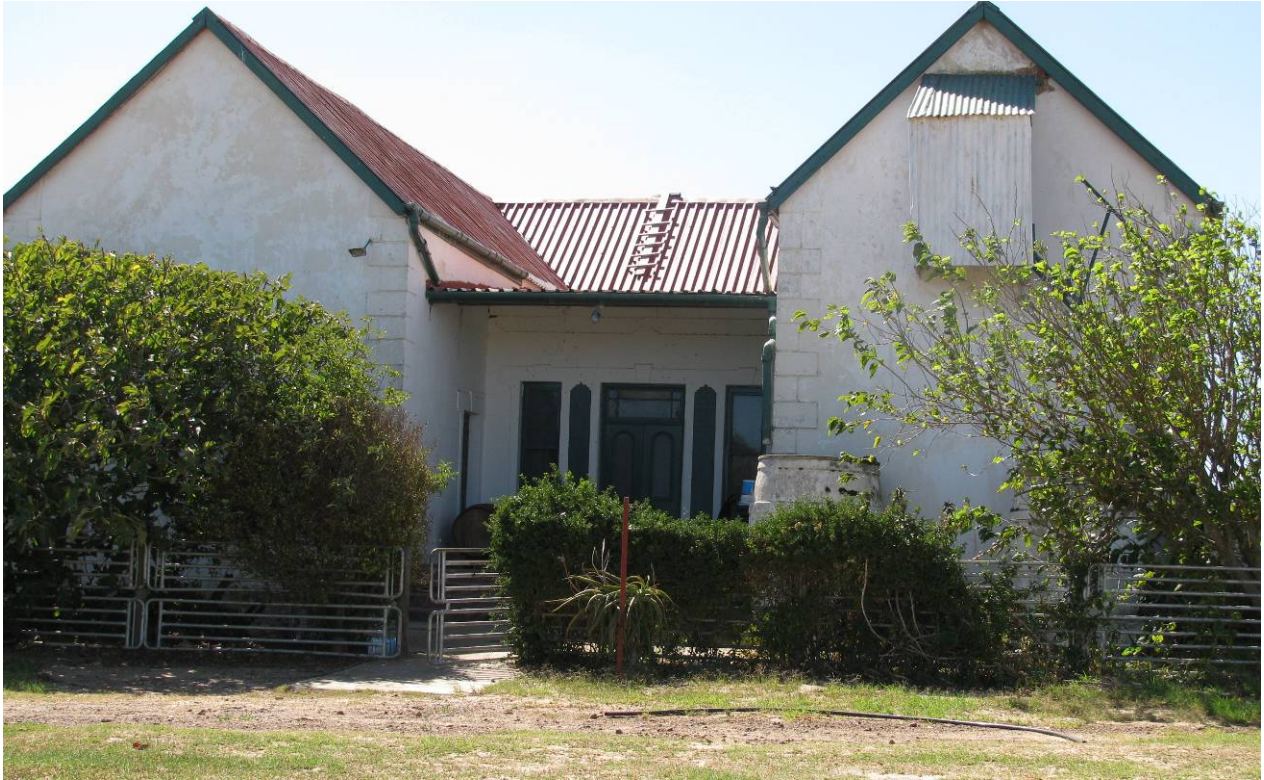
**Figure 5 The main farm house at Vaatjie.**

Deviation 1. Utilisation of this option will result in further fragmentation of the landscape and have negative visual implication for the historic farm Vaatjie, as well as greatly increased visibility from Oliphants Kop. This alternative is not supported.

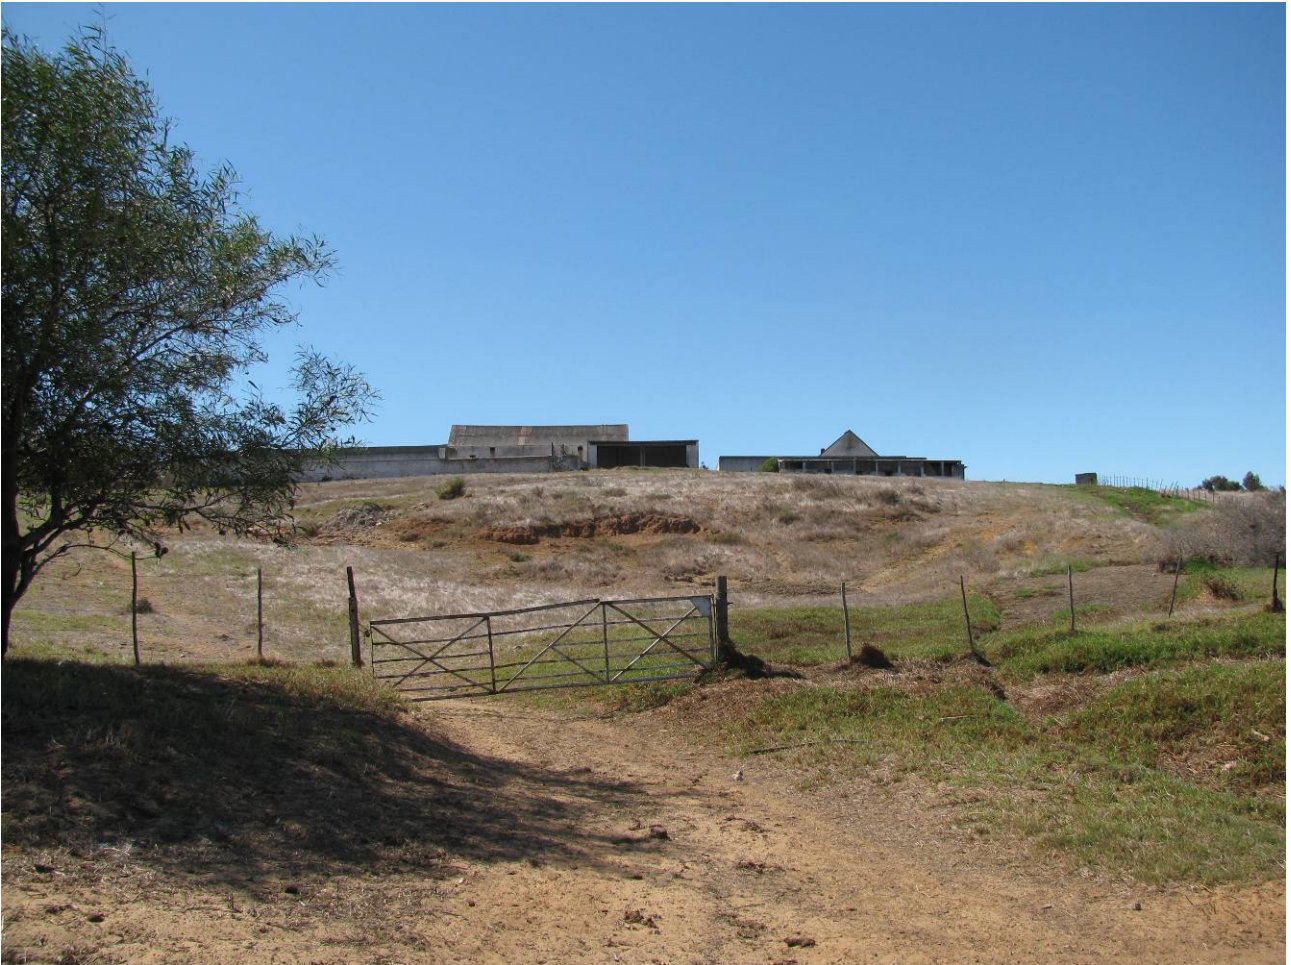
**Figure 7 Kalkfontein: A Swartland farm with early origins characterised by buildings representing several centuries.**

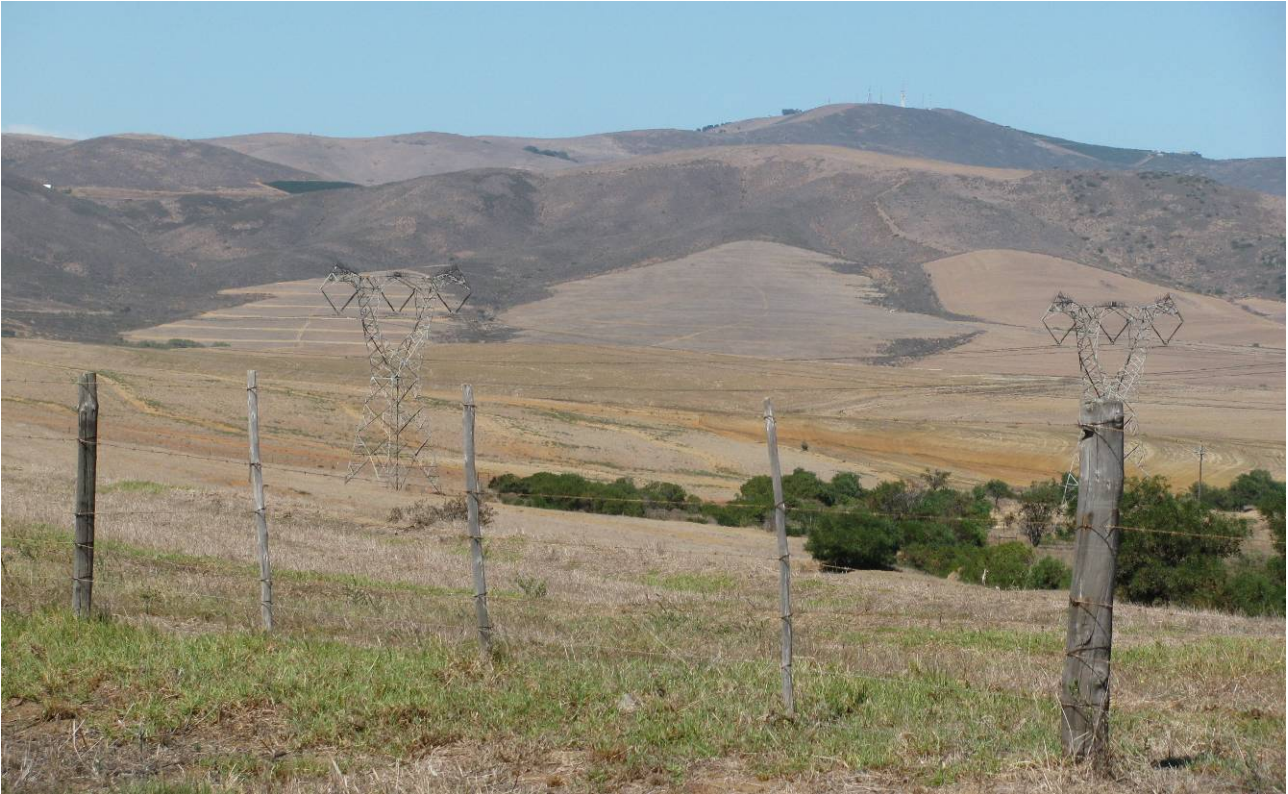
**Figure 8** 4x400 kV transmission lines close to Kalkfontein (above) are quite well absorbed by the rolling landscape despite the fact they are only 340 m from the visual reference point.

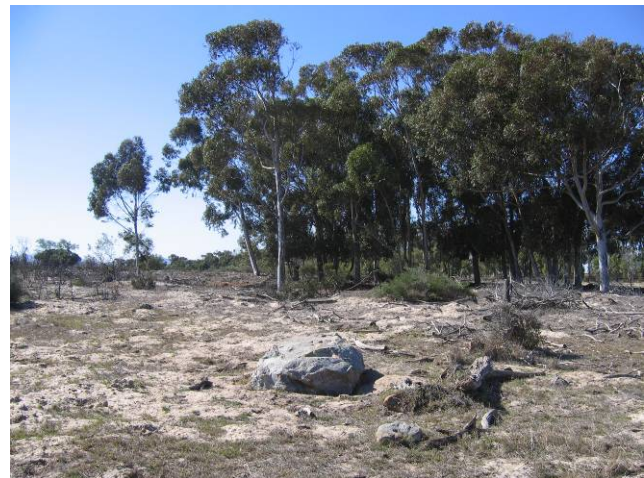
**Figure 4** Disturbed area with silcrete boulder at site 2

by both the R304 and the Atlantis railway line, a distance of nearly 300 m. This area is underlain by "raft silcrete" which is exposed in places, particularly under the gum trees to the west of the railway line. There are some flakes on the surface and evidence of quarrying of the silcrete outcrops. No formal tools were seen but the size and patina of the artefacts suggest at least MSA age. Large silcrete boulders also occur alongside the R304.

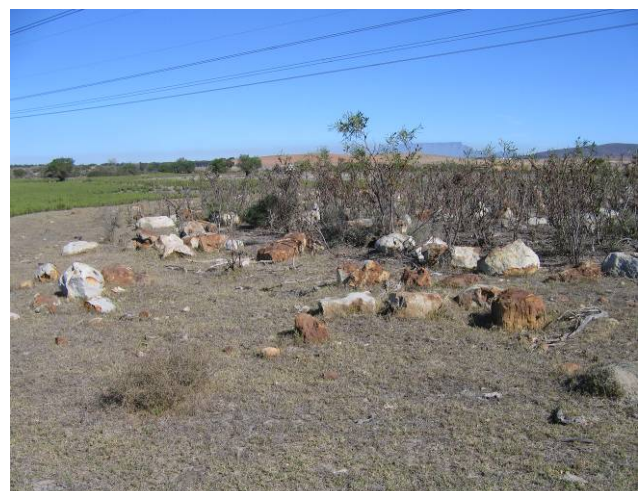
**Figure 5** Silcrete boulders at site 3

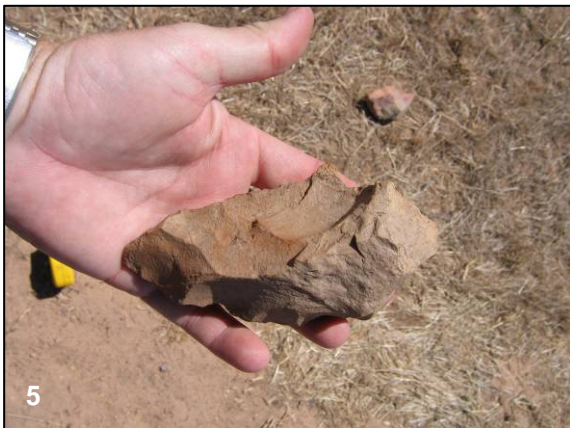
KZR 2 a&b

These are both highly disturbed Early Stone Age artefact scatters occurring on the lower slopes of a ploughed hill immediately adjacent to the jeep track and Donkergats River (plate 2). The scatter is fairly continuous but slightly denser patches are represented by the GPS co-ordinates. The artefacts originate from the deflation zone above the Malmsbury series and have been brought to the surface by ploughing. None of this material is found in the bed of the Donkergats River, but probably dips below. We believe that the sands that line the bed of the Donkergats River are a fairly recent phenomenon probably supplemented by aeolian material. The

scatter covers a large area (approximately 70x 20 meters). The artefacts consist of flakes, chunks and cores. A single small sub-classic biface (plate 5) was also located. Virtually all the material is made on silcrete and is for the most part heavily patinated and are frequently orange in colour. Fresh scars are likely to be due to plough damage.

**Significance:** Early Stone Age sites such as these are common and frequently found in cultivated land. Significance is low.

**Recommendation:** Take the position of the site into account during planning of transport and infrastructure. Although of low significance and disturbed by plowing, damage to the site should be avoided.

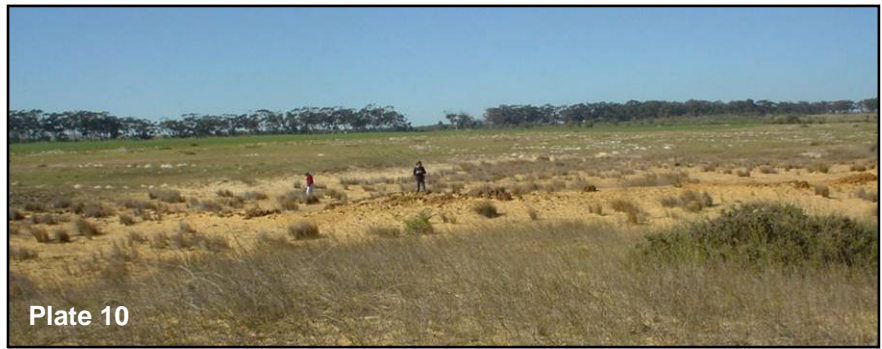
GO2

This site lies just outside the southeastern margin of Alternative C and should not be directly impacted by the erection of the substation here. The site should, however, be incorporated into the management plan for the farm as a whole, both during and after the construction phase. It is

located immediately east of GO3 (S 33° 42' 49.5" E 18° 29' 59.1"; Plate 10) and consists of a sandy deflation containing a scatter of stone artefacts. These seem to be a mixture of MSA and LSA artefacts. Among the latter are three fragments of cobbles, each of which had been used as both a hammerstone and an upper grindstone (e.g. Plate 11), and one larger cobble that had been used as a lower grindstone and anvil (Plate 12). Plate 13 shows a single platform core, possibly of MSA origin. Kaplan (1996) reports that Mr D. Drury of the South African Museum excavated two human skeletons from this site, described as "a large sand dune" (Kaplan 1996: 3), sometime in the mid-20th century. It is interesting to note that the artefacts occur in a deflation which appears to be a relatively recent phenomenon as shown by the blue circles on Figures 4 and 5 (aerial photographs from 1938 and 2001 respectively). The hill (foreground in Plate 10) is currently entirely vegetated and has no archaeological material present on it at all. We are uncertain as to how to reconcile these facts with the site having been recorded as a sand dune in the past. With the current deflation of the site, it is thought that its integrity has been substantially altered by souvenir hunters, with many artefacts probably having been removed over the years. As such, the site could provisionally be graded 3b.

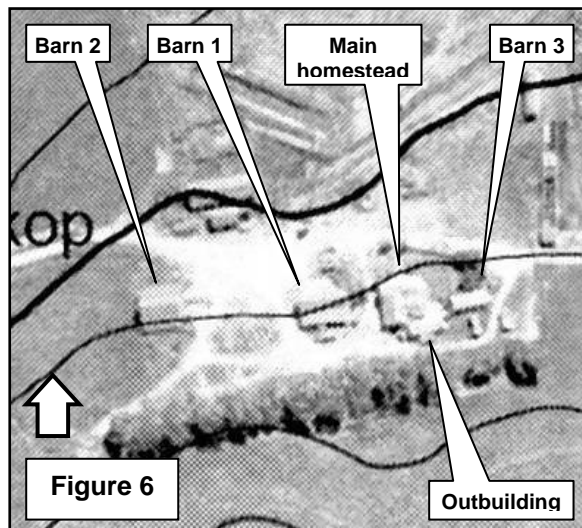
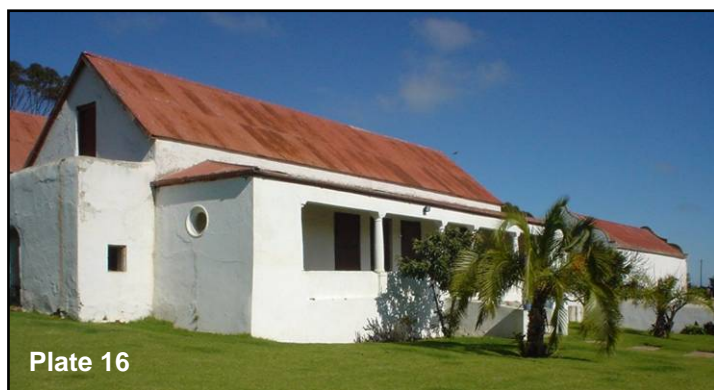
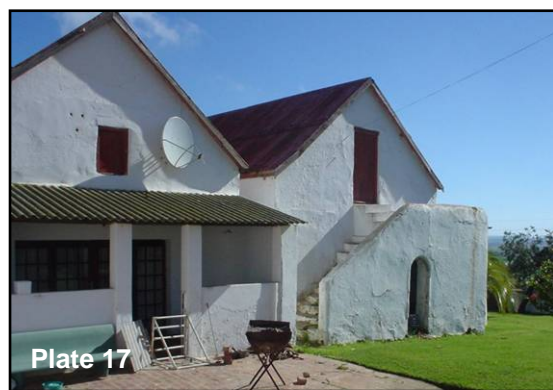
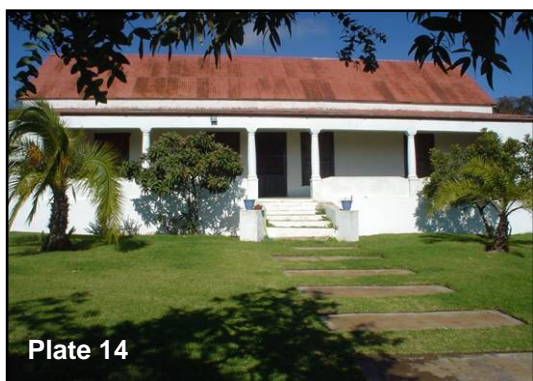
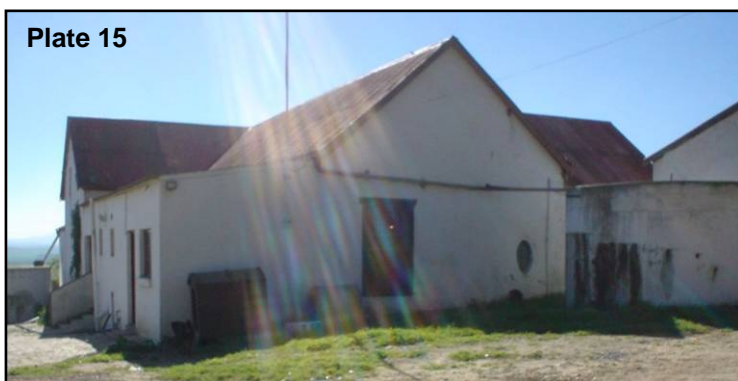
### Main homestead

The main dwelling house (Plate 14) is architecturally very interesting. The previous report by Kaplan (1996) identified the building as late 18th or early 19th century, an estimate with which we agree. The essential form of the building is T-shaped indicating that it had its origins in the Dutch occupation period styles of the 18th century. The seemingly organic growth of this building suggests that it may even have originally started out as a longhouse, in the form of the current front portion. Although various additions were made to the building in later years (e.g. small room on the left in Plate 15 and second wing and later stoep on the left in Plate 17), the T-shaped core still exists. The front stoep (Plates

14 & 16) was probably added in the early 20th century and it is quite likely that the original thatched roof was replaced with corrugated iron at the same time. If the building ever had a front gable, it may well have been removed at this time. There is a solder in the roof space which is accessed by an outside staircase built in stone against the eastern end gable (Plates 17 & 18). Most of the openings in the building have 19th century fenestration ranging from Victorian to Georgian apart from the modern additions to the "T" form which contain contemporary joinery. The farm house has a neat garden bounded by a vernacular style yard wall.

This farmhouse is a significant structure protected by section 34 of the National Heritage

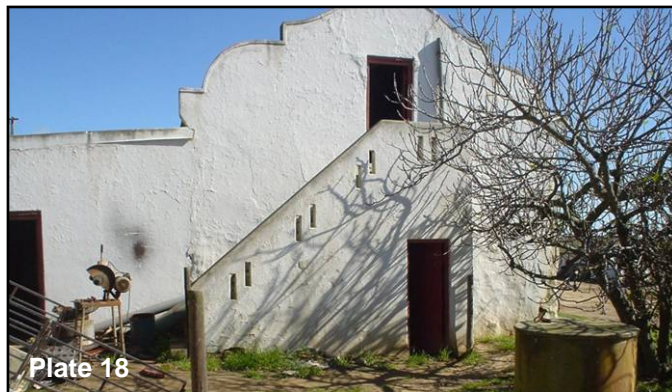
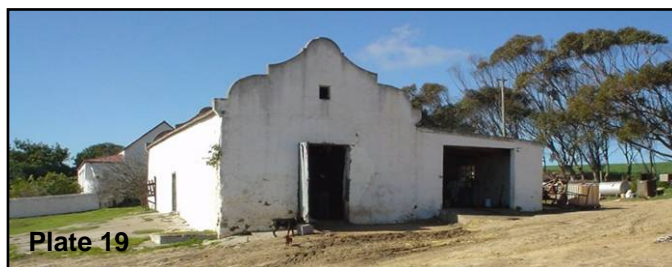
At least four of the outbuildings are old. The dates of 1937 on the barn immediately west of the main homestead (Barn 1; Plate 18 & 19) and 1933 on the barn to the southeast of the main dwelling (Barn 3; Plate 20) do not reflect the true age of the buildings. Rather they date the addition of the Cape Dutch revivalist gables to the already existing structures. Some of the joinery and fabric in the barns certainly predates the end of the 19th century and in all likelihood is earlier. Both the original structures were re-roofed when the gables were added resulting in loss of the original roof joinery. The barn dated 1937 has a modern shed added to its southern side. The last and western-most barn (Barn 2; Plate 21) probably also dates to at least the mid- to late 19th century. Its straight gables are quite likely older than the curved gables of the other barns. This barn has had modern sheds attached to either side.

The outbuildings are protected by section 34 of the National Heritage Resources Act as applied by Heritage Western Cape. A permit must be applied for and issued for their alteration or destruction.

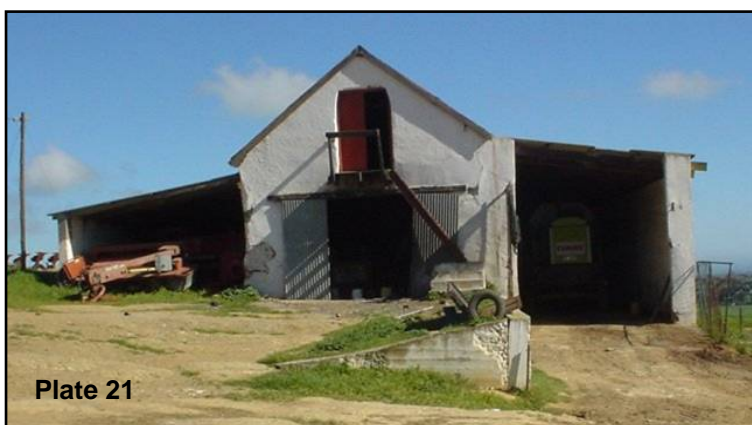
Immediately south-east of the main house is a small outbuilding with an oven attached to it (Plate 22). This building is also old and is “reputed to be older than the main house” (Kaplan 1996: 4). Prior to the installation of a kitchen in the main homestead, this outbuilding may well have functioned as the farm kitchen.

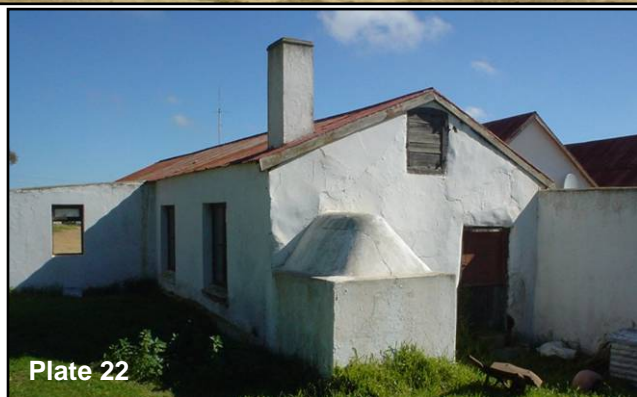
The other houses and farm outbuildings are clearly recent in origin and, although forming

part of the cultural landscape of the farm, are of no specific historical interest.
