S.A. COAL ESTATES
THE ENVIRONMENTAL MANAGEMENT
PROGRAMME REPORT
FOR
KLEINKOPJE COLLIERY
SUPPLEMENTARY REPORT No.27

KLEINKOPJE COLLIERY

PHASE 1 IDENTIFICATION SURVEY OF
HISTORICAL SITES

Anton C. van Vollenhoven
(Archaeologist)
July 1993

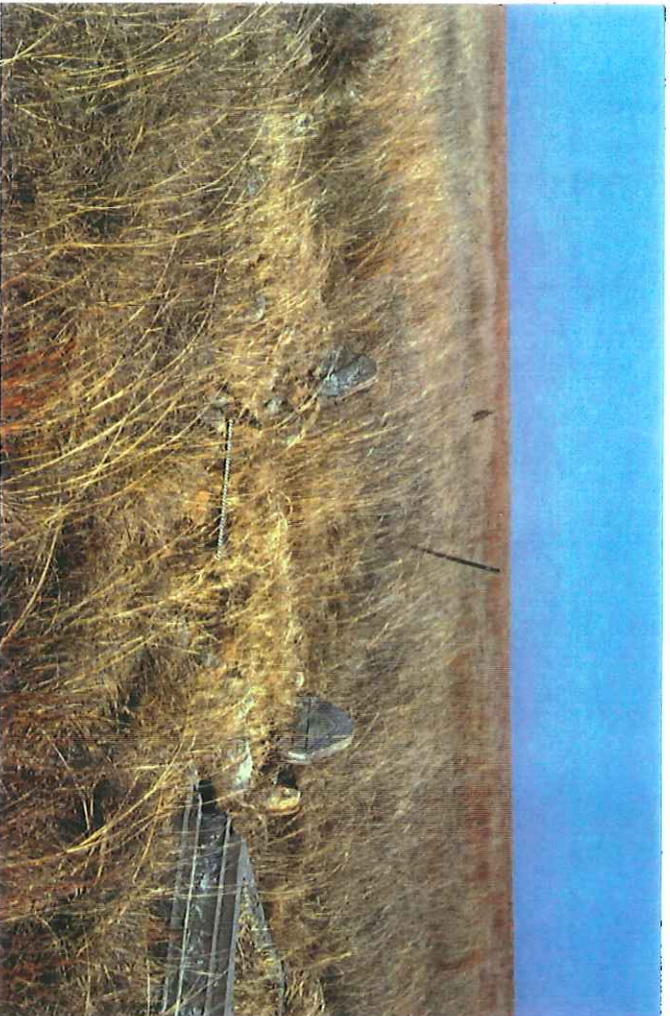
In the southeastern portion of the area an old graveyard was found (figure 2). It consisted of approximately 12 graves, hidden in long grass. No fence exist, but signs of a former fence was seen. The graves were clearly older than fifty years.

Six graves were unmarked and were no more than packed heaps of stone. Five more graves had cement tombstones, but were still unmarked (figure 3). Only one grave was marked (figure 4). It had a cement tombstone. It read: Thomas Mahlan Guwaiala
14.7.19

2. The graveyard in the 5 West mining block shows graves with cement tombstones and stone heaps.

7.1 As the graves in the 5 West mining block are in the way of future mining activities it should be moved. They may be moved, after a permit for this has been obtained from the National Monuments Council. The regulations of these legislation should be followed. As a result of this report no problem in this matter is foreseen.

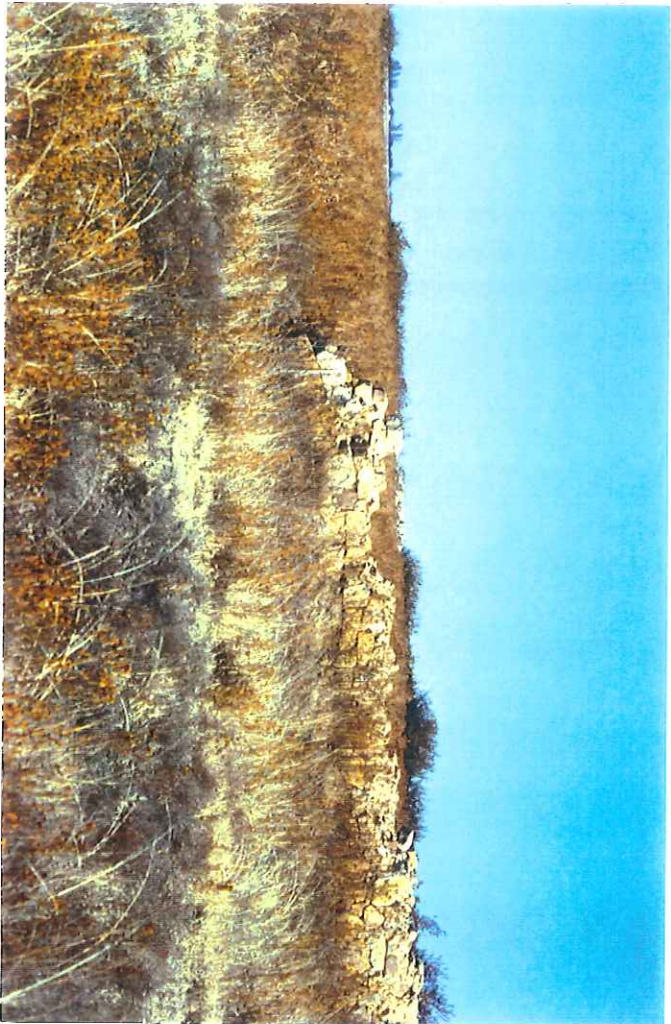
A kraal built from sandstone was found in the southeastern portion of the area, about 200m southwest of the abovementioned graves (figure 5). It is a square structure with an entrance on the eastern side (figure 6). It includes, what seems to be a kraal for calves, attached to it (Naude 1988:210) (figure 7). It's planform is very similar to that of kraal's generally found in the Transvaal, as found by Naude (1988:216) in a study on Transvaal farm structures and buildings.

As no remains of a settlement were found in this area, it is believed to have been built by Europeans. It was probably built there because it is near the river. It is strange that no trace of a farm house or it's remains were found in this area (Naude 1988:208; Naude and Van Vollenhoven 1991:13).

The square form also suggest that it is a European structure. This would probably place it in the latter half of the previous century or early in this century (Naude 1988:208-218).

The most important find is the cattle kraal in the 5 West mining block. As this is but one of a number of well known similar structures (Naude 1988:208-218) it's scientific value decreases. For this reason it should not be in the way of mining activities. However, if it is to be demolished a permit has to be obtained from the National Monuments Council.

5. The cattle kraal, built of sandstone, in the 5 West mining block.

7.3 Although the cattle kraal in block 5 West is older than fifty years it is of minor importance. Thus it may be demolished, but only after obtaining a permit for this from the National Monuments Council. This shouldn't be a problem as a result of this report. If mining activities reveal more information on this and it seems to be of a higher historical value, it should be re-evaluated by an archaeologist.
