Preliminary Archaeological Survey of Karoopoort Farm

**Ceres Magisterial District
Western Cape Province**

Cape Tanqua Tourism Services

24 October 2011

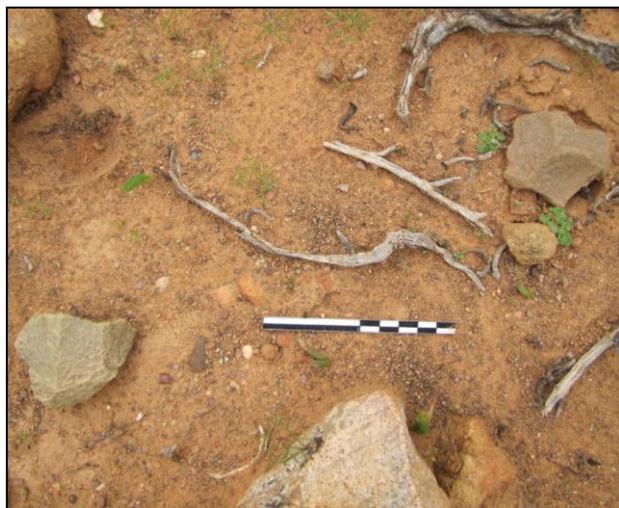
Three GPS points were taken on an amorphous artefact scatter across an area of c. 40m. Several cores and flakes worked from dark grey, coarse grained quartzite are probably MSA in date (Plate 2). One LSA hornfels flake, with possible retouch or use wear (Plate 3), and some unmodified ochre fragments were also found within c. 15m of KRP 7a.

Plate 2: MSA grey quartzite cores

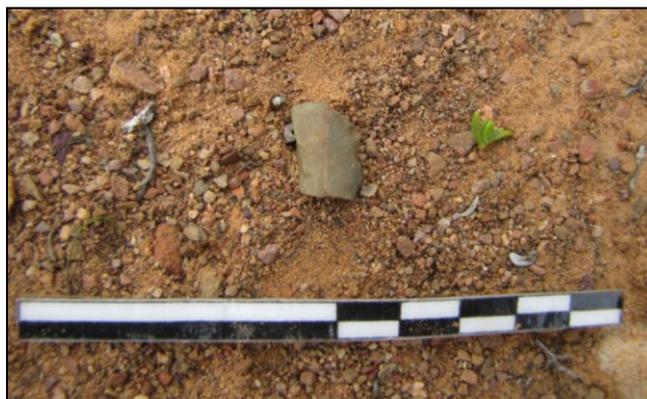
Plate 3: LSA hornfels flake

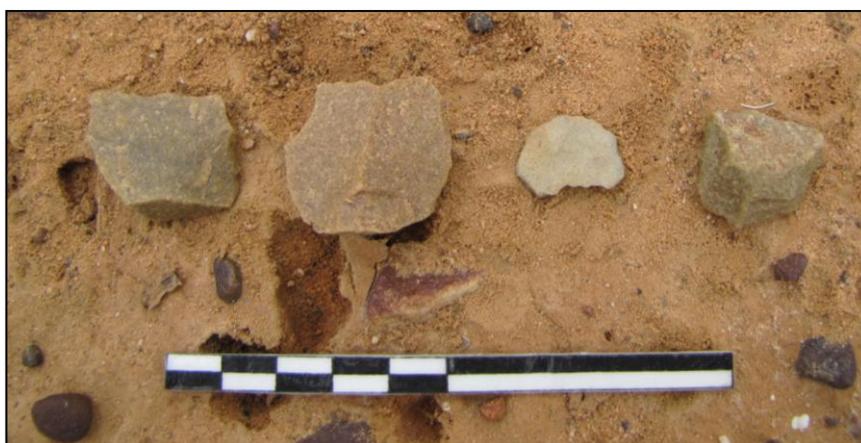
At GPS point KRP 7b there was a denser localised scatter of dark grey, coarse quartzite flakes found in close proximity to a LSA hornfels scraper (Plate 4). An additional hornfels flake with use-wear on both lateral edges, a possible LSA adze tool, was recorded at KRP 7c.

Plate 4: LSA Quartzite flakes and hornfels scraper (third from left)

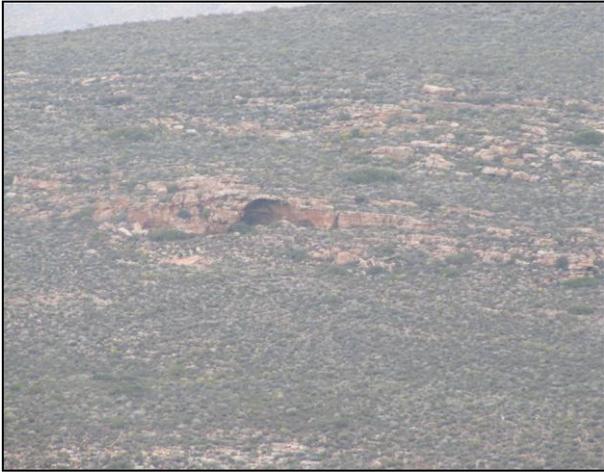
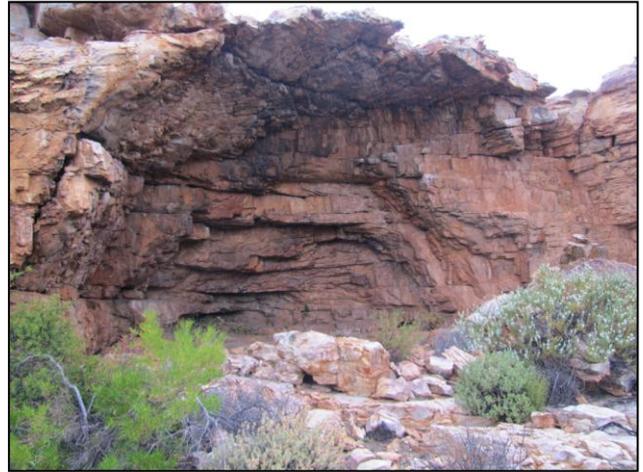
Prominent shelter was located on the north facing slope of sandstone hill, measuring approximately 7m in width (E-W), by 6m in depth (N-S) and 10m in height (Plates 5a and 5b). No sediment was trapped within shelter, but a significant (predominantly) LSA assemblage survives on the shelter floor. Artefacts include several side scrapers/ adzes, discoidal scrapers and fragments of blade cores. These were worked from a broad range of materials, including quartzite, hornfels, cryptocrystalline silicates (CCS) and silcrete (Plate 6). Possible traces of yellow and red paint survive on the eastern cave wall (Plate 7).

Plate 5a: View of slope with rock shelter, view to south (left)
Plate 5b: Close up of rock shelter, view to south (right)

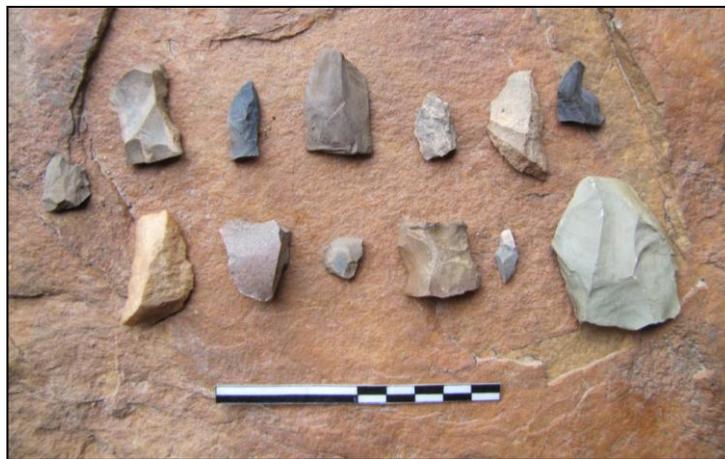
Plate 6: Collection of LSA artefacts from rock shelter floor

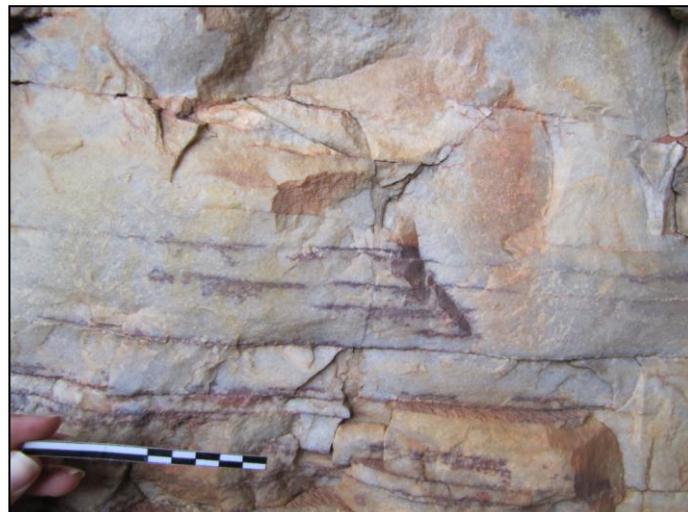
Plate 7: Possible traces of paint on shelter wall

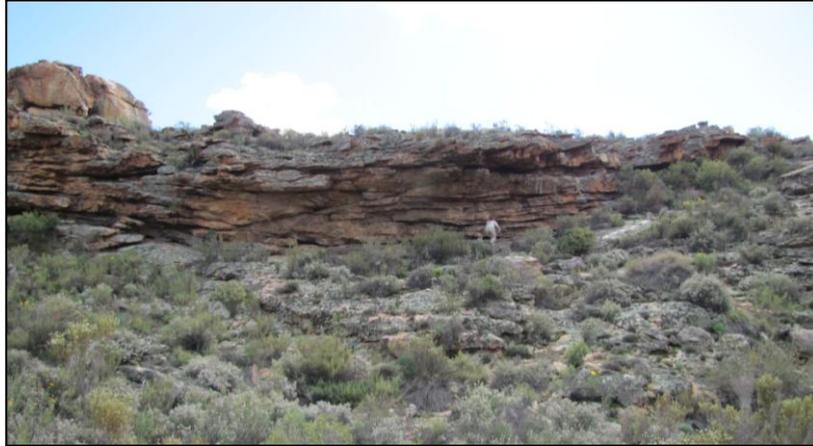
A south facing overhang on the hillside (20m long, 4m deep and 4m high) was recorded at KRP 28f; no rock art was visible but quartzite, chert and CCS flakes were found within the

Plate 8: View of rock shelter, view to north

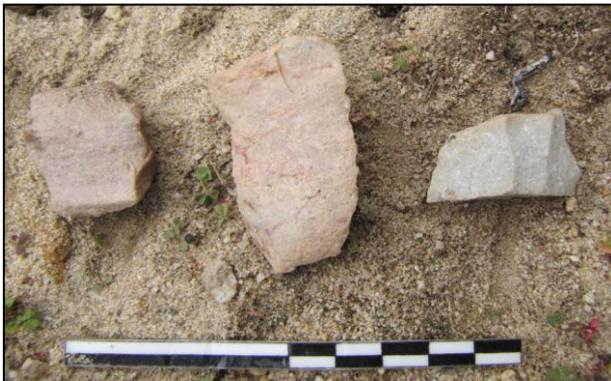
overhang, with additional quartzite flakes on the talus slope to the south (Plate 8). Other artefacts included: a relatively dense spread of quartzite flakes at KRP 28a (Plate 9); quartz and silcrete flakes at KRP 28c; quartzite radial core and large flake at KRP 28g (Plate 10); three quartzite and one hornfels flake at KRP 28i (Plate 11); and a hornfels core at KRP 28j (Plate 12).

Plate 9: Quartzite flakes

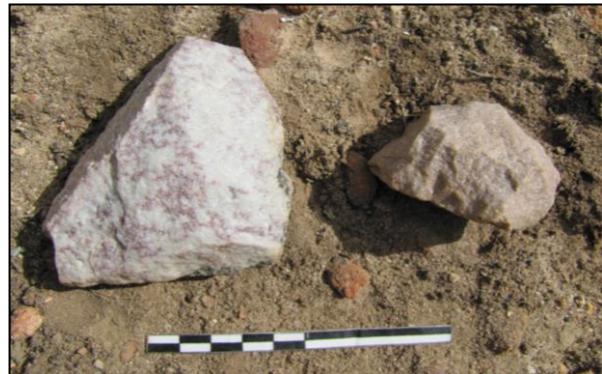
Plate 10: Flake, left, and radial core, right

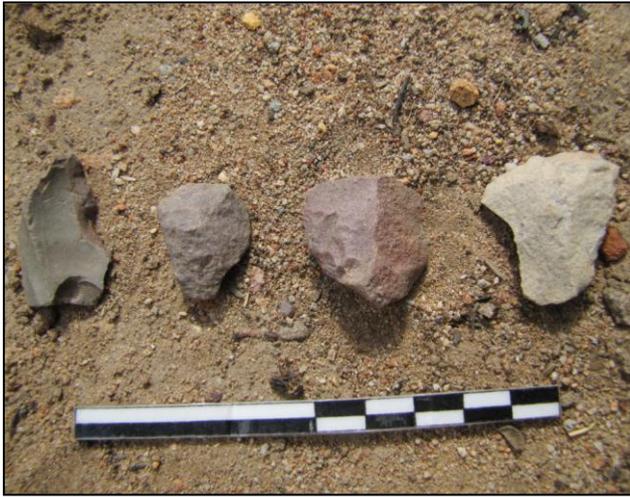
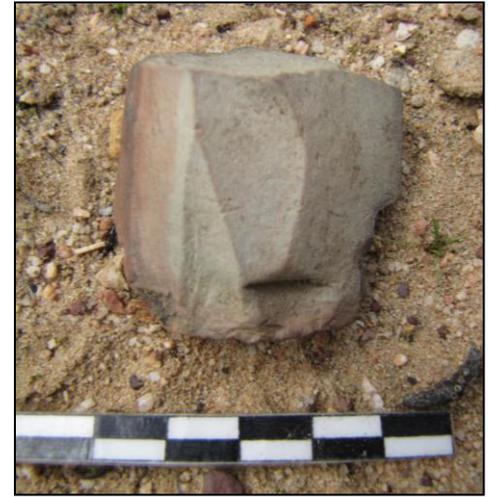
Plate 11: Flakes on hornfels, first on left, and quartzite (left)
Plate 12: Hornfels core (right)

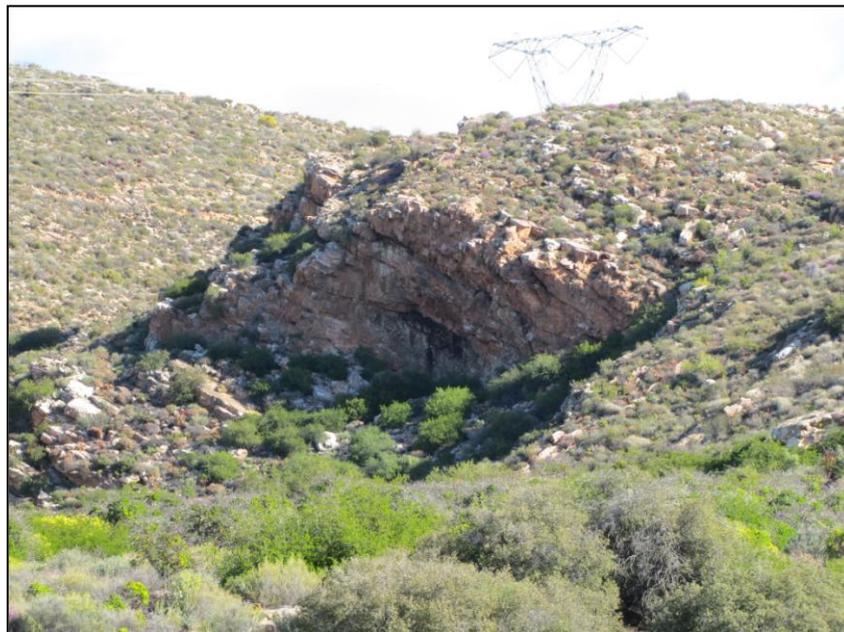
A significant shelter was recorded at KRP 32a on a steep NE facing slope. It was located within a 'horse-shoe' kloof that faced the same direction, on the hills that form the southern limit of the Karoo plain. The shelter measures 20m in width from north to south, though only the northern 10m has a flat floor; 7m in depth from east to west; and a height of c. 10m (Plate 13).

Plate 13: View of rock shelter, view to south west

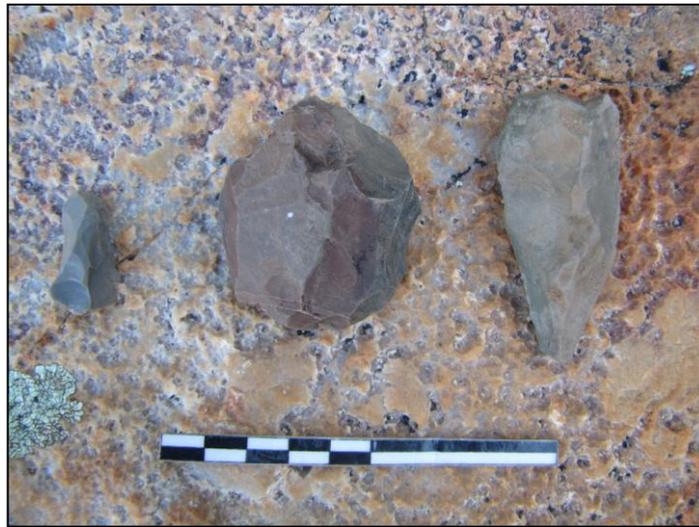
A substantial quantity of artefacts was found on the surface of this shelter, comprising a wide range of materials. These included stone artefacts worked from hornfels, CCS, quartz and quartzite within the shelter, with numerous other artefacts, including a silcrete adze (KRP 32b), on the talus slope to the east of the shelter (Plate 14). Fragments of ostrich egg shell were also present within the shelter itself (Plate 15).

Plate 14: Silcrete adze, left, quartzite core, centre, and hornfels flake, right

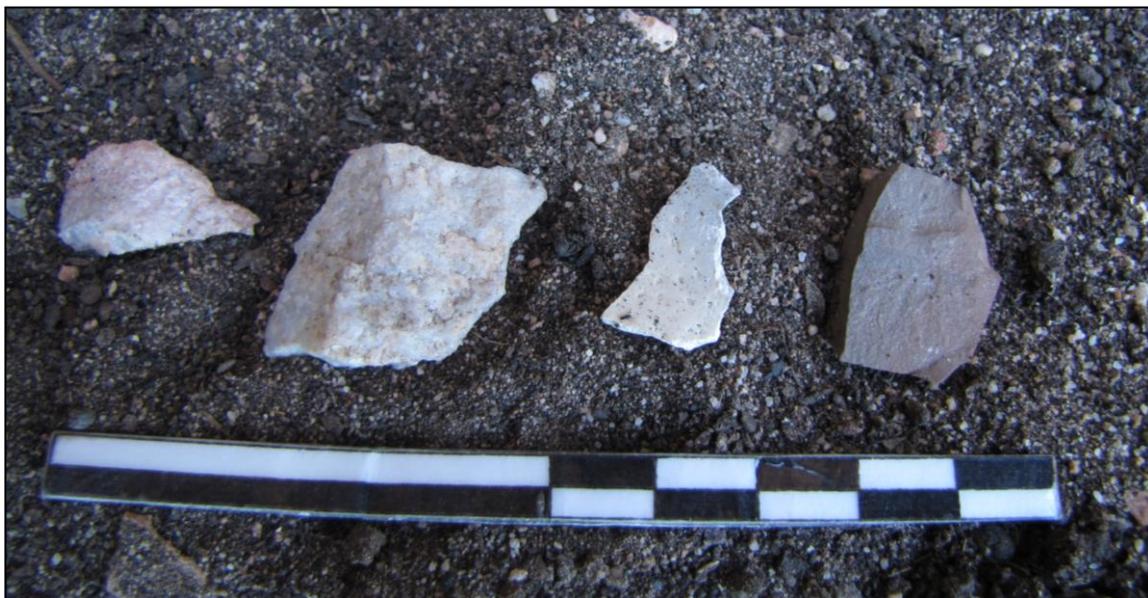
Plate 15: Quartzite flakes (left) ostrich eggshell (centre right) and hornfels flake (right)

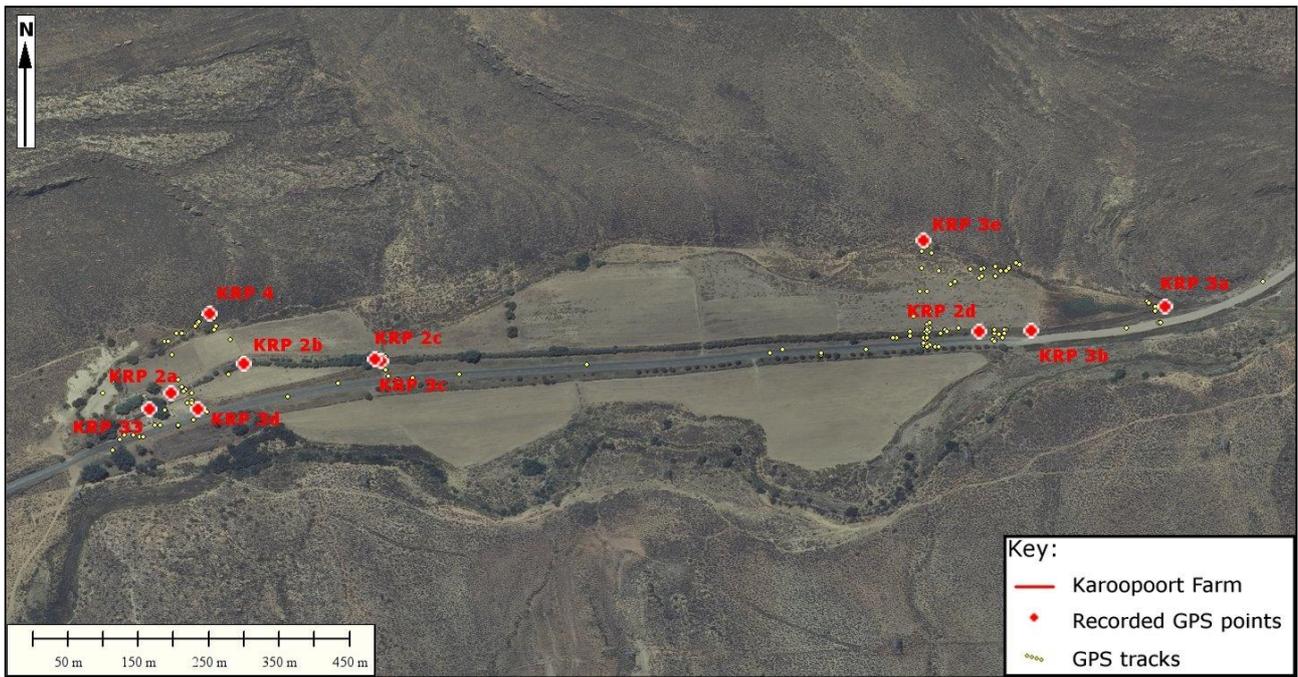
Figure 6: Aerial photo showing GPS points taken on the farmstead (© Chief Directorate Surveys and Mapping)

A list of all GPS points taken on observed historical remains is given in Table 2, with further description of sites given below. The location of recorded GPS points is shown in Figure 6 and coordinates for each are given in Appendix 1.

These walls were built to demarcate the overall Karoopoort farmstead. An additional purpose of these structures would have been to separate ploughed fields used for agriculture, clearly identified in the aerial photographs (Figure 6), from fields used for stock grazing and to prevent animals grazing in the former.

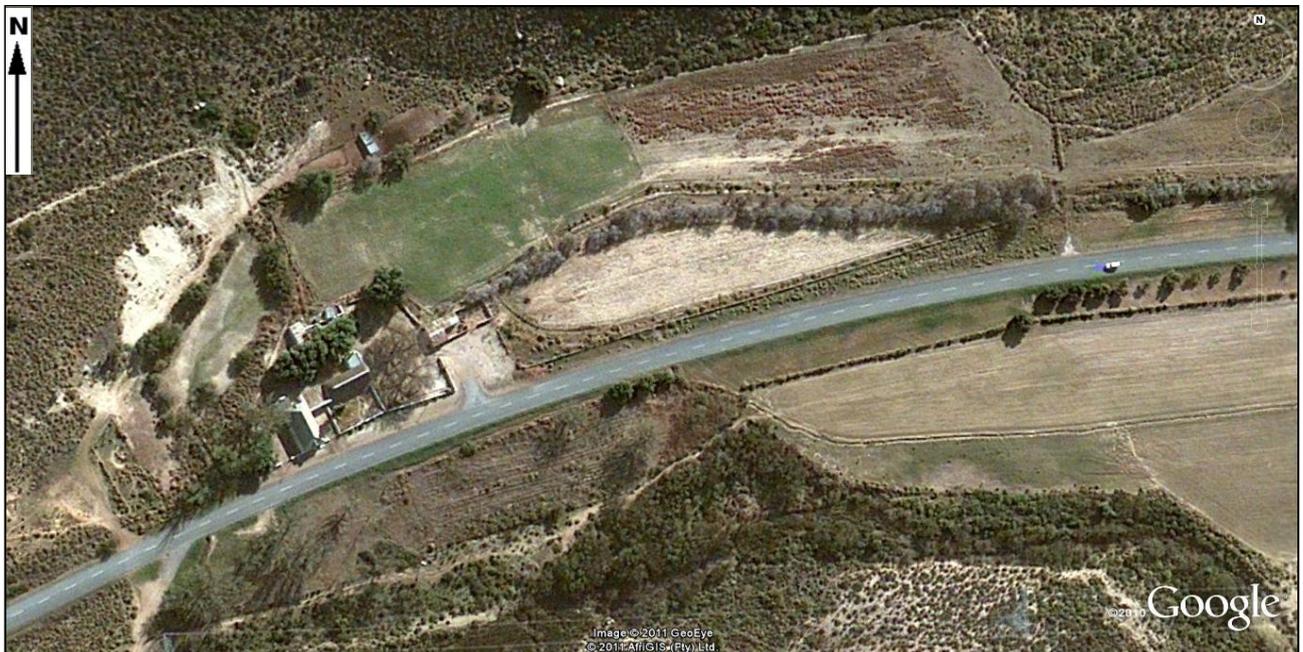
Figure 7: Google Earth image of the Karooport werf (Accessed 13/10/2011)

The farmstead is delineated by a farmyard (werf) wall and was built on a NE-SW alignment, roughly parallel to the route of the R355 to the south though more closely

matching the alignment of the fig tree avenue (KRP 2) extending from the farmyard to the NE (Figures 6 and 7). It comprised five buildings enclosed within the farmyard and two outbuildings immediately outside it, adjacent to the eastern werf wall. These have been labelled Buildings A to G; a schematic plan of the farmstead is presented in Figure 8.

Two tracts of field boundary walls run to the east of the Karoopoort farmstead (Figure 7). These were dry-stone structures built using selected tabular blocks forming two faces and a core filled with small irregular stones, capped with large tabular blocks (Plates 31a and 31b).

GPS point KRP 3a represents the eastern end of this structure, built adjacent to the base of the slope forming the NW side of the mountain pass. From there the wall continues in a west by south-west direction for c. 163m (KRP 3b) and then turns west and continues for c. 775m to GPS point KRP 3c. Up to this point the wall runs along the north of and parallel to the fig tree alignment described above and together they represent the tract of the original wagon route approaching the farmstead from the east. This is also the point where the single row of fig trees to the east continues as an avenue with two rows of fig trees to the west, with a gap in the wall probably representing the original entrance from the road into the farmstead itself. From here the wall and tree alignment diverge, with the wall continuing to the SW for another 227m to KRP 3d where it turns 90° NW to meet the continuation of the avenue and encloses a triangular field to the north of the wall (Figure 7).

2. The Grade 2 listing of the two main buildings in the farmyard, recorded as Buildings A and C, be extended to include the all structures linked to the main farmyard (KRP 33; Figure 8) and the fig tree avenue leading from it (KRP 2; Figure 7).

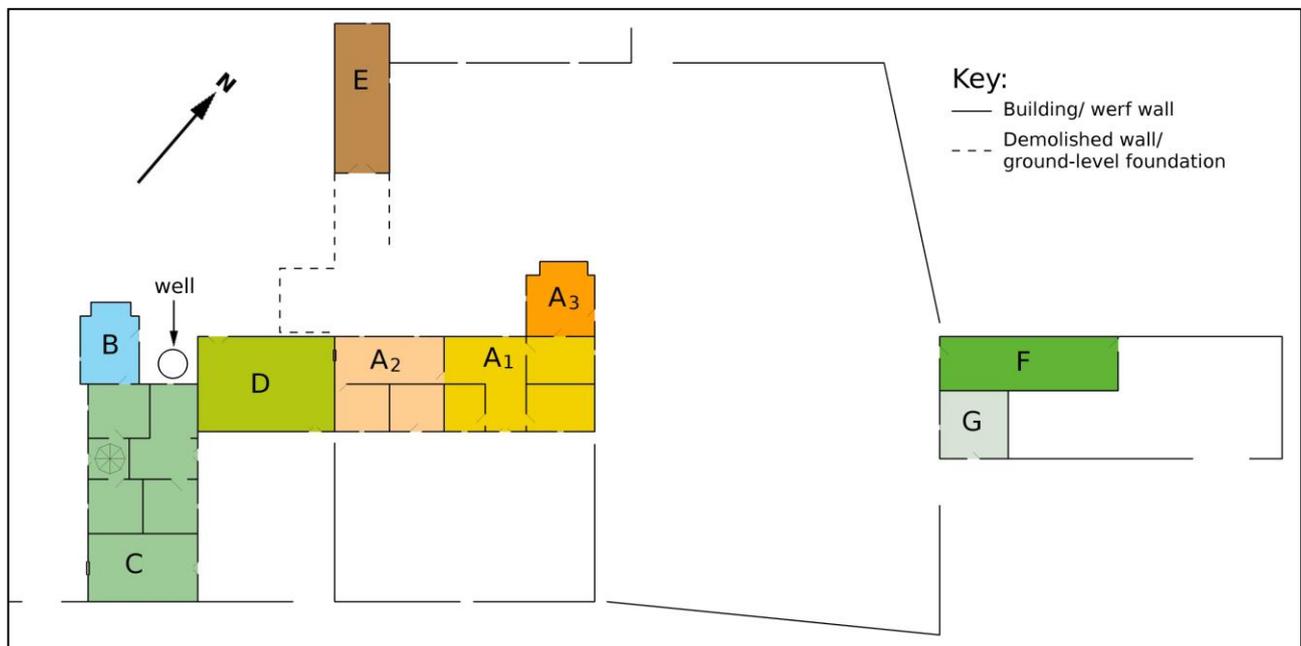
Figure 8: Schematic plan of Karoopoort farmstead

4. In accordance with points 2 and 3 above, a permit under Section 27 of the National Heritage Resources Act (No 25 of 1999) should be granted by HWC for the repair of the outbuilding to the east of the main Karoopoort farmyard, recorded as Building F in this survey (Figure 8).

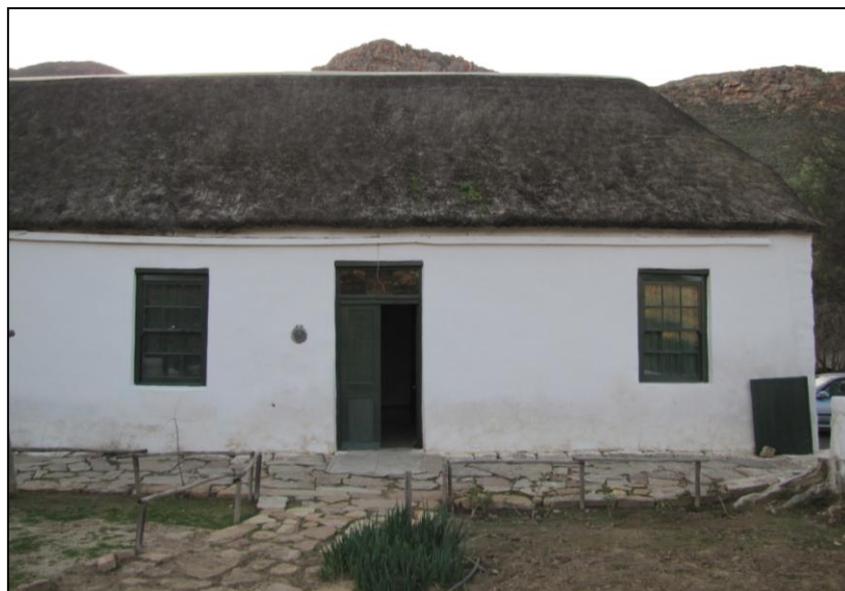
Phase 1 building and is likely to represent the original farmhouse at Karoopoort. Historical references to the farm indicate that construction of this farmhouse would have been completed in the 1860s.

Plate 16: Portion A₁, view to north-west

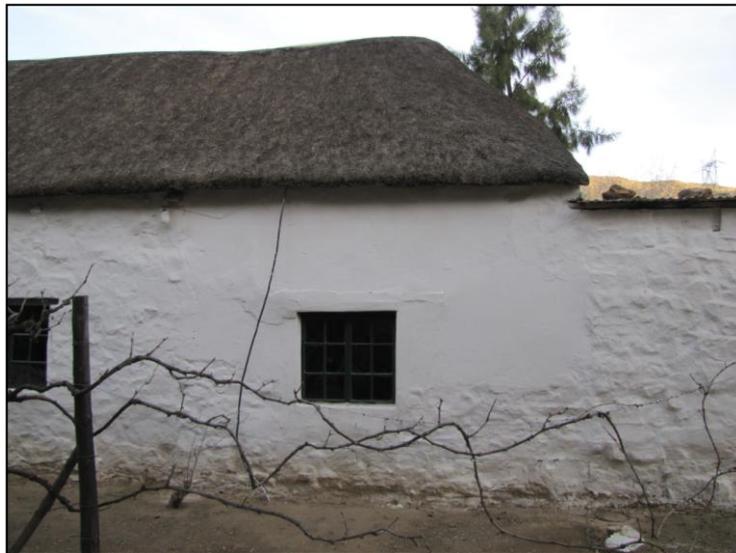
appear to have been built with stone up to a height of c. 1m and then with brick up to roof level (Plate 17). This suggests that Section A₂ itself was the product of at least 2 construction phases: the NE half built as an extension to the A₁ building with an external enclosure to the SW; the walls of this enclosed yard were built up with brick and roofed in a subsequent construction phase, adding to the overall footprint of Building A. The current thatched roof structure spans the entire length of Sections A₁ and A₂, and must have therefore been built after both construction phases of Section A₂ were completed (Plate 18).

Plate 17: Detail of A₂ showing evidence for brickwork in south west, view to south east

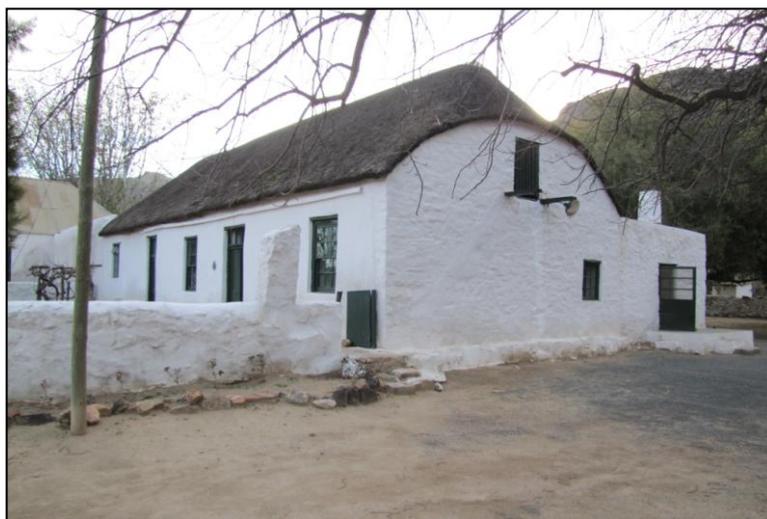
Plate 18: Building A, showing thatch roof spanning the building, view to west

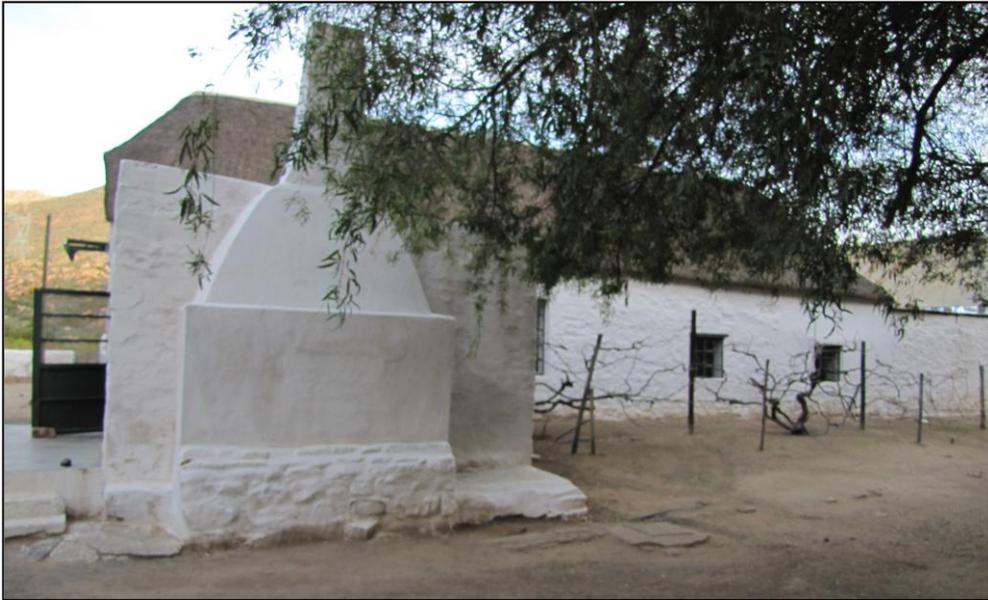
Section A₃ is a further single room extension to the rear of the original Section A₁ farmhouse, at the NW end of the building. The walls of this extension were built with stone up to roof level, with the exception of the hearth and chimney stack at the rear which were built with bricks (Plate 19). Section A₃ has a single-pitch corrugated metal roof sloping down to the SW. This section is currently fitted as a kitchen and has probably been used for this purpose since its construction.

Plate 19: Detail of brick built hearth at rear of A₃, view to southeast

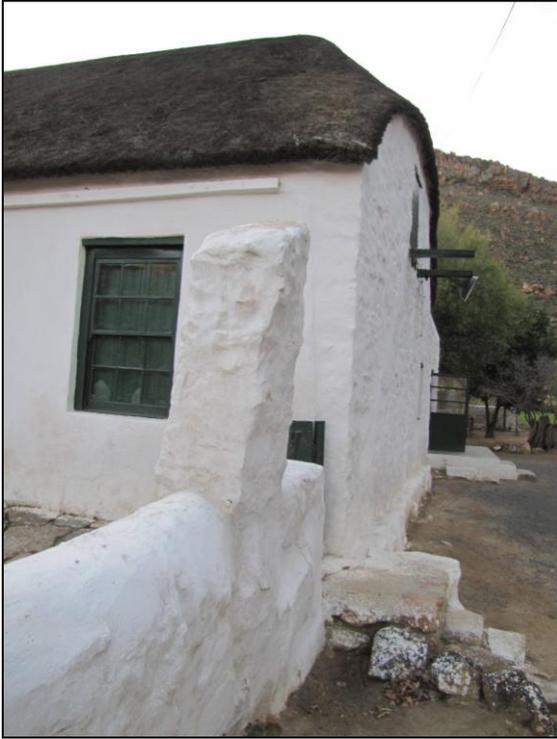
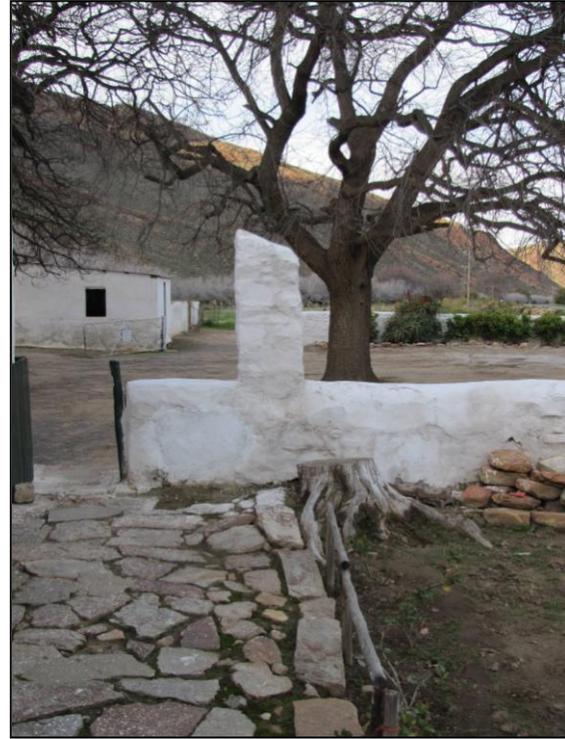
Building A, and in particular Sections A₁ and A₂, were likely the main farmhouse building for a significant period of time prior to the addition of Buildings B, C and D to the SW. This interpretation is supported by the single thatched roof structure unifying Sections A₁ and A₂, a roofing material not used (or maintained) on any of the other structures within the farmstead; and by the yard wall to the front of Building A that clearly demarcated a yard in front of Sections A₁ and A₂ only. A pillar built as part of this yard wall close to the NE end of the building suggests that there once was a sloping verandah roof at the front of Building A (Plates 20a and 20b).

Plate 20a: Probable support pillar for verandah roof, view to west (left)

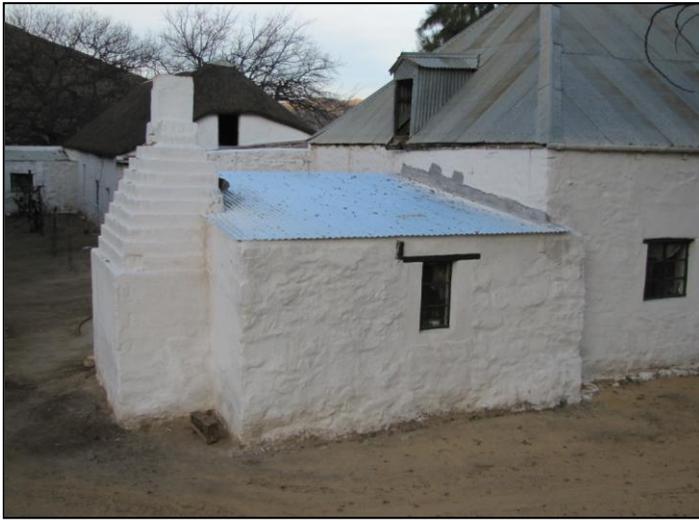
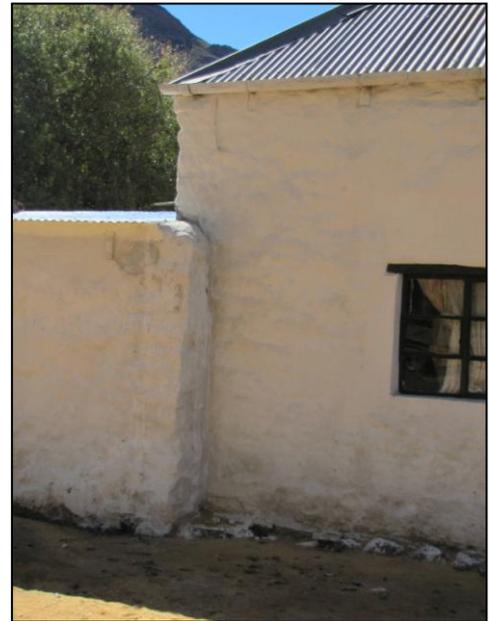
simple farm worker's cottage, that was incorporated into a substantial farmhouse dwelling in a subsequent construction phase, represented by Building C to the SE.

Plate 21a: Building B, showing Building C abutting to the southeast, view to north-east (left)

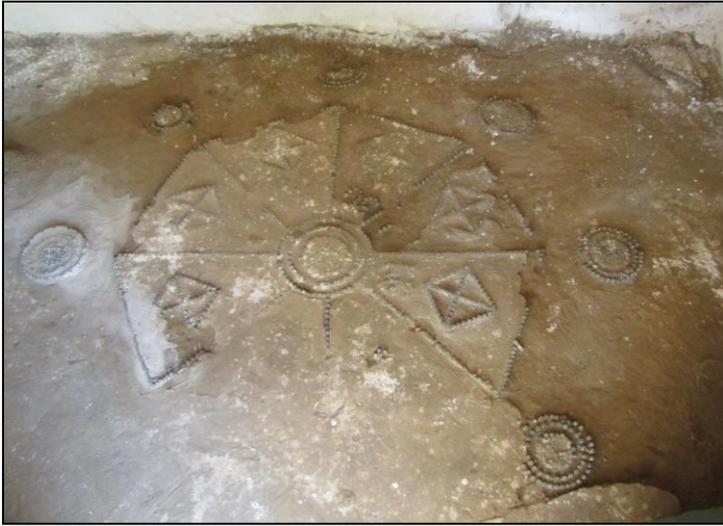
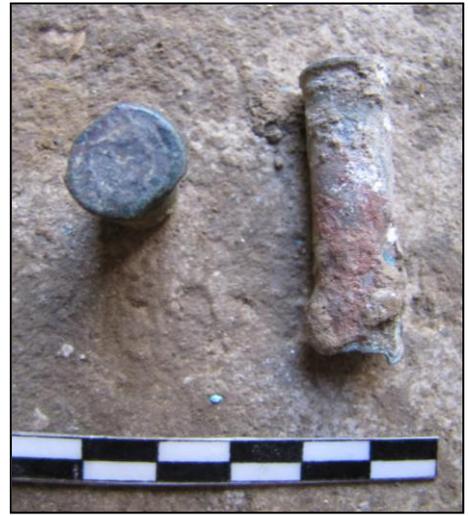
An interesting feature of Building C survives within its smallest room on the SW side of the building. An octagonal 'wagon wheel' pattern (Plate 22a), with other internal and surrounding geometric shapes, was designed with spent ammunition shells inlaid into the floor of this room (Plates 22a-d). This small room, with a door through the SW elevation and doorways into adjacent rooms (the one into the room to the NE having since been blocked), served as an entrance hall; the pattern inlaid in its floor would have undoubtedly served to impress visitors entering the building. It has been suggested that the large calibre size of the shells in the floor are similar to those used during the 1899-1902 Anglo-Boer War (Du Plessis 1994b), and it is possible this feature was made during this period as there are reports of British soldiers being stationed at Karoopoort (Smuts 1988: 138). This feature is in an advanced state of disrepair, with the mortar floor into which the shells were inlaid having almost completely broken up. Detailed recording, in the way of scale plans and photographs, followed by conservation measures to clean, consolidate and preserve this feature should be undertaken as a matter of urgency.

Plate 22a: Design of inlaid ammunition shells in Building C (left)
 Plate 22b: Close up of shells (right)

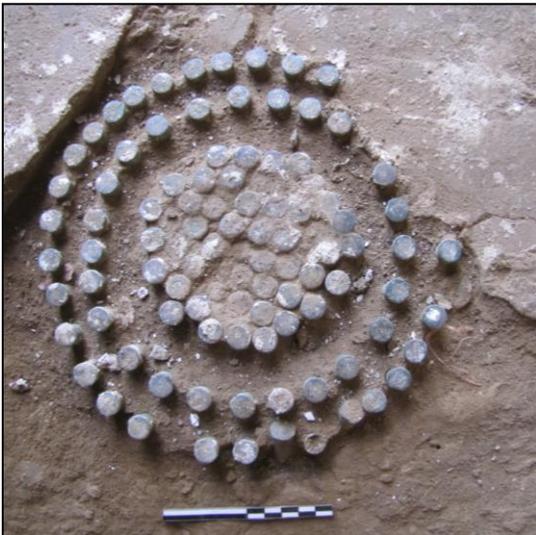
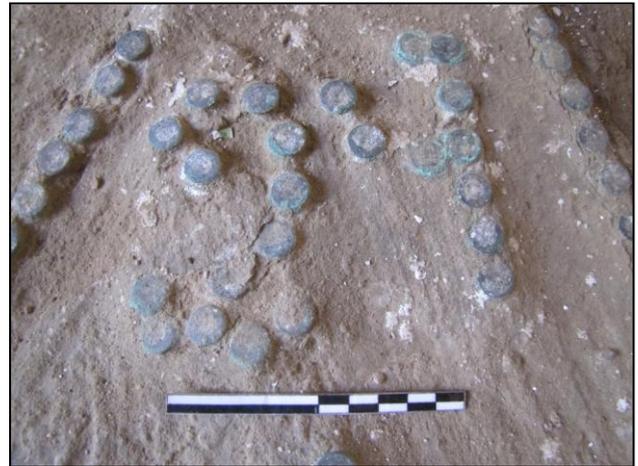
Plate 22c: Detail of rosette design at outer points of "wagon wheel" (left)
 Plate 22d: Detail of numerical design, possibly a date or regiment (right)

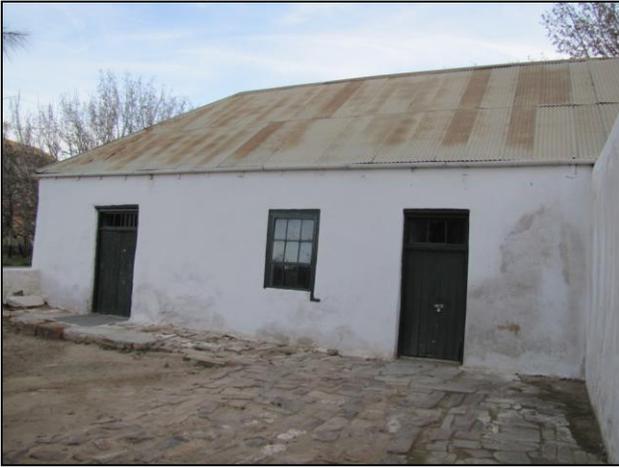
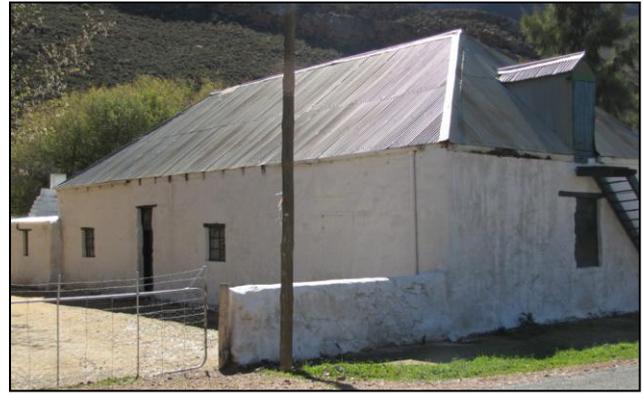
In total there were at least four entrances into Building C: two on the NE elevation that are still in use (Plate 23); and two more opposite these on the SW elevation, with only the northernmost of these still in use (Plate 24), providing access into the entrance hall with the 'wagon wheel' pattern inlaid in the floor (Figure 8). On the SW elevation these doorways alternated symmetrically with two windows that had been narrowed and replaced with casement windows, but were probably sash windows originally. This pattern was probably repeated on the NE elevation, though the northernmost of these would have been blocked by the construction of Building D (Figure 8).

Plate 23: View of openings on north-east elevation of Building C, view to south-west (left)

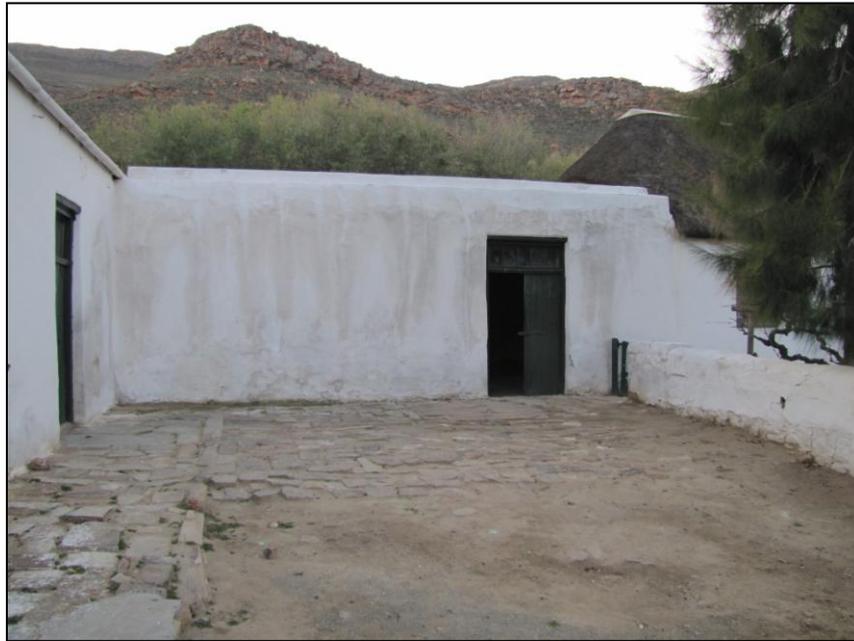
Plate 25: Building C, showing the continuous stoep of Building D, view to north-west

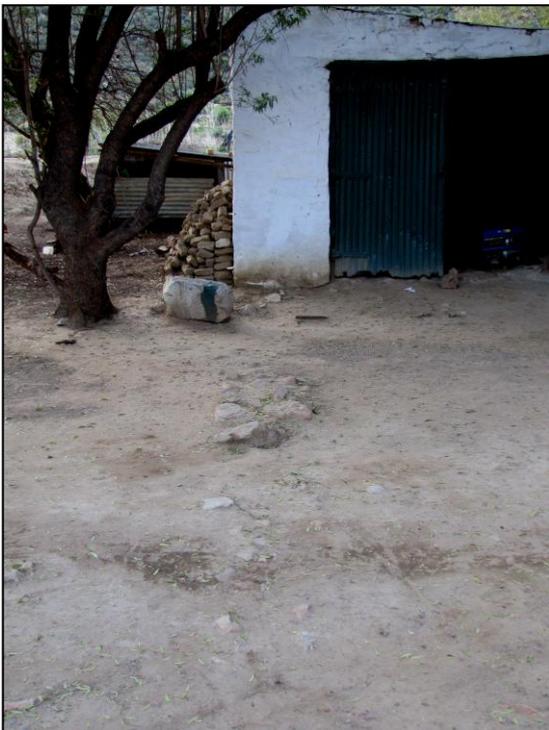
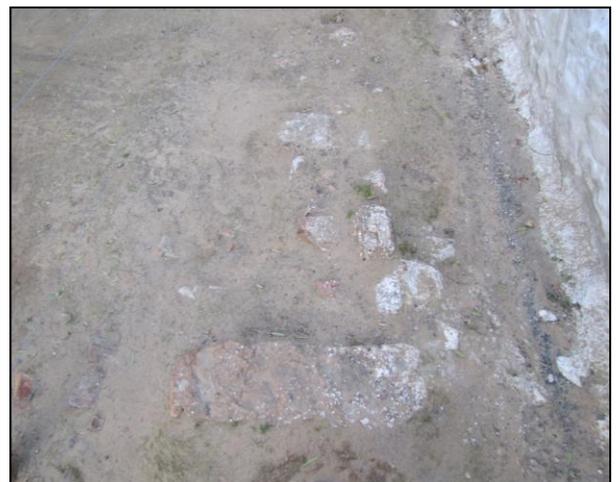
Stone foundations were visible on the ground immediately SE of Building E. These were the same width as the building and appeared to be an extension of its side walls that had been demolished to ground level (Plates 26a and 26b). The westernmost of these could be traced for c. 7m to the SE at which point it turned 90° to the SW and continued for c. 4m before turning again to the SE and extending almost as far as Building D. At this point the exposed foundation turned to the NE, suggesting an original 'T'-shape to building E (Figure 8). This would be an unlikely (though not completely implausible) shape for a simple outbuilding, and it is possible that this structure was once a more significant building that was converted to a shed once it was superseded by larger and grander structures within the farmstead.

Plate 26a: View of footings extending southeast from Building E, view to north-west (left)
Plate 26b: Return of footings at rear wall of Building D, view to north-east (right)

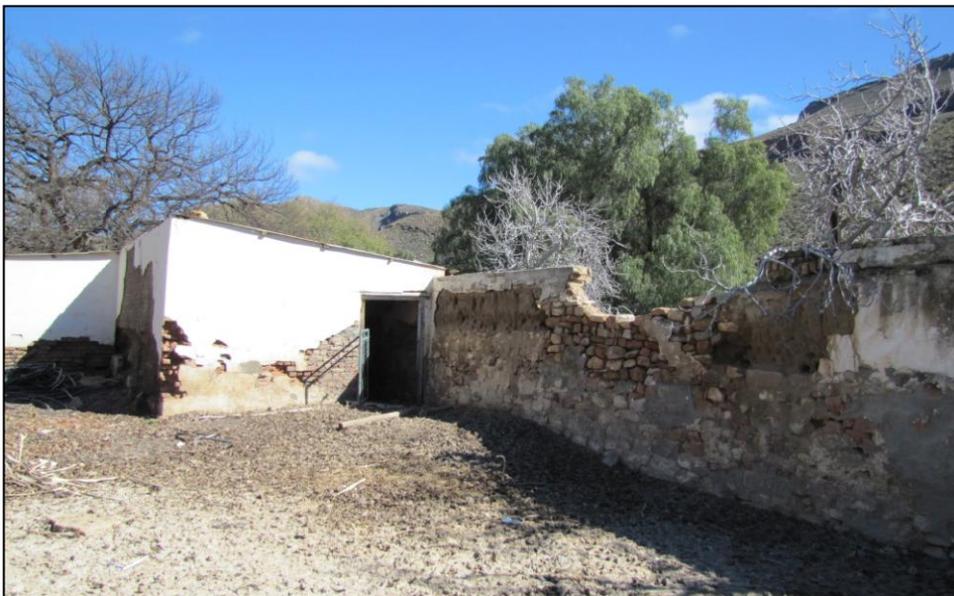
Building F is a cattle shed/stable to the north of the farmhouse (Figure 8 and Plate 27); the building is 13m long and 4m wide and aligned along the same axis as the farmhouse (Buildings A and C). The north wall is built in stone to 1.5m above ground level and continued with unbaked mud bricks to roof level, although a portion of it has collapsed and it has been patched in fired brick set in mud mortar (Plate 28). The west wall has been repaired with fired, uneven bricks set in mud mortar, while the east wall shows even more recent repairs with modern bricks and cement. The south wall is constructed entirely of unbaked mud bricks and is in a very poor state of repair. Its external face is very badly weathered and the whole wall in danger of imminent collapse (see Plate 30 below). Internally, the southern wall is abutted by 6 low feeding troughs at the eastern end of the building and 4 taller troughs to the west (Plate 29); each trough has a tethering/harnessing ring attached and the two westernmost have two each.

Plate 27: View across the cattle yard of the eastern end of Building F, view to south-west

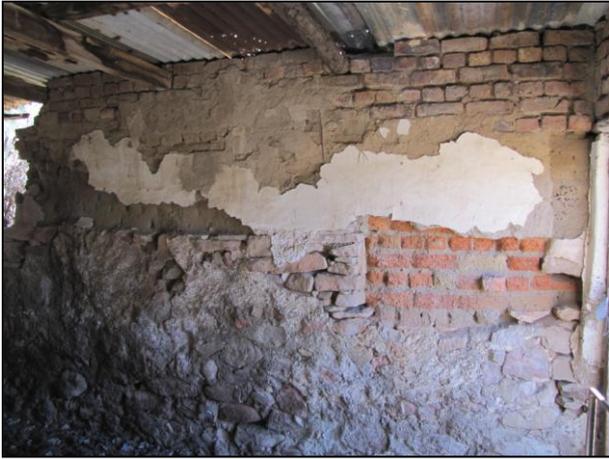
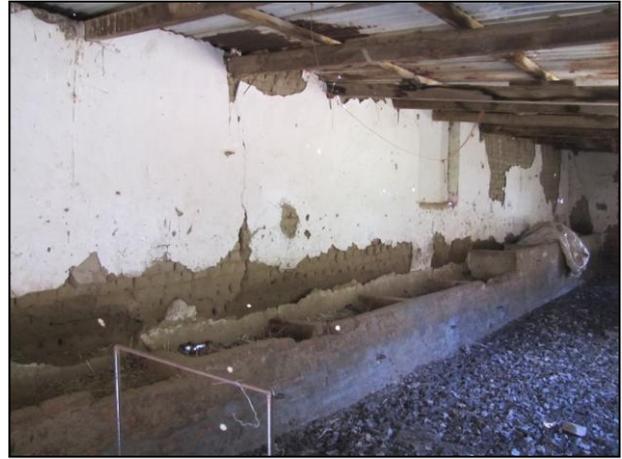
Plate 28: North wall showing original construction and patching; collapse visible at left of photo, view to north-west

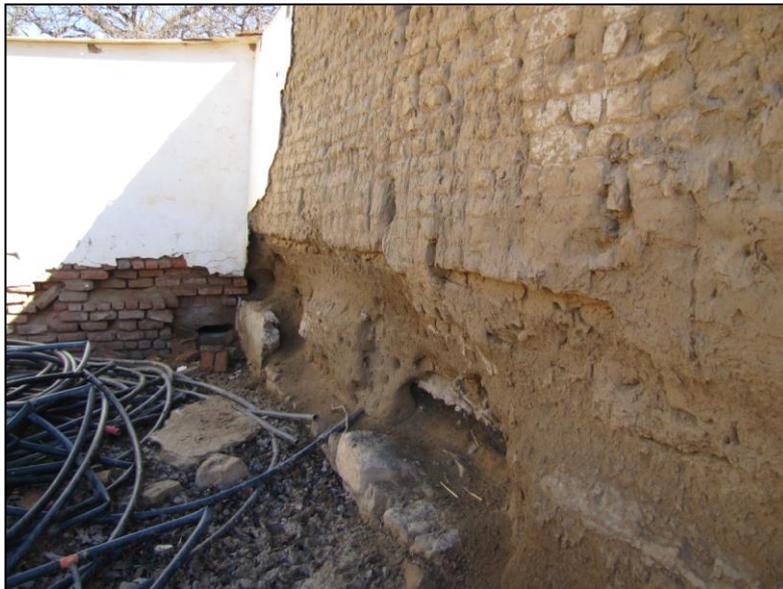
are built in the same fabric as Building G and abut the stonework of the north-west yard wall continuing from Building F's north-east elevation. This indicates that Building G and the enclosed yard are contemporary structures that abut, and are of a later construction phase than, Building F. Building G, the only one in the farmyard with a barred window, has anecdotal evidence of having been used as a cell for prisoners in transit (Clarence Johnson, pers. comm.).

Plate 30: Building G abutting the badly weathered south wall of Building F, view to north-west

With regard to recommendation 4, the Section 27 permit should be issued as soon as possible as this structure is in danger of collapsing and needs stabilisation (Plate 30). Ideally this should be done with the appropriate construction materials of stone and sun-dried bricks; while local stonemasons can be employed to undertake the former (Clarence

Johnson, pers. comm.), artisans and tools for the production of the latter will be harder to source. Given the urgency of the required repairs, it is recommended that these be undertaken with as close approximation to the original materials as can be readily sourced.

- similar stone to that of the original fabric;
- if possible, a sifted soil and lime mortar (with distinctly different colouring from the original soil mortar), or a 'soft' cement mix with a high lime content, to be used in all repairs;
- a similar lime render to be applied to the inner and outer faces of all repairs, and any exposed building fabric on any farm buildings and werf walls (if evidence of previous rendering is obvious and certain);
- the use of modern bricks to fill gaps in place of original bricks (Plate 30) is preferable to filling with any type of cement based mortar as a filler, as bricks will be more porous and allow a closer approximation to original materials. However, the closer these bricks are to the low-fired/ sun-dried bricks used in the original construction the better.

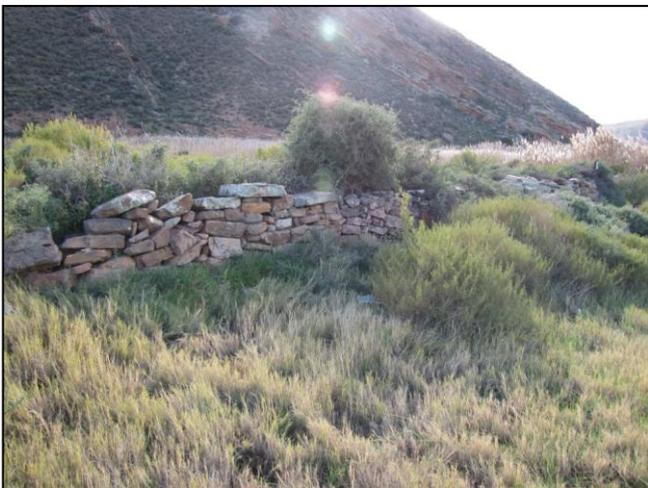
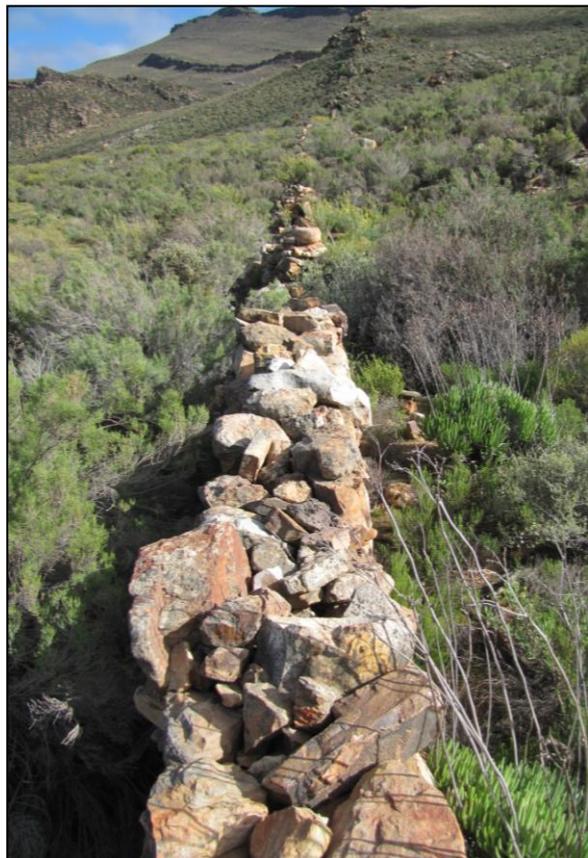
Plate 31a: Dry stone walling, view to north-east (left)
Plate 31b: Dry stone walling, view to west (right)

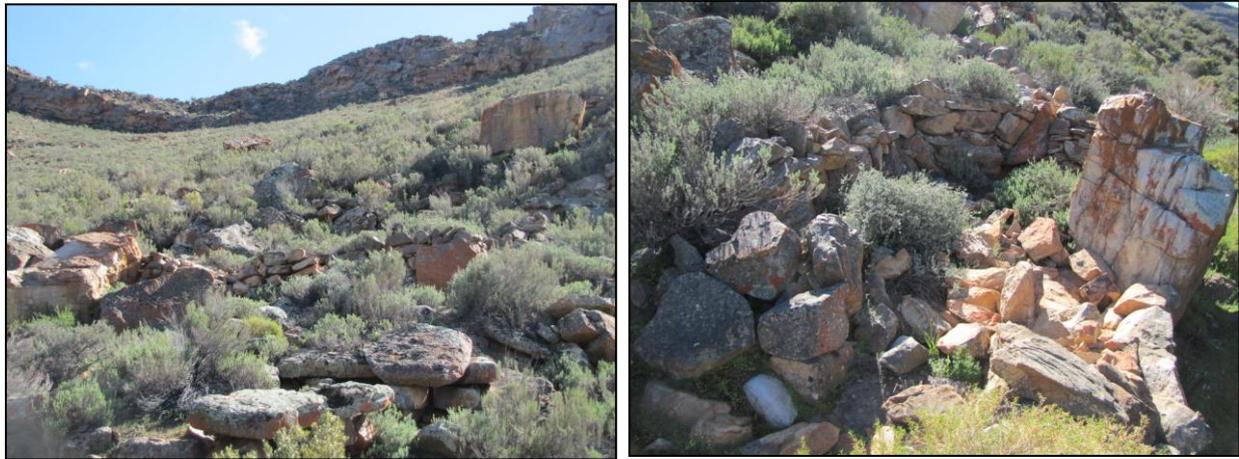
rock outcrops to form the northern side of the enclosure (Plates 32a and 32b). A dry stone wall extended from these kraals towards the farmyard to the SW.

Plate 32a: Detail of southern kraal, view to north-west (left)

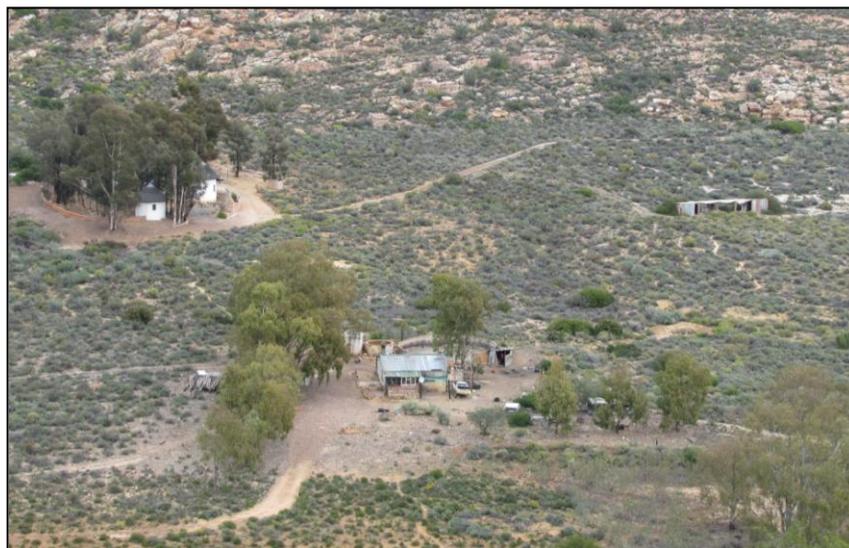
Plate 33: Ghwarrieberg farmstead, view to north-west

KRP 10: Ghwarrieberg farmstead

KRP 10 comprises a farmhouse with adjacent concrete water reservoirs, at least two rondavels within a stand of eucalyptus trees and associated outbuildings (Figure 3 and Plate 33). Located outside area of investigation and part of neighbouring Ghwarrieberg (or Guarrieberg) Farm.

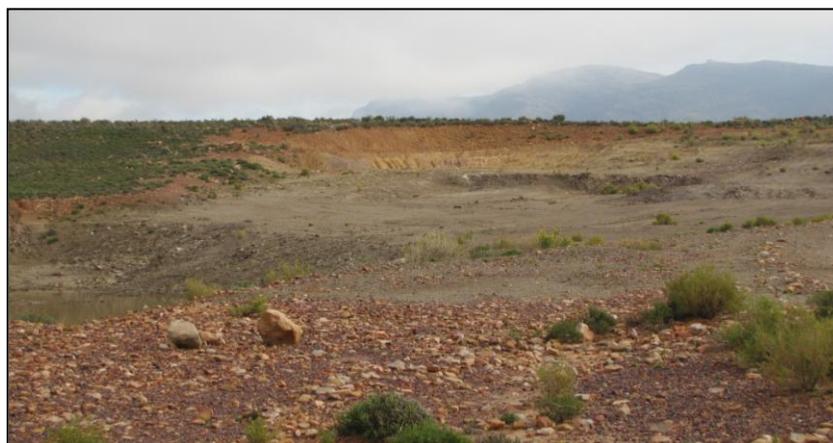
Substantial borrow pit visible on the 1:50 000 topographical map, measuring approximately 208m NW to SE by 80m NE to SW (Figure 3). The pit was probably quarried for material used to re-surface local gravel roads (Plate 34).

Plate 34: Borrow pit, view to north
