Preliminary Archaeological Survey of Karoopoort Farm

**Ceres Magisterial District
Western Cape Province**

Cape Tanqua Tourism Services

24 October 2011

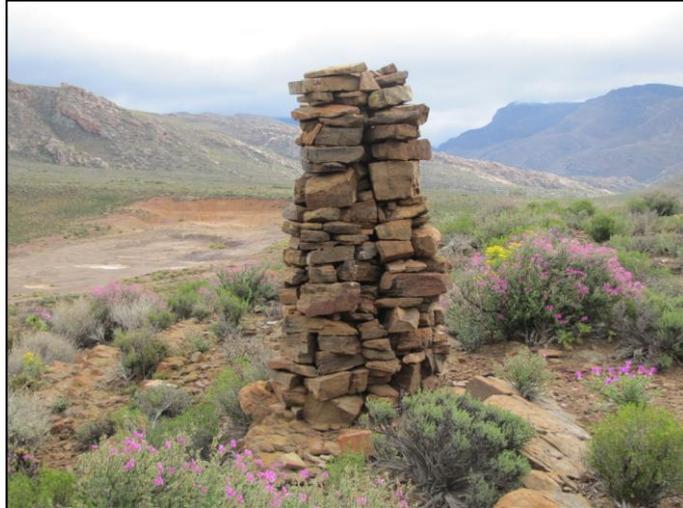
A dry stone cairn was located on high ground, north-west of the R355 (Figure 3 and Plate 35). The cairn is built of stacked, tabular slabs of shale, and stands approximately 1.7m high. While the pillar is within the farm boundary, it is certainly served as a beacon of some sort and possibly indicated a property boundary.

Plate 35: Stone cairn, view to north-west

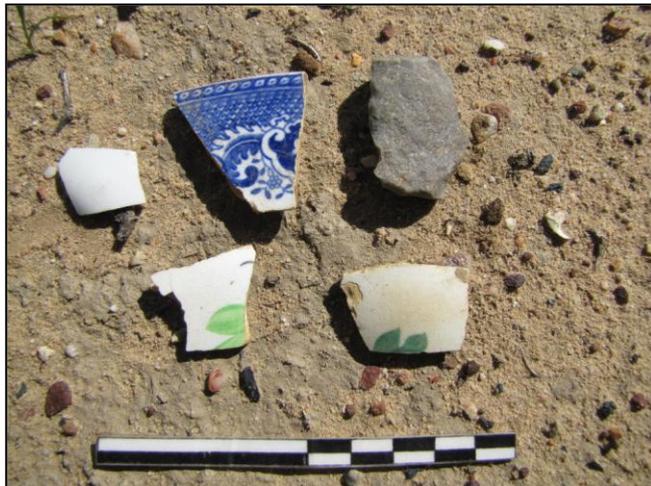
An isolated scatter of historic ceramics and a single quartzite flake (KRP 31) were found on the north facing slope of a low rise in the north eastern quadrant of the farm (Plate 36). The ceramics were all nineteenth century white wares and included two painted pieces and a single piece of transfer printed ceramic.

Plate 36: Historic ceramics and single quartzite flake (top right)

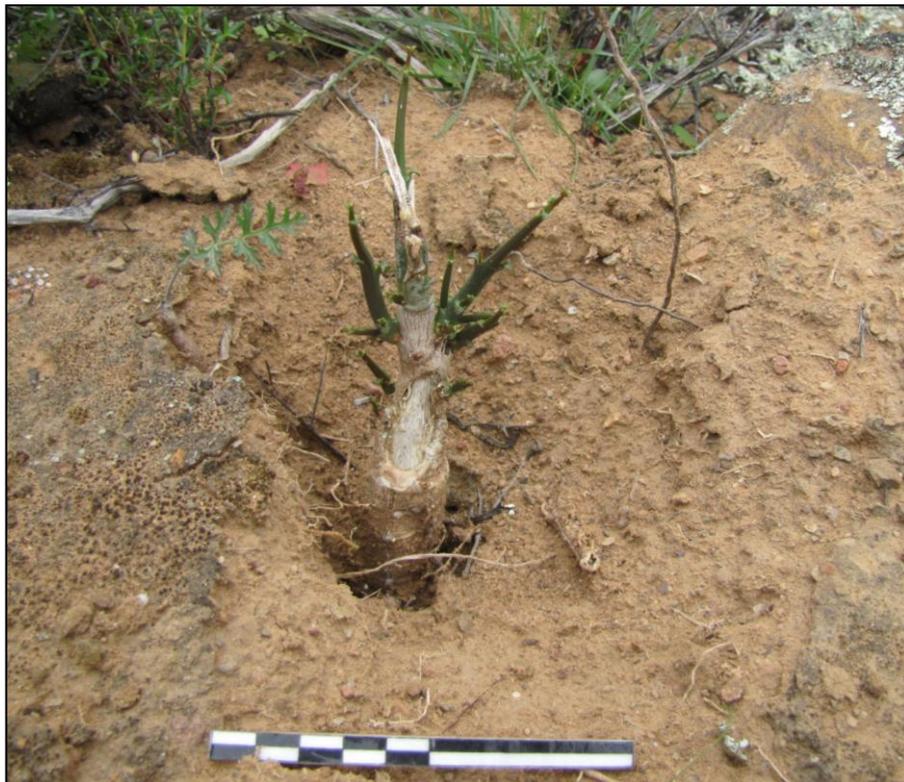
The ground surrounding a small plant had been excavated to expose its root stem and section of the exposed bark stripped. The section of removed bark was a regular shape and there were no obvious animal gnaw marks, indicating this specific part of the plant had clearly been deliberately harvested by a person (Plate 37). This may have been used as a cooking ingredient or possibly for medicinal purposes. The plant utilised is a *Pelargonium crithmifolium* (Sapphire leaved pelargonium). Certain pelargonium plants (*Pelargonium sidoides*) are used in the treatment of upper respiratory tract infections elsewhere in the country (Wiley 2001), and this is a possible use for the harvested bark. Confirmation of this could be obtained through interviews with the communities living on and around the farm.

Plate 37: Specimen of *Pelargonium crithmifolium*, with evidence for bark stripping
