HERITAGE IMPACT ASSESSMENT

Environmental Impact Assessment for the Proposed Development of a 75 MW Solar Photovoltaic Facility (Boven Solar PV4) on Boven Rugzeer 169/remainder, northeast of Kenhardt, Northern Cape Province

11 January 2016

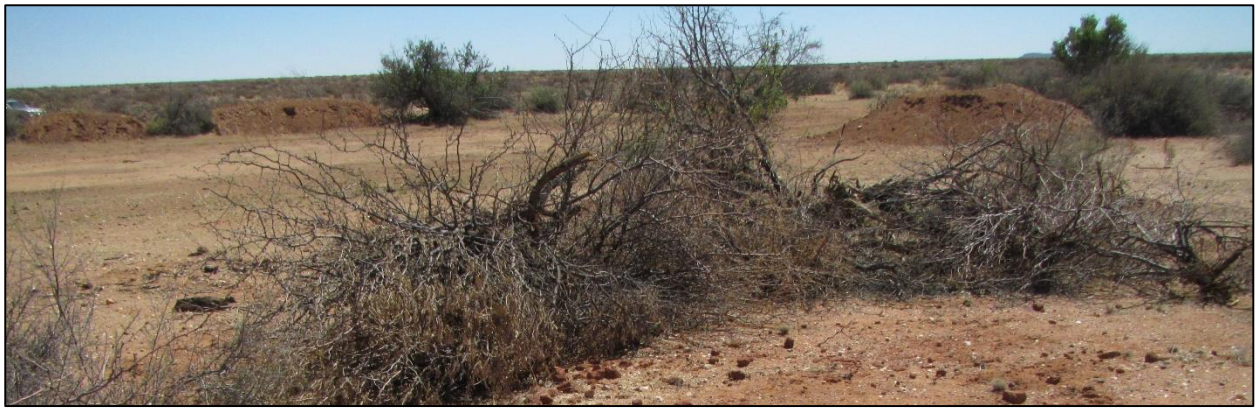
Figure 4: View of the recently excavated pan in the western part of the Boven Solar PV4 study area.

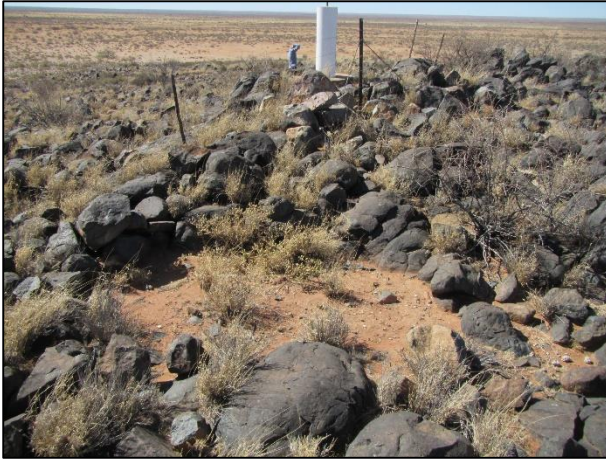
Figure 8: A small cleared circle at waypoint 791 with stone artefacts and ostrich eggshell in it.

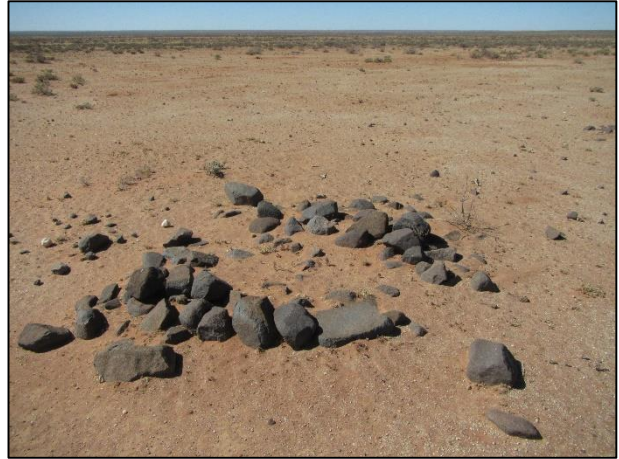
circular structure (Figure 9). It had stone artefacts, ostrich eggshell, metal and glass associated with it. A lower grindstone made on a relatively square dolerite slab was incorporated into the wall of the structure. It is difficult to tell its age: it might have been Stone Age but then reused by historic herders, or it might have been built by Stone Age people working for colonial farmers (hence the access to glass and metal), or it might be historical with the Stone Age material pre-existing on the surface. The grindstone may have simply been seen as another rock and incorporated into the wall. Other finds on this koppie were a stone cairn near its summit, a mound of stones that seemed grave-like but was rather large, another circular stone enclosure with no associated artefacts and a peculiar engraving that, from its unpatinated nature, is no doubt recent.

Figure 9: A stone structure on the sand below the koppie at waypoint 797.

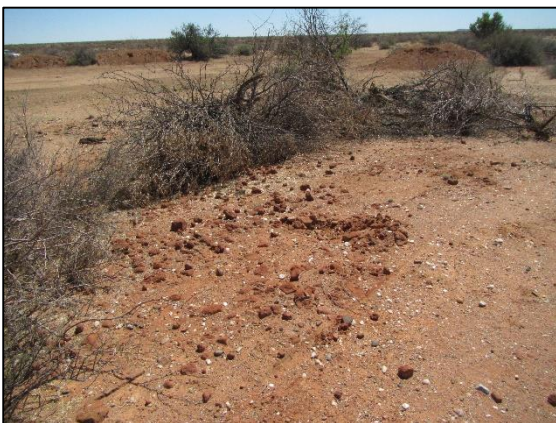
One historical site was also found. It was comprised of a brick foundation alongside the pan in the west of the study area (waypoint 798). The bricks were low-fired, probably locally made clay bricks. No artefacts were found and there is no way to know what the original structure was.

Figure 10: View of the brick foundation at waypoint 798 alongside the pan.

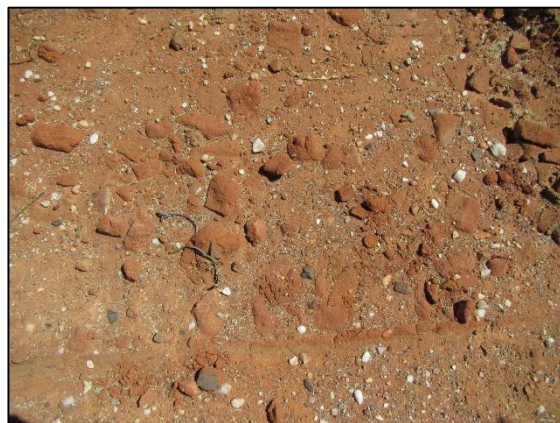
Figure 11: Close-up view of the clay bricks at waypoint 798.

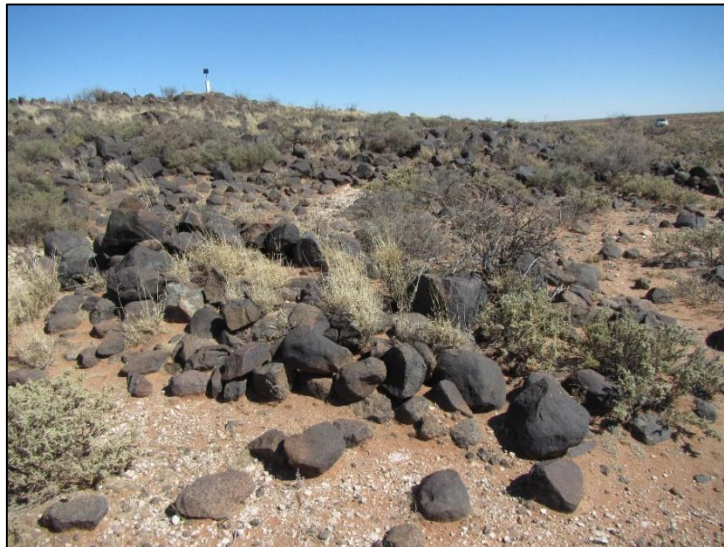
The only possible grave affected by the preferred proposal lies within the electrical corridor (Figure 12). This is on the koppie as noted above at waypoint 796. Although larger than expected for a grave, the accumulation was certainly not natural.

Figure 12: View of the grave-like mound of dolerite rocks towards the koppie to the north.
