**KOKSTAD CRU HOUSING PROJECT, GREATER
KOKSTAD MUNICIPALITY, KWAZULU-NATAL**

Phase 1 Heritage Impact Assessment

November 2016

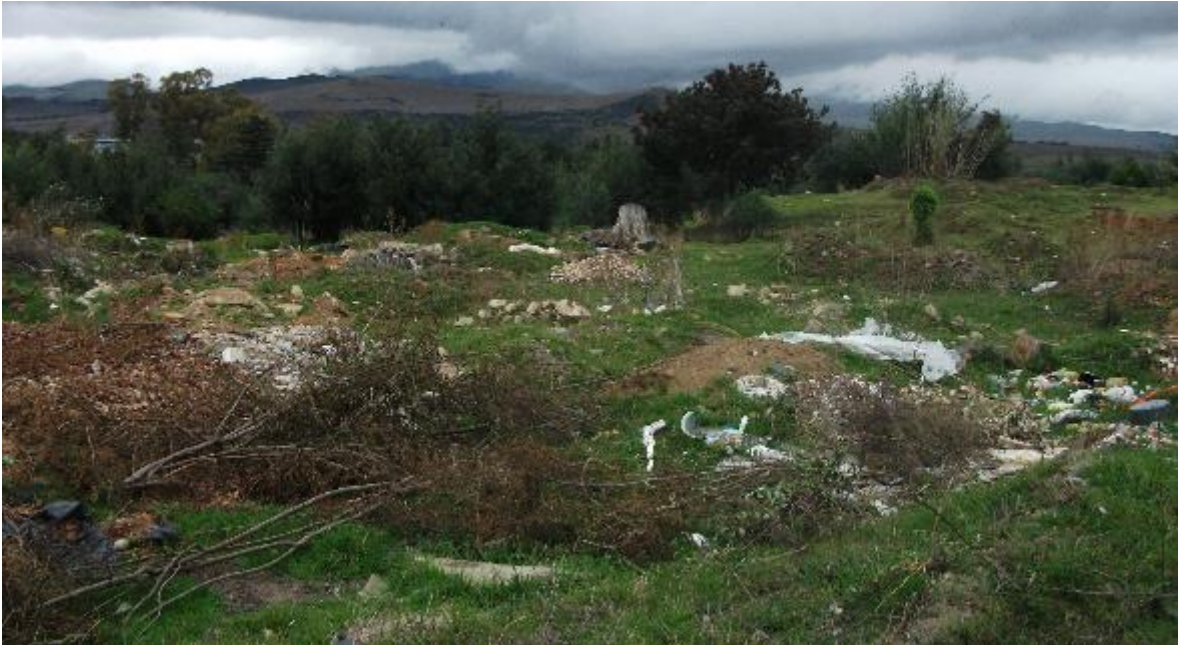
A walk through of the project area revealed a site that has been used for the dumping of waste and rubble for an extended period. Vegetation has grown over the older dumping areas and there is litter strewn over the project area with recent dumping activities. There are a number of informal roads and paths that cross it and small sections of the area have been excavated for soil.

Figure 3: Looking south over project area

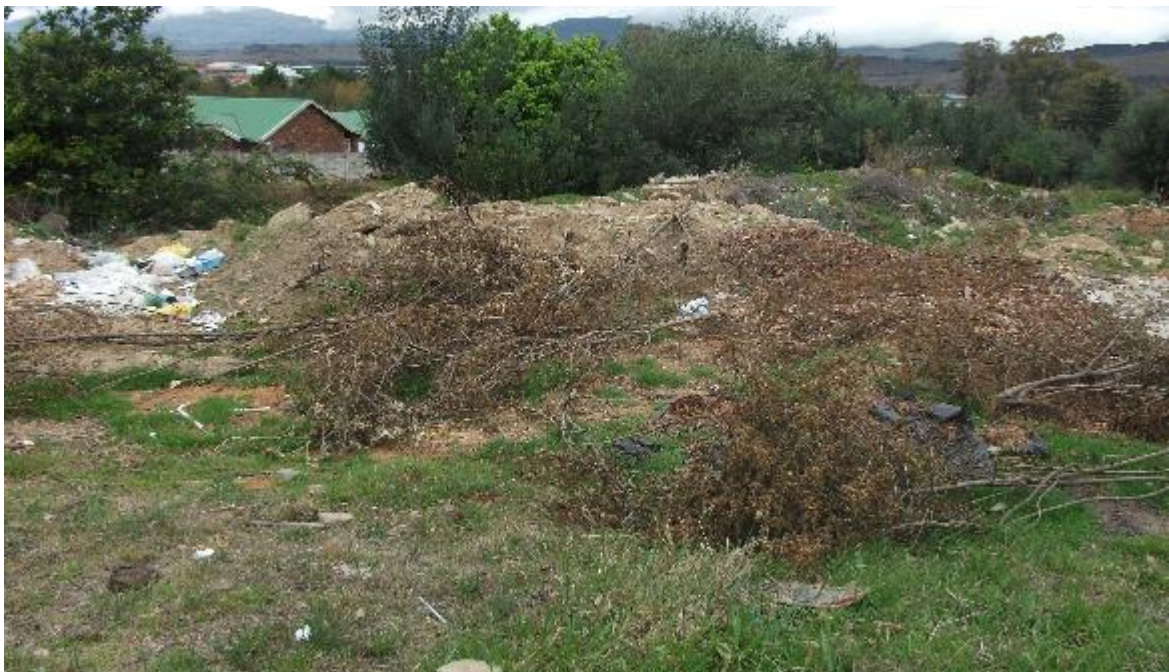
Figure 4: Rubble and waste along eastern boundary

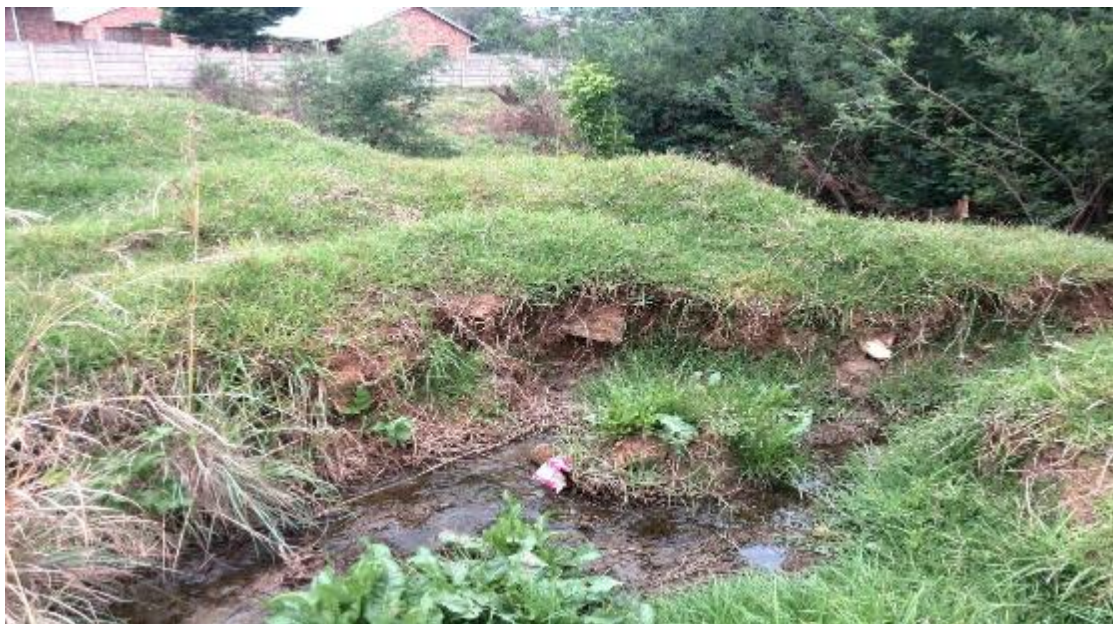
A small stream or watercourse runs through the project area close to its eastern boundary and several recent geotechnical test pits were observed during the site inspection.

Figure 6: Stream running through project area

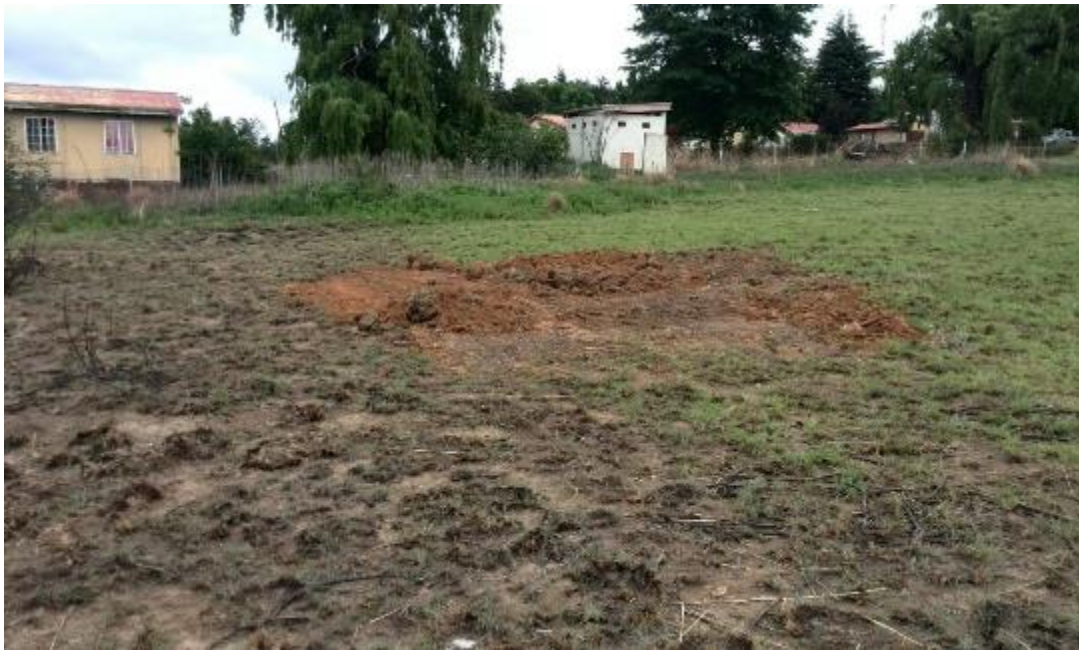
Figure 7: Recent geotechnical test pit near western boundary and residences

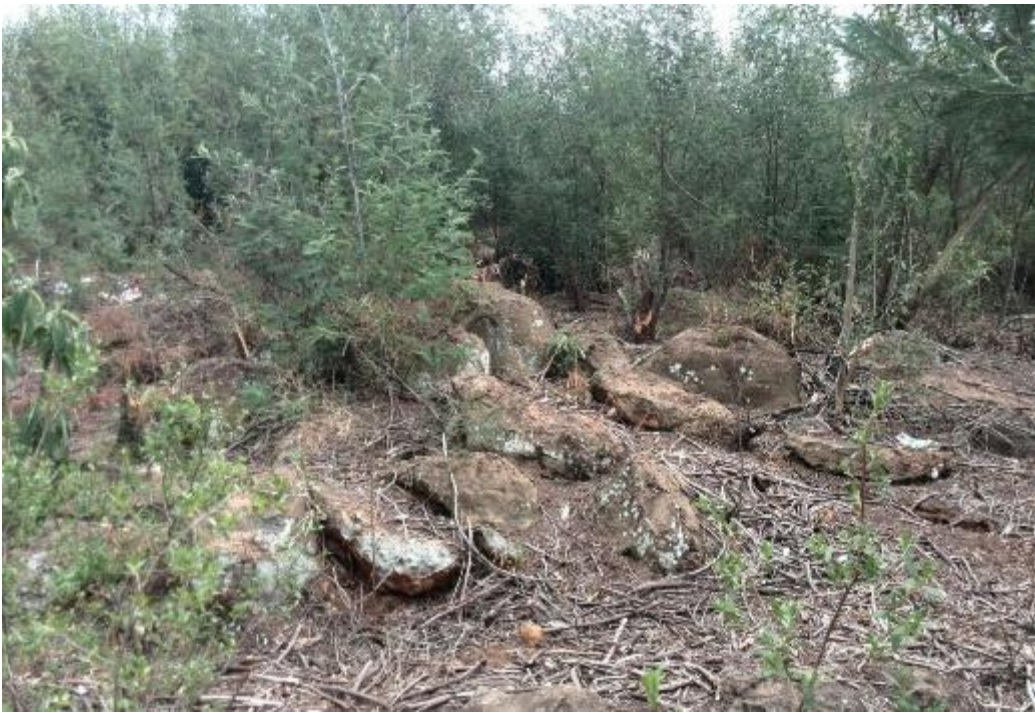
No heritage sites, such as graves, remains of old structures, archaeological material, etc, were found during the site inspection. However, a large rocky outcrop is located in the southern half of the project area. The rock type is unknown but this area could indicate the presence of fossils (see palaeontological section below) and it is recommended that the rocky outcrop remains undeveloped and becomes an open area within the housing development.

Figure 9: Rocky outcrop overgrown by wattles

It is also recommended that if possible the rocky outcrop should be left as is and that the housing development is constructed around it.
