**PHASE 1 PALAEOLOGICAL IMPACT ASSESSMENT FOR CONSTRUCTION
OF THE KWAKOPI WATER SUPPLY SCHEME, MSINGA LOCAL
MUNICIPALITY, UMZINYATHI DISTRICT MUNICIPALITY, KWAZULU-NATAL**

Gary Trower

1 July 2019

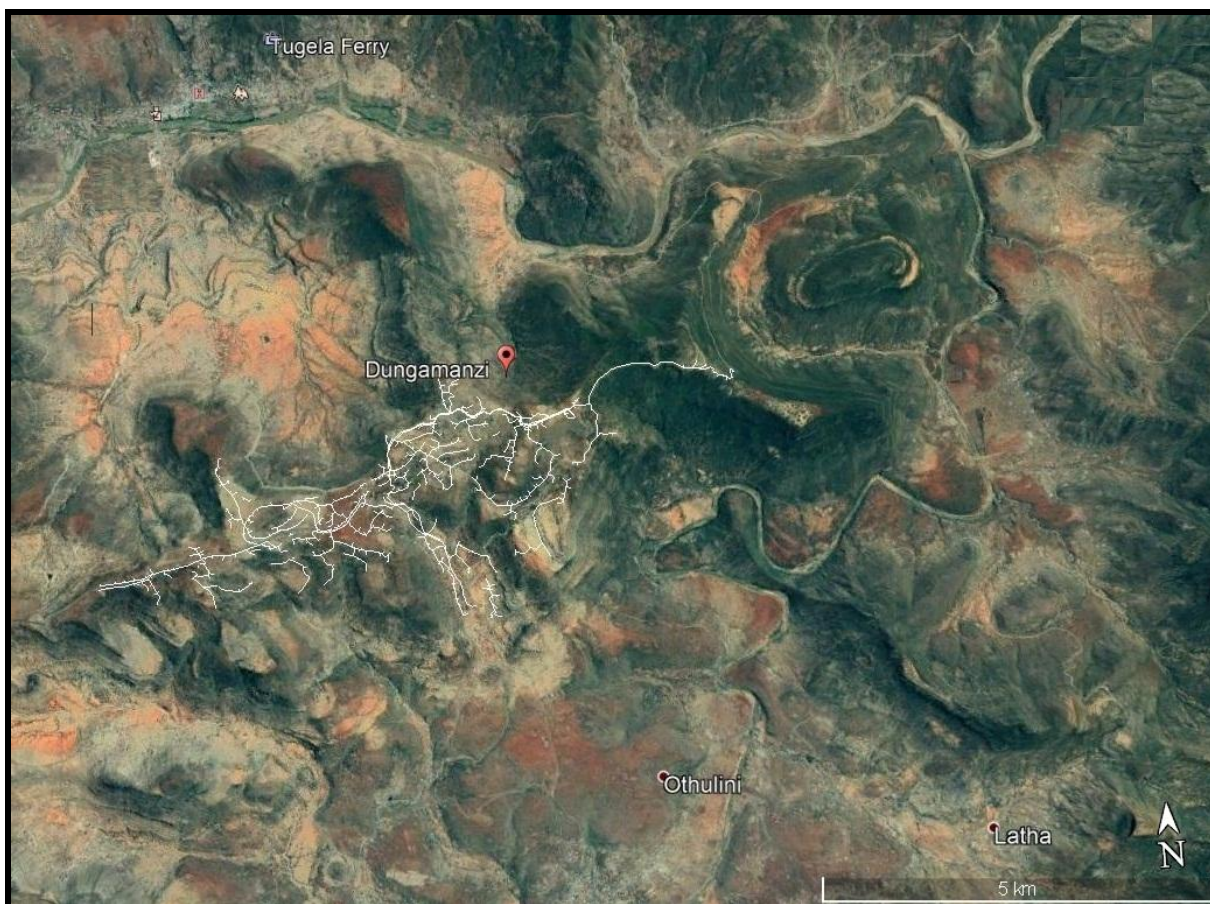
Figure 1: Satellite view from above showing the layout of the pipeline network, just a few kilometres south of the uThukela (Tugela) River. The vast majority of the water supply scheme will occur atop the mountains between KwaKopi, Dungamanzi and Embangweni. (Modified Google Earth image, AfriGIS, 2019)

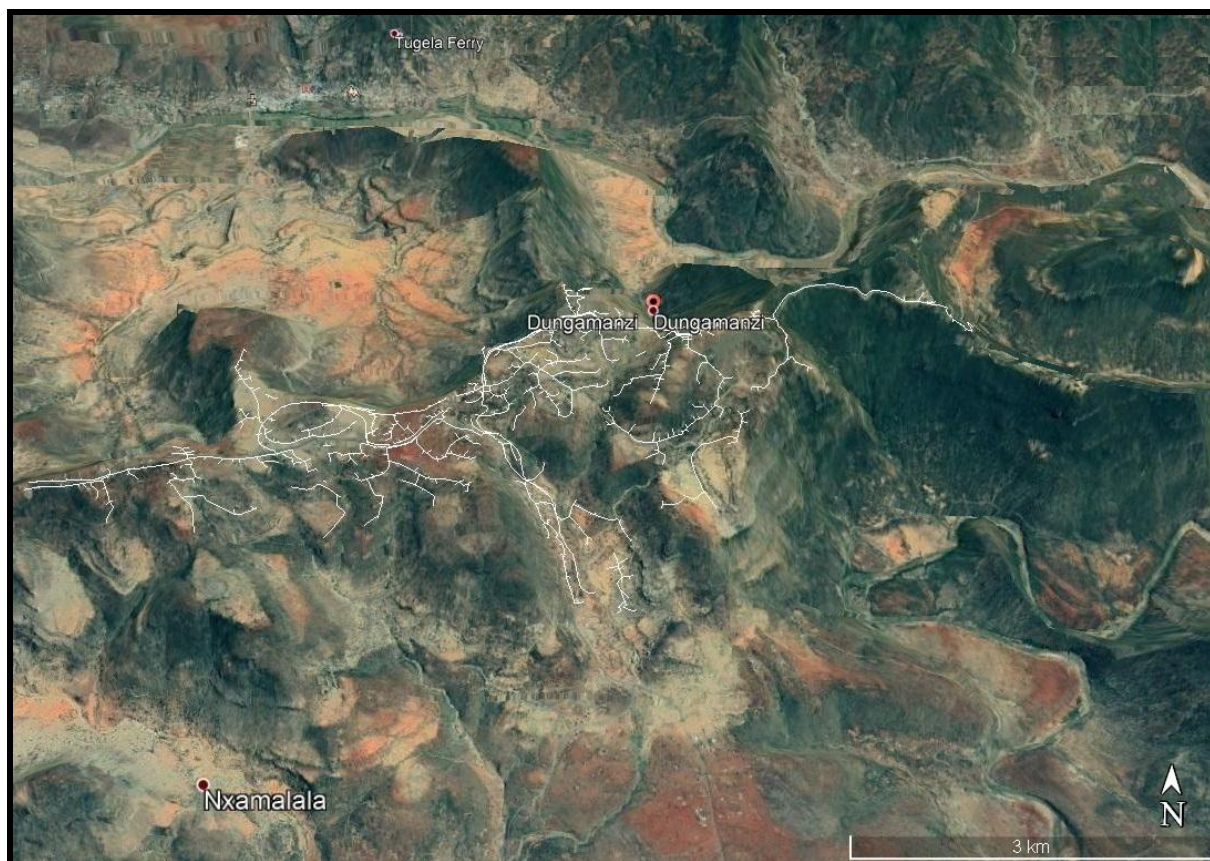
Figure 2: Satellite view from the south, looking north. This image clearly depicts the layout of the pipeline in the high-lying areas. The proximity of the pipeline to the prominent uThukela (Tugela) River hints at the likelihood that this territory has been used by the ancestors of humankind since at least the Early Stone Age. (Modified Google Earth image, AfriGIS 2019)

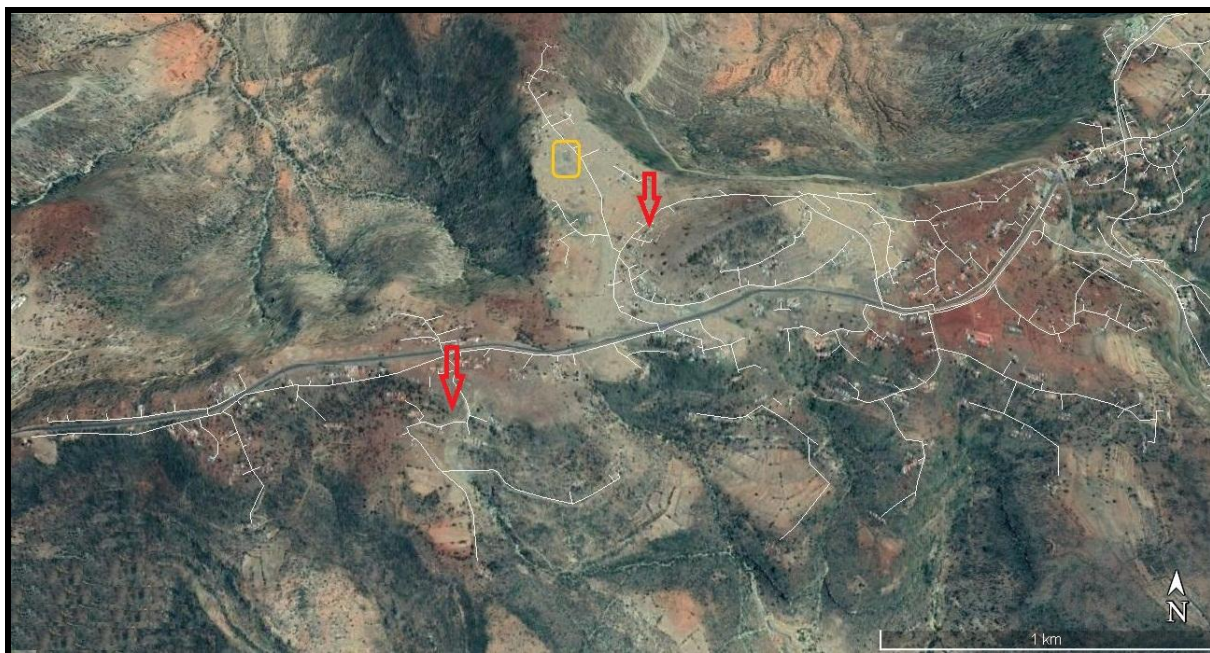
Figure 4: A satellite view of the western arm of the pipeline network. The yellow square indicates the quarry in Fig. 18 where fossils were recorded, and the red arrows point to graves (Fig. 35-37) which were located fairly close to the route of the pipeline. (Modified Google Earth image, AfriGIS 2019)

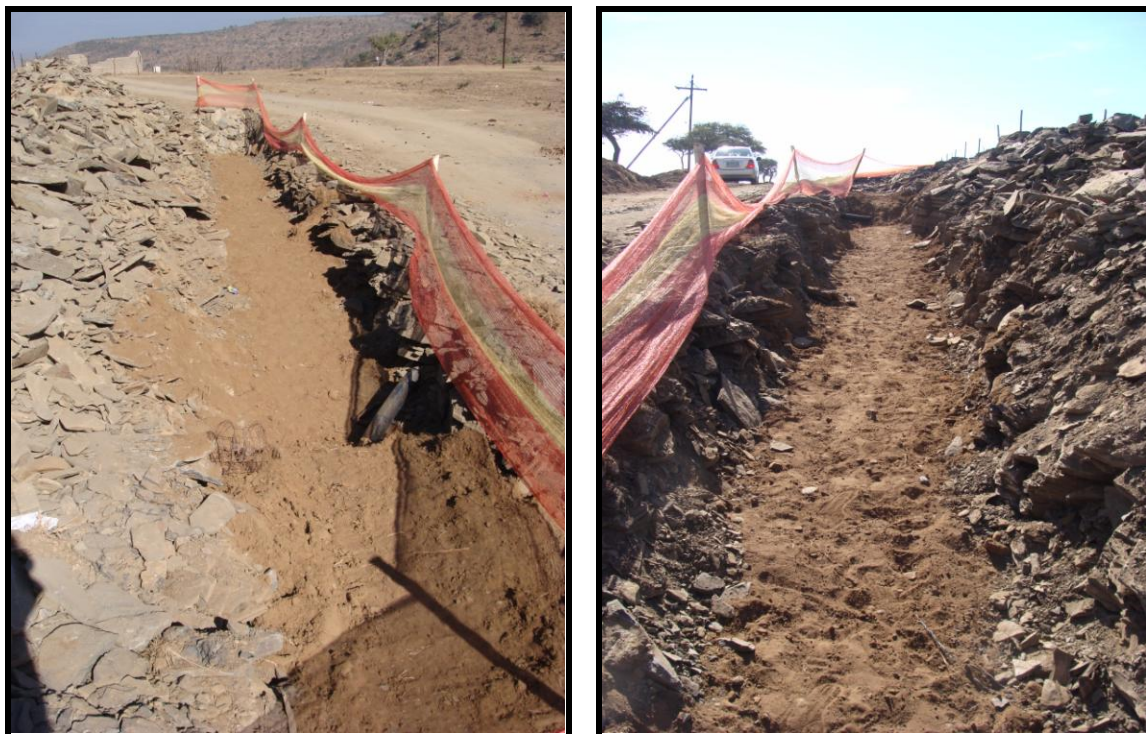
Figure 10 & 11: Pipeline trenches dug adjacent to the road leading up to iNhlabamkhosi, with piles of shale waiting to be pushed back over the trench once the pipeline has been laid and connected. These piles were examined for traces of fossils, but were dusty and unstable, making them challenging to survey.

During the survey it was noted that construction activities were already in an advanced stage of completion and that work had commenced before the PIA was conducted. Several sections of the pipeline had already been laid and earth moving equipment was on site digging new trenches (Figure 10-17). The fact that several of the pipeline extensions had already been laid and covered up made it difficult to gauge the nature of the underlying bedrock that had been exposed during digging activities. In other areas there were still sections of freshly exposed shale piled next to the pipeline route, which were investigated to ascertain the possibility of fossil occurrences. The slabs of shale were dusty and heaped up, making it difficult to get a clear view of exposed rock surfaces which need to be relatively clean to reveal fossil material within them (Figure 10-12).

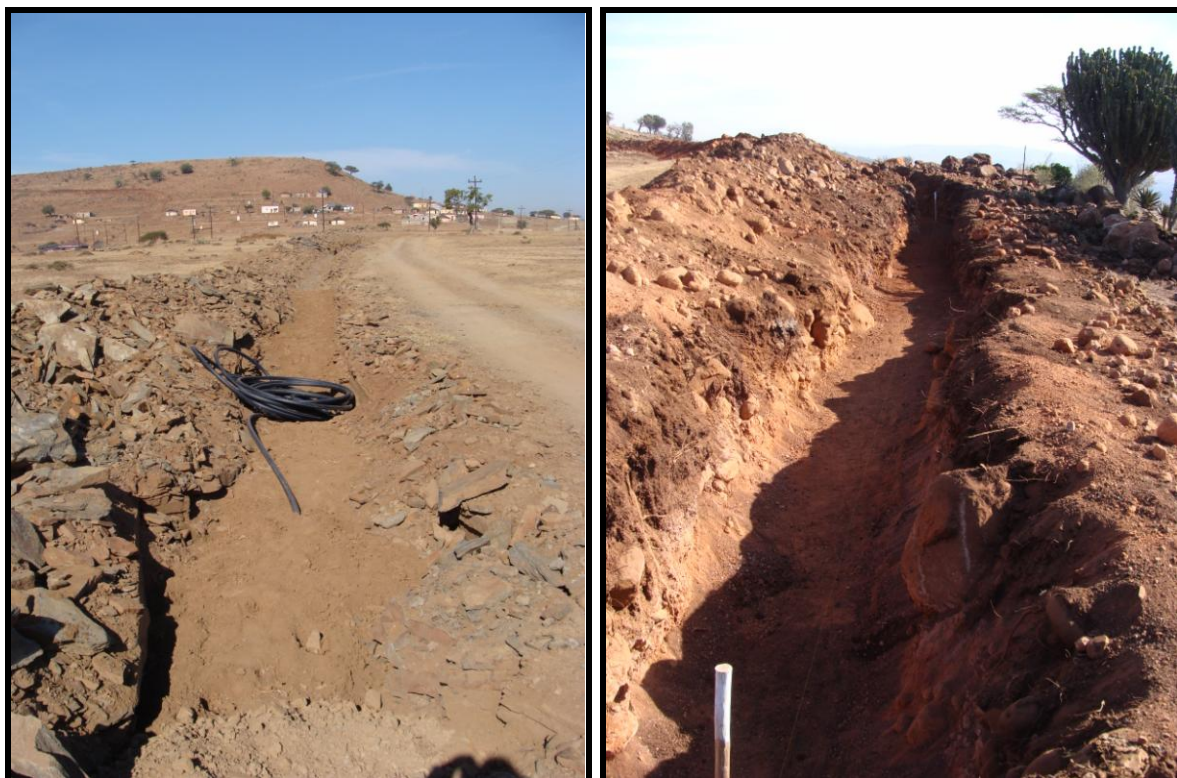
Figure 12 & 13: Sections of the pipeline network had already been laid (left), and new trenches were actively being dug and prepared (right). In Fig.12 the bedrock is fossiliferous shale and immediately to the right of this photo is the quarry where the fossils were recorded. In Fig.13 the bedrock is dolerite

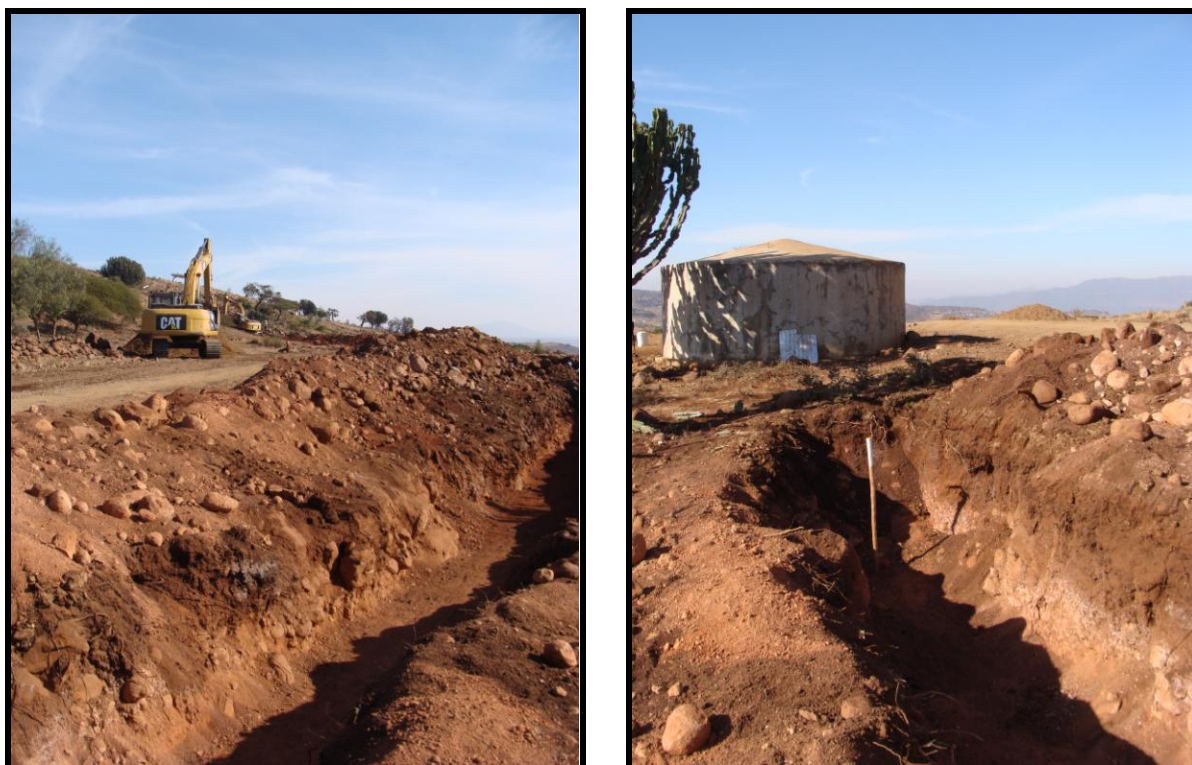
Figure 14 & 15: On top of a dolerite hill a construction crew were busy digging the trench leading up to one of the existing reservoirs, which will be replaced with a new 350kL concrete/steel reservoir. Another team of workers was inside the completed section of the trench and were preparing the base of it for the laying of the pipe. The specifications given for the trench is that it is to be 0.8 m wide, but this ditch considerably exceeded that. The reason for this could be because of the fact that this bedrock was non-fossiliferous and caution wasn't needed to be exercised, or because it was maybe a more difficult rock-type to excavate

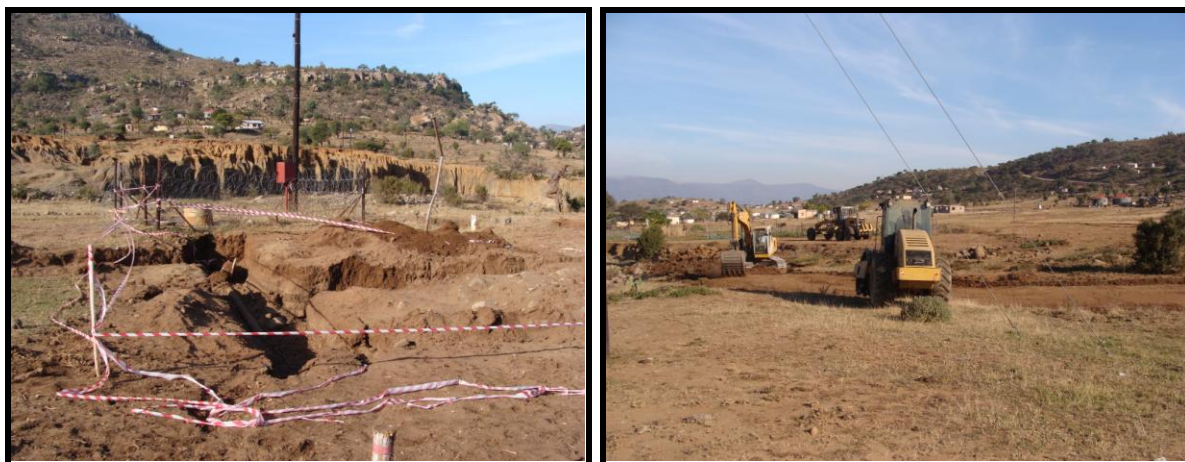
Figure 16 & 17: To the east of the R33 and adjacent to the Fabeni River, a pocket of Quaternary alluvium was exposed very close to the position of the borehole (left). A stratified sediment package is visible behind the power line pole, which contained archaeological material but no visible fossils. A construction crew were busy with heavy earth moving equipment and were busy digging into the uppermost part of the floodplain deposit, a unit which is likely to contain abundant lithic material

On the eastern side of the stream several dongas were exposed which contained stratified floodplain deposits (Figure 16). These were surveyed in order to ascertain whether any

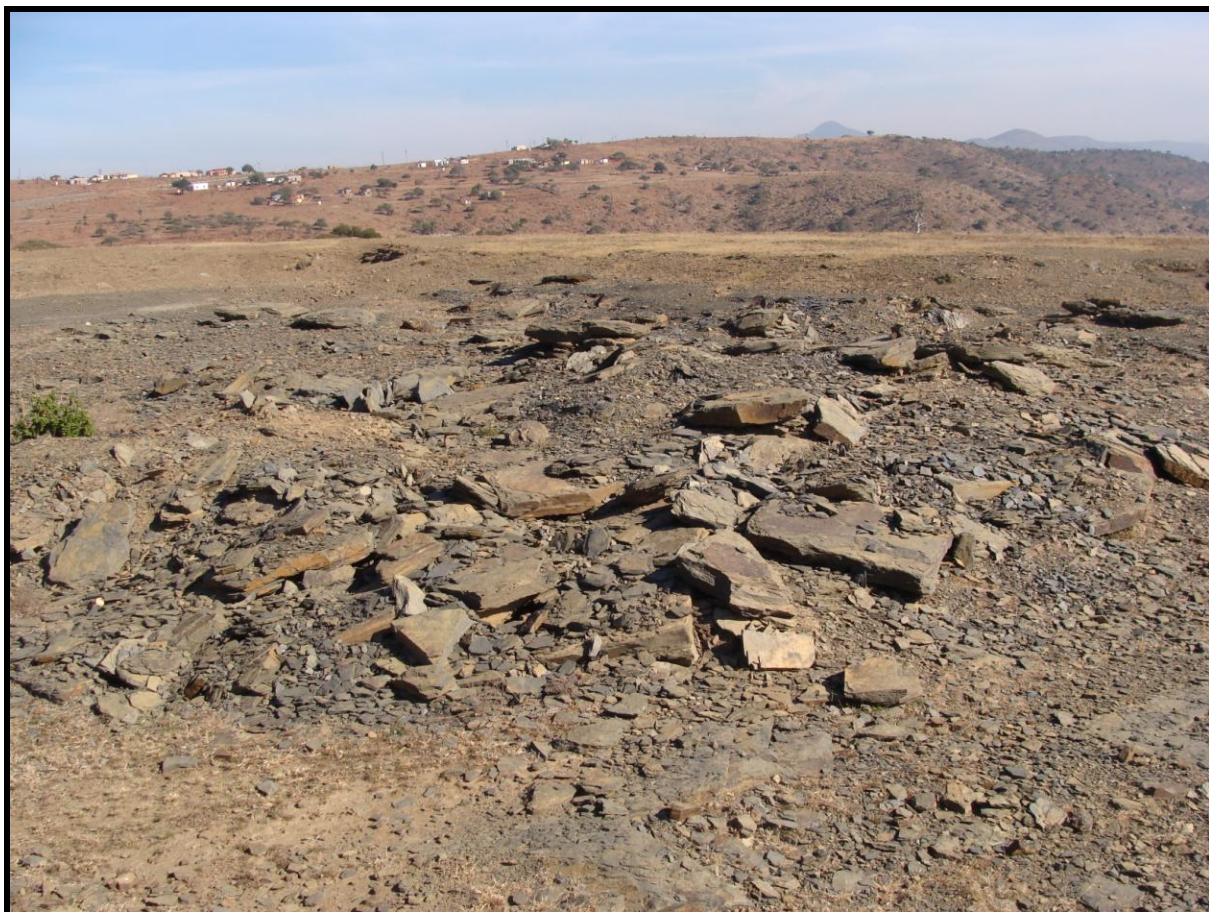
Figure 18: The quarry highlighted with the yellow square in Figure 4 & 5, GPS coordinates: 28° 48' 13.22" S, 30° 27' 10.37" E. This area has been exposed to the elements for many years so the surfaces on the rock slabs are clear with lots of detail visible. Several trace fossils were observed, with worm trails being especially common.

Immediately adjacent to the pipeline at GPS coordinates 28° 48' 13.22" S, 30° 27' 10.37" E a quarry-like area was observed (yellow squares in Figure 4 & 5). These rocks have been exposed to the elements for years and have been washed clean of dirt and sand, thereby presenting clear flat surfaces of embedded imprints representing trace fossils in the form of invertebrate burrows, as well as material which appeared to represent fossilized leaves. Throughout the entire survey this was the only patch of rocks which presented a good opportunity to gauge the fossiliferous potential of shales disturbed during pipe-laying operations, and this quarry showed that fossils are abundantly present as correctly predicted by the SAHRIS map. None of the material recorded was rare or exceptional and although invertebrate trails were common, no animal fossils (invertebrate or vertebrate) were observed.

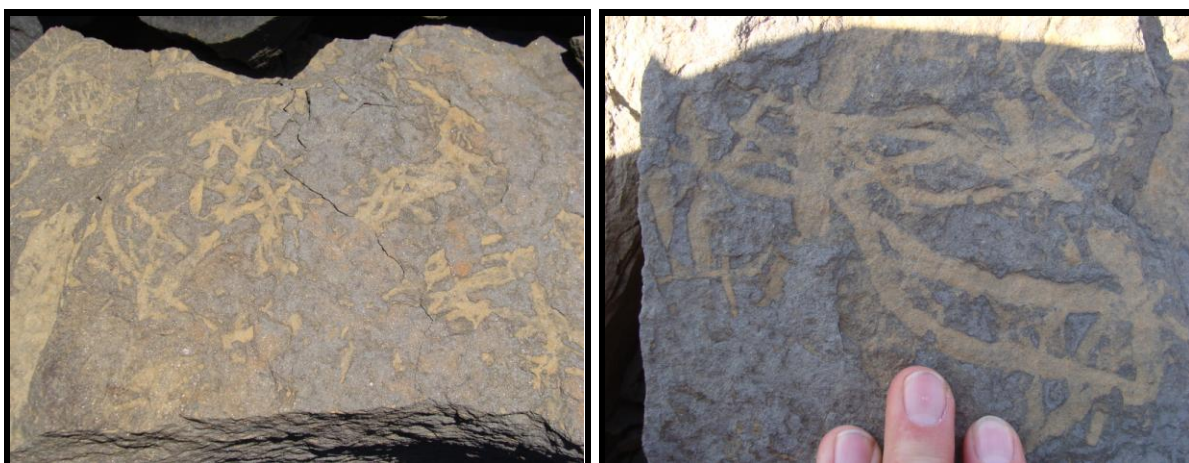
Figure 19 & 20: The tunnels and burrows of invertebrates were visible on several of the rock surfaces in the quarry and appear to represent worm trails, GPS coordinates: 28° 48' 13.22" S, 30° 27' 10.37" E

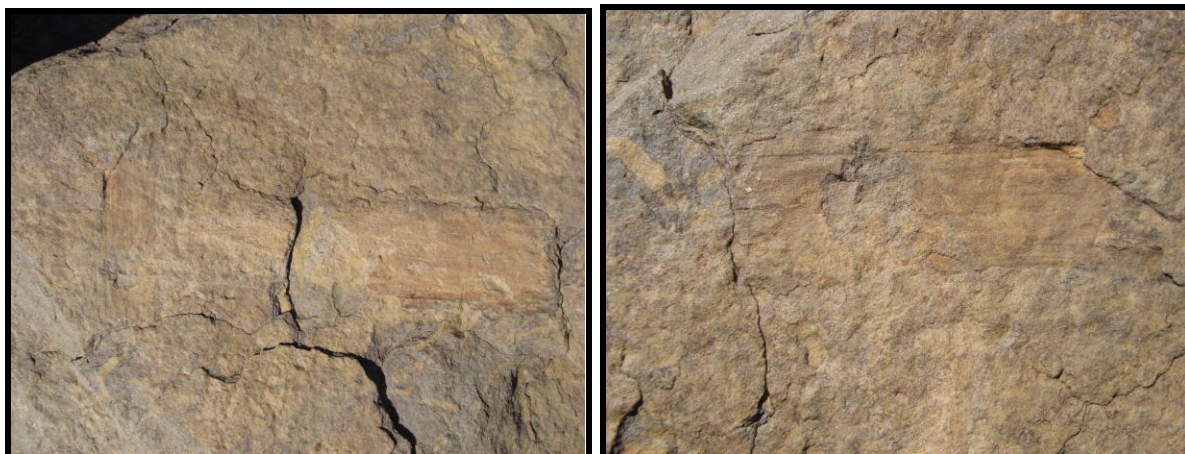
Figure 21 & 22: Visible on one of the exposed rock surfaces within the quarry area were fossils which appeared to represent the imprints of fossil leaves. GPS coordinates: 28° 48' 13.22" S, 30° 27' 10.37" E

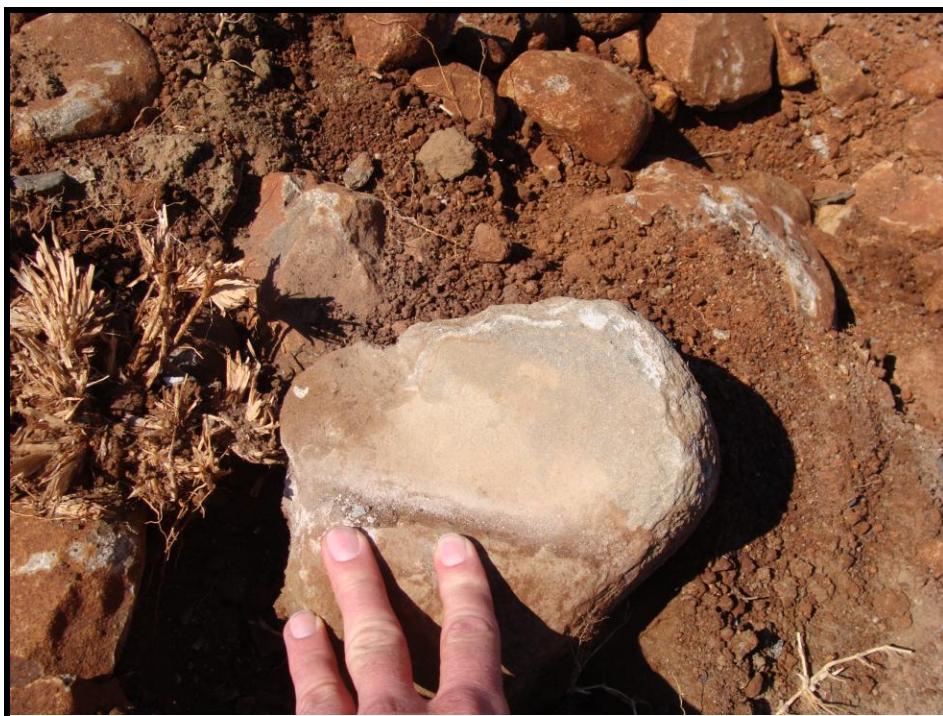
Figure 23: A badly damaged lower grindstone. It was lying amongst a pile of dolerite boulders that had been piled up adjacent to the pipeline trench. The grinding surface revealed a low-medium use wear

During the survey, three locations were recorded where stone tools were present. The first site was located at GPS coordinates 28° 48' 03.31" S, 30° 27' 04.44" E and comprised of a partial lower grindstone. It was in its current position due to the creation of the pipeline trench and was resting amongst other rocks (Figure 23). It was broken and had low-medium use wear damage on its grinding surface. The second archaeological occurrence was along the river, where an abundance of artefacts was visible. On the very edge of the floodplain a single large flake with a faceted platform was recorded, indicating that it likely originates from the MSA as this method of flaking was not used in the LSA (Figure 24, GPS coordinates 28° 49' 12.00" S, 30° 29' 05.76" E). Whilst walking across the floodplain to where the back-actors were digging the trench, a single thumbnail scraper was observed (Figure 25, GPS coordinates 28° 49' 11.70" S, 30° 29' 07.26" E).

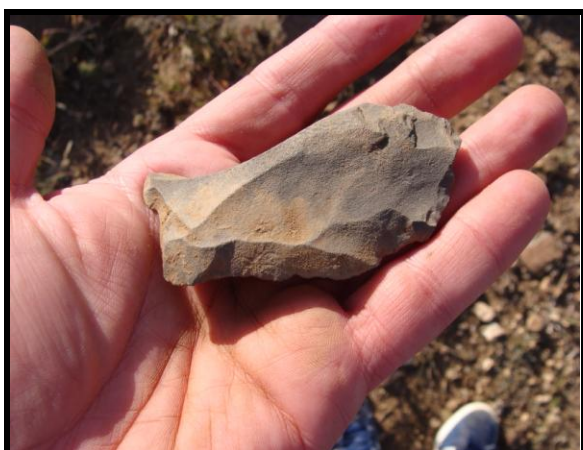
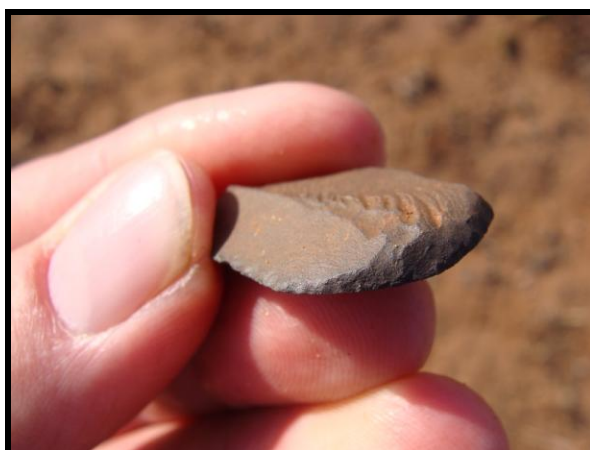
Figure 24 & 25: A MSA flake with faceted platform (left) & a thumbnail scraper (right), found within the floodplain of the Fabeni River

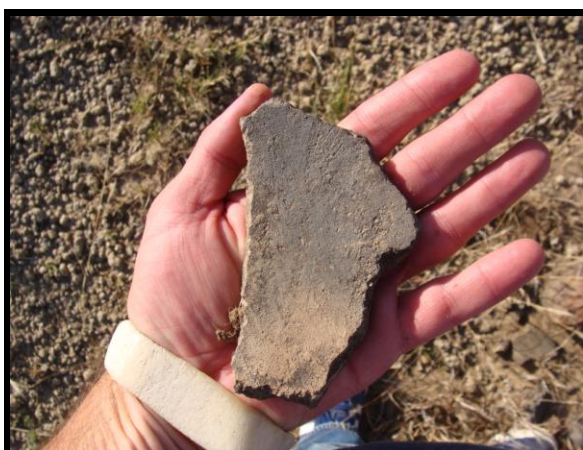
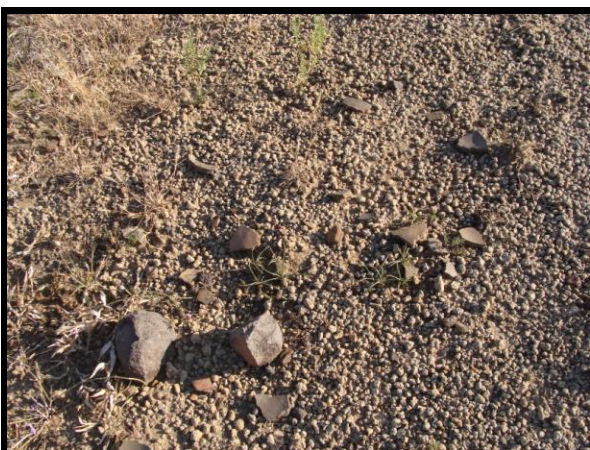
Figure 26 & 27: A survey of the dongas found east of the borehole revealed abundant pottery fragments, several of which appeared to refit and were confined to a small area. Although these may be a few hundred years old, iron slag fragments found close to the ceramics seem to suggest it could be Iron Age material

Quaternary fauna had preserved within this pocket of valley alluvium, but no fossils were recorded. Pottery fragments were observed which could be a few hundred years old or could date back to the Iron Age (Figure 26, 27 & 29, GPS coordinates 28° 49' 08.98" S, 30° 29' 11.42" E). Several of the larger pieces appeared to refit, representing a large section of a pot that had survived and was confined to a small area (Figure 27). A few pieces of iron slag were also noted within the dongas (Figure 28). The third archaeological site comprised of several LSA flakes and tools, including numerous adzes and scrapers (GPS coordinates 28° 48' 52.20" S, 30° 26' 57.31" E, Figure 30-34). These tools appear to represent wood-working activities, although some of them could have been used for working animal hides. The current vegetation growing on the mountain slopes and within the valleys includes numerous trees and bushes, and early man may have sought out such a resource for producing tools such as spears, bows, or digging sticks, thereby leaving behind the stone implements which were most suited to shaping them.

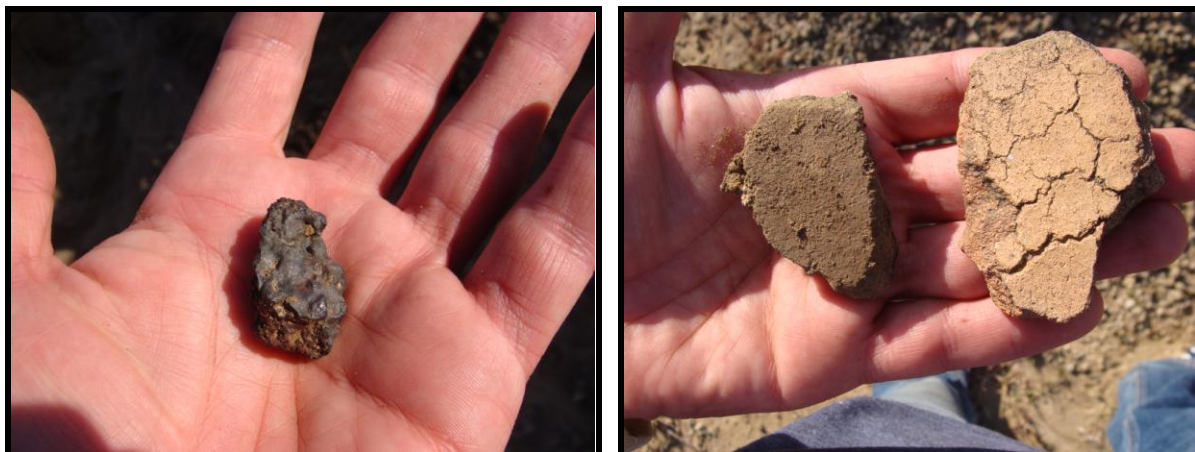
Figure 28 & 29: A fragment of iron slag (left) & two pottery fragments (right), also part of the archaeological material preserved within the Quaternary alluvium of the Fabeni River

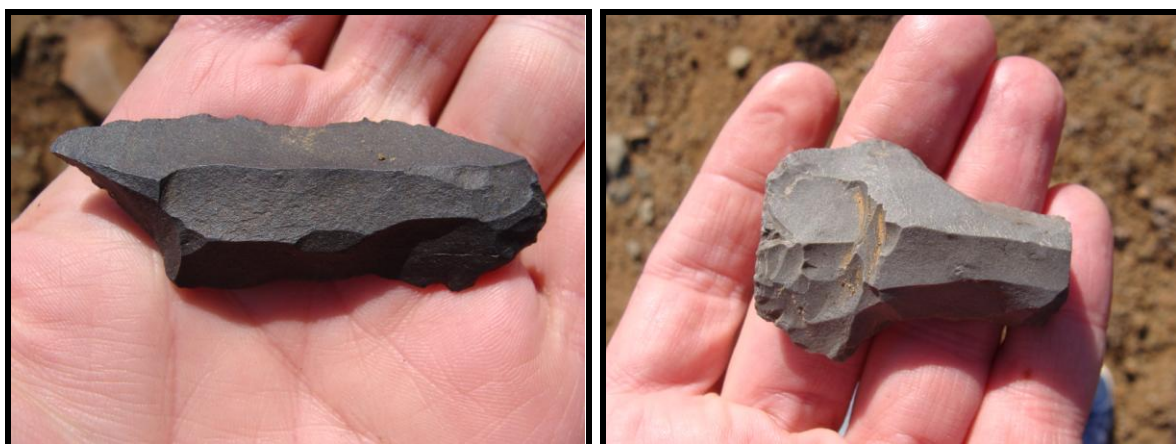
Figure 30 & 31: Multiple flakes and stone tools were spread across several metres of a mountain slope, right in the direct pathway of the pipeline. These were out of context and due to the fact that the soil is so shallow on the slopes, it was difficult to pinpoint exactly where they originated from. A blade or knife is visible on the left and an adze is displayed on the right

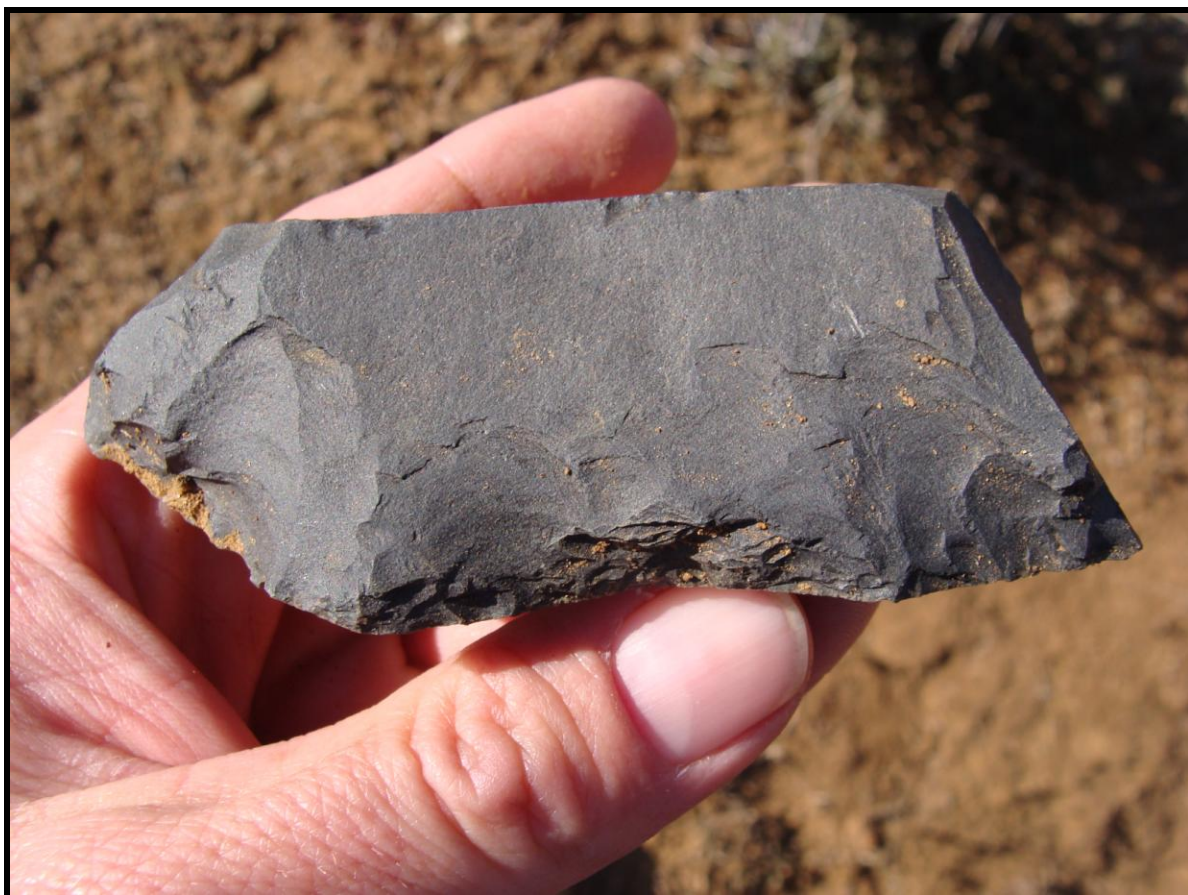
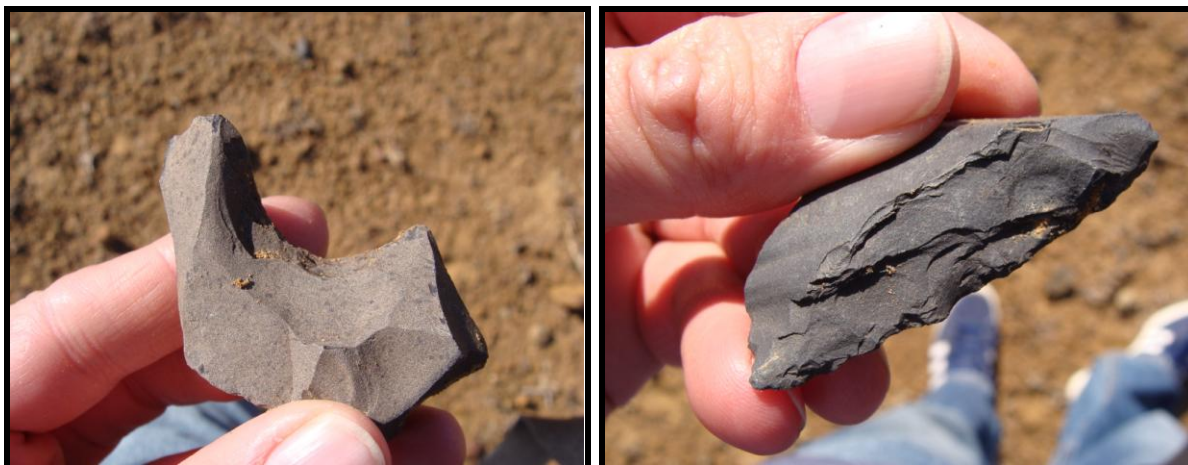
Figure 32, 33 & 34: Along a section of the mountain slope, several LSA tools were encountered which seemed to suggest some form of wood-working activity. An adze has a typical steep-sided, chisel-like edge, which is ideal for stripping bark off stems and shaping wood with a chiselling-rasping action. The circular shape of the tool depicted in Fig 33 is ideal for shaping a branch into a bow or spear. The mountains in this region are covered with bushes and trees and early humans occupying the landscape may have sought out species of tree growing on the slopes, leaving their wood processing tools behind. Scraping tools such as these can also be used for shaving layers of tissue off animal skins in order to prepare them for tanning

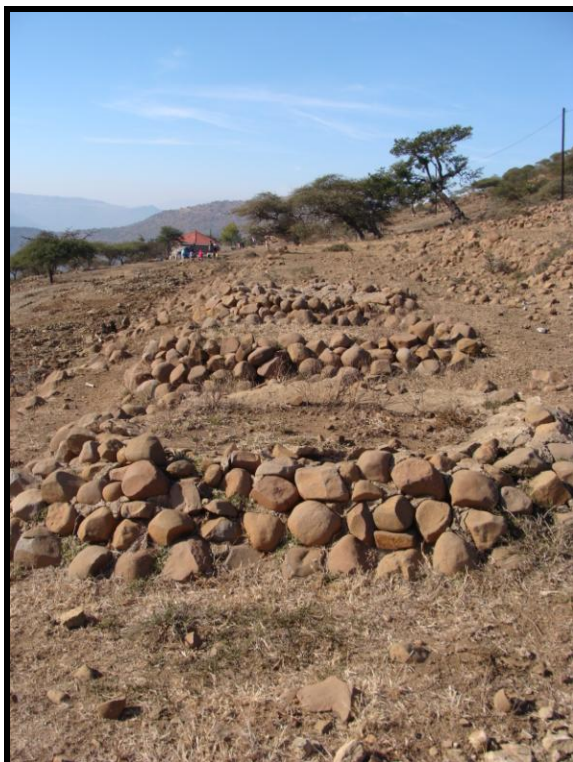
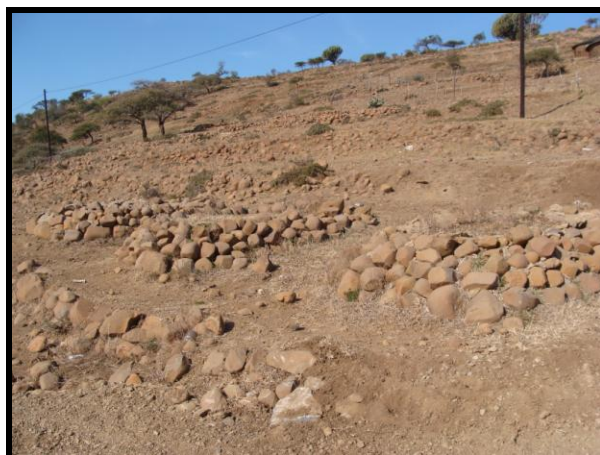
Figure 35, 36 & 37: Several graves were recorded that were fairly close to the route of the pipeline. Fortunately these were easily recognisable by the technique of covering them with dolerite boulders, but older graves that are overgrown with vegetation may be more difficult to recognise.

In terms of graves, there are several points where the path of the pipeline comes within metres of graves, and it is always important to maintain a sufficient buffer zone around these culturally sensitive features (GPS coordinates 28° 48' 48.52" S, 30° 26' 58.33" E, Figure 35-37). Although graves are mostly easily recognizable due to the dolerite boulders packed on them, the engineers will need to be cautious in the case where graves are many decades old and have become overgrown with aloes and small trees, making them less recognizable amongst established vegetation.
