**PHASE 1 HERITAGE IMPACT ASSESSMENT FOR THE PROPOSED  
CONSTRUCTION OF THE NEW GRAVEL ROAD L3415, ALFRED DUMA LOCAL  
MUNICIPALITY, KWAZULU-NATAL**

1 December 2019

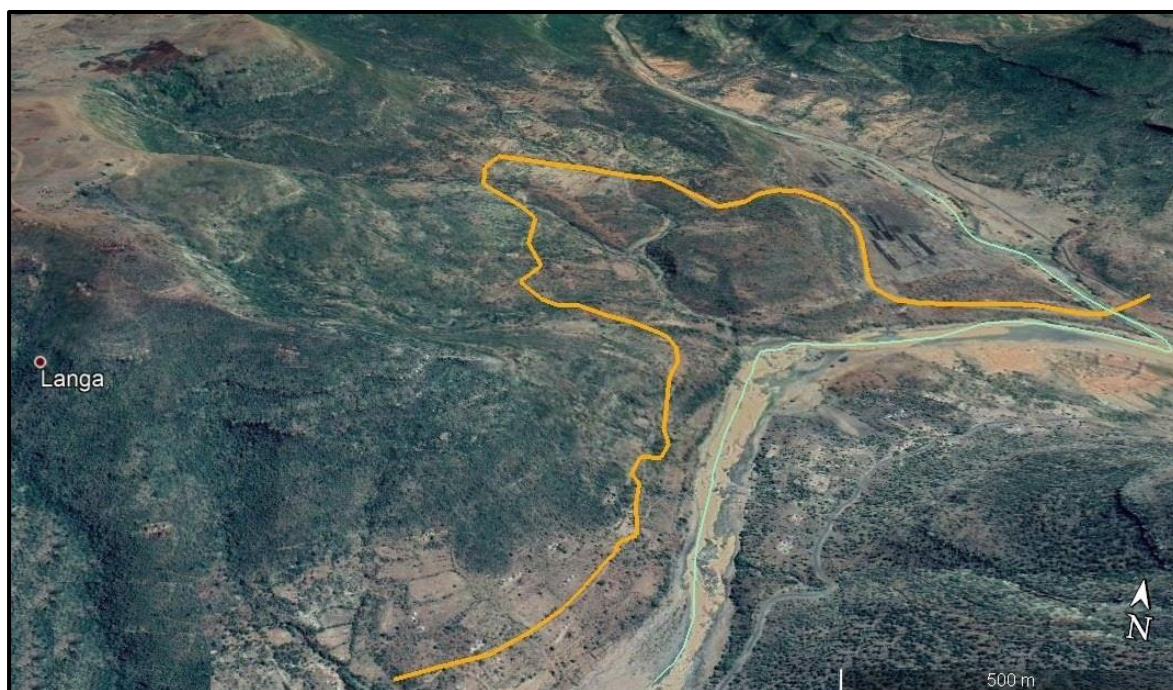
**Figure 1:** Satellite image showing the layout (yellow line) of the proposed road in the context of existing road accessibility and in relation to the position of Langa. North is at the top of the image. Modified Google Earth image, AfriGIS 2019

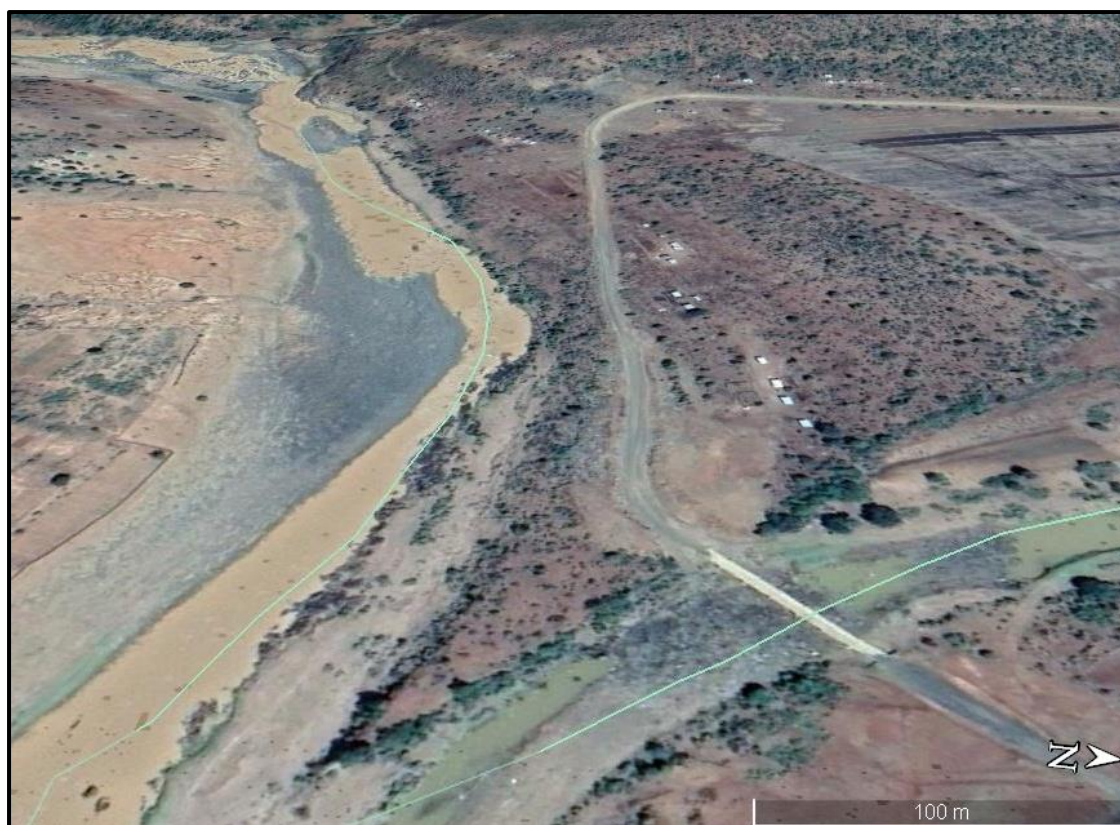
**Figure 2:** Satellite image showing the starting point of the proposed road, at the bridge crossing. This section of the road is already well established and is built on top of dolerite and Quaternary deposits. North is to the right of the image. Modified Google Earth image, AfriGIS 2019

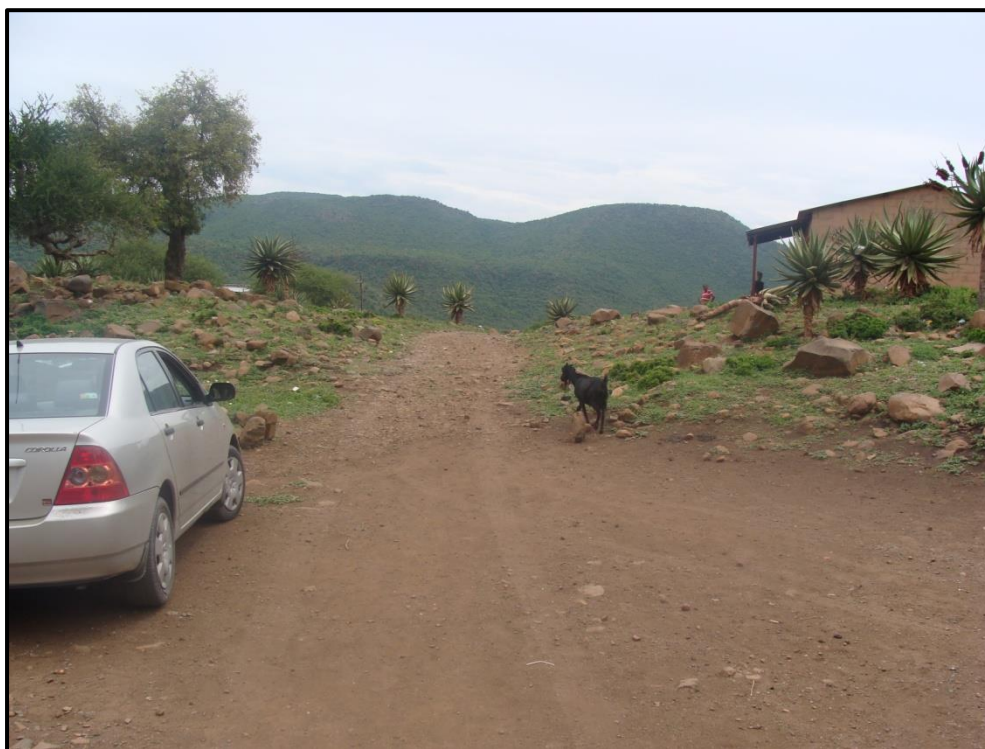
**Figure 7:** The first part of the route had a driveable road but it ended before the half-way mark, so the rest of the survey was done on foot

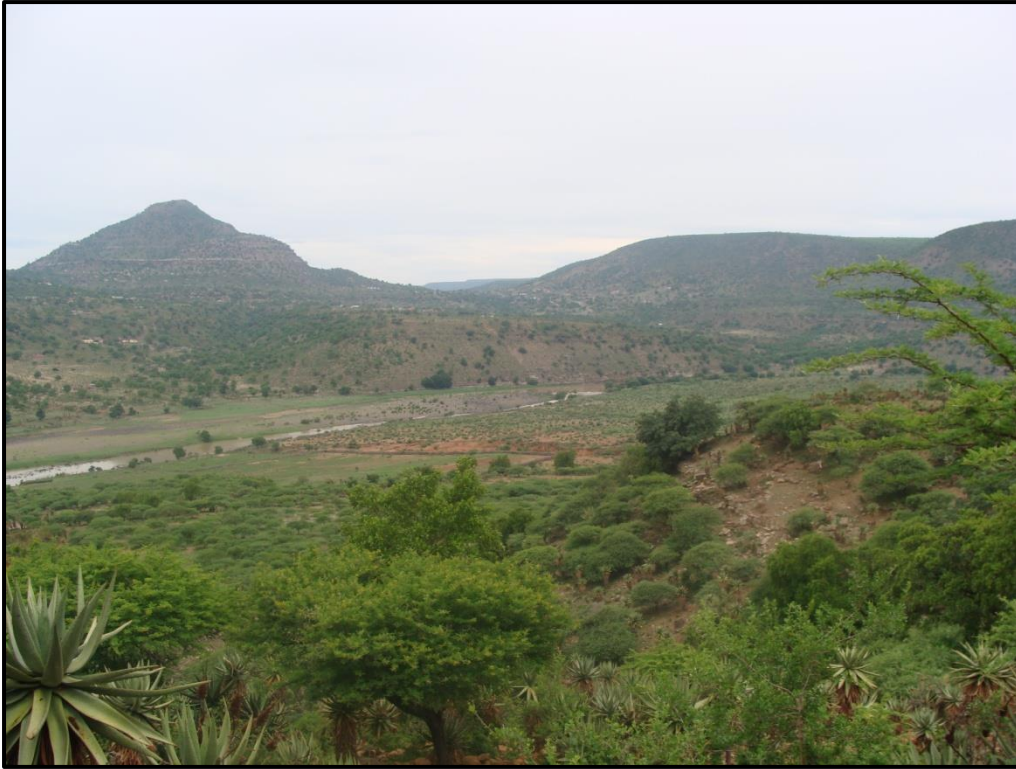
**Figure 8:** Photograph taken at GPS co-ordinates 28° 41' 44.23" S 30° 16' 06.93" E along the route of the proposed road. The last section of the road is built on the river floodplain so archaeological material and possibly Pleistocene fauna is likely to be preserved in pockets of Quaternary alluvium

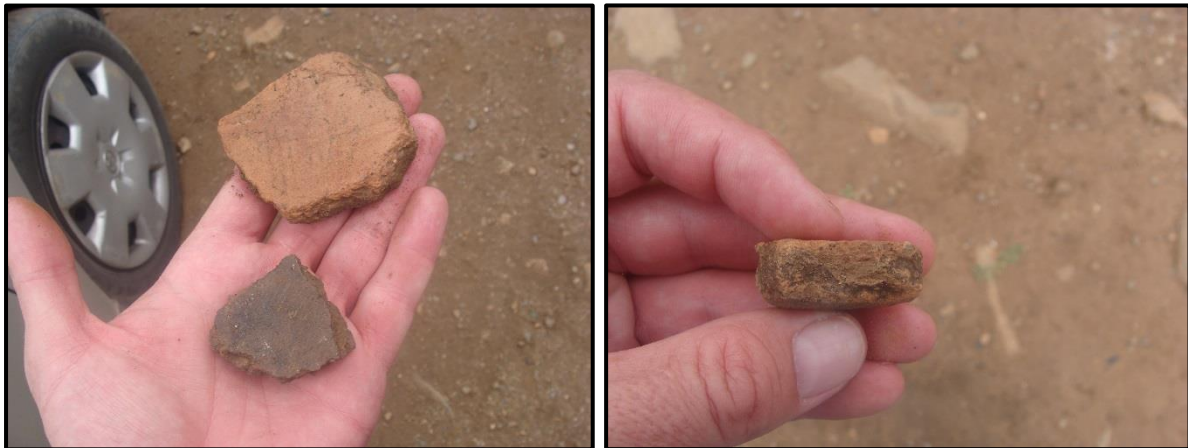
Pottery fragments were fairly common on the site footprint, with both decorated (red ochre) and undecorated pieces observed, as well as the occasional stone flake. They were however fragmentary, out-of-context, surface finds and did appear to be part of an archaeological site but rather individual occurrences (Figure 9 & 10).

**Figure 9 & 10:** Pottery fragments are fairly common in the valleys, as some pots used for collecting water likely got accidentally dropped during visits down to the river. These pottery fragments accumulated over many generations and could be hundreds or even over a thousand years old. They therefore likely represent pots from a specific occasion and are not necessarily part of collection of artefacts eroding out of an archaeological site

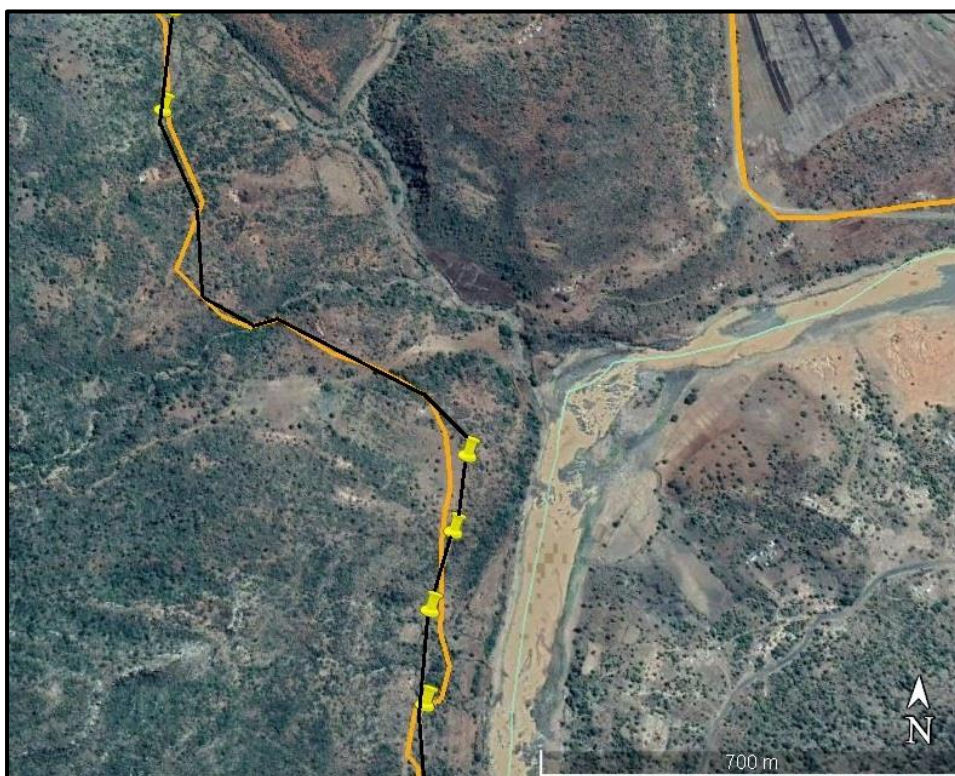
**Figure 12:** Satellite image showing a suggested alternative route for the proposed road, indicated in black. This option tries to avoid vegetated areas and to rather stick to existing paths and open patches of ground

proposed road. Site engineers and planners will need to be cautious and sensitive to these occurrences as old graves that are overgrown with vegetation will be almost invisible, so the final route for the proposed road should avoid thick patches of bush but rather stick to existing roads, footpaths, cattle trails and small clearings, as indicated in Figure 11 & 12.
