# HERITAGE STATEMENT:

## LONG COTTAGE, 248 MAIN ROAD

### ERF 87086, MUIZENBERG

Conducted in terms of sections 27(18) of the NHRA (Act 25 of 1999)

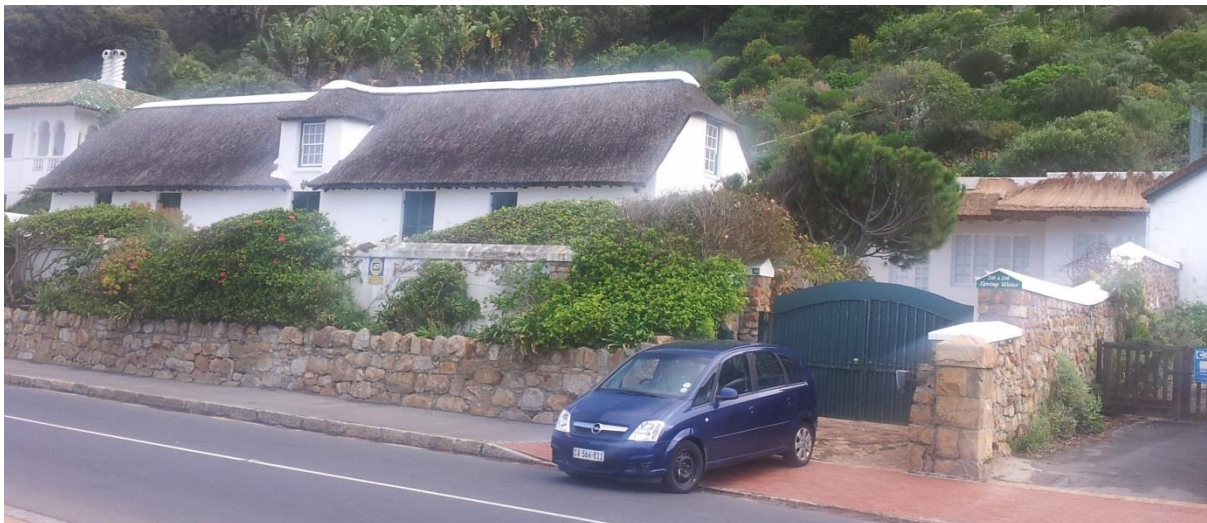
The house seen from Main Rd. Note unauthorised new thatch "skirt" on the outbuilding on the RHS.

1. The removal of the thatch on the protruding portion of the cottage front façade
2. Strict adherence to the building plans once approved.

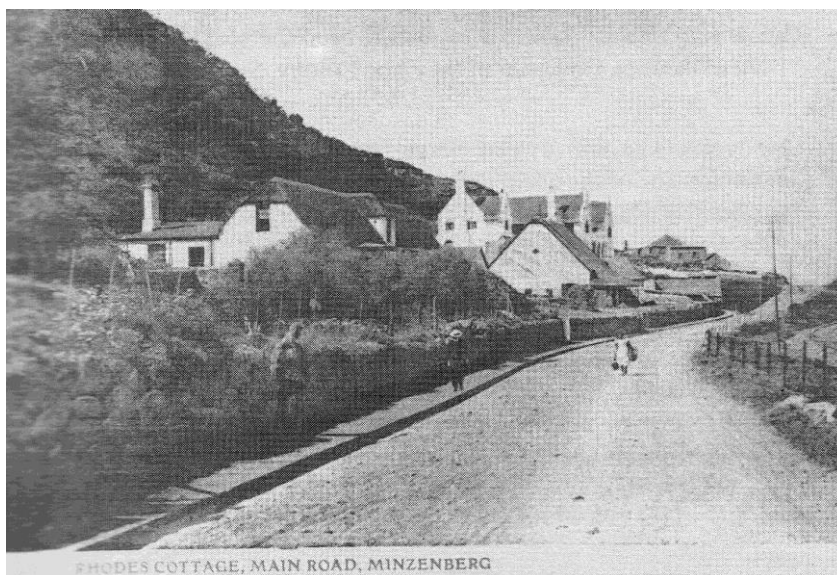
Figures 5 and 6 are c1905 views of Long Cottage. Figure 6 is particularly interesting as it shows the rear of the house. A lean-to room with a chimney is visible. Due to the quality of the image, it is hard to tell if the room is flush with the end gable wall or set back – i.e. whether this is the room we now know as the kitchen or the rear wing in the T-shaped stage of the house. However, the

chimney is in the same position as the one currently in the kitchen and so it is possible that by 1905 the T-shape had been filled in to form the current L-shaped plan. The first floor addition to the rear of the house is not visible and thus post-dates 1905.

Figure 6: view up Main Road, showing the rear of Long Cottage. Again, this is again c1905 as Rust-en-Vrede has already been built. (Walker 1997:63)

The house is a thatched longhouse building with hipped centre gable and French doors from each front room onto a stoep. A passage, stoep, kitchen and bathroom have been added to the rear under lean-to roofs sometime between 1904 and 1955, although Walker (1997:64) asserts that alterations were done in 1900 and 1911. A second storey was added to a part of the rear of the building sometime after 1905 (refer Figure 6).

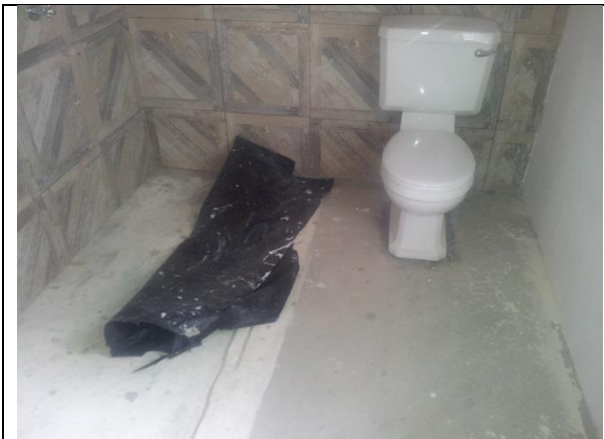
<p>Downstairs bathroom.</p> <p>New toilet pan and cistern, new wall tiles. Floor tiles and shower proposed.</p>
---	---

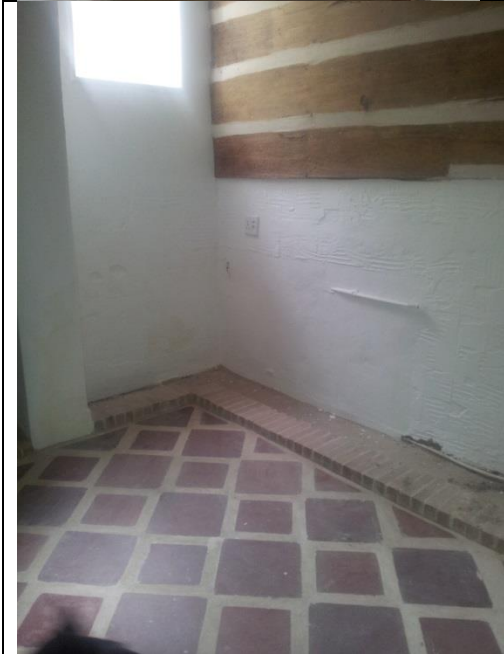
Kitchen.  
New floor tiles.  
Kitchen cupboards removed. New, freestanding units proposed.  
New decorative wall panelling in the area shown only.

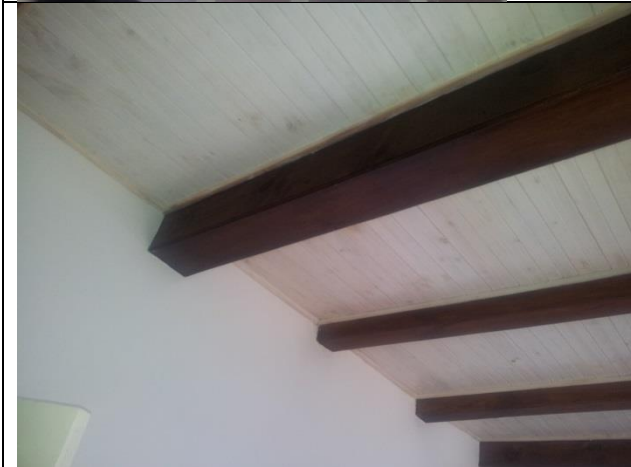
Some beams in rooms in the front wing of the house were condemned by the structural engineer (refer attached report) and have been repaired according to the engineer's method statement.

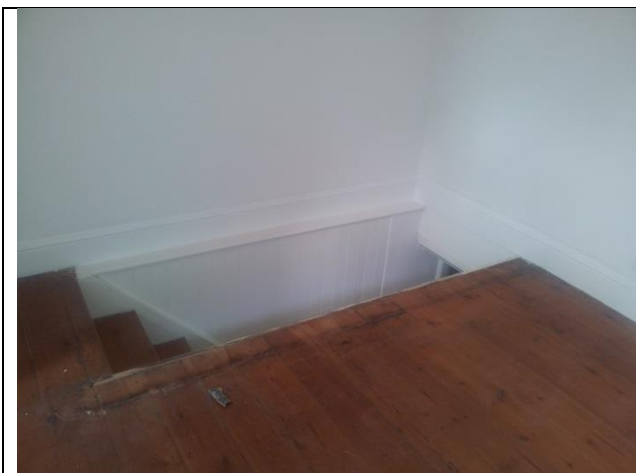
<p>Railing to stairwell in rear first floor room to be replaced. To be 22mm x22mm bannisters under reproduction early C20th handrail and painted to match existing joinery in the room.</p>

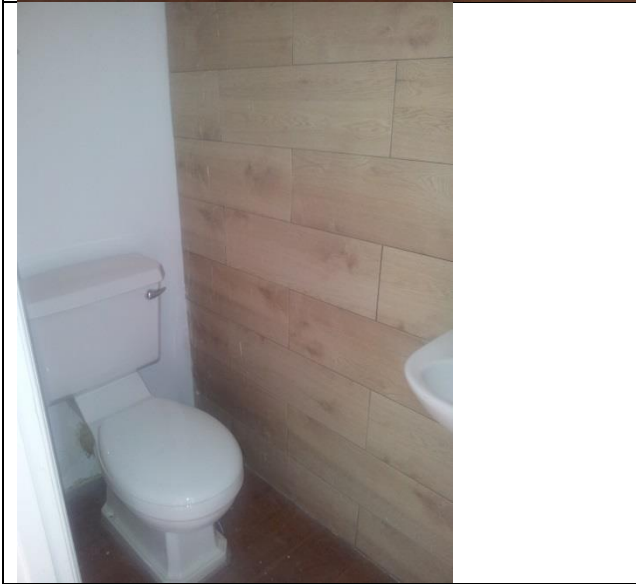
<p>Bathroom in first floor room. Sanitaryware replaced and wall and floor retiled.</p>

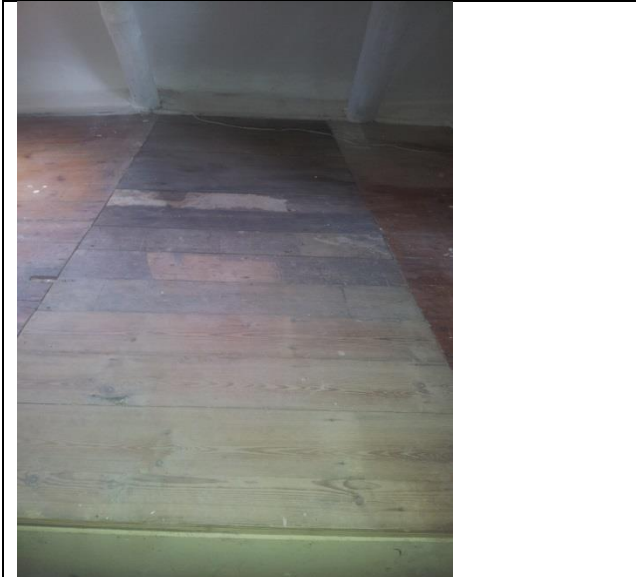
<p>Attic. Repaired rotten floor boards using recycled timber of a similar age.</p>

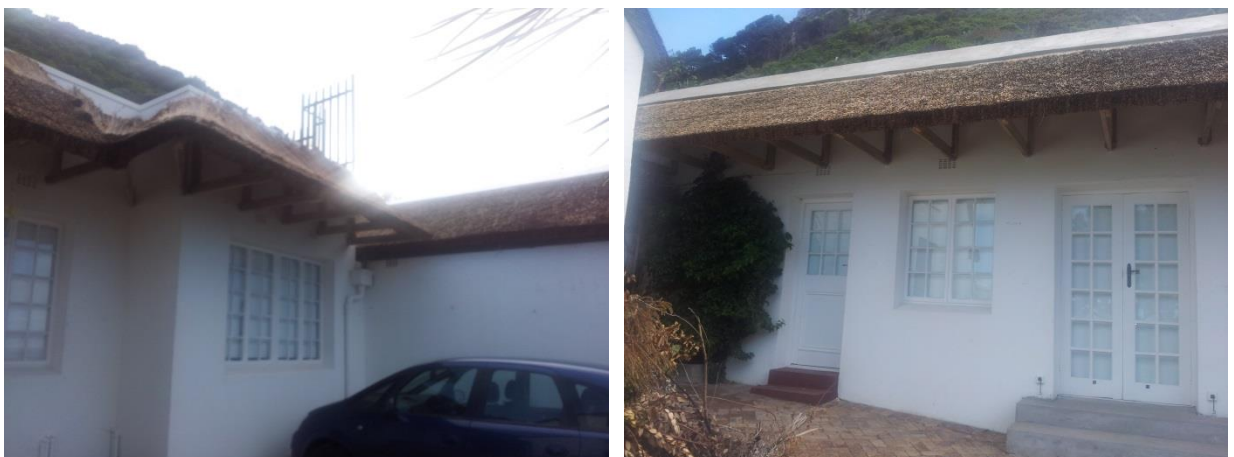
The “skirt” to the whole of the street (south) façade of the cottage has already been fixed, albeit not finished or flashed all the way across.

Figure 8 (left): view of “skirt” with thatched garage at Rhodes’s Cottage to RHS.  
 Figure 9 (right): “skirt’ with flashing complete

This is the intervention that has the most impact. The motivation for the addition is aesthetic and functional – it is felt that the overhang will protect the timber windows and doors as well as provide shade.

The section of thatching along the protruding portion of the cottage and the hipped turn (see Figure 8) should be removed. Thatch along the front of the cottage (See figure 9) that ends in the corner formed by the protruding portion of the cottage can be considered.

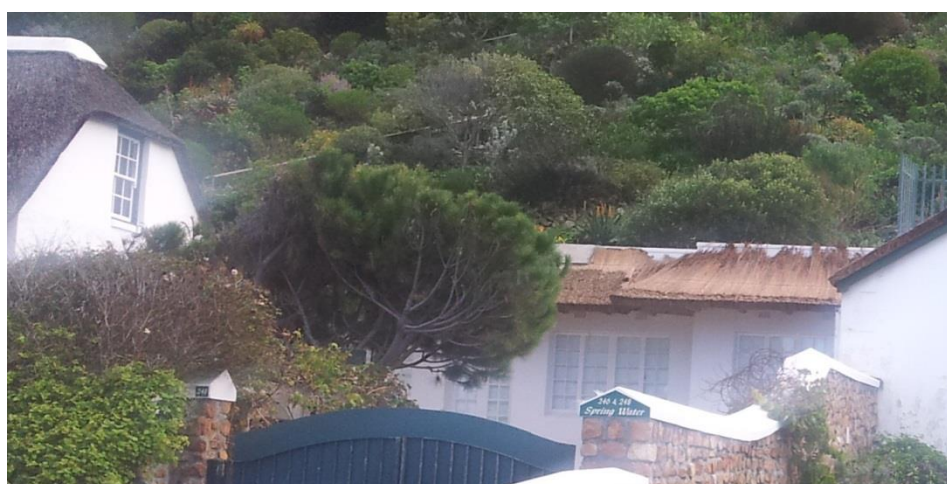
The “skirt” currently extends all the way to the adjacent garage at Rhodes's Cottage. As can be seen below, it is the portion closest to the garage that is most noticeable from Main Road.

Figure 10: View from across Main road, opposite Rhodes's cottage

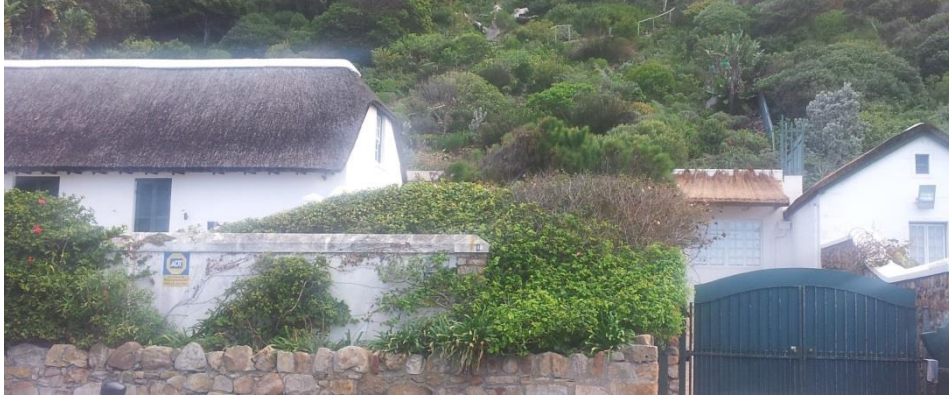
Figure 11: View from across Main road, directly opposite the house

The “skirt” is currently very noticeable. However, if the thatch in front of the portion of the cottage that extends forward were removed, the impact would be substantially less. It would mean (refer Figure 11) that, from across the road and directly in front of the house, the “skirt” would not be visible.

The 'skirt' as built is inappropriate for the site. If it were to be removed from the protruding portion of the cottage's façade, its visual impact on the view of the house from across the road would be mitigated.
