Ladysmith National Route 11. Emnambithi-Ladysmith Local Municipality. Enviroedge.

**FIRST PHASE CULTURAL HERITAGE IMPACT ASSESSMENT
OF THE PROPOSED REHABILITATION OF NATIONAL
ROUTE 11 SECTION 2, LADYSMITH, EMNAMBITHI-
LADYSMITH LOCAL MUNICIPALITY, KWAZULU-NATAL.**

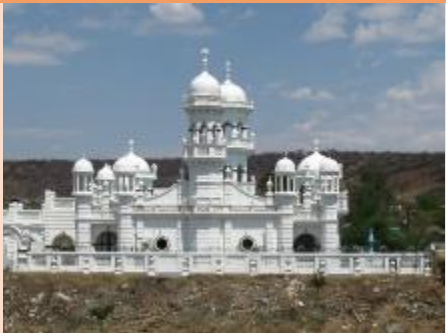
Site No.	Site Name	Description	Co-ordinates	Photo
1	Soofi Temple (Map 3).	A big white building situated adjacent to the Klip River. Building is younger than 60 years old. In active use.	S28° 34' 14.144", E20° 46" 40.58"

No.	Name	Rating	Value	Mitigation
1	Soofi Temple.	Local Grade IIIA	This site is considered to be of HIGH significance locally. It should be retained as a heritage site	No mitigation is necessary as the site is situated more than 200 m from the proposed development. The site is not threatened by the proposed road upgrade.
2	First Wagon Bridge	Generally Protected A	High to medium significance	Mitigation necessary before destruction. A Built Heritage Specialist should be consulted during a Phase II heritage Assessment before this structure may be altered in any way.
3	British Soldier Memorial of W.H. Dick Cunyngham V.C.	Local Grade IIIA	This site is considered to be of HIGH significance locally	The site should be retained as a heritage site. This site is not in danger of being impacted by the proposed project. It is situated more than 100 m from the project footprint. Any alteration of this feature requires the consultation of a Built Heritage Specialist during a Phase II heritage Assessment.

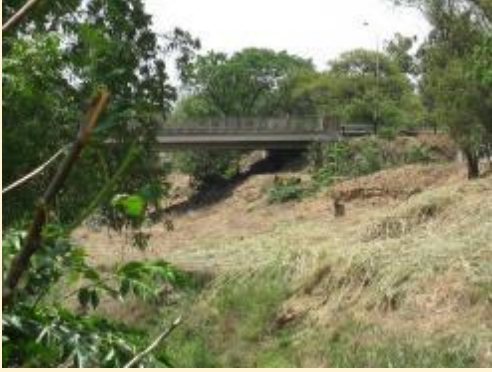
2	First Wagon Bridge (Map 3)	A modern bridge younger than 60 years of age, situated on the same spot that the original bridge was located over the Klip River in 1888.	S28° 34' 4.20", E29° 46' 15.39"

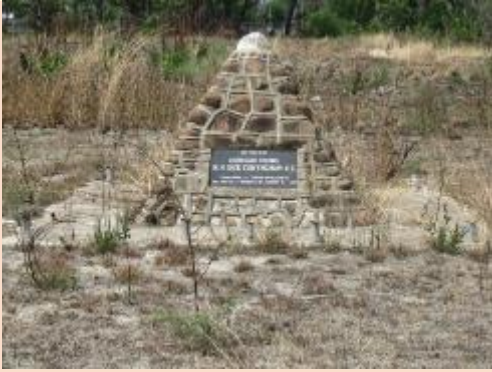
3	British Soldier Memorial of W.H. Dick Cunyngham V.C (Map 3)	This is a Memorial Site. Monuments and Memorial Sites are protected by National Heritage Legislation. The memorial indicates the position where Dick Cunyngham was killed during the Anglo-Boer War.	S28° 34' 9.64", E29° 46' 9.43"

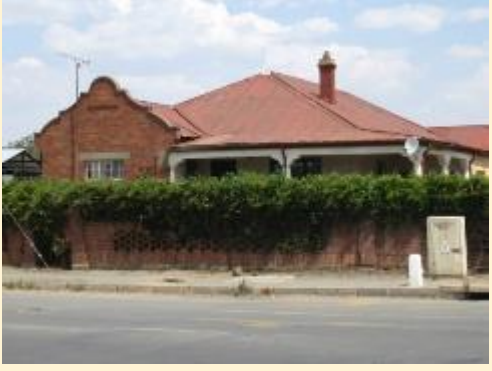
4	Red Brick House with Gable in Lyell Street (Map 3).	An old historical red brick house with gable in Lyell Street. Possibly build in the 1940's.	S28° 33' 28.37", E29° 46' 51.72"

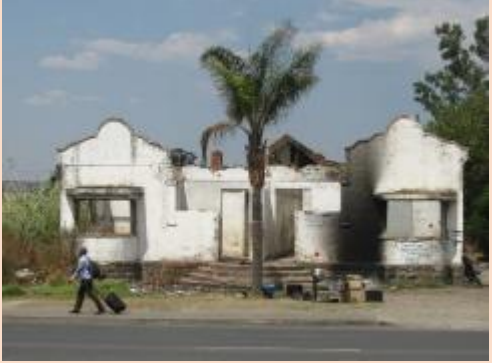
5	White Cape Dutch Burnt House with gable (Map 3).	A beautiful white historic house, with gable. In the Cape Dutch style. Older than 60 years of age. Partially burnt down. Presently being used as an informal place to fix cars.	S28° 33' 44.37", E29° 46' 54.40"

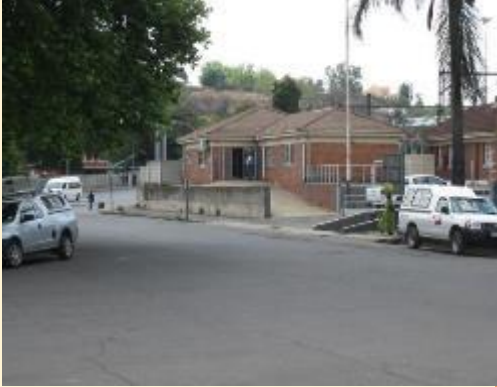
6	Ladysmith Station associated Buildings (Map 4).	Two red brick historic buildings, older than 60 years, and with clear historic cultural associations. Both associated with the main Ladysmith Station building. One building is situated virtually on top of the N11, Section 2 route and will most certainly be impacted by the proposed rehabilitation.	S28° 33' 28.21", E29° 47' 8.34"

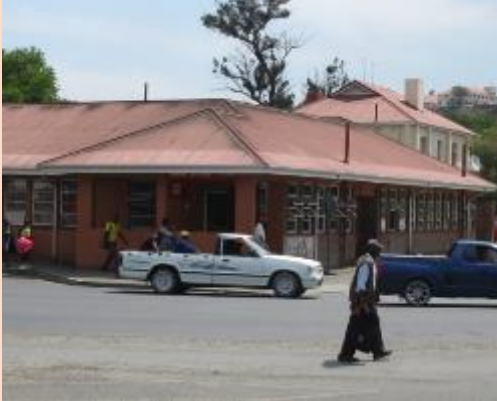
7	Red Brick House Opposite Station (Map 4).	A historic red brick house, older than 60 years of age, located opposite the Ladysmith Station, across Lyell Street. Victorian/Edwardian in style.	S28° 33' 27.34", E29° 47' 5.67"

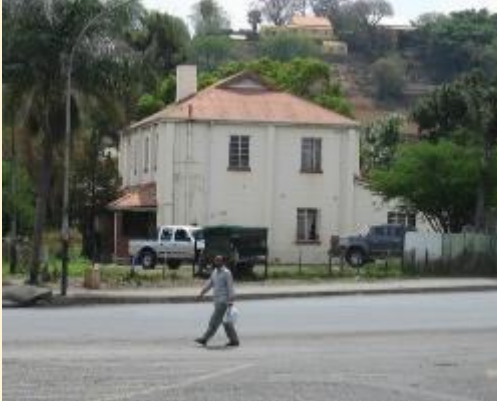
8	Large double story historic house (Map 4).	Large double story historic house. Older than 60 years. Located diagonally opposite the Ladysmith Station	S28° 33' 25.77", E29° 47' 5.66"

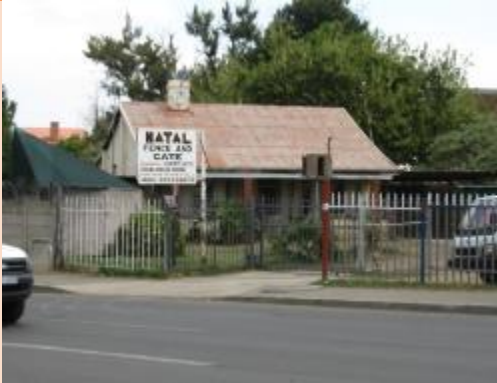
9	Cottage (Map 4).	Cottage older than 60 years of age. The property is close to the road. Used today by a small business, Fence and gate, for their business activities.	S28° 33' 23.66", E29°, 47' 5.27"

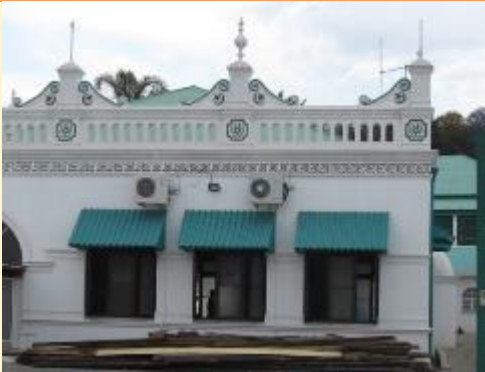
10	White Mosque in Lyell Street (Map 5).	A white mosque back façade lies on Lyell Street. Very close to the road. About four metres from the road.	S28° 33' 16.98", E29° 47' 8.22"

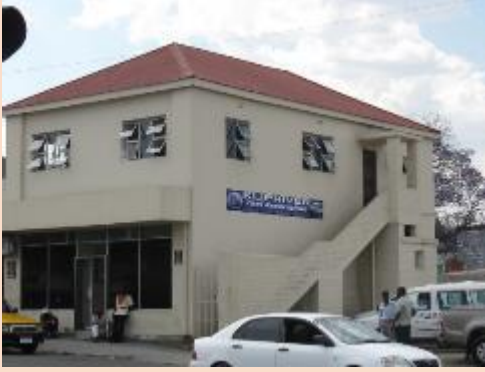
<p>Although the Mosque appears to be younger than 60 years of age, its function designates it as having Living Heritage value, and as such is afforded heritage Protection.</p>		
11	Big white double story house 2 (Map 5).	A second big white double story house, very similar to the previous one, No. 8, recorded on this table.	S28° 33' 12.10", E29° 47' 11.36"

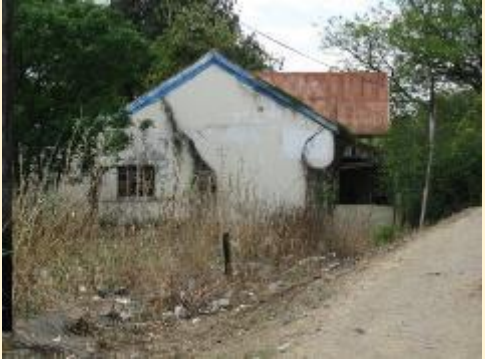
<p>This house is very close to the road and is likely to be impacted by the proposed road workings.</p>		
		<p>Parts of the house are likely to be over 60 years of age,</p>		
12	Derelict House (Map 5)	A lovely small historic house, older than 60 years. Located right next a bend in the road as the road ascends over a bridge.	S28° 33' 10.00", E29° 47' 14.25"

<p>The house is in very bad repair, but its historic significance and charm suggests that it should be restored and maintained.</p>		
		<p>Any proposed work on the road is highly likely to damage this historic house.</p>

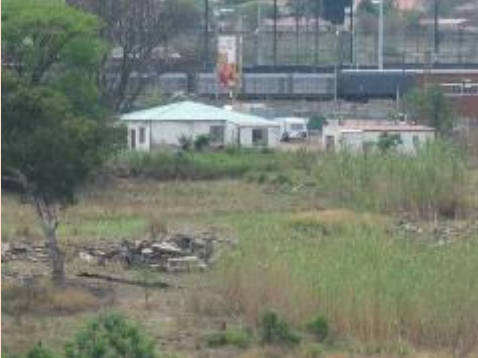
<p>13 Railway House Cluster (Map 5).</p>	<p>A cluster of Railway-type houses and associated structures, possibly over 60 years of age. Located on a hill overlooking the N11 Route.</p> <p>These houses are more than 30 m from the N11 and are not very likely to be impacted by the proposed road working, so long as the developers strictly maintain a buffer-zone of 20 m around this cluster.</p>	<p>S28° 32' 27.82", E29° 47' 46.48"</p>

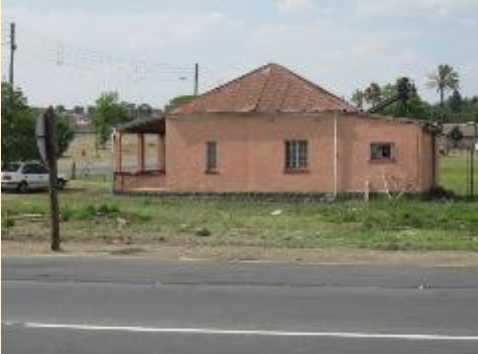
<p>14 Old Farm House (Map 5).</p>	<p>An old Farm House/Trading Store located on the edge of a township, just outside of Ladysmith.</p> <p>Dating to the early 20th century. This is situated about 30 m from the N11. A buffer zone of 20 m must be maintained around this house by developers during road workings.</p>	<p>S28° 32' 14.45", E29° 48' 6.16"</p>

them. Developers should be very careful to report any old material which erodes from the ground during excavation or workings.
14	Old Farm House	Local IIIA	Grade	This site is considered to be of HIGH significance locally	<p>The site should be retained as a heritage site. No damage should be inflicted on this building. A buffer zone of 20 m must be maintained around this house by developers during road workings.</p> <p>Historic homes often have hidden cultural material associated with them. Developers should be very careful to report any old material which erodes from the ground during excavation or workings.</p>
15	Iron Age Stone-walled Circle 1	Local IIIA	Grade	This site is considered to be of HIGH significance locally	<p>The site should be retained as a heritage site. No damage should be inflicted on these features. A buffer zone of 20 m must be maintained around these features by developers during road workings.</p>

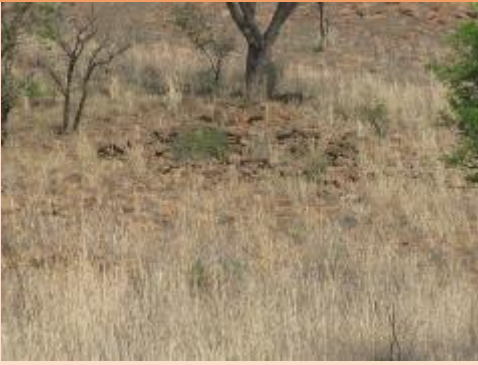
<p>15 Iron Age Stone-walled Circle 1 (Map 6)</p>	<p>A cluster of six stone-walled Iron Age circles. Average diameter of circles is about 4 m.</p> <p>Extensive stone-robbing has taken place on four of these circles.</p> <p>Most of the circles are only visible on aerial photographs.</p>	<p>S28° 29' 43.43", E29° 50' 25.46"</p>

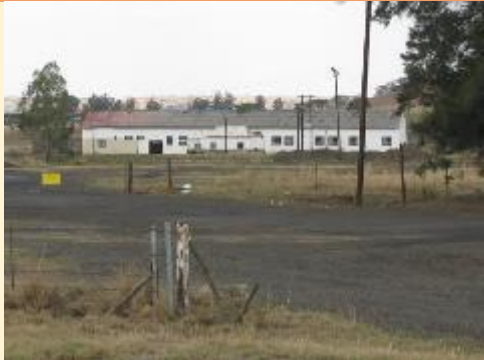
16	Outbuildings of Platberg Farm stall (Map 6)	A long white outbuilding most likely older than 60 years of age. It is associated with the Platberg Farm stall which is itself an historic building older than sixty years of age.	S28° 22' 6.36", E29° 57' 11.98"

16	Outbuildings of Platberg Farm stall	Generally Protected A		High to medium significance	<p>.The site should be retained as a heritage site. No damage should be inflicted on the building. A buffer zone of 20 m must be maintained around the building by developers during road workings</p> <p>Historic buildings often have hidden cultural material associated with them. Developers should be very careful to report any old material which erodes from the ground during excavation or workings.</p>
17	Platberg Farm stall Historic Homestead	Local IIIA	Grade	This site is considered to be of HIGH significance locally	<p>The site should be retained as a heritage site. No damage should be inflicted on these buildings. A buffer zone of 20 m must be maintained around these buildings by developers during road workings.</p> <p>Historic homes often have hidden cultural material associated with them. Developers should be very</p>

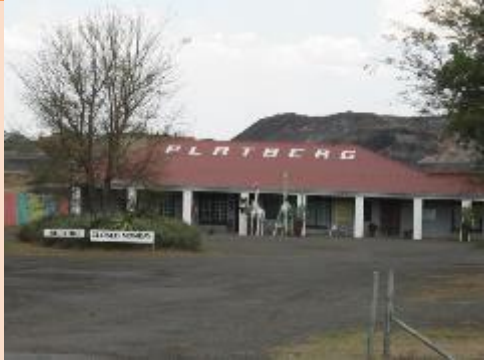
17	Platberg Farm stall Historic Homestead (Map 7)	A long low building with veranda, most likely to be an old farmstead of more than sixty years of age. Currently acting as a road-side farm stall.	S°28 21' 55.33", E29° 57' 19.36"

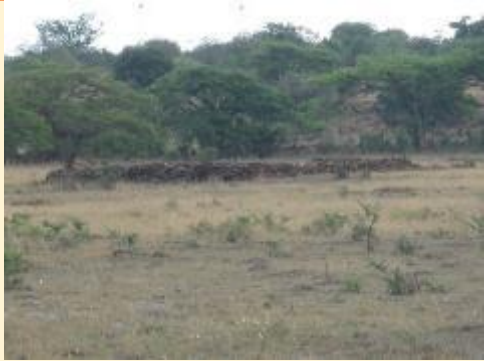
18	Square Stone Wall (Map 7)	Stone-walling built in a square shape, located about 200 m from the R11 route. This is almost certainly an historic feature relating to farm work.	S28° 21' 18.13", E29° 57' 31.53"

careful to report any old material which erodes from the ground during excavation or workings.
18	Square Stone Wall	Local III B	Grade	This site is considered to be of HIGH significance locally	The site should be mitigated, and part retained as a heritage site. No alterations, or damage should be inflicted on these features. A buffer zone of 20 m must be maintained around these features by developers during road workings
19	Iron Age Stone-walled Circle 2	Local III A	Grade	This site is considered to be of HIGH significance locally	The site should be retained as a heritage site. No damage should be inflicted on these features. A buffer zone of 20 m must be maintained around these features by developers during road workings
20	Historic Sandstone/Slate Farm House	Local III A	Grade	This site is considered to be of HIGH significance locally	The site should be retained as a heritage site. No damage should be inflicted on these buildings. A buffer zone of 20 m must be maintained around these buildings by developers during road workings. Historic homes often have hidden cultural material associated with them. Developers should be very careful to report any old material which erodes from the ground during excavation or workings.

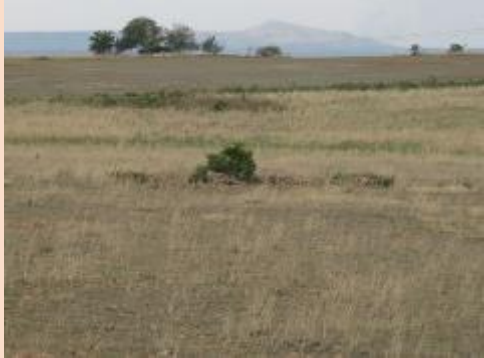
19	Iron Age Stone-walled Circle 2 (Map 8)	An Iron Age stone-walled circle. Like the other stone-walled circles, No. 15, this circle has also been robbed of stone. The stone circle has a diameter of 4.5m.	S28° 18' 4.25", E29° 58' 57.20"

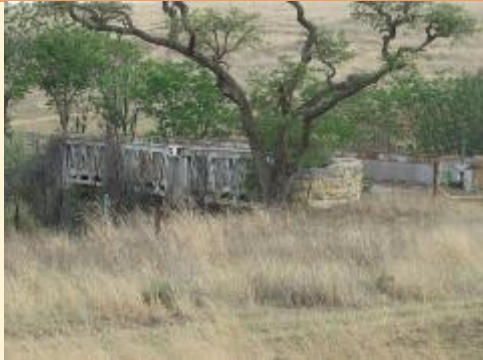
20	Hime Bridge (Map 8)	Hime Bridge is an historic bridge of more than 60 years which was built over the Sundays River in 1883 by Major A.H. Hime of the Royal Engineers. It was used extensively during the Anglo-Boer War.	S28° 15' 4.36", E29° 58' 10.09"

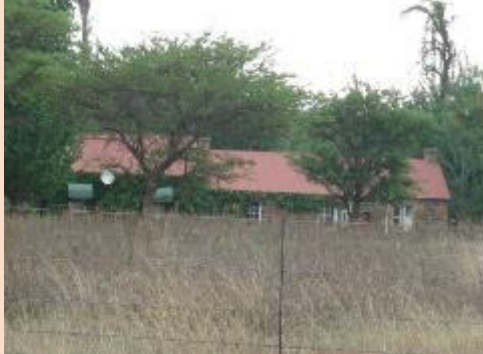
21	Historic Sandstone/Slate Farm House (Map 8)	A historic sandstone, or slate, farm house, older than 60 years of age. While located some distance from the N11 road developers must be very careful to maintain a buffer of 20 m from the structure, and to avoid any alterations to the building.	S28° 14' 22.03", E29° 57' 36.02"

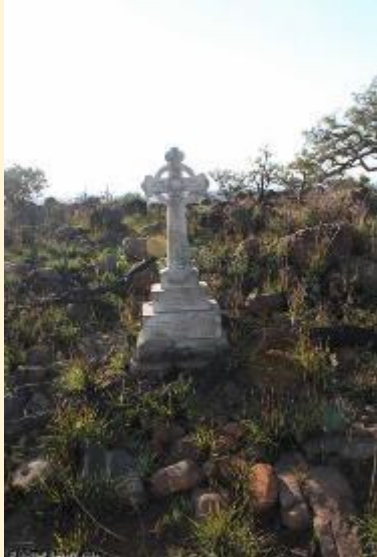
22	Red Hill Memorial (Map 9)	A memorial erected in memory of the men of the Royal Irish Fusiliers who died during the Siege of Ladysmith.	S28° 34' 6.30", E29° 45' 18.80"

22	Red Hill Memorial	Local III A	Grade	This site is considered to be of HIGH significance locally	The site should be retained as a heritage site. No damage should be inflicted on these features. A buffer zone of 20 m must be maintained around these features by developers during road workings.
