**PROPOSED LAKESIDE INDUSTRIAL & ASSOCIATED
SERVICES PROJECT, STANGER, KWADUKUZA
LOCAL MUNICIPALITY, KWAZULU-NATAL**

Phase 1 Heritage Impact Assessment

April 2022

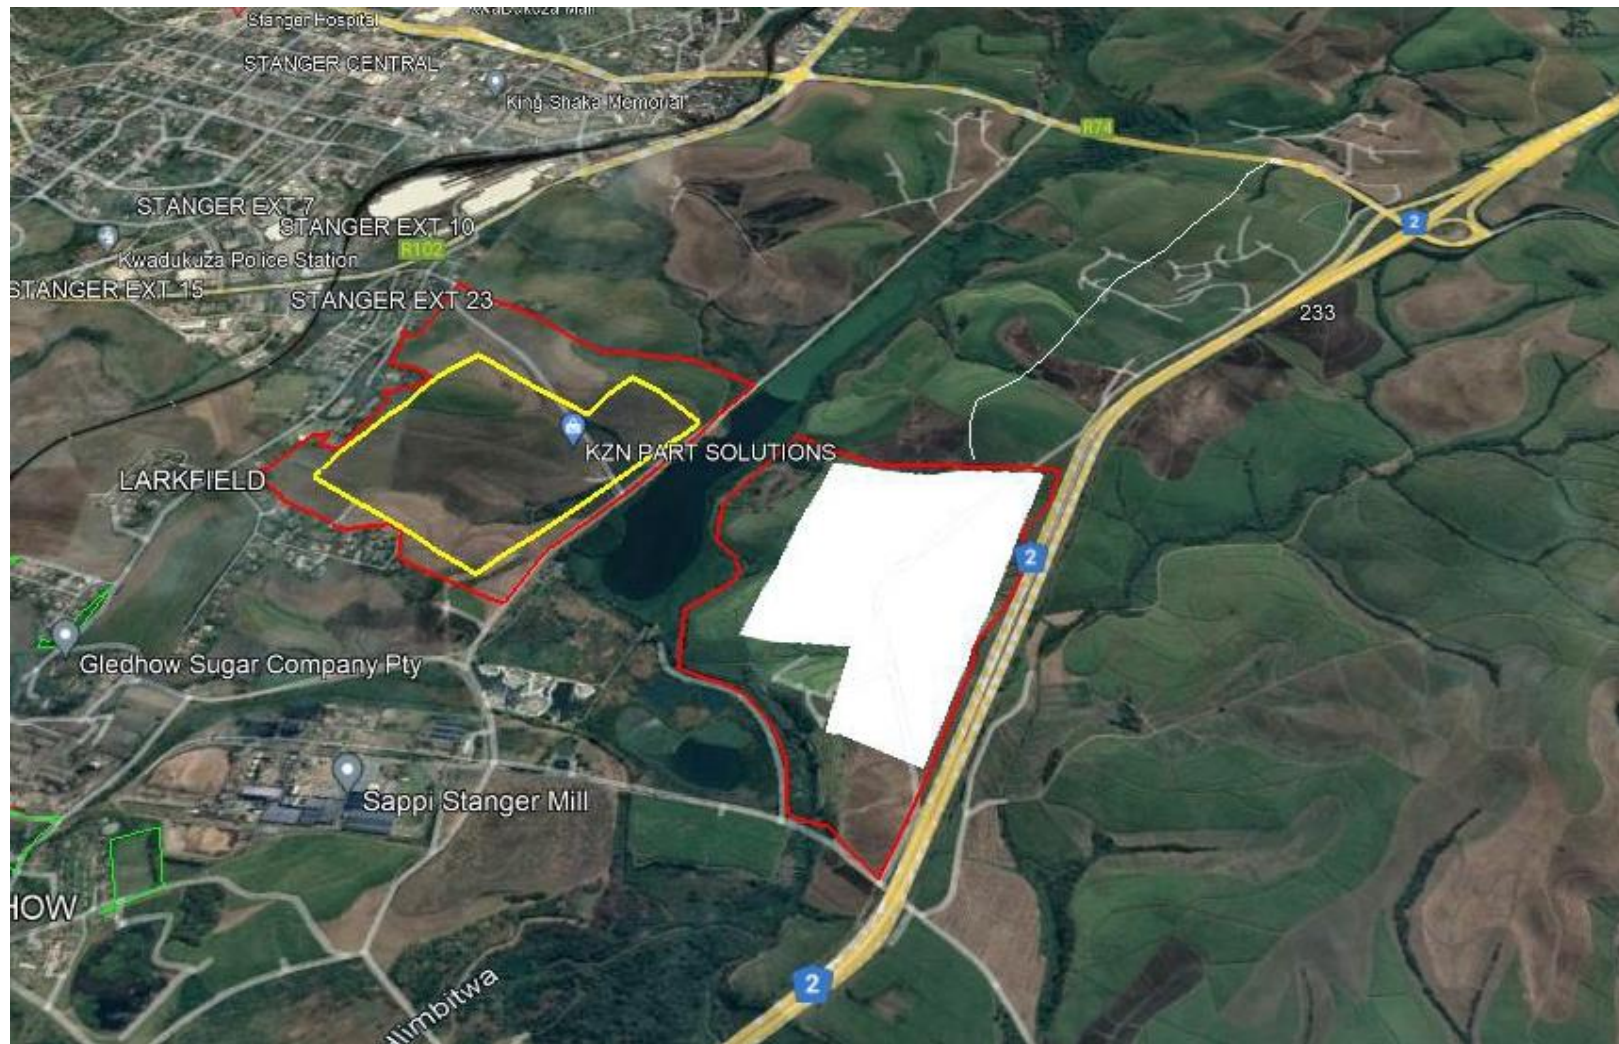
Figure 1: Lakeside development sites outlined in red with platforms indicated in yellow & white

The Lakeside industrial and associated services development is located between the N2 highway and the town of Stanger which forms part of the KwaDukuza Local Municipality. The two sites are located south of the R74 road and are adjacent to one another (**Figs. 1 and 2**).

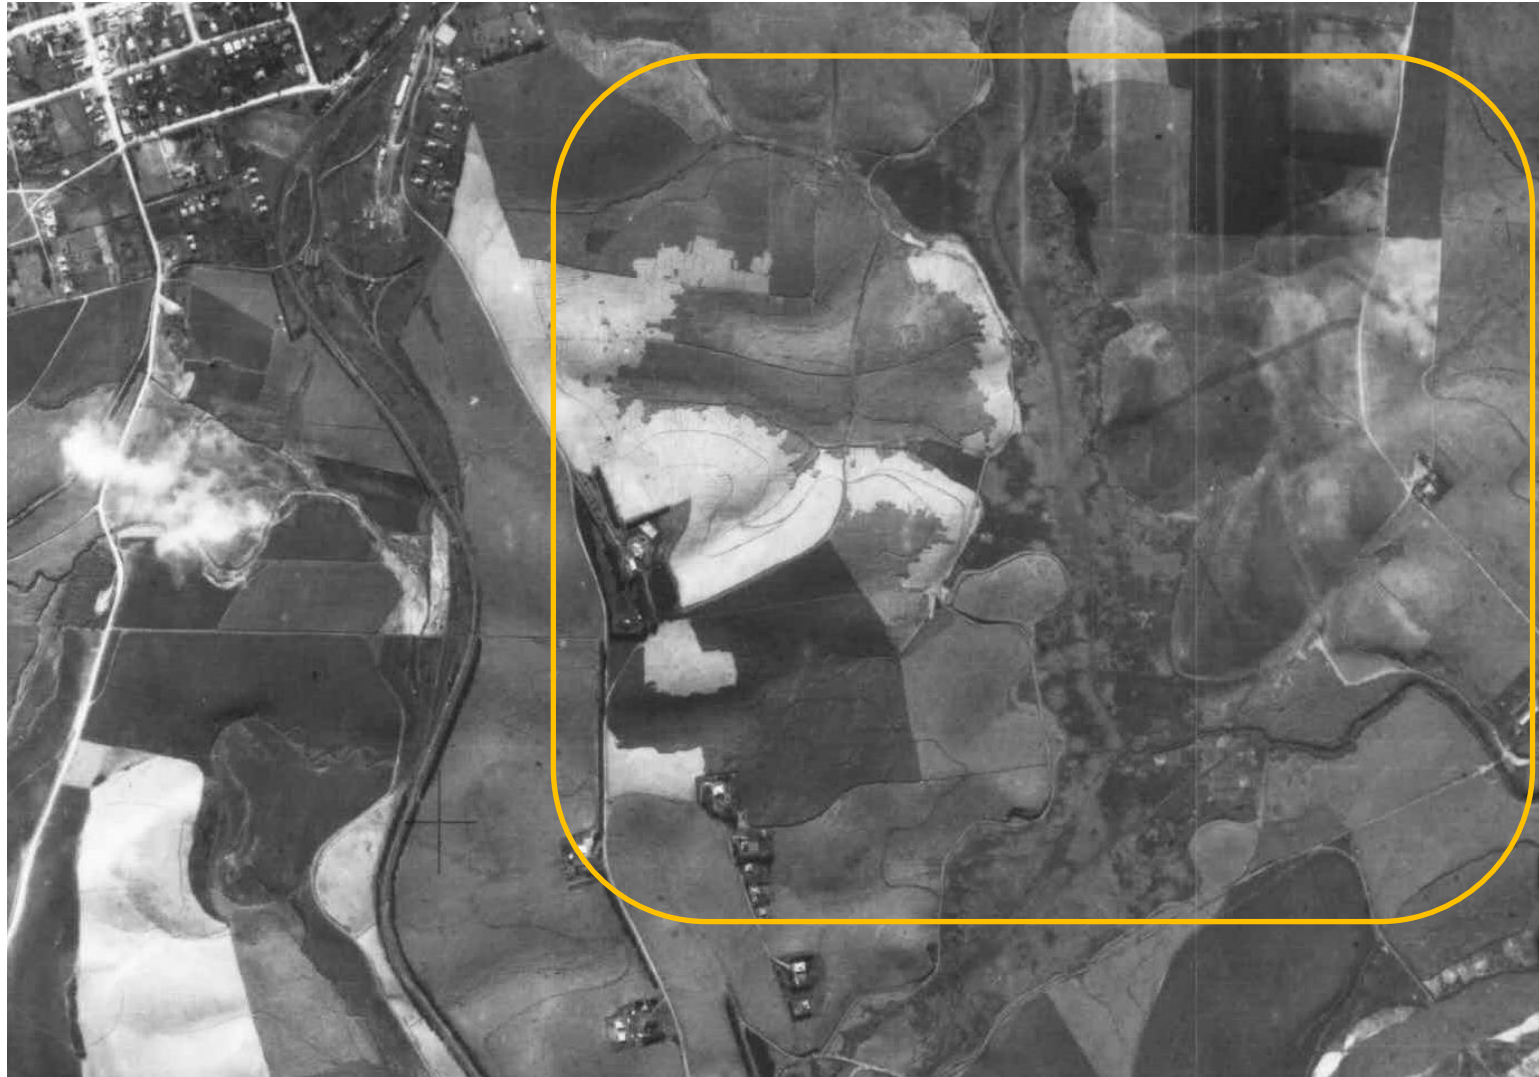
The 1937 aerial photograph shows the project area with the railway line to the west of the project area as well as several structures, and roads. By 1967, the structures visible in the 1937 image have disappeared and a labourer’s compound is visible on site 1. In both images, the farmstead on alternative site 2 is visible.

Figure 3: 1937 aerial photograph of project area

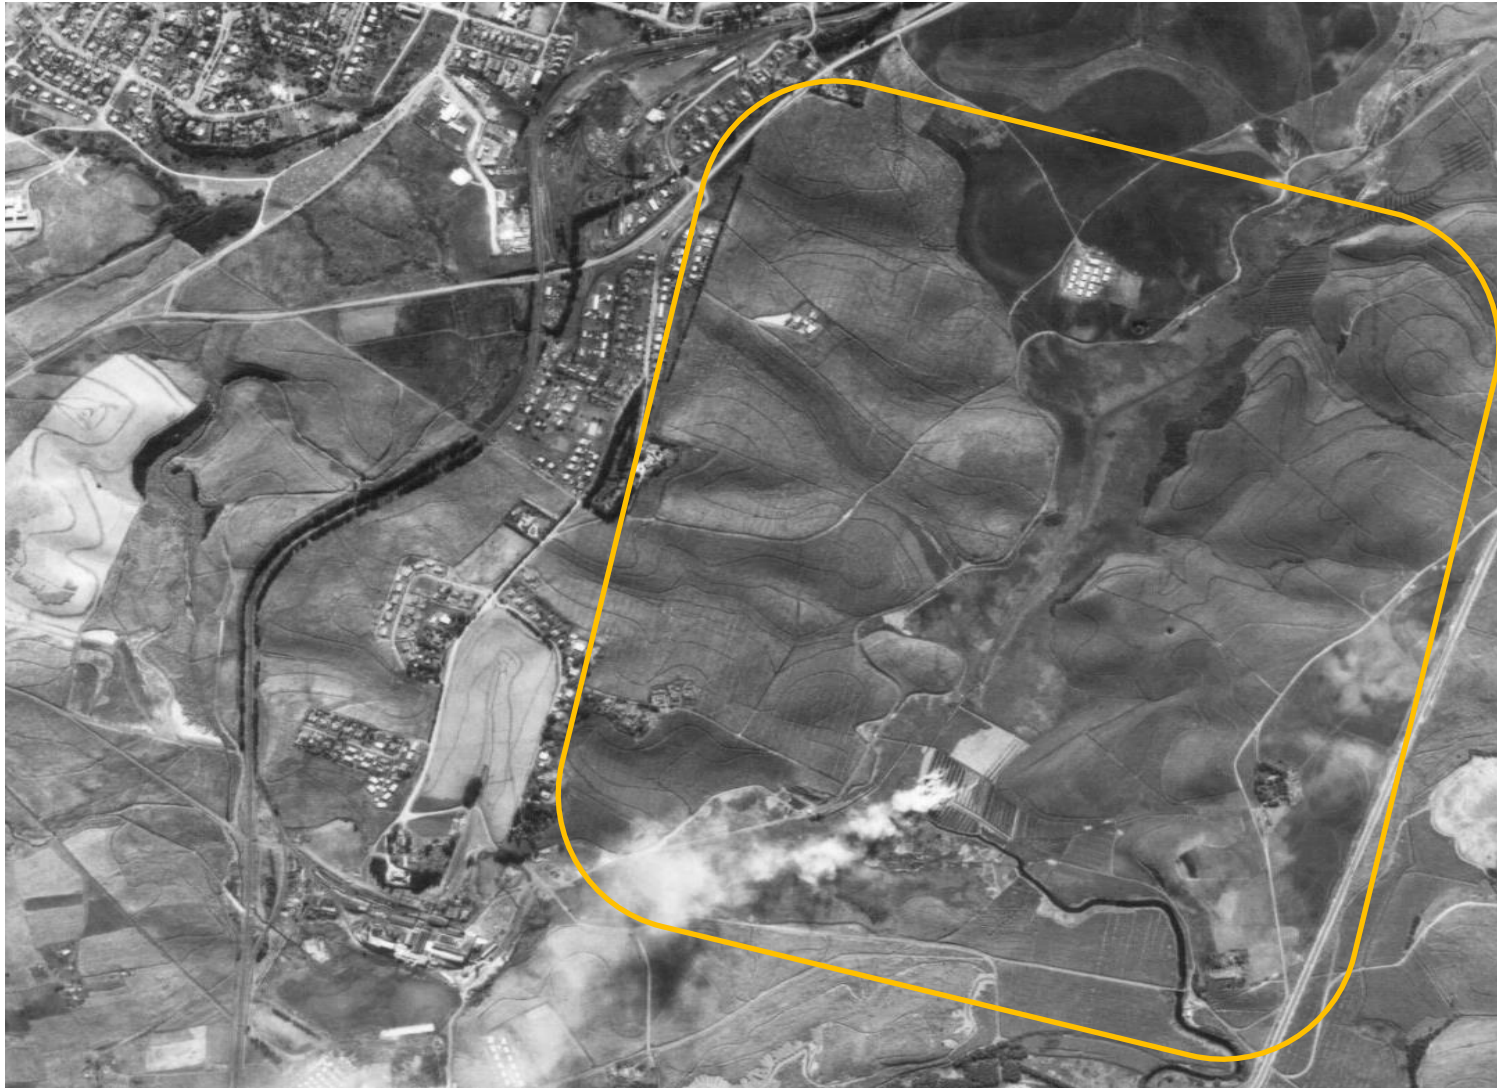
Figure 4: 1967 aerial image of project area

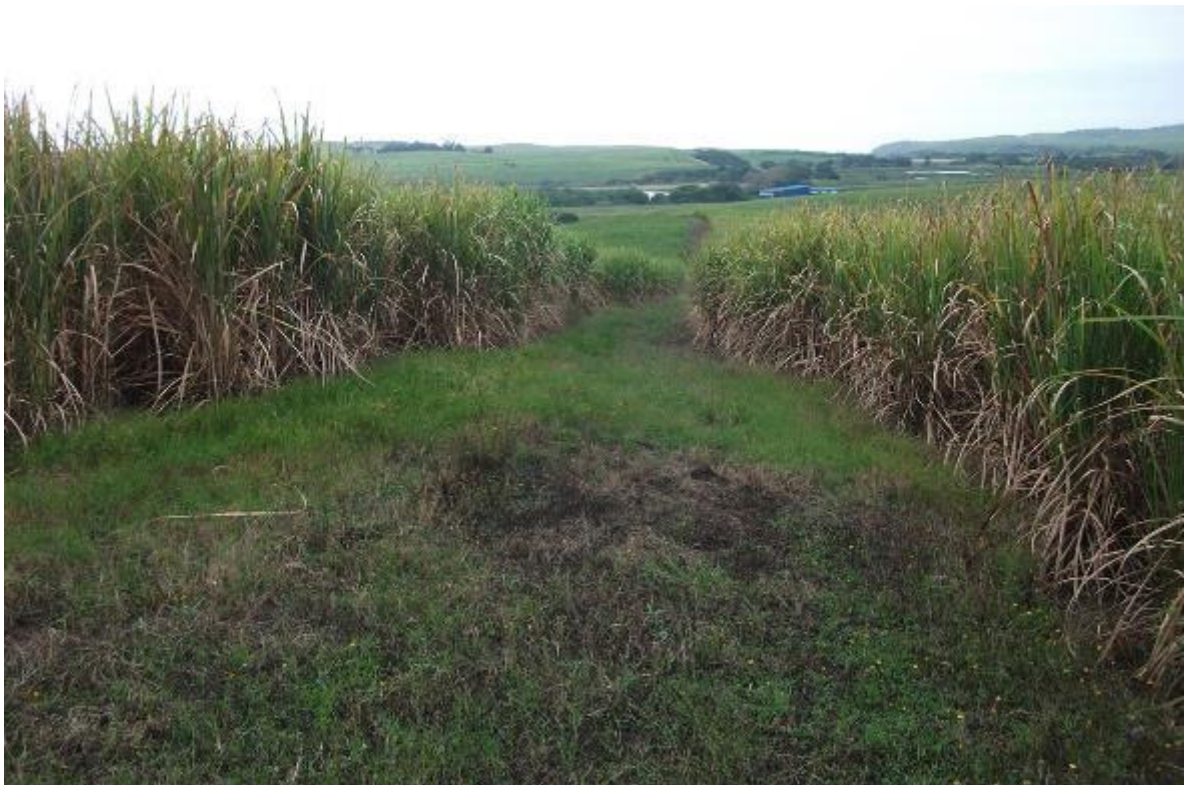
Figure 9: Looking east towards site 2

A tarred road bisects site 1. **Figs. 9 - 12** are photographs of the south-western section of site 1.

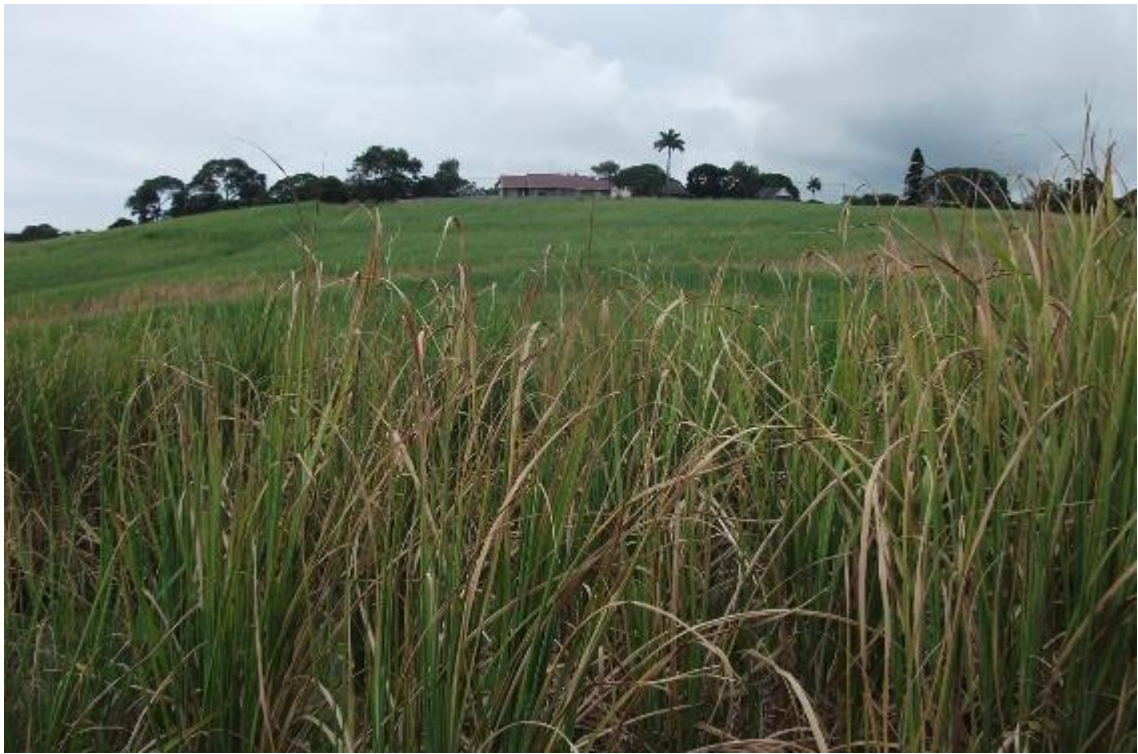
Figure 10: Looking towards residences on south-western boundary of site 1

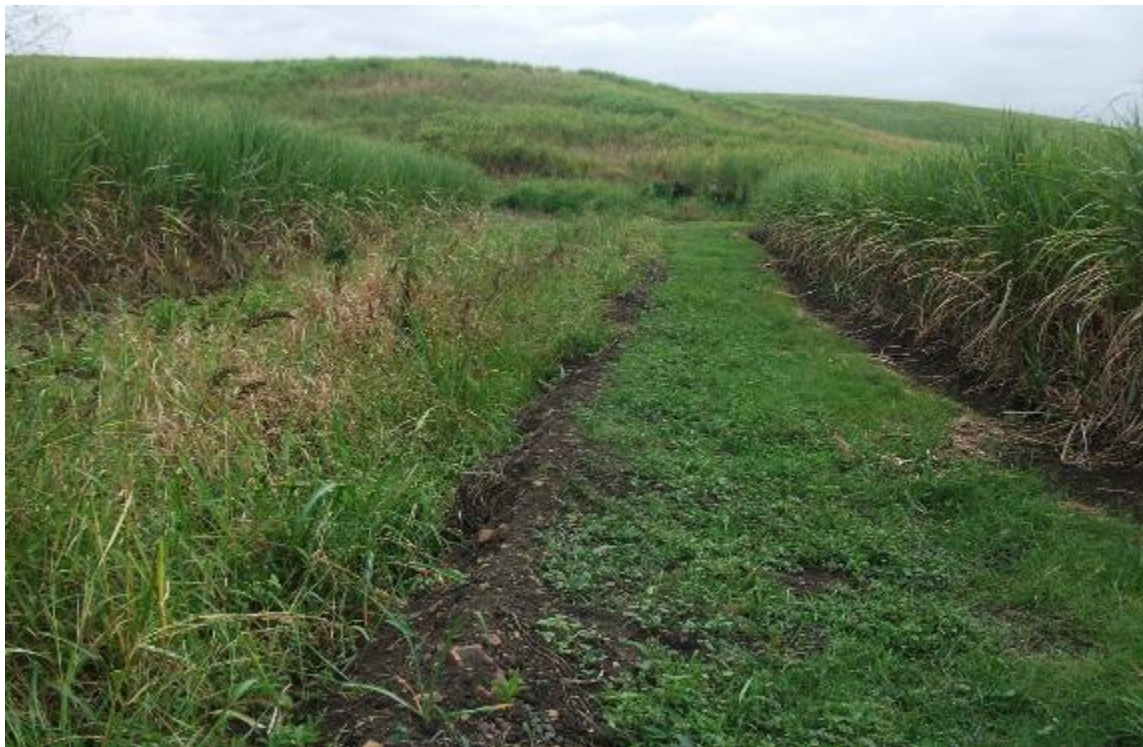
Figure 11: Watercourse on site 1

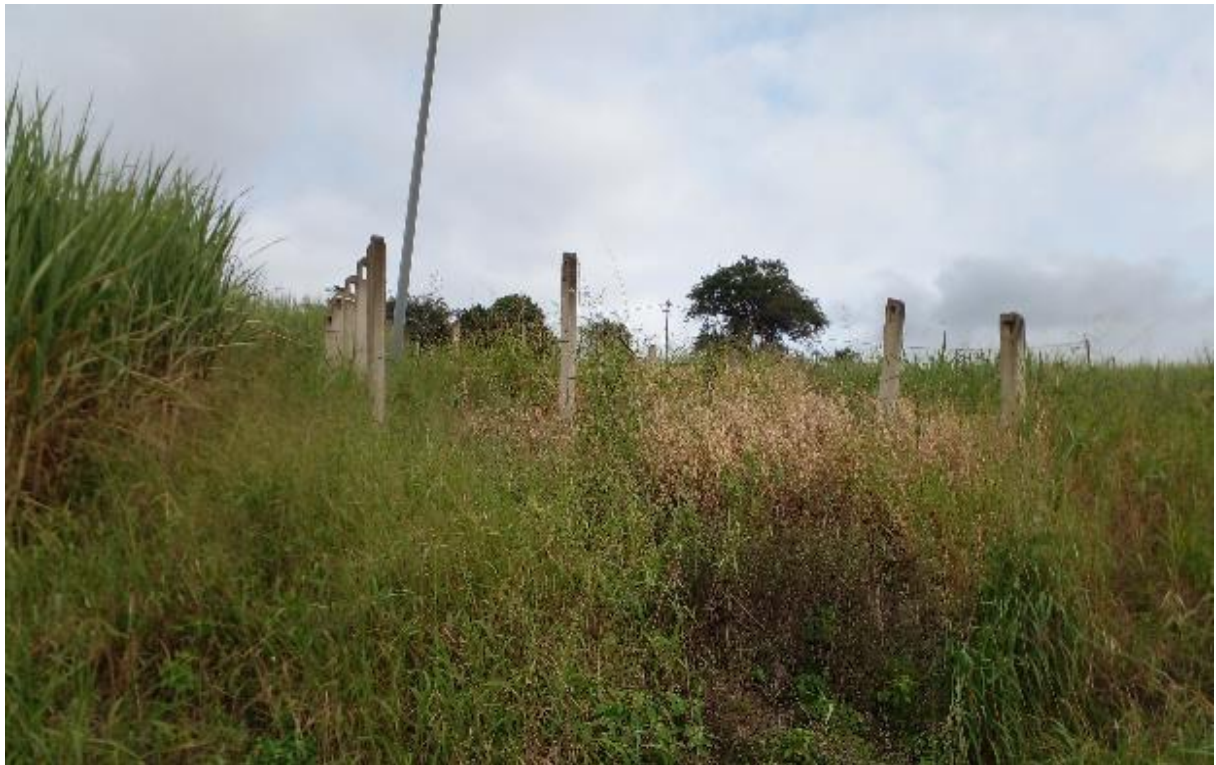
On the south-western boundary of the platform proposed for site 1 and within the boundary of overall area of site 1 are a set of concrete poles and a tall pole. It is unclear what this is but it is possibly to do with sugar cane cultivation. It is a fairly recent addition.

Figure 12: Concrete bollards and tall pole

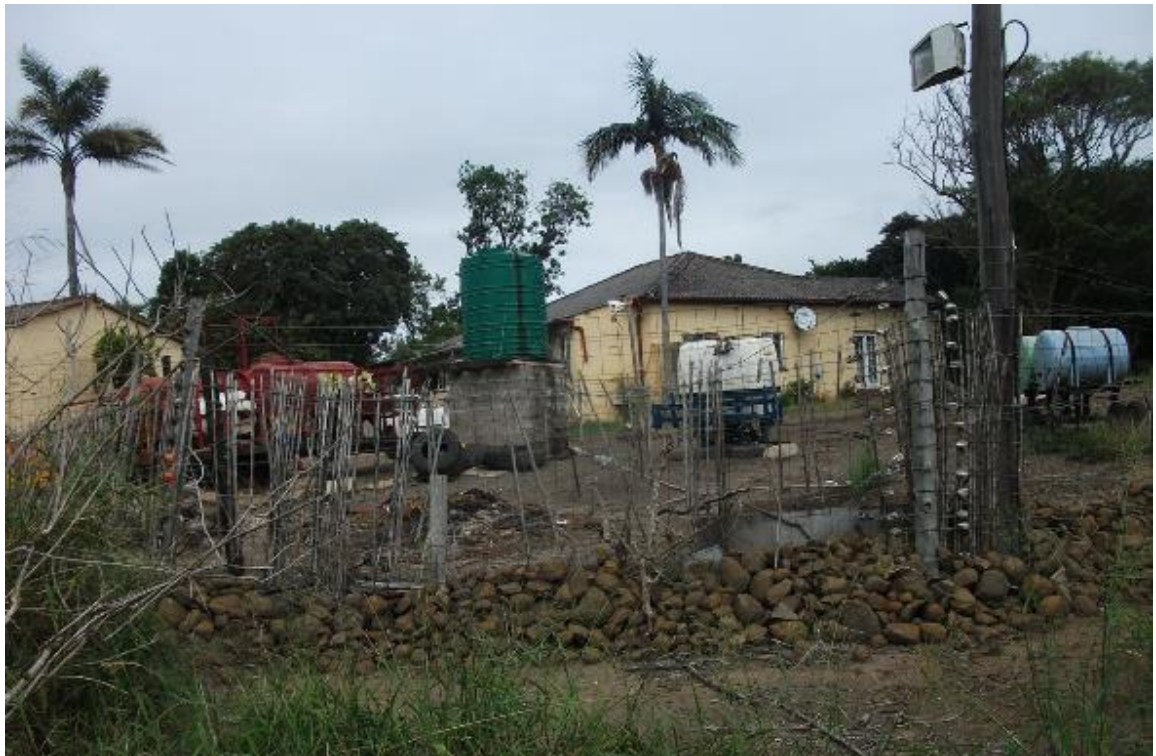
Site alternative 2 was also inspected on foot. There are two homesteads/farmsteads on site 2. A built heritage specialist undertook a desktop assessment (**Appendix 1**) and concluded that the farmstead near the south-eastern boundary was built prior to 1937 and was most likely built by an early sugar farmer. As the farmstead is older than 60 years, it is a protected structure (Napier 2022:1).

Figure 13: Homestead and associated buildings

The Built Heritage Environment Impact Assessment Report of the two farmsteads on alternative site 2 (**Appendix 2**) states that the earliest aerial photographs of the area from 1937 indicate that the farmstead near the south-eastern boundary was built prior to 1937. This farmhouse has a hipped sheet roof (asbestos) with a single gable and veranda facing the garden. The house is built of brick, plastered and painted. It is raised above the ground with timber floorboards in the living rooms and bedrooms and concrete floors to bathrooms and kitchen. The internal doors and front door are timber framed that are typical of the 1930s period. The farmhouse type is typical of the 1930s period that consisted of basic construction without any architectural detail and is of low significance and not-conservation-worthy, however, a demolition permit from the Institute will be necessary in order to develop the site. (Napier 2022:8, 11).

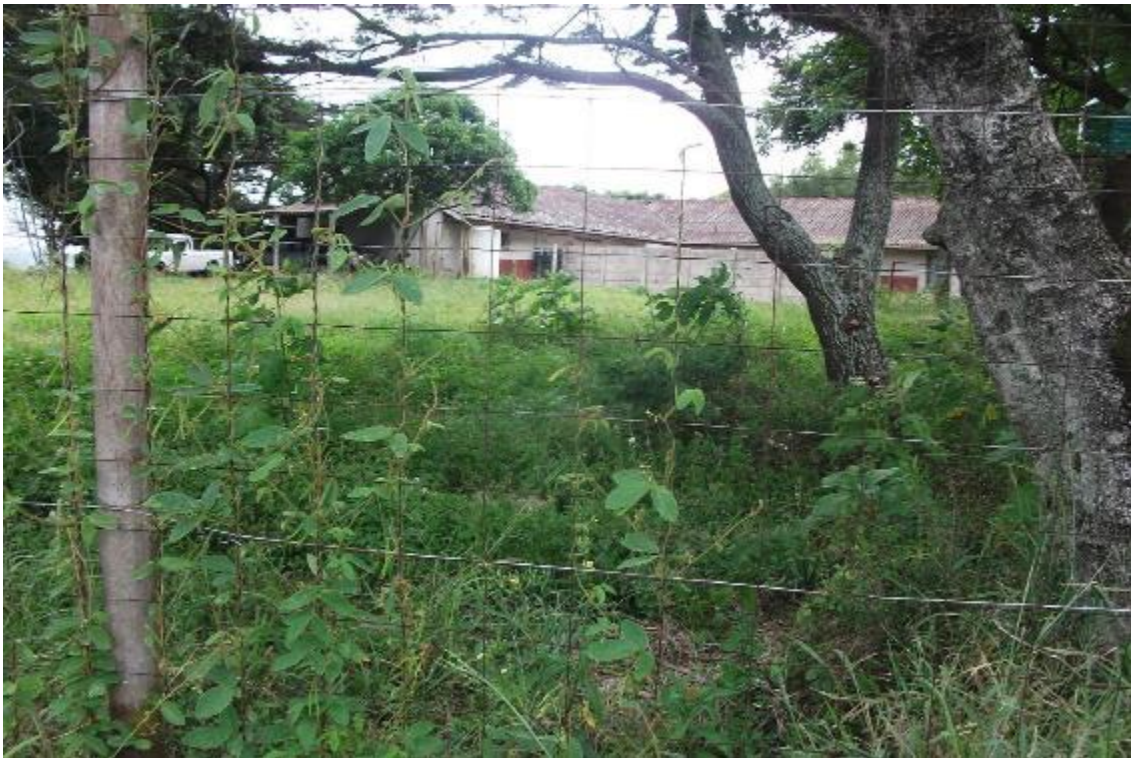
Figure 15: Northern homestead

The second farmstead is not over 60 years old and is therefore not protected by the KZN Amafa Research and Institute Act, 2018 (Napier 2022:11).

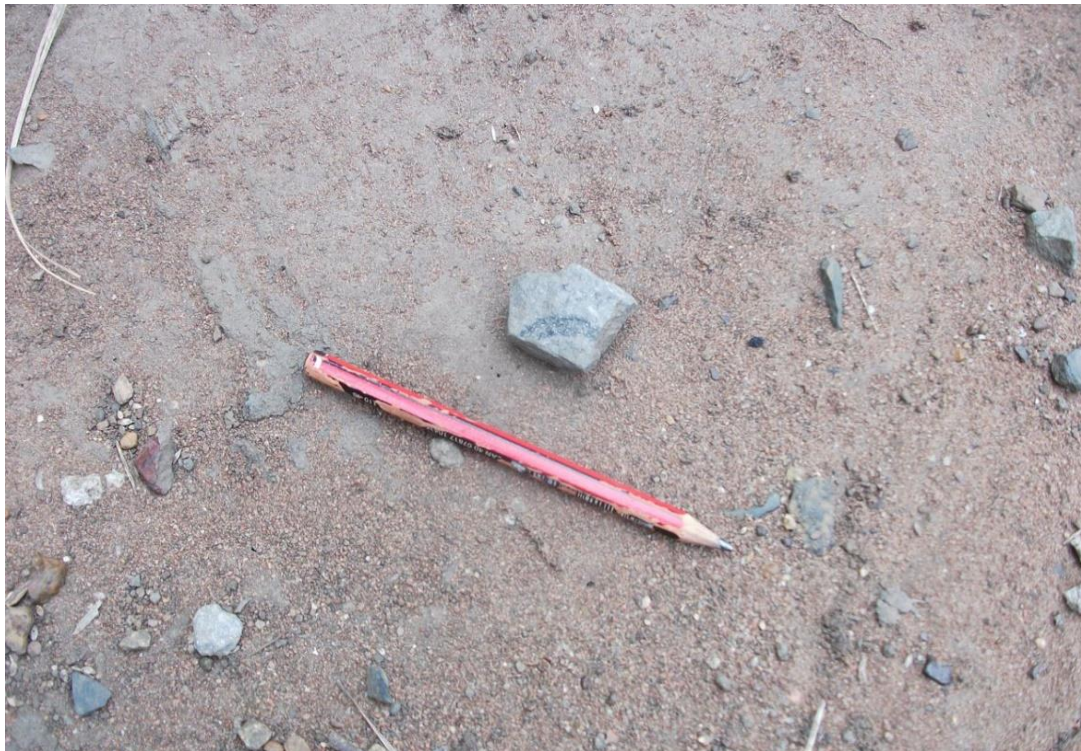
During the inspection, solitary pieces of pottery were found on access roads to the sugar cane fields. The finds were out of context with usually only a very few scattered pieces therefore of no heritage significance.

Figure 18: Engraved piece of pottery

Single individual pottery sherds were found on the sites. The remains are ephemeral and without context and have a low to negligible heritage significance.

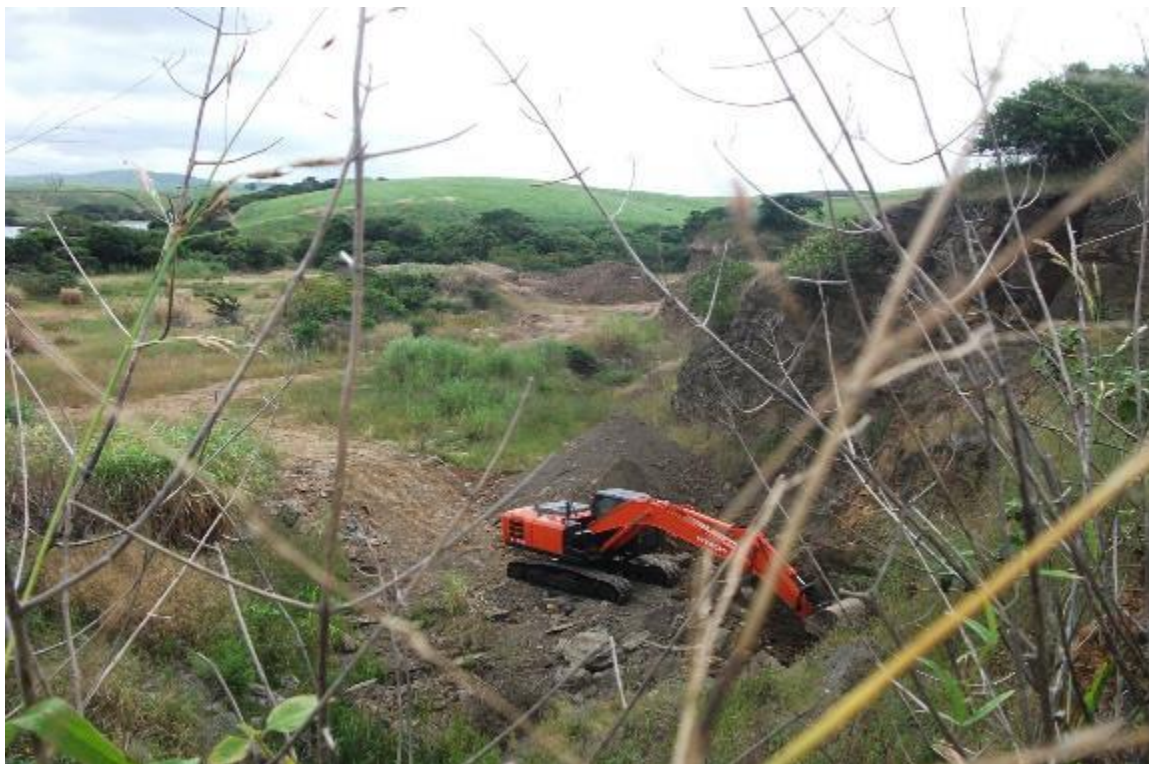
There is an active borrow pit in the northwest corner of site 2. The area is very disturbed.

Figure 20: Active borrow pit

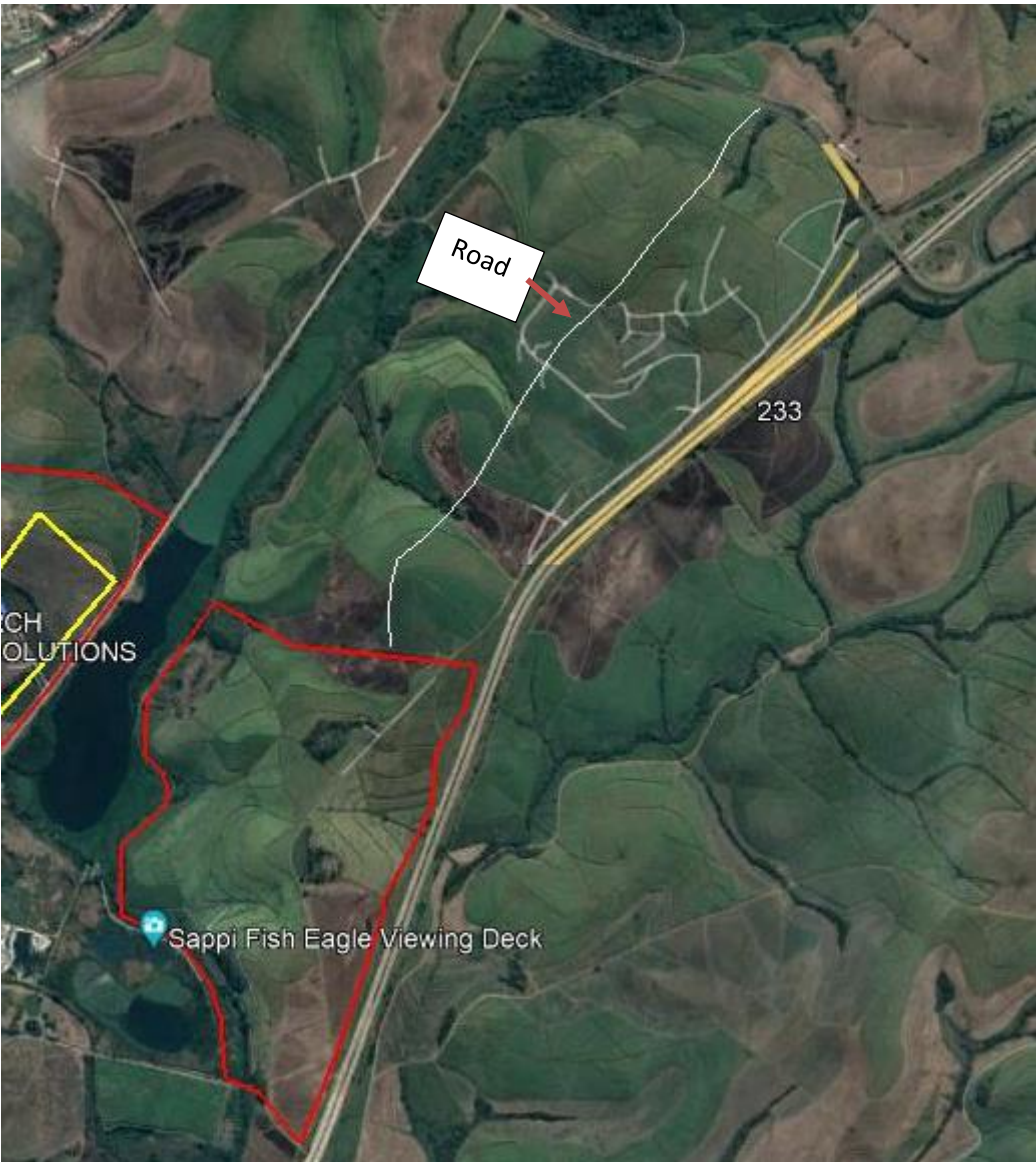
It is proposed that a new access road be built between the R74 and site 2. The proposed road is visible as the white line on **Fig. 22** below. The road was inspected where access to the sugar cane fields would allow it. No heritage sites were found during the inspection.

Figure 22: Proposed access road to site 2

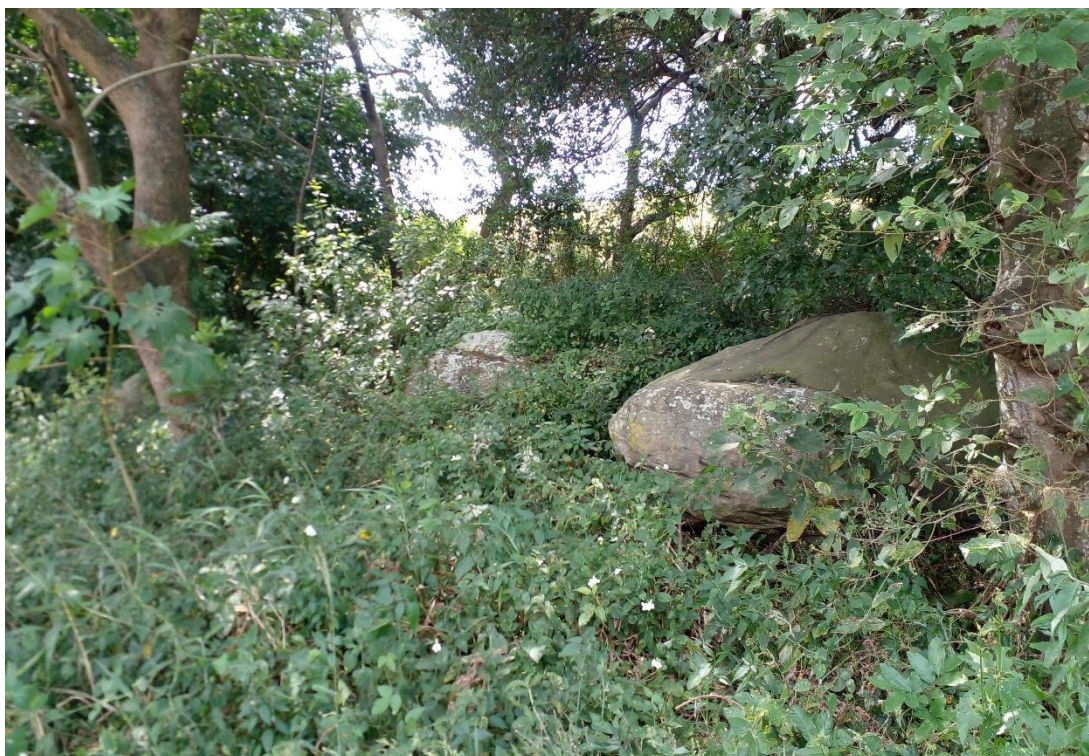
The farm manager took the specialist to the site of the graves near the R74 road. The graves are in a wooded and overgrown area and are no longer visible. He said that he was told that the graves are of Indian people who lived in Stanger and that the graves are very old. The site is located 30m east of the proposed access road to site 2.

Figure 25: Site of old graves

The old graves pointed out to the specialist are located close to the R74 road and to the proposed new access road to site 2. Graves are protected terms of section 39 (1) of the KwaZulu-Natal Amafa and Research Institute Act, which states that graves or burial grounds older than 60 years or deemed to be of heritage significance by a heritage authority- (a) not otherwise protected by the above Act and (b) not located in a formal cemetery managed or administered by a local

Description	Coordinates	Significance	Mitigation
Site of old graves	29°20'37.1" S 31°19'09.4" E	High heritage significance	If the proposed access road is constructed, then a 15m buffer must be placed around the grave site to avoid any damage during construction
Pottery sherds	29°21'11.31"S 31°17'58.50"E	Low heritage significance – scattered pieces of pottery with no surrounding context	None required as site is not to be developed
Single pottery sherd	29°21'26.10"S 31°18'25.50"E	Low heritage significance as no surrounding context or other remains	None required; can be destroyed
Structures < 60 years	29°21'26.95"S 31°18'29.01"E	Low heritage significance	Can be altered or demolished without application to the Institute
Structures >60 years	29°21'37.31"S 31°18'29.58"E	Low heritage significance	Written application for demolition must be made to the Institute

authority, may not be damaged, altered, exhumed, inundated, removed from its original position, or otherwise disturbed without the prior written approval of the Institute having been obtained on written application to the Institute. It is recommended that the graves are left *in-situ* and they are fenced to avoid damage to them during construction of the access road. It is recommended that from a heritage perspective that existing roads be utilised as access to the sites thereby avoiding further disturbance to the area.

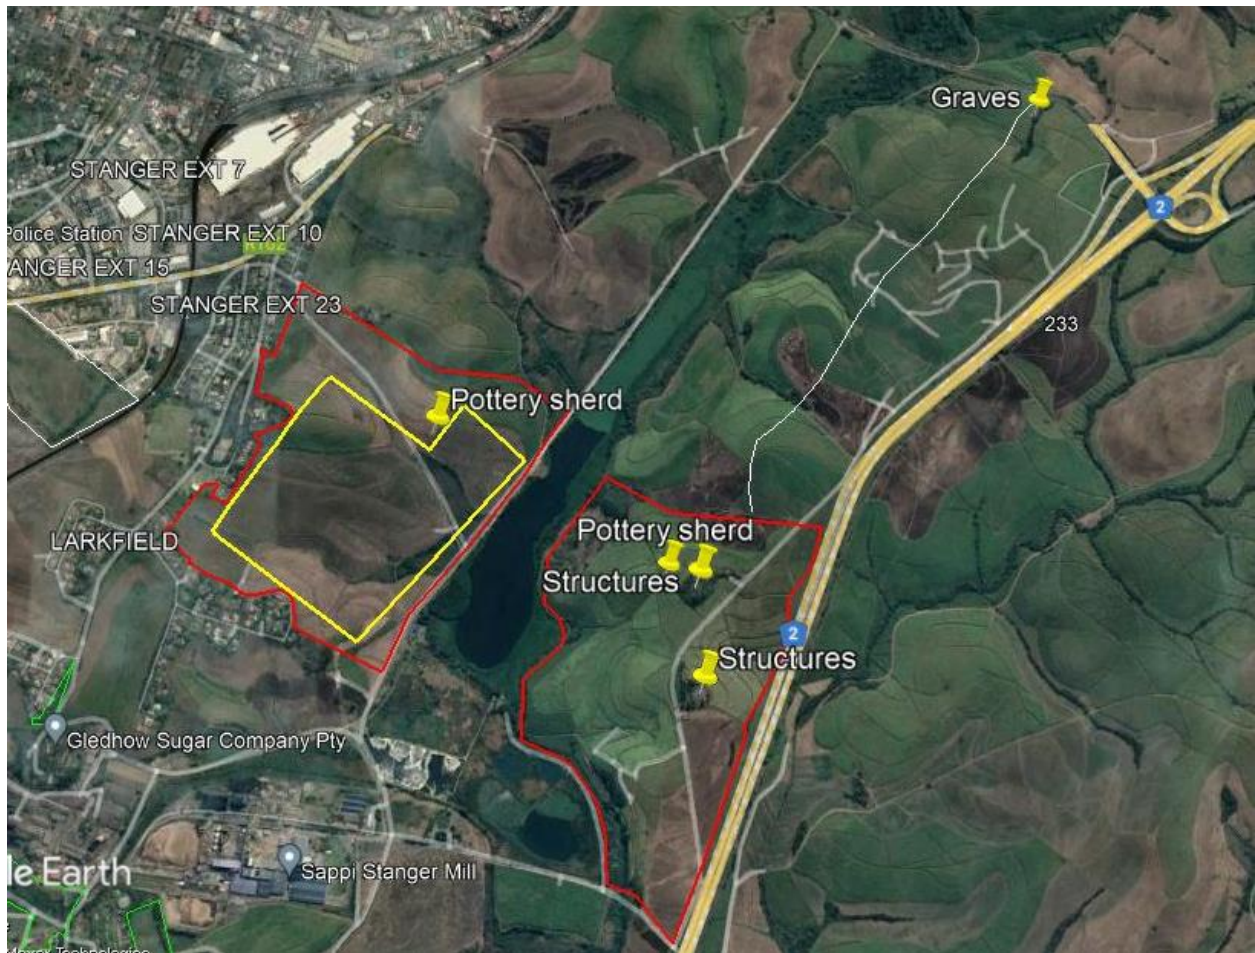
Figure 26: Heritage sites found on project sites
