**First phase heritage impact assessment for the LETHABONG HOUSING
DEVELOPMENT (contract no 19080) in Sebokeng.**

Set Square Developments (Pty) Ltd.

August 2020.

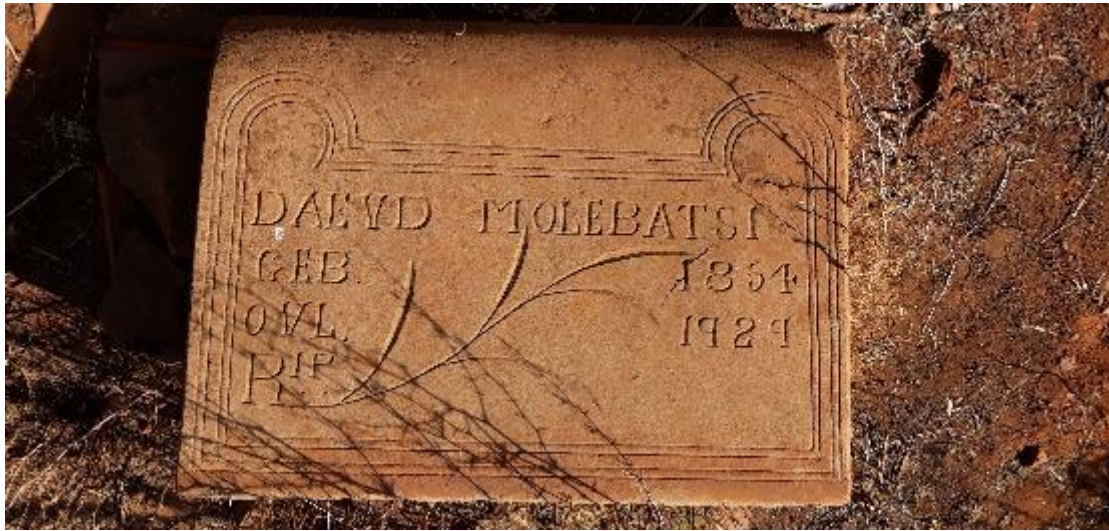
Headstone of David Molebatsi 1854 to 1929 in the Lethabong (Kwaggafontein?) cemetery.

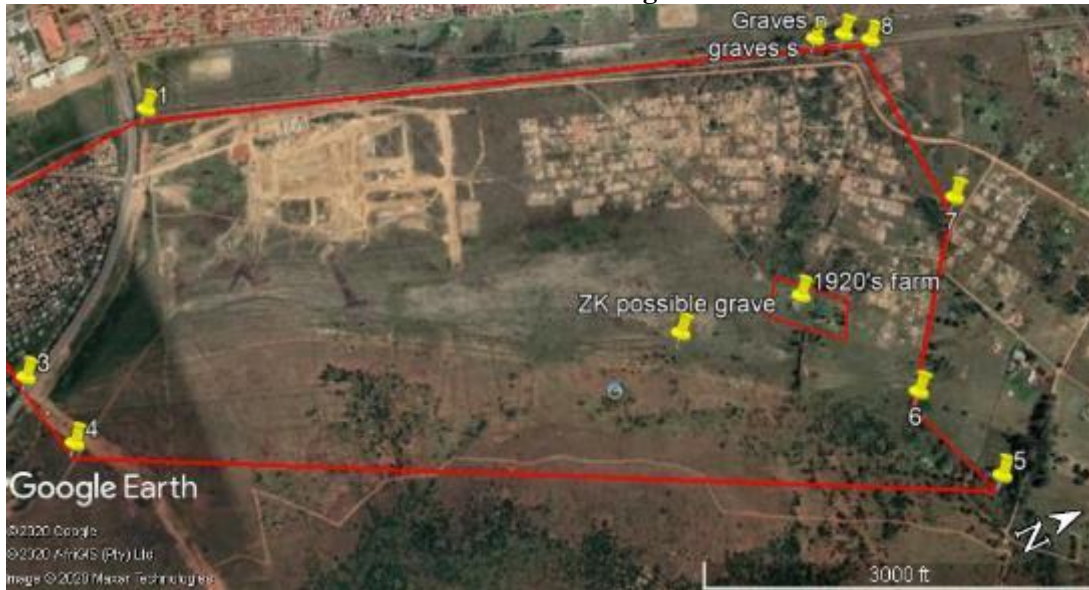
Fig. 01. Above is a 2020 Google Earth image showing the location of the Lethabong site, as well as the location of the graves and the 1920's farmhouse.

3.6.5. The “ZK possible grave” noted by the landscape architect Ziegwald Kūsel and shown in *fig. 01* must be treated as a grave site until otherwise proved by a second phase investigation.

12.6.5. The "ZK possible grave" noted by the landscape architect Ziegwald Kūsel and shown in *fig. 01* must be treated as a grave site until otherwise proved by a second phase investigation.

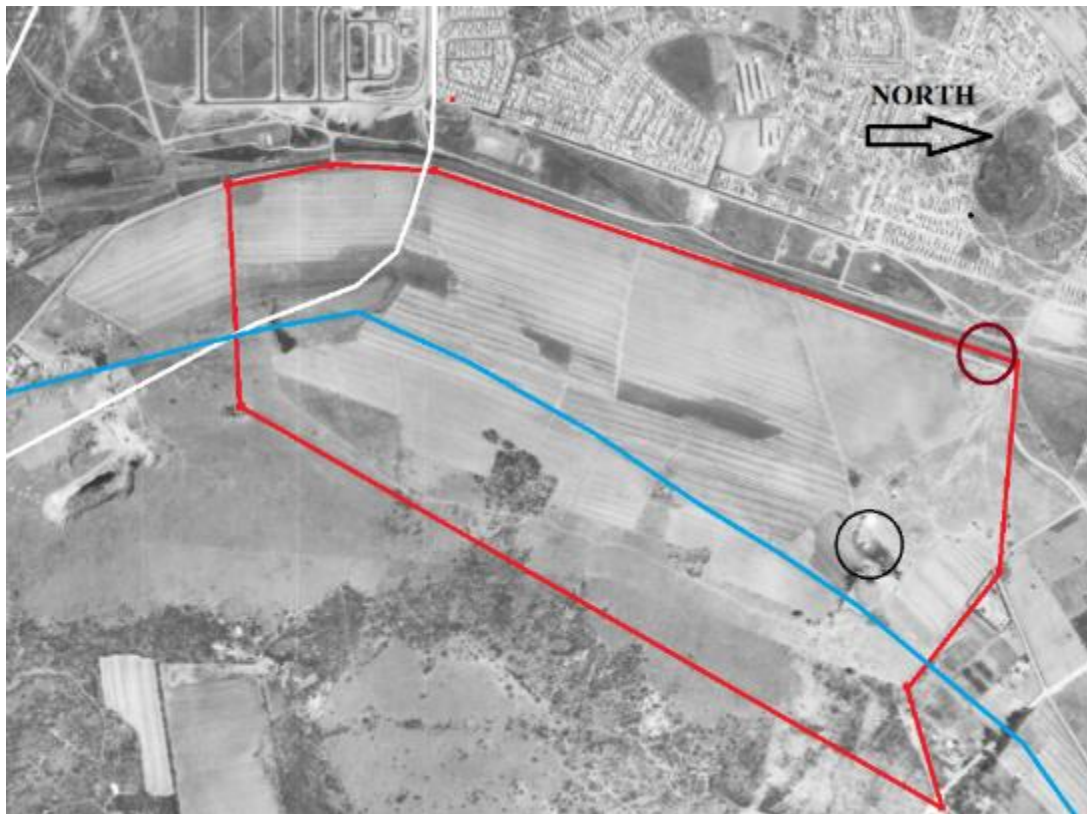
Fig. 08. The 1989 aerial photograph of Kwaggafontein (the now Lethabong development area) clearly shows the long and continuous use of the site as fields for ploughing. Even the area to the east of the drainage-line and the drainage-line itself appears to have been ploughed in a modern structured manner. The red line demarcates the development area, the blue line the drainage line, the white line the recent tar road bisecting the site, the black circle the location of the farmhouse and the brown circle the location of the graves. (Source Ziegwald Kūsel, Landscape Architect. Aerial photo 1989_498_258_002_00677.jpg)

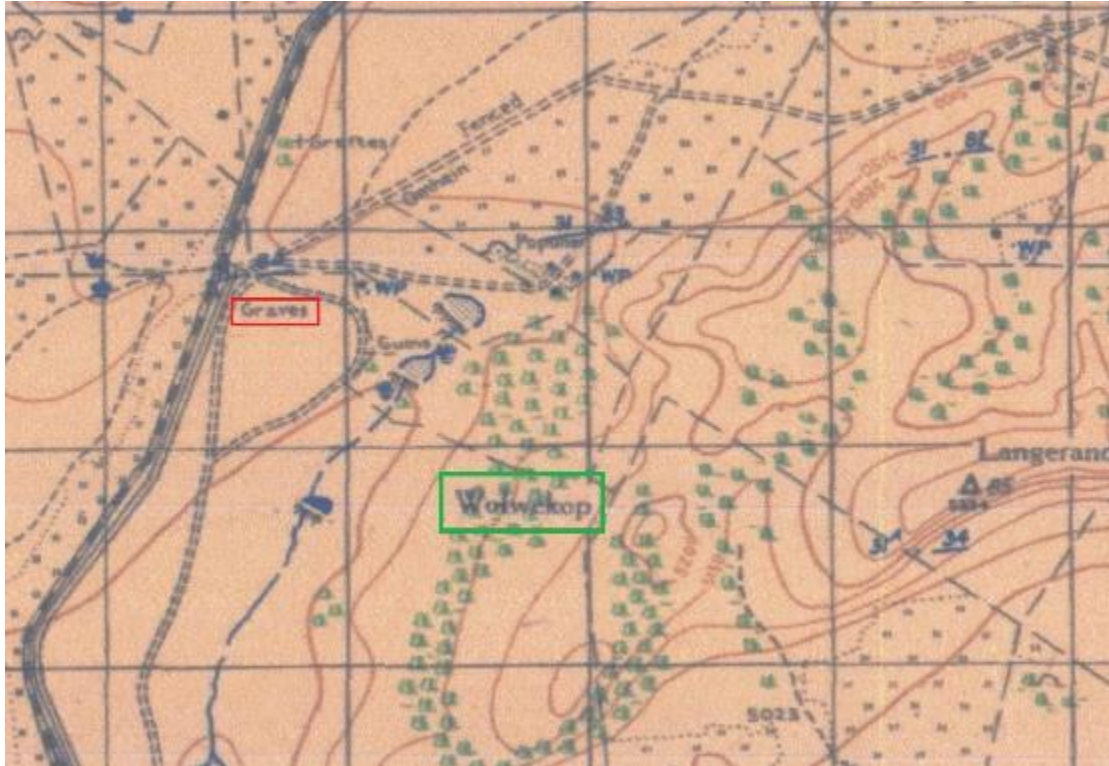
Fig. 10. First edition (1941) 1:50000 map 2627 BD Vereeniging of Surveyor General (Now National Geospatial Information or NGI) showing clearly the grave site on the Lethabong development area. Its location is substantiated by the rail line, the farm roads, the dams in the drainage line and the name Wolwekop that can be compared in fig. 39 on page 20 below on the 1: 50 000 map 2627 BD Vereeniging fifth edition 2006.

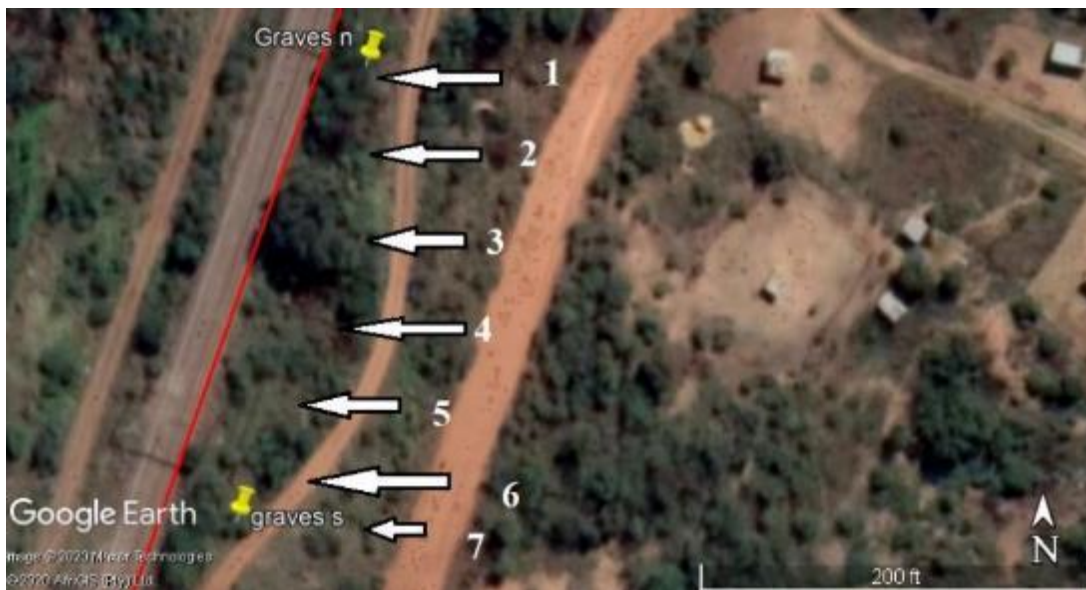
Fig. 11. Google Earth image 2020 of the proposed Lethabong development. The numbers indicate positions from where photographs were taken, as well as the on foot inspection route.

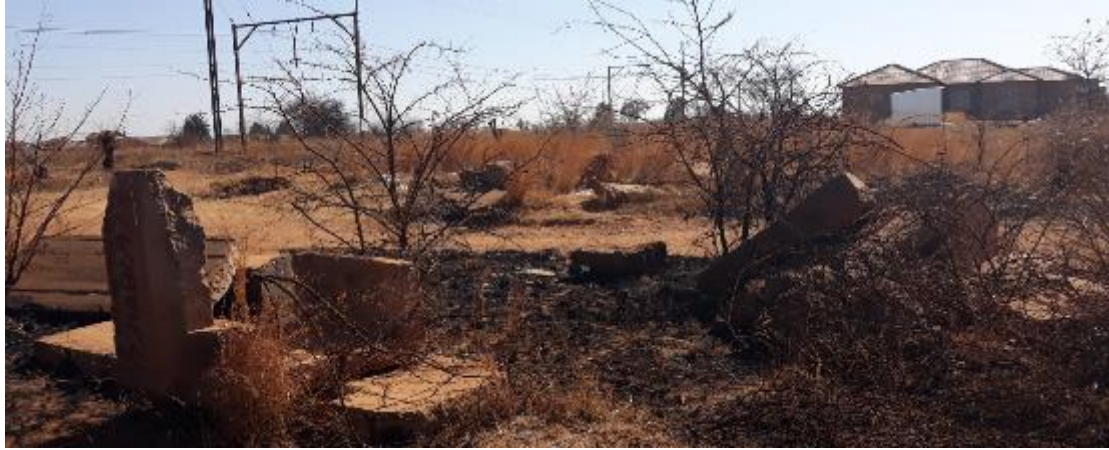
Fig. 12. Area directly north of the cemetery area. Outside the cemetery itself these demolished culverts give incorrect impressions of grave headstones. (Photo S.M. Miller 2020.)

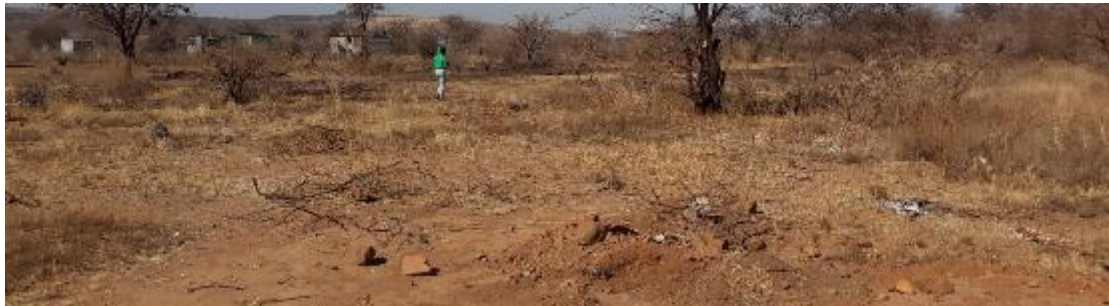
Fig. 13. Area directly east of the cemetery area. In the foreground is the remains of an informal settlement dwelling. (Photo S.M. Miller 2020.)

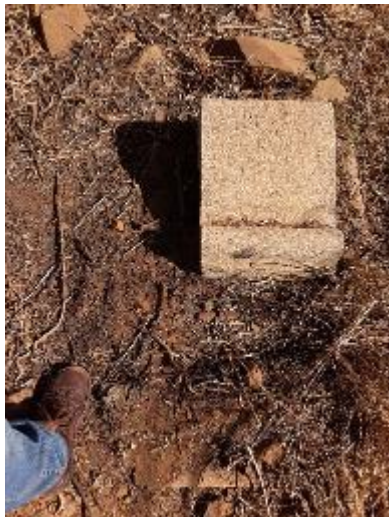
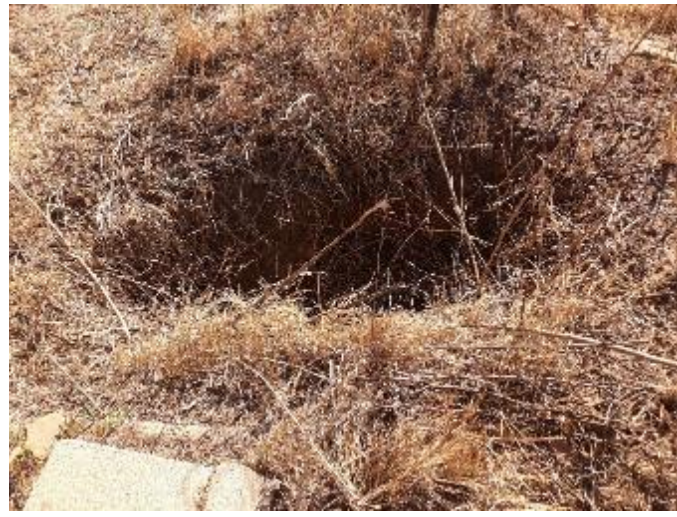
Figs. 14 and 15. These images were taken at marker 1 in fig.11 above. It is the grave of a young child, the grave's extent is defined by the line to the right of the photographer's leg, and next to it a cavity of a robbed grave. (Photos S.M. Miller 2020.)

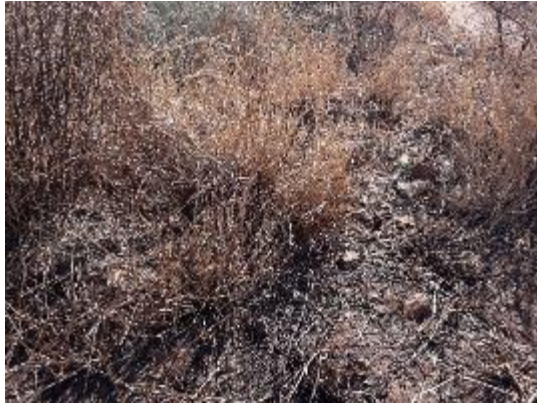
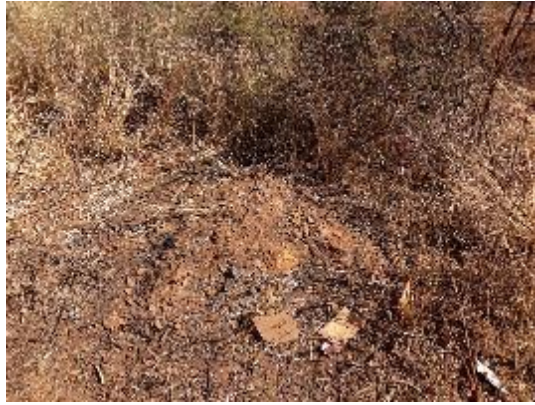
Figs. 16 and 17. These images were taken just above marker 2 in fig.11 above. It is images of graves covered with rubble and a grave partially disturbed. (Photos S.M. Miller 2020.)

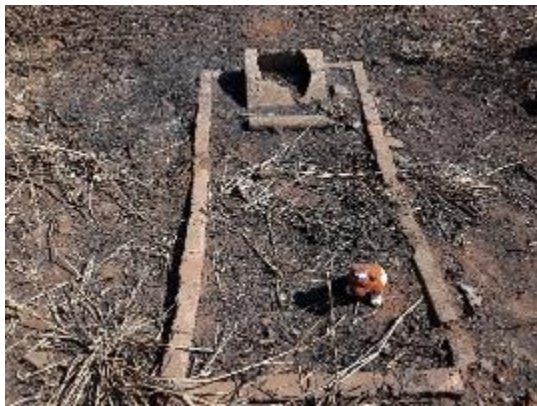
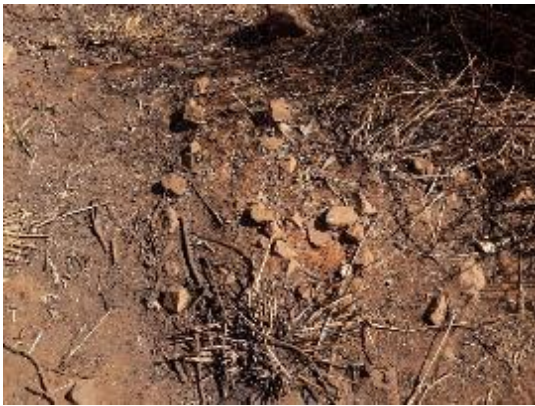
Figs. 18 and 19. These images were taken at marker 2 in fig.11 above. The first is an image of a well-defined grave with a porcelain piggy as grave goods and a vandalised headstone. The second is a typical grave in the cemetery identifiable only through the cobbles infill remaining above normal ground level. (Photos S.M. Miller 2020.)

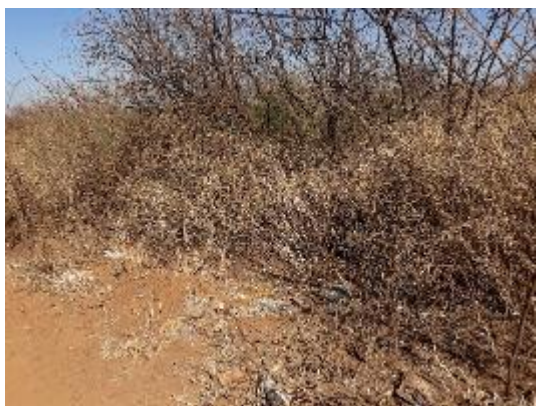
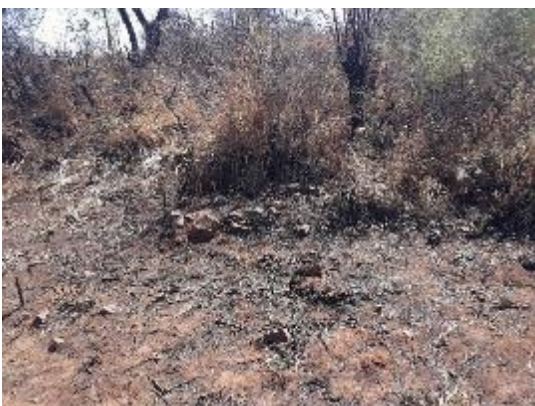
Figs. 20 and 21. These images were taken at marker 3 in fig.11 above. The first is next to the roadway and the second closer to the railway reserves. Both shows material dumped on graves. (Photos S.M. Miller 2020.)

3.6.4. The graves in the northwest corner of the site (+- 40) ought to be properly investigated, cleaned of vegetation and dumped rubble, and fenced off as a first step in action. Negotiations with Set Square Developments (Pty) Ltd must be undertaken as a second step, so as to decide over either the retention or the relocation of the graves.

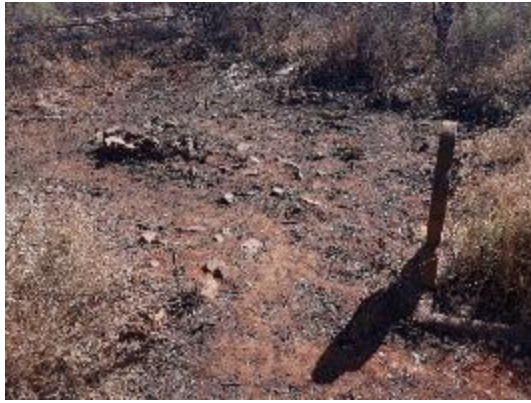
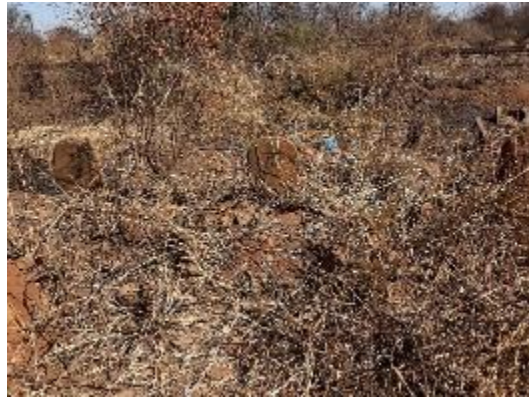
Figs. 22 and 23. These images were taken at marker 4 in fig.11 above. Both shows material dumped on graves, unmarked graves and graves overgrown with a variety of pioneer plants. (Photos S.M. Miller 2020.)

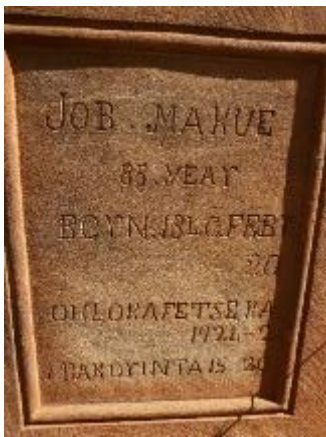
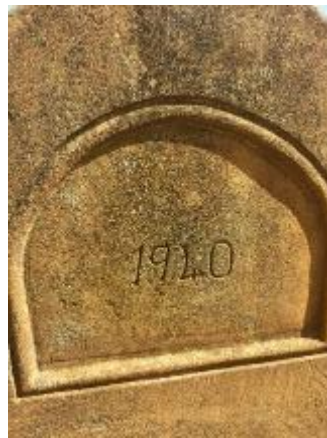
Figs. 24 and 25. These images were taken at marker 5 in fig.11 above. These are both of the same headstone showing the remarkable quality of workmanship (Photos S.M. Miller 2020.)

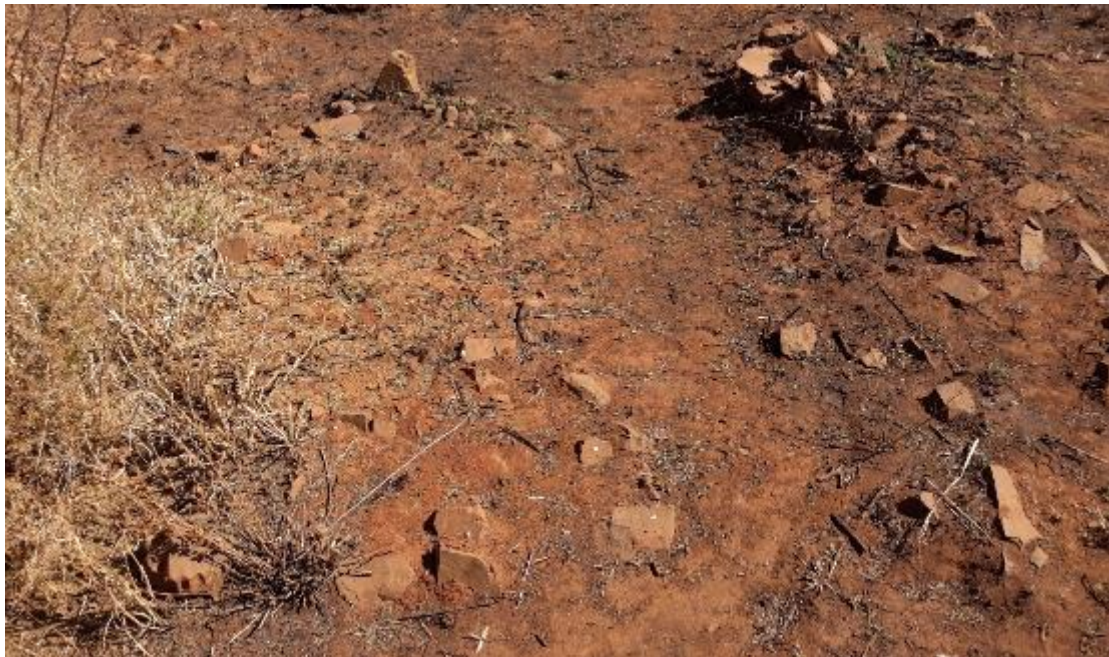
Fig. 26. This image was taken at marker 5 in fig.11 above. This is the typical demeanour of the graves, explaining why material was dumped in the cemetery out of ignorance. Also note the hoof prints captured in mud during the wet season. (Photo S.M. Miller 2020.)

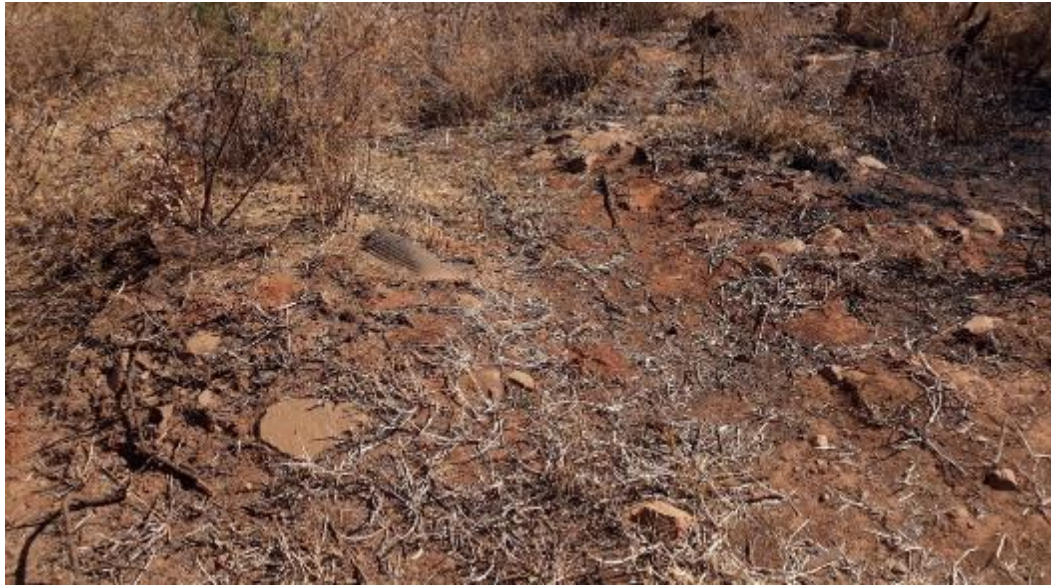
Fig. 27. This image was taken between markers 5 and 6 in fig.11 above. Here where fire had destroyed dry pioneer vegetation the extent of the cemetery can better be observed. Also note that a very low percentage of graves carried headstones, and then again only few are inscribed with details of the deceased. (Photo S.M. Miller 2020.)

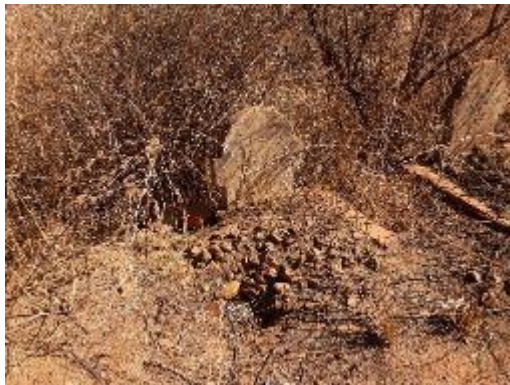
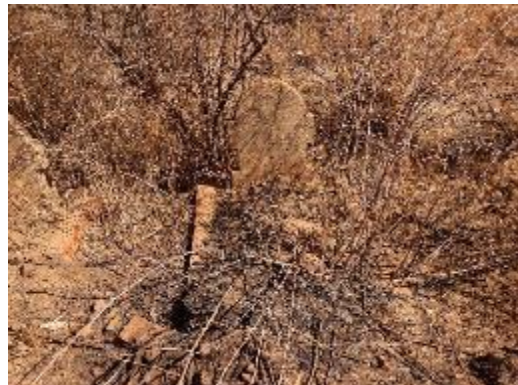
Figs. 28 and 29. These images were taken between markers 5 and 6 in fig.11 above. These headstones are cast in concrete and only inscribed with a cross. (Photos S.M. Miller 2020.)

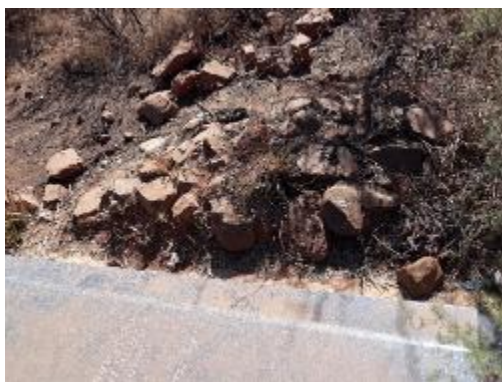
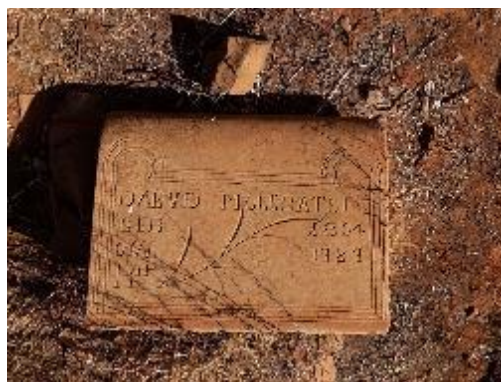
Figs. 30 and 31. These images were taken between markers 5 and 6 in fig.11 above. A well-defined grave covered with large rocks that could have been “built-in” originally and a high quality scrolled headstone that announces David Molebatsi that lived between 1854 and 1921. (Photos S.M. Miller 2020.)

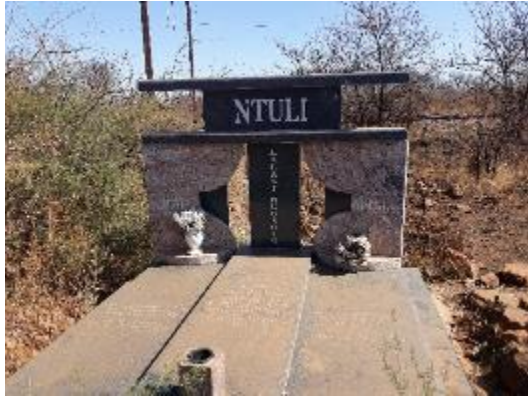
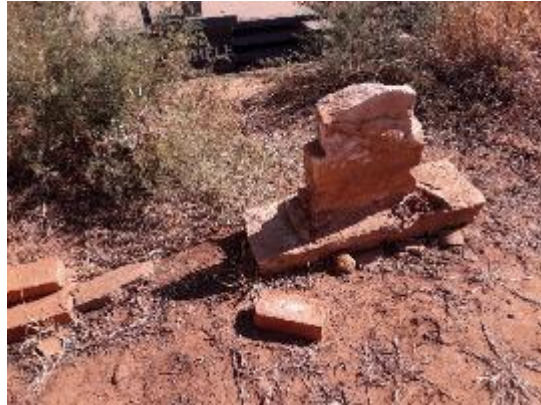
Figs. 32 and 33. These images were taken at marker 6 in fig.11 above. The modern Ntuli headstone are meant to commemorate a number of people, apparently all female. It appears as if the displaced headstone may have been the original headstone from the mid 1900's. (Photos S.M. Miller 2020.)

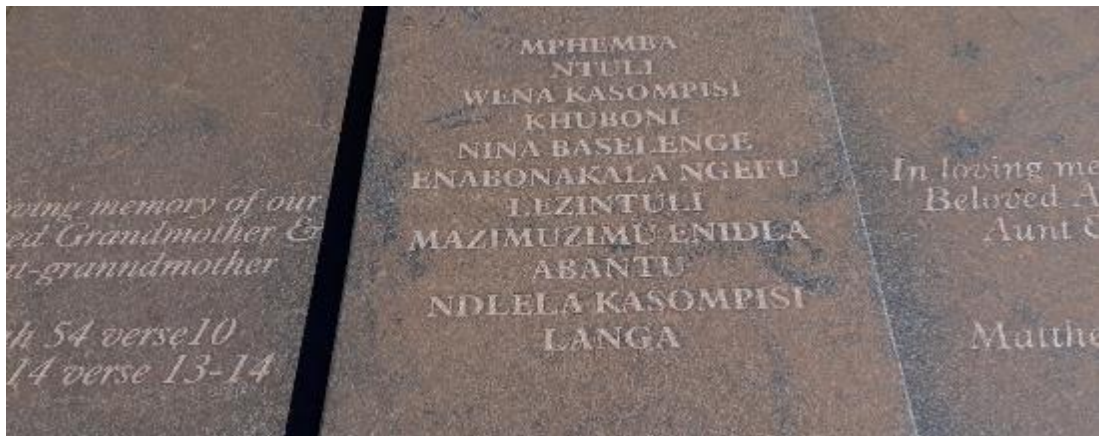
Fig. 34. Inscription on the modern Ntuli headstone (Photo S.M. Miller 2020.)

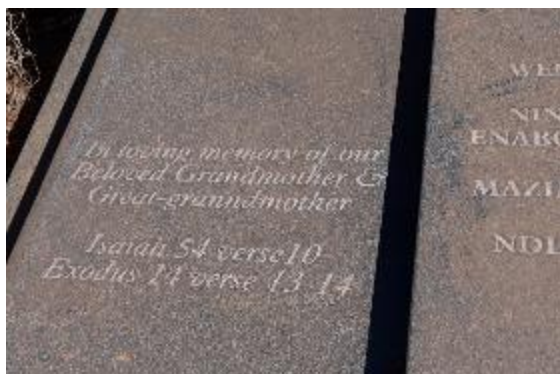
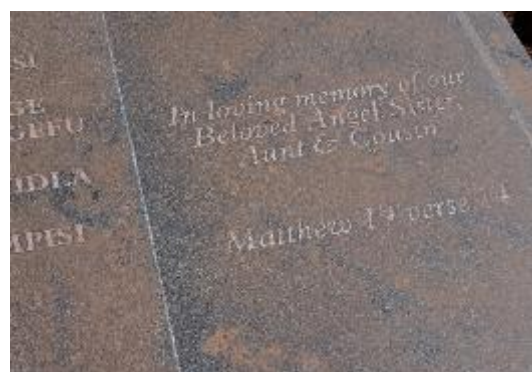
Figs. 35 and 36. Detail of the inscription on the modern Ntuli headstone. (Photos S.M. Miller 2020.)

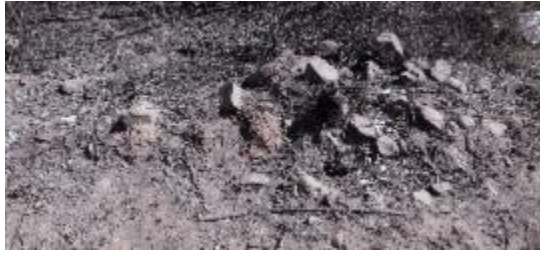
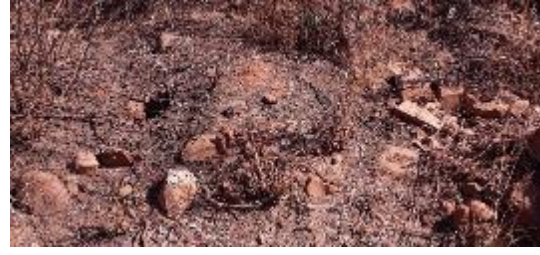
Figs. 37 and 38. These images were taken at marker 7 in fig.11 above. These two unmarked grave to the south of the modern Ntuli headstone appears to herald the boundary of the cemetery. (Photos S.M. Miller 2020.)

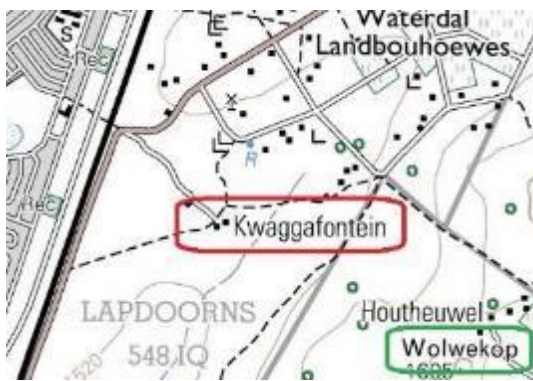
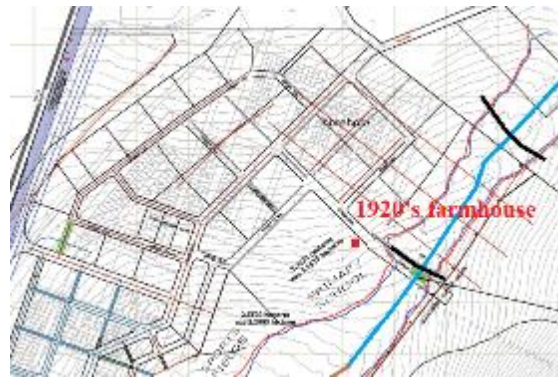
Figs. 39 and 40. Left is the location of the historical farmhouse on the 1: 50 000 map 2627 BD Vereeniging fifth edition 2006, and on the right its location on the development framework plan of Lethabong.¹²

¹² Author's comment: - It is possible that it could be retained as part of the school development. Rather than going through the process of procuring a demolition permit from PHRA-G.

3.7.3. *It is recommended that the 1920’s farmhouse should be retained as a janitors residence as part of the future school site on which it is located.*

13.3. *It is recommended that the 1920's farmhouse should be retained as a janitors residence as part of the future school site on which it is located.*

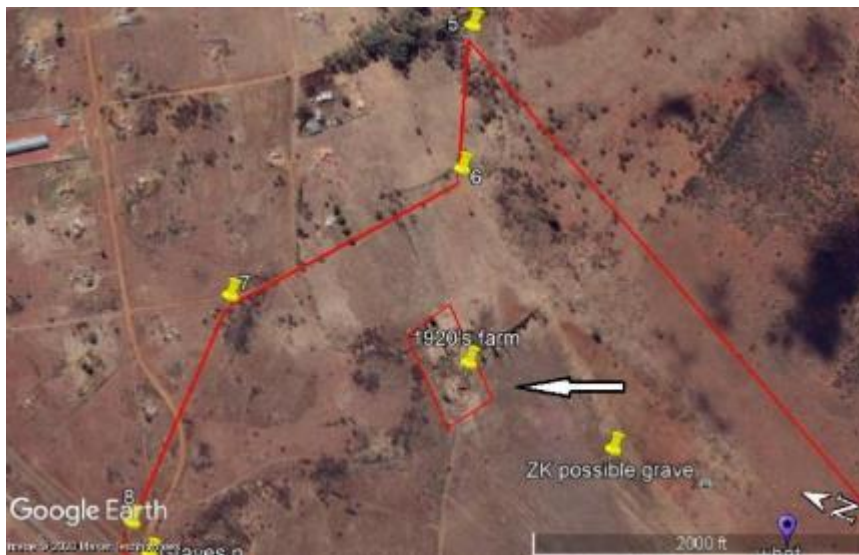
Fig. 41. Google Earth image from 2013 showing point from where photos were taken for the Kwaggafontein farmhouse.

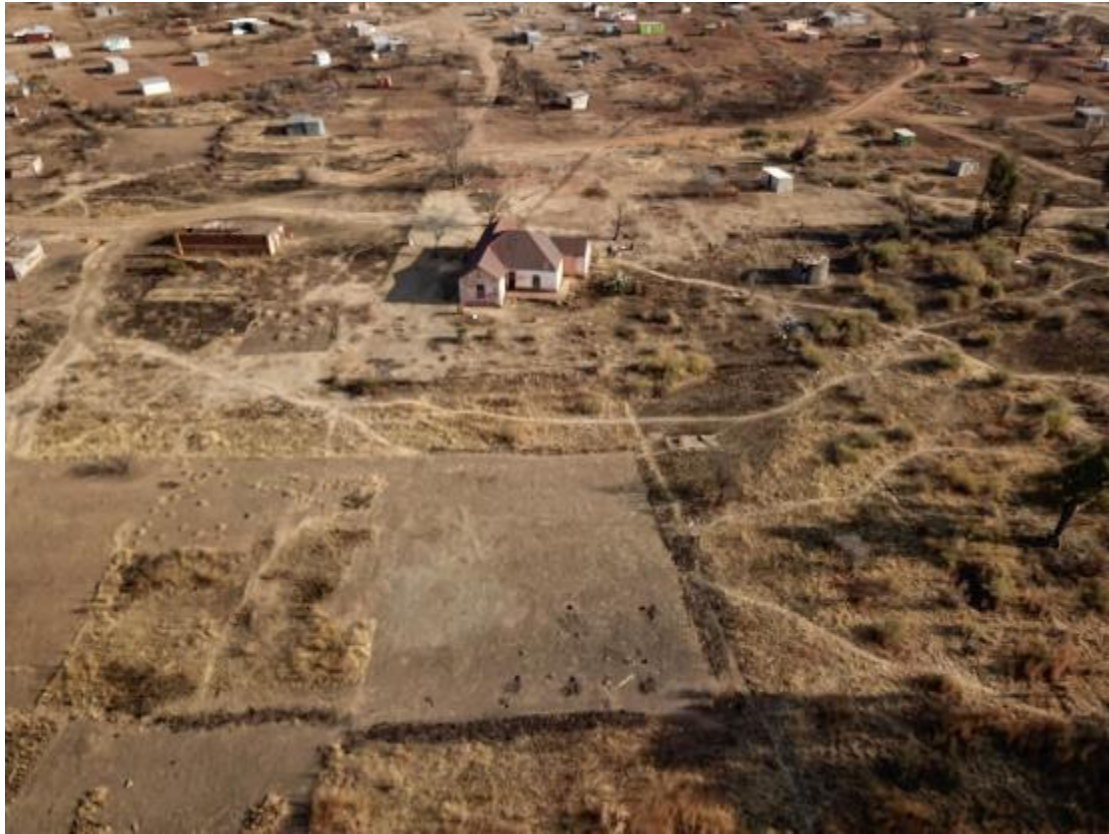
Fig. 42. Eastern elevation of the old Kwaggafontein farmhouse photographed by drone camera. (Photo Ziegwald Kūsel 2020)

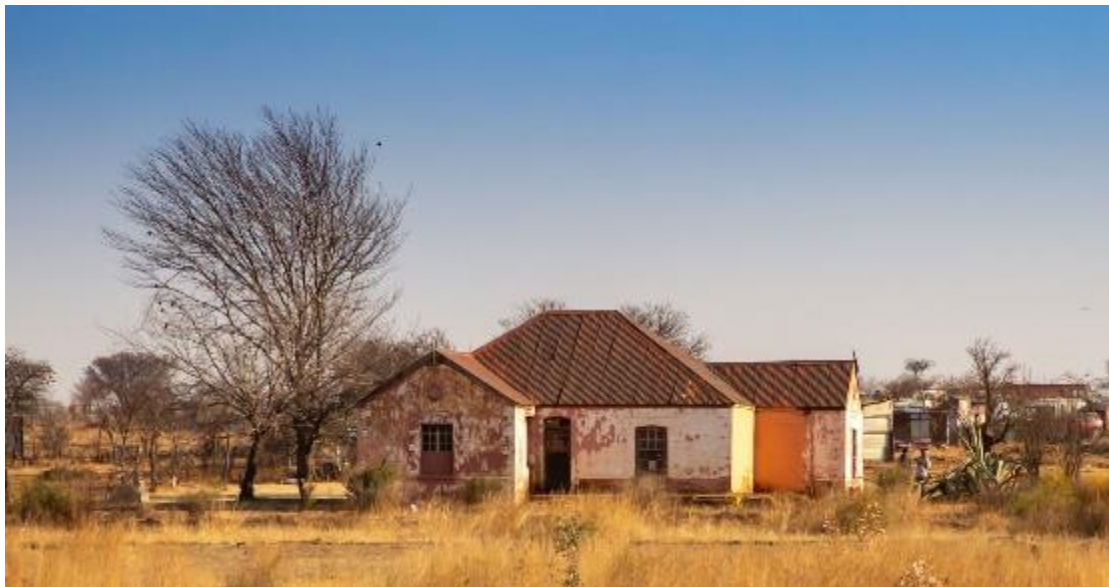
3.6.3. The 1920’s farmhouse has survived the development stress, but as it is of relative low field rating ‘**General’ Protection B. (Field Rating IV B)**’. It should be attempted to retain it on the proposed new school premises. Demolition, if so wished by the developer, may only take place if a demolition permit is obtained from PHRA-G after a second phase HIA.

Fig. 43. Eastern elevation of the old Kwaggafontein farmhouse. Effort ought to be made to retain this structure. It is structurally sound and with a small investment it can be turned into a useful building on the new proposed schoolyard. (Photo Ziegwald Kūsel 2020)

3.7.4. *The 1920’s farmhouse may not be demolished without a second phase study and the obtaining of a demolition permit from PHRA-G.*

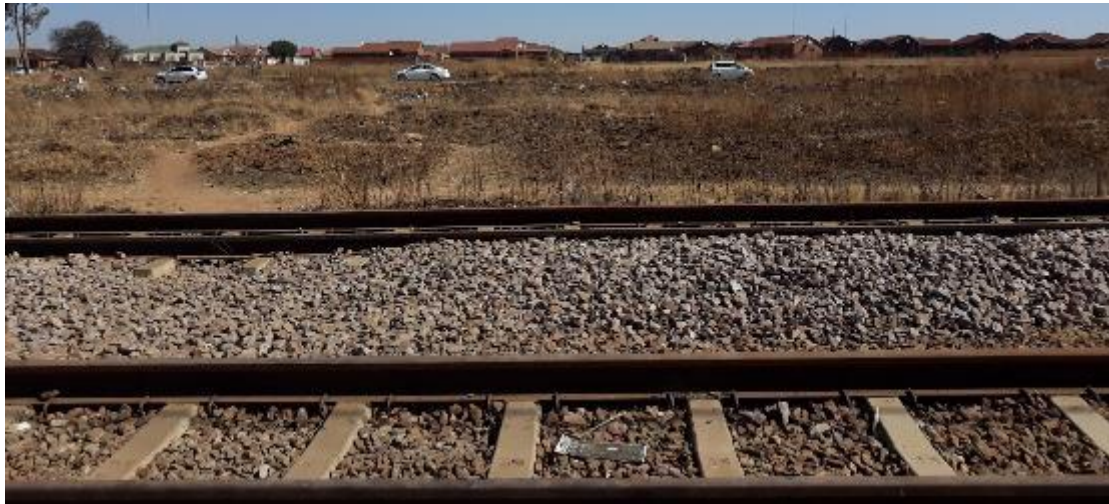
Fig. 50. Looking west from marker 1. Note railway lines unfenced and the rubble in the area between the railway lines and Sebokeng in the background. (Photo S.M. Miller 2020.)

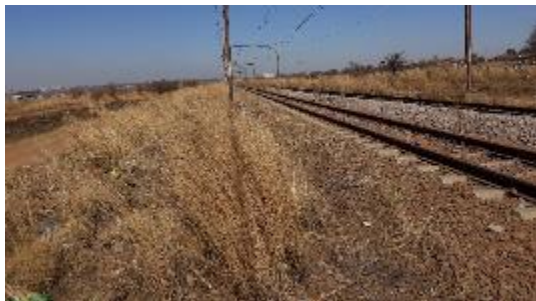
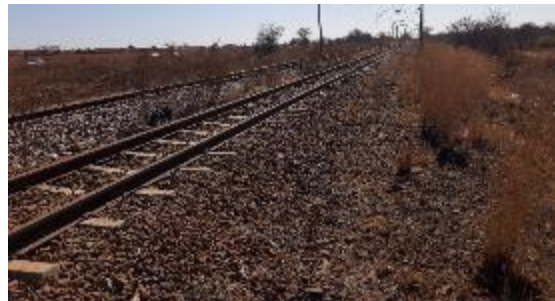
Figs. 51 and 52. Looking northeast and southwest west from marker 1. Note railway lines unfenced. (Photos S.M. Miller 2020.)

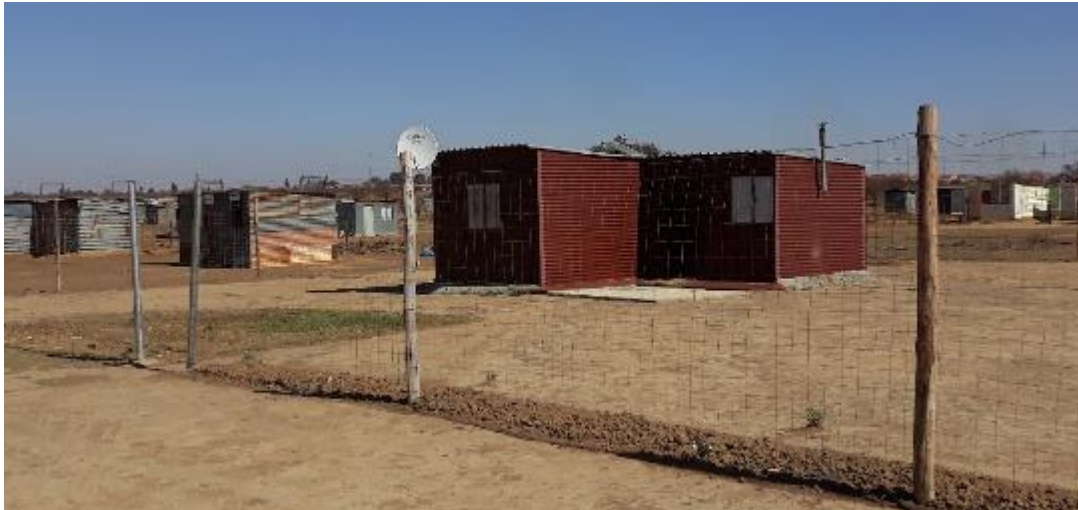
Fig. 58. Photo 28. Looking west from marker 4. Many corrugated iron dwellings are soundly constructed and cared for. Lack of basic services is sadly evident. (Photo S.M. Miller 2020.)

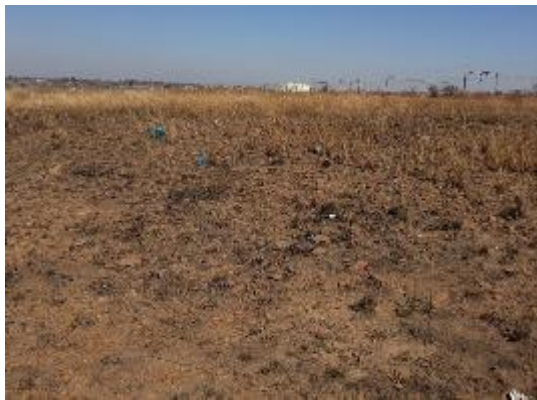
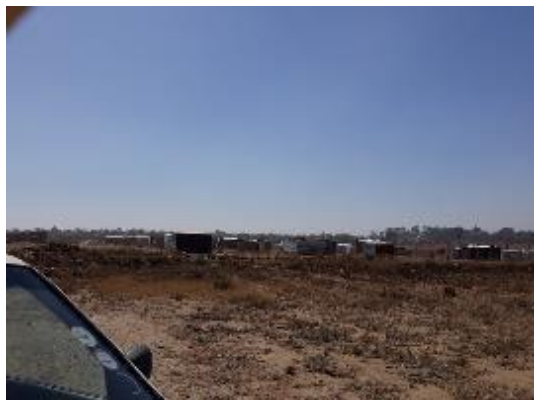
Figs. 59 and 60. Looking west and north from marker 5. On both photographs the effect of ploughing can be observed. (Photos S.M. Miller 2020.)

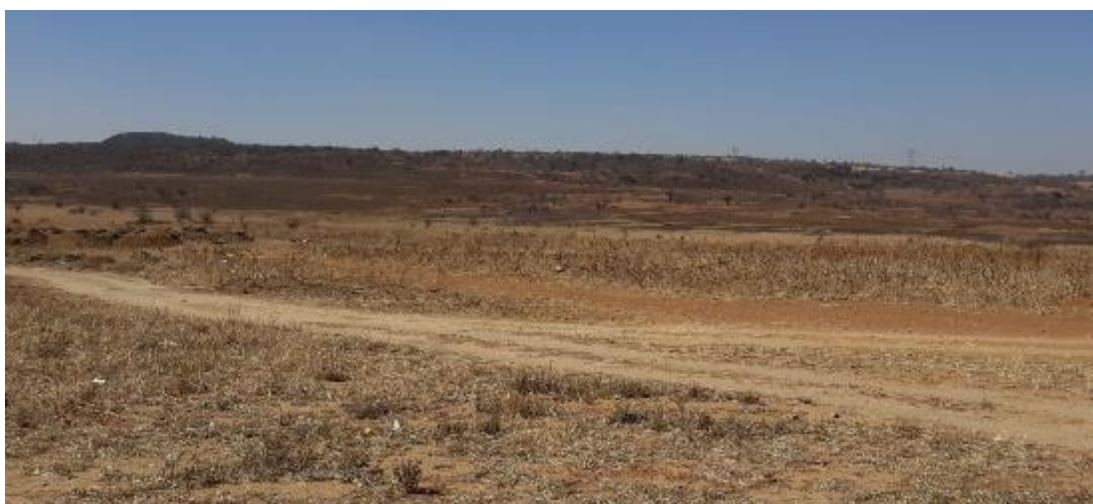
Fig. 61. Looking southeast from marker 5. Here the effects of ploughing, construction work and dumping can be observed. (Photo S.M. Miller 2020.)

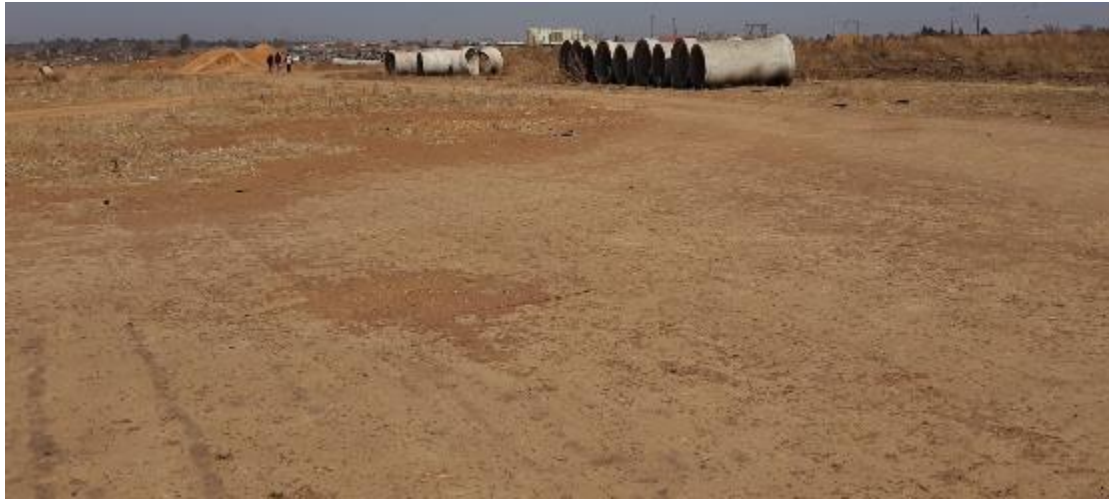
Fig. 62. Looking south from marker 6. Here the effects of ploughing, construction work and dumping can be observed. (Photo S.M. Miller 2020.)

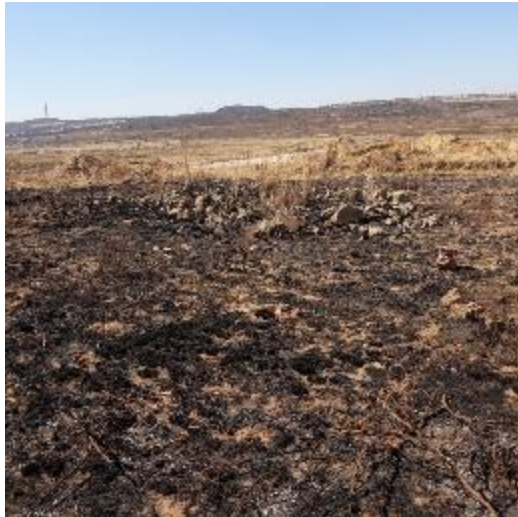
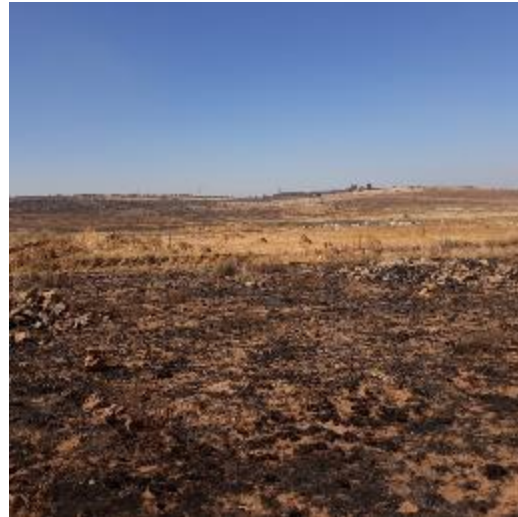
Figs. 66 and 67. Looking southwest from marker 7. Disturbances in the old fields with the new compacted and serviced platforms for new housing in the background. (Photos S.M. Miller 2020.)

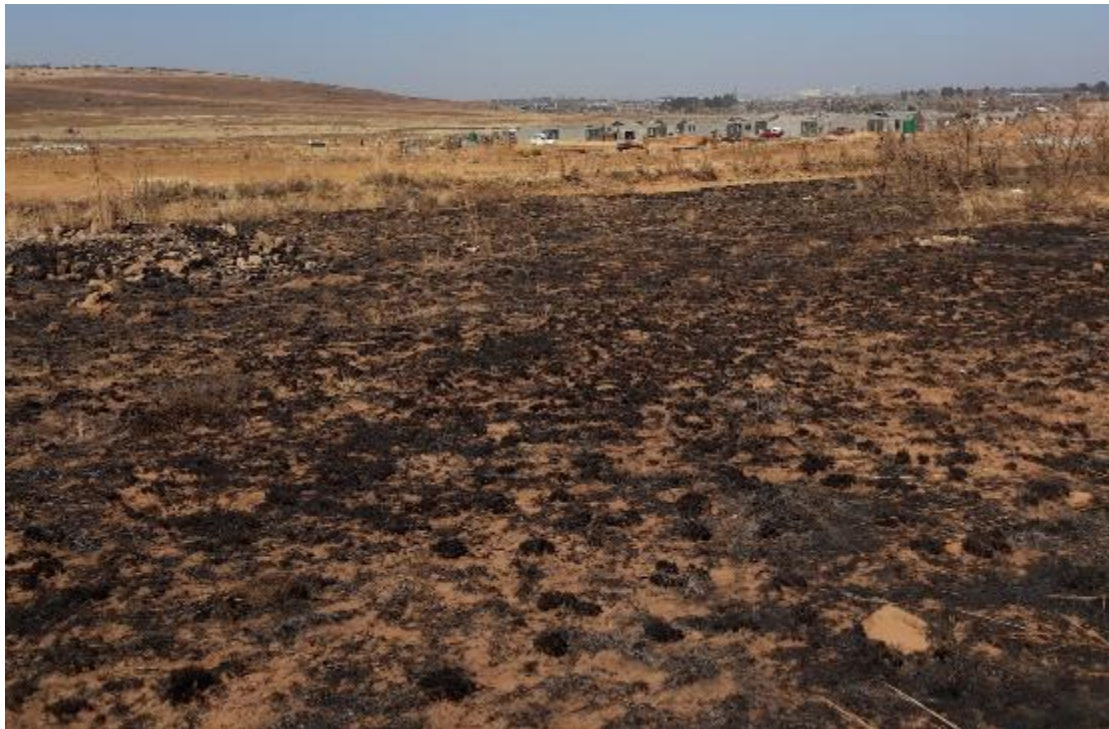
Fig. 68. Looking south from marker 8. Disturbances in the old fields, dumping and the newly constructed housing in the background. (Photo S.M. Miller 2020.)

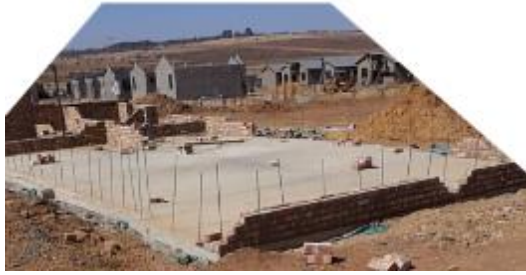
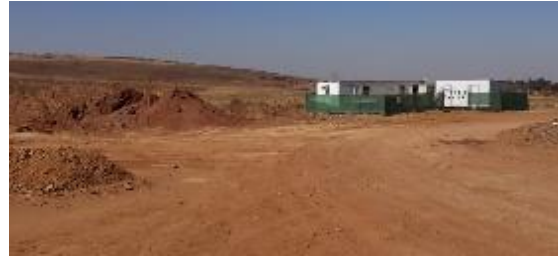
Figs. 71 and 72. Looking south from marker 9, new dwellings and looking south from marker 11 the site office of Setsquare. (Photos S.M. Miller 2020.)

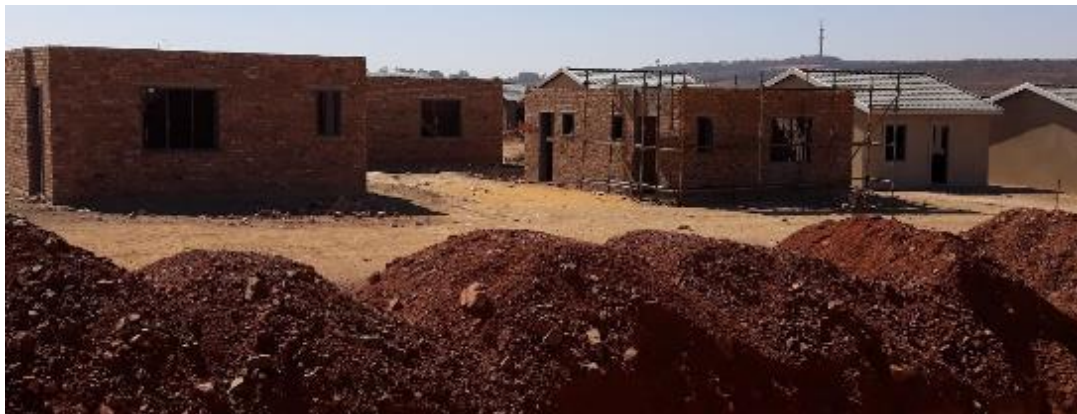
Fig. 73. Photo 65. Looking east from marker 11. New dwellings (Photo S.M. Miller 2020.)

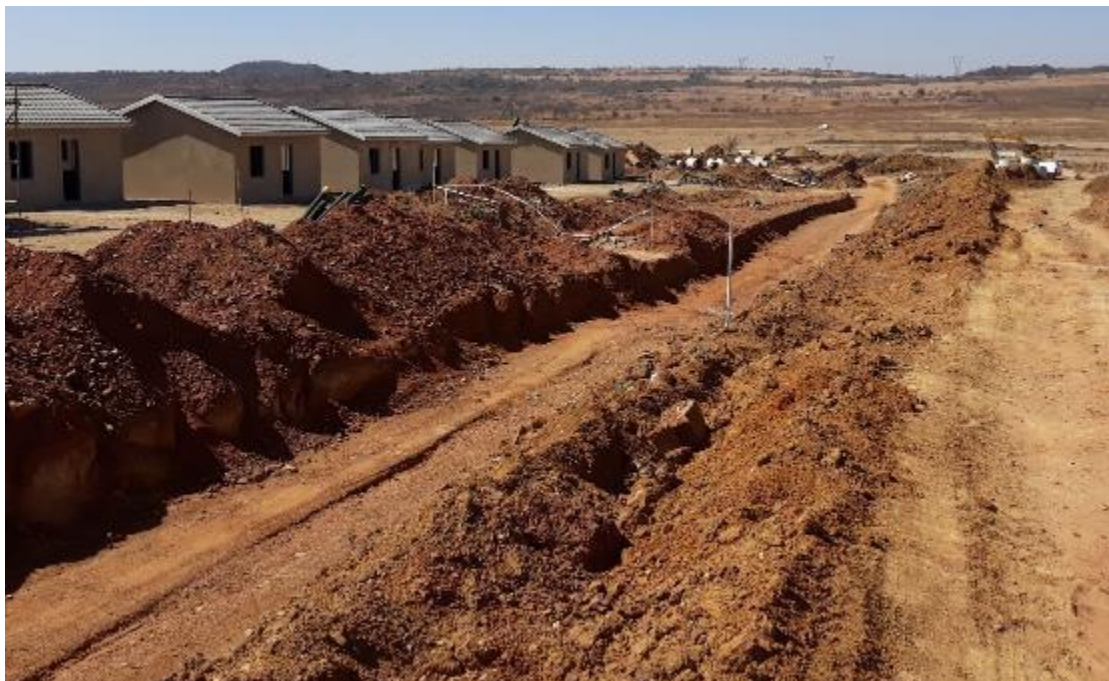
Fig. 74. Photo 65. Looking east from marker 12. New dwellings and services under construction. (Photo S.M. Miller 2020.)

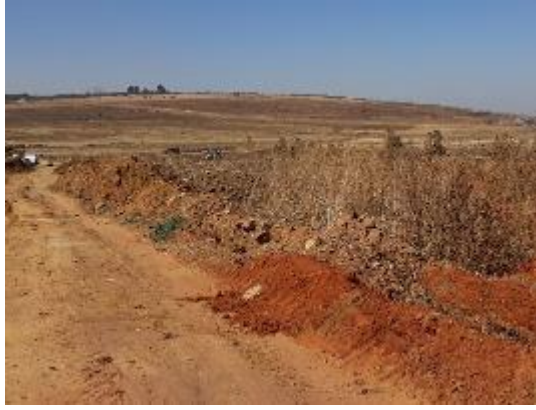
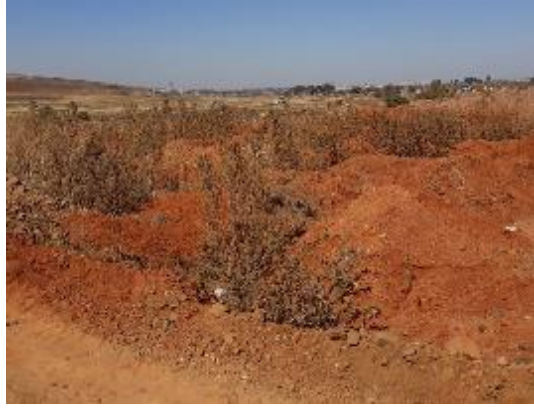
Figs. 75 and 76. Looking east and southeast from marker 12. Construction roads and dumping. (Photos S.M. Miller 2020.)

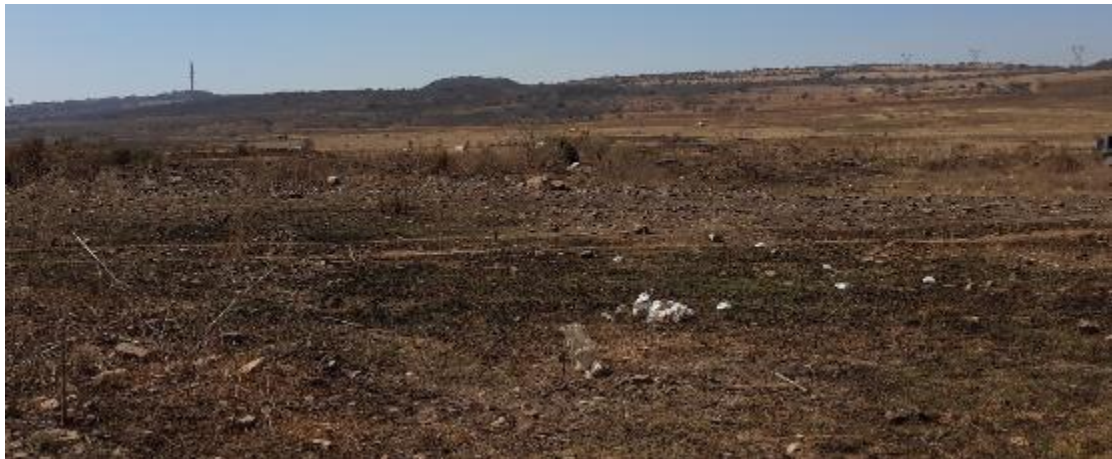
Fig. 77. Photo 65. Looking east from marker 13. Dumping and rouble. (Photos S.M. Miller 2020.)
