**First phase heritage impact assessment for the LETHABONG HOUSING
DEVELOPMENT (contract no 19080) in Sebokeng.**

Set Square Developments (Pty) Ltd.

August 2020.

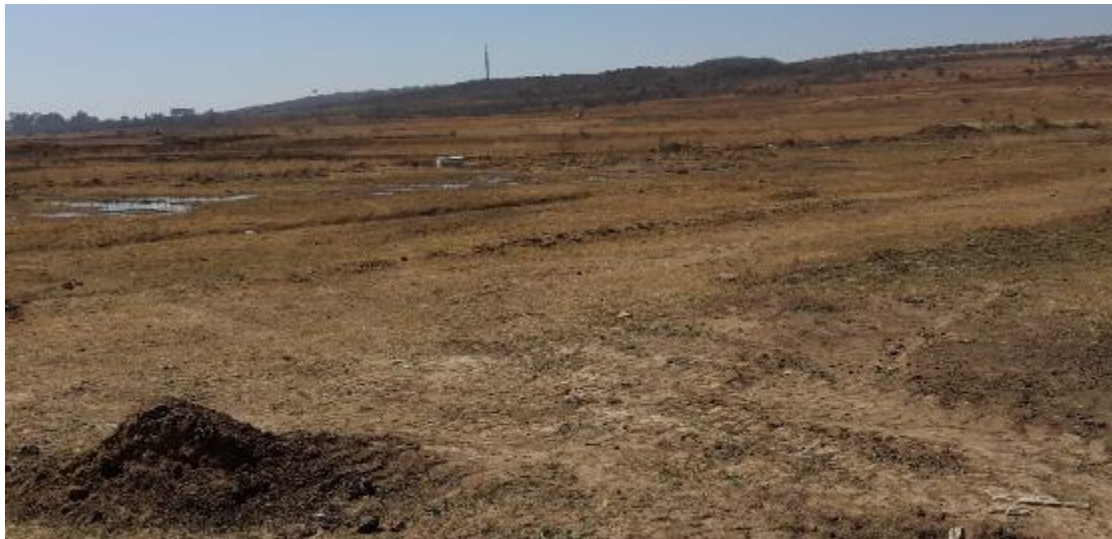
Fig. 78. Photo 65. Looking northwest from marker 14. New work in progress for roads and storm water. (Photo S.M. Miller 2020.)

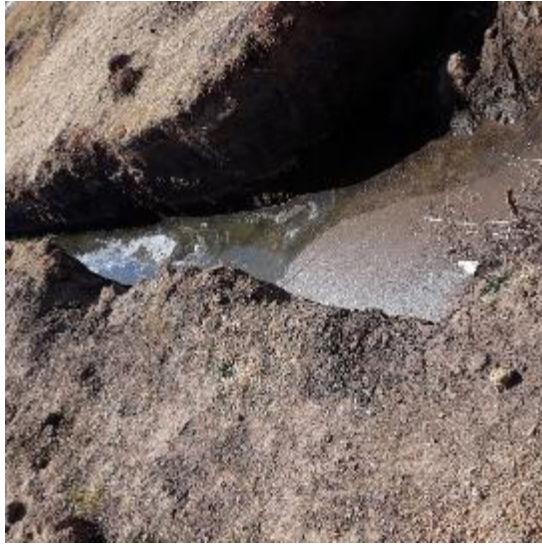
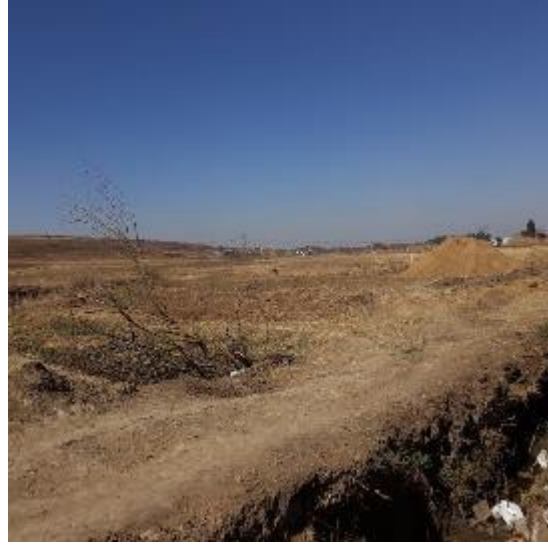
Figs. 79 and 80. Looking north and east from west from marker 15. New work in progress for roads and storm water. (Photos S.M. Miller 2020.)
