**NHRA SECTION 34 APPLICATION
2 LION STREET, BO KAAP**

Erf 1852 Cape Town

23 October 2020

vidamemoria heritage consultants

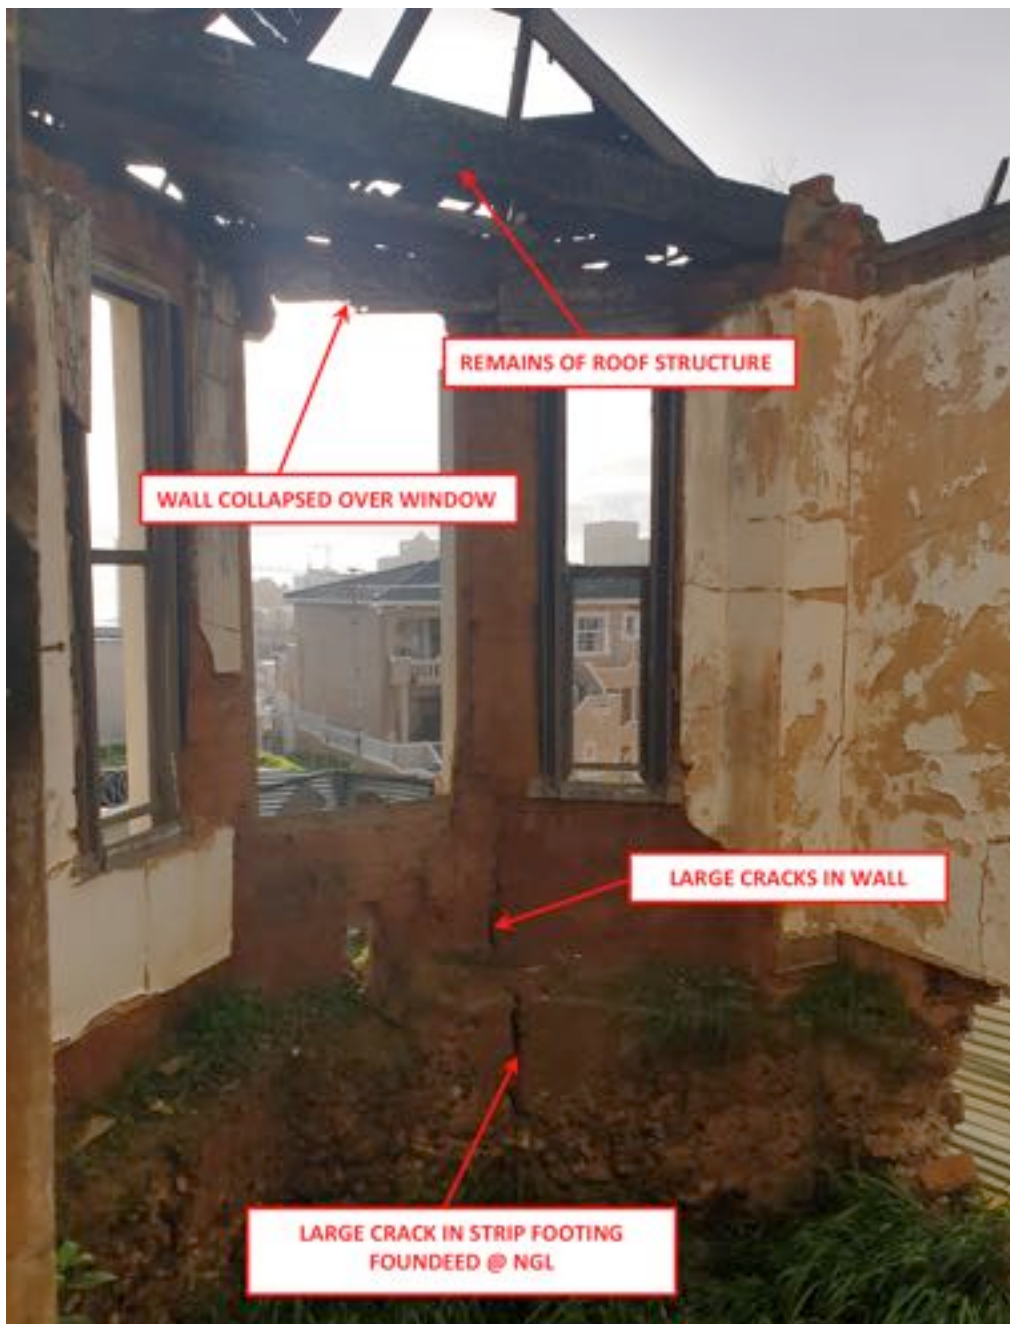
Figure 15: Bay window in lounge (Abe-Struc 2020: 6)

Abe-Structural Engineering Solutions were appointed to investigate the structural integrity of remains of the house that was destroyed in a fire (Annexure A). The remains of the dwelling include brick walls and exposed strip footings. The roof and floors were completely destroyed by the fire. The walls were built off strip footings that were constructed with rocks / boulders, laid in cement mortar and founded at natural ground level. The compressive strength of the footings is unknown. The walls were constructed using clay bricks and clay mortar. Bricks are brittle, some have washed out and the clay mortar beddings are soft.

Grass / shrubs are growing from the walls displacing bricks and mortar. Large cracks (greater than 3 mm and for full depth) induced by the heat of the fire run across wall panels. Timber lintels were damaged by the fire. The street boundary retains the grass patch / garden at mid-height and is cracking at the lower portion of the wall with damp blemishes along the crack lines caused by the water logged ground. The boundary wall is also leaning over towards the street.

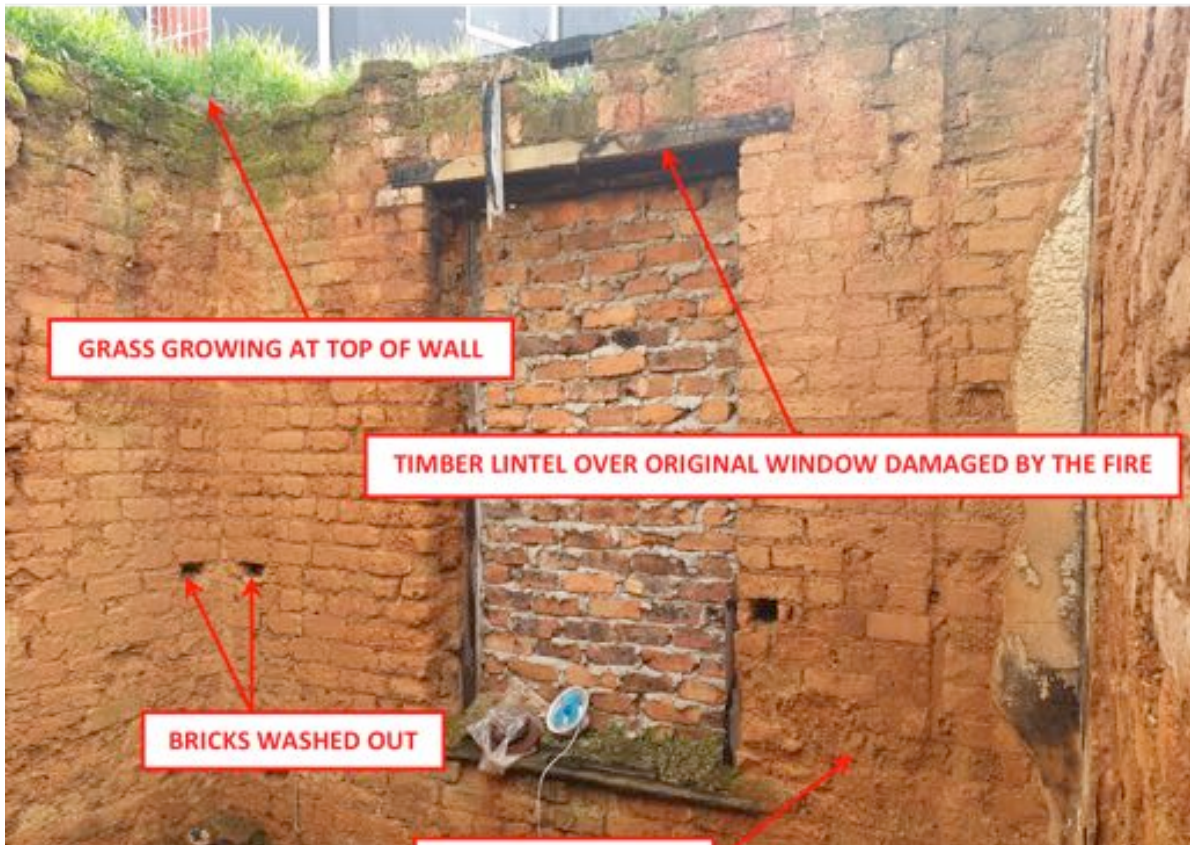
Figure 16: Original window construction (Abe-Struc 2020: 5)

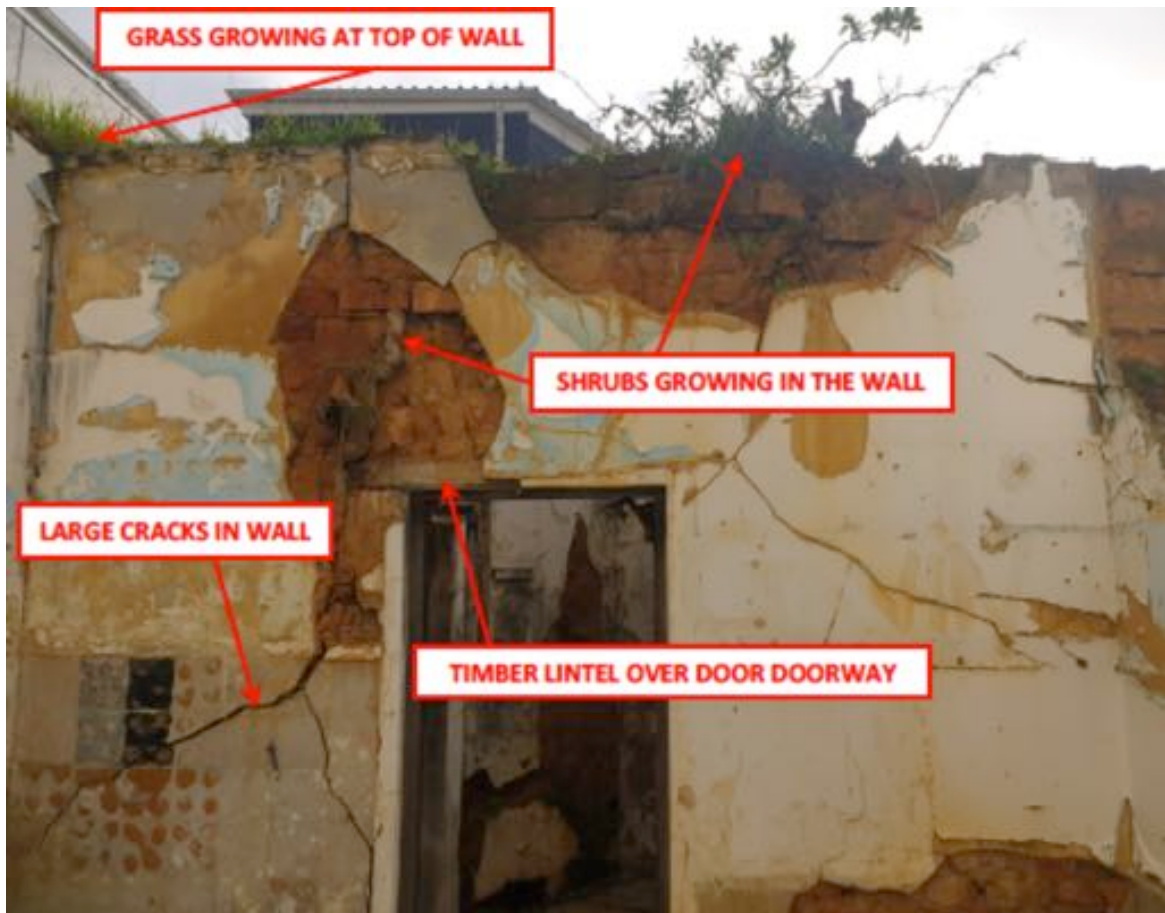
Figure 17: Waal panel with door opening (Abe-Struc 2020: 4)

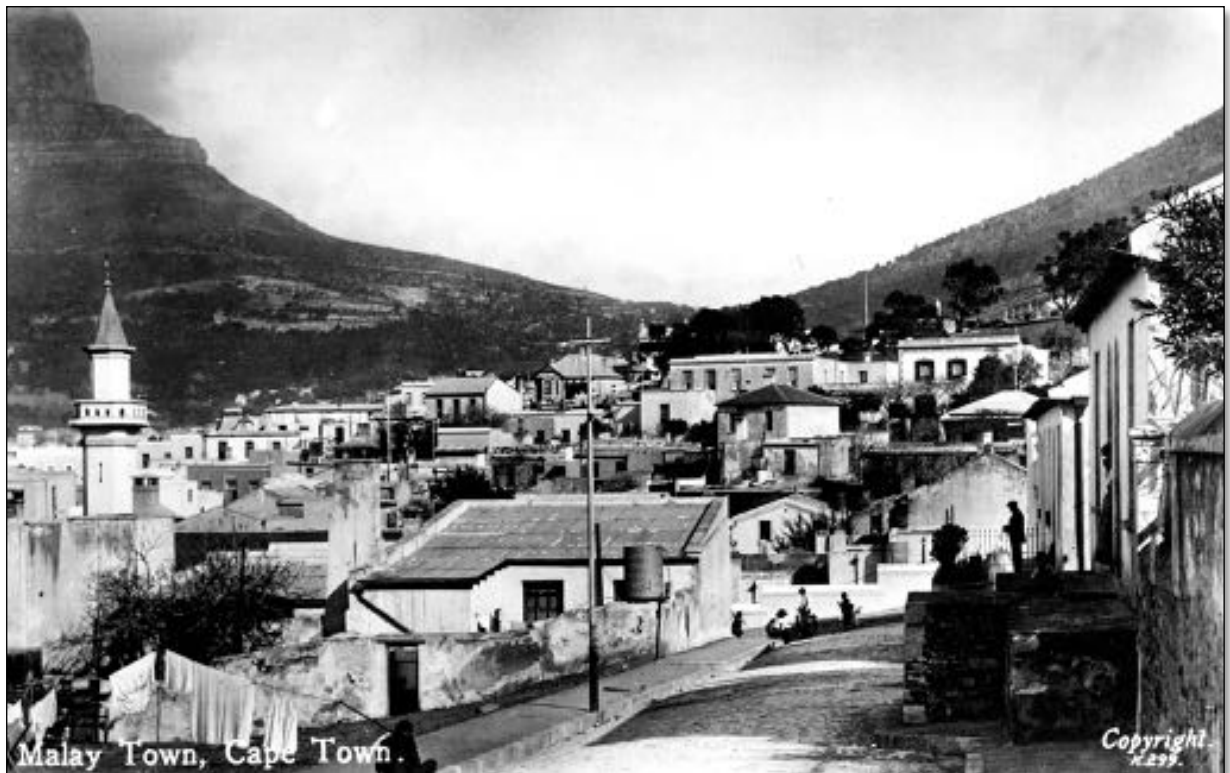
Figure 21a: A postcard (original source unknown) of c.1910 showing Bo-Kaap looking south-east. The Schotshe Kloof opstal (79 Dorp Street) can be seen at the top middle, with 2 Lion Street visible to its left. (Michael Fortune)

The corner dwelling (2 Lion Street, the subject site) can be seen in an undated (c.1910) photograph taken looking south beyond the Schotshe Kloof opstal towards Leeuwen Street (Figure 21). Here the newly built, handsome late-Victorian villa can be seen in some detail. It had typical architectural trimmings of the period, including a bay window with sashes, a gable with timber finial and bargeboard as well as 'large pane sashes and fine bead mould frame and centrally divided 4-panel bolection mould door' with a raised stoep and 'high plinth below bay window...' (Louw 1983: 294). These latter features were added due to the steep embankment of the site as it tapered down to Lion Street. There was also a steep flight of stairs leading to the front stoep from the garden and a narrow pedestrian access gateway leading off Leeuwen Street, flanked by pillars (Figure 31).

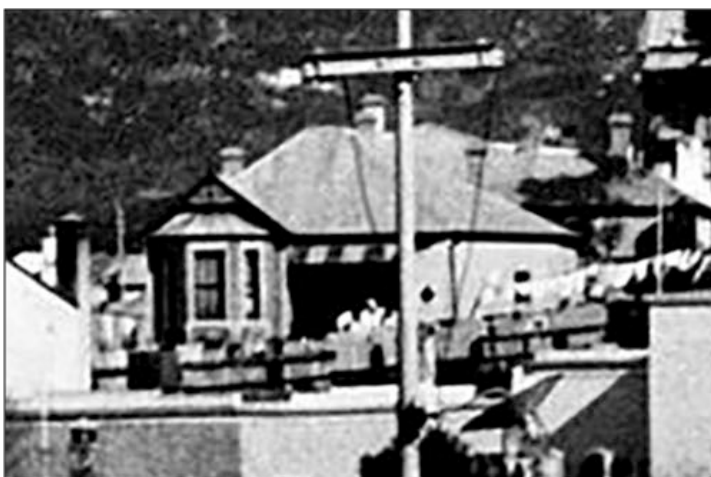
Figure 21b: Detail of the above image showing 2 Lion Street when it was approximately a decade old. It appears that there were three fireplaces, judging by the visible chimneys. (Michael Fortune)

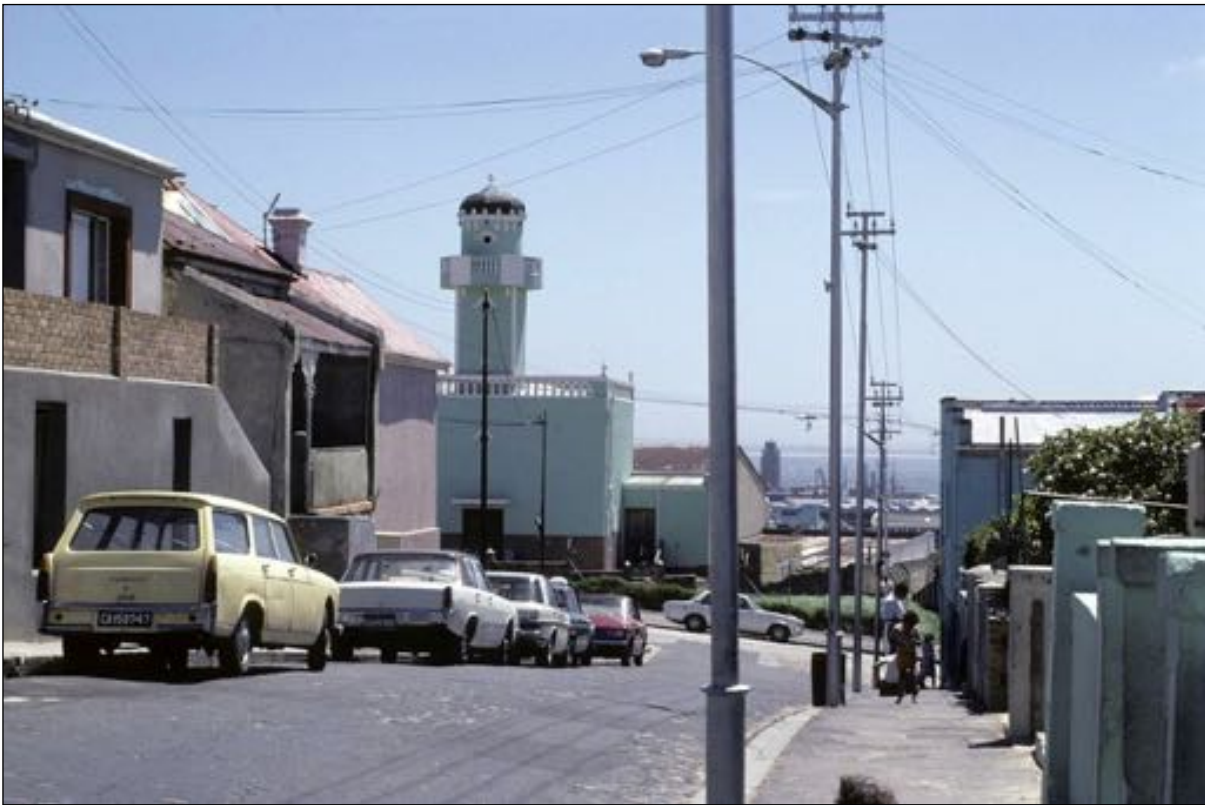
Figure 22: A view of Lion Street from 1972, looking northwards down towards the junction with Leeuwen Street, where the Nurul Huda Masjid mosque (built in 1958) can be seen. The eastern façade of 2 Lion Street (with the chimney) can be seen at middle left. 6 Lion Street (with the broekie lace verandah) has since been completely modernised and is no longer recognisable (see Figure 8 below). (Johannes Köring)

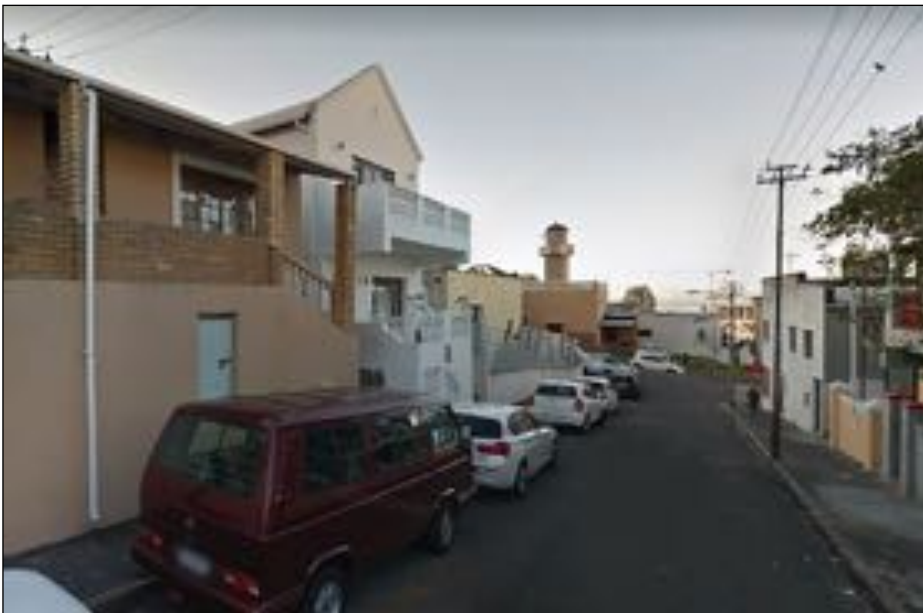
Figure 23: The same view in August 2017 showing the altered streetscape. The ruin of 2 Lion Street (centre, painted cream) can be seen to the left of the mosque. (Google Streetview, Aug. 2017)

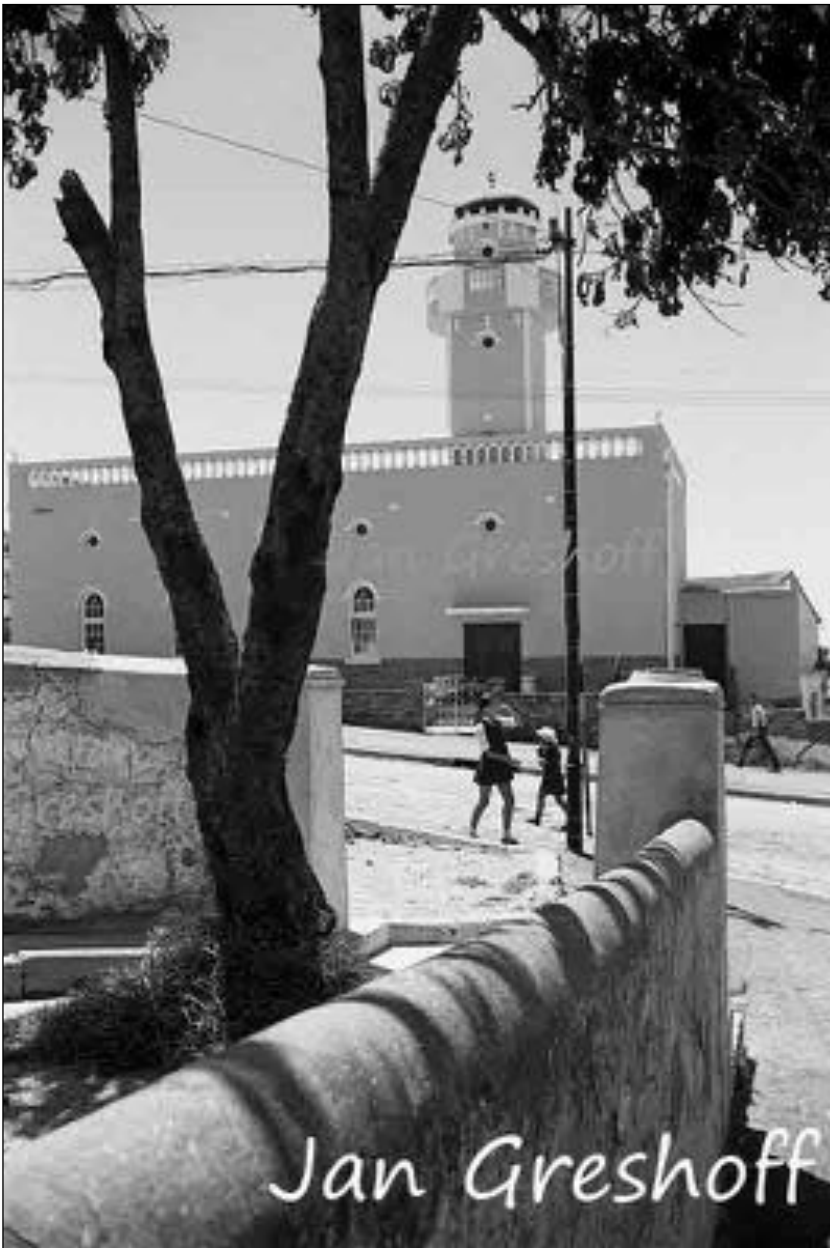
Figure 24: An early 1970s view of Leeuwen Street taken by photographer Jan Greshoff, looking northwards through the pedestrian entrance posts of 2 Lion Street. The Nurul Huda Masjid mosque dominates the skyline in front of the house. The eastern boundary wall of Erf 1852 can be seen on the far right. (Jan Greshoff © Katherine, Martin, Adrian & Robert Greshoff)

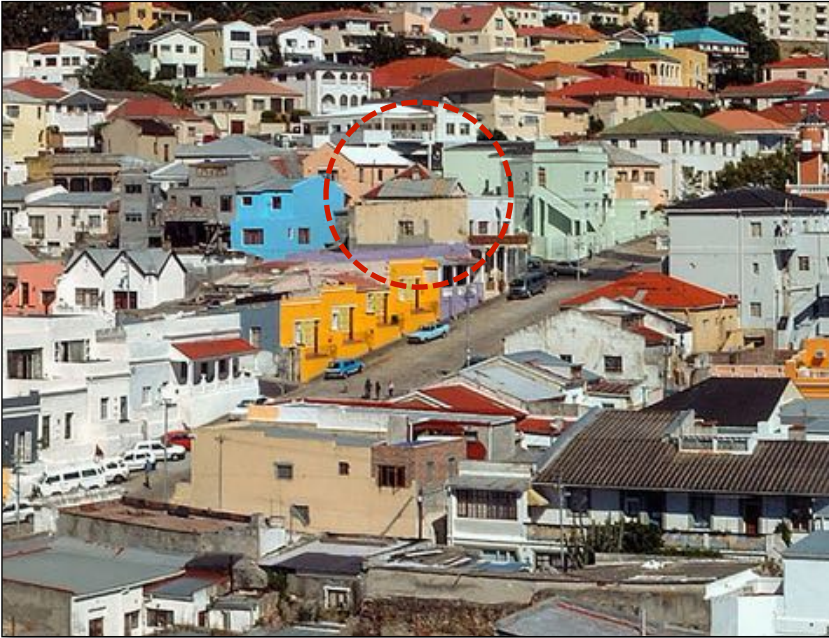
Figure 26: A view of Bo-Kaap, looking west, in 2001. The roof of 2 Lion Street (circled, then still intact, although showing signs of decay) can be seen protruding above the double-storeyed 67 Leeuwen Street (with red balcony). Leeuwen Street runs from bottom left to the top right. (Francois Swanepoel)

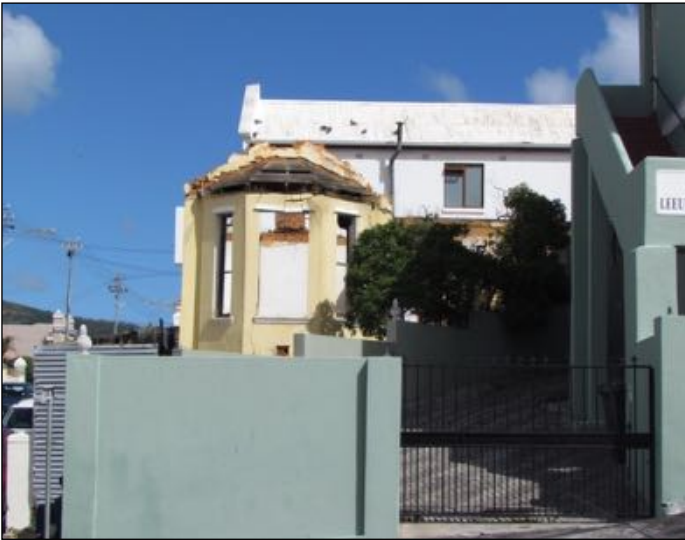
Figure 27: By 2013, the house was a total ruin, with most of the gable and all of the roof gone, and only certain walls remaining standing. (Jim Hislop, 8 March 2013)

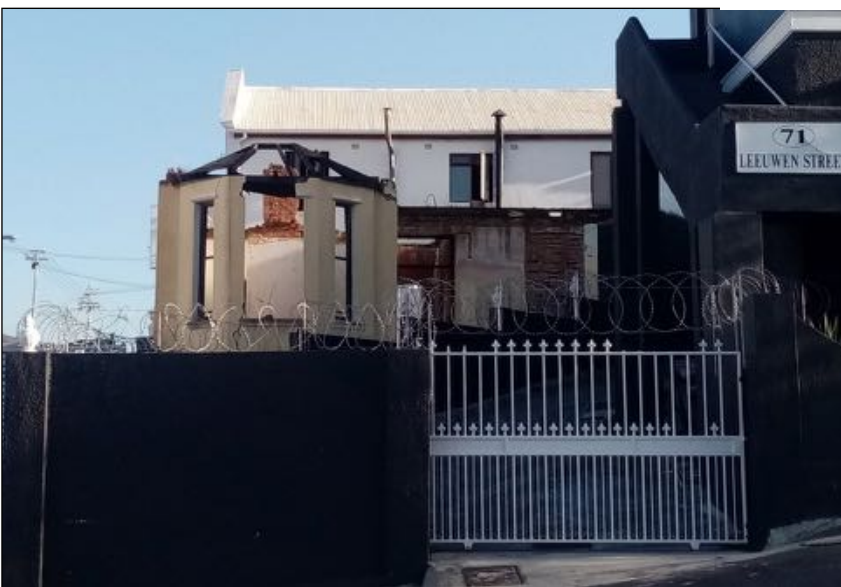
Figure 28: Presently (mid-2020), the bay window roof is missing and the bay window walls are beginning to collapse. (Jim Hislop, 1 June 2020)

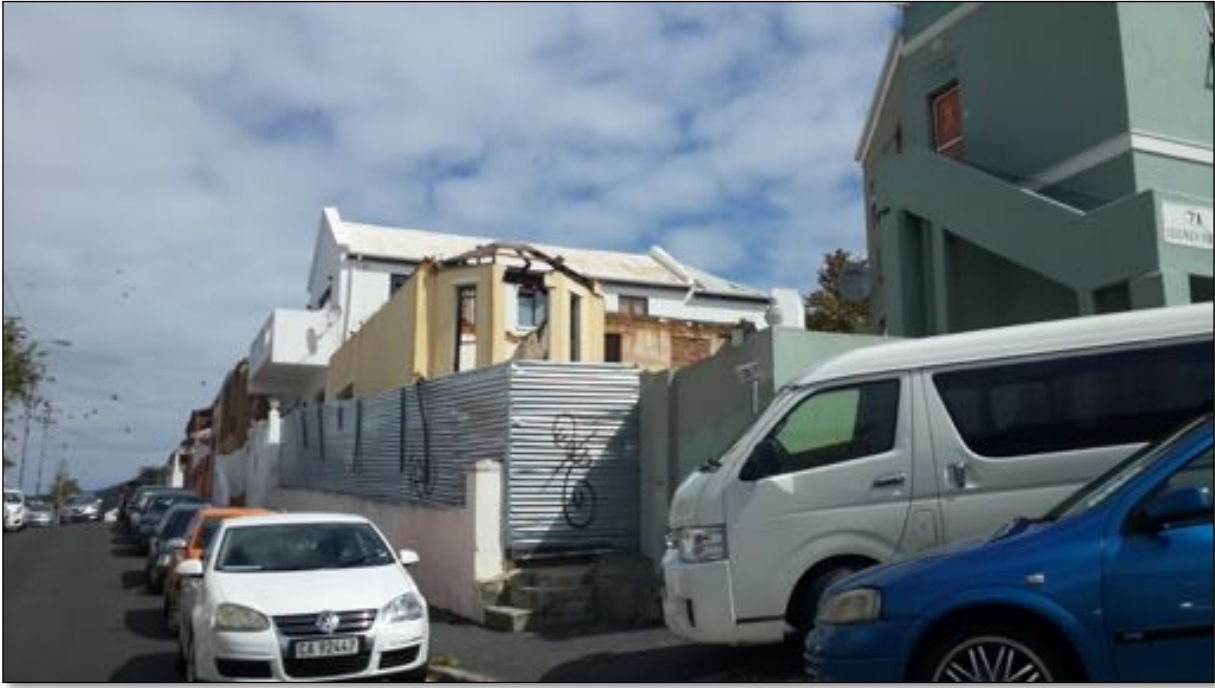
Figure 29: A view of the junction of Leeuwen Street and Lion Street showing northern and eastern façades of the ruined house. (Jim Hislop, 2 April 2016)

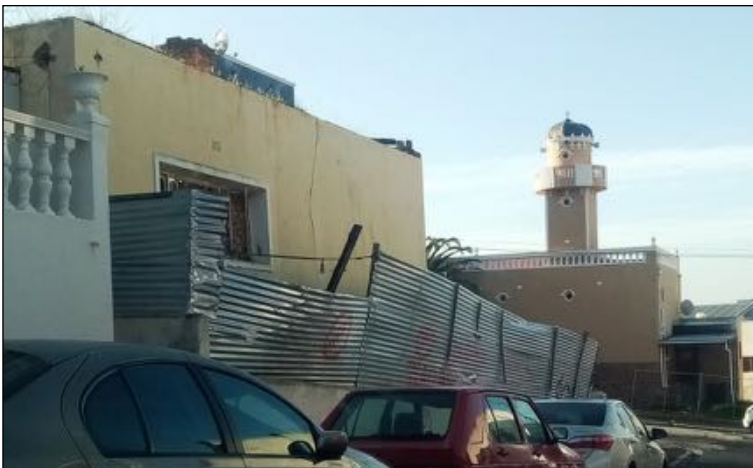
Figure 30: The eastern façade in 2020, showing the remaining eastern wall and steel window that have been bricked up and corrugated iron ‘fencing’ installed in an effort to prevent further vandalism/ degradation of the property. (Jim Hislop, 1 June 2020)

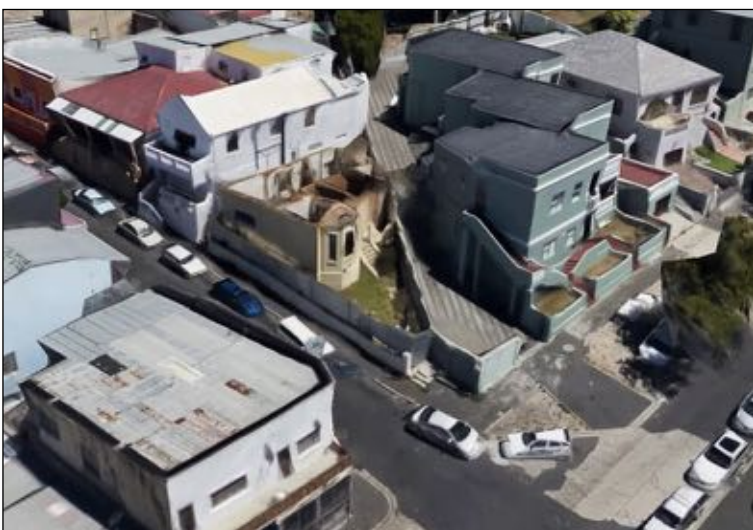
Figure 31: A recent aerial view of the corner of Leeuwen and Lion streets, showing the derelict 2 Lion Street at the centre. Here the steep steep stairs can be seen, as well as the bay windows and internal walls, most of which are still standing. (Google Earth, 2020)

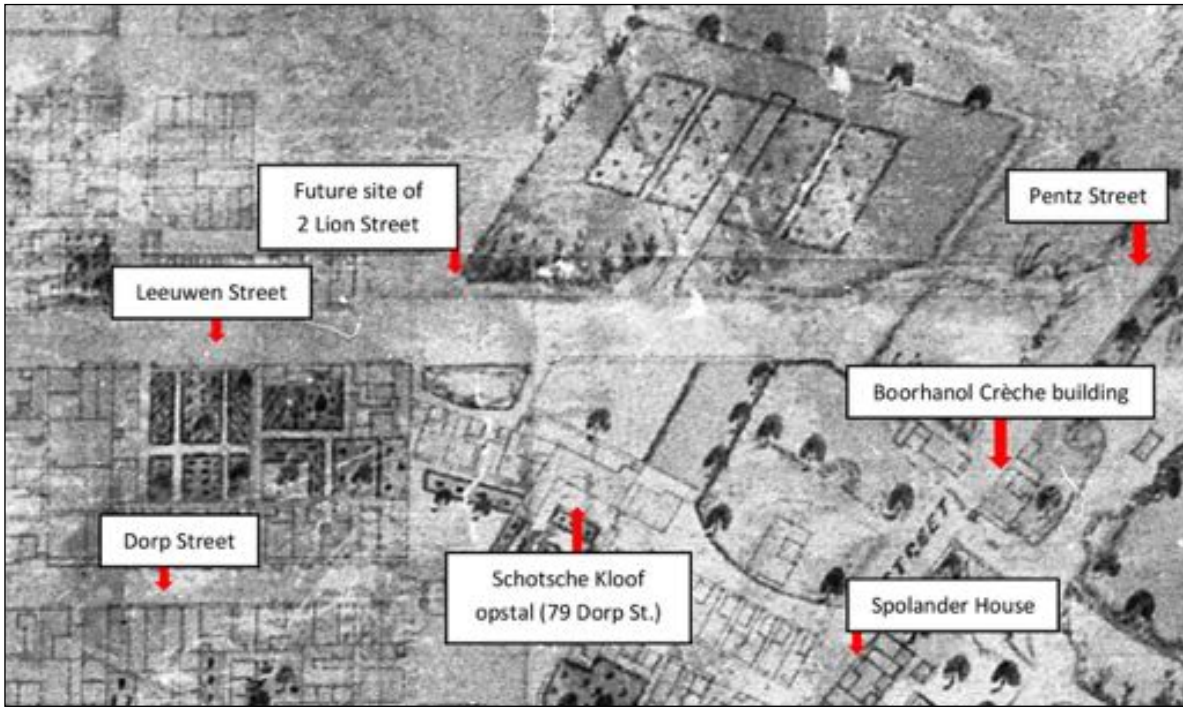
Figure 34: Detail of the 1878 Wilson Survey (Sheet 13), showing the same Bo-Kaap landmarks as in Figure 18. The subject site remained undeveloped at that date). (CoCT Heritage Branch, Wale Street, Cape Town; annotated by J Hislop)

Running in a southerly direction from Upper Leeuwen Street, the portion of Lion Street in the vicinity of the subject site, was developed from the late-19th century on part of the former Schotsche Kloof estate (the homestead of which is still standing at 79 Dorp Street). The 1878 Wilson Survey (*Figure 34*) shows the area that is now occupied by the northern end of Lion Street was still open land at that time and adjacent Upper Leeuwen Street was still largely undeveloped and still largely rural (fields and large gardens).

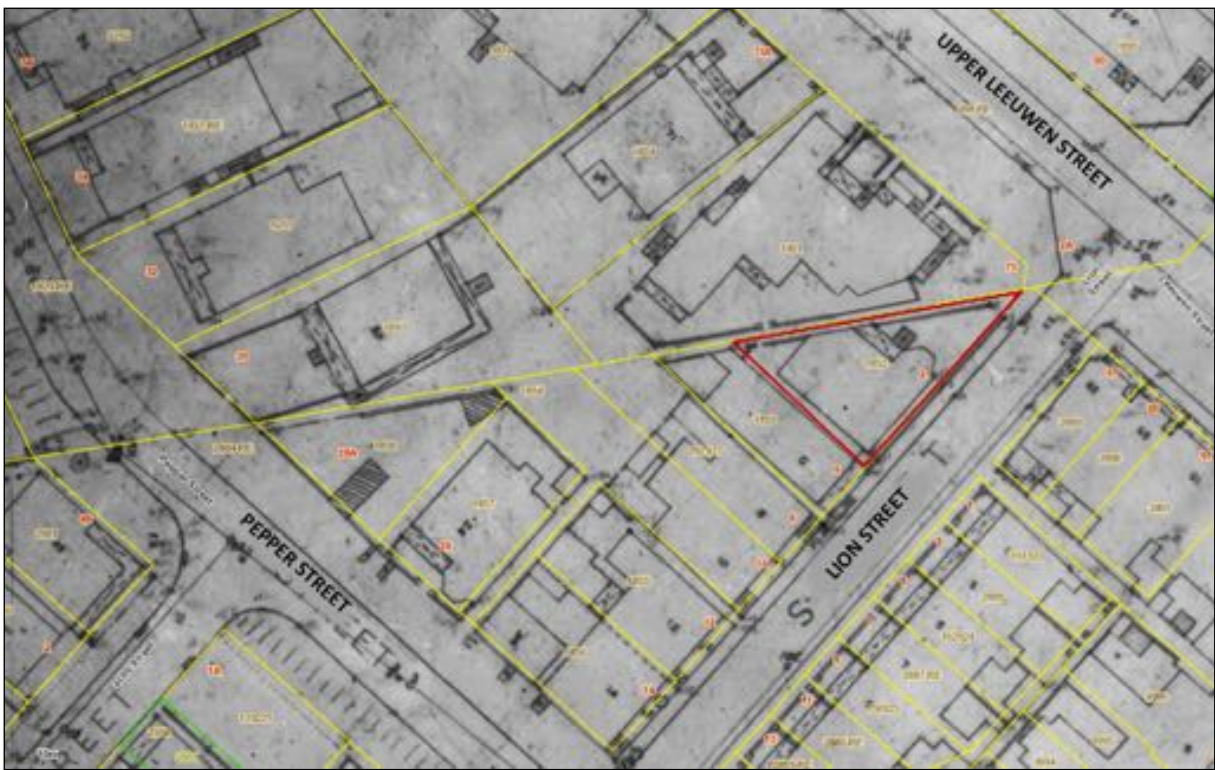
Figure 39: Detail of the City Survey (1944-1966) with modern erven boundaries overlaid. The map shows that the footprint of the house at 2 Lion Street had remained unchanged from the 1918 survey (Figure 21). (CoCT Heritage Branch, Wale Street, Cape Town; annotated by J Hislop)

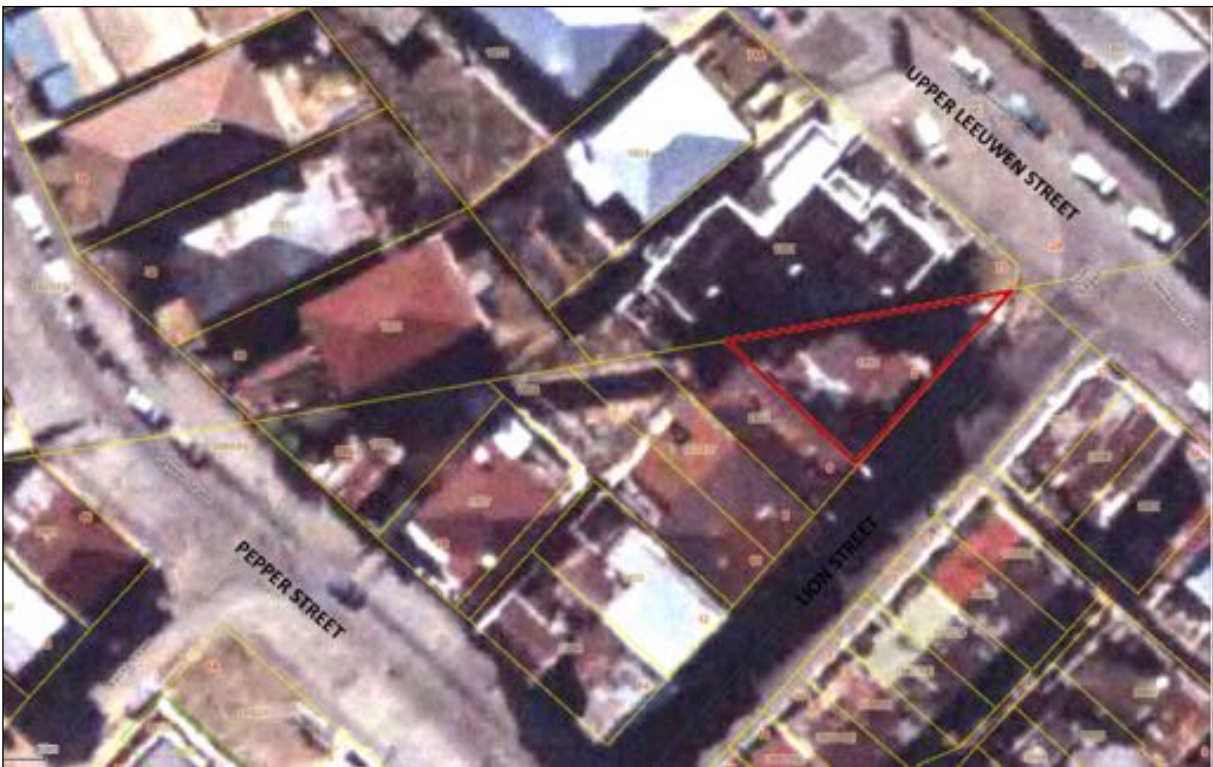
Figure 41: Detail of the government aerial survey of 1971. Because this survey is in colour, it provides more detail of the state of the roof, with its rusty corrugated iron evident. (CoCT Heritage Branch, Wale Street, Cape Town; annotated by J Hislop)

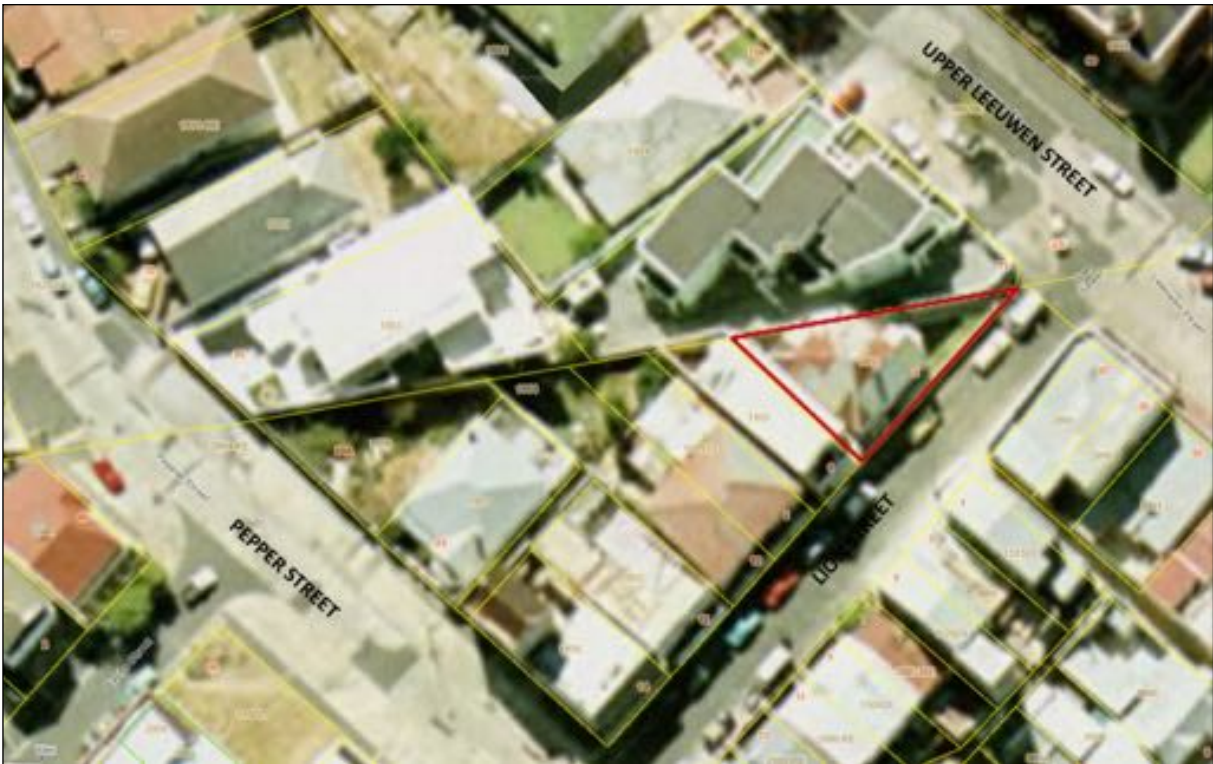
Figure 43: The government aerial survey of 2000. This is the last aerial survey that shows the roof of 2 Lion Street still intact. By 2009 the roof was gone (Figure 29). (CoCT Heritage Branch, Wale Street, Cape Town; annotated by J Hislop)

According to the aerial surveys of the street, between 2000 and 2009 the house became derelict and lost its roof (Figures 43 and 44). According to *Windeed*, it appears that the Petersen family still retained ownership of the property until 2013, when it was purchased by Eusebio Manuel Mora, Cybeles Nunziata Muñoz and Thandi Malaika Nunziata (T30317/2013). In 2019, the current owners, Josep Vicent Puig Gomez and Amaya Olivares Zapiain, took ownership of Erf 1852 (T33082/2019). The site is derelict and the house is missing its roof and ceiling structure.

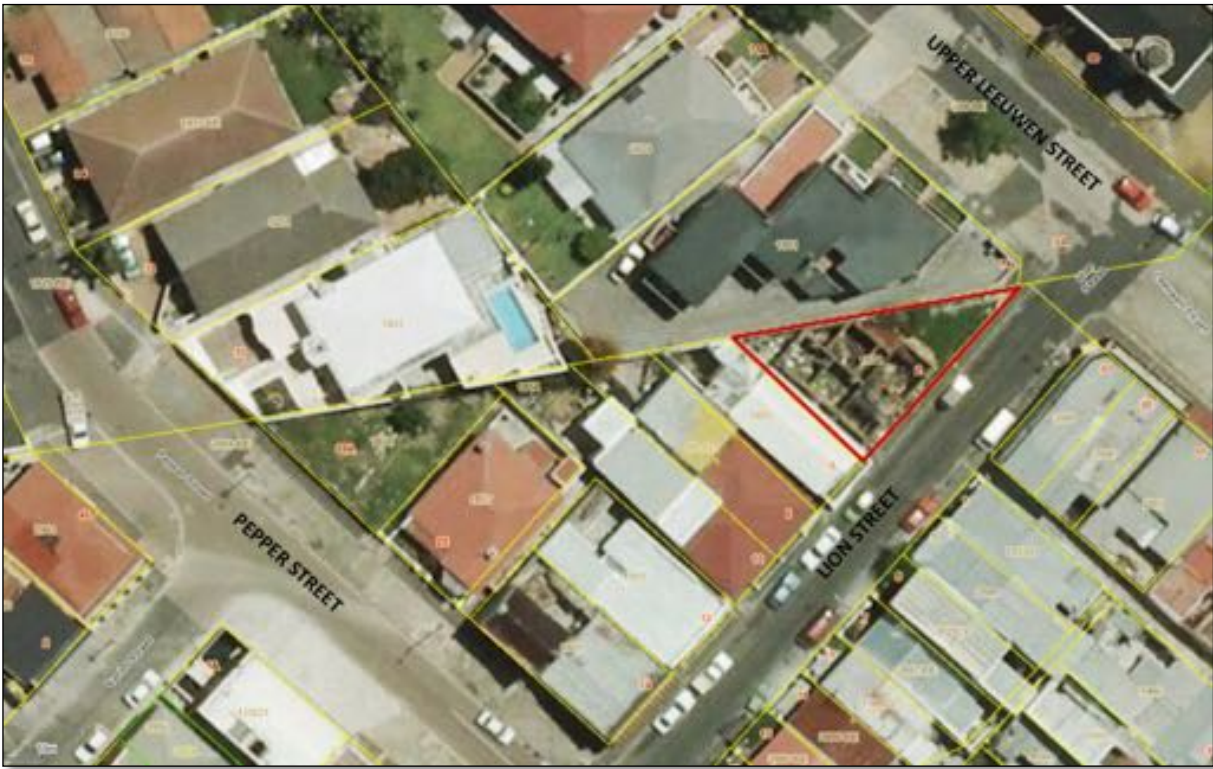
Figure 44: Detail of the government aerial survey of 2009. By this time the roof of 2 Lion Street was gone and the inner fabric of the house was exposed to the elements. (CoCT Heritage Branch, Wale Street, Cape Town; annotated by J Hislop)

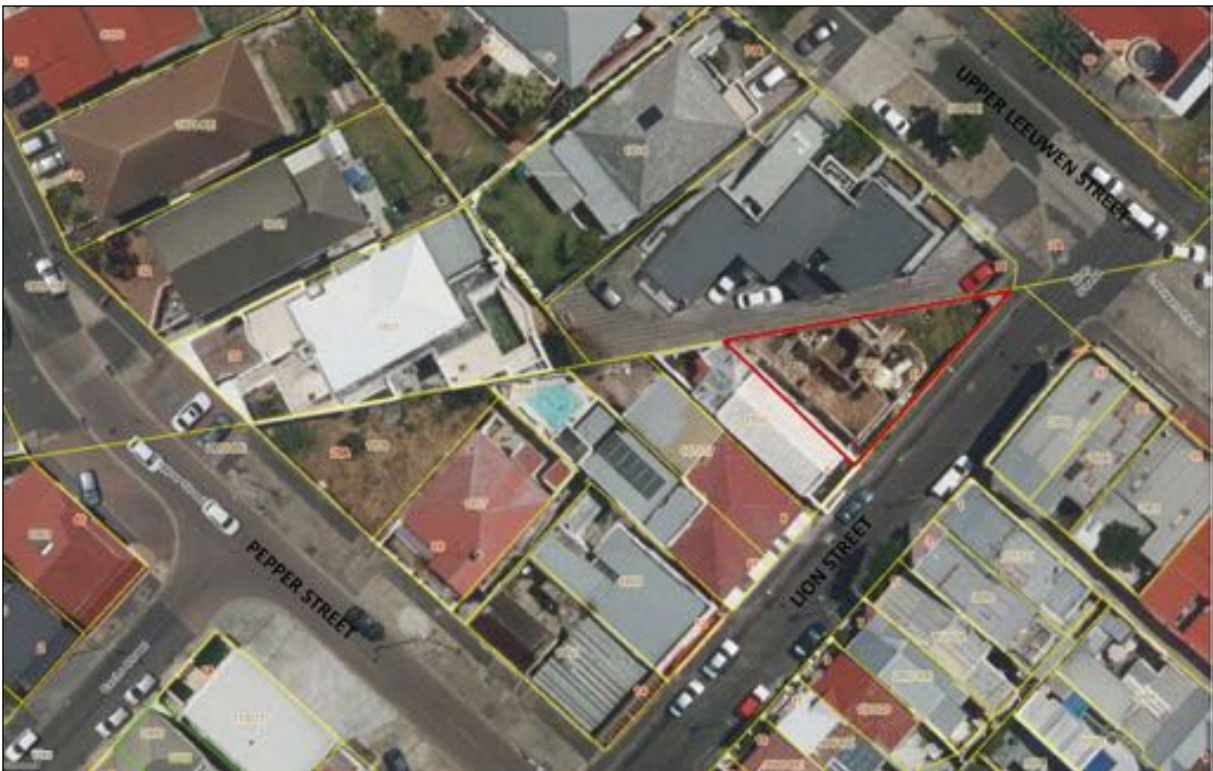
Figure 45: Detail of the government aerial survey of 2019. In the succeeding decade since the 2009 aerial survey (Figure 29), some of the inner walls of 2 Lion Street have collapsed. (CoCT Heritage Branch, Wale Street, Cape Town; annotated by J Hislop)

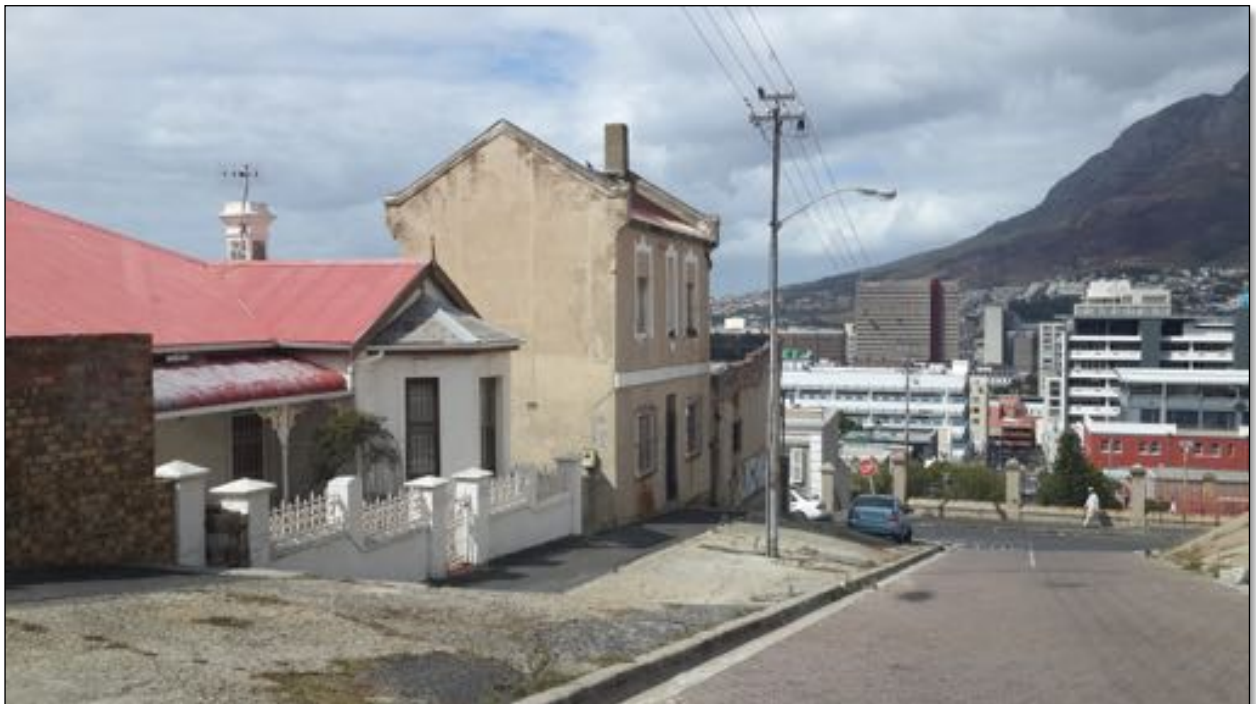
Figure 46: A view of Lion Street in the middle distance, as seen from Upper Pepper Street. The steep set of stairs (behind the stop sign) are a Lion Street landmark (built after c.1897; they are not shown on the Thom Survey, Figure 20), and lead down to the lower section of Pepper Street. The Victorian house on the left (Hillside Villa) is similar to the original building at 2 Lion Street, although the gable is more squat and it was designed by a different architect (W.T. Wilkinson, not Robert Esdon)(Hislop, 2016)

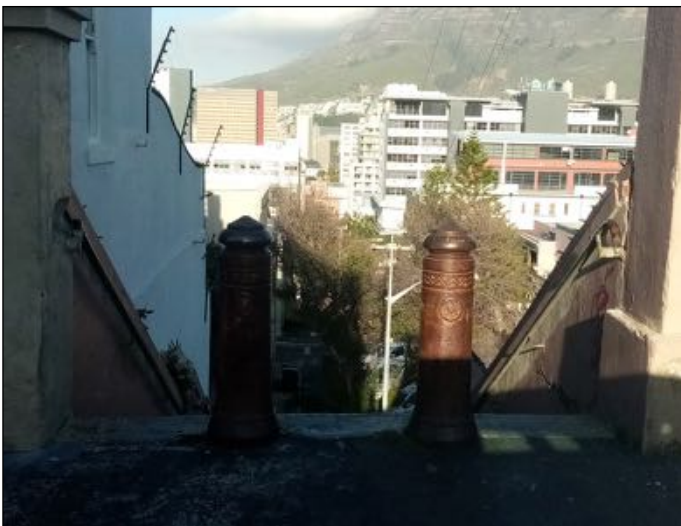
Figure 48: The steep set of late-Victorian stairs that lead via a set of pillars down to Pepper Street form part of the early 20th-century streetscape of the northern end of Lion Street, mostly developed between 1895 and 1906. (Jim Hislop, 1 June 2020)

The subject site forms part of a late-19th century spate of development that occurred in the upper Bo-Kaap area on the south side of Leeuwen Street, on a piece of ground that was obtained by J.W. Hurlingh in 1886, then subdivided for building lots for the newly built west side of Lion Street's northern end. Although in a perilous state, the ruined Victorian villa that was designed by architect Robert Esdon and built in c.1900, forms part of an unbroken line of late-Victorian dwellings (albeit mostly altered) lining the west side of Lion Street between Leeuwen and Upper Pepper streets (*Figures 47 and 48*).

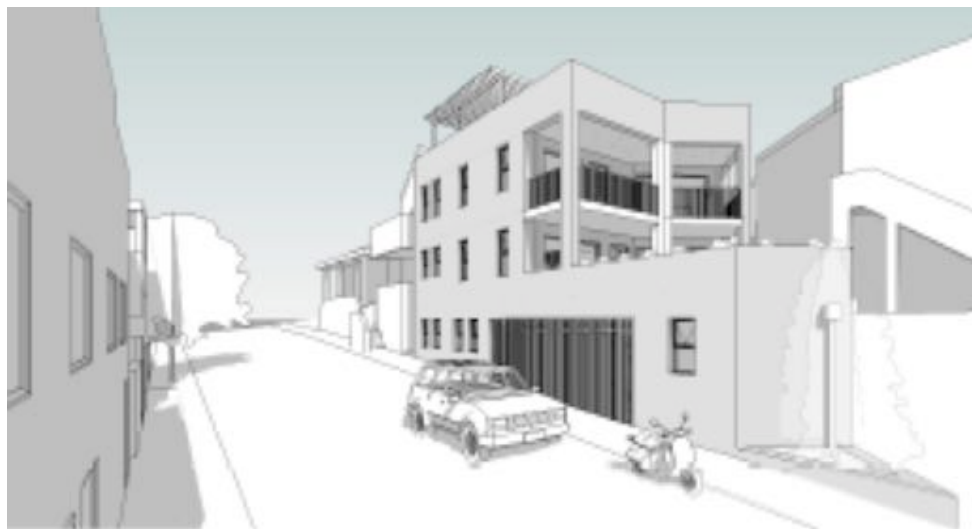
Image 50: Lion Street view from Leeuwen Street (A400 3D, October 2020)

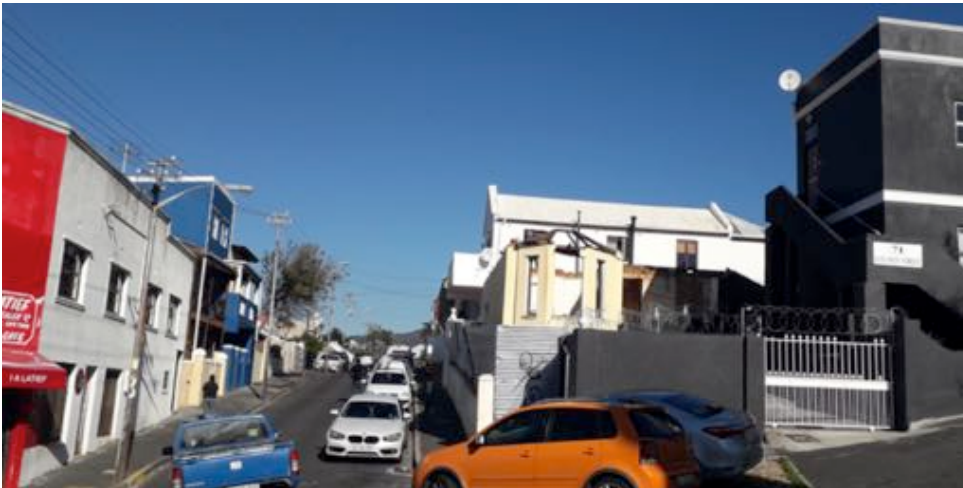
Figure 51: The current situation

Response: Figure 51 illustrates the way the derelict house is set back on its erf, as well as the resultant sense of openness at the Leeuwen/ Lion Street intersection. Extracts from proposal drawings illustrate how this informant is addressed in the design (Fig 52 and 53). While the inclusion of a garage at ground level means that the living level is raised onto a terrace at first floor level, the overall impression of the new dwelling is that, like its predecessor on the site, it sits to the rear of and raised on the site. This interpretation of the existing condition of the dwelling in the proposed replacement building is a positive one, which is in line with the spirit of the design indicator. Thus, the design proposal is considered to be in line with Design Informant

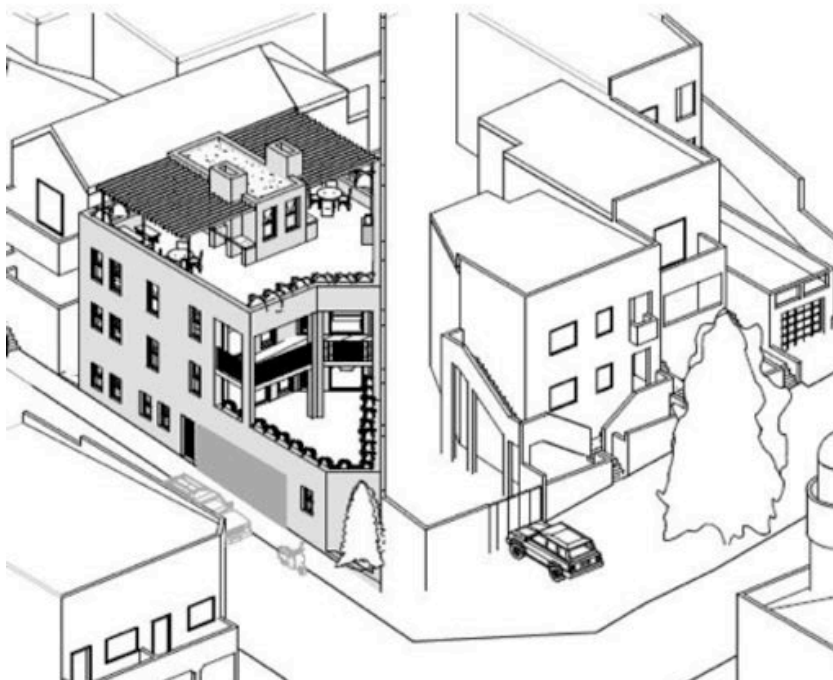
Figure 52: Birds' eye view, showing the intersection, with the mosque visible to RHS in the foreground (Architectural Solutions Studio 2020)

Response: Figures 52 and 53 illustrate the way in which the proposal addresses this design informant. This is further illustrated in the Lion Street elevation, a detail of which is included below as Figure 54. Figure 54 illustrates how the main height and bulk of the building is concentrated closer to 6 Lion Street than to Leeuwen Street.

Response: A positive result of such respect for the existing context would be that the proposed building would fit appropriately into the existing streetscape silhouette. Figures 52 to 54 illustrate that the height, scale and massing of the proposal are in sympathy with the existing, while Figure 55 illustrates that the way the building will sit in the existing streetscape silhouette is also appropriate.
