**NHRA SECTION 34 APPLICATION
2 LION STREET, BO KAAP**

Erf 1852 Cape Town

23 October 2020

vidamemoria heritage consultants

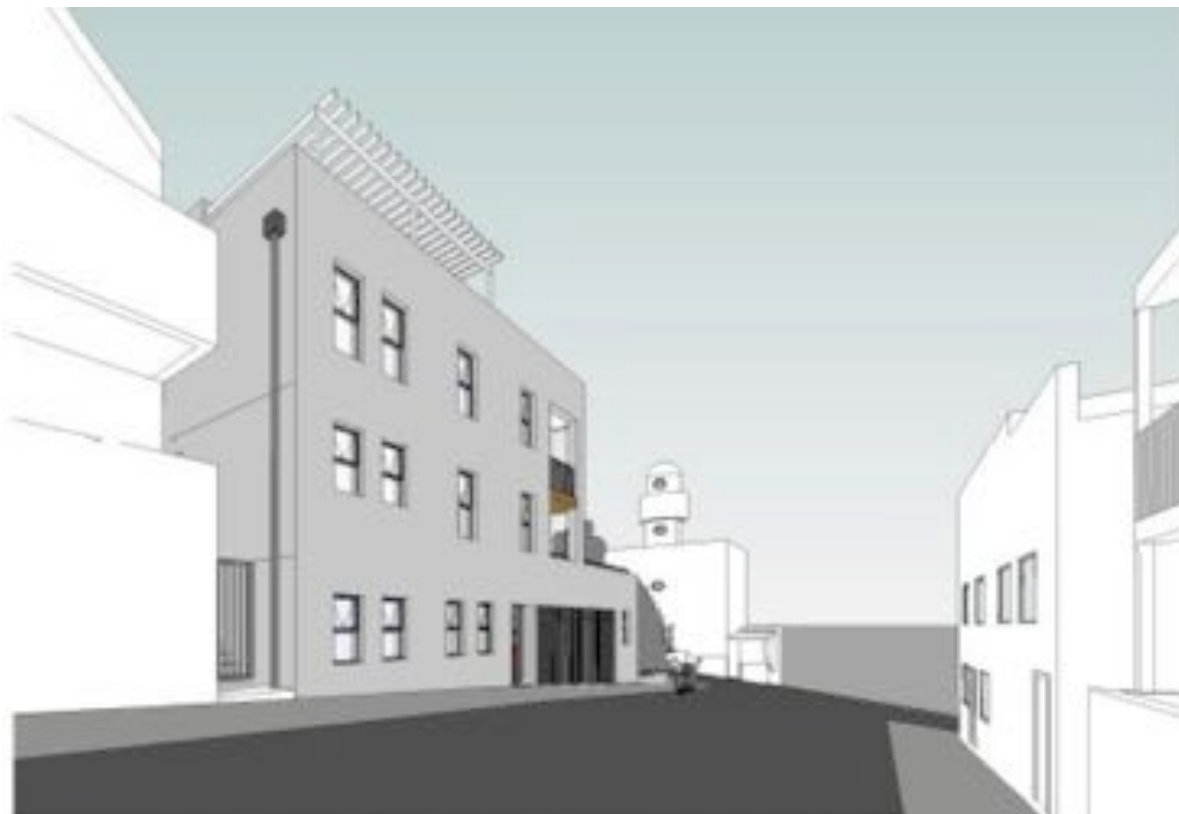
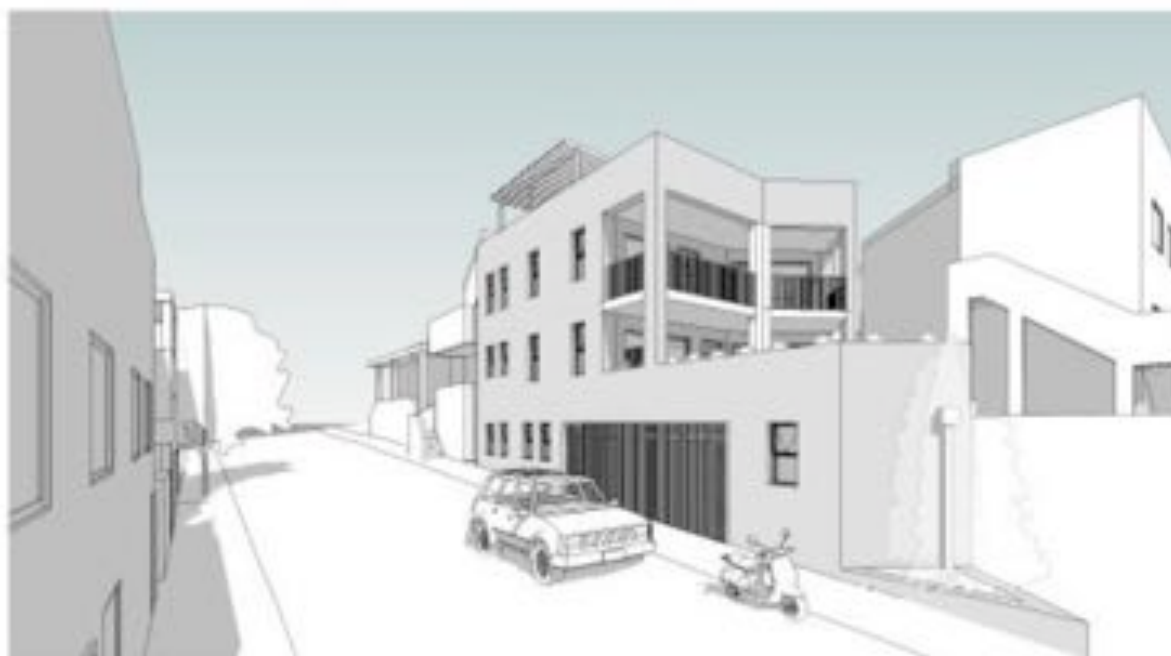
LION STREET VIEW TO LEEUWEN STREET

LION STREET VIEW FROM LEEUWEN STREET

Figure 53: Lion Street views (Architectural Solutions Studio 2020)

Response: Figure 51 illustrates the way the derelict house is set back on its erf, as well as the resultant sense of openness at the Leeuwen/ Lion Street intersection. Extracts from proposal drawings illustrate how this informant is addressed in the design (Fig 52 and 53). While the inclusion of a garage at ground level means that the living level is raised onto a terrace at first floor level, the overall impression of the new dwelling is that, like its predecessor on the site, it sits to the rear of and raised on the site. This interpretation of the existing condition of the dwelling in the proposed replacement building is a positive one, which is in line with the spirit of the design indicator. Thus, the design proposal is considered to be in line with Design Informant

Response: Figures 52 and 53 illustrate the way in which the proposal addresses this design informant. This is further illustrated in the Lion Street elevation, a detail of which is included below as Figure 54. Figure 54 illustrates how the main height and bulk of the building is concentrated closer to 6 Lion Street than to Leeuwen Street.

Response: A positive result of such respect for the existing context would be that the proposed building would fit appropriately into the existing streetscape silhouette. Figures 52 to 54 illustrate that the height, scale and massing of the proposal are in sympathy with the existing, while Figure 55 illustrates that the way the building will sit in the existing streetscape silhouette is also appropriate.

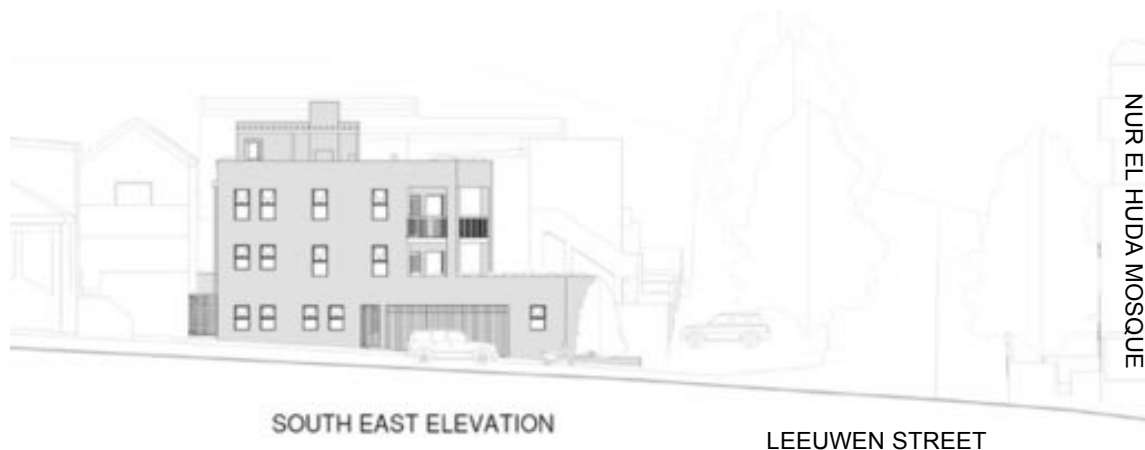
Figure 54: Detail of the Lion Street elevation of the building (Architectural Solutions Studio 2020)

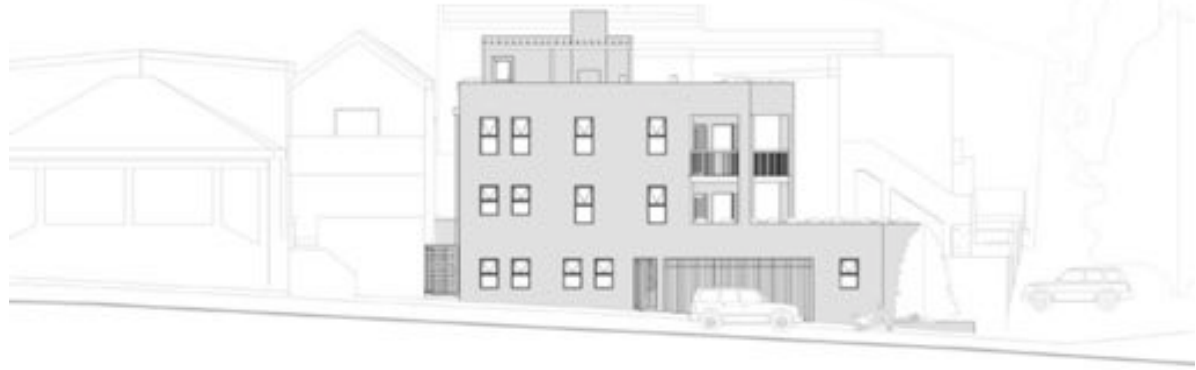
Figure 55: Detail of the Lion Street elevation of the building showing its relationship to 6 and 8 Lion Street
(Architectural Solutions Studio 2020)

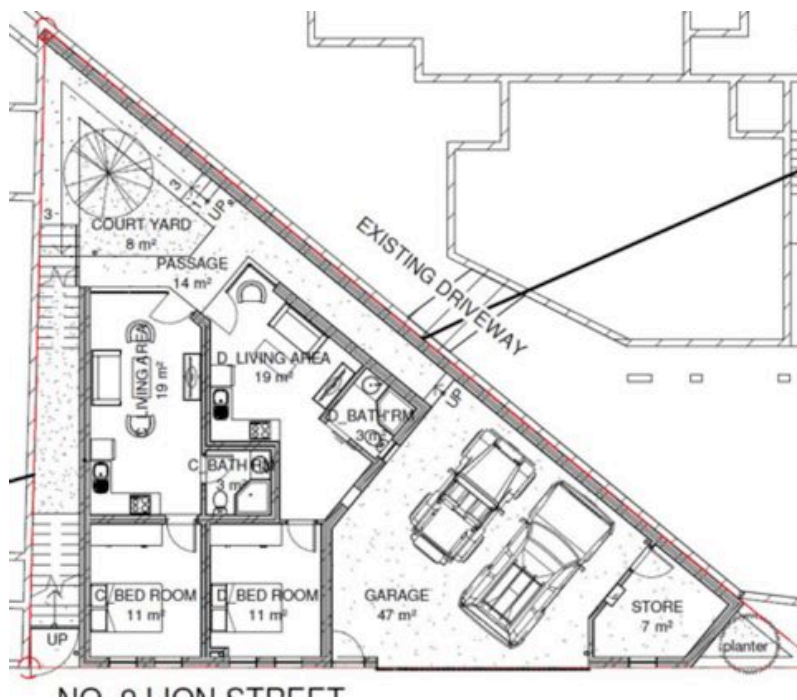
Figure 57: Ground plan of the building (Architectural Solutions Studio 2020).
