FINAL REPORT

MASONITE OLD SITE ARCHITECTURAL HERITAGE ASSESSMENT REPORT

Date: Thursday, 03 June 2021

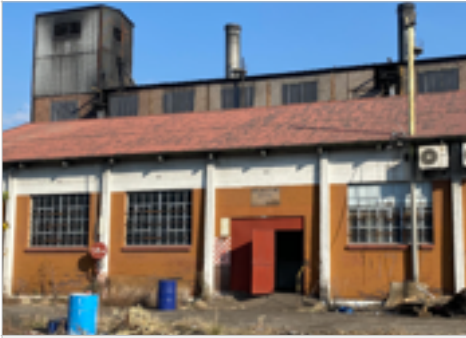
BLOCK-A (MAIN STORES)

- Conventional Construction,
- Approx built in the 1980's (-60 years)

BLOCK	A			EXISTING MAIN STORES
SIGNIFICANCE	RELEVANCE			ADDITIONAL COMMENTS
	Substantial	Recognisable	None	
Architectural			✓	<ul style="list-style-type: none"> The building was designed for solely purpose of the being stores for hazardous materials i.e flammable liquids. No significant architectural aesthetics could be preserved in this structure. The structural integrity of the building appears to be intact, and thus the building still has lifespan and it may be recycled and renovated.
Historical			✓	
Technical			✓	
Scientific			✓	
Contextual			✓	
RECOMMENDATION			DEMOLITION

The client has not future plans for the existing building or be incorporated to the current proposal, thus we recommend, that it be **considered for demolition** and preserve the materials for the re-use.

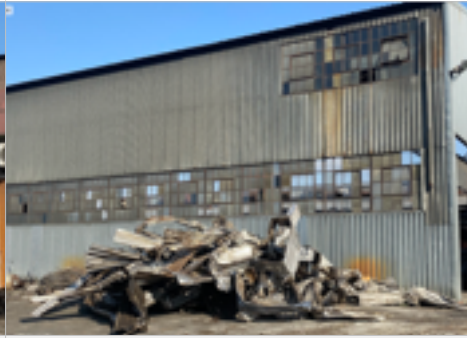
BLOCK-(B)B1 (KILNS & STORES)

- Steel framed structure called with IBR.
- Approx built in the 1980's (-60 years)

BLOCK	B1,B2			EXISTING KILNS & BOILER PLANT
SIGNIFICANCE	RELEVANCE			ADDITIONAL COMMENTS
	Substantial	Recognisable	None	
Architectural			✓	<ul style="list-style-type: none"> This building structure was designed to provide the shelter/weather protection for kilns and thus it has not no architectural elements that could be preserved. No architectural aesthetics which may require preservation. The structural integrity of the warehouse appears to be worn out and very risky to be kept.
Historical			✓	
Technical			✓	
Scientific			✓	
Contextual			✓	
RECOMMENDATION			DEMOLITION

The client has not future plans for the existing building or be incorporated to the current proposal, thus we recommend, that it be **considered for demolition** and preserve the materials for the re-use.

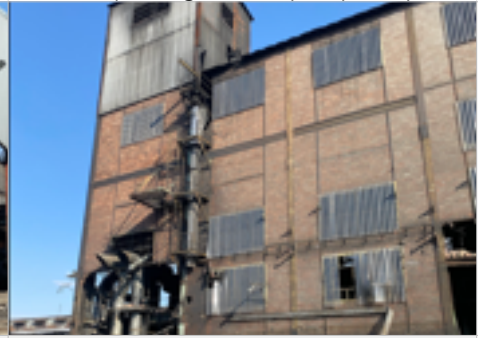
BLOCK-B2 (BOILER PLANT)

- Concrete framed structure with load bearing brickwork.
- Approx built in the 1970's (-60 years)

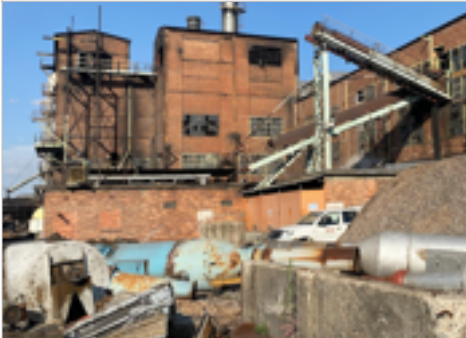
BLOCK-B2 (OLD BOILERS)

- Conc. framed structure with load bearing brickwork in-fill.
- Approx built in the 1970's (-60 years)

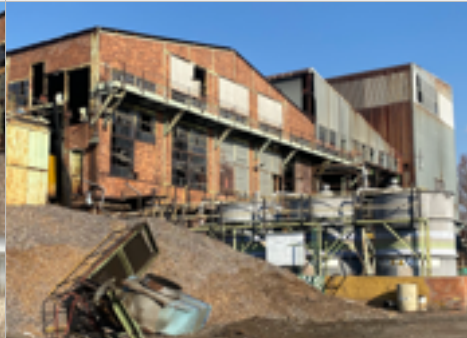
BLOCK-C (PRESS & COE DRIER)

- Conc. framed structure with load bearing brickwork in-fill.
- Approx built in the 1970's (-60 years)

BLOCK	C,D & E			EXISTING TECHNICAL,WORKSHOPS & REFINER
SIGNIFICANCE	RELEVANCE			ADDITIONAL COMMENTS
	Substantial	Recognisable	None	
Architectural			✓	<ul style="list-style-type: none"> Existing buildings have no architectural aesthetics which doesn't require preservation. And their structural integrity being boiler houses appear to be worn out and compromised by the
Historical			✓

RECOMMENDATION DEMOLITION (AMAFA APPLICATION)

The client has not future plans for the existing building or be incorporated to the current proposal, thus we recommend, that it be **considered for demolition** and preserve the materials for the re-use.

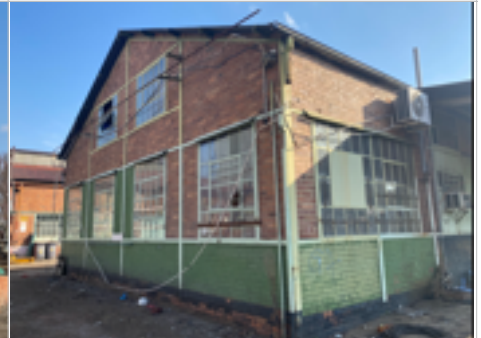
BLOCK-F (WORKSHOPS)

- Conc. framed structure with load bearing brickwork in fill.
- Approx built in the 1970's (-60 years)

BLOCK	F & G			EXISTING ENGINEERING WORKSHOPS
SIGNIFICANCE	RELEVANCE			ADDITIONAL COMMENTS
	Substantial	Recognisable	None	
Architectural			✓	<ul style="list-style-type: none"> The existing building have an industrial architectural aesthetics which may considered for preservation. The structural integrity of the workshops is good.
Historical			✓	
Technical			✓	
Scientific			✓	
Contextual			✓

RECOMMENDATION DEMOLITION

The client has not future plans for the existing workshops and thus we recommend for **demolitions**.

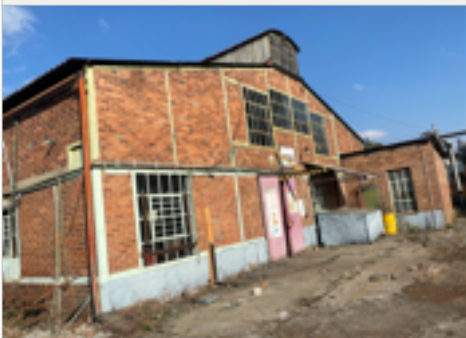
BLOCK-D (TECHN. WORKSHOPS)

- RC concrete framed structure with load bearing brickwork in fill.
- Approx built in the 1970's (-60 years)

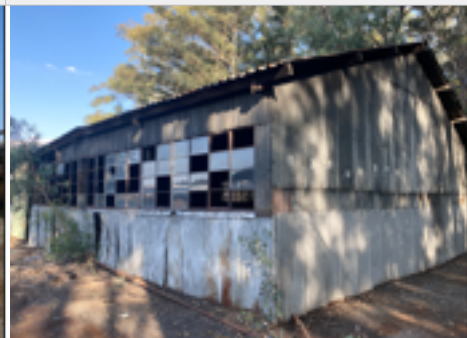
BLOCK-G & H (SHEDS)

- Wooden framed structure clad with corrugated iron.
- Approx built in the 1940's (+60 years)

BLOCK	H to K			EXISTING SHEDS OLD PUMP HOUSE
SIGNIFICANCE	RELEVANCE			ADDITIONAL COMMENTS
	Substantial	Recognisable	None	
Architectural			✓	<ul style="list-style-type: none"> The existing sheds were designed as ancillary structure to support the main factory and thus they have no architectural aesthetics.
Historical			✓	
Technical			✓	
Scientific			✓	
Contextual			✓

RECOMMENDATION DEMOLITION

The client has not future plans for the existing sheds and thus we recommend, for **demolitions**.

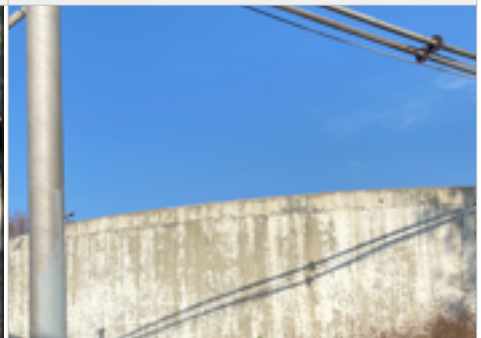
WATER TANK - FLOCCULATOR

- Reinforced concrete structure, to be demolished
- Approx built in the 1980's (-60 years)

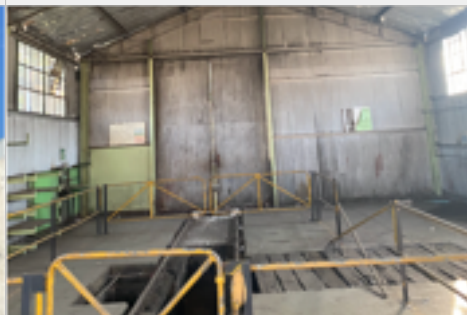
BLOCK-E2 (MECHANICS SHOP)

- Steel framed structure with load bearing brickwork in fill.
- Approx built in the 1960's (+60 years)

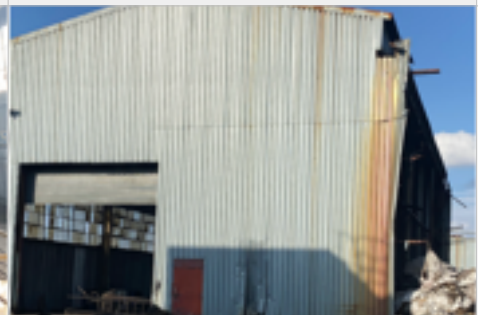
BLOCK-D (WORKSHOPS)

- Steel framed structure with load bearing brickwork in fill.
- Approx built in the 1980's (-60 years)

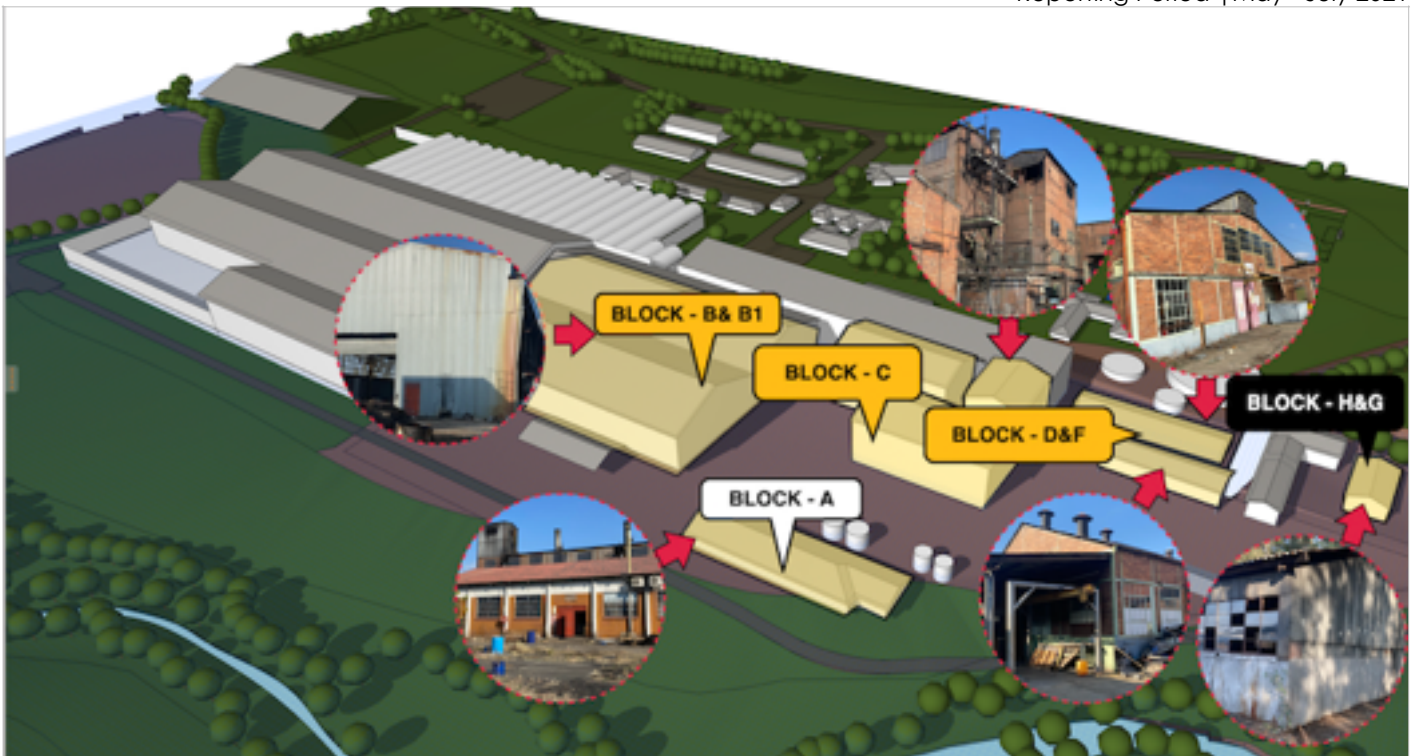
3D - SUMMARY OF THE BLOCKS TO BE DEMOLISHED

- Block - C, D and F only qualifies for the KZN Amafa Heritages application.

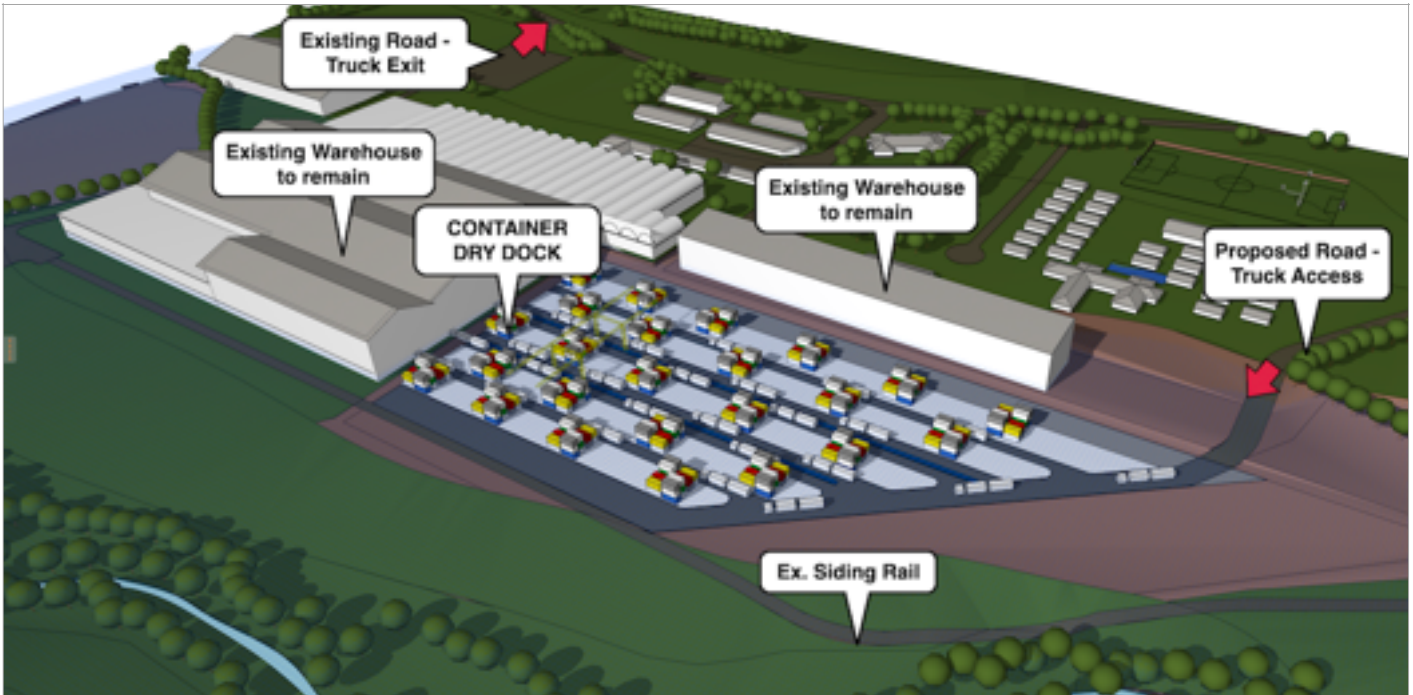
Proposed demolition will create vast space for container dry docking. Concept design indicates ease circulation for rail and vehicular freight logistics.
