Heritage Impact Assessment of a proposed new pump station facility and associated pipeline in Heuwelsig, Bloemfontein, Free State Province.

A heritage impact assessment was conducted for the construction of a new pump station and associated pipe line situated within an area designated as a public space in Heuwelsig, Bloemfontein, Free State Province. The region's unique and non-renewable archaeological and palaeontological heritage sites are 'Generally' protected in terms of the National Heritage Resources Act (Act No 25 of 1999, section 35) and may not be disturbed at all without a permit from the relevant heritage resources authority. As many such heritage sites are threatened daily by development, both the environmental and heritage legislation require impact assessment reports that identify all heritage resources including archaeological and palaeontological sites in the area to be developed, and that make recommendations for protection or mitigation of the impact of the sites.

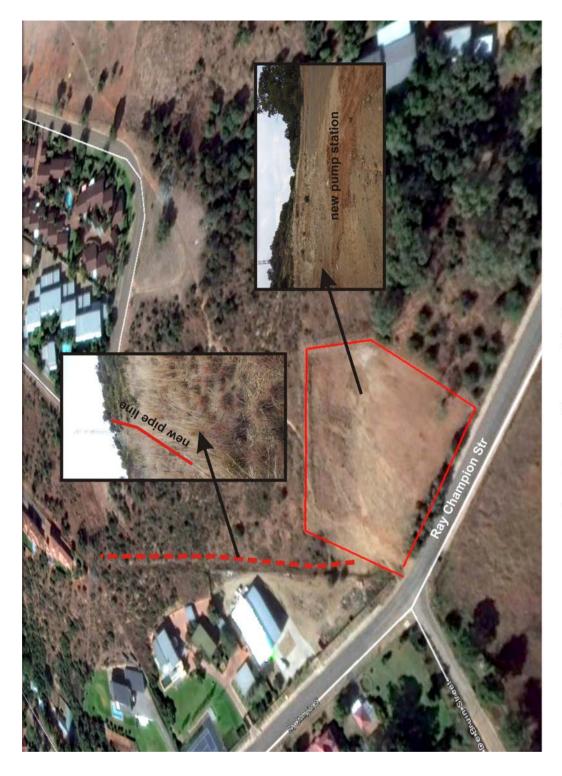
Figure 3. Layout of the proposed development.

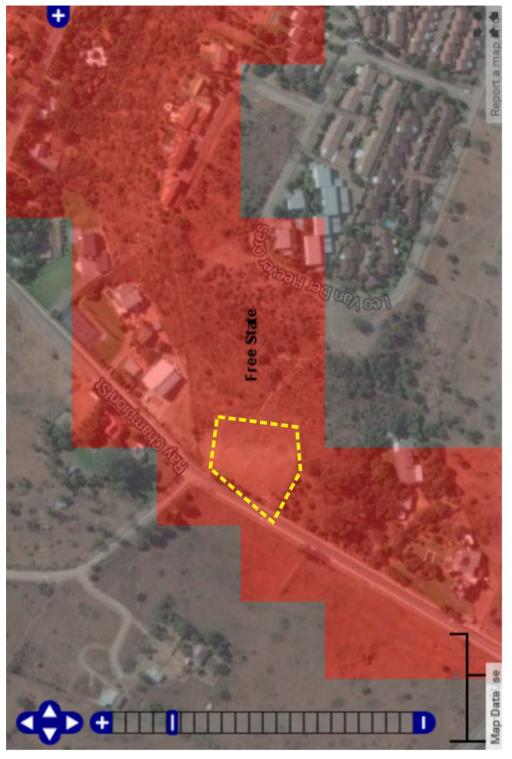
The study area lies within a palaeontologically sensitive area on fossil-bearing bedrock (Fig. 4). Regionally the palaeontological footprint is primarily represented by Late Permian Karoo vertebrate fauna and late Quaternary mammalian fossils that are often associated with intact Middle Stone Age artefact assemblages (Fig. 5). The Karoo geological strata within the affected area are assigned to the Dicynodon Assemblage Zone (AZ) (Fig. 6). Therapsids from this biozone occur generally wellpreserved in mudrock horizons and are usually found as dispersed and isolated specimens associated with an abundance of calcareous nodules (Kitching 1977; Kitching 1995). Molluscs, insects, plant (Dadoxylon, Glossopteris) and trace fossils also occur in the biozone. Alluvial deposits of the nearby Modder River and its tributaries north of the footprint area, are associated with abundant Quaternary mammalian fossils (Broom 1909 Churchill et al 2000; Rossouw 2006). Except for a one therapsid fossil exposure located south of the proposed development footprint, there are currently no records of Karoo palaeontological sites situated within the 2926 AA map sheet area (**Fig. 7**).

Figure 4. Location of the site in relation to palaeontologically sensitive areas in the region (after SAHRA Palaeontological Sensitivity Map 2015). The area covered in red is considered to be highly sensitive.

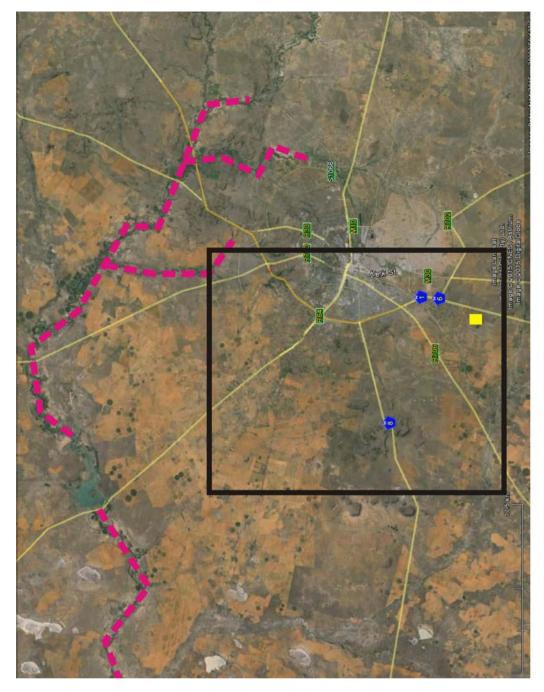
Figure 7. Position of a therapsid fossil exposure (yellow square) situated within the 2926 AA map sheet area (black square) and located 18 km to the south of the proposed development footprint.

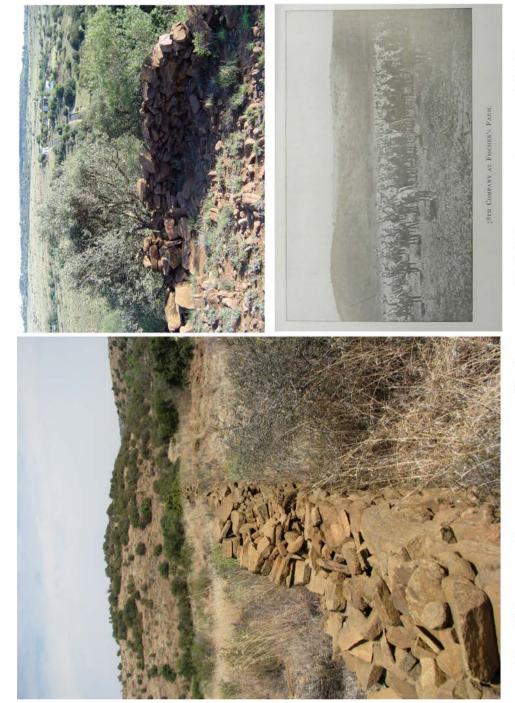
Figure 10. Low stonewall structures represent some of the last remnants of the British army camps that were established north of Bloemfontein during and shortly after the South African War (left & top right). Some of the walls were built by British engineers, which had their camp stationed at Tempe. The wall originally ran from the water towers east of Tempe to the edge of Hillandale farm. A large remount camp existed at Hillandale (bottom right).

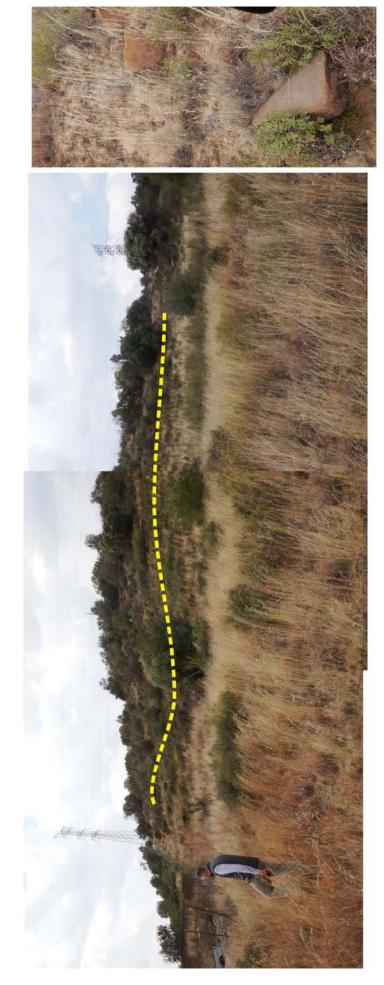
The topography of the terrain is marked by sandstone outcrop that is in part metamorphosed by intrusions of dolerite (**Fig. 11**). Vegetation and topsoil has been removed from the proposed pump station area and signs of earlier disturbance are clearly visible along the existing pipe line footprint (**Fig. 12 & 13**). A foot survey revealed no evidence of *in situ* paleontological remains or exposures, archaeological remains, ancient structures, graves or historical buildings older than 60 years within the vicinity of the study area.

Figure 11. The topography of the terrain is marked by a sandstone outcrop (left) that is in part metamorphosed by intrusions of dolerite (right).

The terrain is reasonably disturbed by ground-clearing activities and the installation of an existing pipe line. The probability of impact by the development on intact fossil remains is considered low, but it is advised that any excavations into *in situ* (fresh) sedimentary bedrock should allow for inspection of fresh exposures by a qualified palaeontologist at the appropriate time. The sedimentary bedrock component at the site is therefore assigned the rating of Generally Protected B (GP.B). It is unlikely that the proposed development will result in any archaeological impact at the site. The terrain in general is regarded as of low archaeological significance and is assigned a rating of Generally Protected C (GP.C).

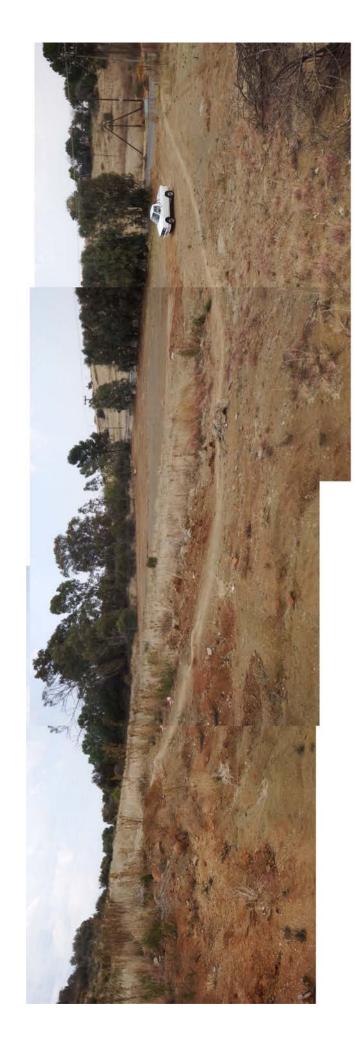
Figure 12. The proposed pump station locality, looking southwest.

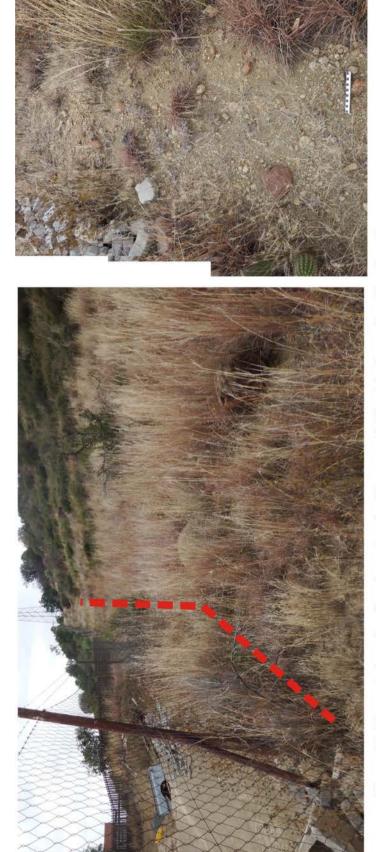
Figure 13. The existing pipe line footprint, looking east (left) with signs of earlier disturbance as a result from the installation of the existing pipe line.
