**HERITAGE SURVEY OF THE PROPOSED MFUNDA
YOPHONGOLO IRRIGATION CLUSTER ONE
PROJECT, KZN**

FOR AFZELIA ENVIRONMENTAL CONSULTANTS

DATE: 30 NOVEMBER 2019

**Umlando: Archaeological Surveys and Heritage
Management**

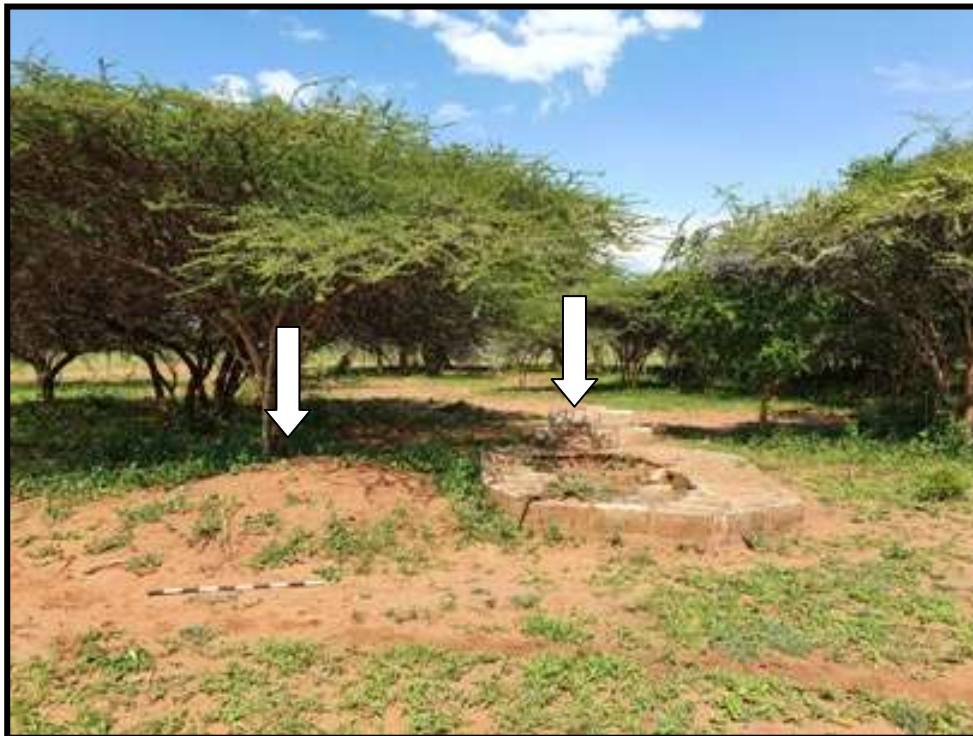
FIG. 8: TWO GRAVES SHOWING DIFFERENT TYPES OF DEMARCATION

The last obstacle to the survey is that of human graves. In most cases graves are demarcated with mound of sand and/or *Acacia* spp trees. If unattended, these graves will disappear within 15 -20years. Fig. 8 shows two grave types side-by-side. Only a few graves are demarcated with tombstones or cairns. The more traditional method of demarcating graves would be to plant *Euphorbia ingens*, *Erythrenia* spp., or *Ziziphus mucranata* on top of the grave. There are regional variants as well. No old *Z. mucranata* and *Erythrenia* spp. were observed during the survey however several old *E. ingens* were noted. The rule of thumb is that these older plants are on graves until proven otherwise. In a few instances stone cairns are used to demarcate a grave. These tend to be oval in shape and on the side of the settlement. Stone cairns are by default graves until proven otherwise. It is not possible to record subsurface and unmarked graves however these can be managed and this is discussed later.

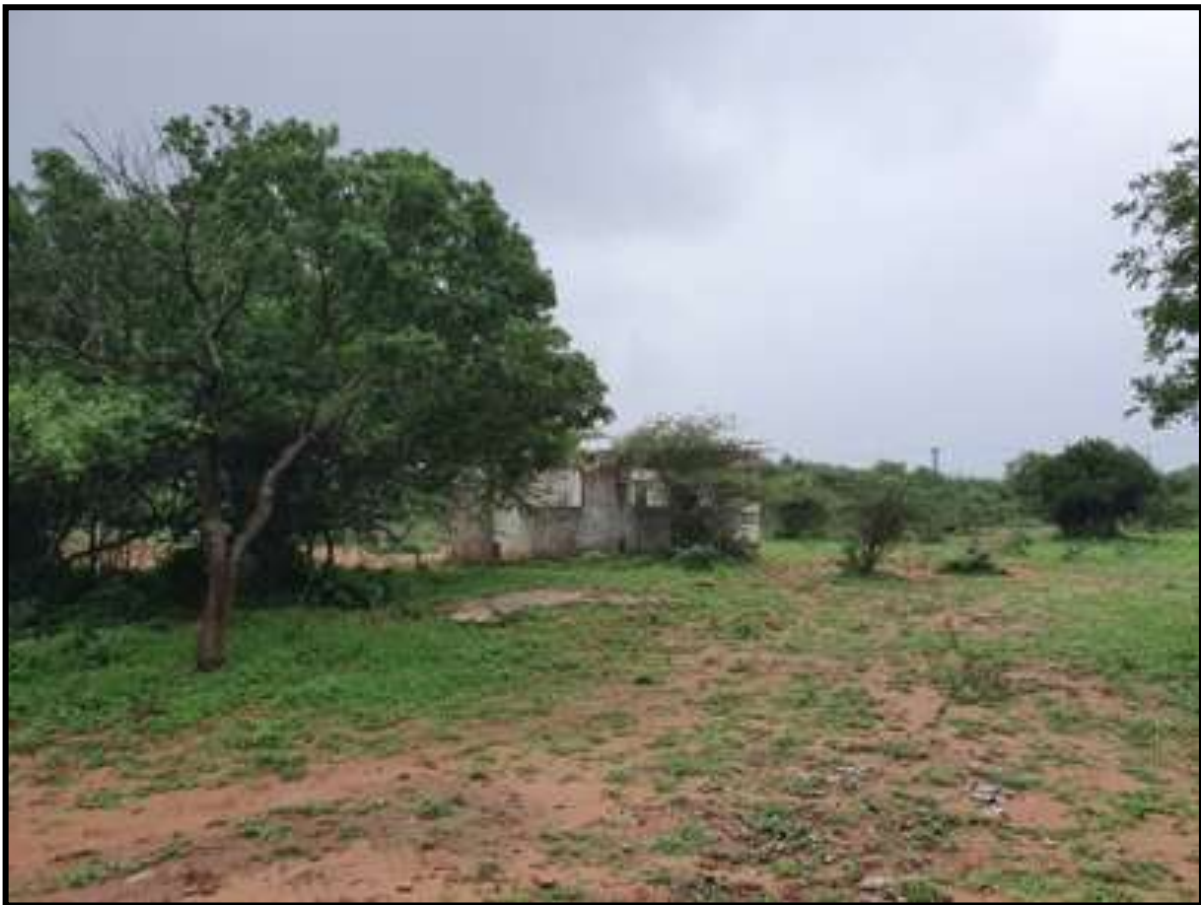
FIG. 9: MADO01

The site is located in the northeastern corner of the study area. The site consists of a recent main rectangular house and some smaller building foundations around it (fig. 9). No graves were noted in the area.

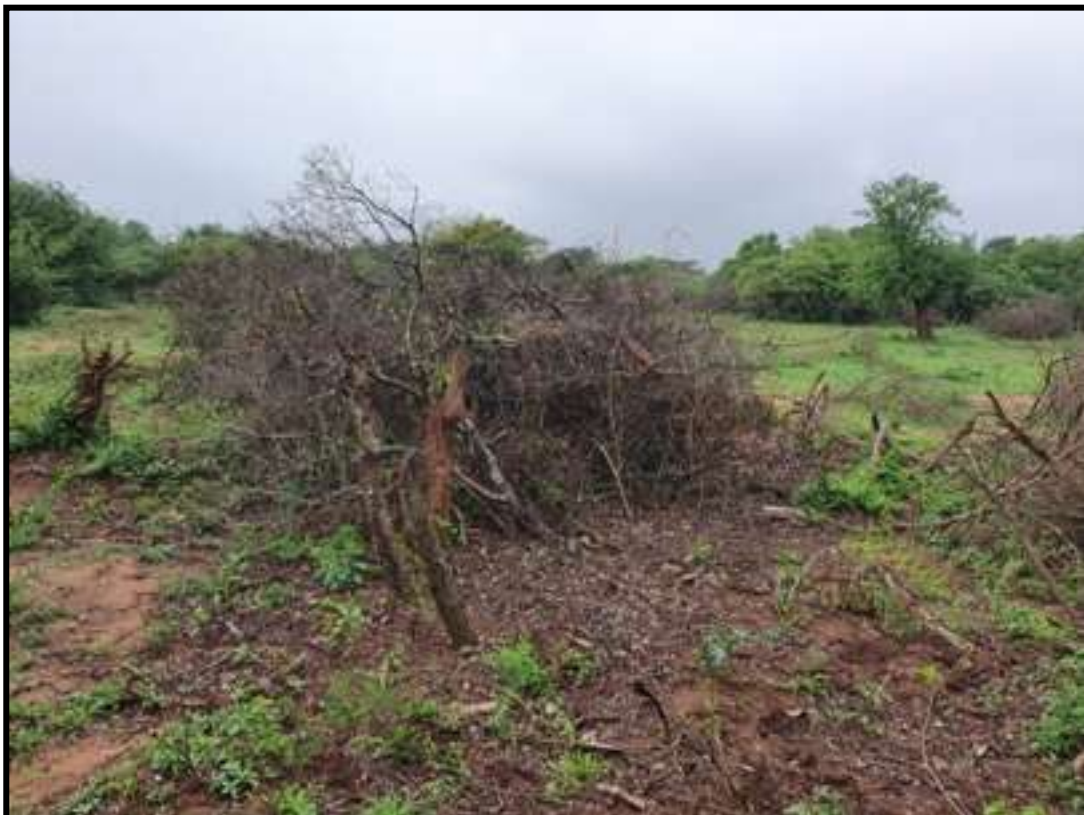
FIG. 10: MADO02

The site consists of two slightly separate sites that I grouped together in retrospect. The site is located in a cleared area and consists of modern artefacts, house remains and possible graves. There are three possible graves on the western part of the site. The “graves” were covered with thornbush and I could not discern if they were natural mounds of sand or human made (fig. 10). The site is recent enough for members of the community to identify if these are graves and if so, to whom they belong. They must be treated as graves until further confirmation.

SAHRA Rating: 3a

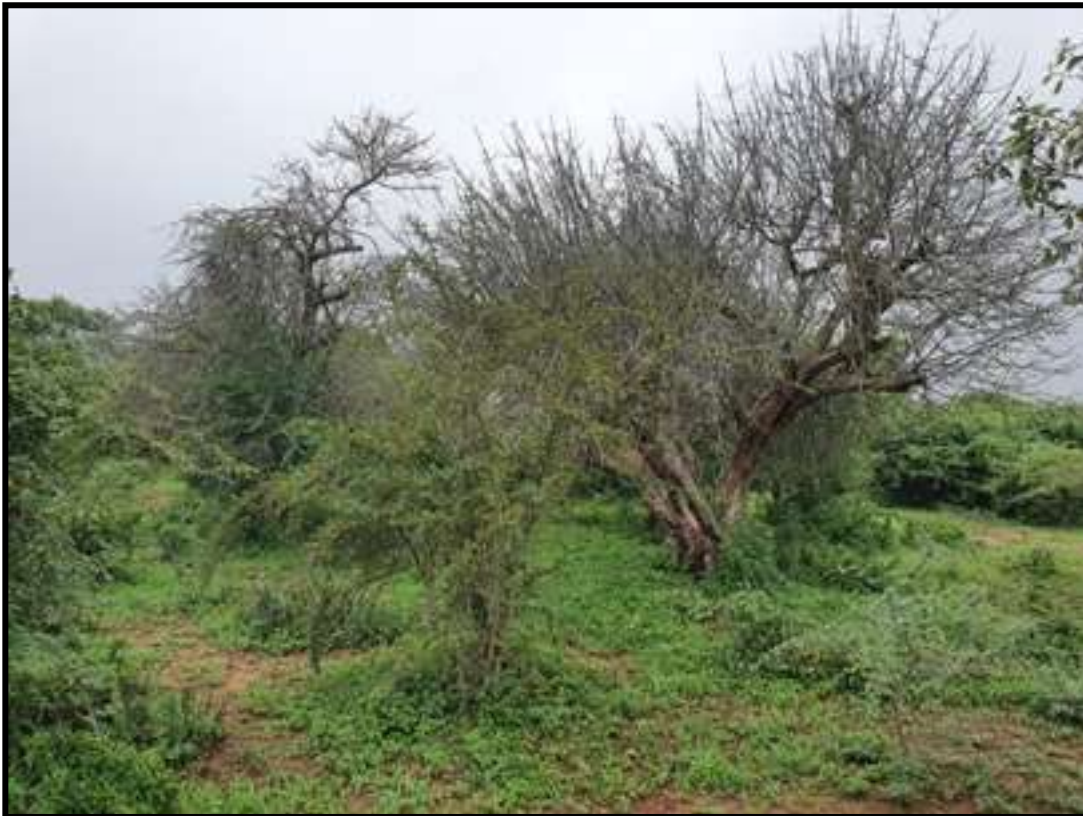
FIG. 11: FRUIT TRESS AT MADO04

The site is located in a previously cleared area that has now overgrown. It was identified as 'h5' on the desktop study. The site consists of house floor, modern artefacts and fruit trees (fig. 11). No graves were visible; however this is probably due to the dense vegetation.

SAHRA Rating: 3c

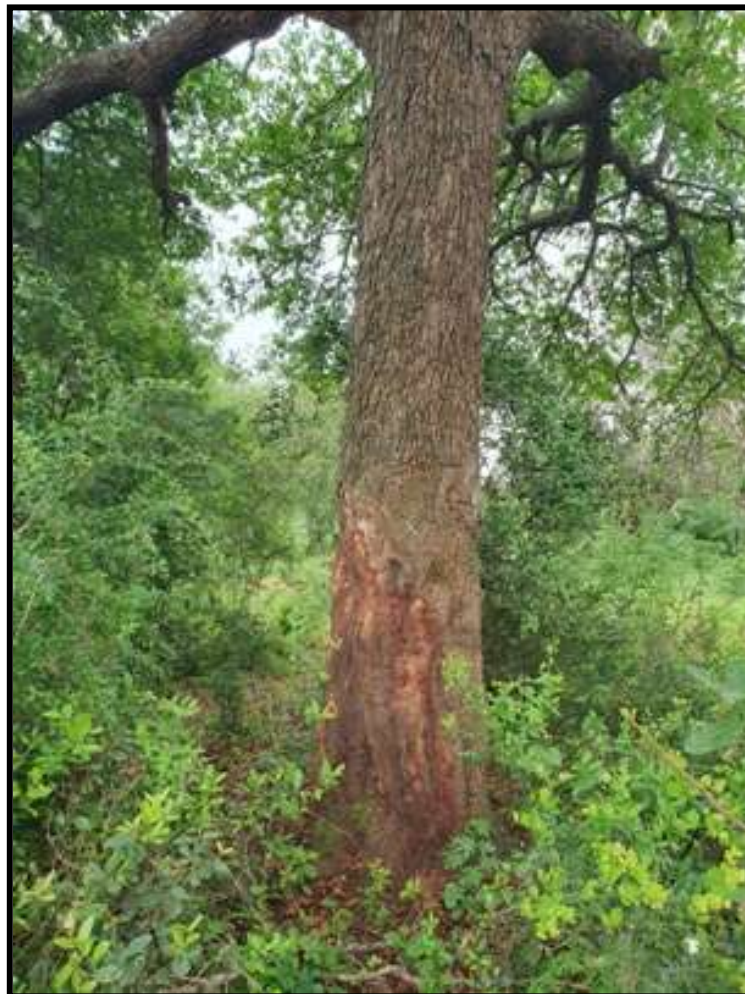
FIG. 12: MADO05

The site is located in a previously cleared area that has now become overgrown. The site consists of two Marula trees that have been used for muthi purposes. The trees are probably part of a settlement (fig. 12). Trees that have been used for medicinal purposes are part of the heritage of the area and are protected by heritage legislation. The area was too overgrown to detect a settlement.

SAHRA Rating: 3b

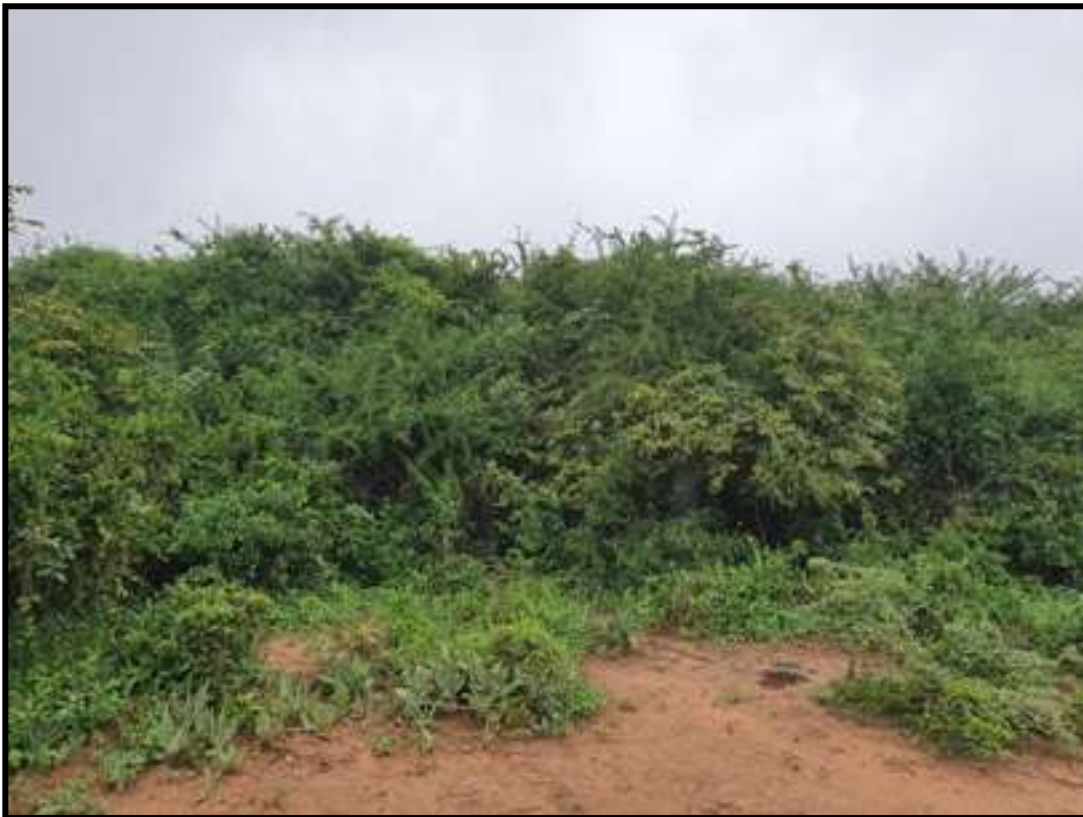
FIG. 13: MADO07

The site is located near an (overgrown) track and probably relates to 'h7'.the area is overgrown but two house floors were barely visible (fig. 13). The rest of the site is probably under the vegetation. No graves were noted.

SAHRA Rating: 3C

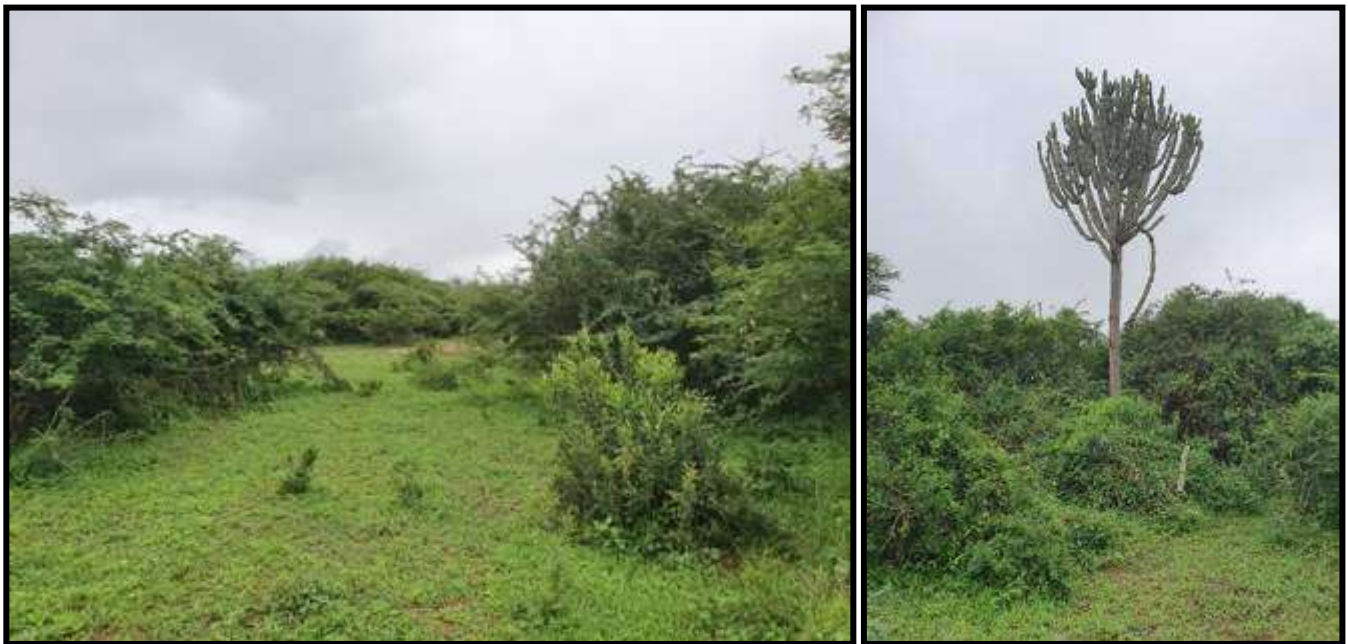
FIG. 14: MADO08

The site is located south of the track at MADO07 and correlates with 'h8'. The site consists of a cleared area with modern artefacts on the surface. There is an *E. ingens* at the south of the site that might be part of a grave. Fig. 14 shows these features

SAHRA Rating: 3A for the possible grave.

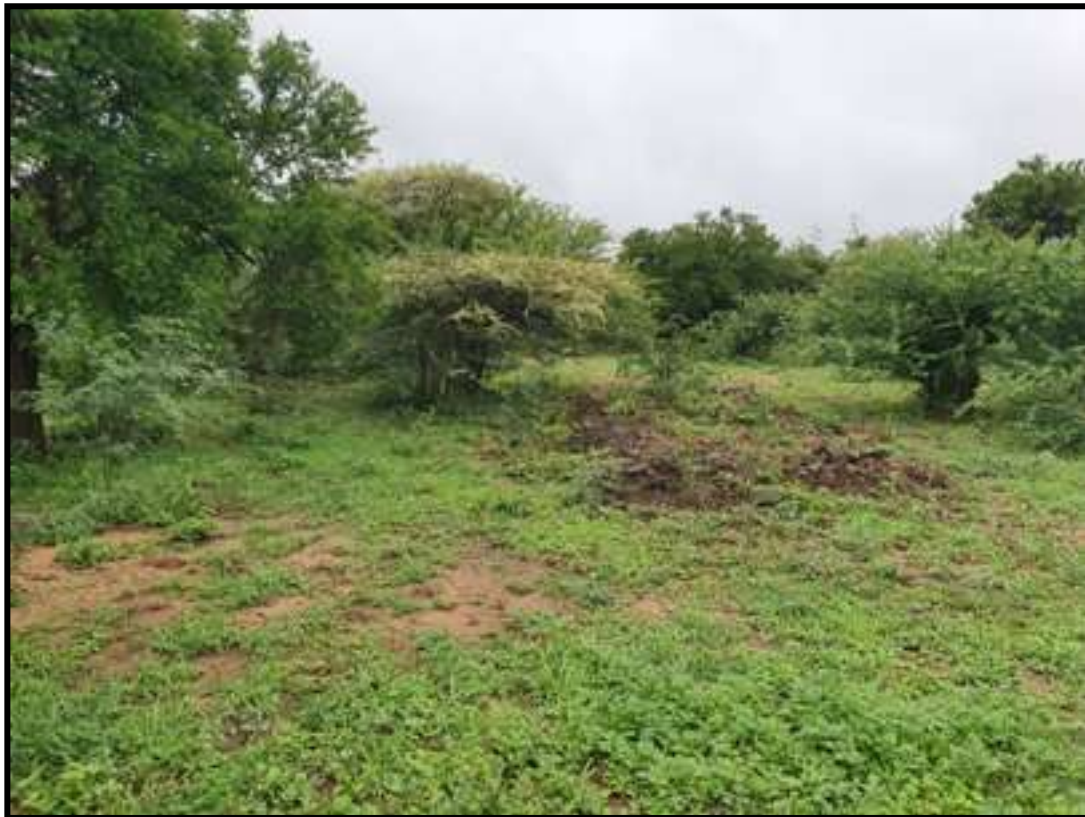
FIG. 15: MADO09

The site is located in a previously cleared area. The site is slightly overgrown, and consists of at least one house with modern artefacts (fig. 15). No graves were noted in the area.

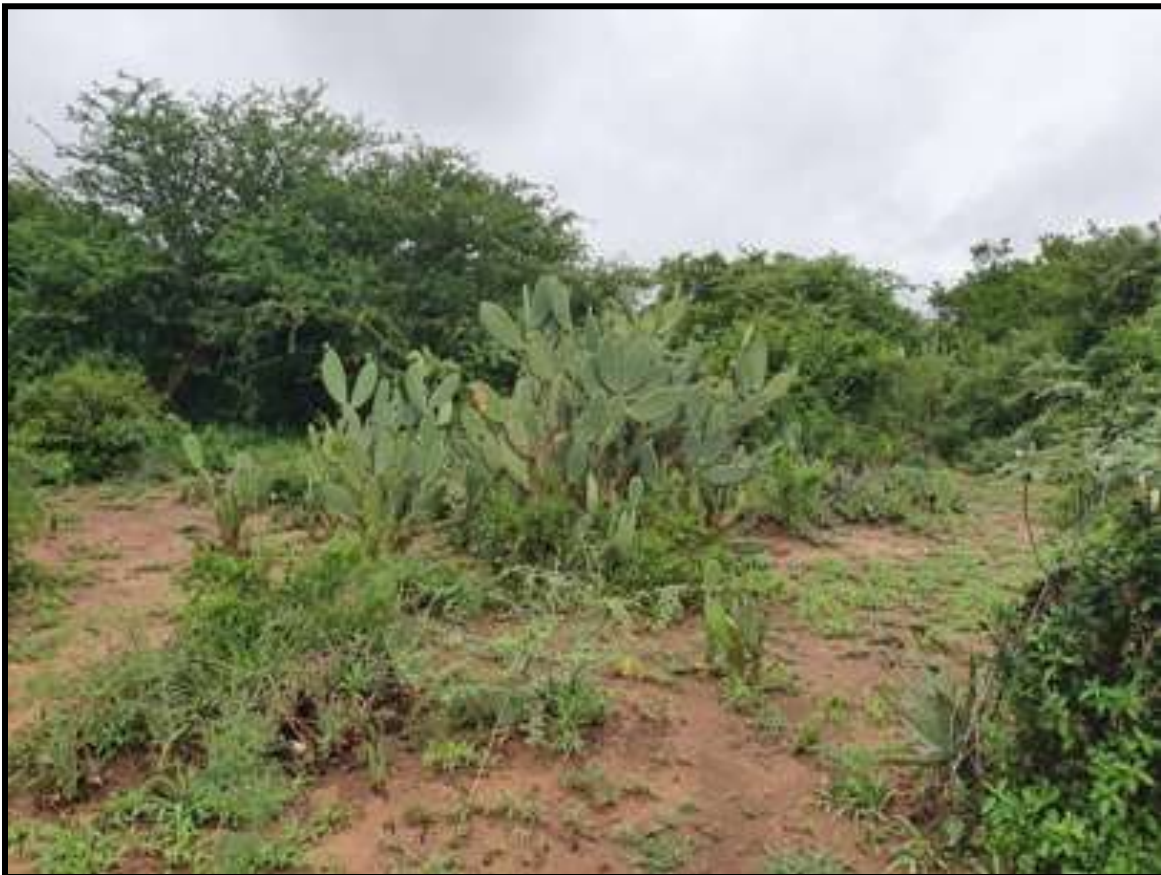
FIG. 16: MADO010

The site is located in a cleared area that has now slightly overgrown. The site consists of alien cacti normally associated with settlements. (fig. 16). A few modern artefacts were noted on the surface.

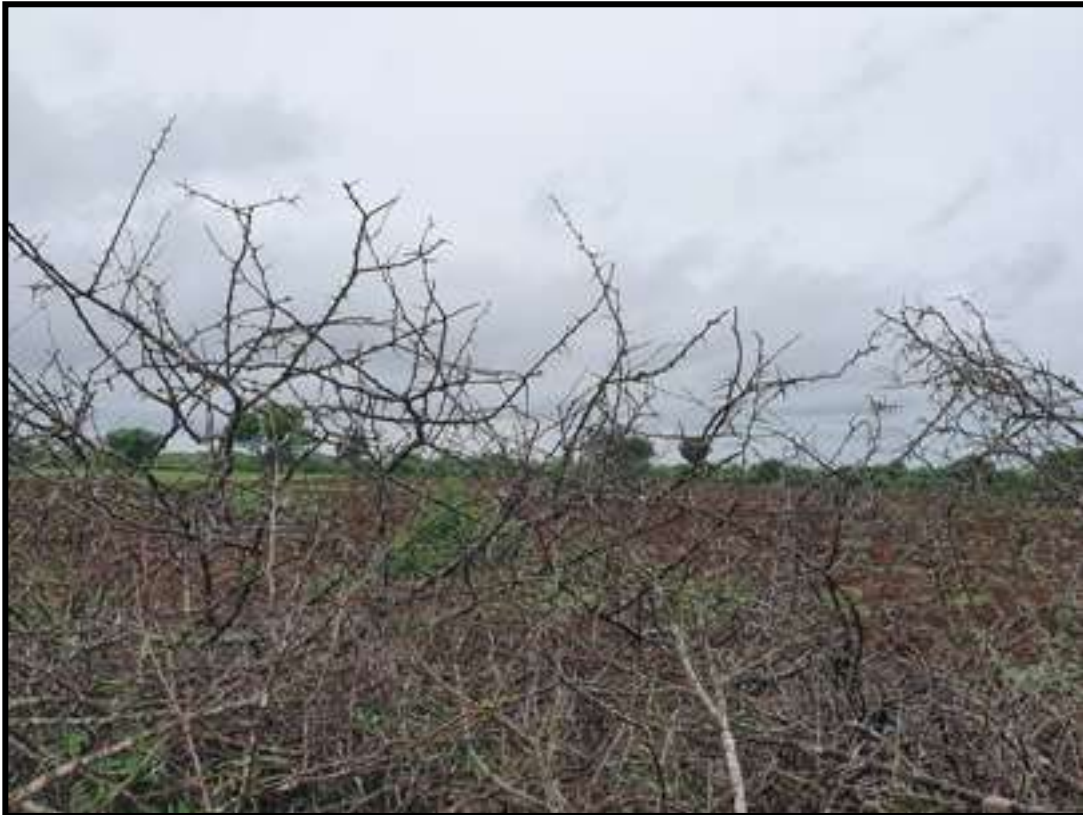
FIG. 17: MADO011

The site is an *E. ingens* located in the middle of a ploughed field (fig. 17). The *E. ingens* should be treated as a grave. Access to the tree was limited.

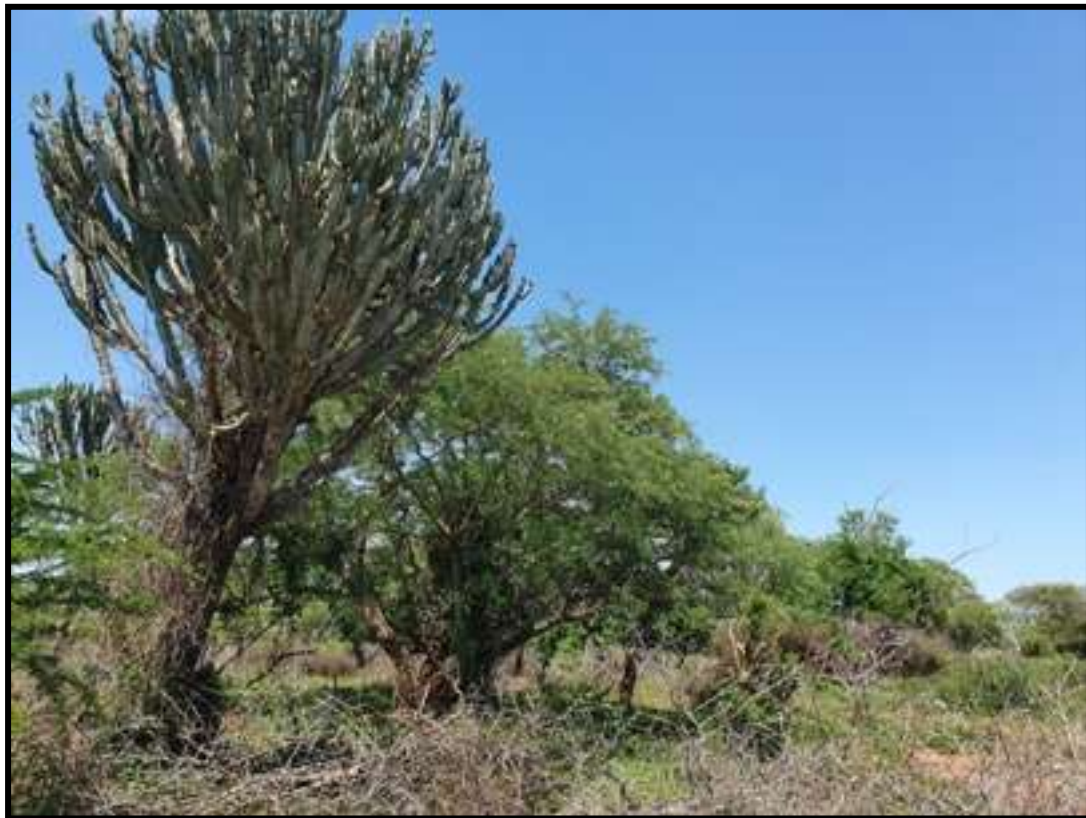
FIG. 18: MADO012

The site is located to the east of a ploughed field. The site consists of three *E. ingens* in close proximity to each other (fig. 18). No house floors or artefacts were noted.

SAHRA Rating: 3a

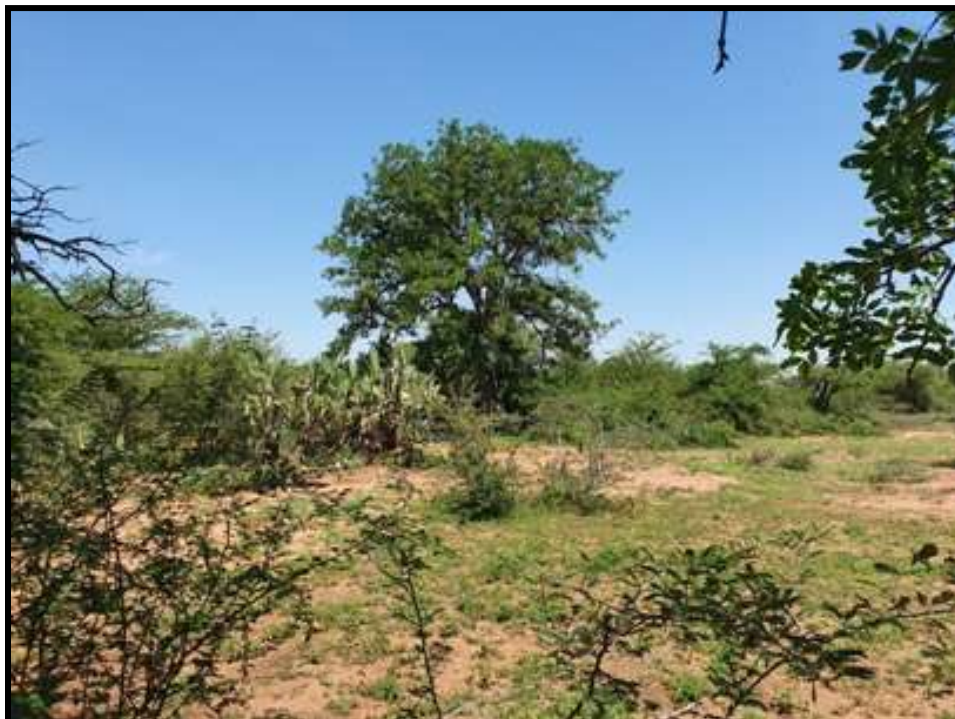
FIG. 19: MADO014

The site is located in a previously cleared area and correlates with 'H9'. The site consists of a scatter of artefacts, cacti and a central tree (fig. 19). No graves were noted.

SAHRA Rating: 3C

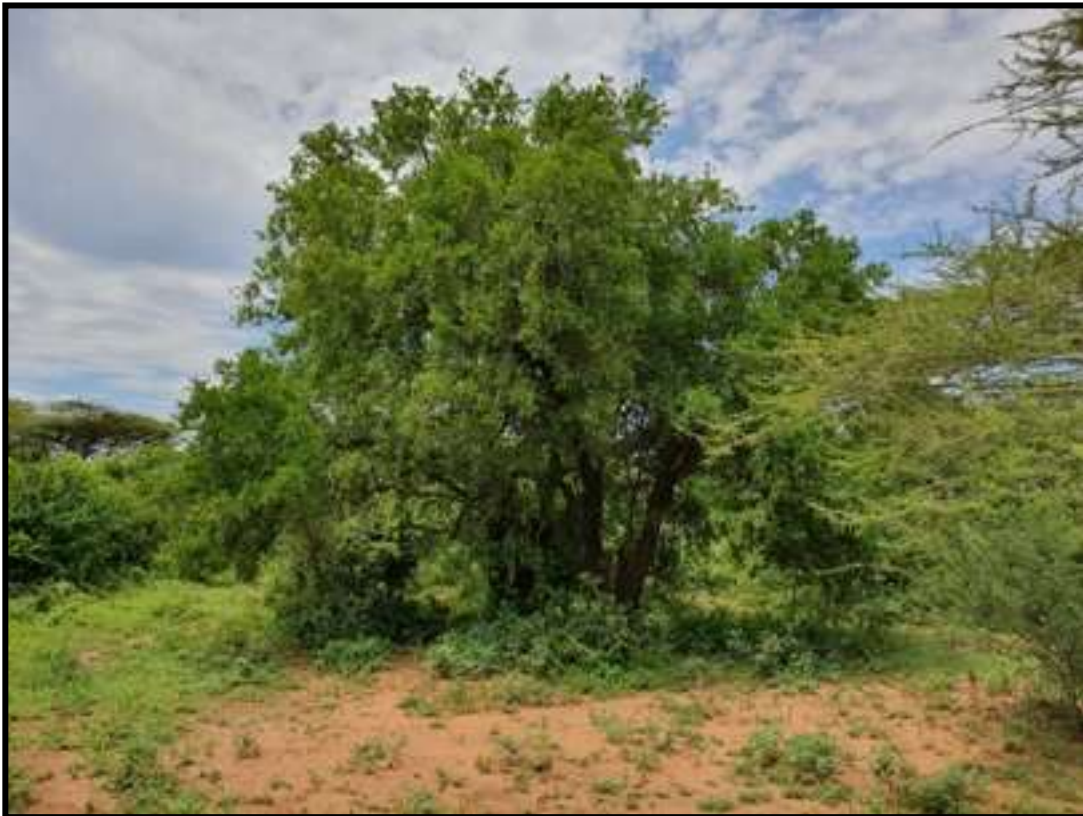
FIG. 20: MADO015

The site is located to the west of an existing cleared field. The site could correlate with 'h3'. The site consists of a settlement with daga house floors, modern artefacts, a central tree and an *E. ingens*

SAHRA Rating: 3A for the possible grave.

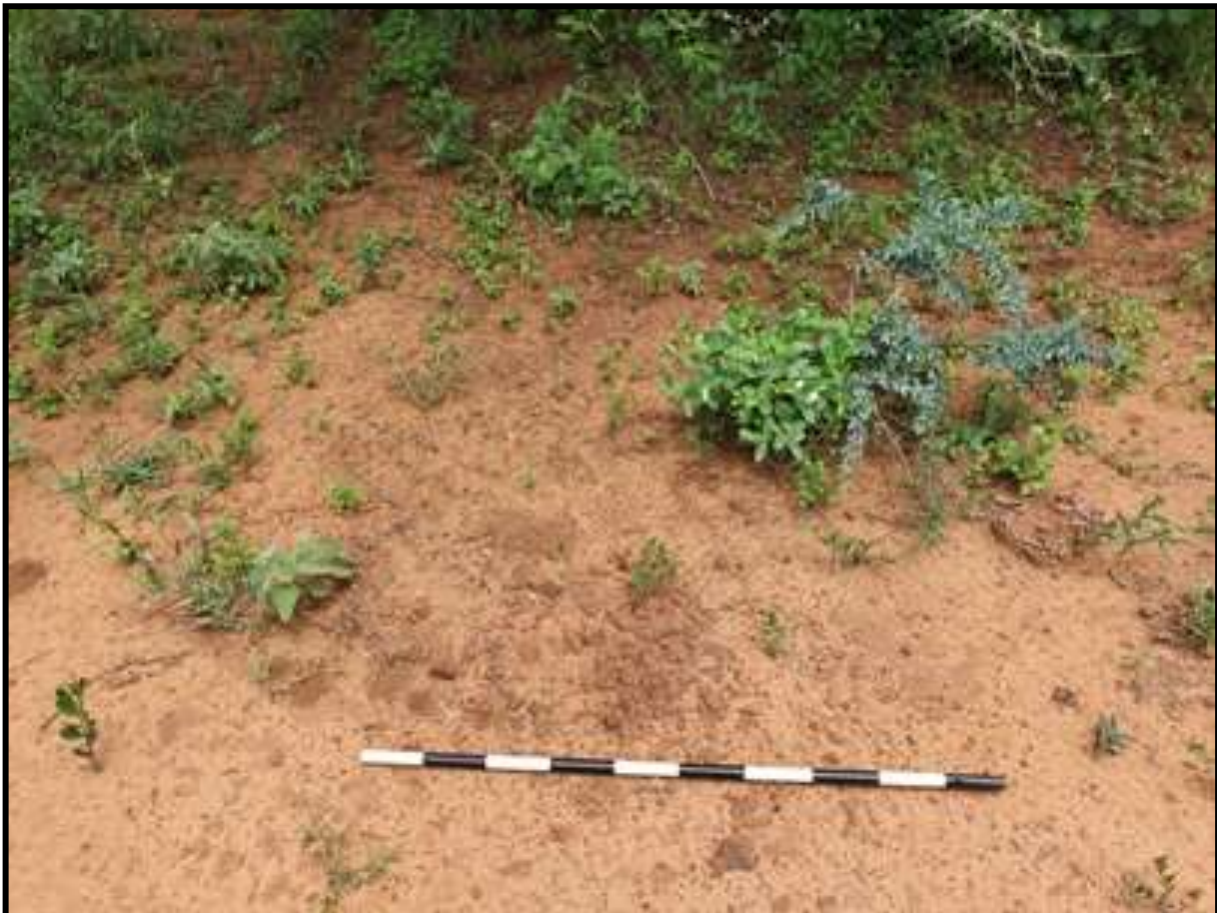
FIG. 21: MADO016

The site is located just south of MADO015 and could be part of 'h3'. The site consists of a daga house floor that is being exposed from the vegetation (fig. 21). No graves were noted in the area.

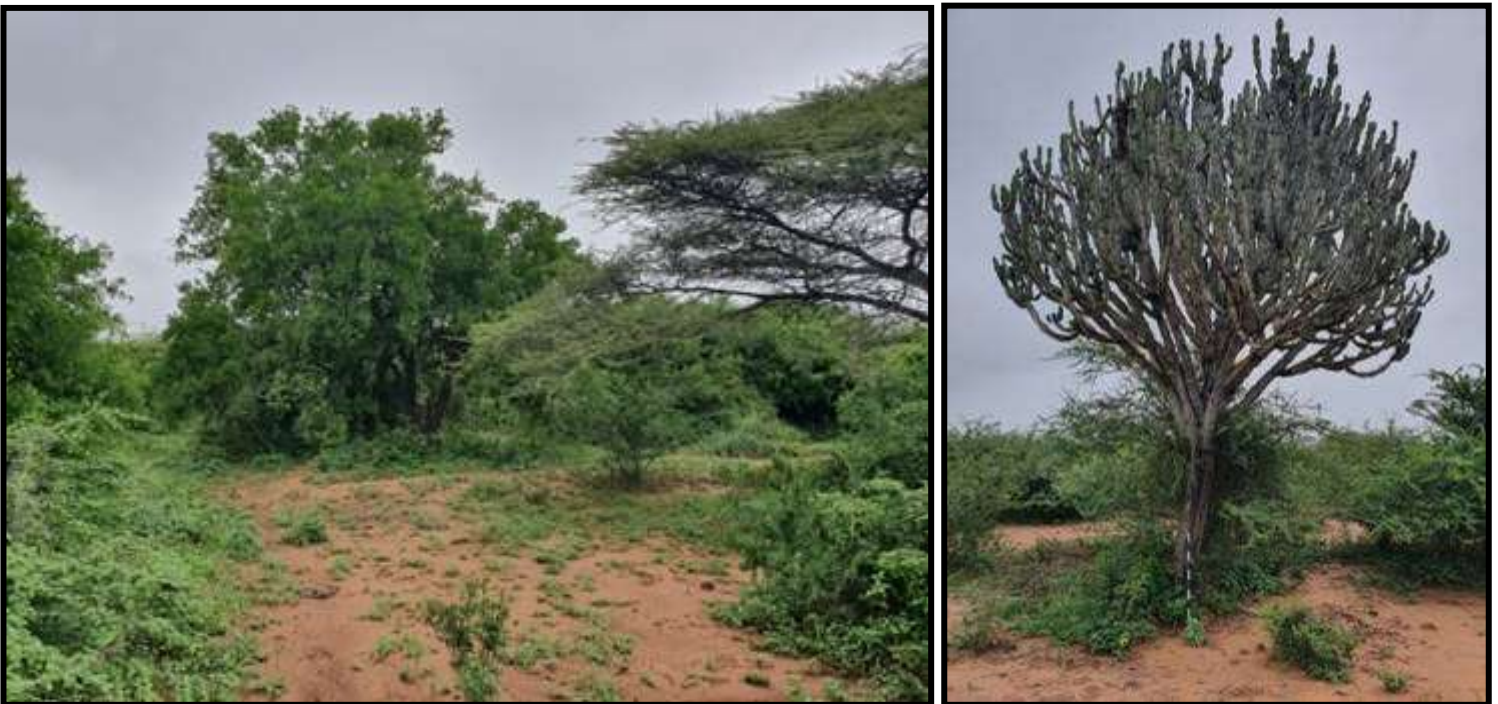
FIG. 22: MADO017

The site is located in the middle of an old cleared area. The site consists of house floors, a large Marula tree and an *E. ingens* (fig. 22). Semi-modern and modern artefacts were noted on the floor.

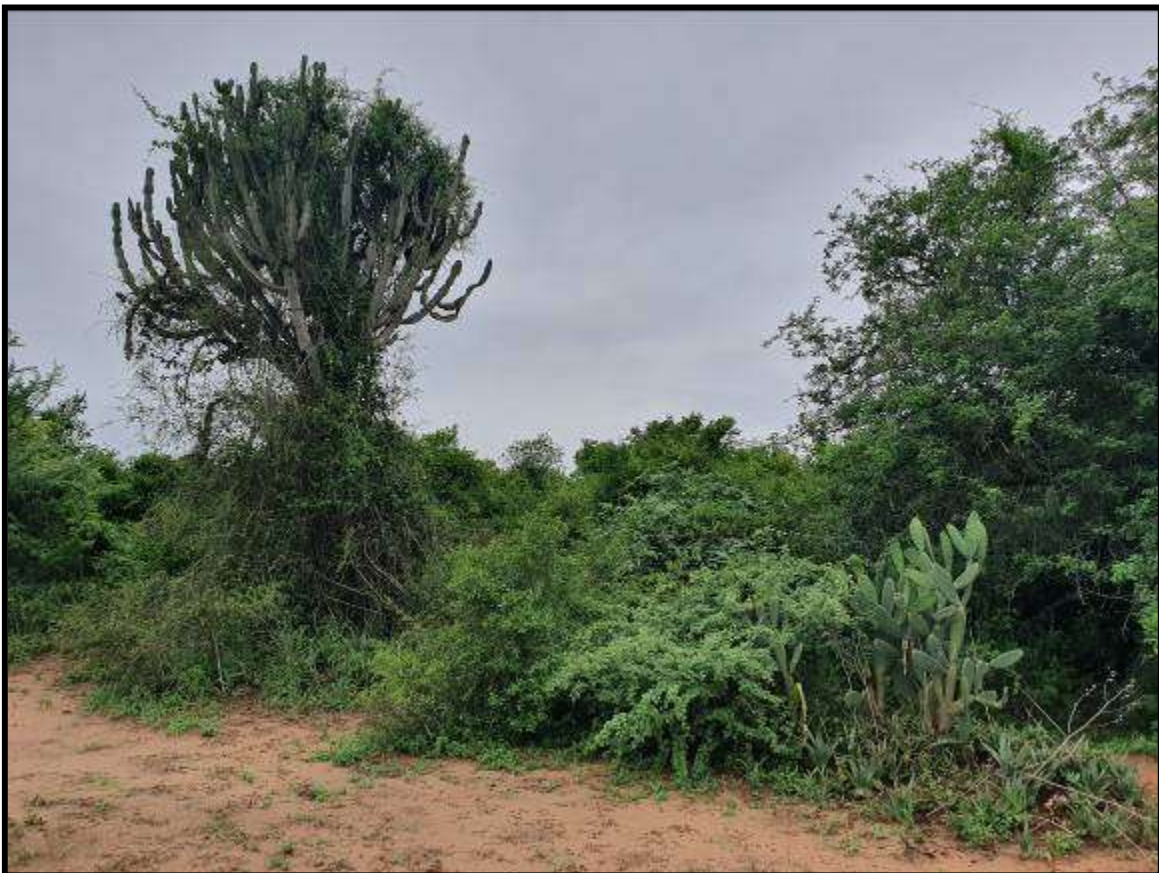
FIG. 23: MADO018

The site is located on the edge of a wetland and near the main track. The site consists mainly of a post 1970s settlement in an open area with house floors and *E. ingens* (fig. 23).

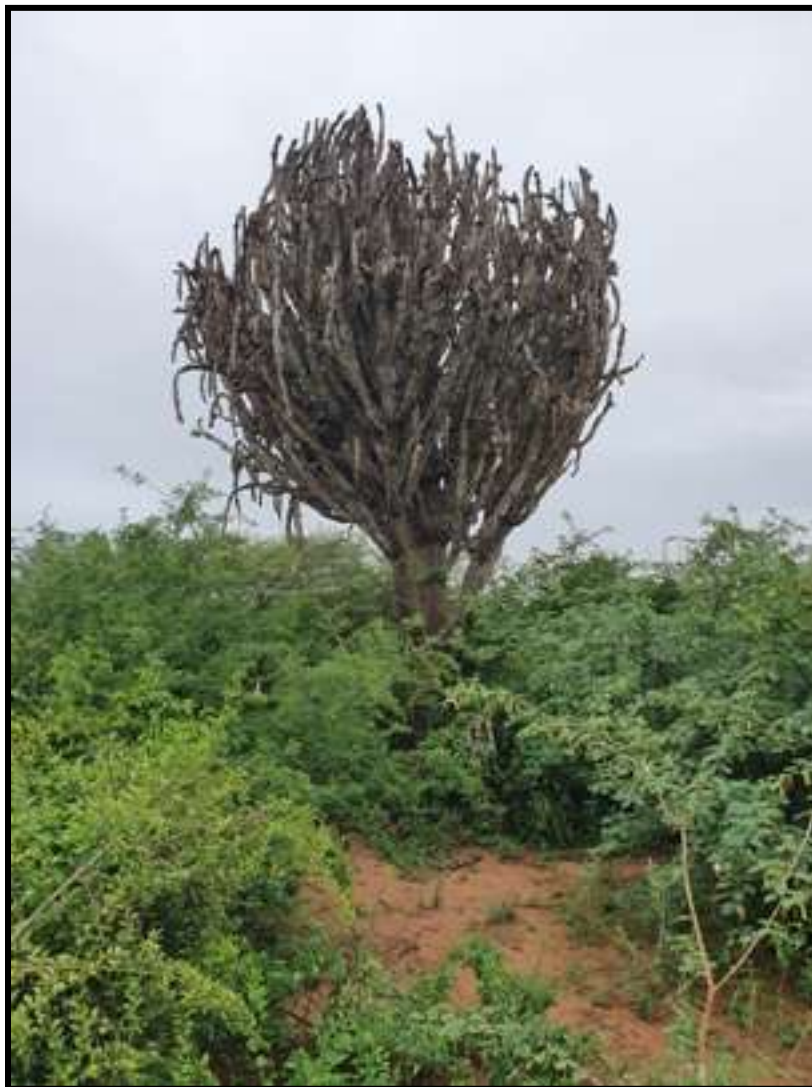
FIG. 24: MADO019

The site is located near an area cleared for farming and a road. The site might be related to 'h2'. No artefacts were noted; however, a single *E. ingens* occurs on the edge of the field (fig. 24).

SAHRA Rating: 3A

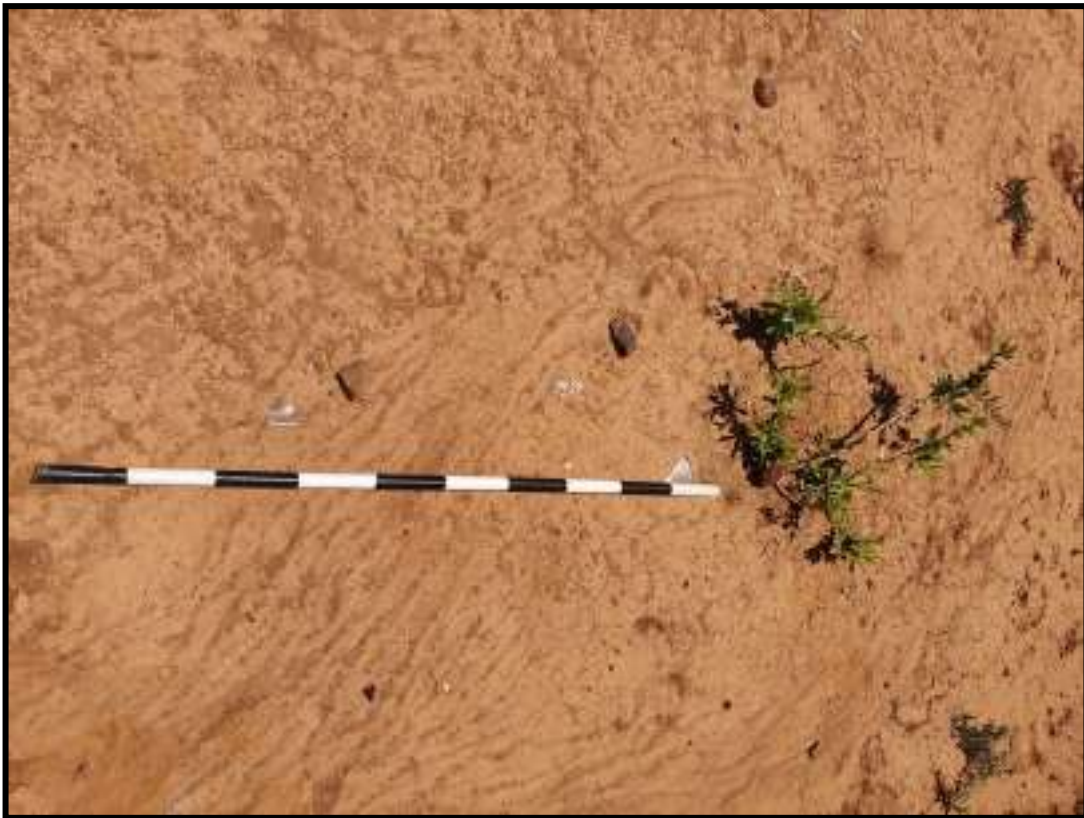
FIG. 25: MADO020

The site is located in a previously cleared area and could be associated with 'h20'. The site consists of a house floor and some artefacts that include glass, clothing, plastic and pottery (fig. 25).

SAHRA Rating: 3C

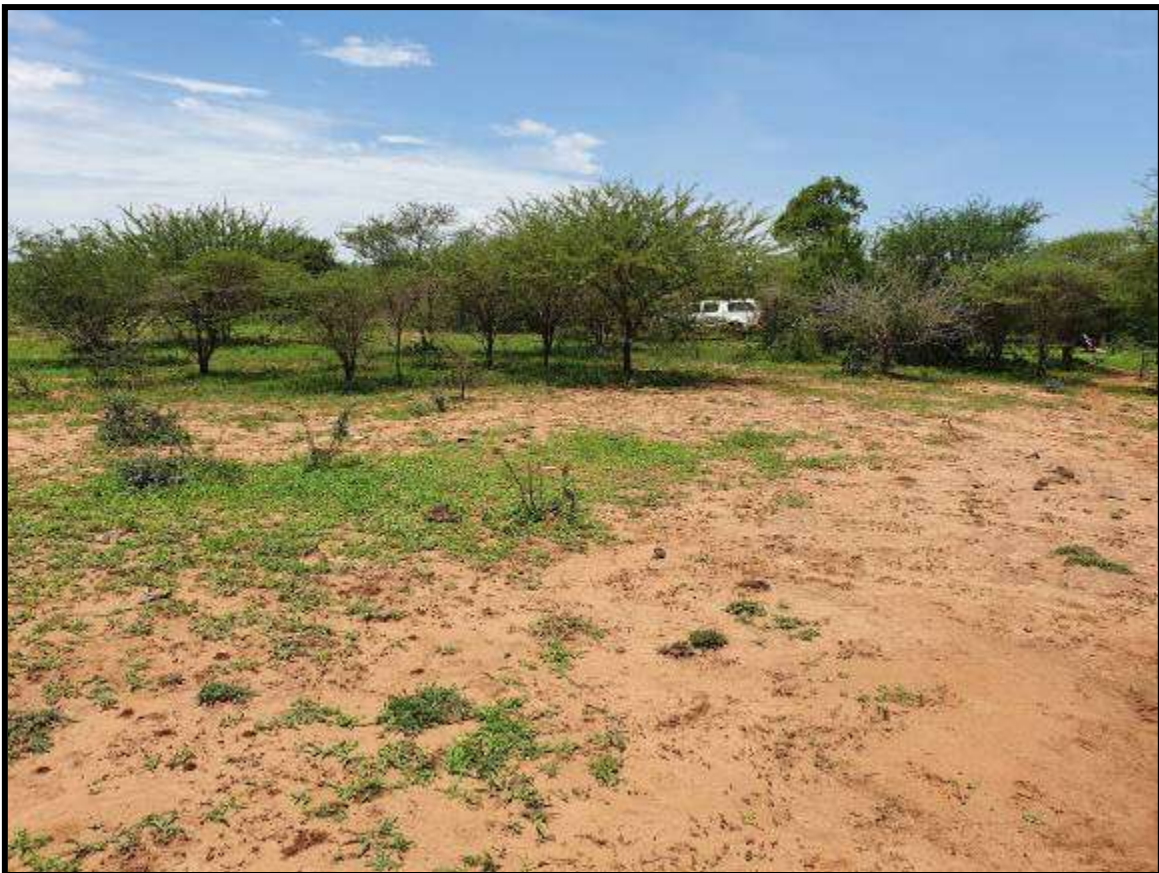
FIG. 26: MADO021

The site is located 55m southeast of MADO20 and might be associated with 'h2'. The site consists of several house floors and modern artefacts (fig. 26). No graves were noted. MADO20 and MADO21 might be part of the same settlement.

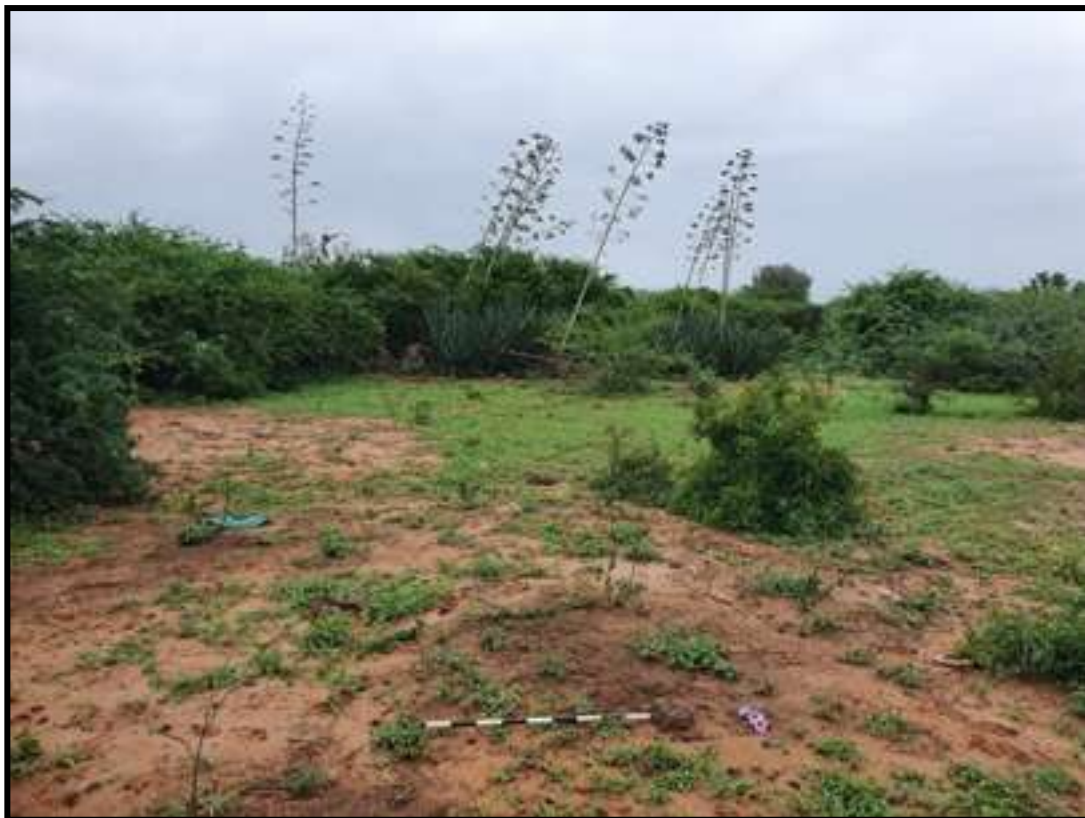
FIG. 27: MADO022

The site is located near the eastern edge of the development. The site consists of a large open area surrounded by sisal. There is one *E. ingens* nearby (fig. 27). The area between MADO022 and MADO023 is a concentration of stone tools and pottery shards. However, these are all in a secondary context and form part of a lag deposit.

SAHRA Rating: 3A

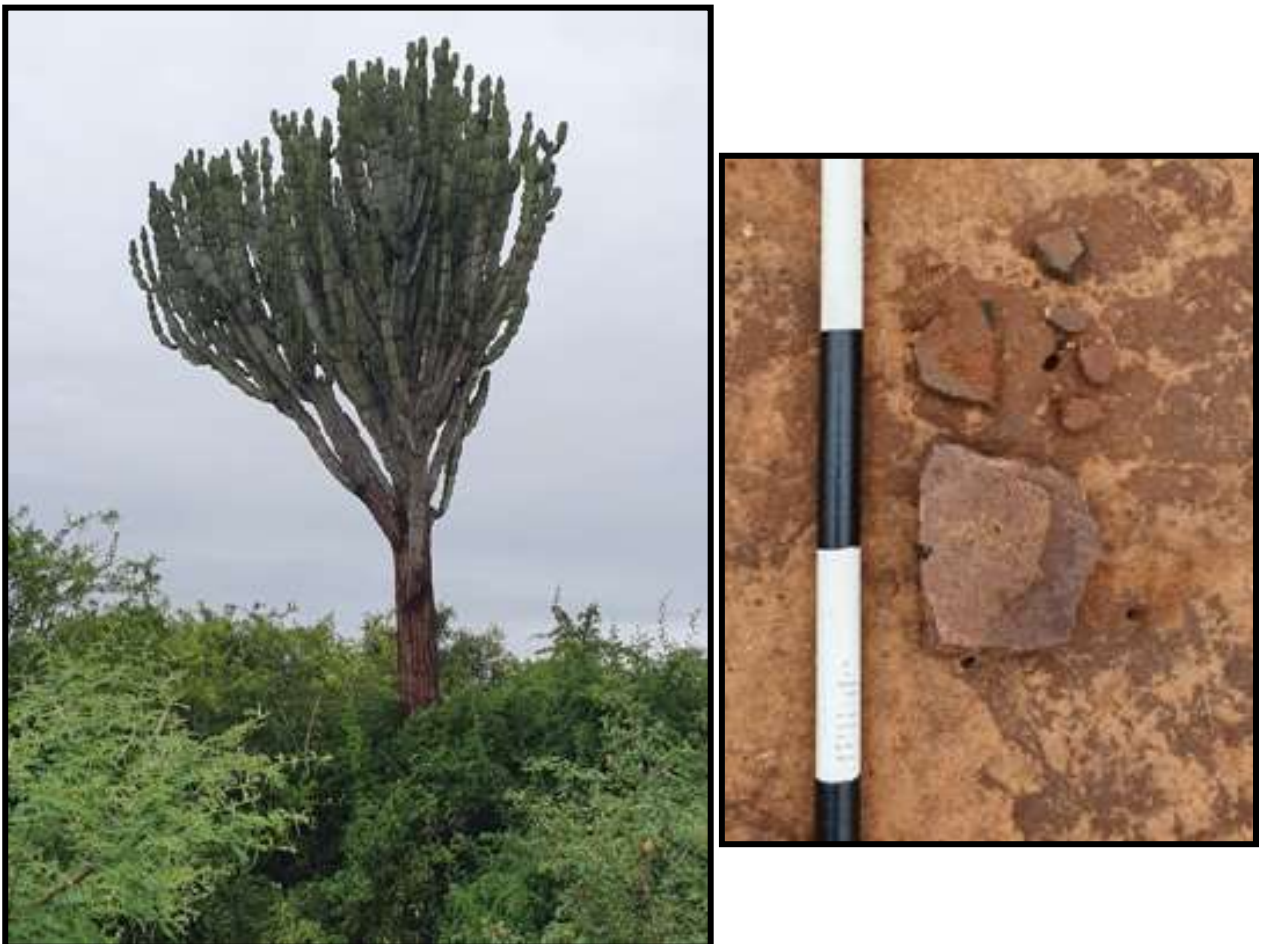
FIG. 28: MADO023

The site is located near the eastern edge of the development. The site consists of three *E. ingens* and scatter of pottery near the one *E. ingens* (fig. 28). The area between MADO022 and MADO023 is a concentration of stone tools and pottery shards. However, these are all in a secondary context and form part of a lag deposit.

SAHRA Rating: 3A

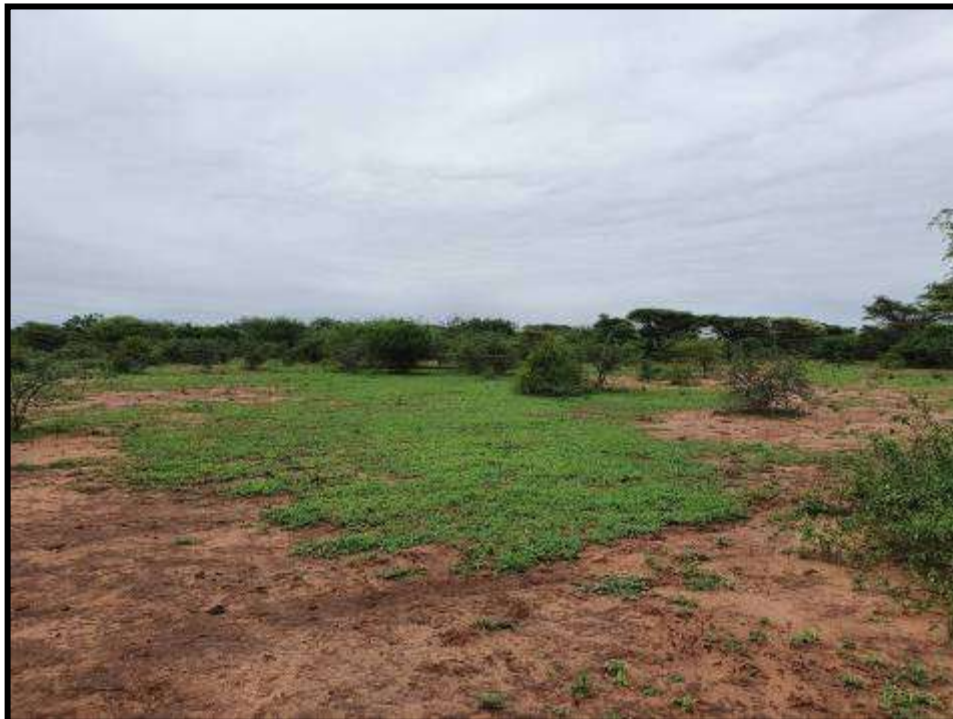
FIG. 29: MADO026

The site is located in a previously ploughed field (fig. 29). The site consists of a high concentration of pottery shards, of which some are EIA shards, and a range of other pottery (fig. 30). The artefacts are in a secondary context.

SAHRA Rating: 3C

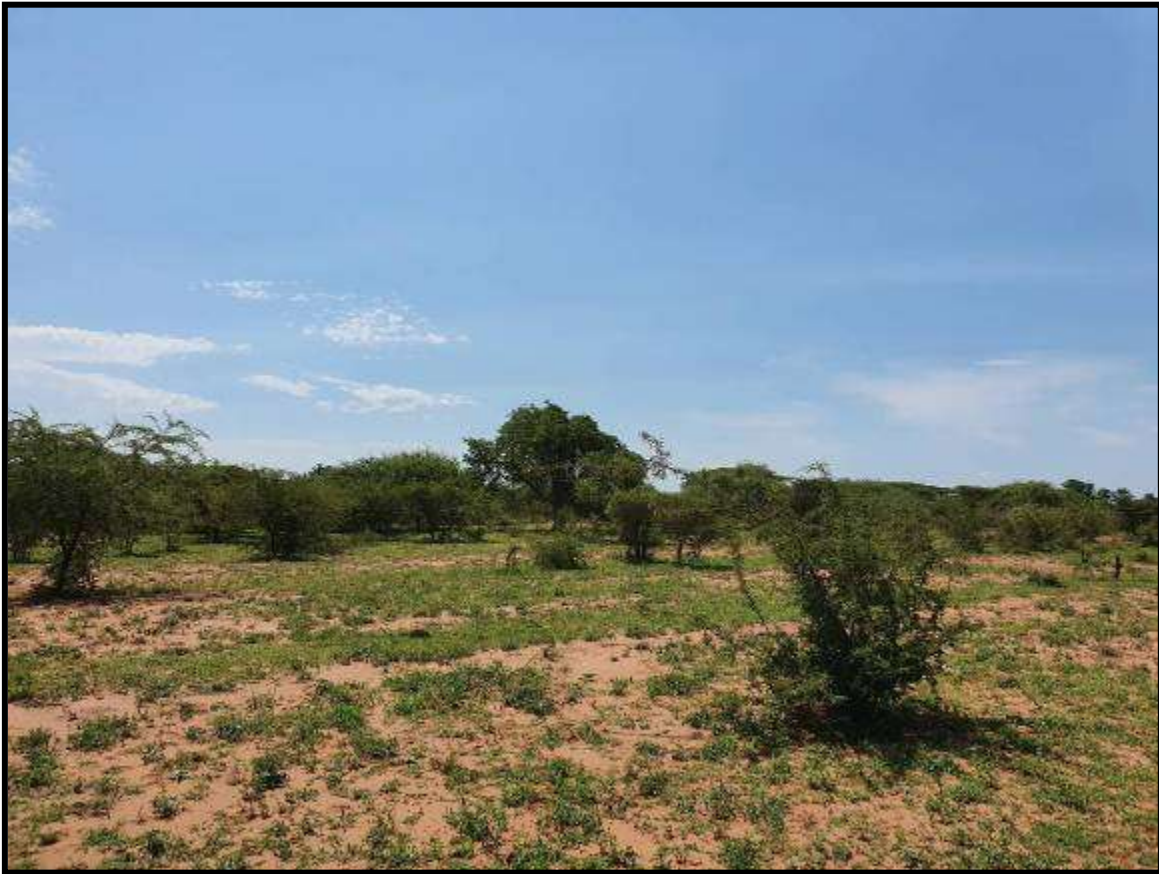
FIG. 31: MADO026

The area is located in a previously cleared area and was 'h15' in the desktop study (fig. 31). While no artefacts or features were found, I noted the site as an example of how fast sites can 'disappear' if not continuously inhabited. Many of the other 'h' or desktop sites were inhabited for 20+ years and left many plastic and glass artefacts even in ploughed fields. MADO026 had no artefacts
