**HERITAGE SURVEY OF THE PROPOSED MFUNDA
YOPHONGOLO IRRIGATION CLUSTER ONE
PROJECT, KZN**

FOR AFZELIA ENVIRONMENTAL CONSULTANTS

DATE: 30 NOVEMBER 2019

**Umlando: Archaeological Surveys and Heritage
Management**

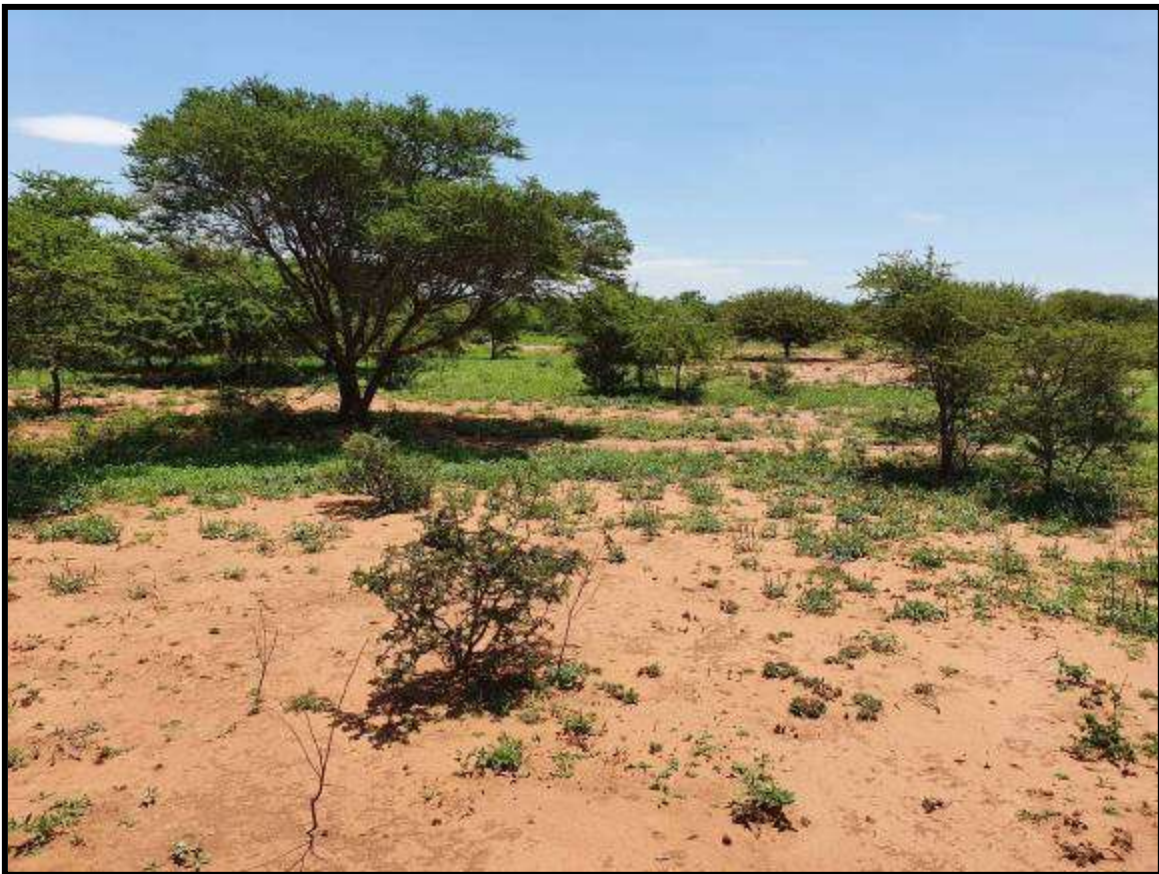
FIG. 32: MADO027

The site is located in an older cleared area. The site consists of house floors and semi- to modern artefacts (fig. 32). No graves were noted.

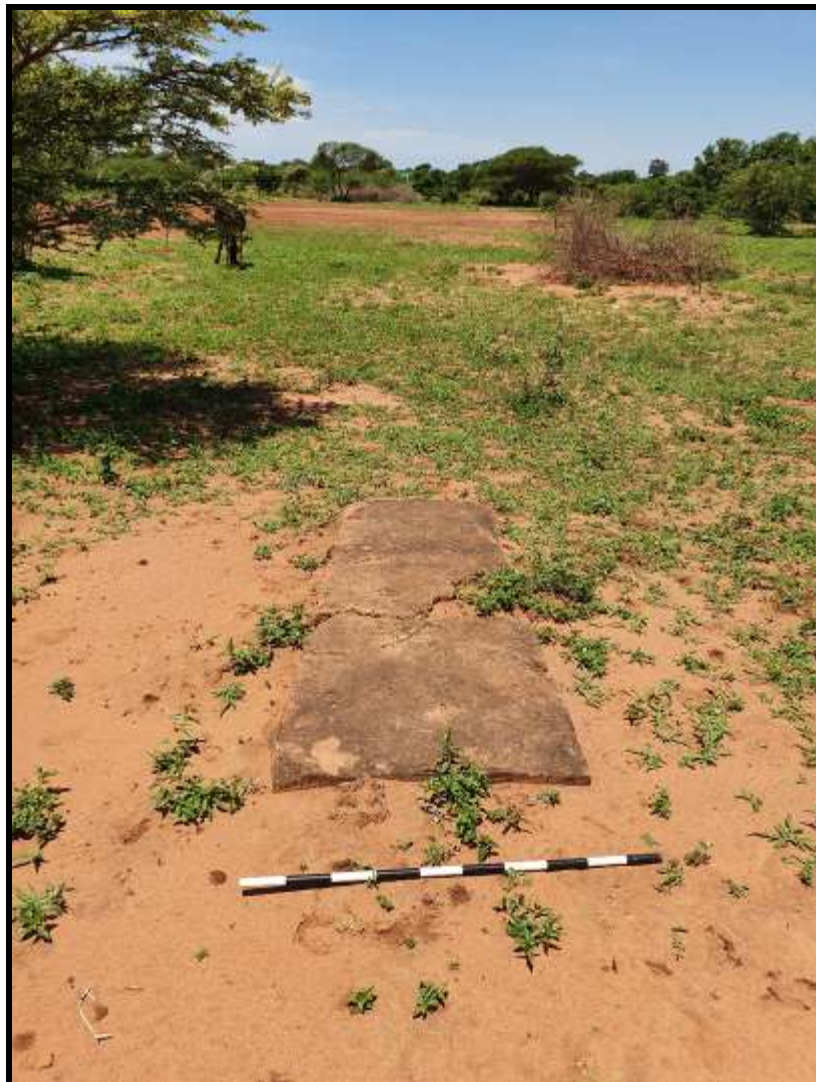
FIG. 33: MADO028

The site consists of a single grave covering made of 'cement' (fig. 33). The grave could be associated with 'h16'. There are probably more graves in the immediate area.

SAHRA Rating: 3A

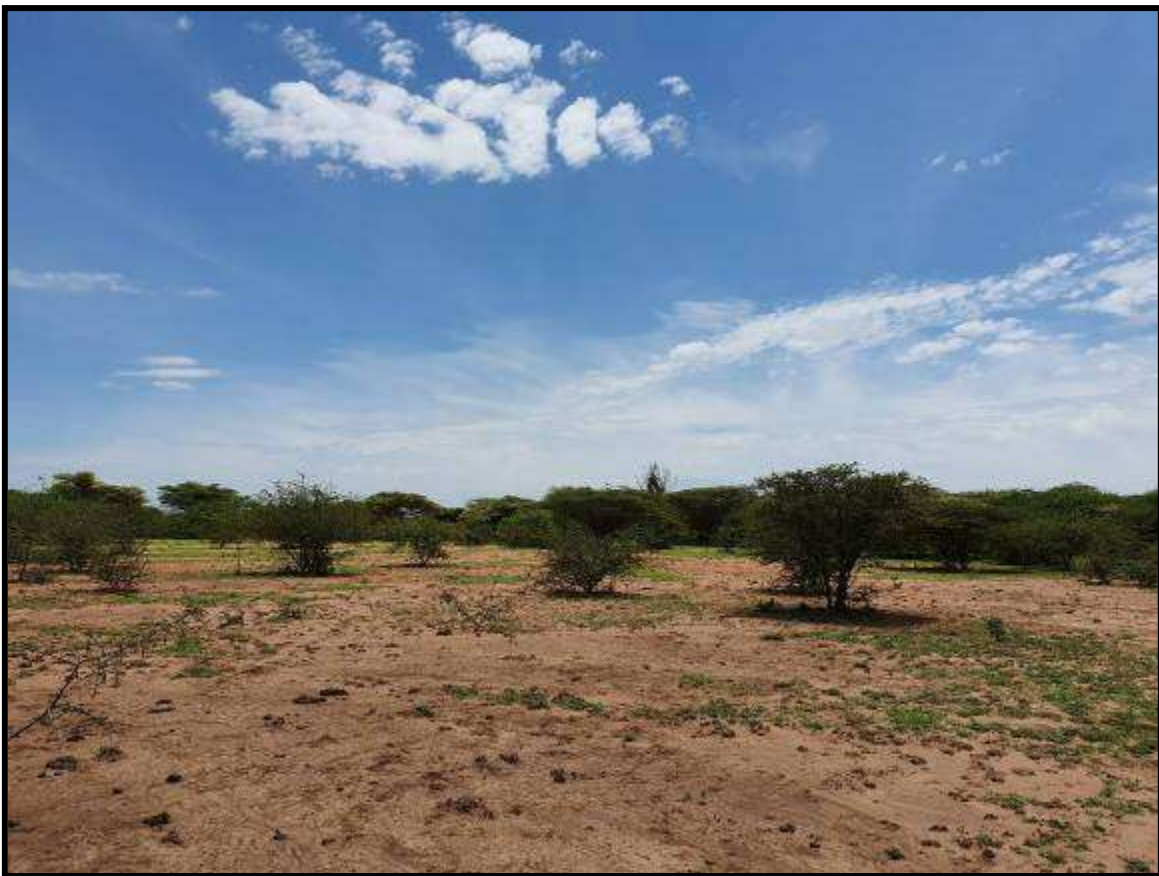
FIG. 34: GENERAL AREA FOR MADO029

The site is located in a cleared area. The site consists of a house floor and some modern artefacts (fig. 33).

SAHRA Rating: 3C

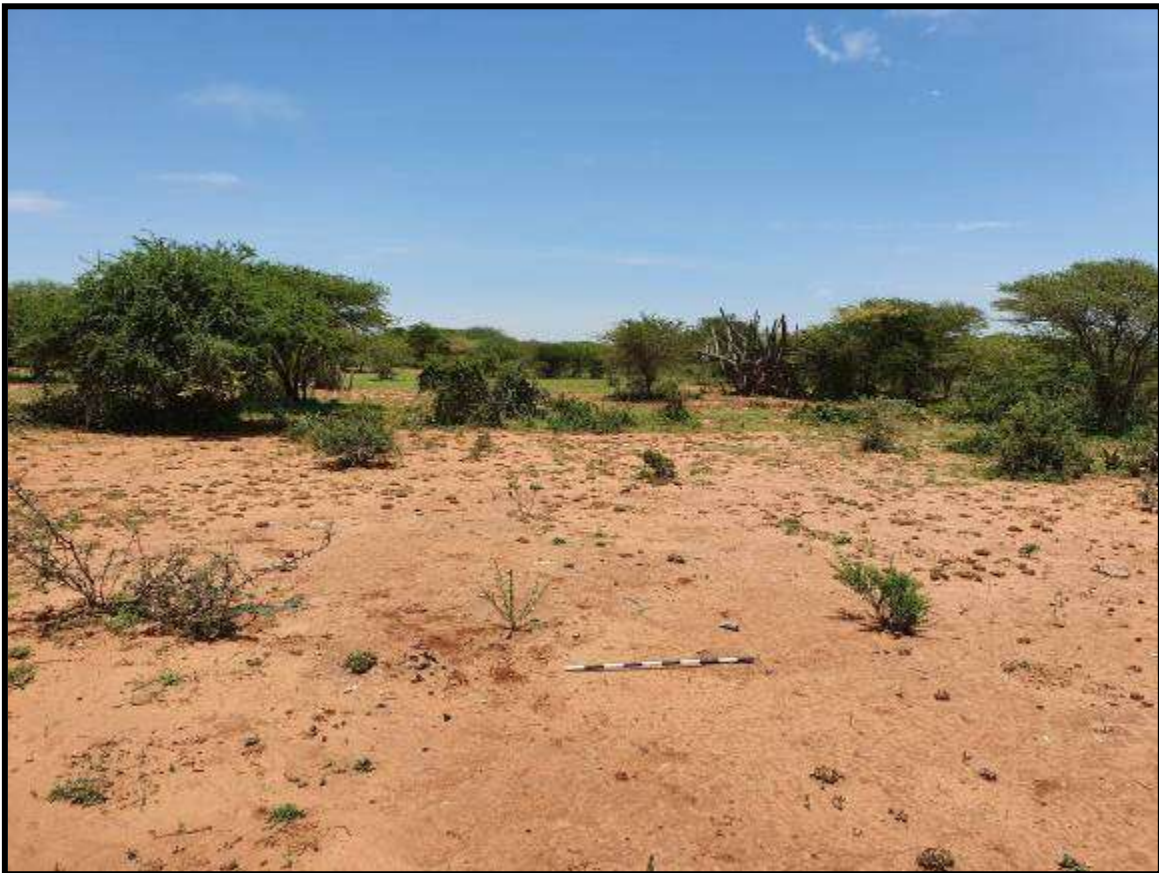
FIG. 35: MADO030 & MADO031

The sites are located on the opposite side of a cleared area. The sites consists of several house floors and modern artefacts (fig. 35: MADO031 in background. No graves were noted.

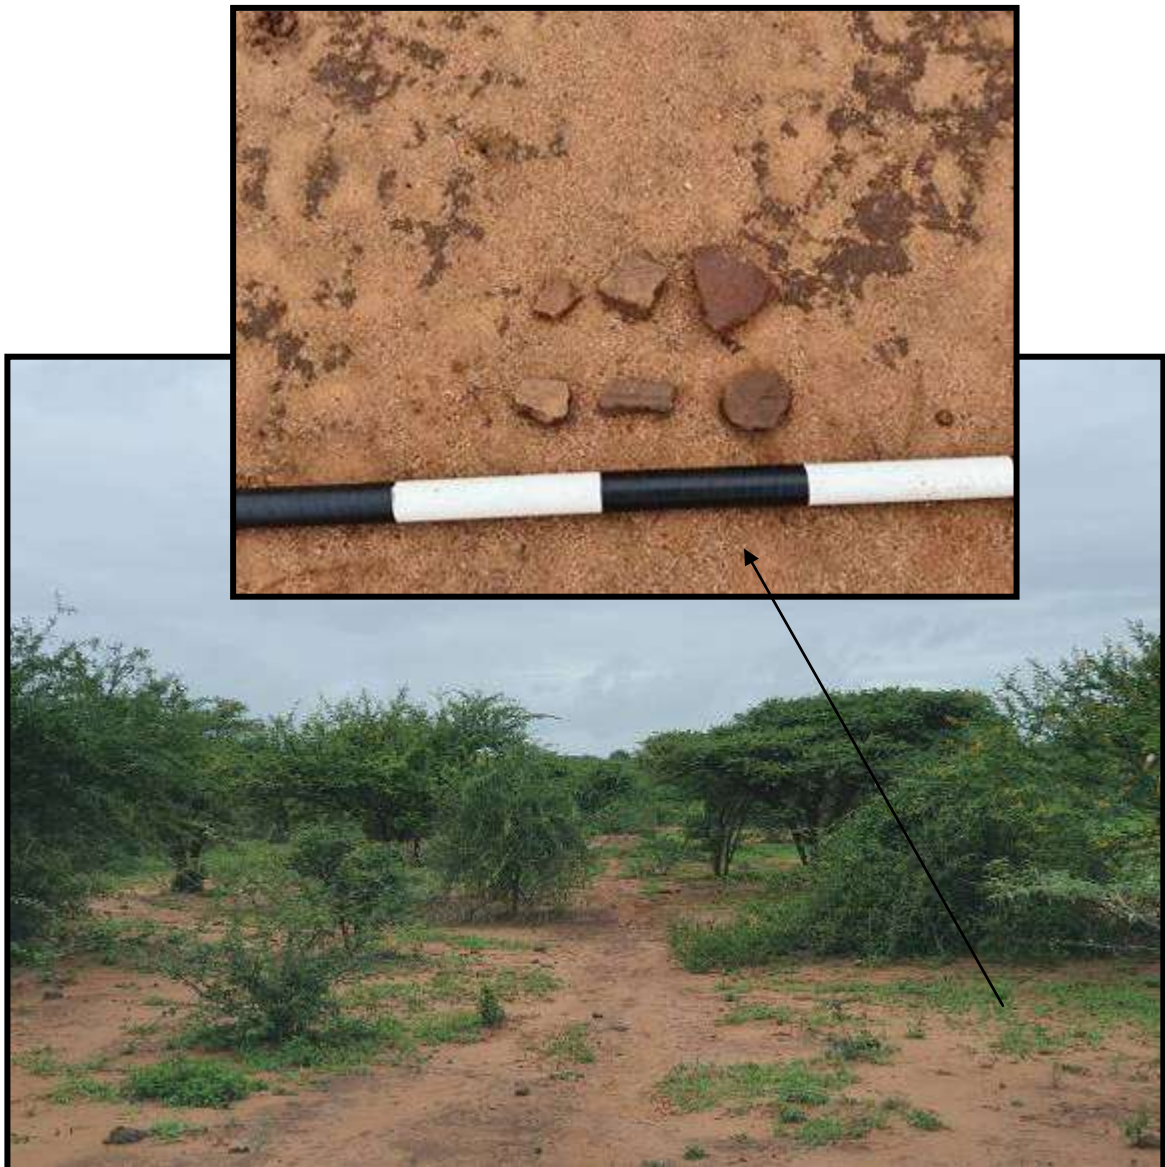
FIG. 36: MADO032

The site is located in a previously cleared area. The site consists of a scatter of Early Iron Age Pottery (fig. 36). The pottery dates to the Mzonjani Phase and dates between 1 700 and 1 500 years in age.

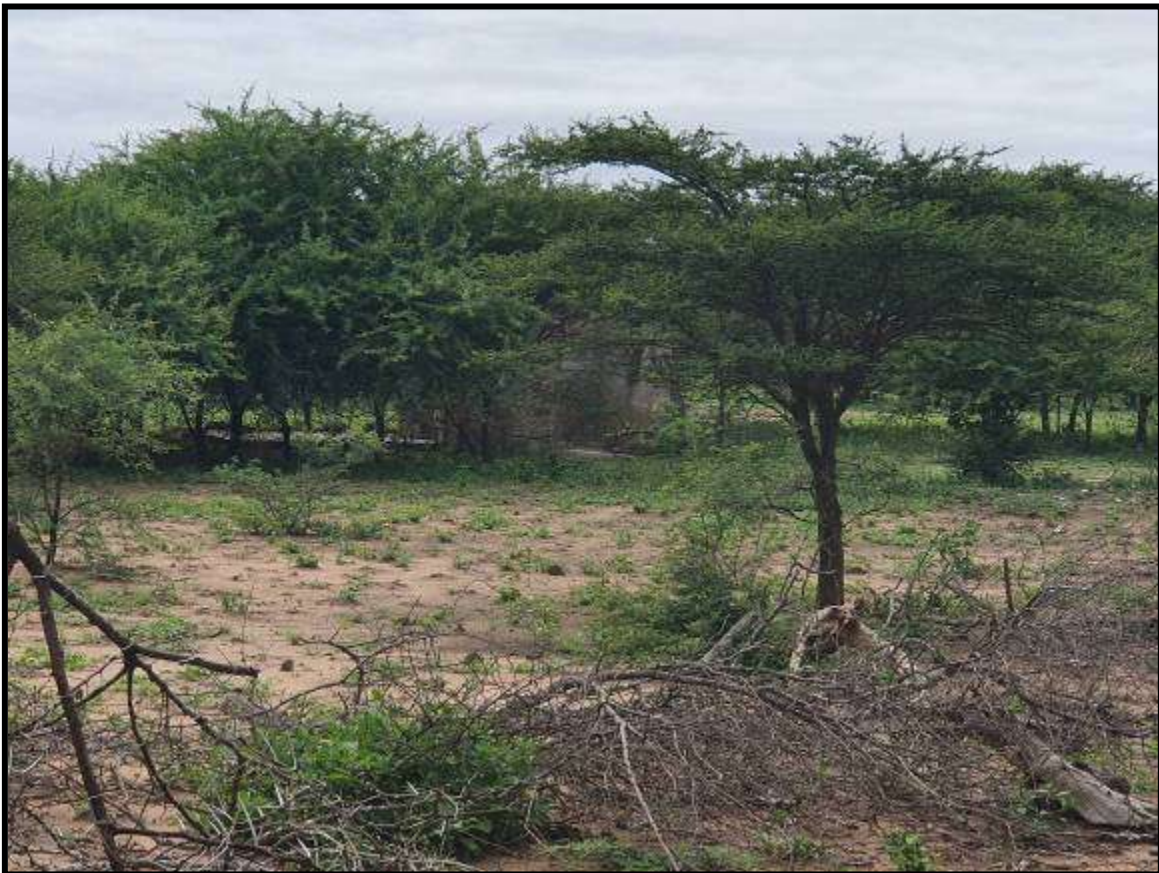
FIG. 37: MADO033

The site is located on the edges of, or in a wetland (fig. 37). It correlates with 'h21'. There is a more recent house ~30m to the east. Modern artefacts were noted.

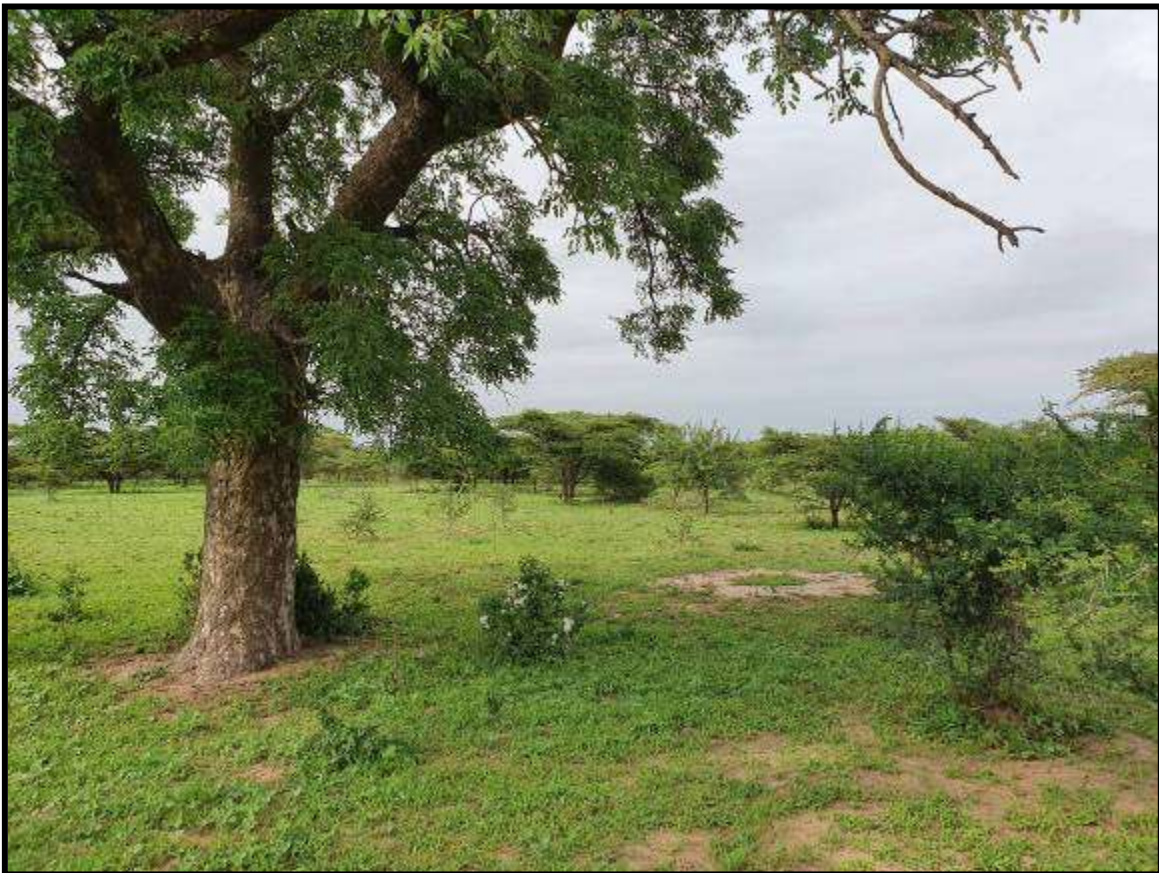
FIG. 38: MADO035

The site is located in a demarcated wetland and will not be affected. The site consists of a large opening with several house floors and artefacts (fig. 38). No graves were noted.

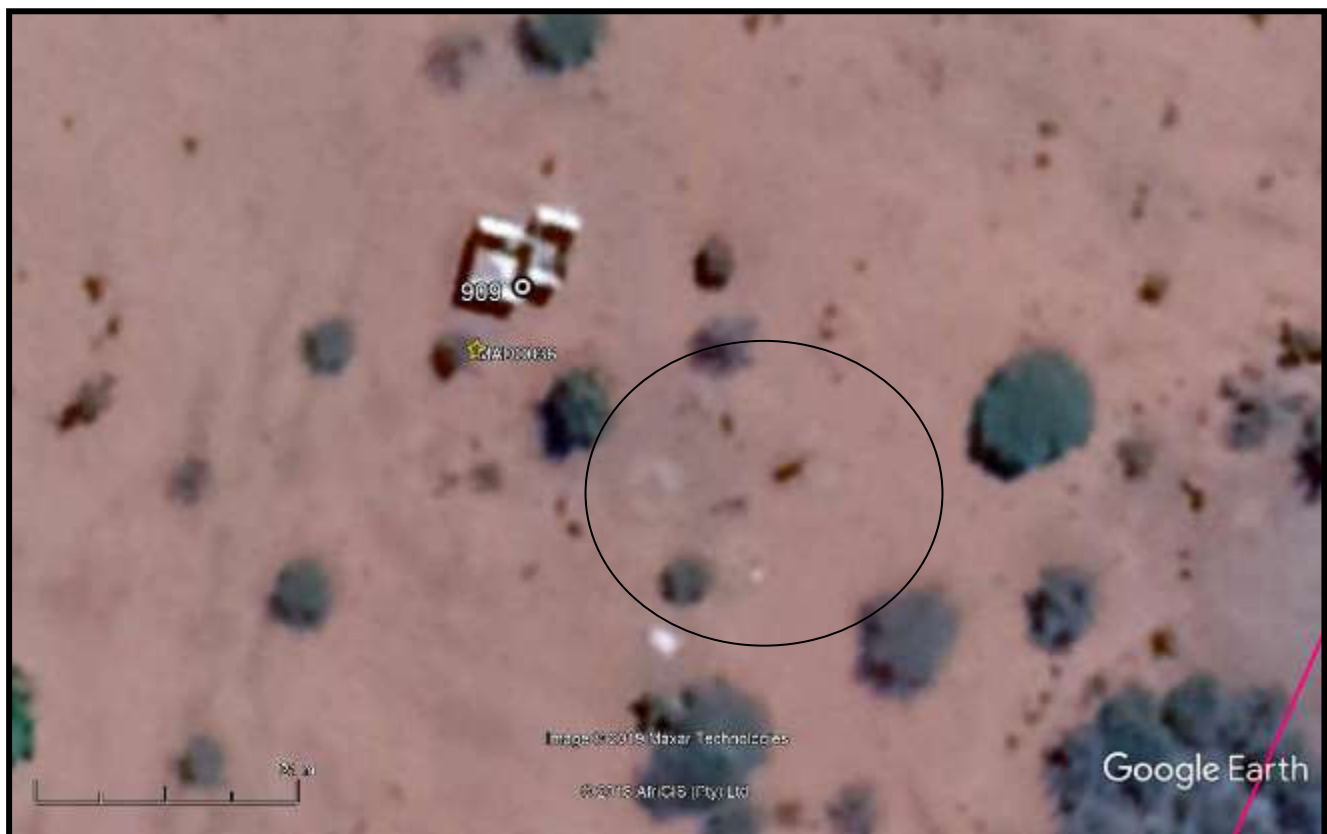
FIG. 39: MADO036

The site is located in the middle of a cleared area. The site was not accessible during the survey but is noticeable on the Google Earth map. Several features occur to the east and southeast of the main house, and these could be graves (fig. 39). Since the house is modern, the community will know if there are graves associated with it. The circle in fig. 40 indicates the area of potential graves.

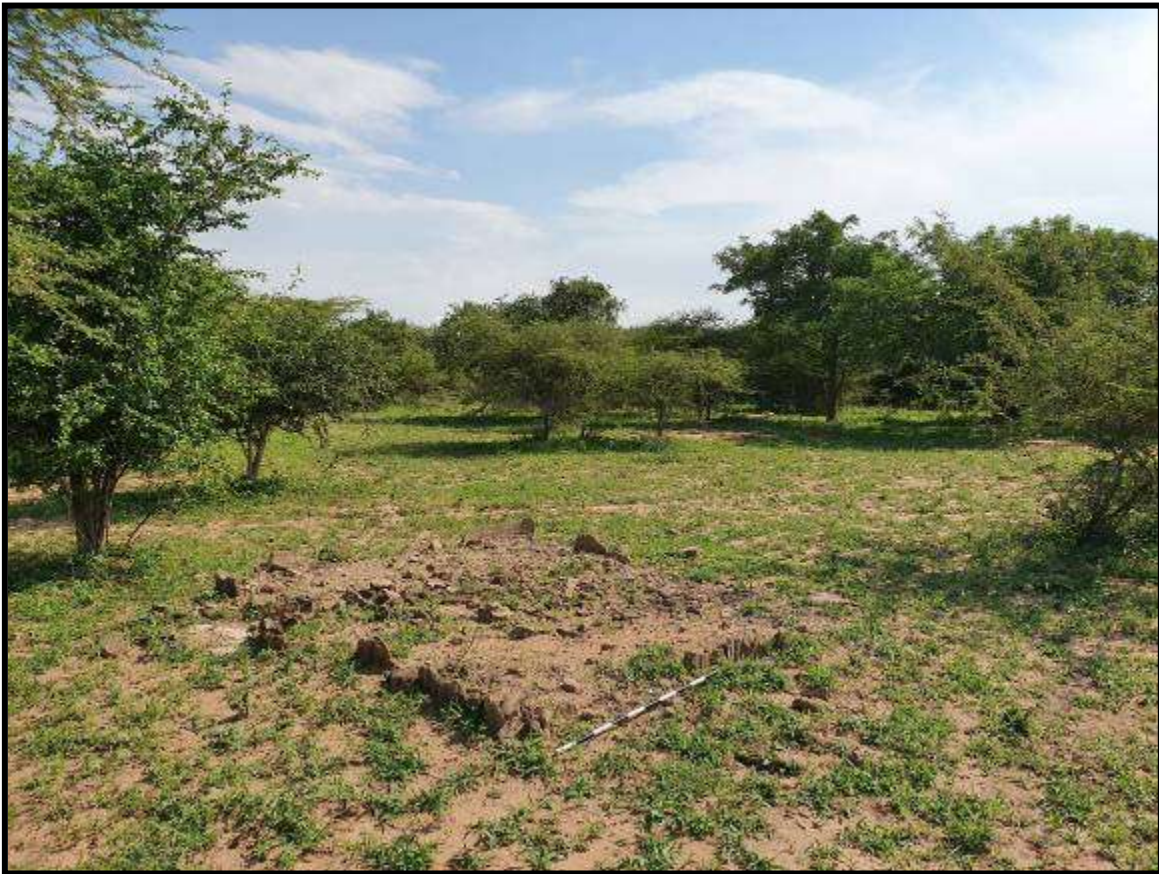
FIG. 40: MADO037

The site is located to the southeast of two older agricultural fields. The site consists of several house foundations that form a settlement (fig. 40). The site is associated with 'h63'. No human graves were noted.

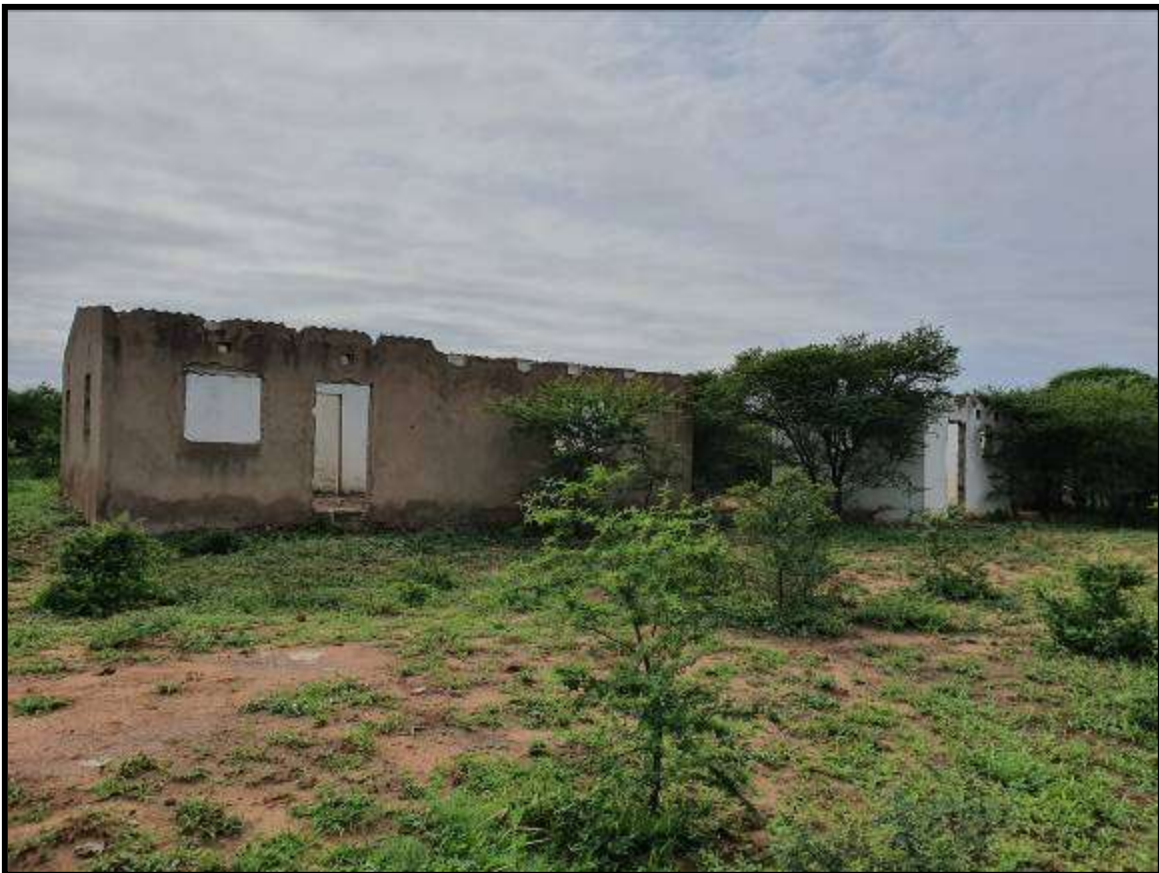
FIG. 41: MADO038

The site is located on the edge of a demarcated wetland, with the majority of the features just inside the current wetland boundary. The site consists of a modern house with three additional buildings (fig. 41). There are three graves 15m – 20m to the east of the main house (fig. 42). One grave might be a different feature, but was rated as a grave due to its proximity to the others.

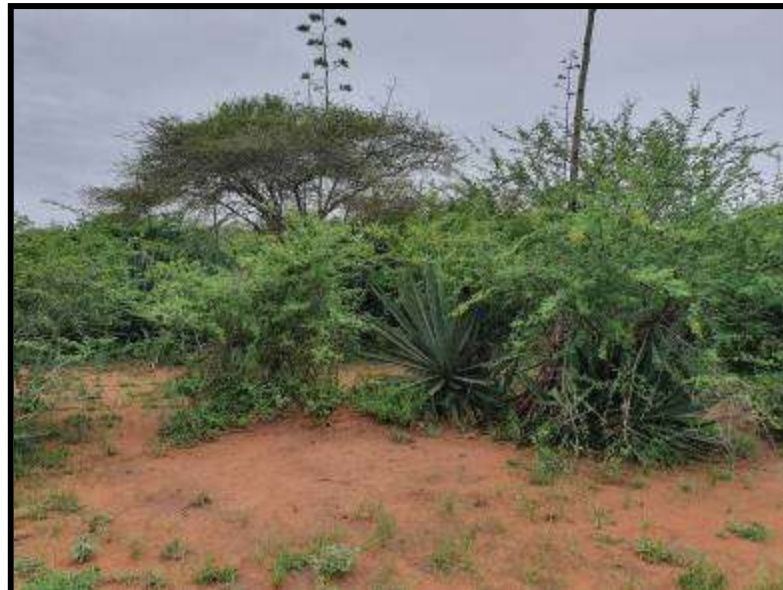
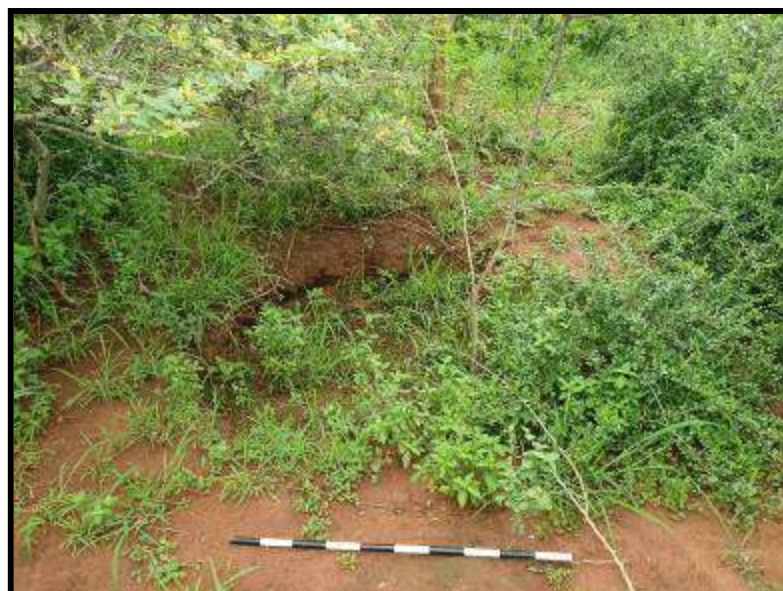
FIG. 43: MADO039

The site is located in a cleared are amongst the thornbush. The site consists of several house floors, modern artefacts, and a [possible sunken grave (fig. 43).

SAHRA Rating: 3A

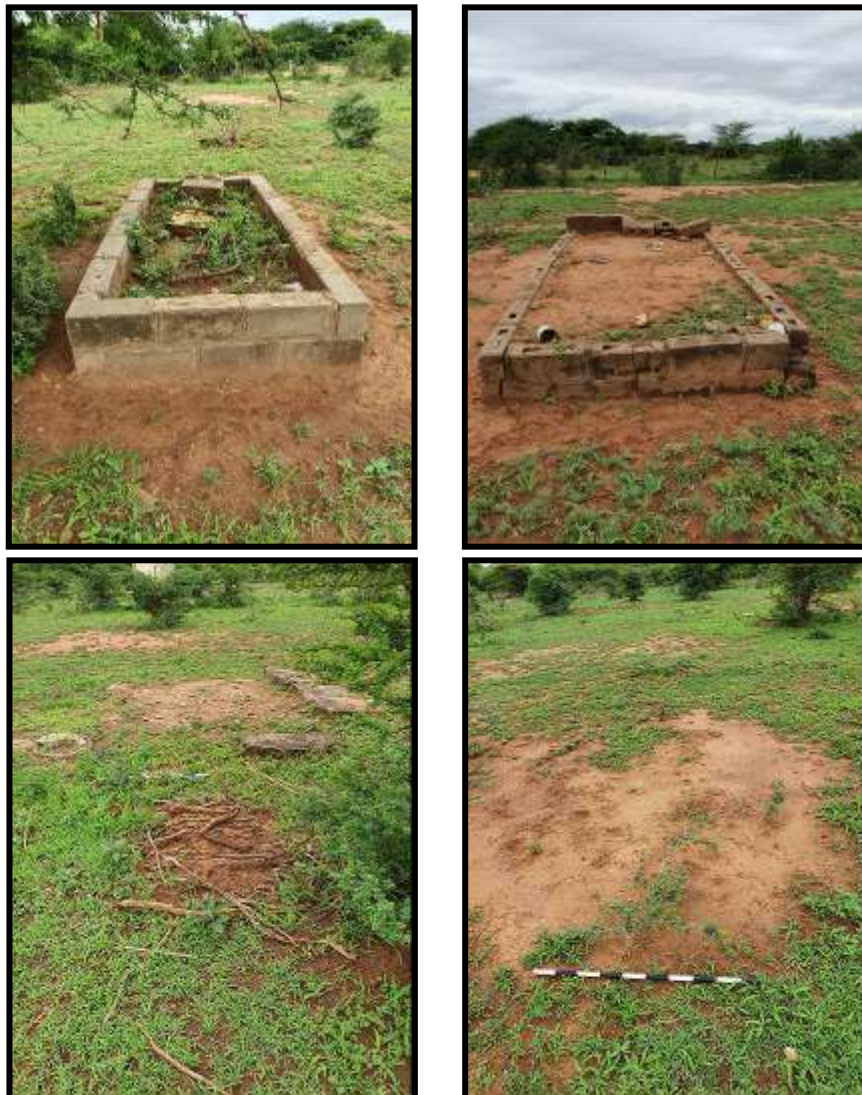
FIG. 45: GRAVES AT MADO043

The site is located adjacent to a used track. The site consists of a more recent building that is currently occupied (MADO042). Approximately 50m to the east are ruins are six graves (MADO043) of various constructions (fig. 45). The two may/not be related.

SAHRA Rating: 3A

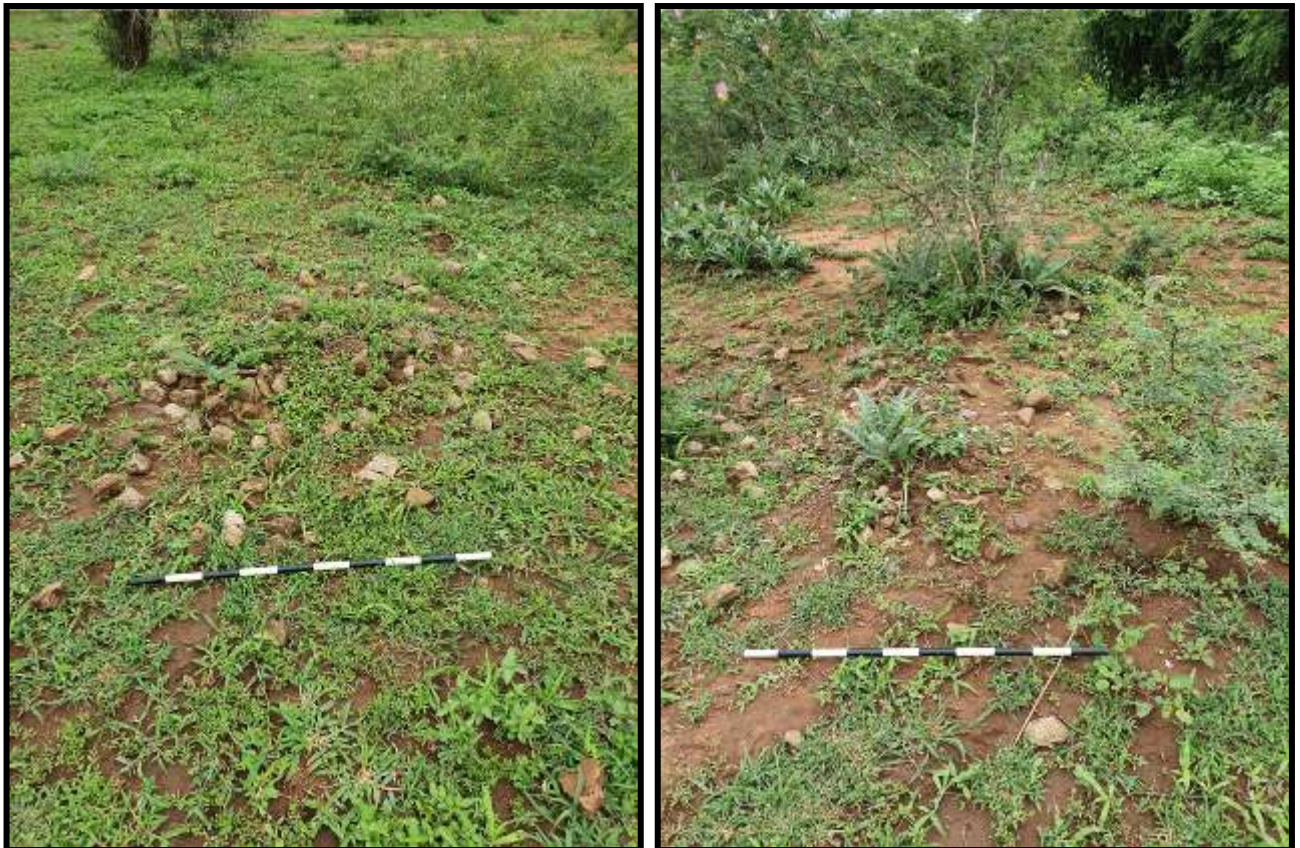
FIG. 46: CAIRNS AT MADO044

The site is located to the south of MADO032/033. The general site consists of a modern, currently used, house and some ruins to the east. Amongst the ruins are two stone cairns that resemble graves (fig. 46).

SAHRA Rating: 3A

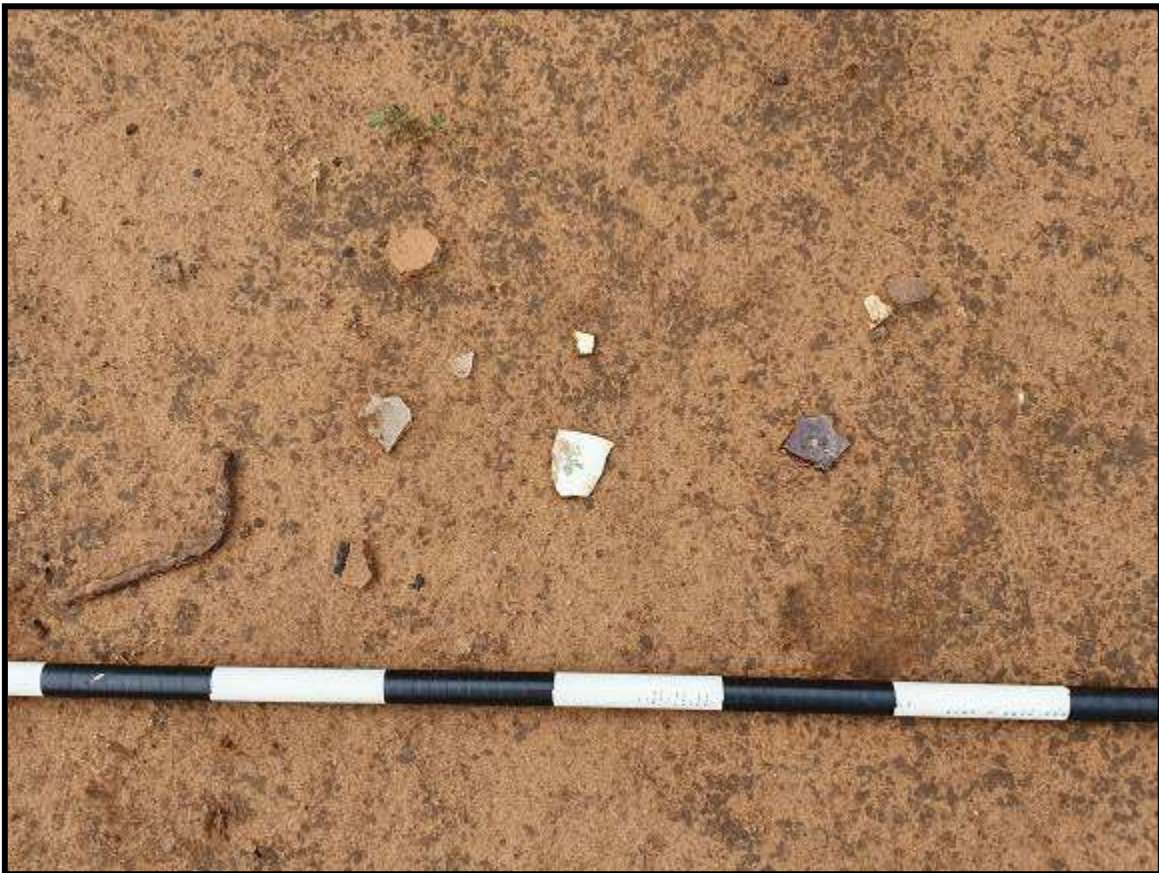
FIG. 47: SETTLEMENT AT MADO045

The site is located on a cleared area and is probably related to 'h26'. The site consists of house floors and modern artefacts (fig. 47). No graves were noted in the area.

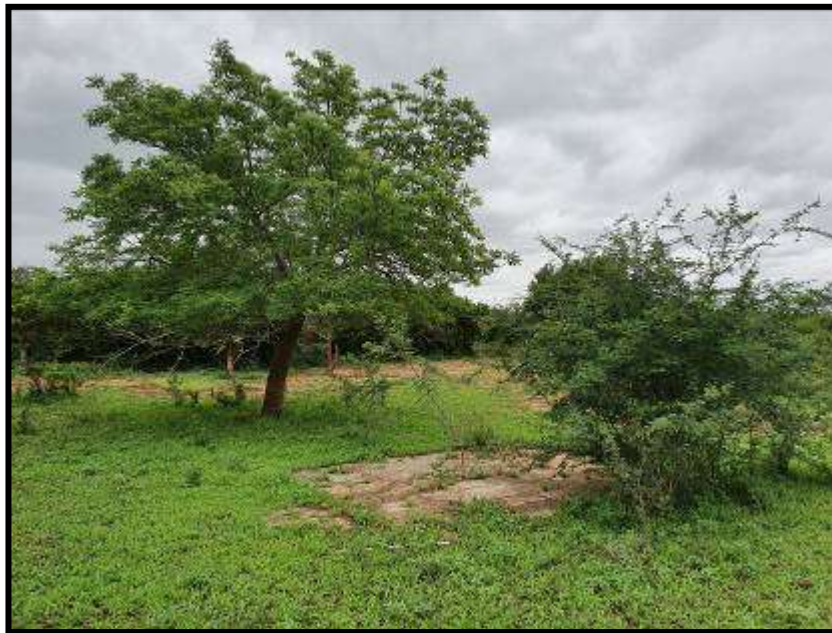
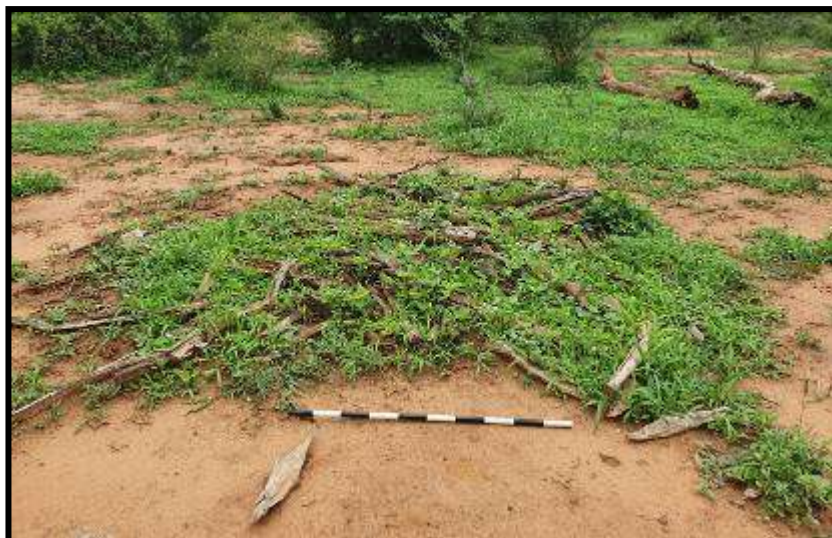
FIG. 49: OPENING AT MADO047

The site is located on the eastern side in a cleared area. The site consists of house floors and two possible graves (fig. 49). One graves has a cement covering, while the other is covered with wooden branches.

SAHRA Rating: 3A

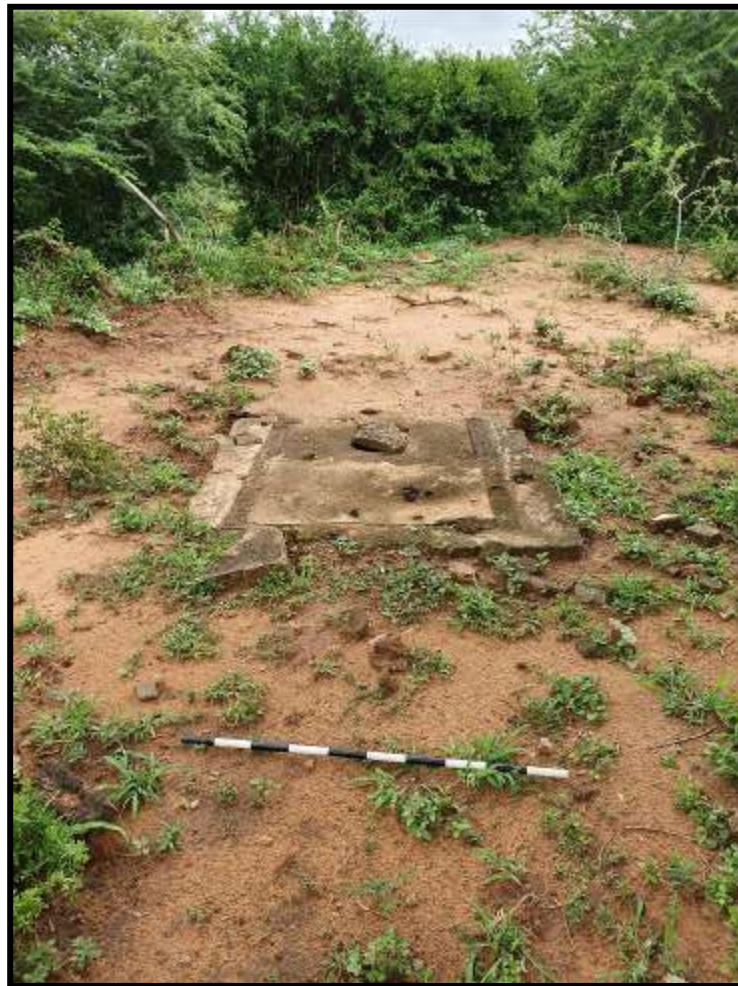
FIG. 50: GRAVE AT MADO048

The site is located 40m southwest of MADO47. It was separated as it appeared to be a different settlement and the grave was separate from the other graves. The site consists of a single grave (fig. 50).

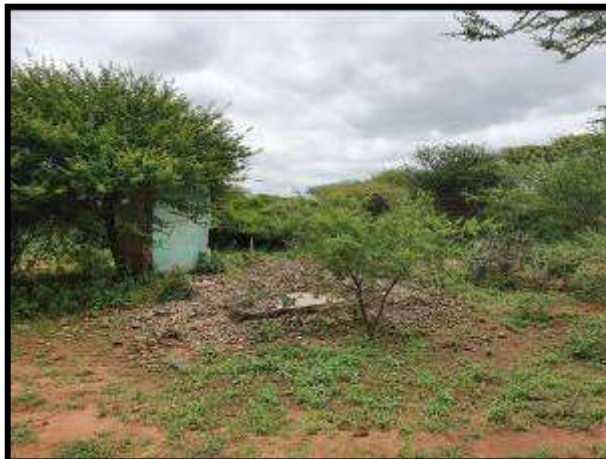
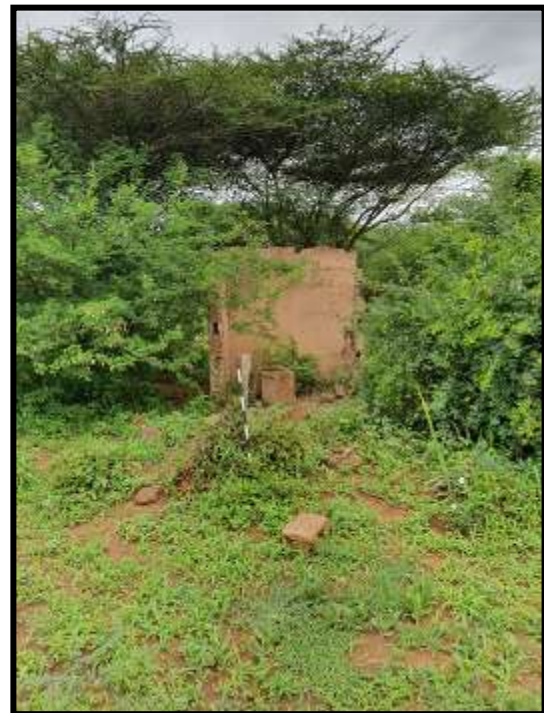
FIG. 51: MADO049

The site consists of two ruined buildings that appear to be of the same settlement (fig. 51). Modern artefacts occur on the surface. No graves were noted.

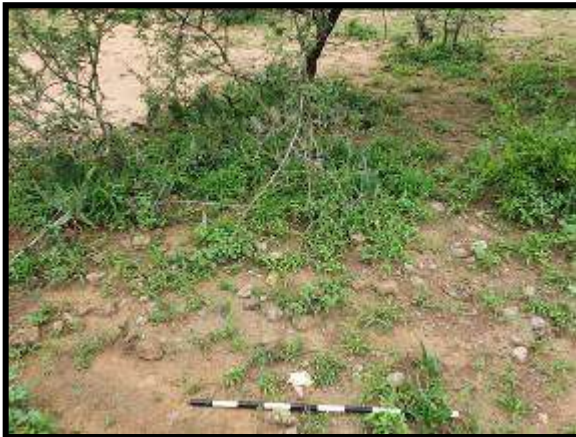
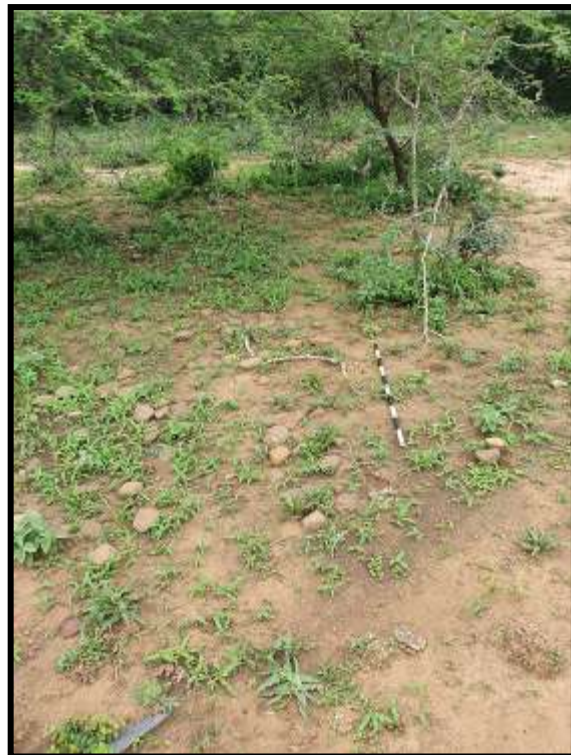
FIG. 53: GRAVES AT MADO051

The sites are located in a cleared area and are probably the same site now separated by vegetation regrowth. The site consists of two houses 30m apart (MADO052), and two potential graves (MADO051) near the entrance to the settlement from the road (fig. 53). The potential graves are stone cairns.

SAHRA Rating: 3A

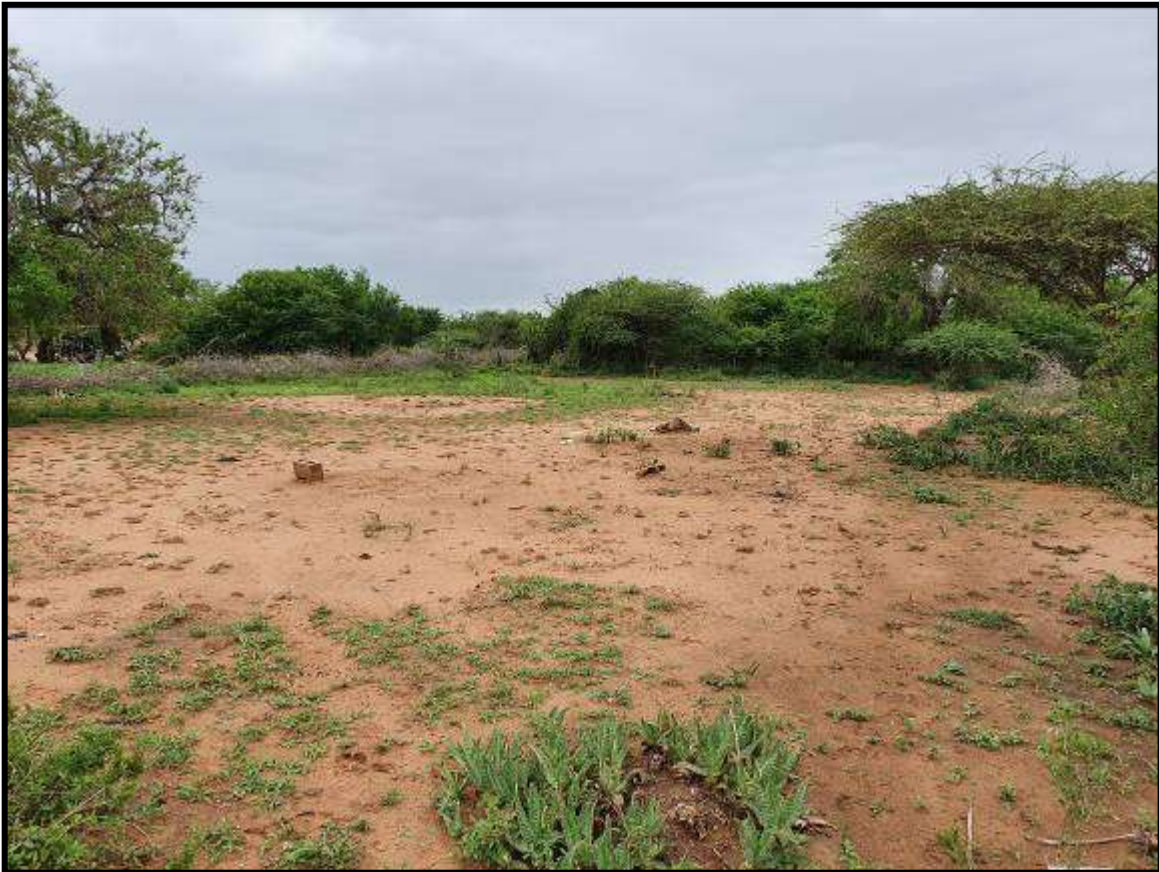
FIG. 54: MADO053

The site is located in an old clear area. The site consists of a recently abandoned settlement of a house floors and a 'long drop' (fig. 54). Modern artefacts were visible on the surface. No graves were noted.

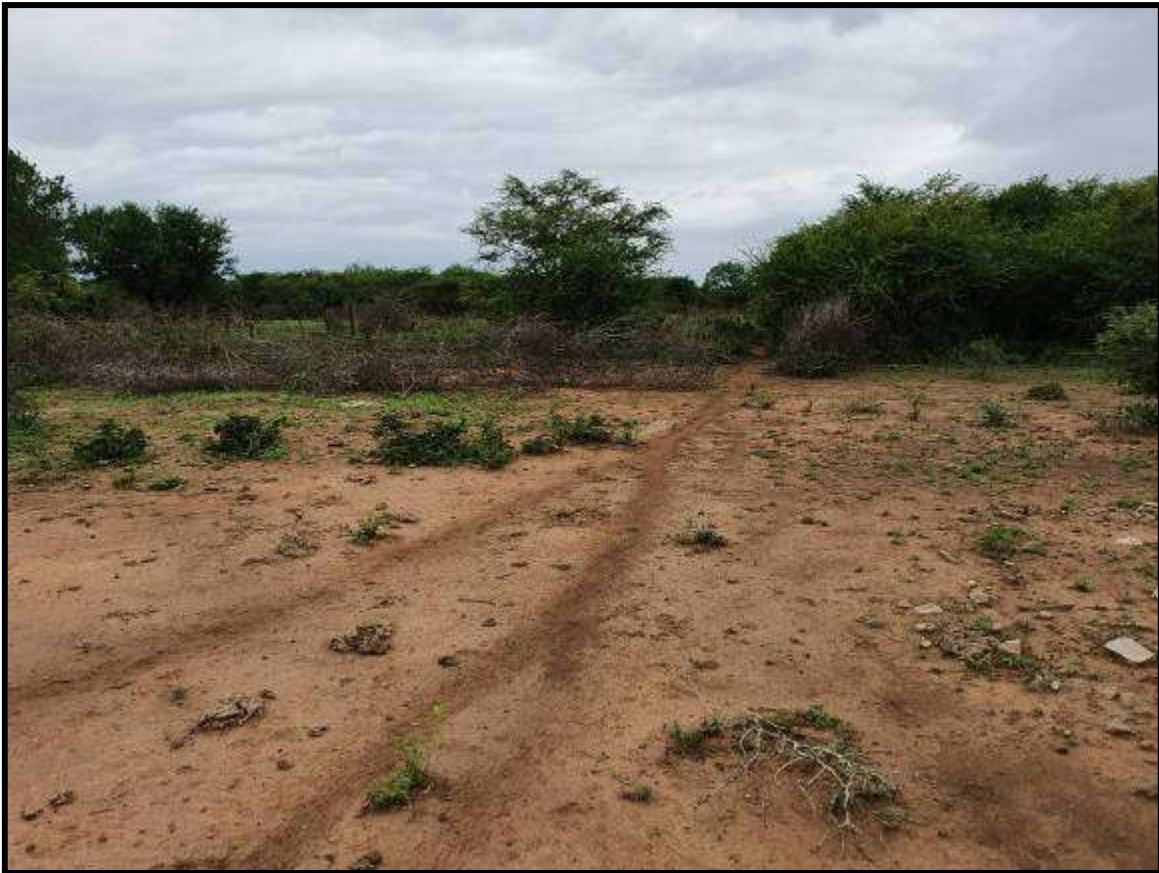
FIG. 56: MADO055

The site is located in a previously cleared area. The site consists of a single house floor (fig. 56). The artefacts at the settlement are modern, and not extensive.

SAHRA Rating: 3C

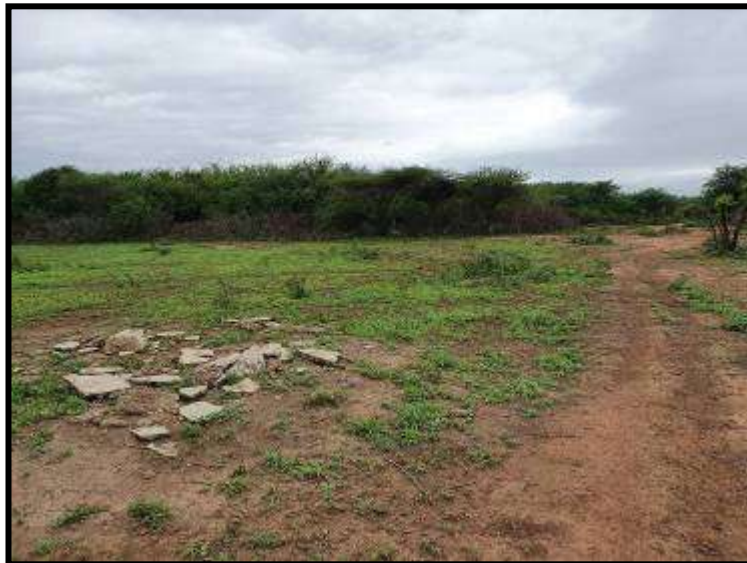
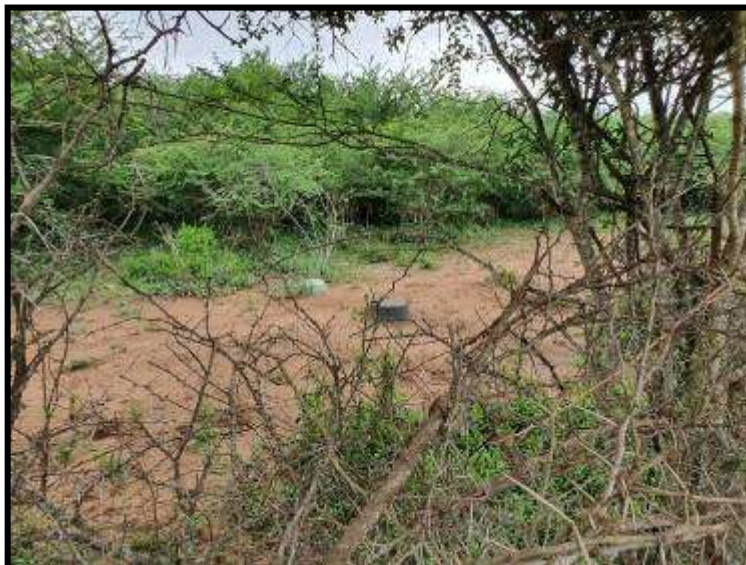
FIG. 57: MADO056

The site is located in a clear area northeast of MODO055. MAD056 consists of modern house remains and artefacts and two possible graves (fig. 57). The possible graves occur on the eastern side of the settlement.

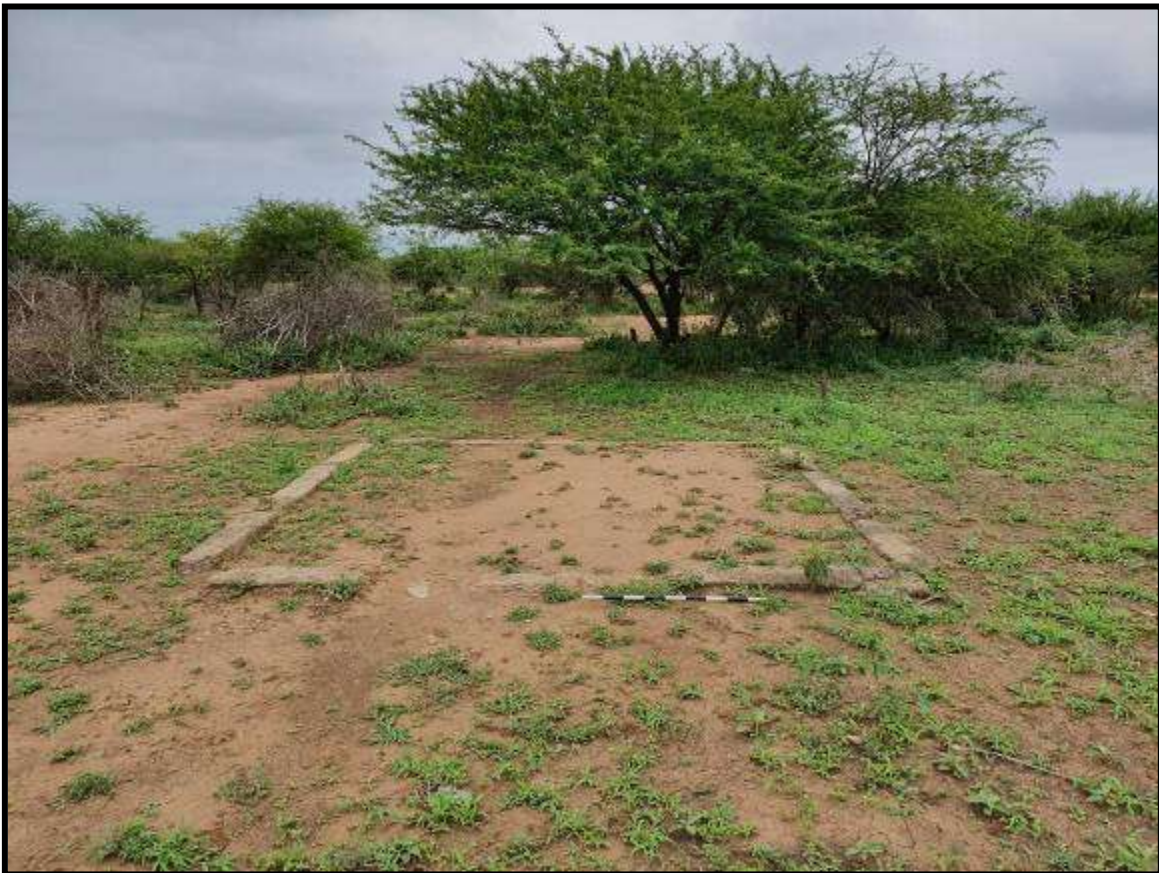
FIG. 58: MADO057

The site is located in the northern part of a cleared area. The site consists of a 3m x 3m outer foundation (fig. 58). This is either a foundation for a house, or for a (double) grave.
