**HERITAGE SURVEY OF THE PROPOSED MFUNDA
YOPHONGOLO IRRIGATION CLUSTER ONE
PROJECT, KZN**

FOR AFZELIA ENVIRONMENTAL CONSULTANTS

DATE: 30 NOVEMBER 2019

**Umlando: Archaeological Surveys and Heritage
Management**

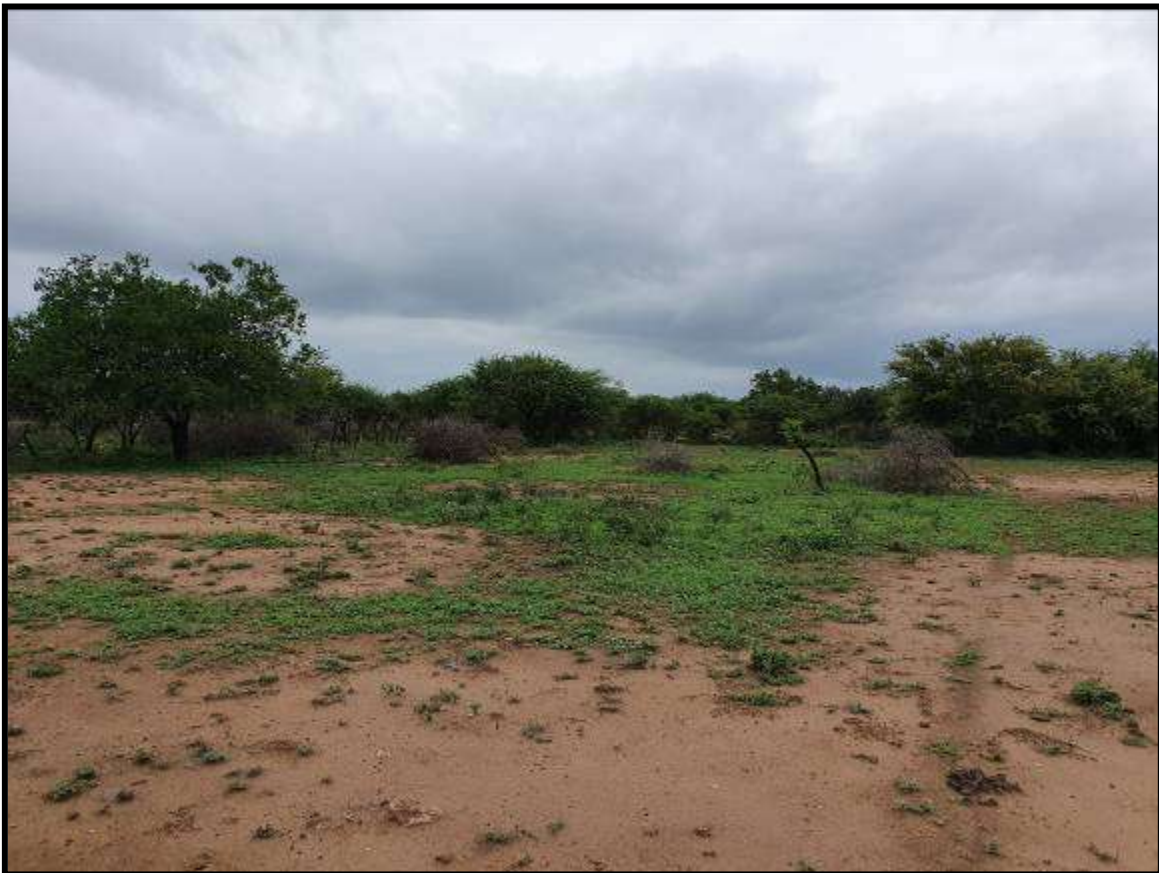
FIG. 59: MADO058

The site consists of several house floors and modern artefacts (fig. 59). The site postdates the 1989 as a 10c coin with an arum lily was noted at the one house. No human graves were found.

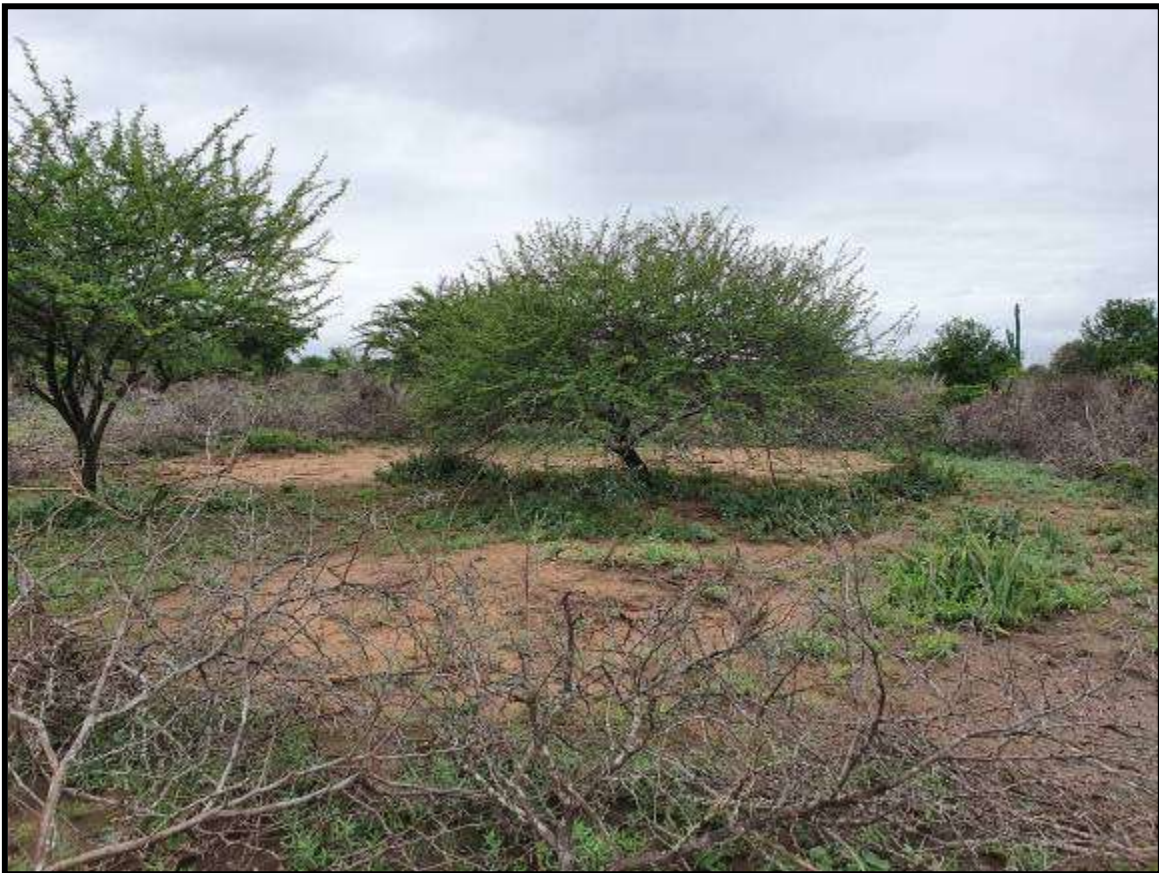
FIG. 60: MADO059

The site is located ~40m south of MADO058 in the same cleared area. The site consists of three graves under the *Acacia spp.* (fig. 60).

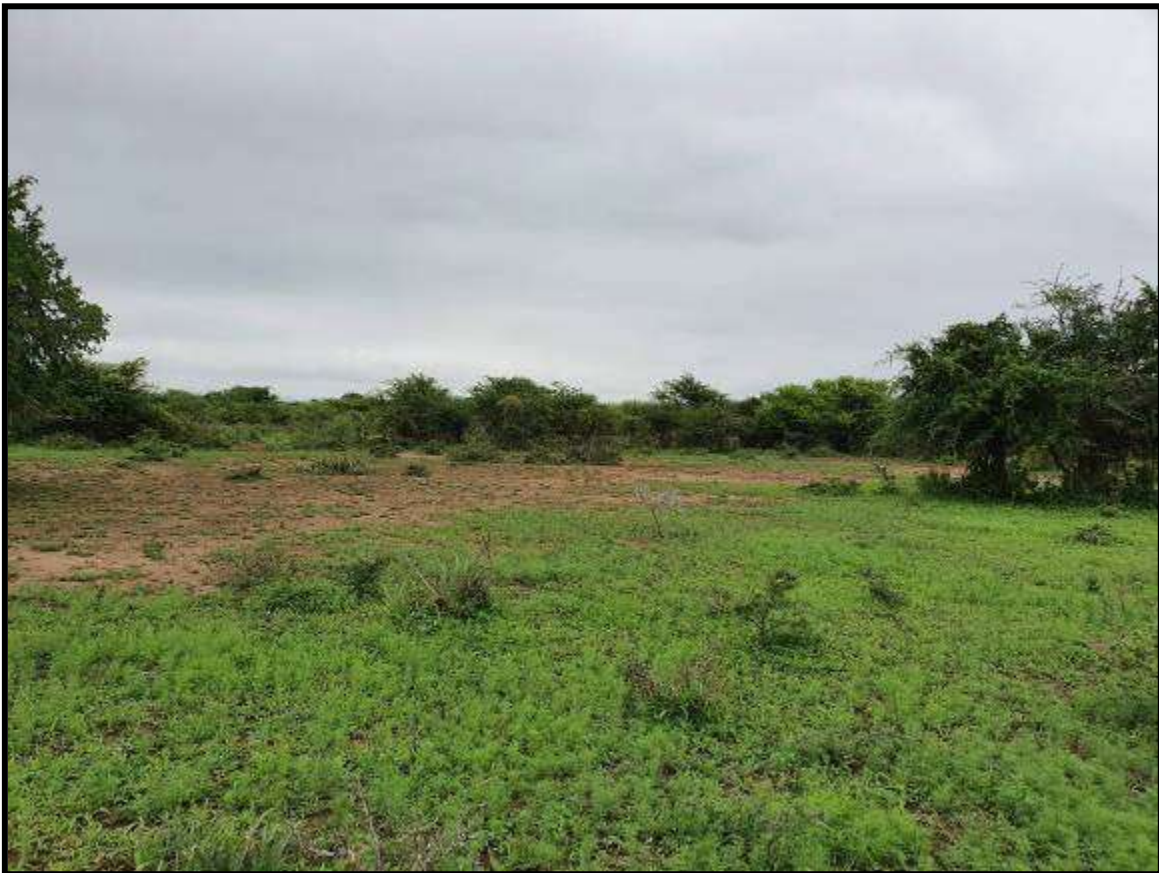
FIG. 61: MADO060

The site consists of a few house floors and modern artefacts (fig. 61). No human graves were noted.

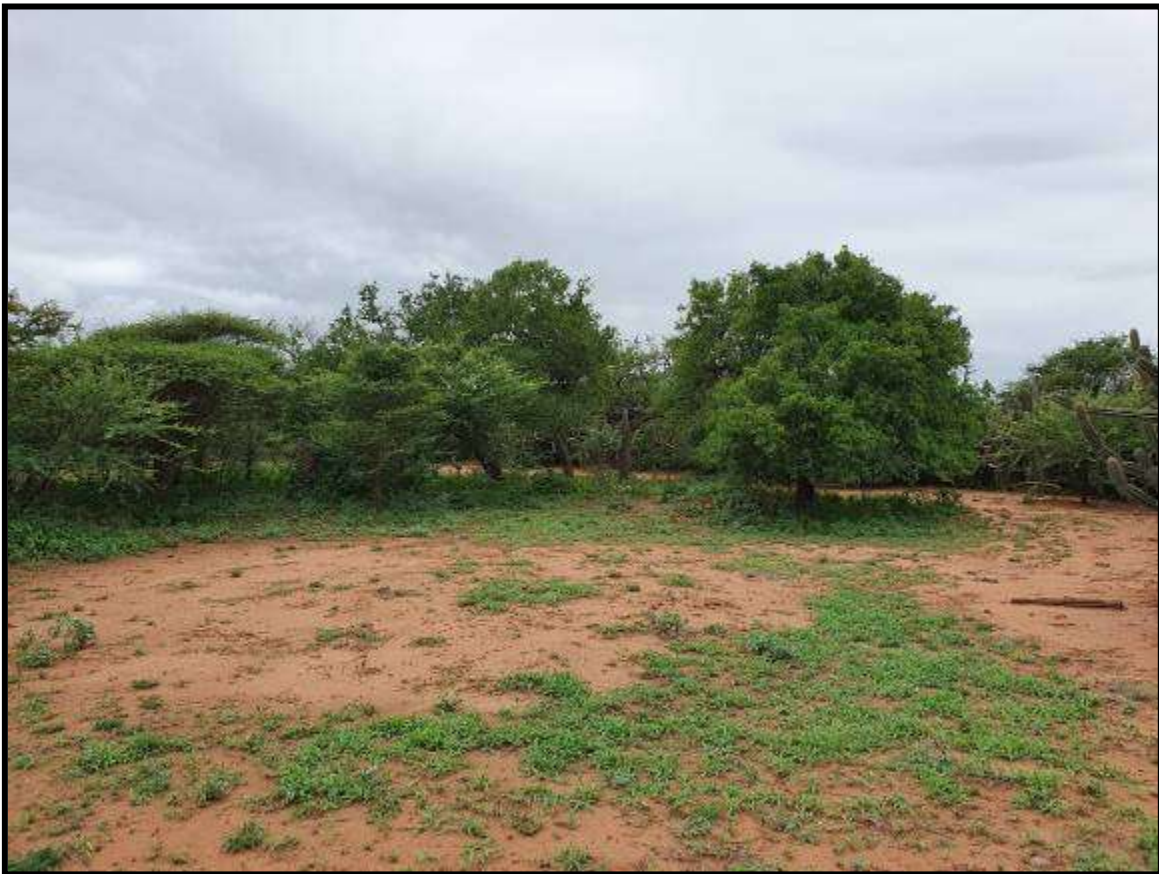
FIG. 63: MADO062

The site is located in a cleared area in the thornbush. The site consists of a settlement and possible grave (fig. 63). Modern artefacts occur in the area.

SAHRA Rating: 3A

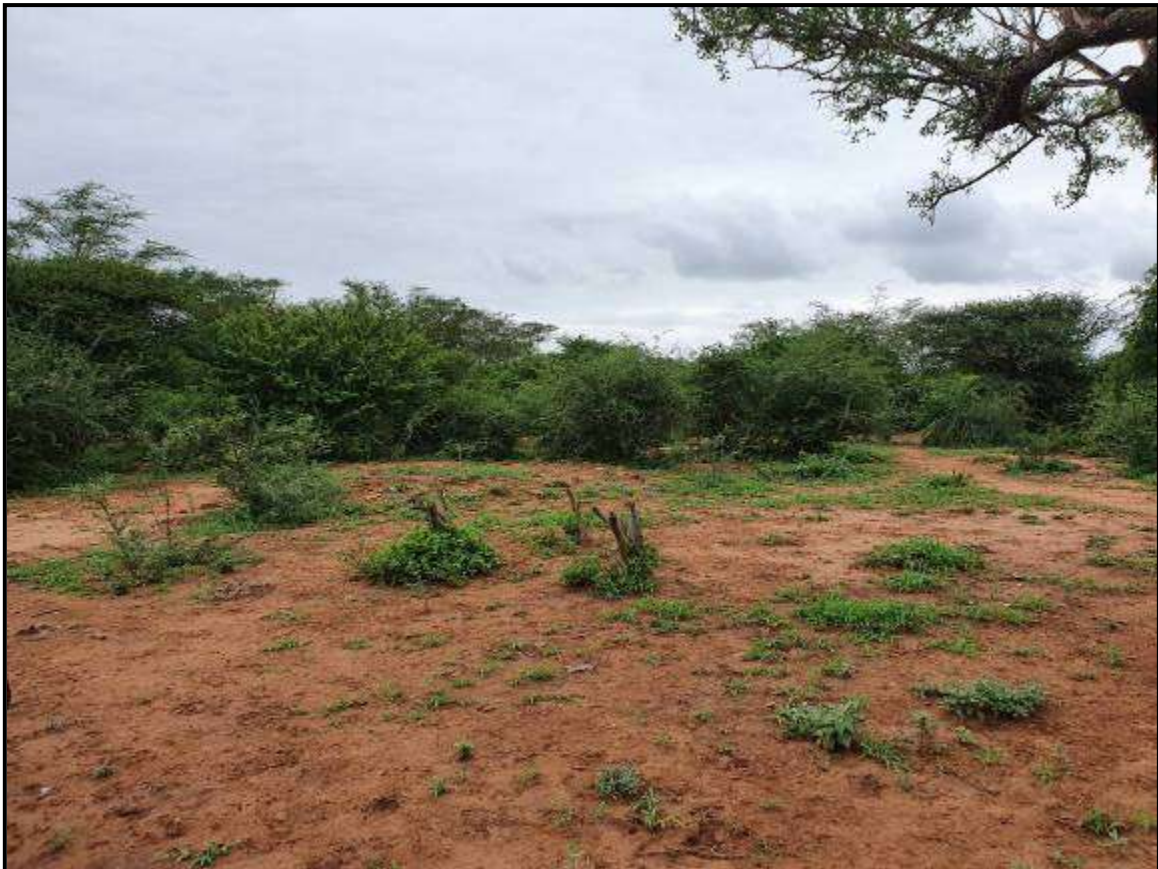
FIG. 64: MADO083

The site is located next to the main access road and in a cleared area. The site consists of a settlement with house floors and modern artefacts (fig. 64). No graves were observed.

SAHRA Rating: No further mitigation is required.

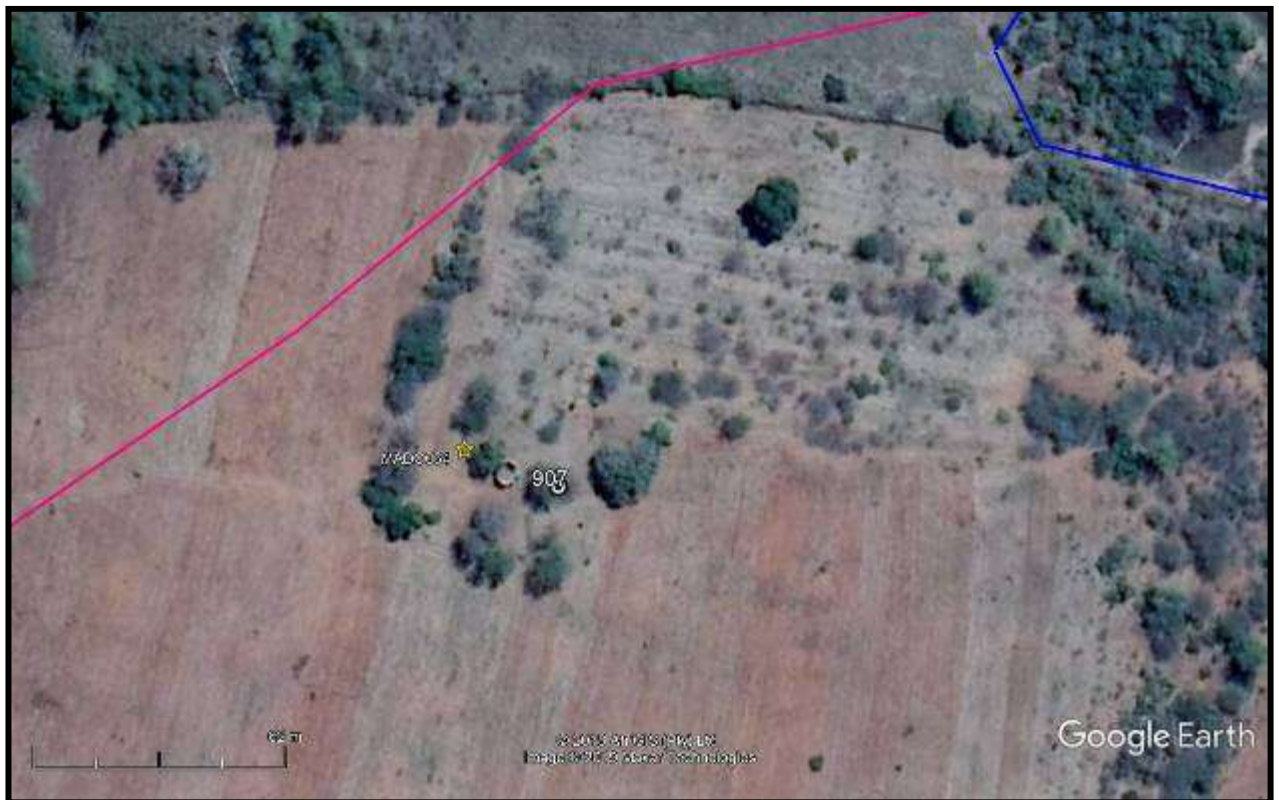
FIG. 65: MADO064

The site is located on the western side of the study area. The site was not accessible due to dense vegetation. The site consists is a settlement in a previously ploughed area (fig. 65).

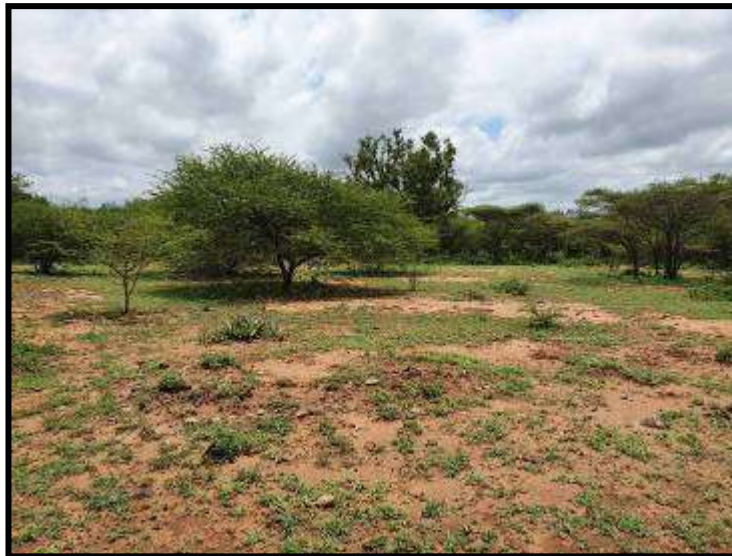
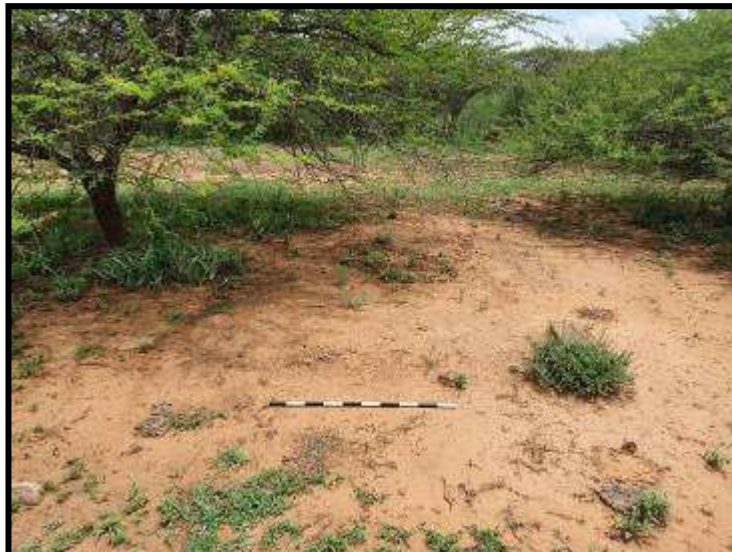
FIG. 66: SETTLEMENT AND GRAVES AT MADO065

The site is located in a cleared area in the thornbush. The site consists of recent settlement with house floors, modern artefacts and two graves (fig. 66).

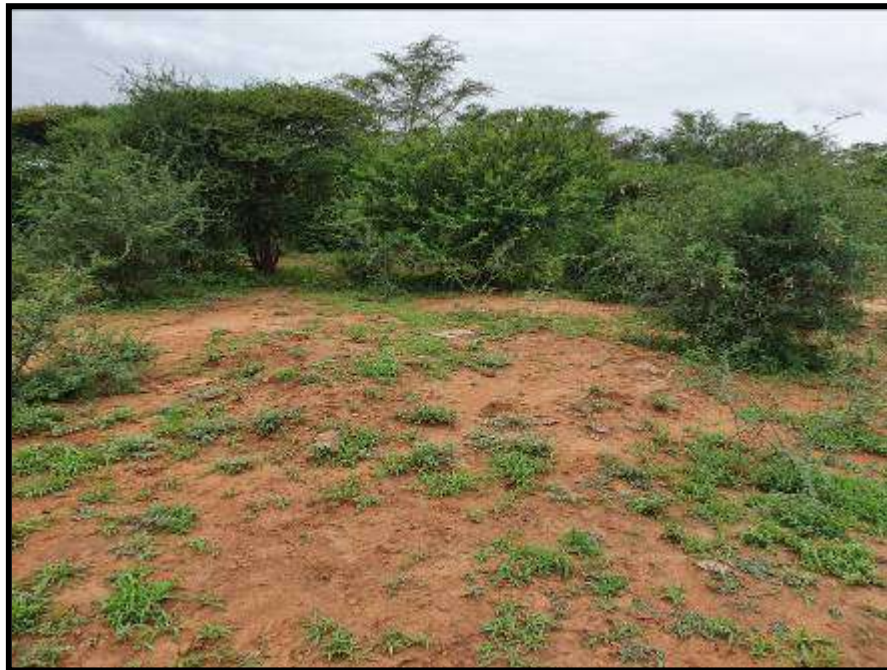
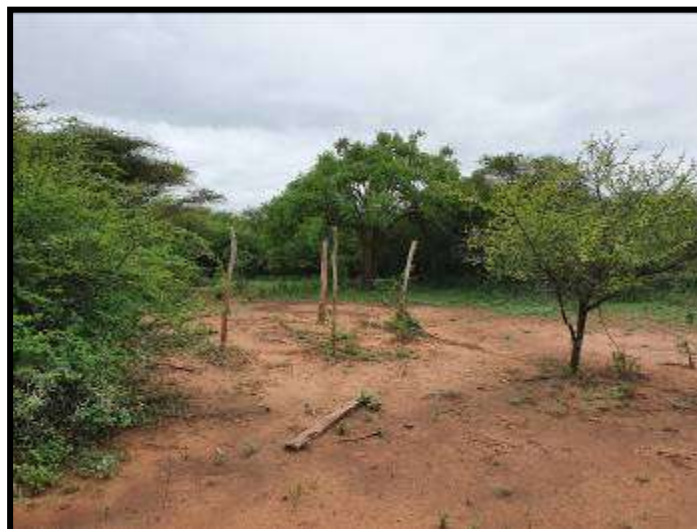
FIG. 65: MADO064

The site is located in a cleared area into the thornbush. The site consists of pottery, modern ceramics, glass and house foundations (fig. 65). The site shares the same location as 'h41'. No graves were noted.

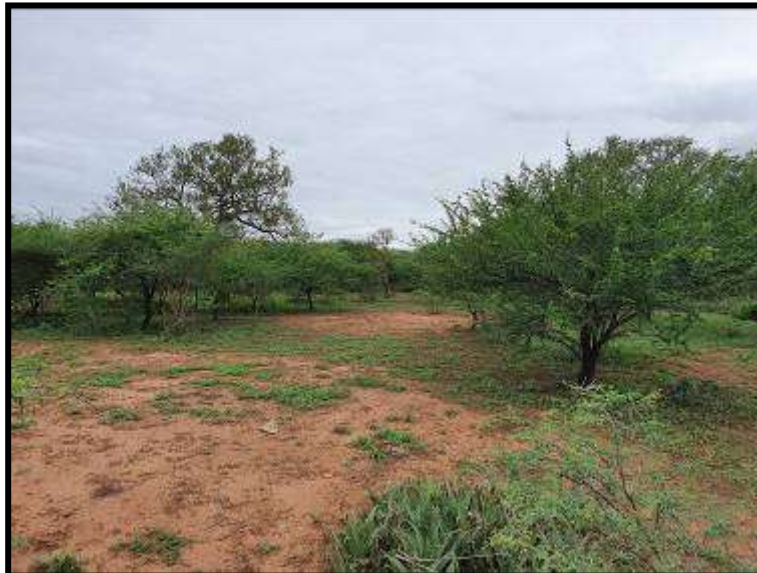
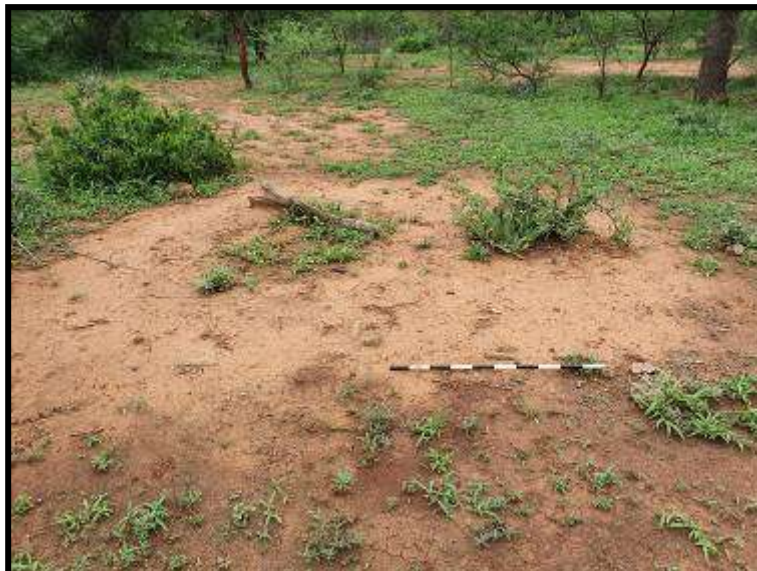
FIG. 68: MADO067

The site is located in a cleared area in the thornbush. The site consists of settlement with two possible unmarked human graves (fig. 68). Modern artefacts occur in the settlement.

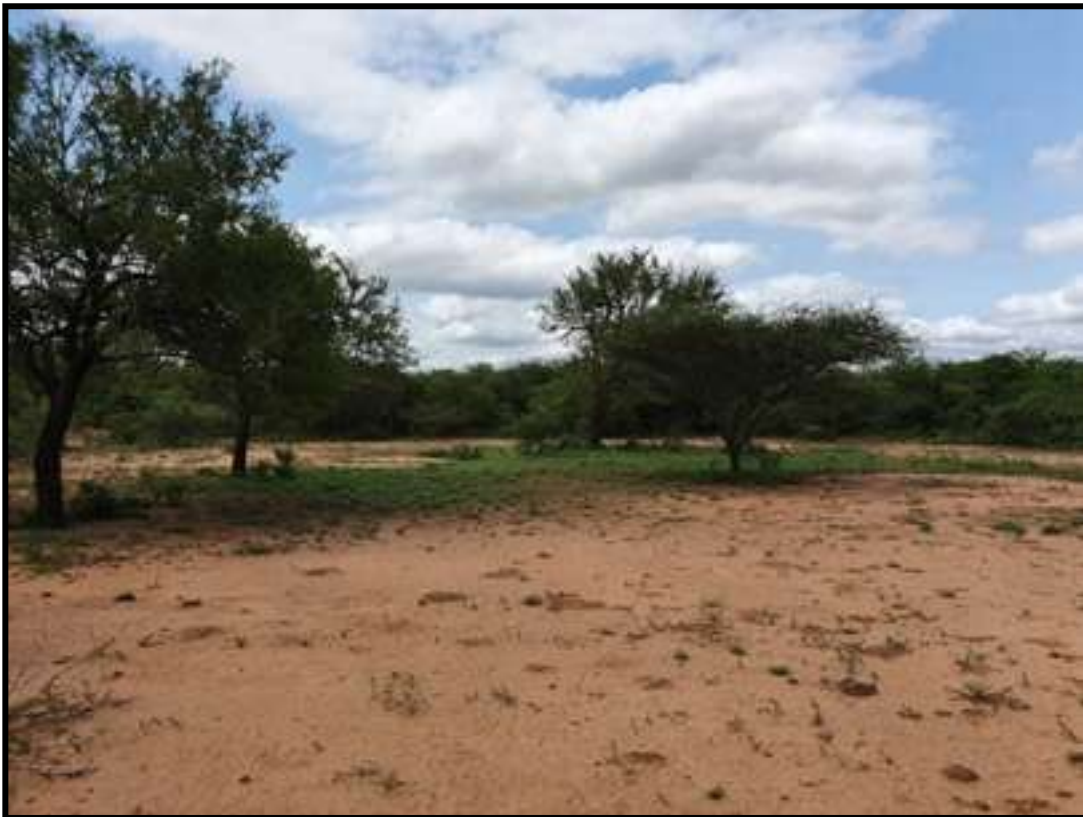
FIG. 69: MADO068

The site is located next to a main access road and in a cleared area. The site consists of settlements with house floors and modern artefacts (fig. 69). No human graves were noted.

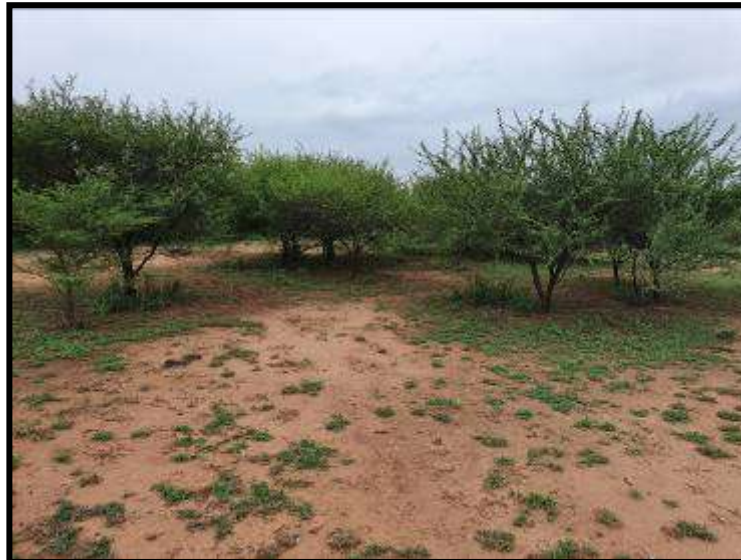
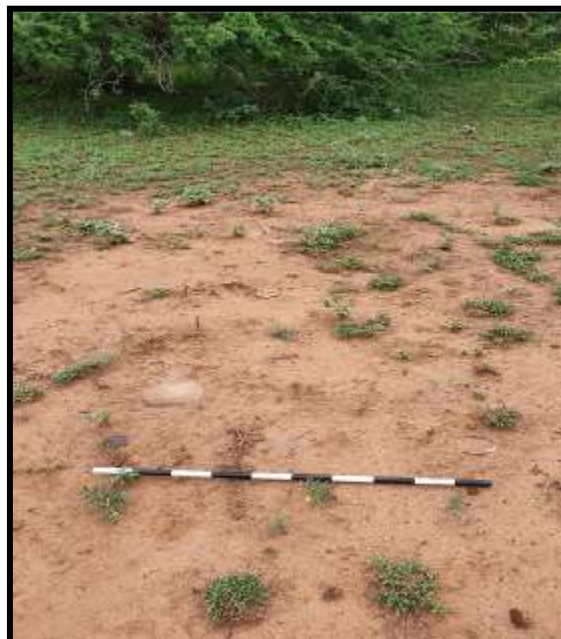
FIG. 70: SETTLEMENT AND HOUSE FLOOR AT MADO069

The site is located in a cleared area in the thornbush and on the edge of an agricultural field. The site is associated with 'h45'. The site consists of a settlement with house floors and modern artefacts (fig. 70). No graves were noted. MADO070 is probably an extension of this settlement.

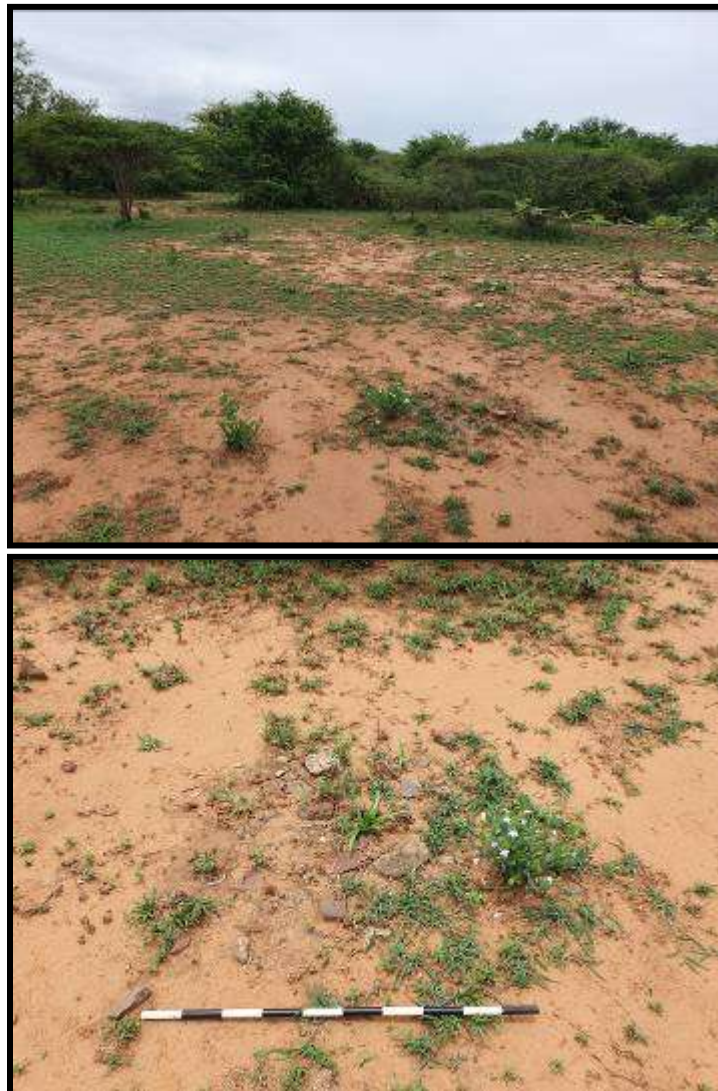
FIG. 72: SETTLEMENT AND GRAVE AT MADO071

The site is located in a cleared area besides the road. The site consists of a settlement with house floors and modern artefacts (fig. 72). A stone cairn occurs in the northeastern part of the site and it is possibly a grave.

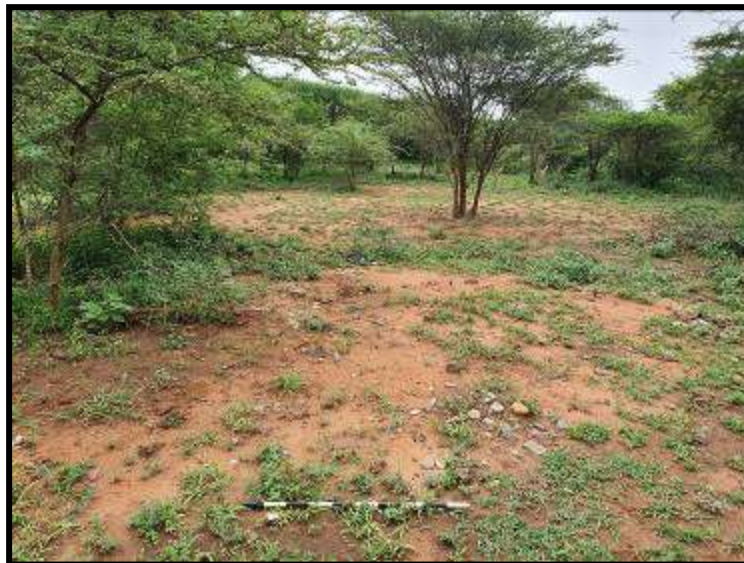
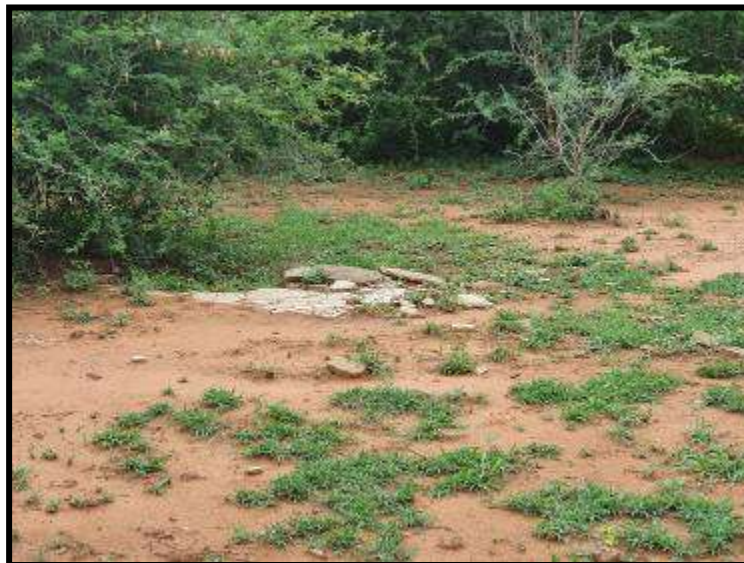
FIG. 73: MADO072

The site is located on the edge of a ploughed field. The site consists of a settlement with house floors, modern artefacts and a possible grave (or small floor) (fig. 73).

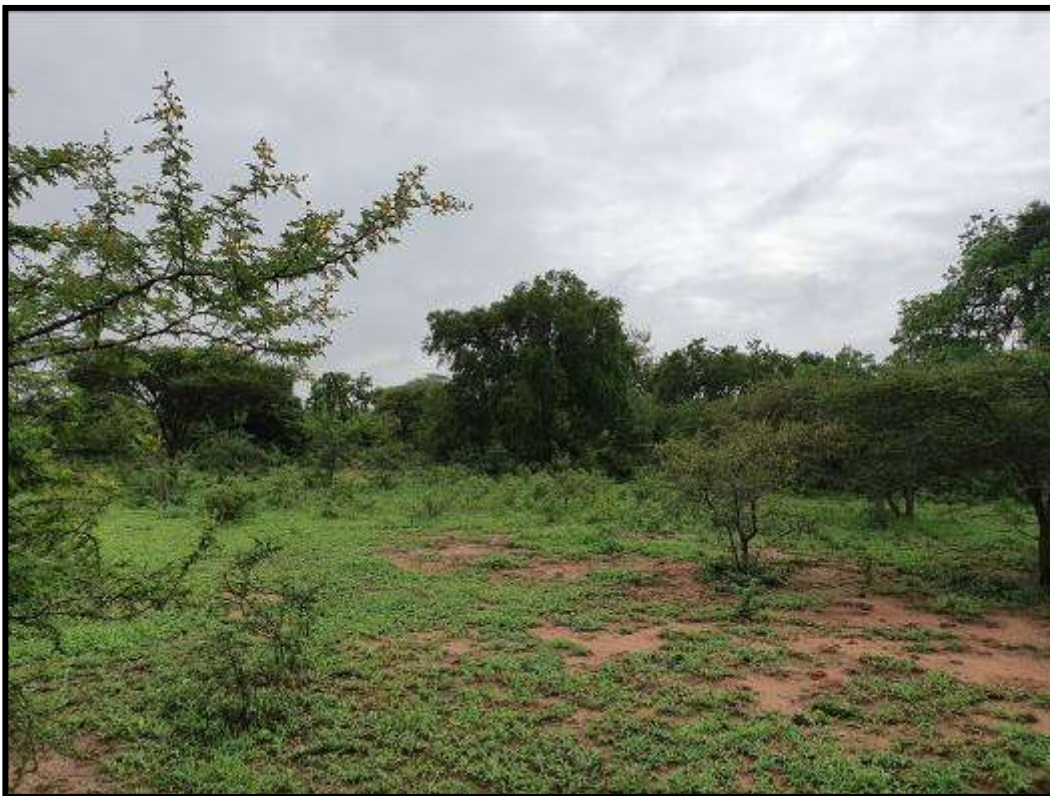
FIG. 74: MADO073

The site is located in a cleared area near the main track. The site consists of a settlement with modern artefacts and house floors (fig. 74). No human graves were noted.

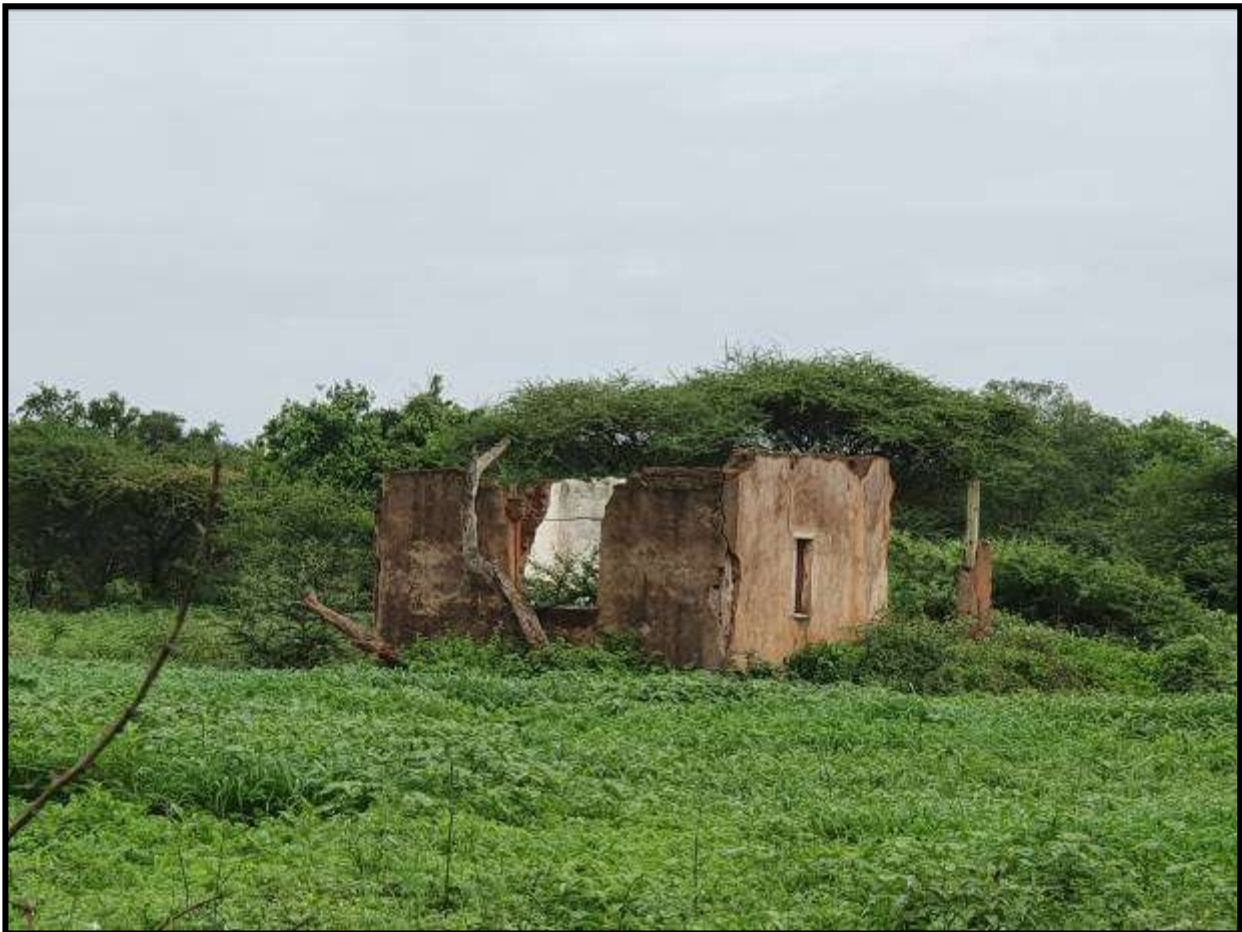
FIG. 75: MADO074

The site is located in the middle of a fallow agricultural field. The site consists of a single main house (fig. 75). There was no access to the overgrown field, but Google Earth imagery indicates three smaller houses nearby.

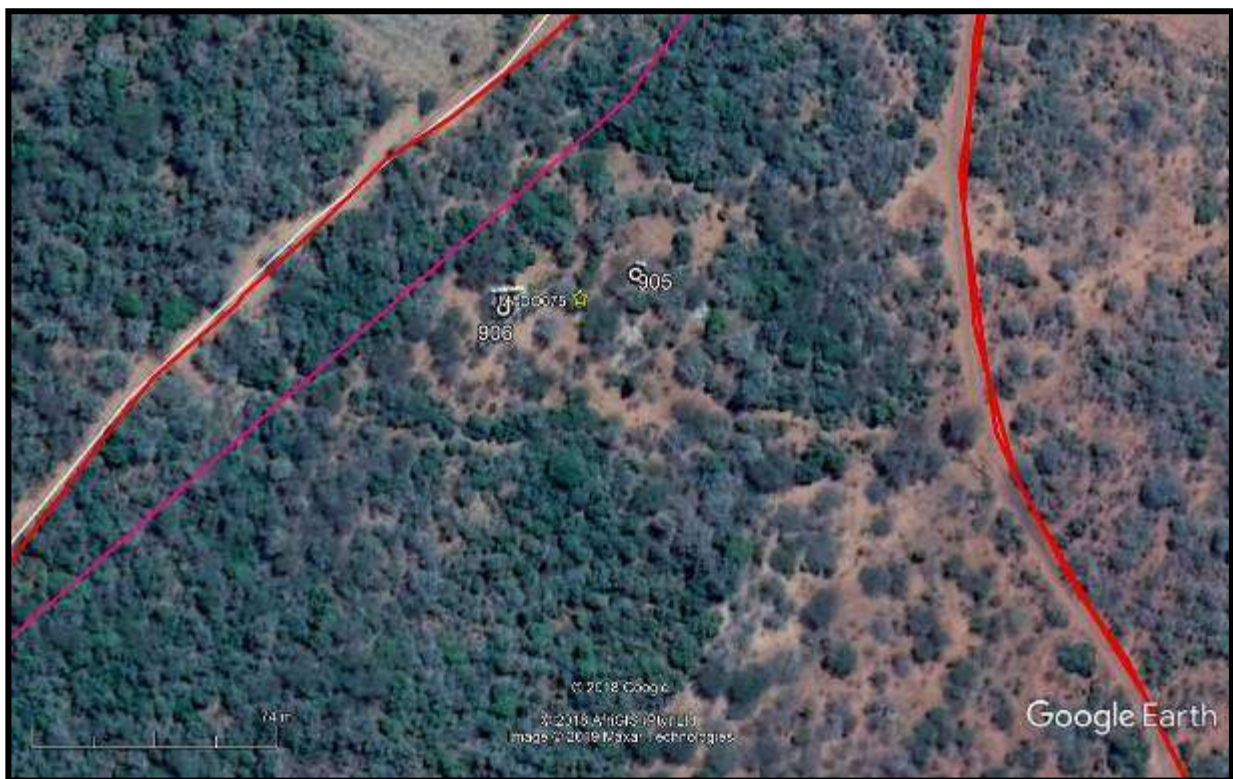
The site is located within a thornbush thicket with no access. There are two abandoned houses at the site.

FIG. 76: AERIAL IMAGE OF MADO075

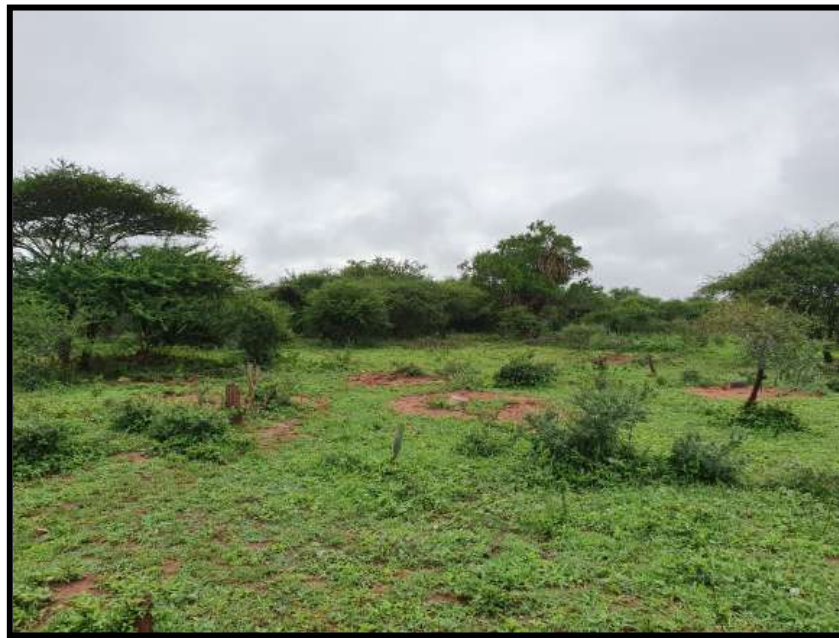
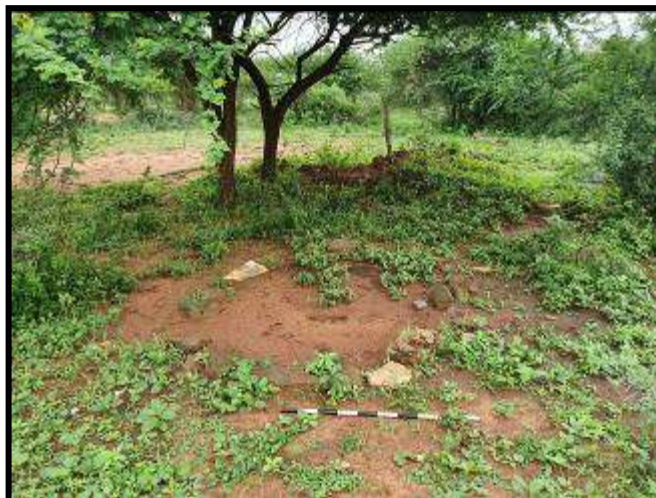
The site is located on the edge of an agricultural field and near a wetland. The site might be associated with 'h60'. The site consists of a settlement with house floors, modern artefacts and a possible grave (fig. 77).

FIG. 77: SETTLEMENT AND GRAVE AT MADO076

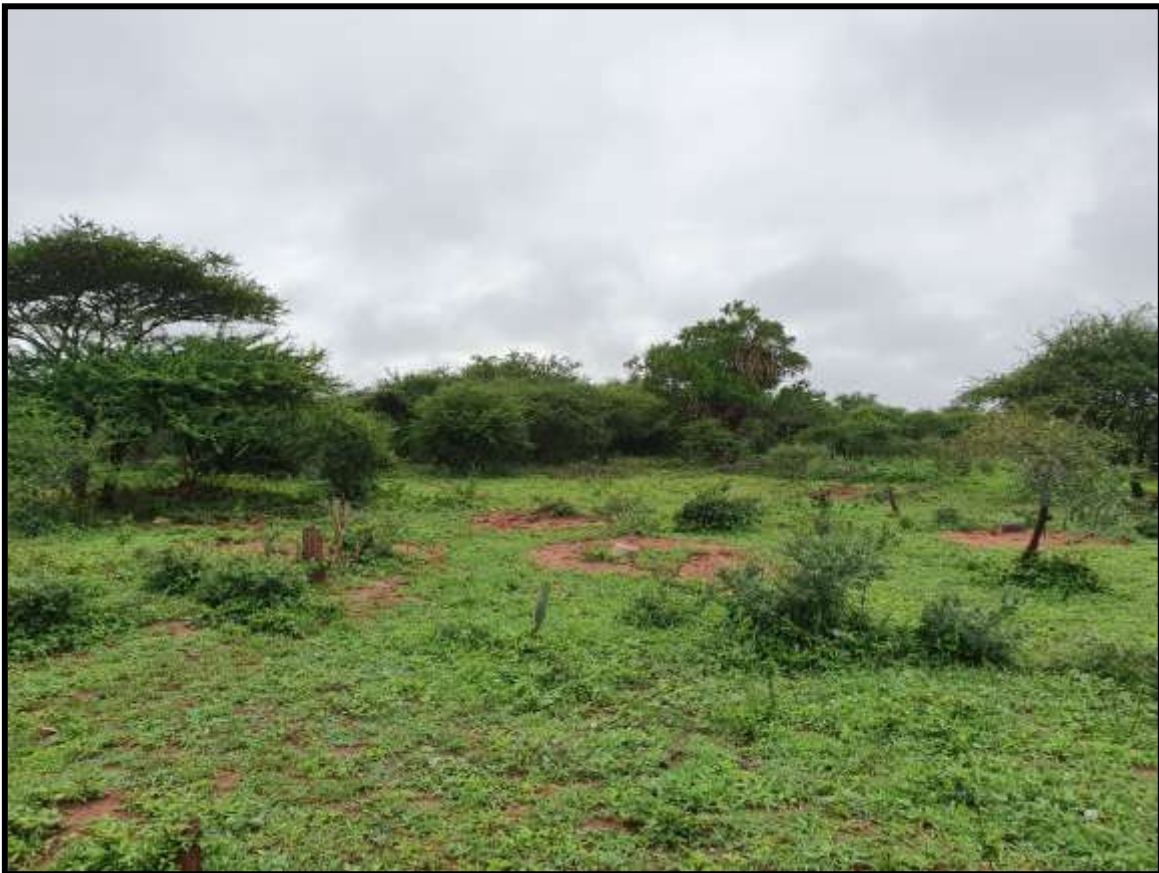
FIG. 78: MADO077

The site is located near the main track and in a semi-cleared area. The site consists of several house floors and modern artefacts (fig. 78). No graves were noted in the area.

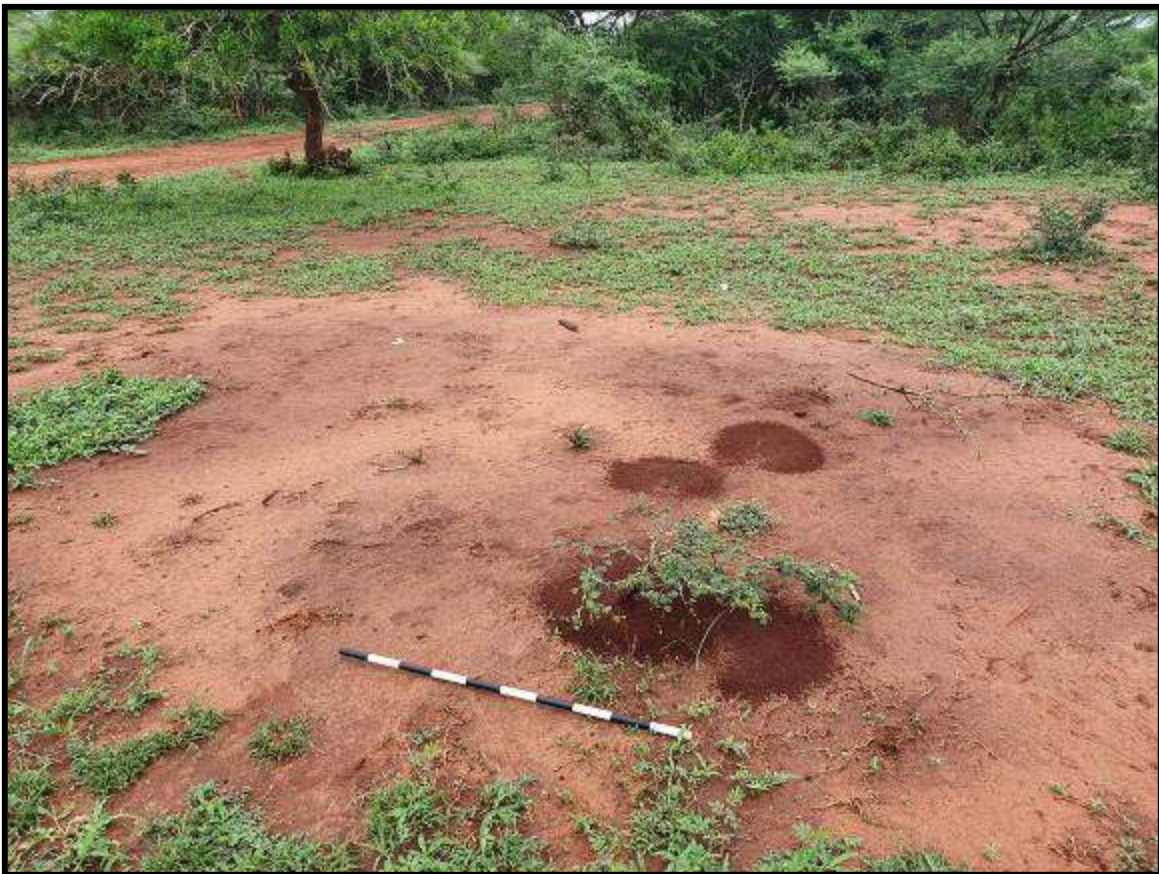
FIG. 78: MADO079

The site is located next to the main track. The site consists of a single house floor (fig. 79). No graves were noted.

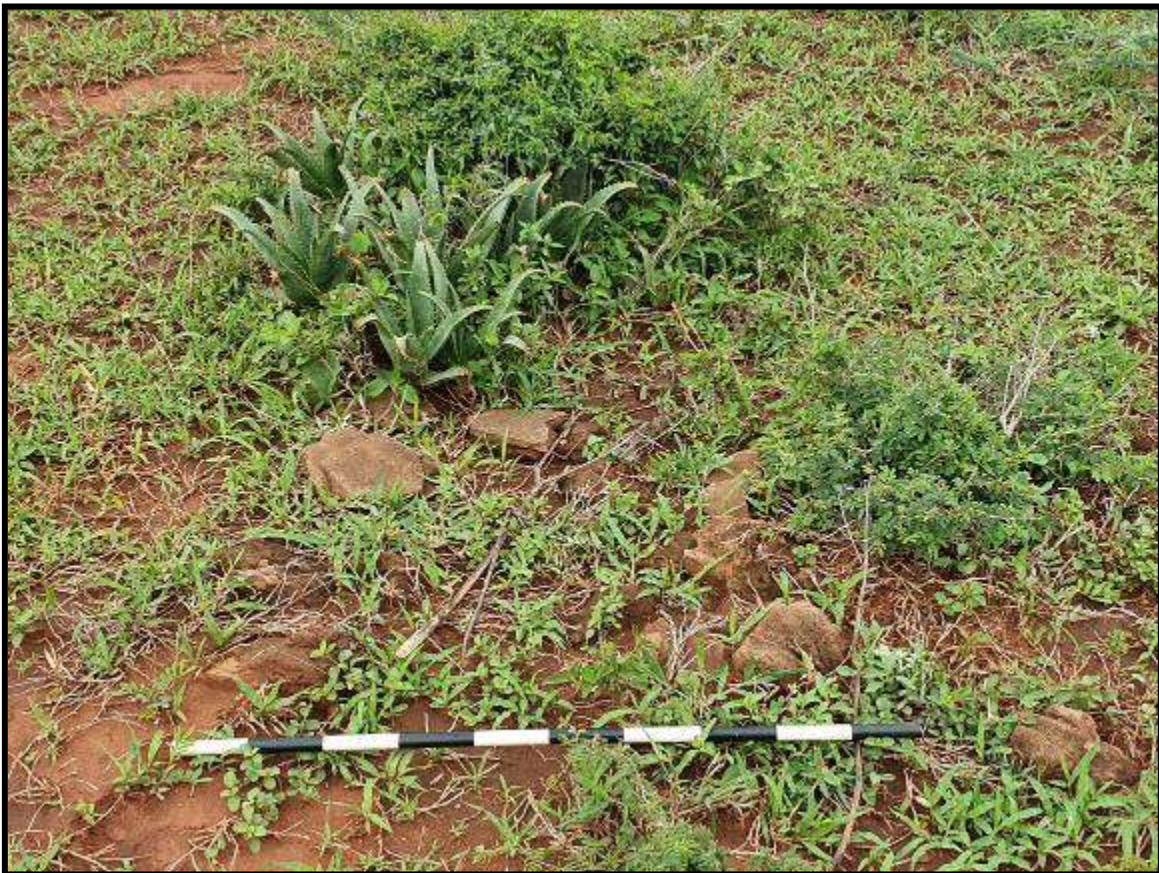
FIG. 80: POSSIBLE GRAVE AT MADO079

The site consists of a stone cairn that could be a grave (fig. 80). No other features were noted, but the area is consistent with other settlements.

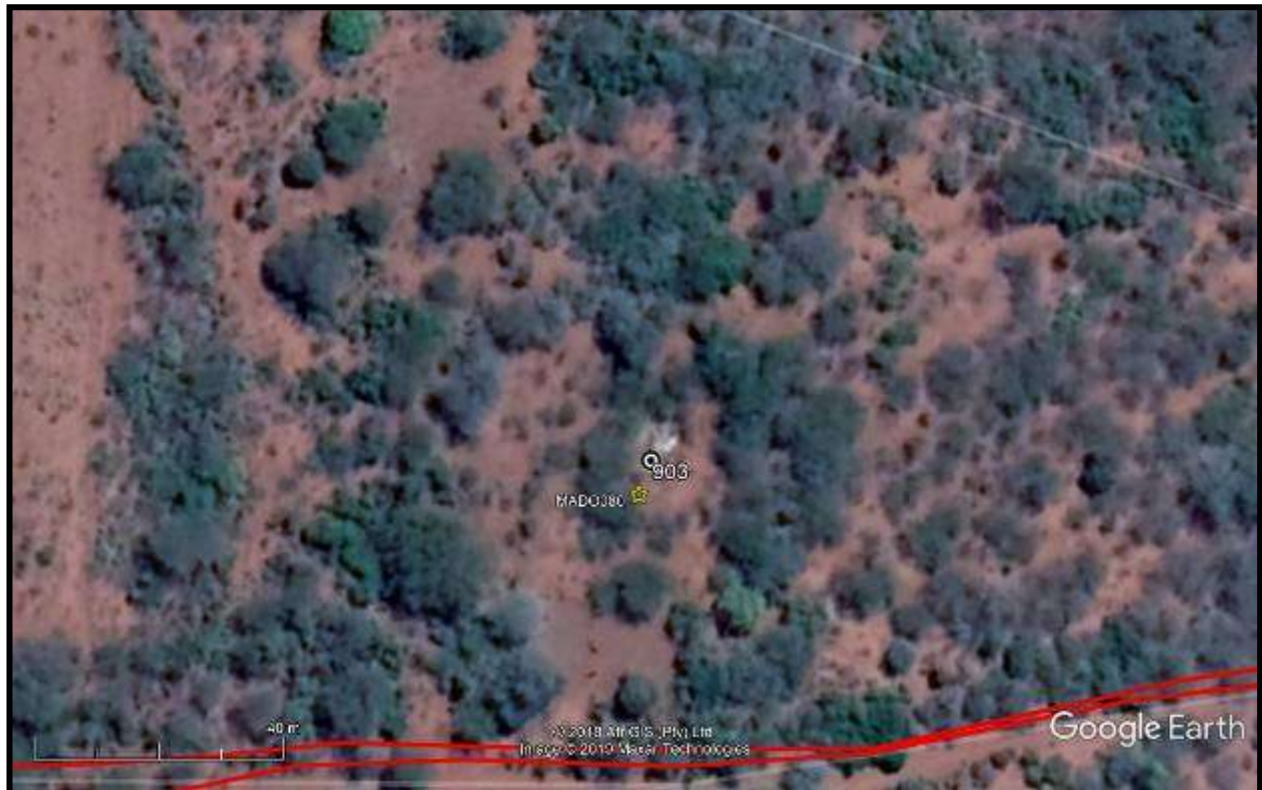
FIG. 81: MADO080

The site is located in the middle of an *Acacia spp.* thicket. There was no access to the site. The site consists of a single house (fig. 81).

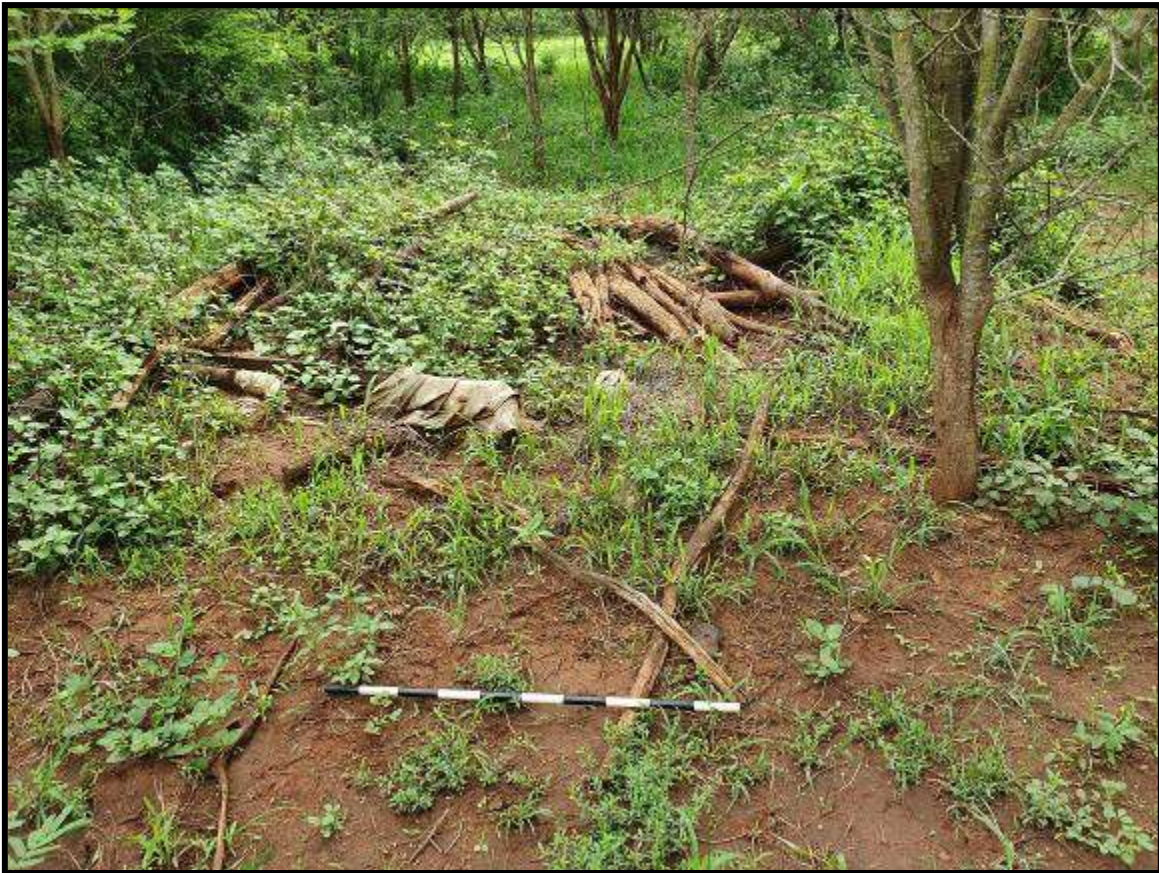
FIG. 82: MADO081

The site is located in an *Acacia spp.* regrowth area. The site consists of two recently abandoned houses. The one house was made from wooden poles (fig. 82). No graves were noted.

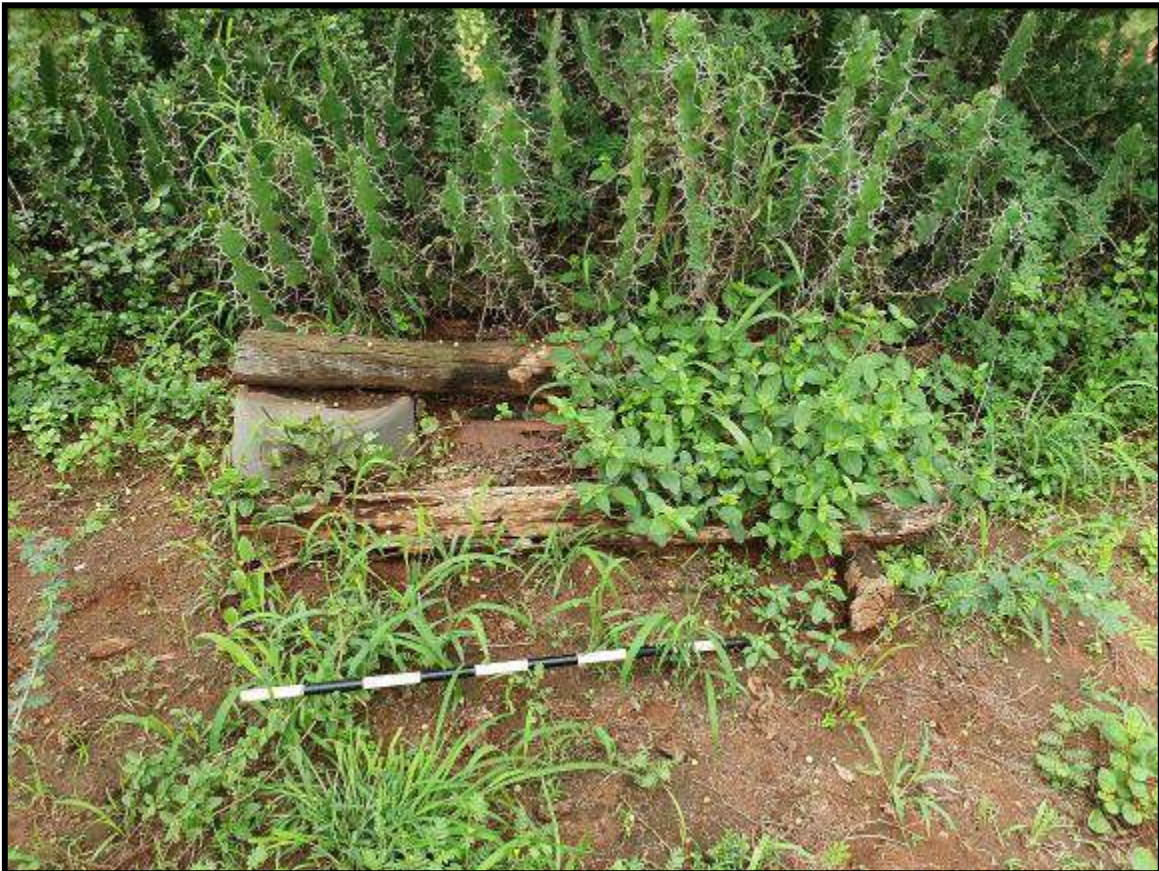
The site is located near the main track and south of MADO82. The site consists of several shortened wooden poles that are covering a hole in the ground (fig. 83). This is probably a grave.

FIG. 83: GRAVE AT MADO083
