**HERITAGE SURVEY OF THE PROPOSED MFUNDA
YOPHONGOLO IRRIGATION CLUSTER ONE
PROJECT, KZN**

FOR AFZELIA ENVIRONMENTAL CONSULTANTS

DATE: 30 NOVEMBER 2019

**Umlando: Archaeological Surveys and Heritage
Management**

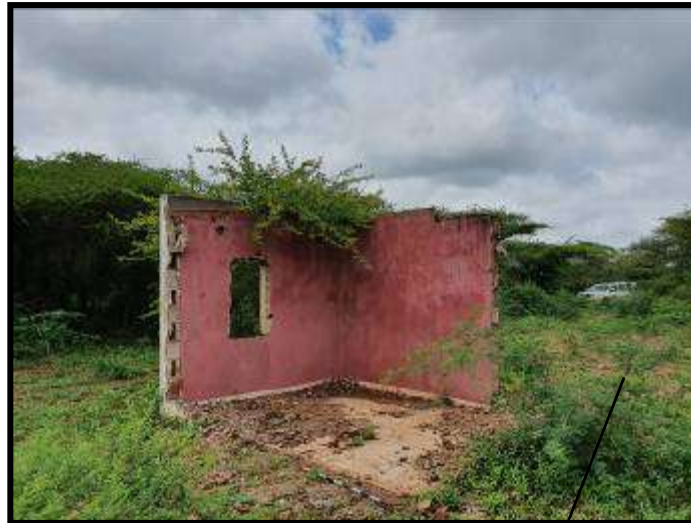
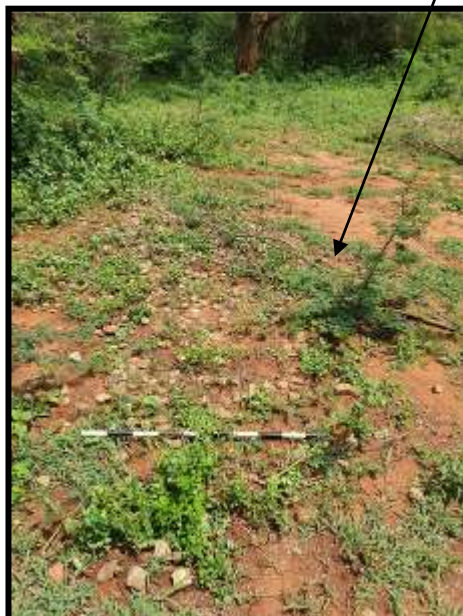
FIG. 84: MADO084 & MADO095

The site is located next to a main track. The site consists of two houses (MADO084), modern artefacts, and a stone cairn (MADO085) (fig. 84). The stone cairn might be a grave.

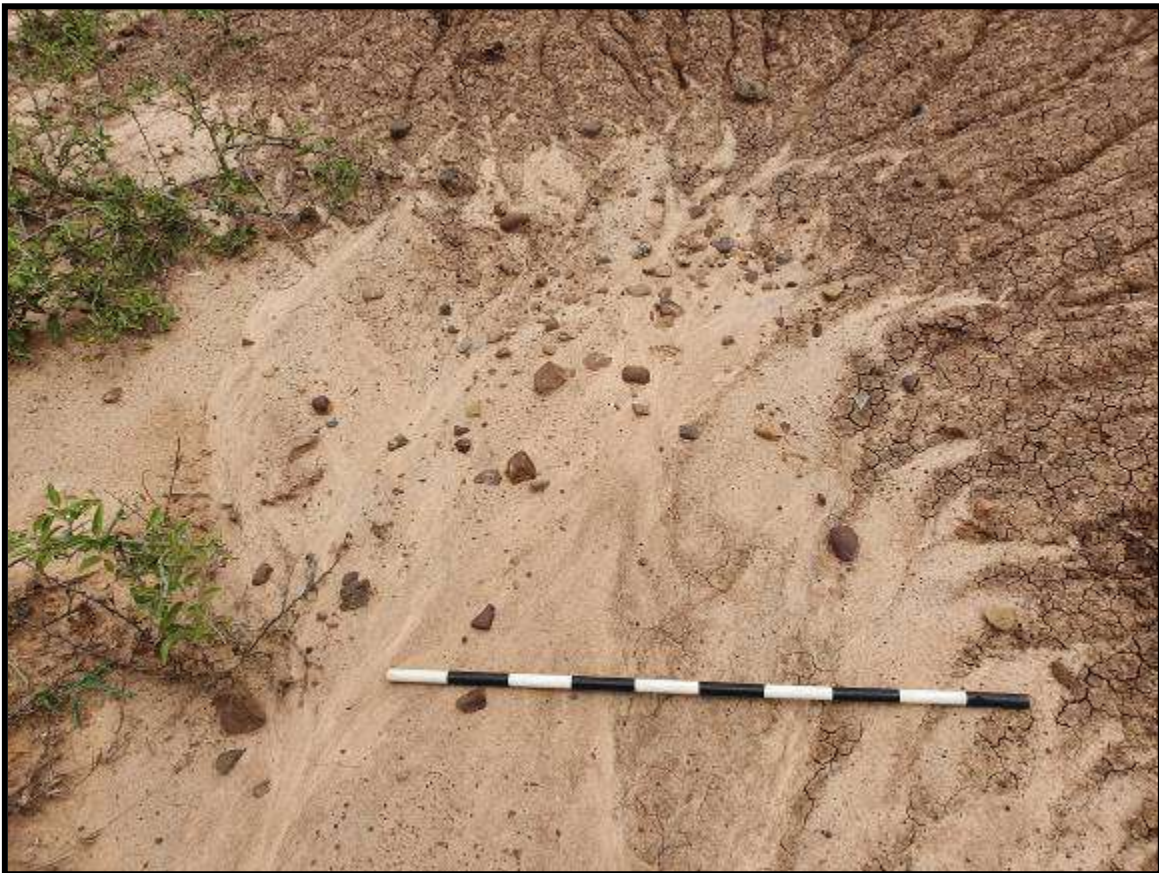
The site is located in an erosion gully. The site consists of a lag deposit of ESA, MSA and LSA stone tools (fig. 85). All of these tools are in a secondary context. The tools occur on this hardened clay layer throughout the study area.

FIG. 85: STONE TOOLS AT MADO086

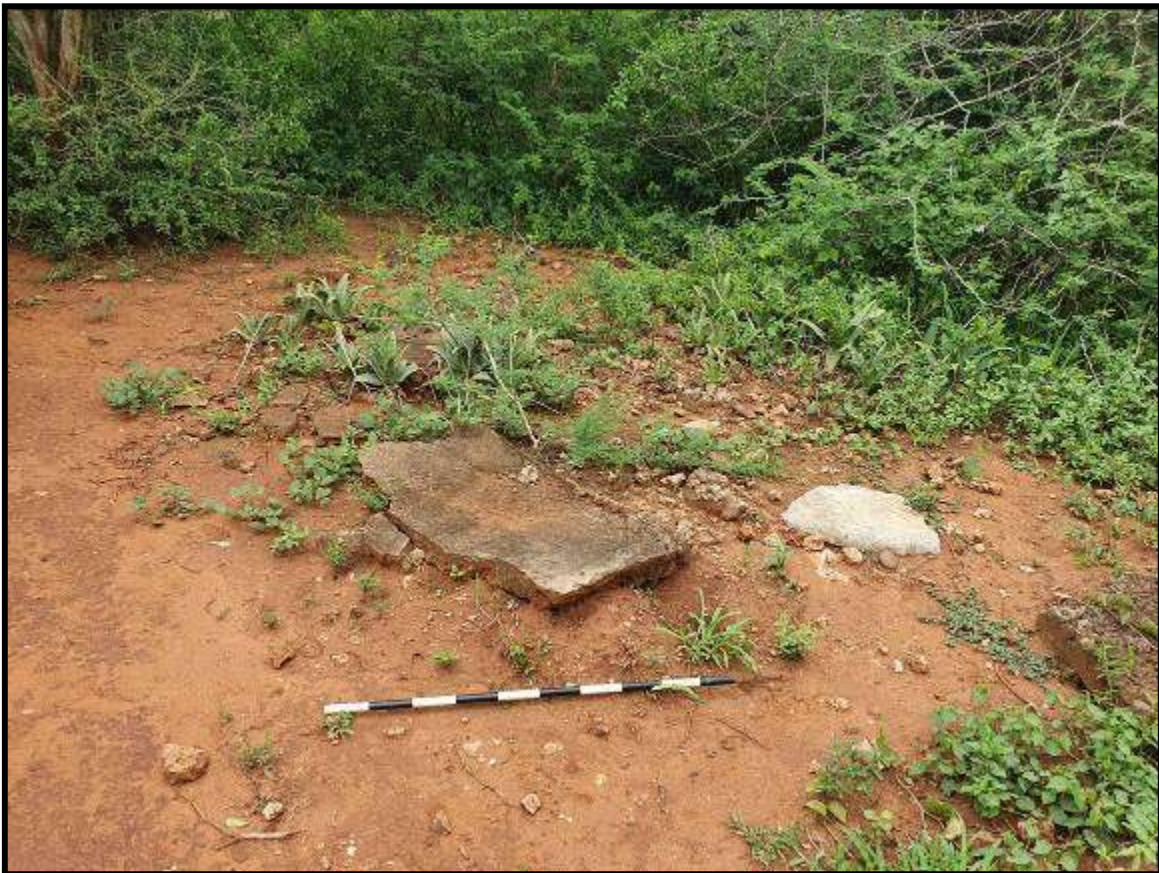
FIG.87: HOUSE REMAINS AT MADO087

The site is located next to the main track. The site consists of two ruined houses (fig. 87). No other artefacts or features were noted due to the dense vegetation.

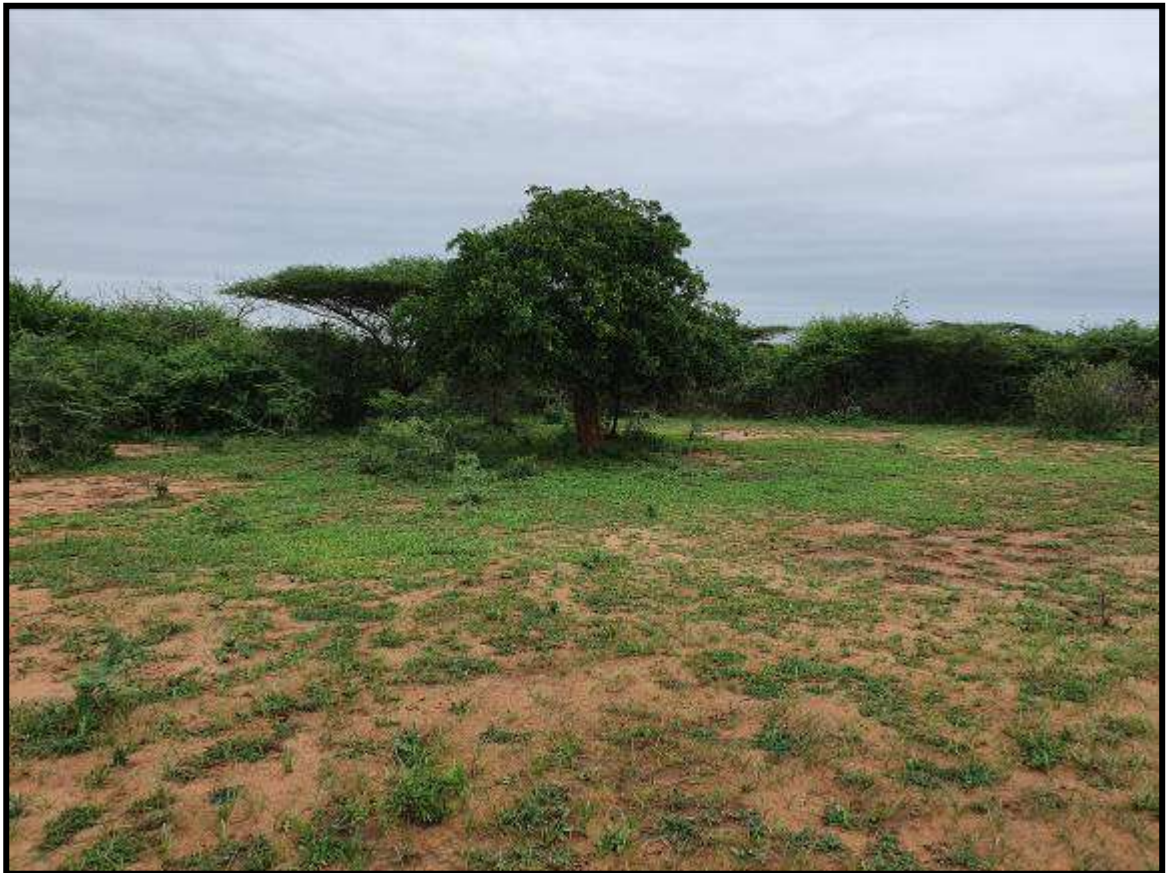
FIG.88: SETTLEMENT AT MADO088

The site is located in a cleared area near an agricultural field. The site consists of house floors (fig. 88). No other artefacts or features were noted due to the dense vegetation.

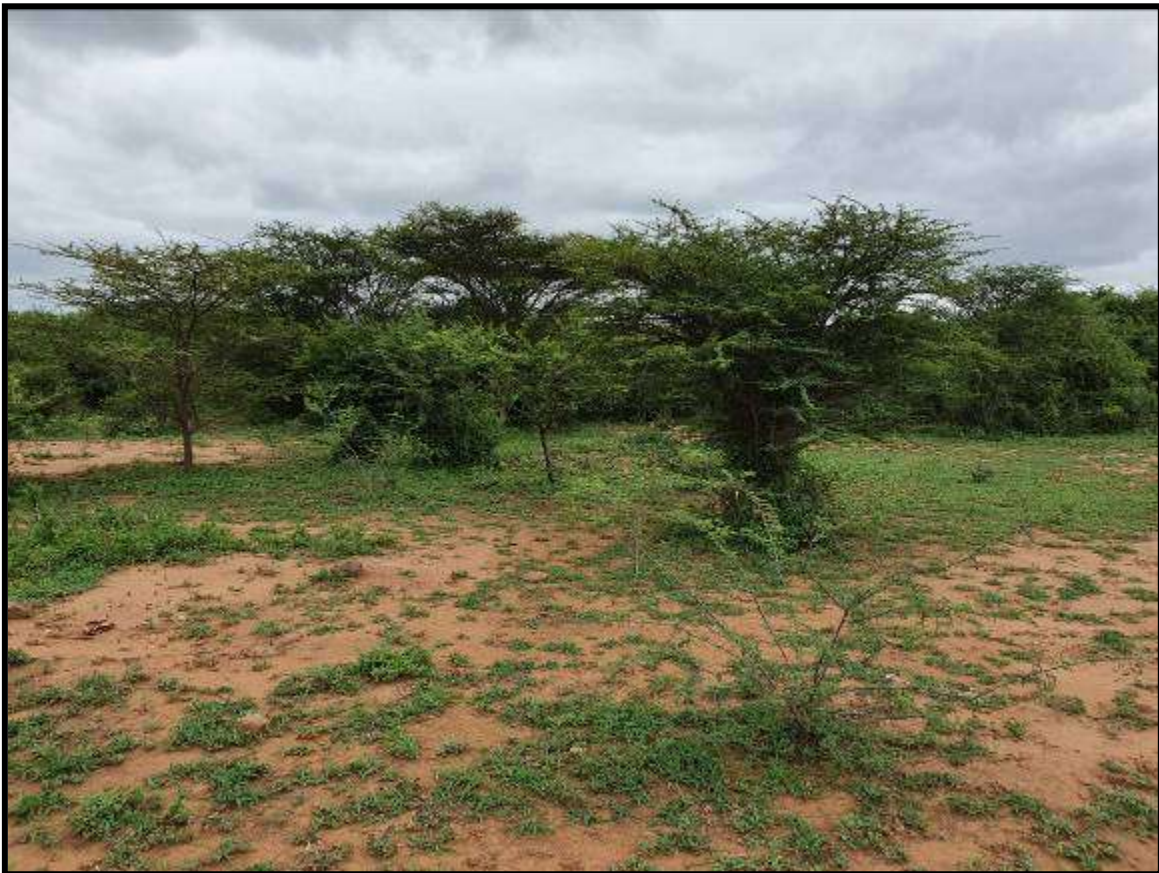
FIG. 89: SETTLEMENT AT MADO089

The site is located in a cleared area near an agricultural field. The site consists of a settlement with house floors and modern artefacts (fig. 88). No graves were noted.

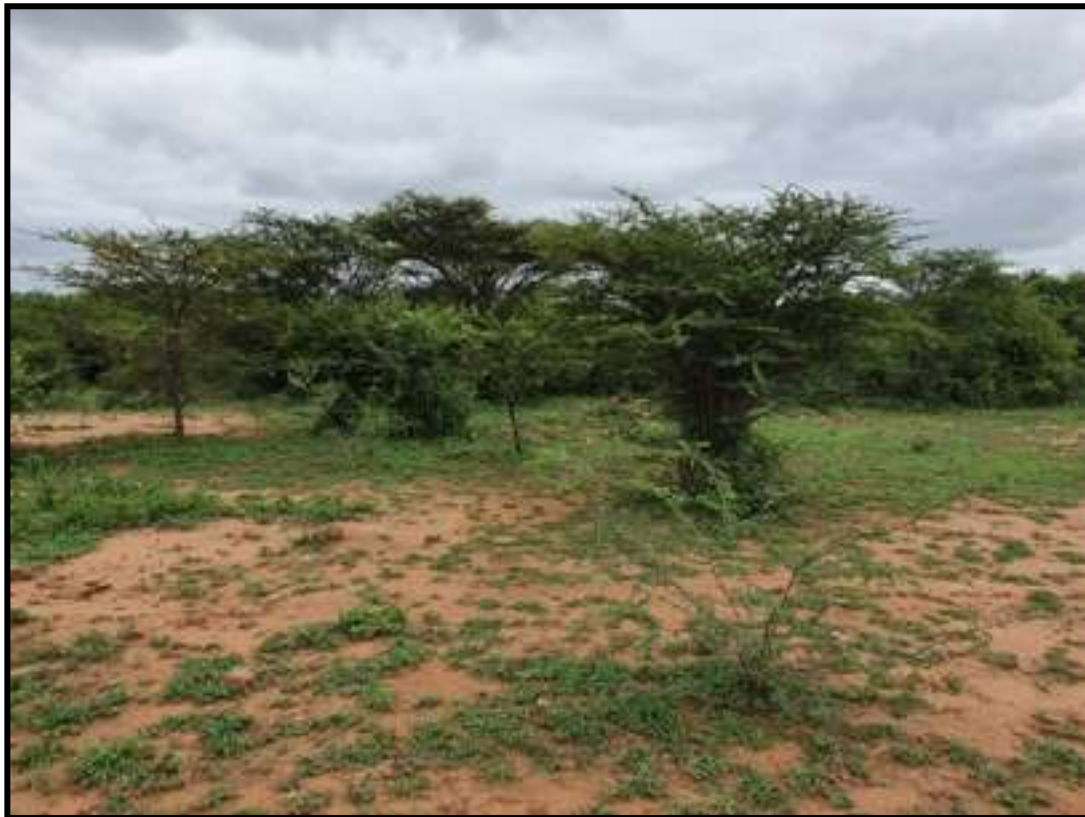
FIG. 90: SETTLEMENT AT MADO090

The site is located in a cleared area near an agricultural field. The site consists of a settlement with house floors and modern artefacts (fig. 90). No graves were noted.

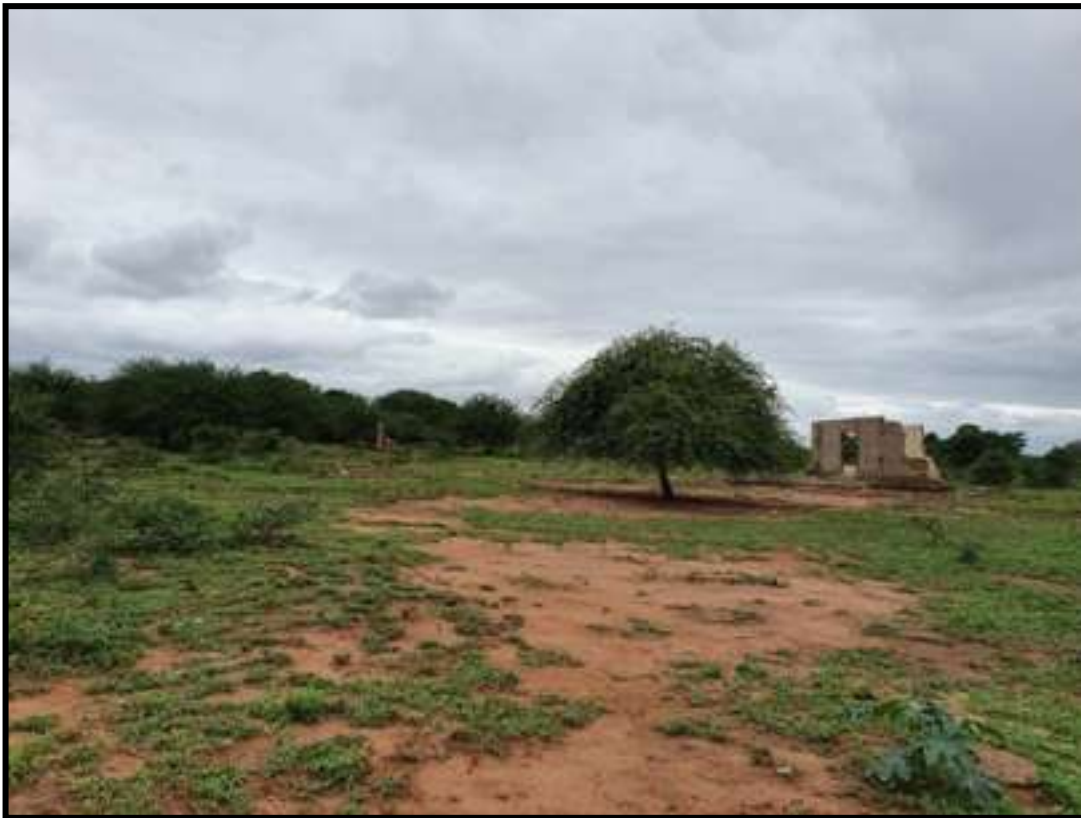
The site is located in a cleared area near an agricultural field. It might relate to 'h36'. The site consists of a settlement with house floors and modern artefacts (fig. 91). No graves were noted. There is a more recent building in the area.

FIG. 91: SETTLEMENT AT MADO091

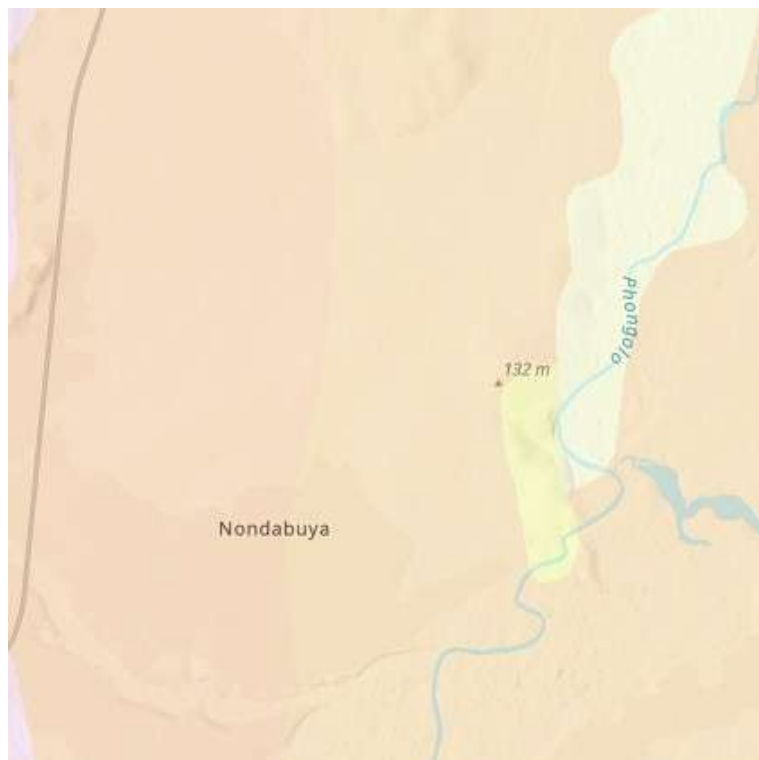
The land in question comprises alluvium deposited by the Pongolo River. This alluvium formed from weathering of Cretaceous rocks. This surface layer will be underlain by fossiliferous Cretaceous Rocks at depth (Fig. 3). Cretaceous rocks will underlie the alluvium (at depths of at least 2m) and are likely to be weathered.

Figure 3: *Proposed project area (yellow), superimposed on the 1: 1000 000 Geological map (Arcgis). This project is within Pongolo River alluvium with no fresh or weathered rock being effected.*
