**HERITAGE SURVEY OF THE R61 MTHATHA -
BAZIYA ROAD UPGRADE**

FOR COASTAL ENVIRONMENTAL SERVICES

DATE: 25 February 2013

**Umlando: Archaeological Tourism and Resource
Management**

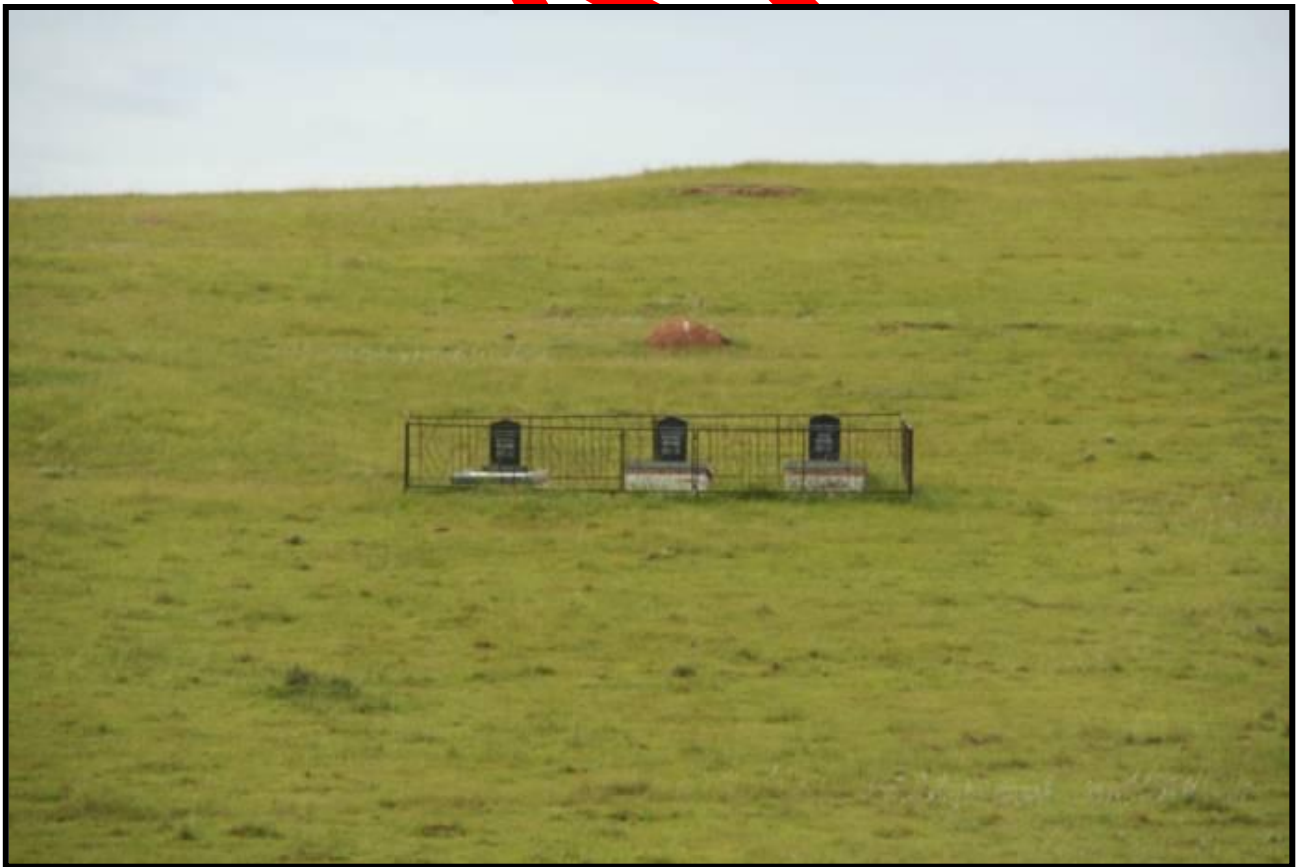
Fig. 7: Graves At UMT01

UMT01 is located halfway up the hill to the south of the road. The site consists of three graves in a fenced area (fig. 7). There are faint remains of a settlement further uphill from the graves. The site probably post-dates 1974.

The graves are ~130m from the current road edge, and will not be directly affected.

Significance: The site is of high significance.

SAHRA Rating: 3A

Mitigation: No further mitigation is required.

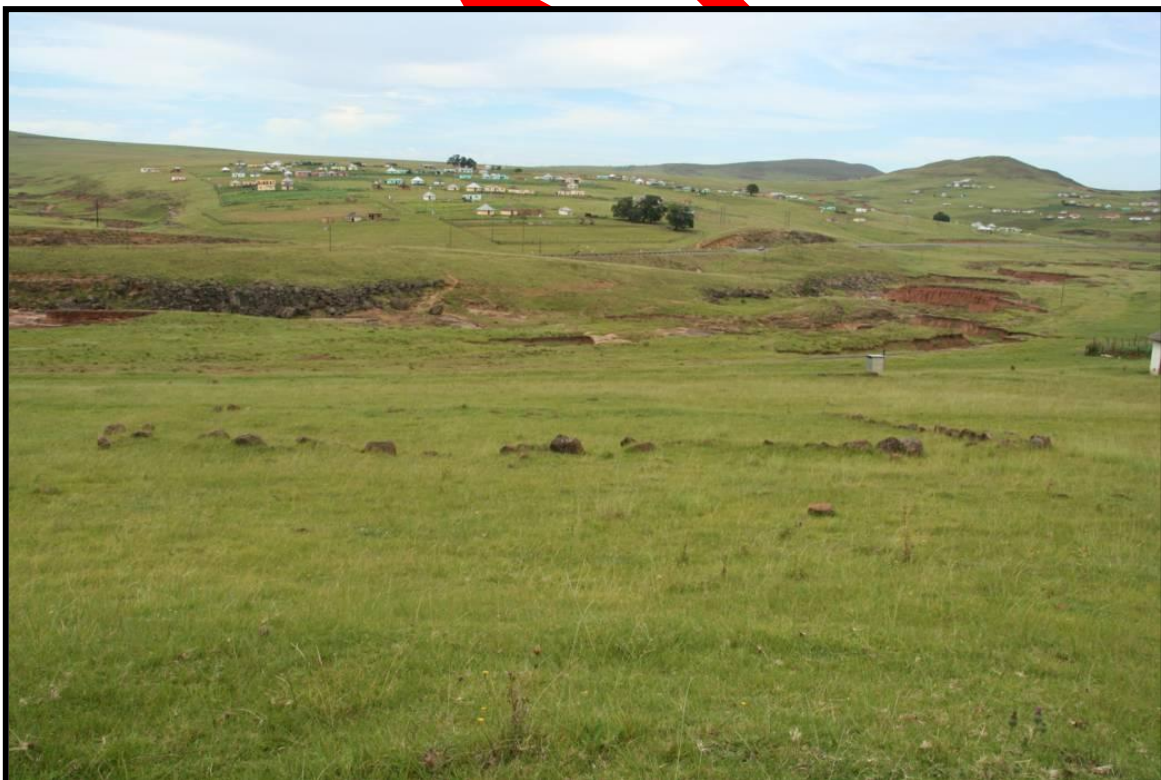
Fig. 8: Kraal At UMT02

UMT02 is located halfway up a hill along the access road for Quarry 1. Part of the site consists of four circular house foundations to the north (uphill) of the road. The rest of the site occurs downhill from the road. This lower area consists of a kraal (fig. 8) with an additional rectangular “wall”. No graves were observed. The site probably dates to the last 40 years maximum. The site probably post-dates 1974.

Significance: The site is of low significance.

SAHRA Rating: 3C

Mitigation: No further mitigation is required.

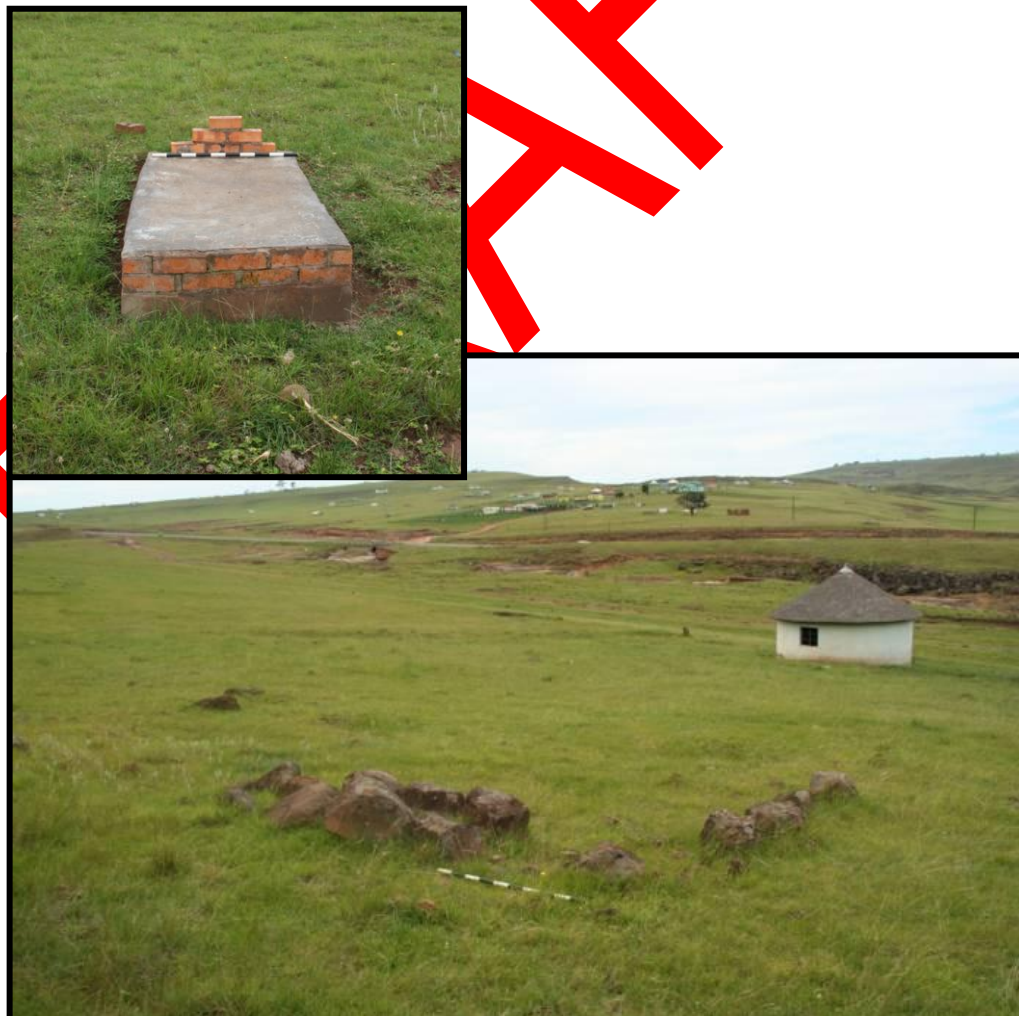
Fig. 9: Kraal And Grave At UMT03

UMT03 is located ~30m west of UM02. The site consists of four house foundations, a small kraal and a single grave (fig. 9). The grave is 30m south of the access road, and will not be directly affected. The site probably post-dates 1974.

Significance: The site is of low significance except for the grave that is of high significance

SAHRA Rating: 3c and 3A (for grave)

Mitigation: The grave should be fenced off prior to any construction activity.

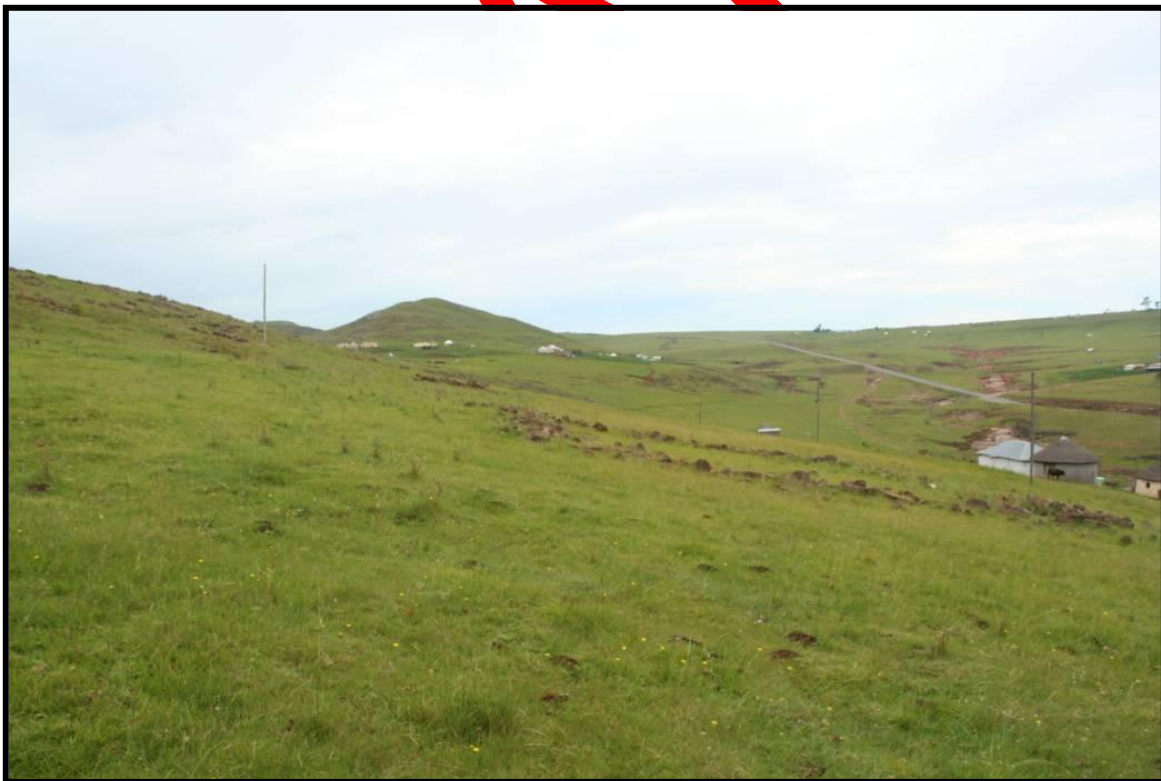
Fig. 10: House Foundations And Kraal At UMT04

UMT04 is located ~250m to the west of UMT03 and between 6m and 70m from the access road. The site consists of four circular house foundations, a kraal, and an agricultural field (fig. 10). No grave was observed. The site probably post-dates 1974.

Significance: The site is of low significance.

SAHRA Rating: 3C

Mitigation: No further mitigation is required; however, the area should be noted for containing potential graves, especially near the road.

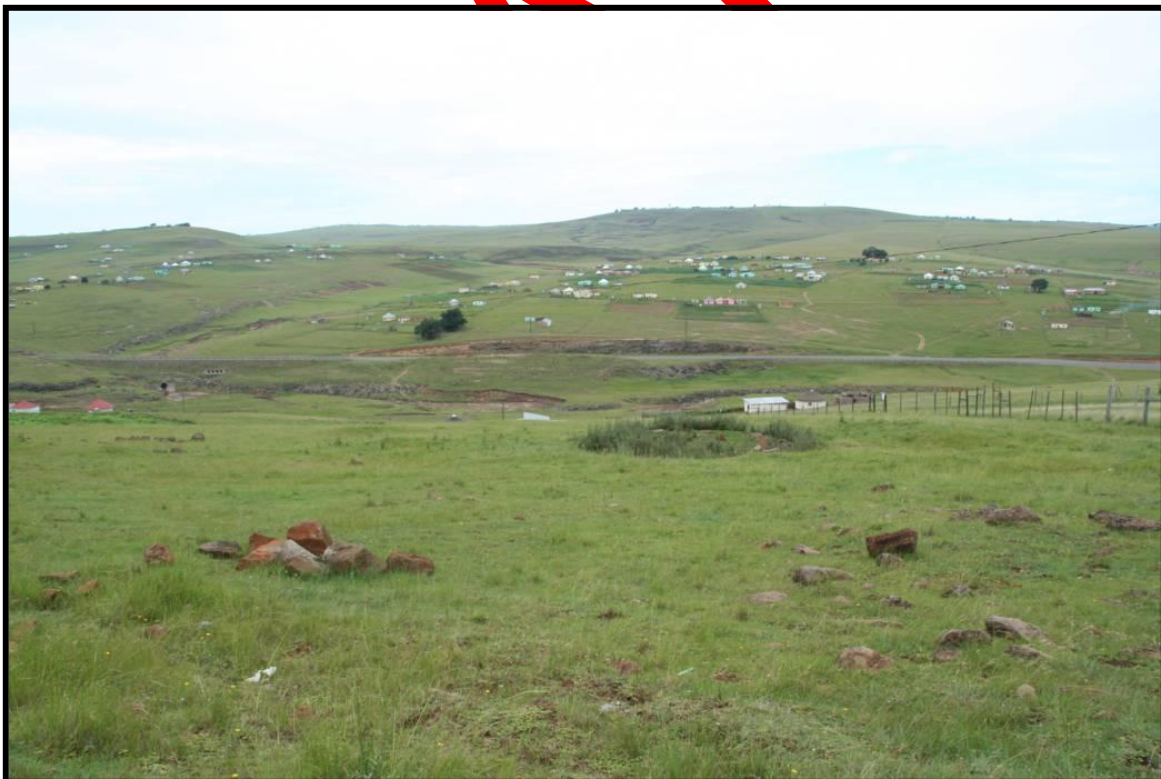
Fig. 11: House Foundations At UMT05

UMT05 is located 90m to the west of UMT04, and 90m uphill from the access road. The site consists of four circular house foundations, a kraal, and an agricultural field (fig. 11). No grave was observed. The site probably post-dates 1974.

Significance: The site is of low significance.

SAHRA Rating: 3C

Mitigation: No further mitigation is required; however, the area should be noted for containing potential graves, especially near the road.

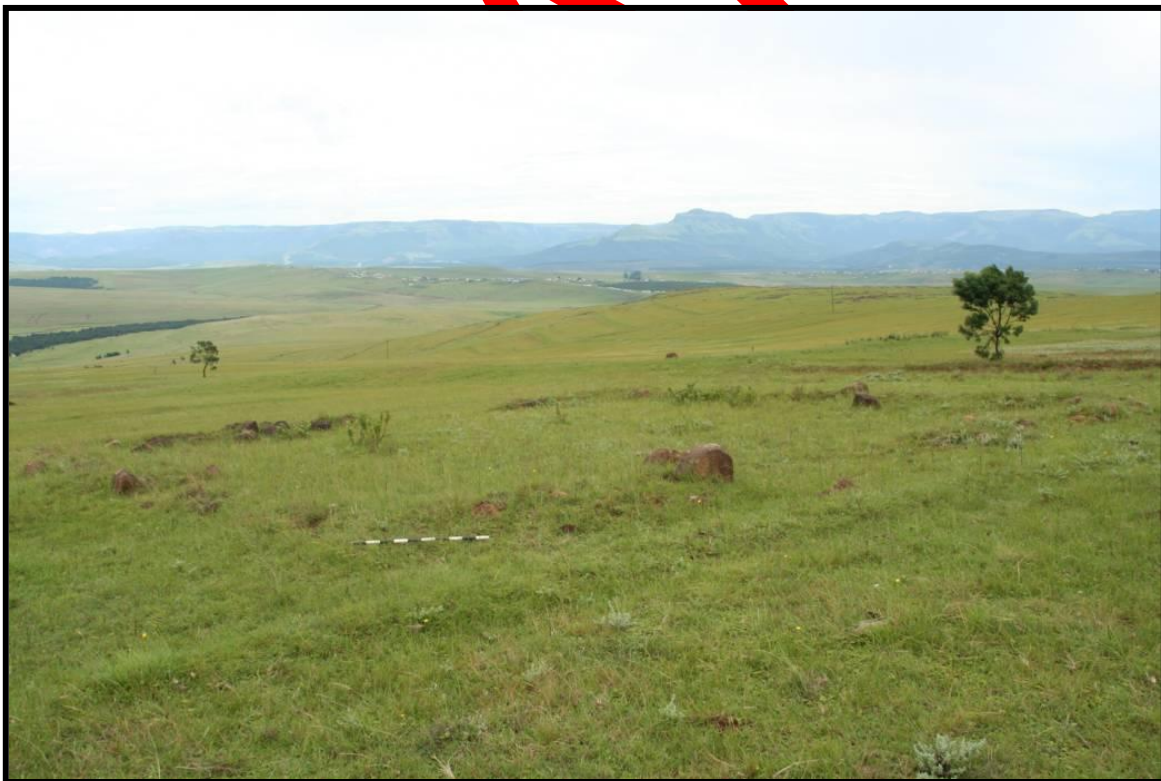
Fig. 12: House Foundations At UMT06

UMT06 is located on the top of a hill that will be used for Quarry 3. The site consists of four circular house foundations, a kraal, and an agricultural field (fig. 12). No grave was observed. The site probably post-dates 1974. The site occurs on the edge of the Quarry 3 outer edge.

Significance: The site is of low significance as the tools are few in number and a secondary context.

SAHRA Rating: 3C

Mitigation: No further mitigation is required; however, the area should be noted for containing potential graves, especially near the edge of the quarry.

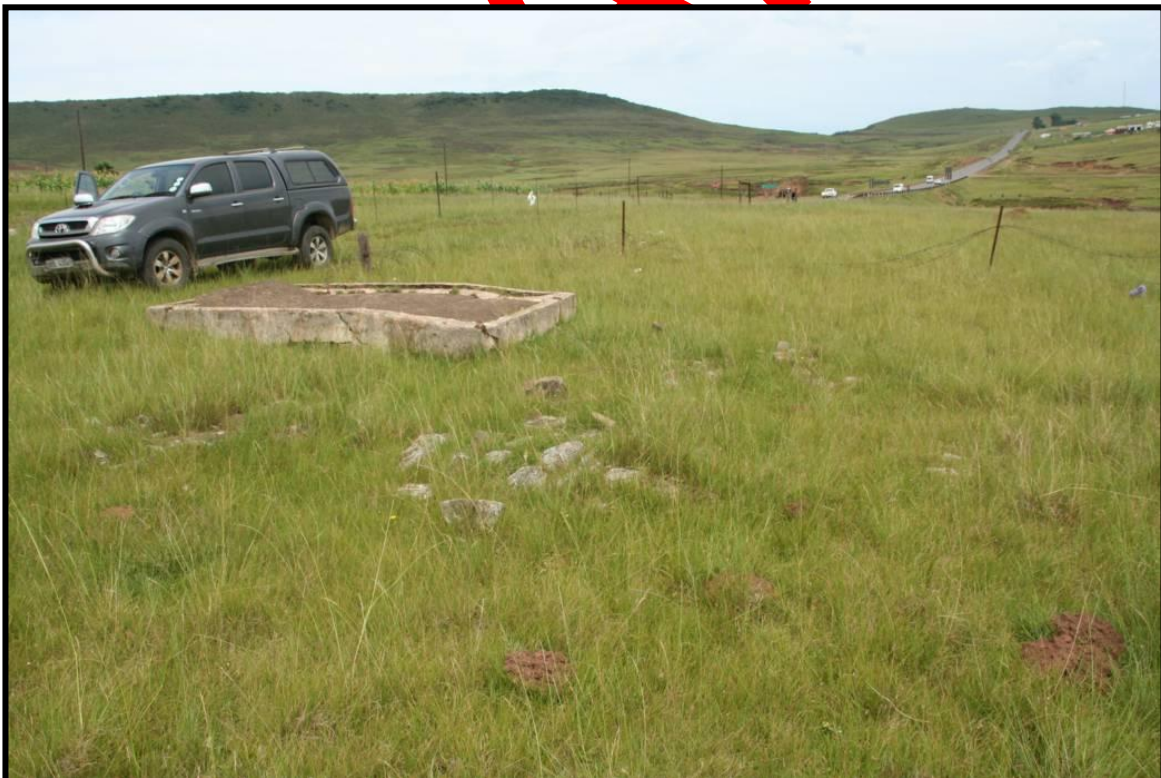
Fig. 13: Graves At UMT07

UMT07 is located ~20m to the north of the existing road and about 10m from the road reserve. The site consists of six graves in a semi-fenced off cemetery (fig. 13). Five of the graves consist of sunken stone cairns, and one is a more formal grave. The graves could be associated with Houses 14 – 18 from the 1959 topographical map. The grave will be affected by the road upgrade.

Significance: The site is of high significance.

SAHRA Rating: 3A

All graves within 50m of the footprint should be clearly and visibly demarcated before construction phase, to avoid possible damage to the graves. I also suggest that the line is re-aligned as opposed to removing the graves. The process of grave removals is a complex one that requires community consultation, advertisements, several permits, and finally reburial. Moreover, those graves older than 60 years require a qualified archaeologist to undertake the entire process. This process is summarised as follows².

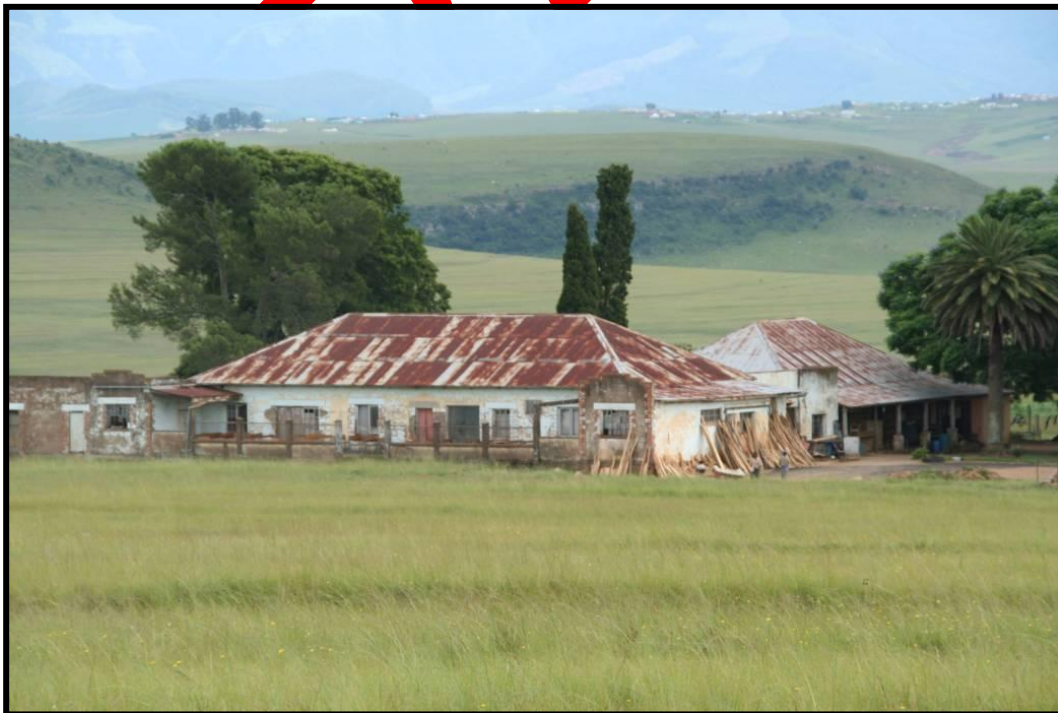
Fig. 14: Buildings At UMT08

UMT08 is located on a small hill above the road and just north of Quarry 2. It is currently used for funeral services. The site consists of several buildings and a yard that were probably part of the original farm buildings of Selborne and Ncise (fig. 14). The buildings occur on the 1959 and 1974 maps, and are more than 60 years in age. It is unknown if the buildings will be affected by the road construction.

SAHRA Rating: 3B

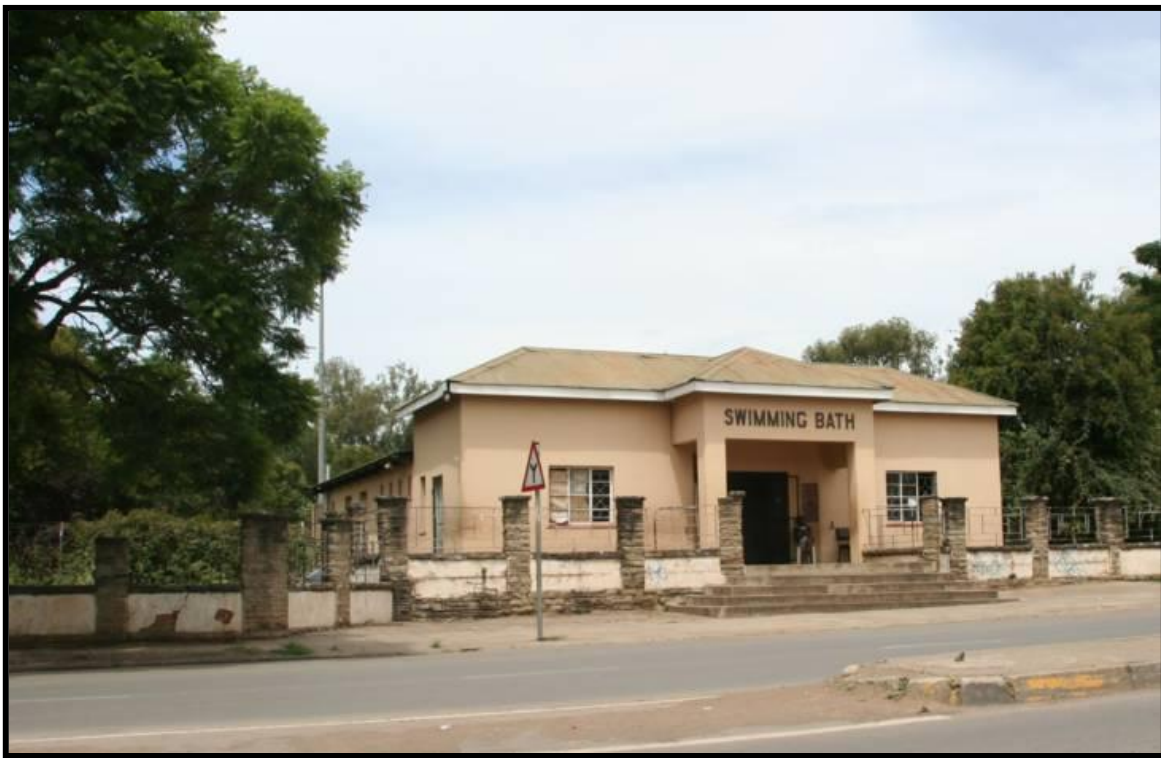
Fig. 15: Public Swimming Baths In Mthatha

The Swimming Baths are located on the edge of the main town (fig. 15). The outer walling of the swimming baths may be protected.

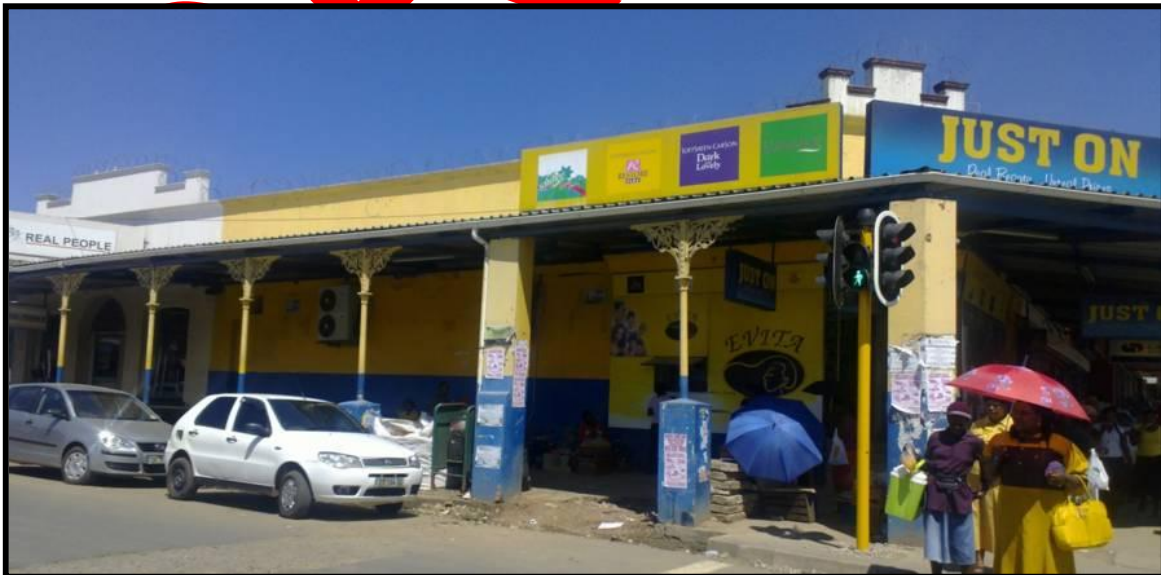
Fig. 16: "Just On" Store

'Just On' trading store is an old building with Brookie Lace decorations (fig. 16). The Brookie Lace and supporting poles may be affected by the road construction.

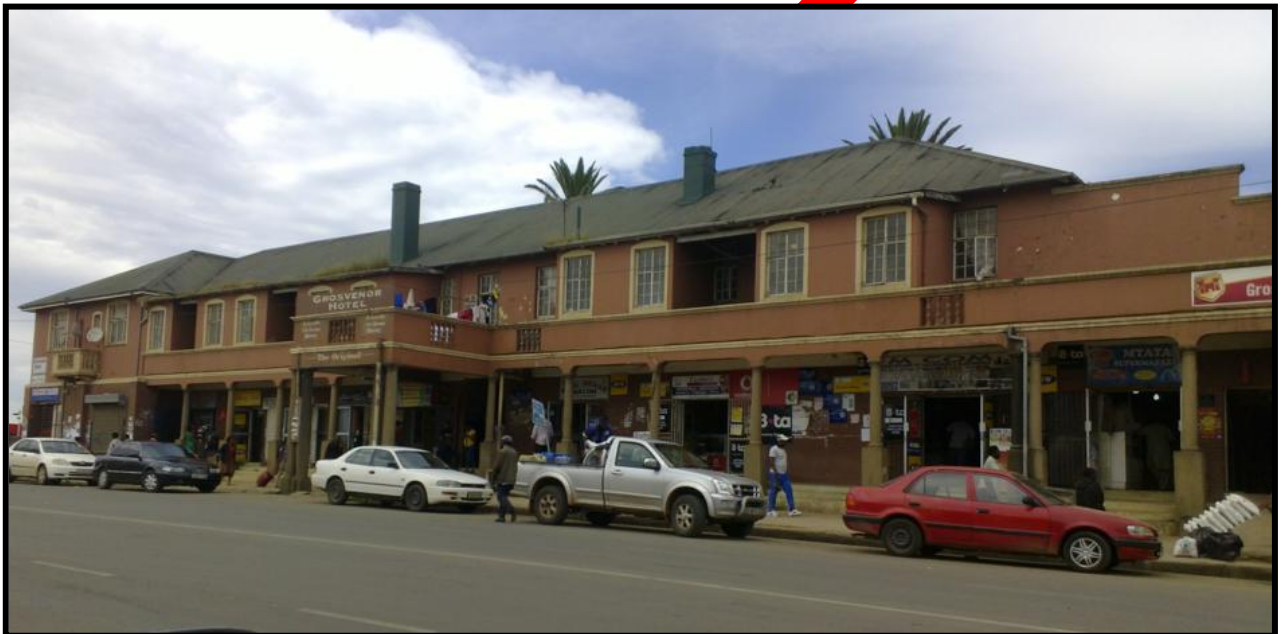
Fig. 17: Grosvenor Hotel

The Grosvenor Hotel was built before 1908 – unfortunately, there is no visible date on the building (fig. 17). The entrance hall and supporting structures may be affected by the road construction.
