**PROPOSED UPGRADE OF THE MAHADENI
VEHICULAR BRIDGE, NDWEDWE LOCAL
MUNICIPALITY
KWAZULU-NATAL**

Phase 1 Heritage Impact Assessment

March 2017

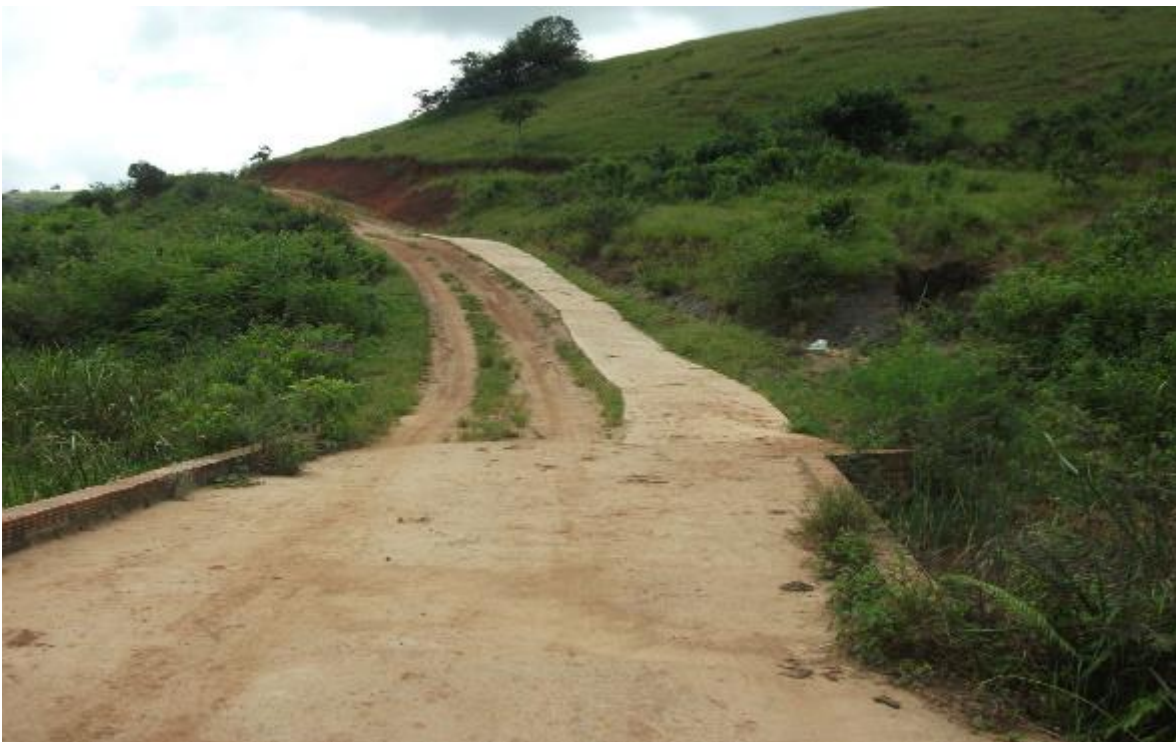
The existing bridge is a low concrete slab situated over the Mahadeni River. There are no residences in close proximity (within 50 m) of the bridge with the closest residence situated some 170m from the bridge. Recent and past rains have eroded the sides of the bridge and some piping has been exposed in the eroded areas.

Figure 3: View of existing bridge

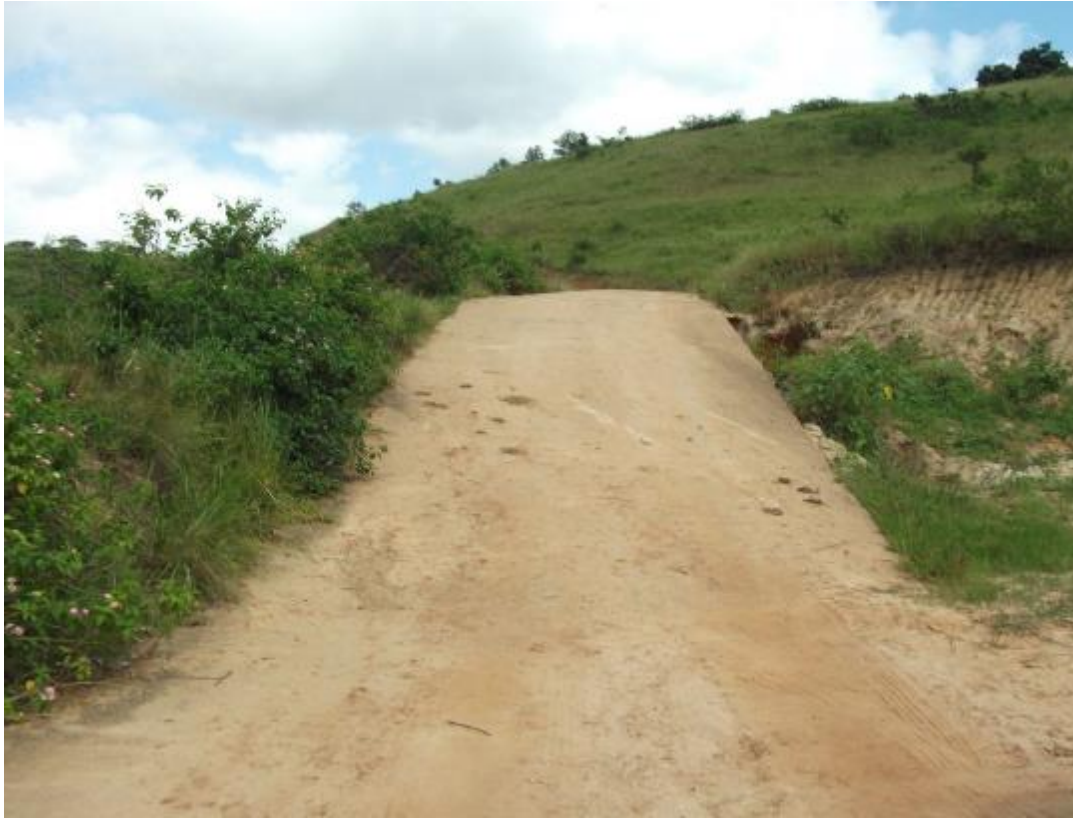
Figure 4: View of bridge and associated erosion

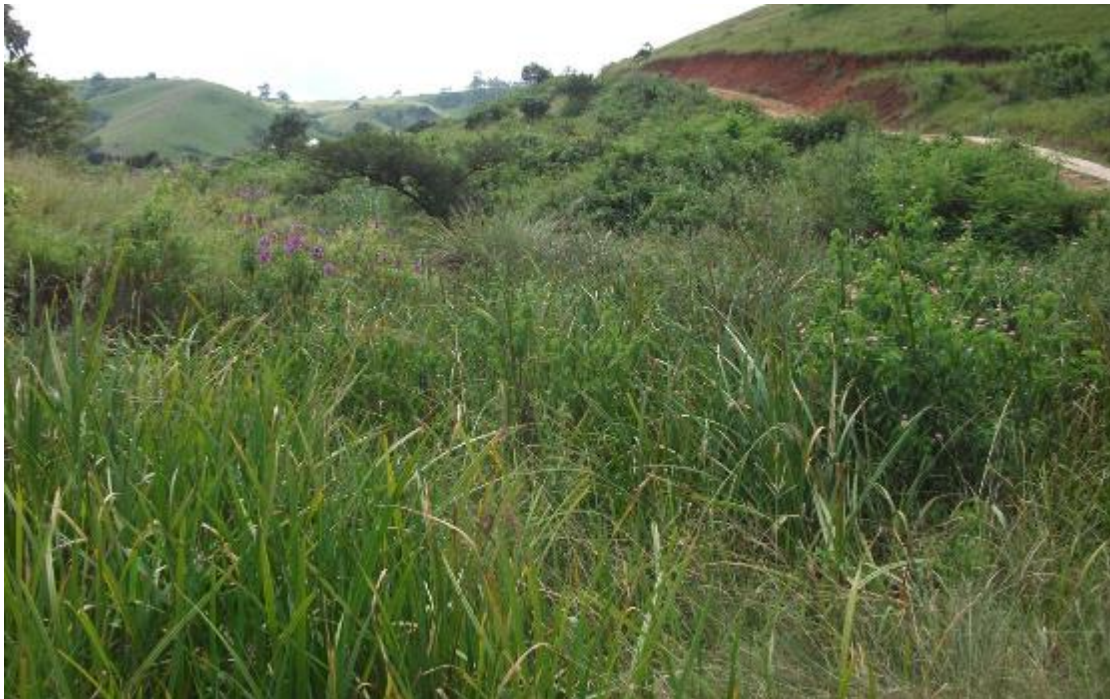
A site inspection of the bridge where the upgrade is to take place was undertaken on 07 March 2017. The river vegetation was densely overgrown and access to some parts were difficult due to this. Otherwise site conditions were good.

Figure 5: Dense vegetation along river

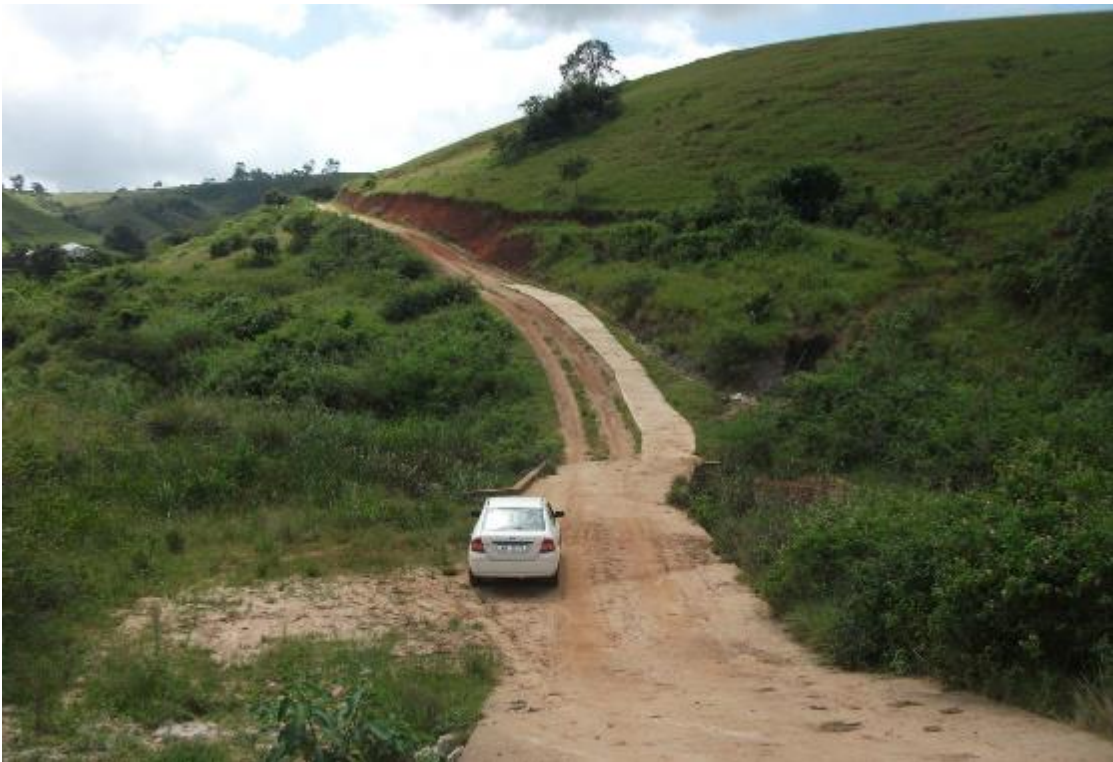
Figure 7: General overview of bridge
