Eleven Solar PV Facilities and Supporting Electrical Infrastructure
near Dealesville in the Free State Province Proposed by
Mainstream Renewable Power Developments (Pty) Ltd.

HERITAGE IMPACT ASSESSMENT

CSIR Report No.:
CSIR/CAS/EMS/ER/2014/0011/B

July 2015

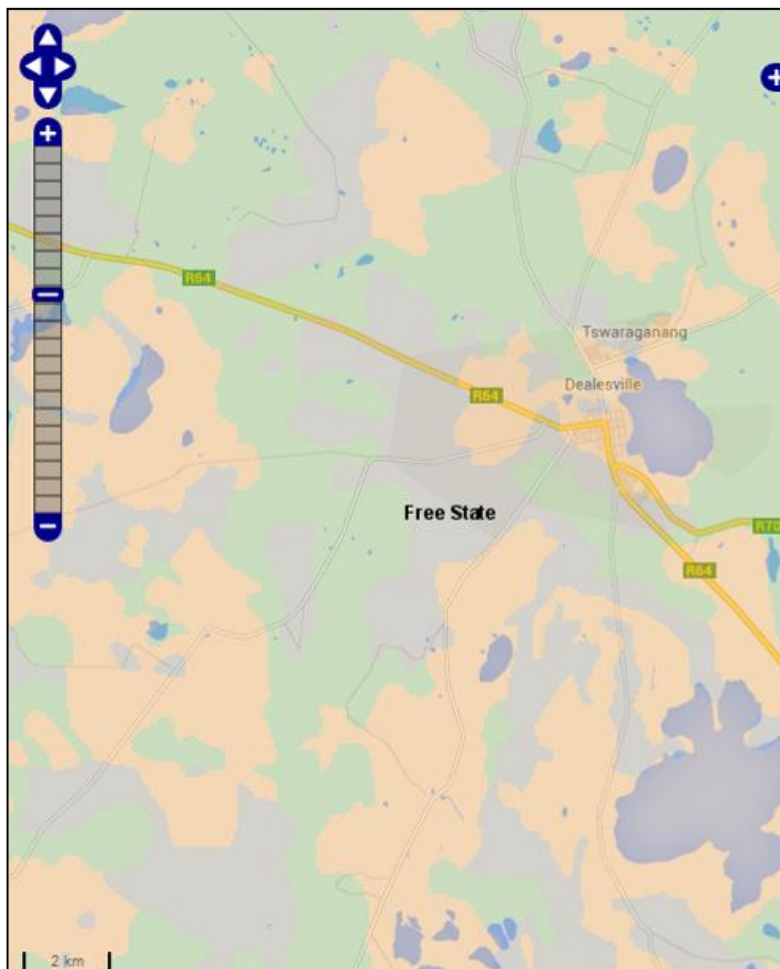
Figure 27: Palaeontological sensitivity map from SAHRIS (Orange = high sensitivity, Green = moderate sensitivity, grey = zero sensitivity. Note that the dark grey/blue patches are pans showing through the sensitivity layer (these are generally within the orange areas).

In terms of palaeontology, the study area is mapped on SAHRIS as being underlain by geological rock units with varying sensitivity. Although there are no areas of very high sensitivity, the area does include patches of high and moderate sensitivity. Some areas are known to be unfossiliferous and thus of no sensitivity at all. Figure 27 illustrates this.

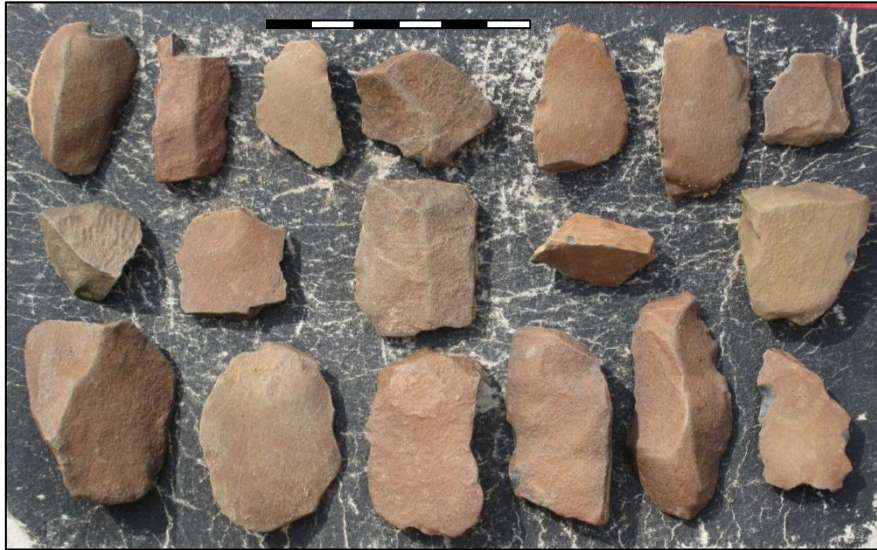
Figure 28: MSA hornfels artefacts from a lightly eroding area on Leliehoek (point 081). The scale bar is in 10 mm intervals.

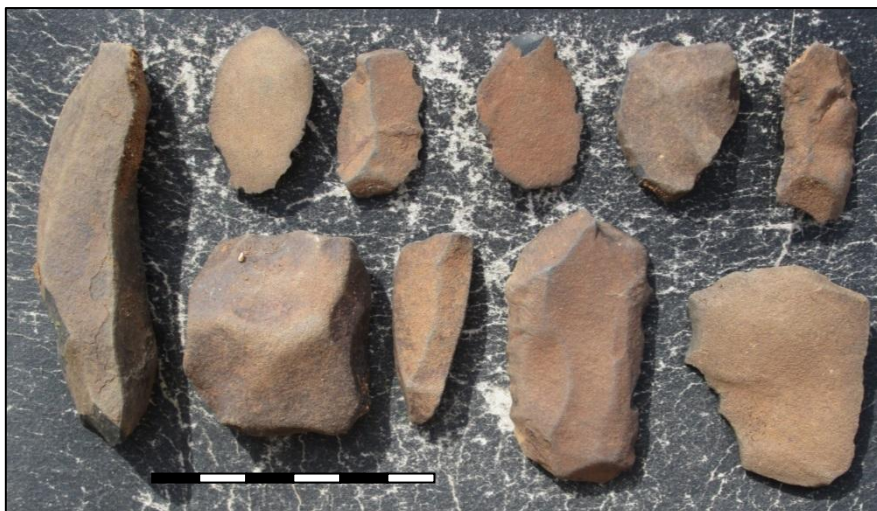
Figure 29: MSA hornfels artefacts found associated with an outcrop of calcrete on Braklaagte (point 089). The scale bar is in 10 mm intervals.

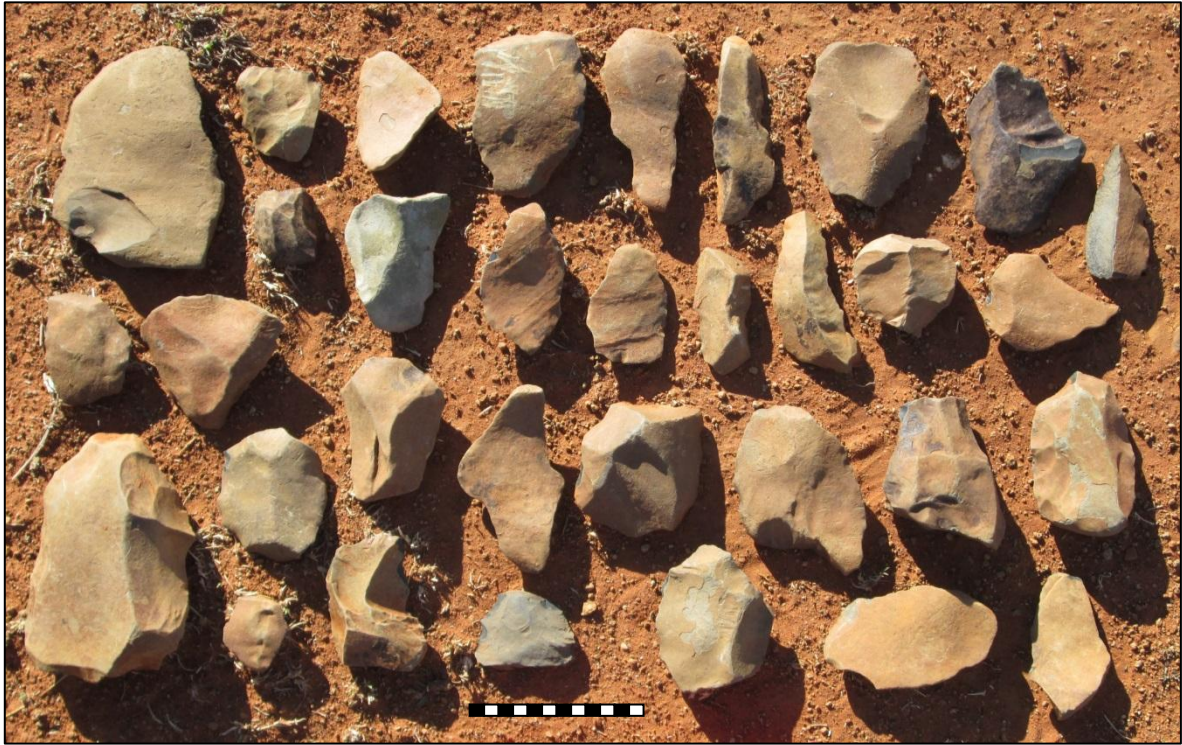
Figure 30: A large collection of MSA hornfels artefacts found in an eroding context on Klipfontein (point 092). The scale bar is in 10 mm intervals.

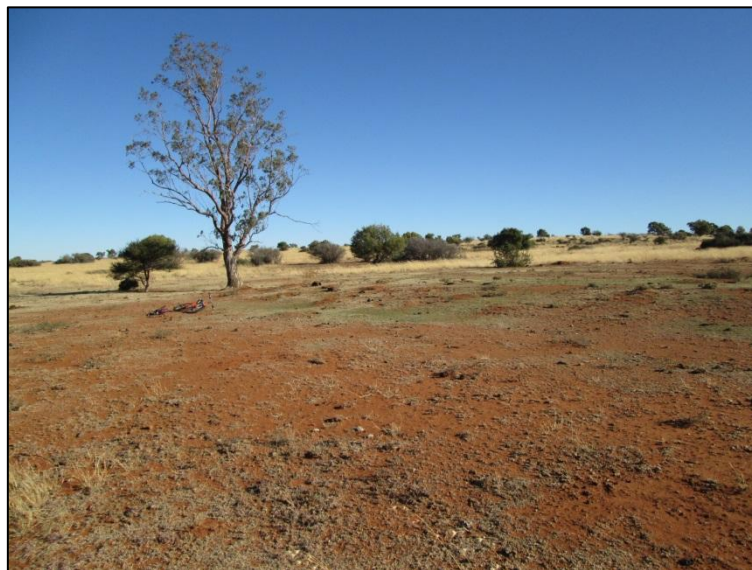
Figure 31: The eroding area in which the artefacts shown in Figure 30 were found.

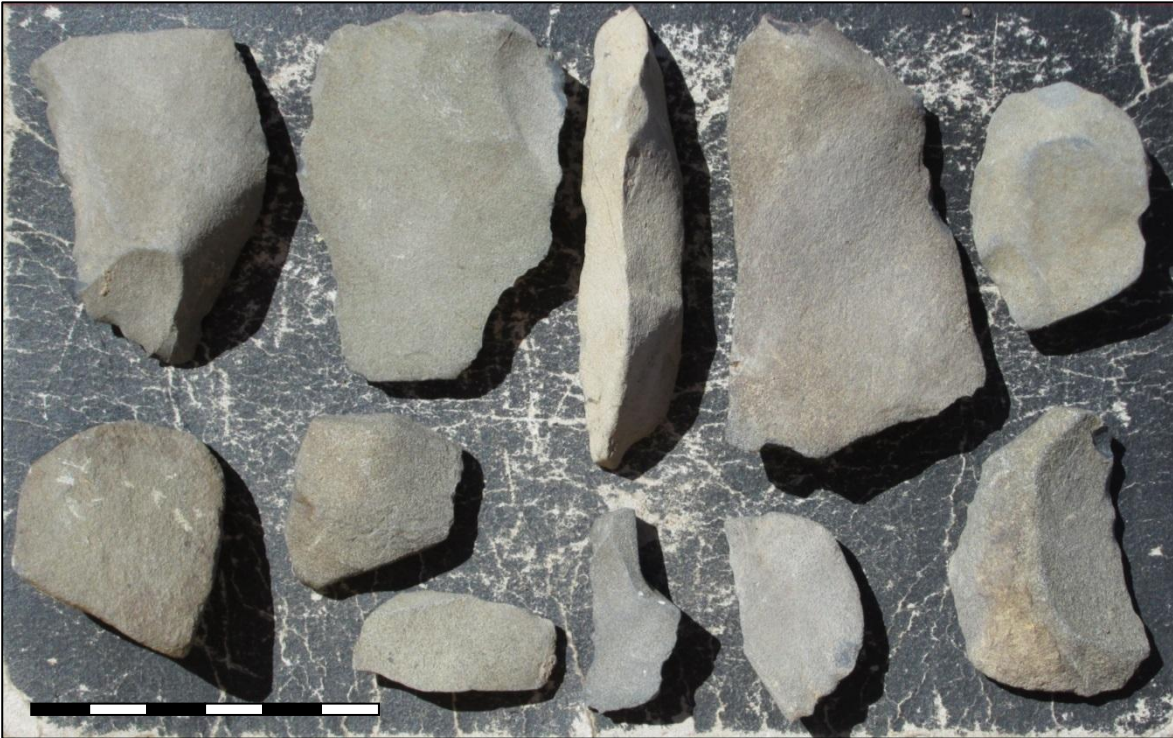
Figure 32: MSA hornfels artefacts found along an ephemeral stream where the banks are eroding and revealing buried artefacts. This location is on Klipfontein (point 164). The scale bar is in 10 mm intervals.

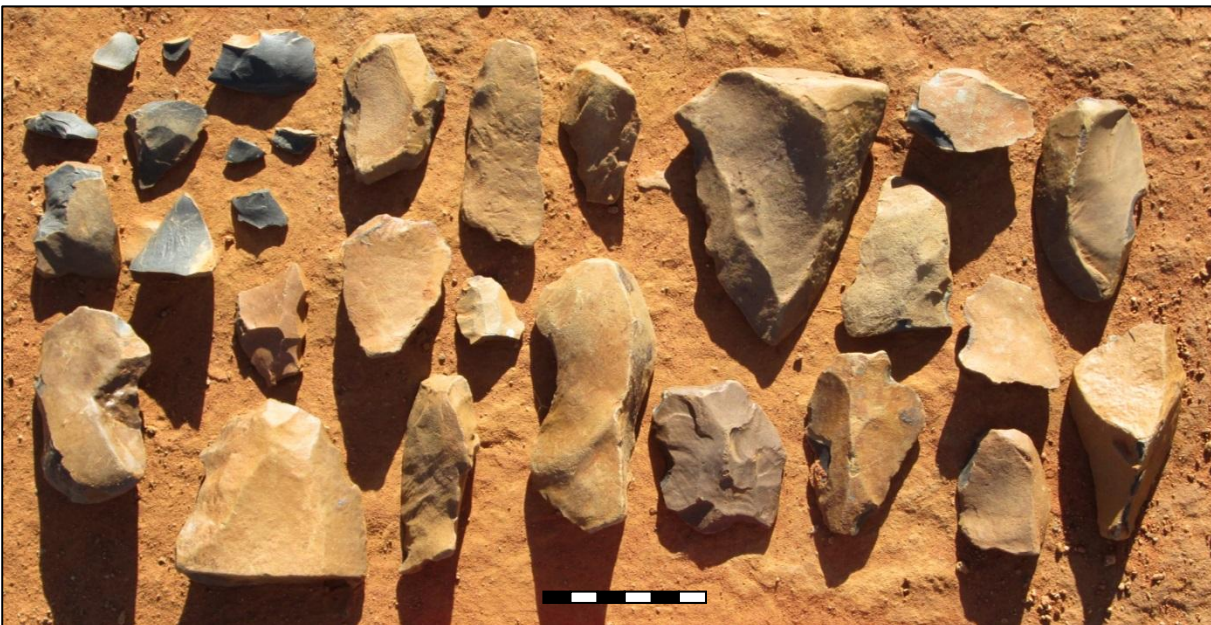
Figure 33: Collection of MSA (brown coloured) and LSA (darker coloured) artefacts from the crest of the hill in the western part of Klipfontein (point 094). The site has been disturbed by the construction of a cell phone tower on the hill. The scale bar is in 10 mm intervals.

A number of artefact scatters related to the MSA were noted in various parts of the study area, while even more widespread were individual MSA artefacts. These were all found in areas where the surface had become denuded and often eroded and this suggests that these artefacts are generally beneath the surface sands and could in fact be far more common than is expected. The context is essentially secondary, with the artefact accumulations having been the result of erosion, deflation and reburial; they could thus be referred to as background scatter. Despite this, some of the scatters are dense enough to merit mitigation because a large enough collection could be made to be informative about the local MSA. Figures 28 to 33 show various examples of scatters of MSA artefacts located across the study area with Figure 31 showing the context of one of them. The majority are in the central area, close to the rockier part of the landscape. The artefacts are all made on a rock type known as hornfels. This rock forms a very clear patina with the result that the original dark colour initially becomes lighter then gradually turns orange or brown. This allows a relative sequence to be created by assuming the darker, blacker artefacts to be younger and the browner ones to be older. Comparison of the artefacts in Figure 30 (which has older MSA material) and Figure 32 (which has younger MSA material) makes this clear. In Figure 33 the strong contrast in colour between MSA and LSA artefacts is also evident.

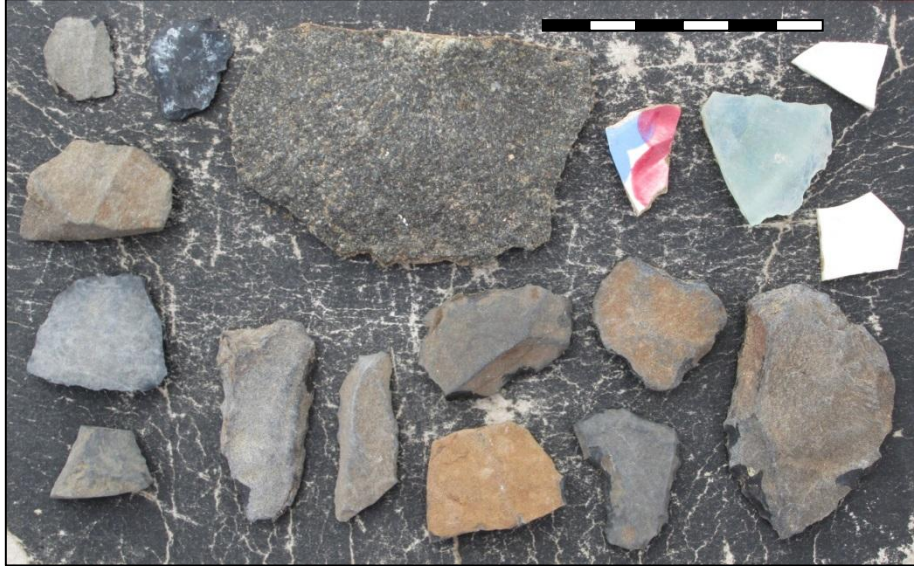
Figure 34: Scatter of LSA and historical artefacts associated with the spring on Constantia (point 069). The LSA artefacts are mostly in hornfels, but one large flake in another material (probably dolerite) was also present. The scale bar is in 10 mm intervals.

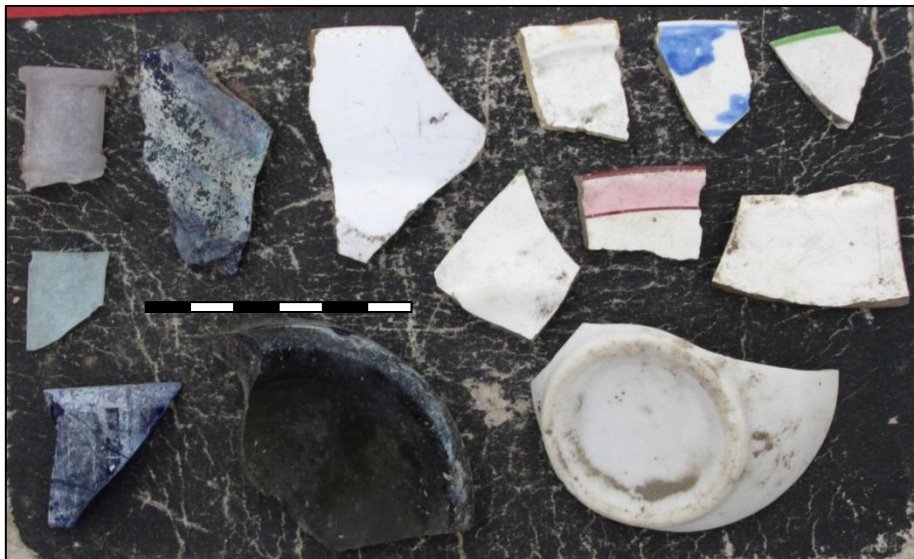
Figure 35: Historical artefacts found associated with an ash heap alongside a small stone foundation on Constantia (point 071). The scale bar is in 10 mm intervals.

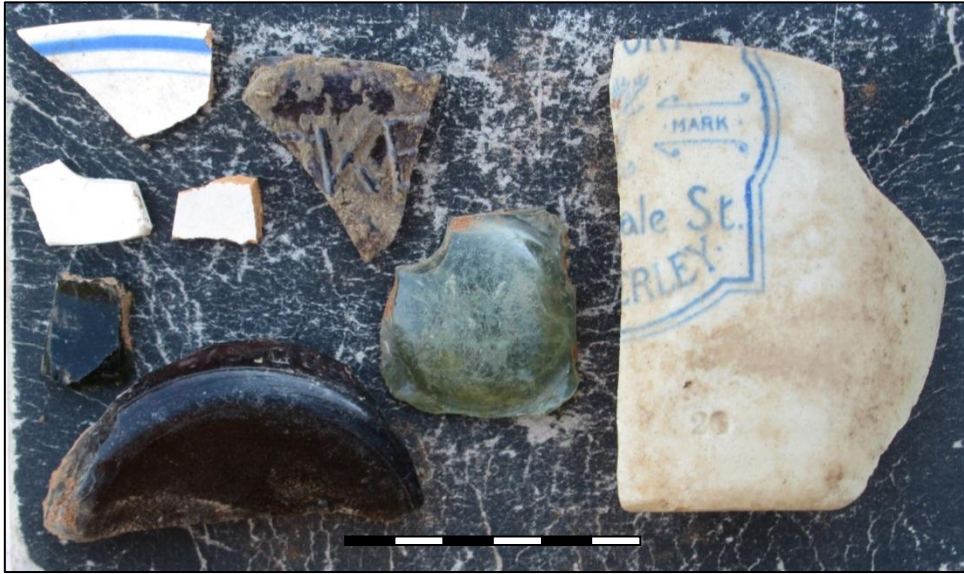
Figure 36: Historical artefacts found in association with small ruined structures on Doornrandjes (points 137-8). The scale bar is in 10 mm intervals.

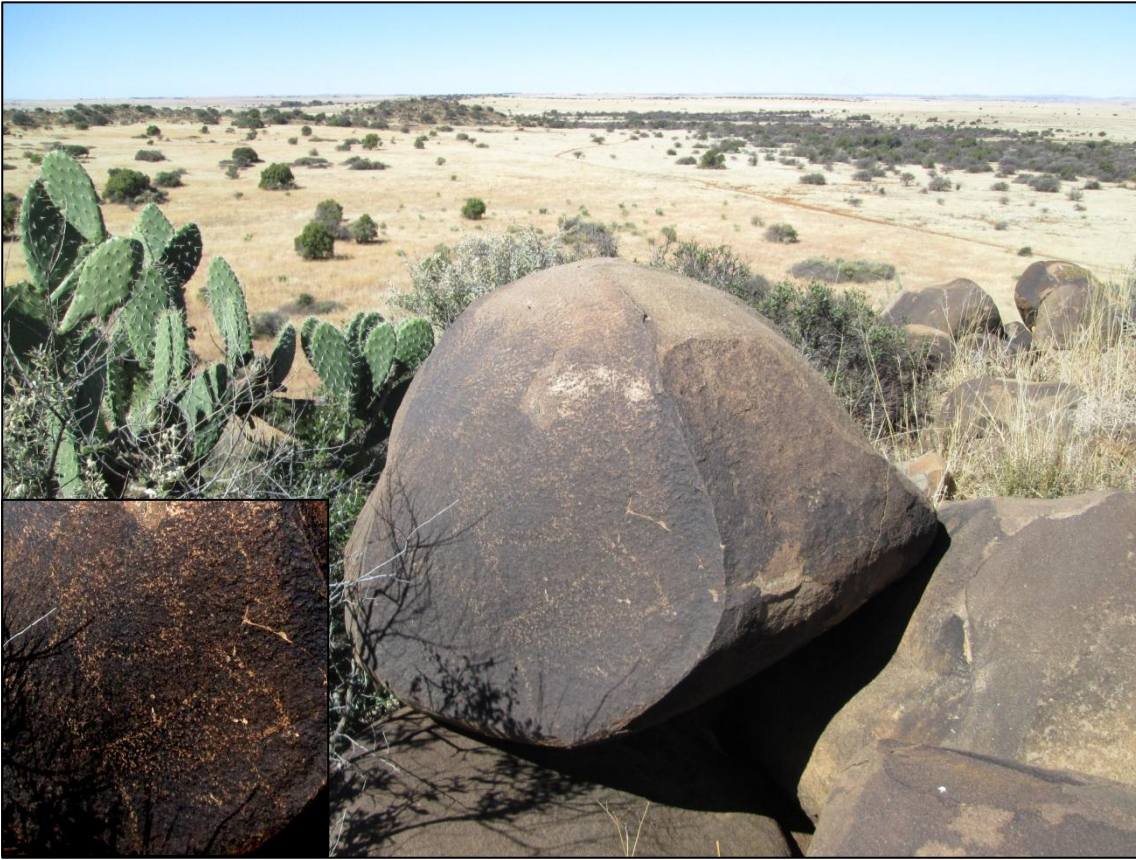
Figure 37: Engraved boulder on the north-eastern part of a hilltop on Doornrandjes (point 115). The inset shows the rock art with brightness and contrast altered to maximise visibility.

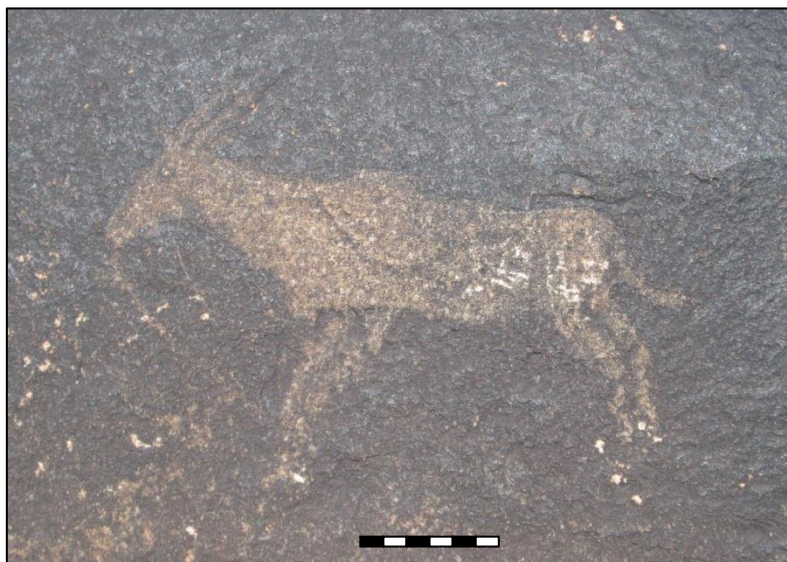
Figure 38: A engraving of an eland on the north-western part of a hilltop on Doornrandjes (point 119). The scale bar is in 10 mm intervals.

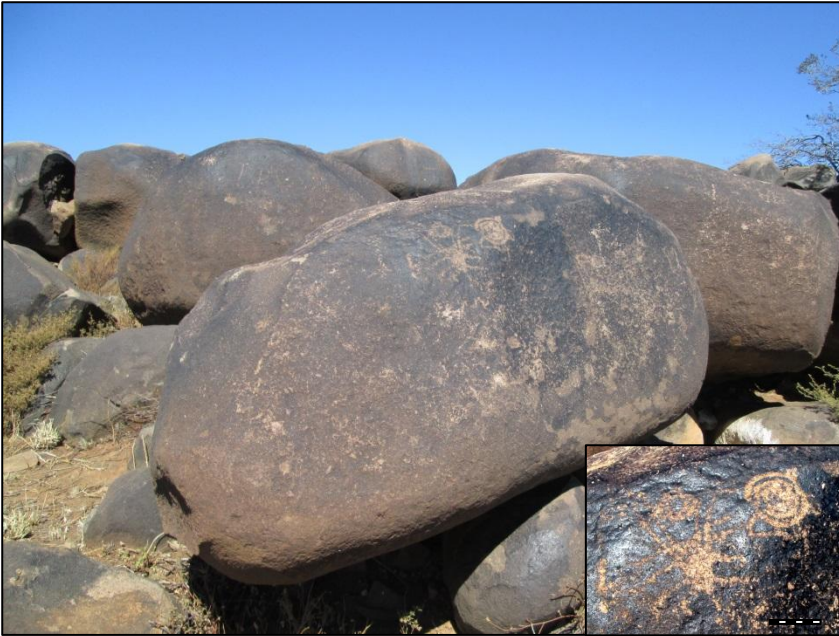
Figure 39: View of one of the engraved boulders at point 146 on Modderfontein. The inset shows engraved geometric images with brightness and contrast adjusted to maximise visibility. The scale bar is in 10 mm intervals.

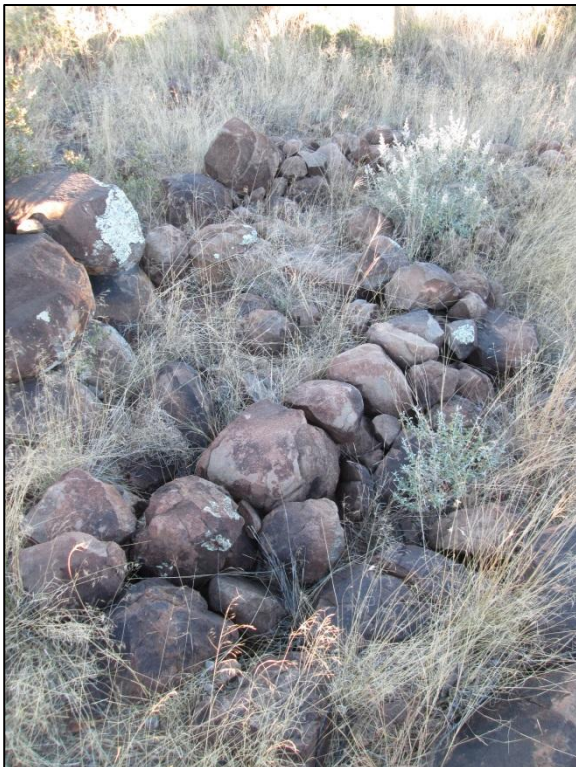
Figure 49: Piled stone structure on a hillside on Doornrandjes (point 132).

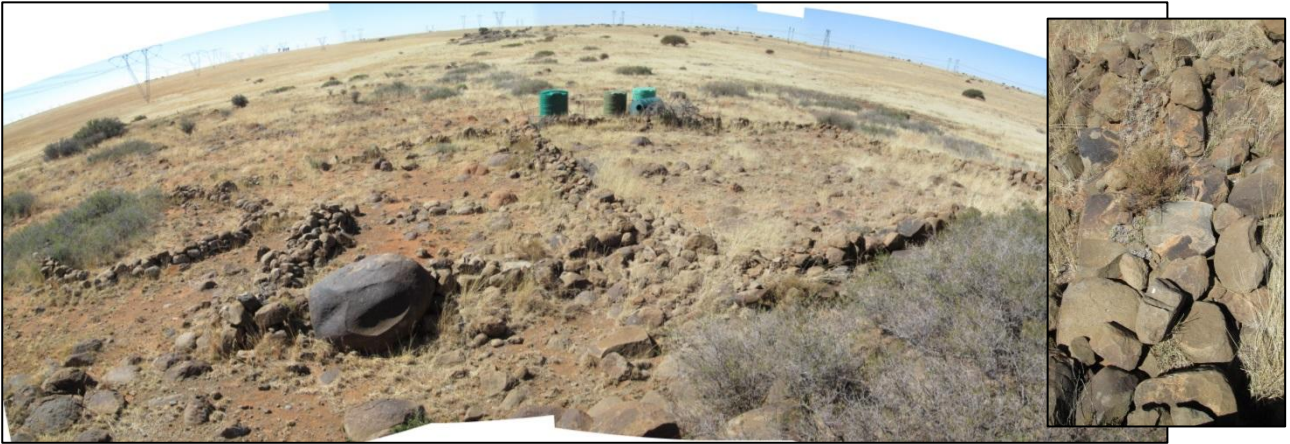
Figure 51: View towards the east of the historical kraal on Modderfontein (point 145). The inset photograph shows the historical building style of two skins with a rubble fill.

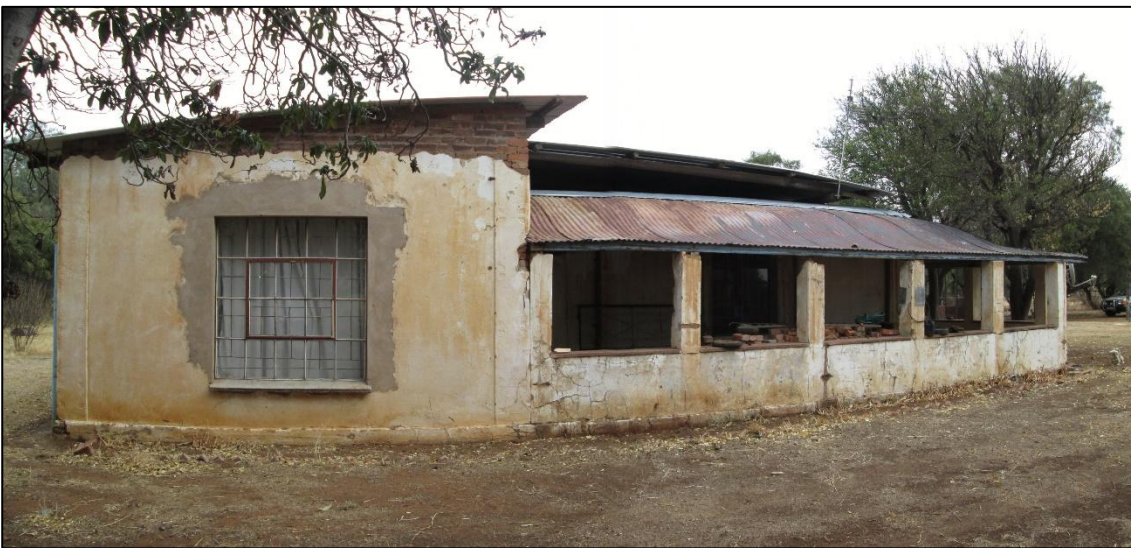
Figure 56: The main farm house on Walviskuil (point 080).

The farm werf at Walviskuil seems to have once had much heritage character but, partly through a fire that destroyed part of the main house, this has become somewhat degraded. Figure 56 shows the now modified main house which has had a new roof added but which retains a Victorian-type veranda. Figure 57 shows an outbuilding constructed from calcrete rocks and mud. This outbuilding demonstrated very well the traditional building style in an area where proper building materials were either scarce or expensive to obtain.

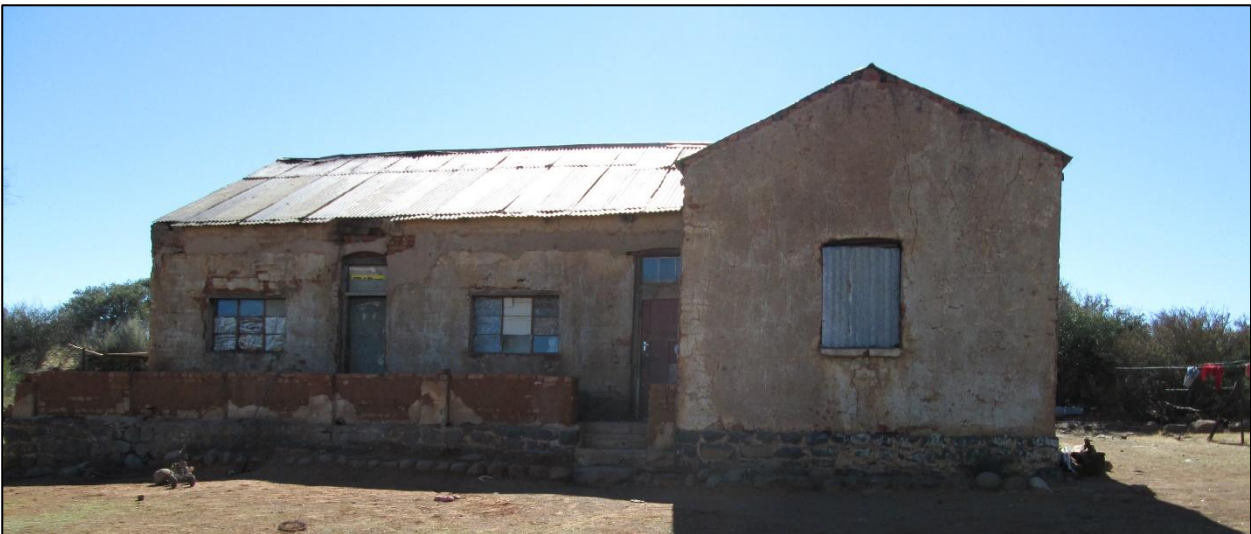
Figure 58: The west-facing façade of a historical house on Doornrandjes (point 099).

On Doornrandjes there was a very well preserved historical house that looked as though it might date to the early twentieth century. It is a plastered brick house placed over a dolerite block foundation and has a corrugated iron roof (Figure 58). Joinery is a mixture of wood and steel. The house is presently occupied. Sadly, its context has been eroded by the placement of large power lines immediately to the south of the house (Figure 59).

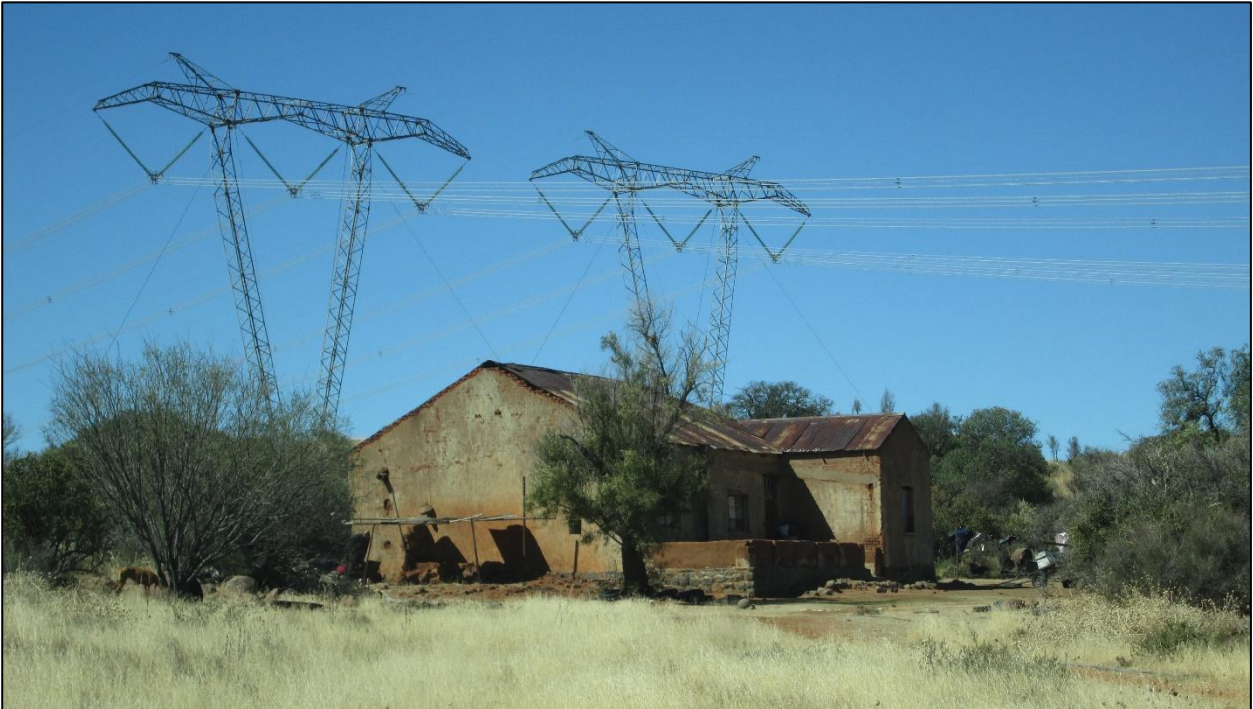
Figure 59: The northern end of a historical house on Doornrandjes (point 099).

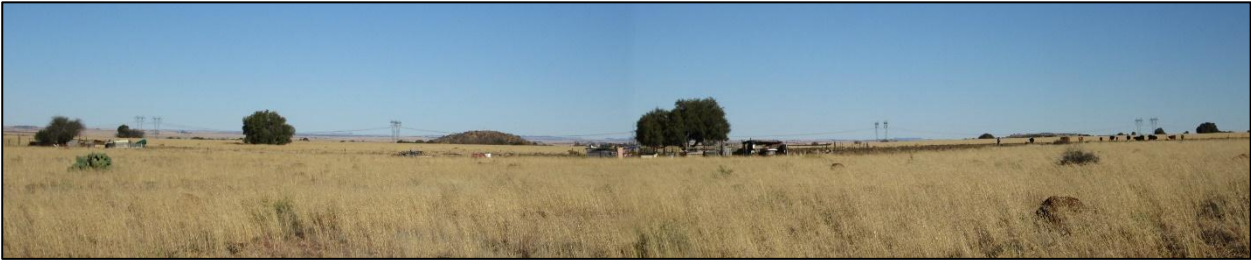
Figure 66: Two stock posts on the southern part of Klipfontein. One is visible at far left and one in the centre. A small herd of cattle is grazing at far right.

The Klipfontein farm gave the strong impression of having served as town commonage for some time. It certainly presently serves that purpose and a number of stock posts and a small reservoir and wind pump were seen scattered across the area (Figures 63 to 66). These were not individually mapped, although an abandoned post (not old enough to legally be counted as archaeological) did have its position recorded (Figures 67 & 68). In a number of other areas it was obvious that stock posts had been moved since the denuded nature of the surface indicated where livestock had congregated in the recent past. Another in the central part of Klipfontein yielded glass bottles in addition to metal and enamel items.

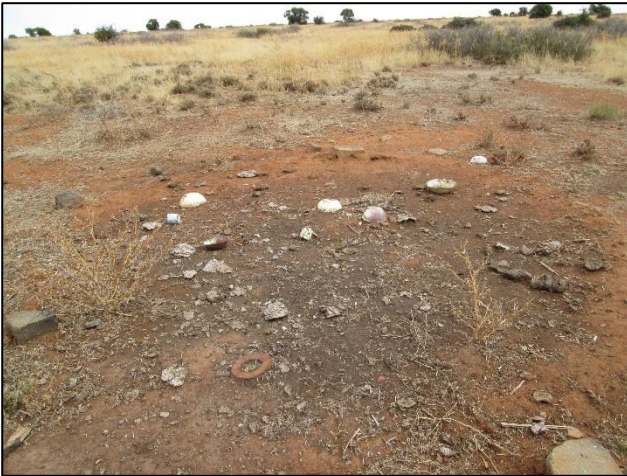
Figure 67: Denuded area with remains of an old stock post. Finds include metal items and enamel bowls and mugs (point 086).

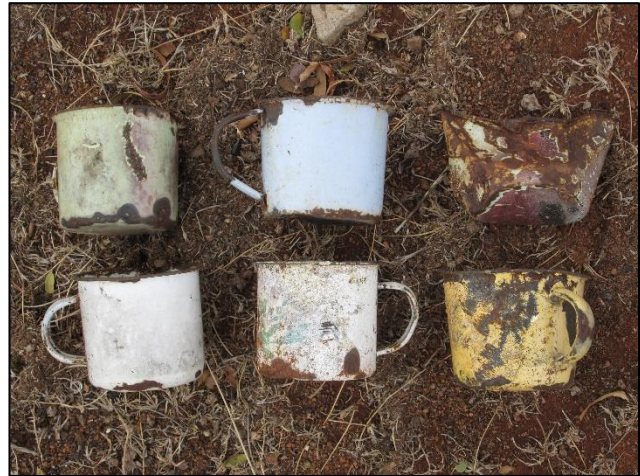
Figure 68: Collection of old enamel mugs found at the old stock post at point 086.

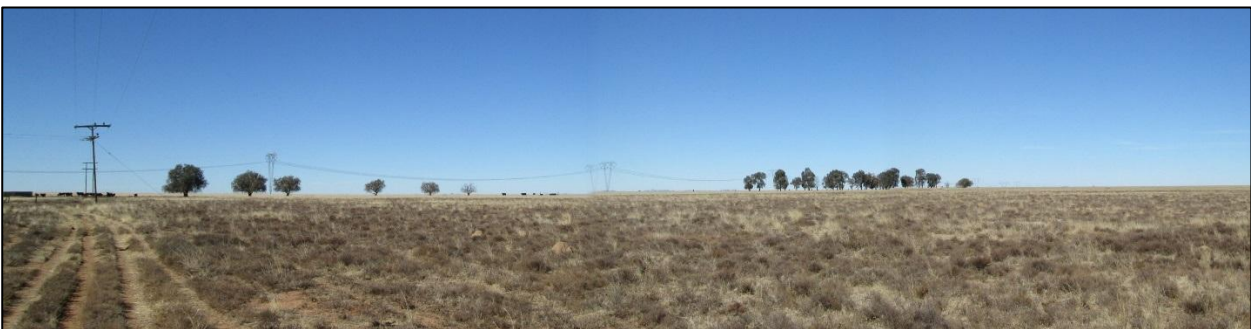
Figure 70: View towards the southeast showing the tree line. The trees on the right hand side are in fact a double row.

The vicinity of Dealesville does not have a well-developed cultural landscape. Farmsteads are widely scattered and are not linked by any features such as tree lines. Tree lines, in fact, are very rare in the area. On Leliehoek there are a number of intersecting tree lines enclosing paddocks and creating spaces close to the farm werf (Figure 69), while remnant tree lines occur on Braambosch (Figure 26) and Rossouw in the south. The most common feature of the cultural landscape is fences which surround all the farms and divide each into a number of camps. Being small and barely visible at distance, they do not contribute strongly to the cultural landscape. Of more significance are the many power lines that cross the study area and the two large substations - these have transformed the landscape into an ‘electrical landscape’

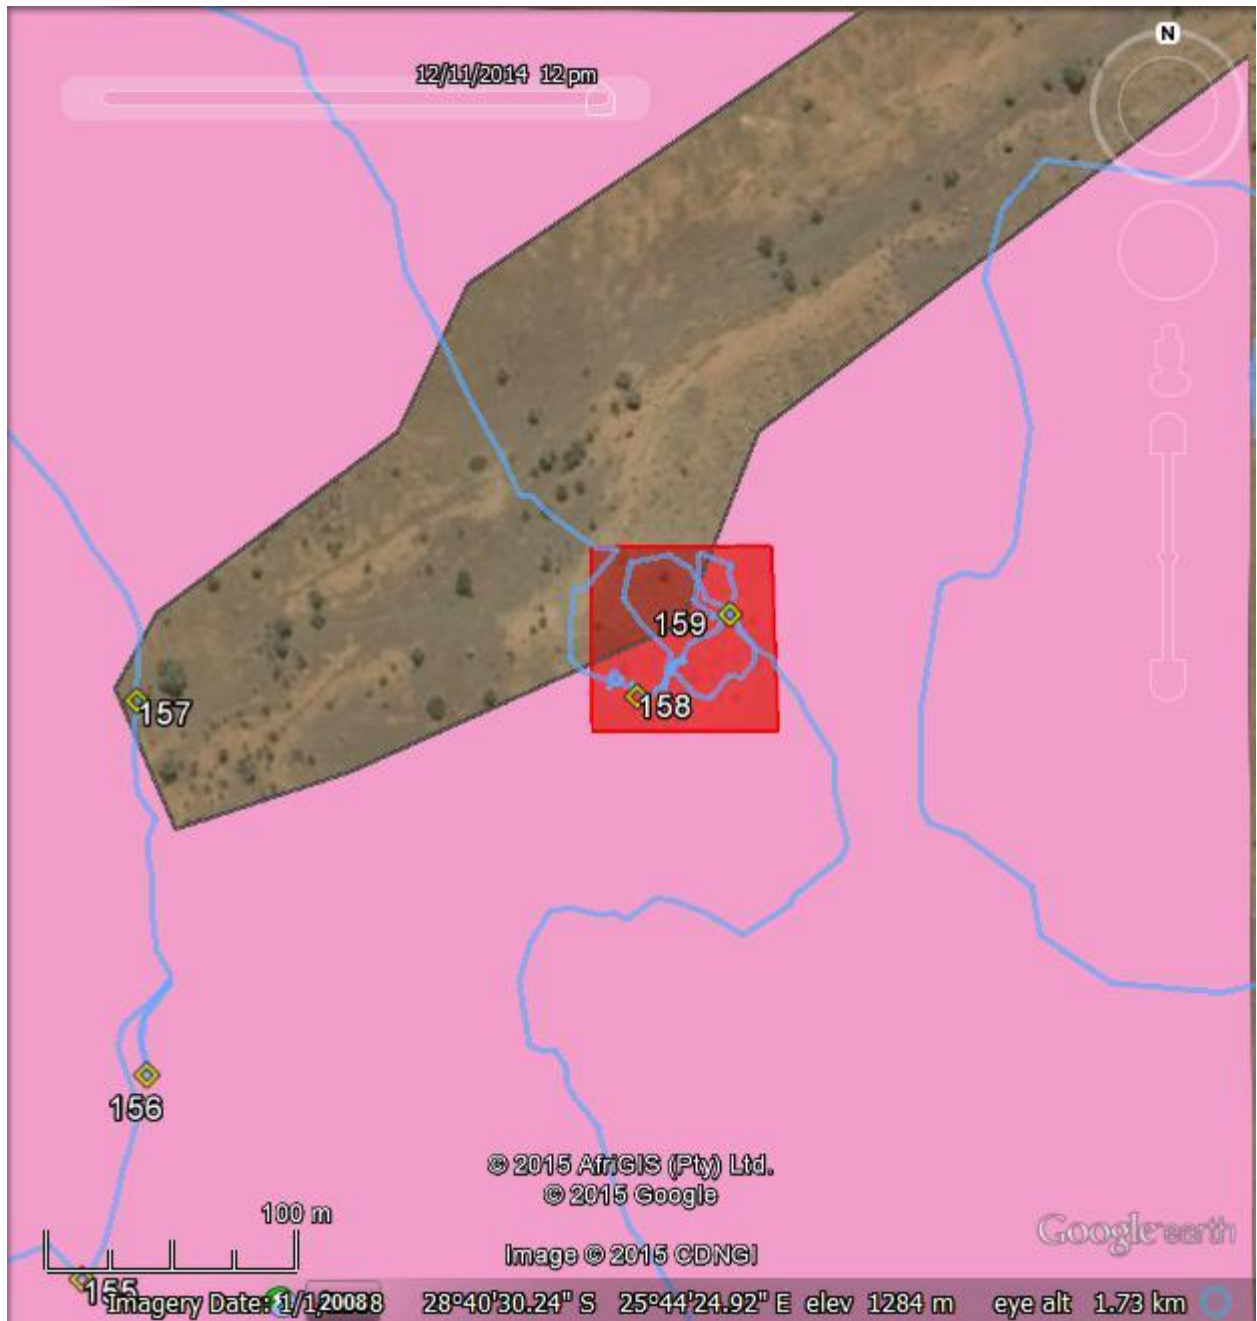
Figure A2.4: Sites requiring mitigation at waypoints 158 and 159.
