HERITAGE IMPACT ASSESSMENT: PROPOSED 33 kV POWERLINE NEAR DEALESVILLE, BOSHOF MAGISTERIAL DISTRICT, FREE STATE

Required under Section 38(8) of the National Heritage Resources Act (No. 25 of 1999) as part of a Heritage Impact Assessment.

16 October 2021

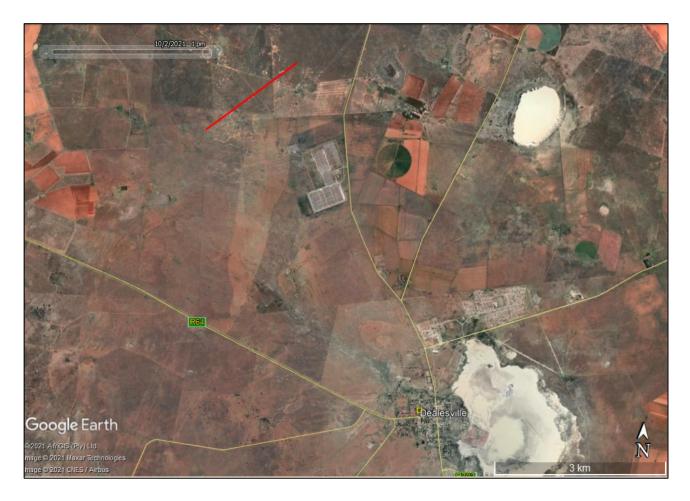
Figure 2: Aerial view of the development area and surrounds showing the landscape around the site (red line) with Dealesville to the southeast.

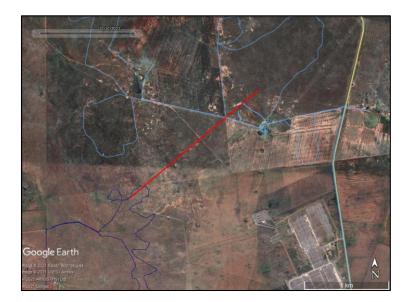
Figure 3: Aerial view of the proposed powerline (red line) showing the survey tracks recorded during surveys for other projects (blue lines).

The site was not specifically surveyed, although small parts of it have been covered by the present author during the course of other assessments. These other surveys were on 23rd August 2014 and 2nd October 2021. These were during winter and spring, before the onset of the rainy season. This meant that ground visibility for archaeological resources was good. Other heritage resources are not affected by seasonality. During the surveys the positions of finds and survey tracks were recorded on a hand-held Global Positioning System (GPS) receiver set to the WGS84 datum (Figure 3). Photographs were taken at times in order to capture representative samples of both the affected heritage and the landscape setting of the proposed development.

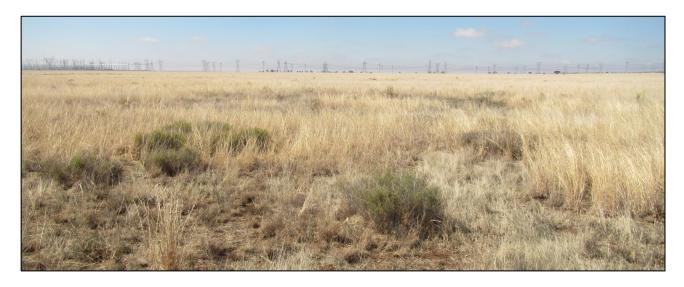
Figure 5: View towards the southeast in the south-western end of the study area (23.10.2021).

The site is comprised almost exclusively of grassland. Figures 5 to 8 show views of the development area. The surface is generally sandy with minimal gravel clasts.

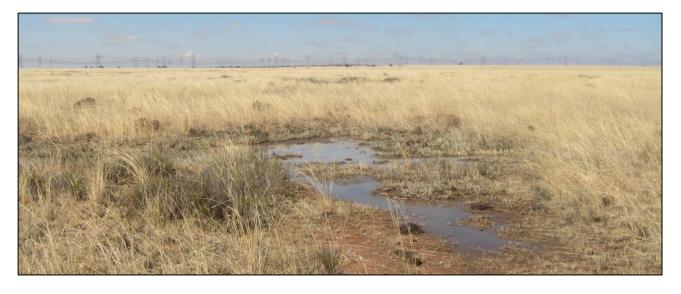
Figure 6: View towards the south across the route of the proposed powerline in its south-western part. Puddles had formed on the very flat surface after recent rains (23.10.2021).

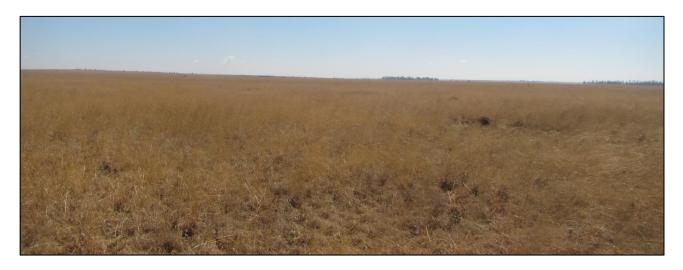
Figure 7: View towards the north looking towards the proposed powerline (23.10.2021).

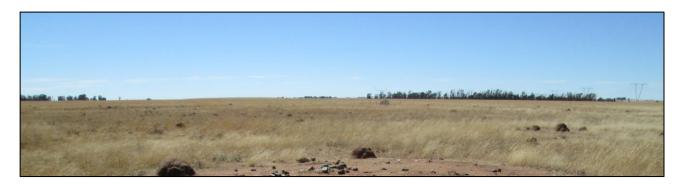
Figure 8: View towards the north through the northern part of the proposed powerline alignment (23.08.2014).

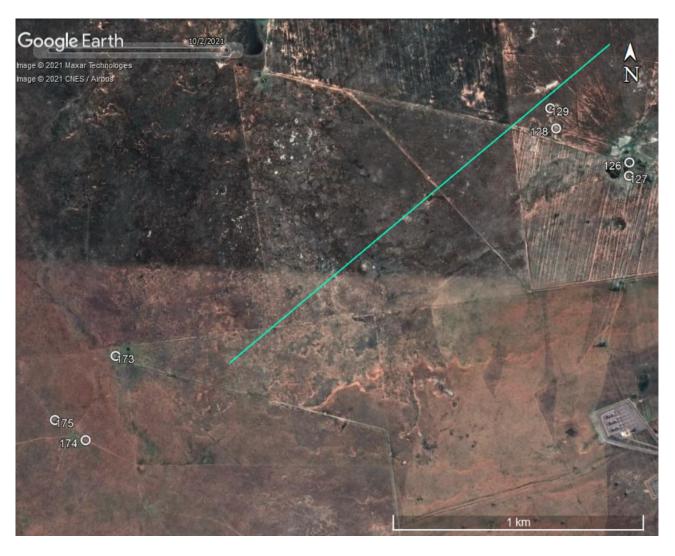
Figure 9: Map showing the locations of finds.

The two site visits that covered parts of the powerline did not locate any heritage materials within the footprint. It is clear from aerial photography that no landscape features like rocky hills or outcrops, or groves of trees (or any trees) occur within the proposed footprint and its immediate surrounds. Nevertheless, a few heritage resources are known from the wider area (within 1 km of the proposed footprint) and these are listed and described in Table 2. All are archaeological resources.

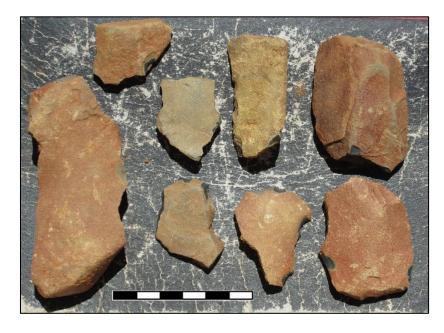
Figure 10: Stone artefacts from waypoint 174.

Stone Age resources were seen in one area (waypoints 174 and 175) and comprised of background scatter artefacts of low density and low significance (Figure 10). Such finds have been widely recorded in the area.

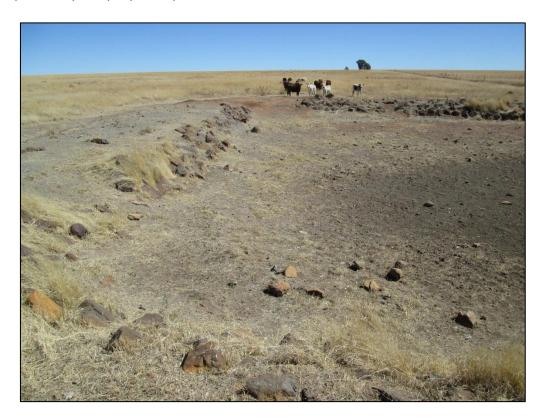
Figure 11: The small dolerite-lined dam at waypoint 173.

All other records are of historical features. They include a small dam lined with dolerite cobbles (Figure 11), a ruined farm complex (Figures 12 to 14) and the ephemeral remains of a stock post (Figures 15 and 16). While the am and stock post are of low significance, the house preserves a number of architectural details (see Table 2) and is of more concern. It is in very poor condition though, having been stripped of its joinery, presumably for reuse elsewhere. None of these finds will be impacted by the proposed powerline.

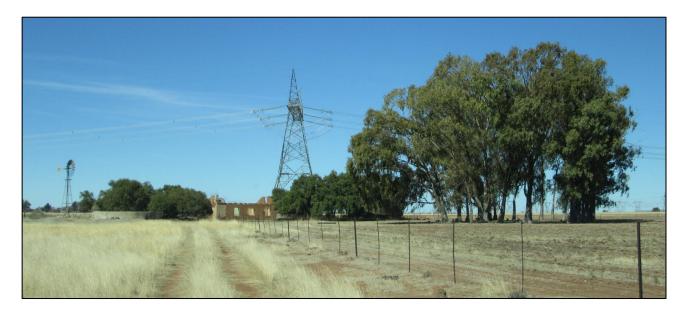
Figure 12: The setting of the farm complex at waypoints 126 and 127.

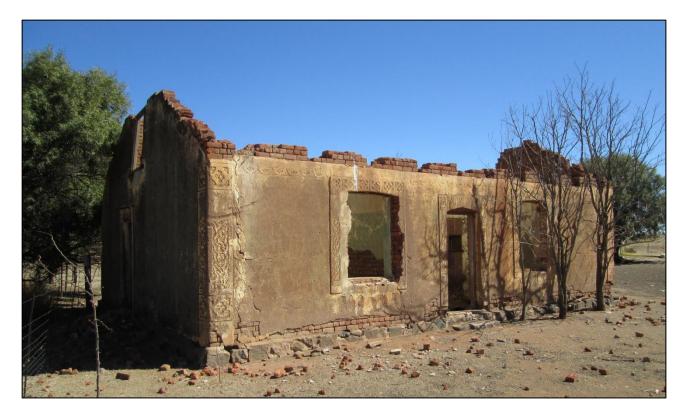
Figure 13: The farmhouse ruin at waypoint 126.

Waypoint	Location	Description	Significance (Grade)
126	S28 37 28.8 E25 44 20.5	Ruined farmhouse of 11 m by 8 m with an external hearth and chimney stack, looks like it was Victorian. The external walls and chimney (which was a later addition) were made of red clay bricks with frogs, while other walls were made from locally manufactured sun-baked bricks made from local soil and organic matter. The house had six rooms. There is plaster rustication around the openings. Barbed wire has been built into the walls for strengthening. The kitchen has a cement floor but the rest of the house would have had a wooden floor. The house has stone foundations under every wall.	Medium (GPA) <mark>AVOID</mark>
127	S28 37 30 5 Stope foundation with the remains of brick walls above Structure		
128	S28 37 24.4 E25 44 09.8	Old stock post, twentieth century artefacts present, but the site may have had its roots in the 19th century. Most artefacts lying about are glass and metal, including parts of an old cast iron single bed.	Very low (GPC)

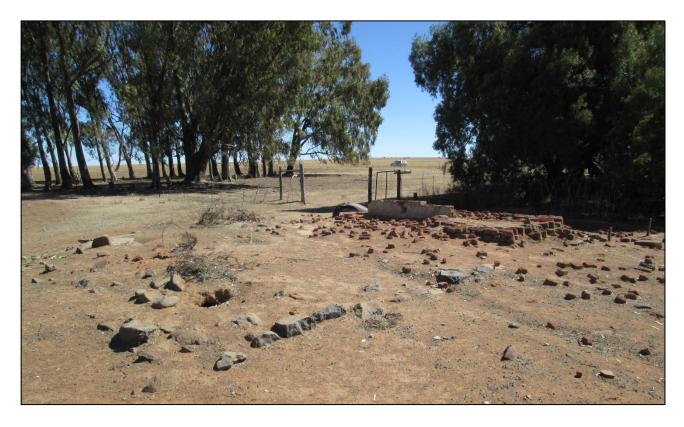
Figure 14: Stone and brick foundations at waypoint 127.

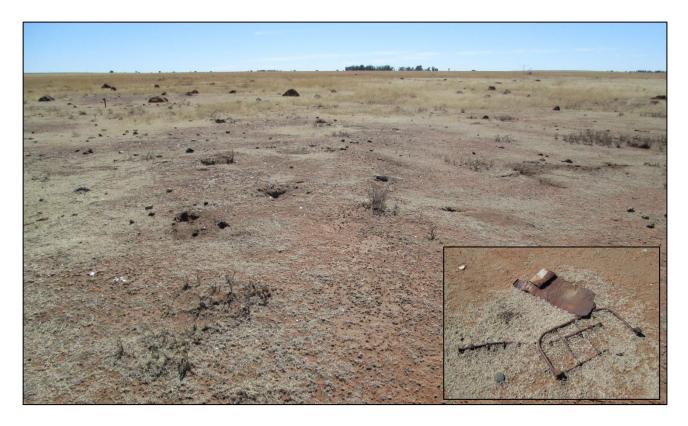
Figure 15: Very low density artefact scatter at an old stock post at waypoint 128.

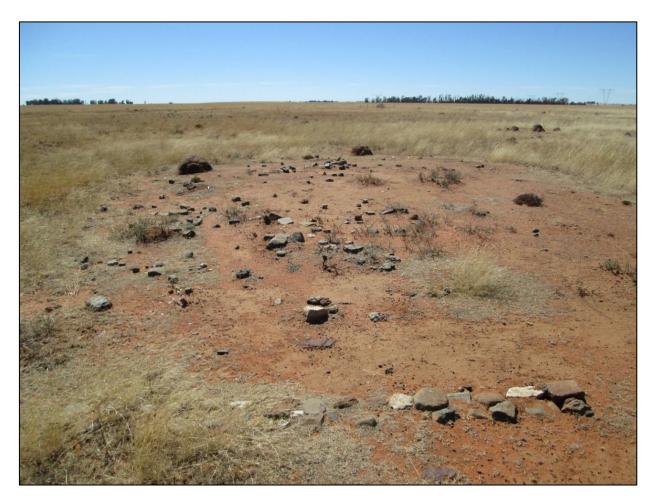
Figure 16: The ephemeral remains of a structure at waypoint 129.

129 S28 37 21.8 E25 44 08.9		Stone foundation located some 70- 80 m south of the stock post area but probably related to it. Also some Coronation bricks here.	
173	S28 37 53.7 E25 43 05.3	Small dam with walls lined with packed dolerite cobbles and boulders.	Very low (GPC)
174	S28 38 04.4 E25 43 00.9	Scatter of MSA hornfels artefacts eroding out of a farm road.	Very low (GPC)
175	S28 38 01.8 E25 42 56.5	Scatter of MSA hornfels artefacts in a deflated area that has gravel present in it as well.	Very low (GPC)
