Phase 1 Archaeological and Heritage Impact Assessment on the farm
Malelane 389 JU and alongside 10km of the N4 National Road in respect of
the proposed widening of section 8X as well as certain access roads,
Malelane, Mpumalanga Province.

Surveyor: Mr JP Celliers

13 October, 2020

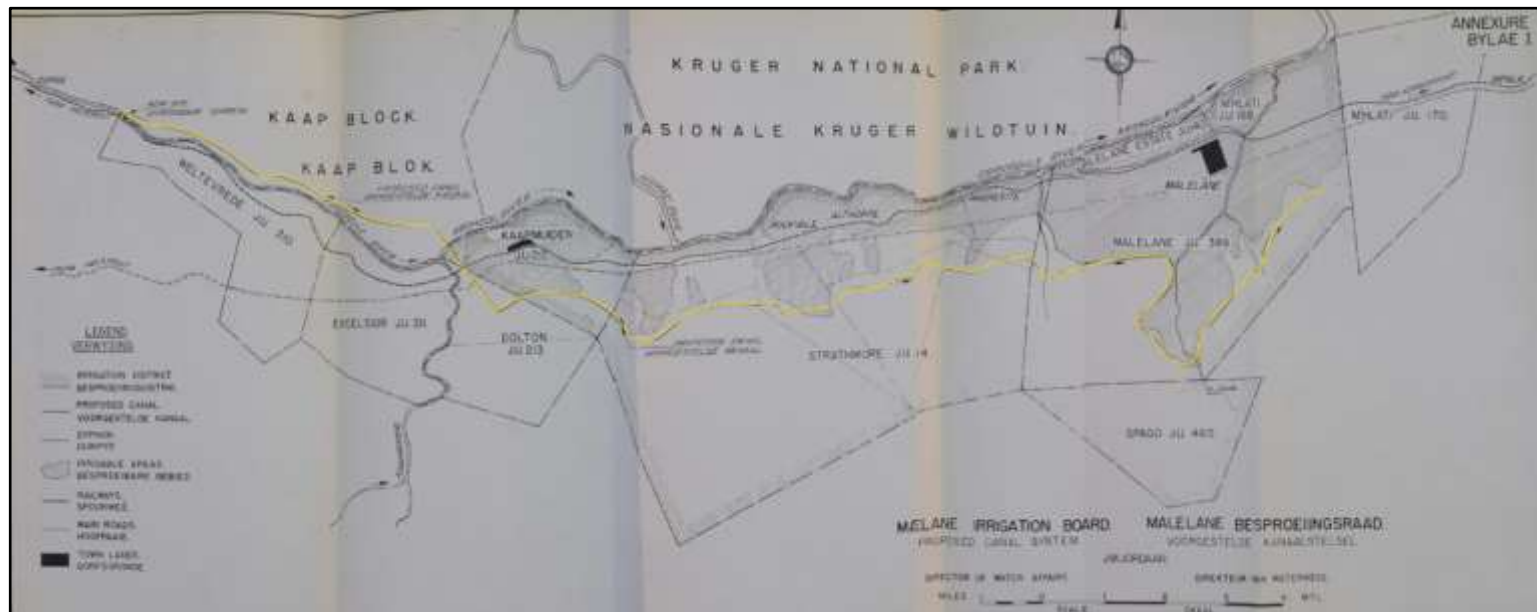
Figure 4.5. A map of the Malelane Irrigation Board's canal system dated 1961, which was submitted to Parliament. The canal system is shown with a yellow line (NARSSA TAB, TRB: 2/1/689 124/10/152).

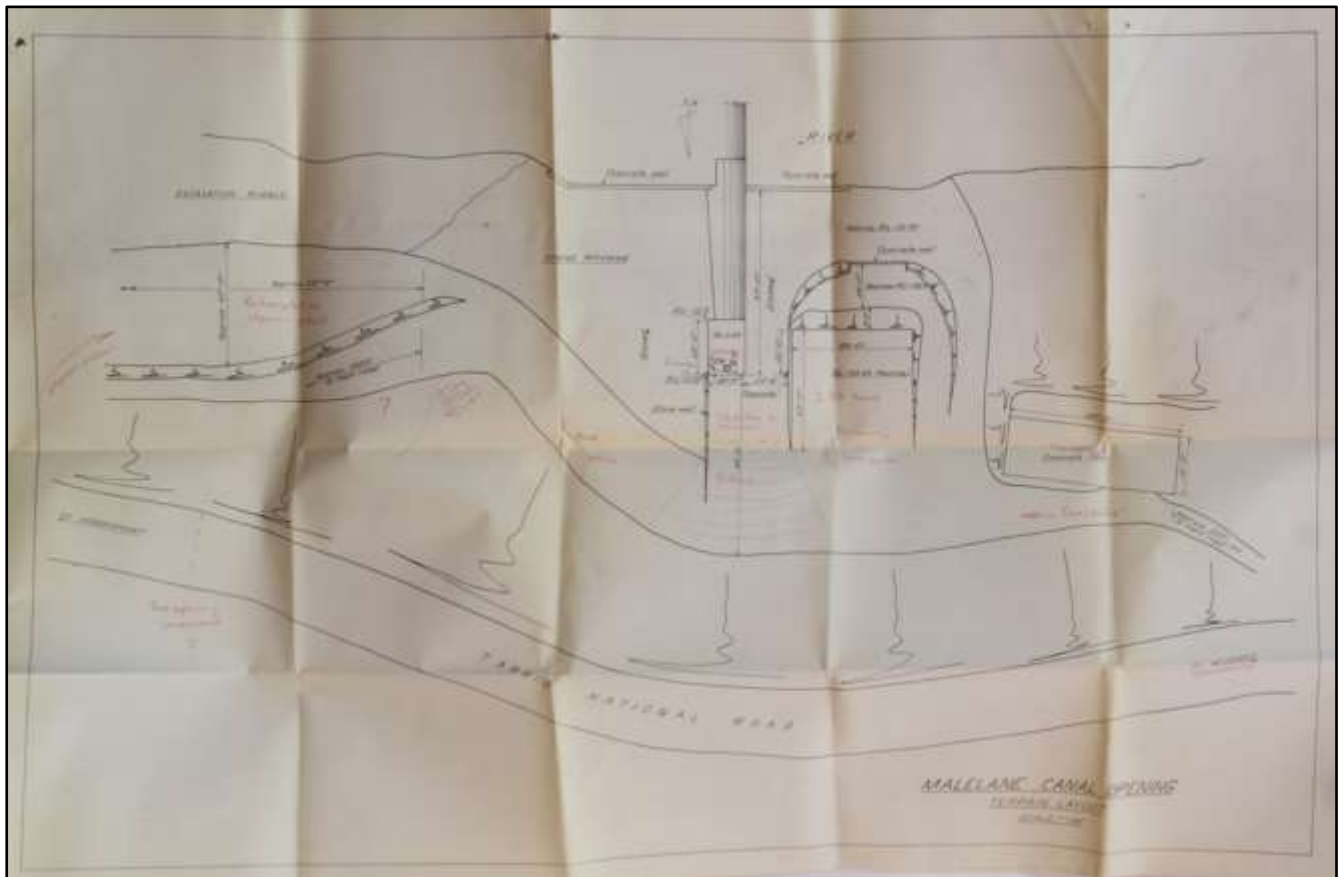
Open concrete canals were built in accordance with the usual parabolic shape which has been developed by the Department of Water Affairs and the pipelines were constructed from locally produced pre-stressed concrete pipes with a maximum diameter of 52 inches and 16 feet long (NARSSA SAB, WW: 111 K4/34).

Figure 4.7. Map and detail plan of the Malelane Canal during its official opening circa 1967 (NARSSA SAB, WW: 111 K4/34/1).

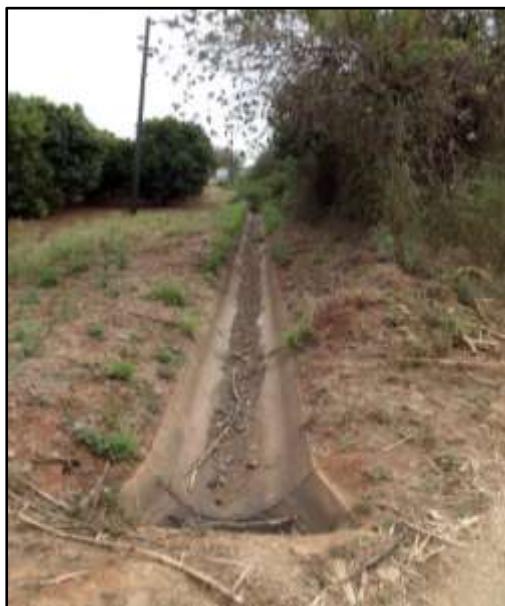
View north-east

5.1.2. Site MAL 2

Recommendation: The canal is 54 years old and therefore does not currently fall under the ambit of the Act (25 of 1999) which automatically protects structures and features older than 60 years (section 34 of the Act). It should however be noted that it is fast approaching the 60 year mark. Given its well documented origin and the drive behind its construction it is regarded as having high heritage value for the town and surrounding farming community. Current or imminent impacts should be kept minimal or avoided at best. A 20 meter buffer zone is recommended to minimize impact. If the canal or a section thereof will be negatively impacted upon, pre-emptive mitigation is recommended.

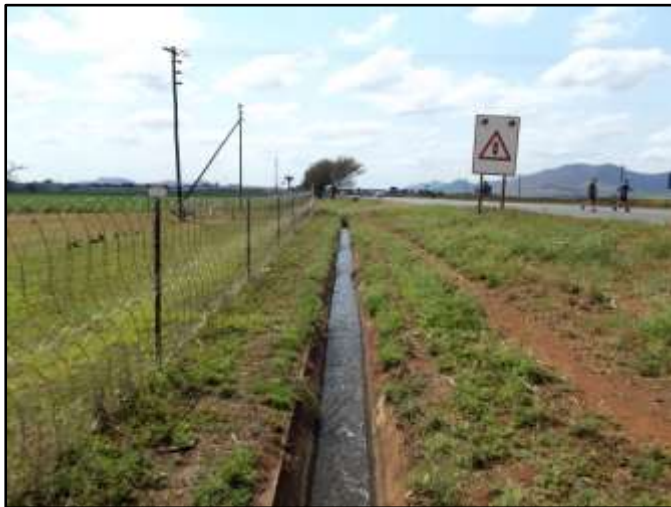
View north-east

5.1.3. Site MAL 3

Recommendation: The canal is 54 years old and therefore does not currently fall under the ambit of the Act (25 of 1999) which automatically protects structures and features older than 60 years (section 34 of the Act). It should however be noted that it is fast approaching the 60 year mark. Given its well documented origin and the drive behind its construction it is regarded as having high heritage value for the town and surrounding farming community. Current or imminent impacts should be kept minimal or avoided at best. A 20 meter buffer zone is recommended to minimize impact. If the canal or a section thereof will be negatively impacted upon, pre-emptive mitigation is recommended.

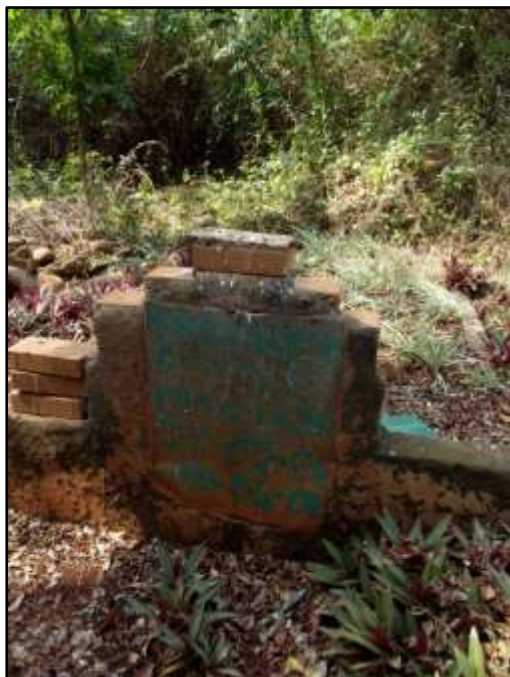
View north-east

5.1.4. Site MAL 4

Recommendation: It is recommended that the graveyard be fenced prior to any construction activity in order to protect the graves. Any surviving relatives should be allowed access. If this is not possible, heritage legislation guides alternative options. The Human Tissues Act 65 of 1983 applies to graves younger than 60 years. Graves which are older than 60 years are protected under section 36 of the NHRA (25 of 1999) and therefore a permit must be issued by SAHRA before the graves may be relocated or exhumed. A buffer zone of at least 20 meters is recommended to minimize impact.

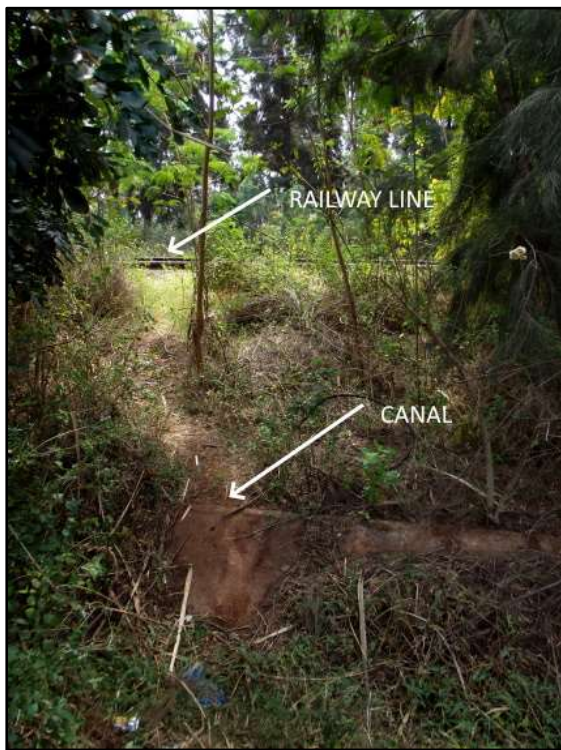
View north

5.1.5. Site MAL 5

Recommendation: The canal is 54 years old and therefore does not currently fall under the ambit of the Act (25 of 1999) which automatically protects structures and features older than 60 years (section 34 of the Act). It should however be noted that it is fast approaching the 60 year mark. Given its well documented origin and the drive behind its construction it is regarded as having high heritage value for the town and surrounding farming community. Current or imminent impacts should be kept minimal or avoided at best. A 20 meter buffer zone is recommended to minimize impact. If the canal or a section thereof will be negatively impacted upon, pre-emptive mitigation is recommended.

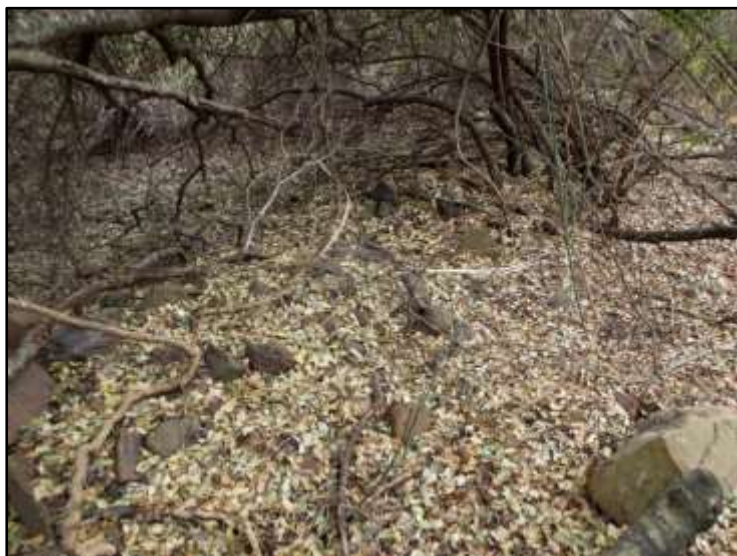
View north-west

5.1.6. Site MAL 6

Recommendation: The site is located within a dense thicket close-by and north of the existing N4 road. It is clear that some sort of dwelling which is now demolished, was here. It may have served as farm workers quarters. It is possible that unmarked graves are located in the immediate vicinity of the demolished structure. A buffer of 20 meters is recommended in order to safeguard against impact on possible unmarked graves.

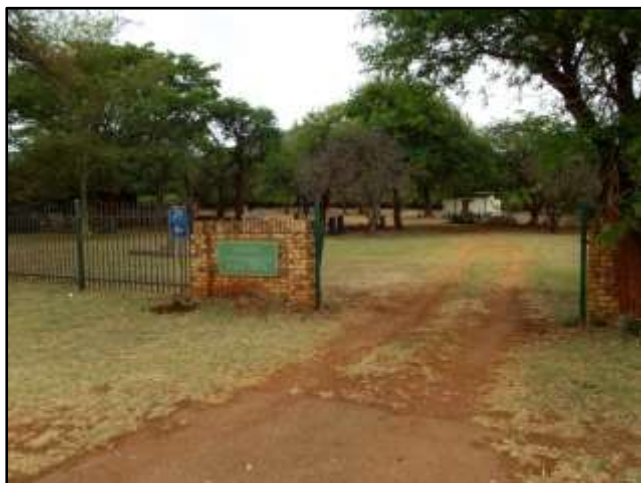
View south

5.1.7. Site MAL 7

Recommendation: The proposed activities will not negatively impact on the graveyard. It is recommended that any proposed construction or expansion activity be outside a minimum buffer zone of 20 meters around the graveyard. No additional recommendations.

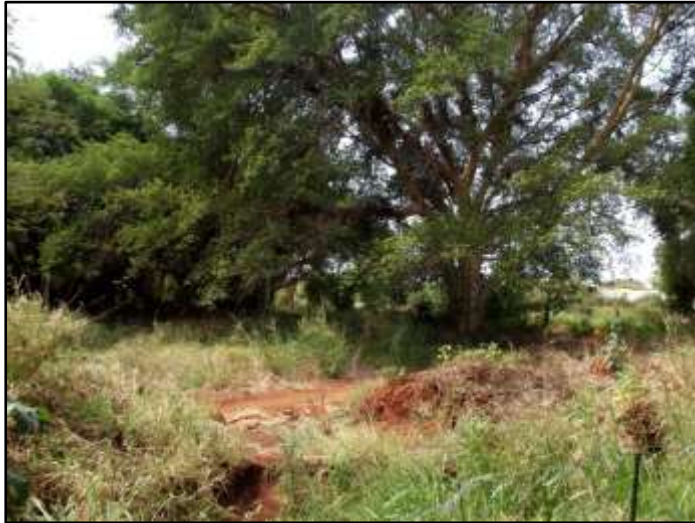
View north-east

5.1.8. Site MAL 8

Recommendation: Although no grave dressings could be located at this spot, it is recommended that no construction or earth-moving activity be conducted here in an effort to prevent any damage to unmarked graves or human remains. A 20 meter buffer zone is recommended to minimize impact and fencing of the area.

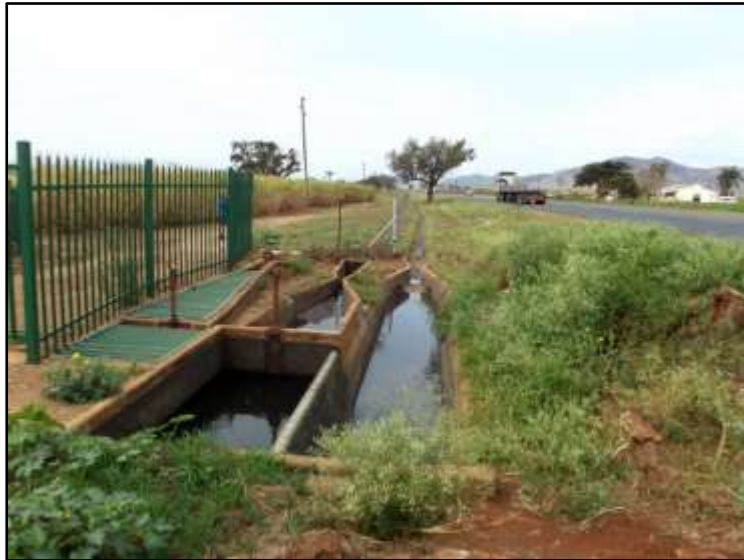
View east

5.1.9. Site MAL 9

Recommendation: The canal is 54 years old and therefore does not currently fall under the ambit of the Act (25 of 1999) which automatically protects structures and features older than 60 years (section 34 of

the Act). It should however be noted that it is fast approaching the 60 year mark. Given its well documented origin and the drive behind its construction it is regarded as having high heritage value for the town and surrounding farming community. Current or imminent impacts should be kept minimal or avoided at best. A buffer zone is recommended to minimize impact. If the canal or a section thereof will be negatively impacted upon, pre-emptive mitigation is recommended.

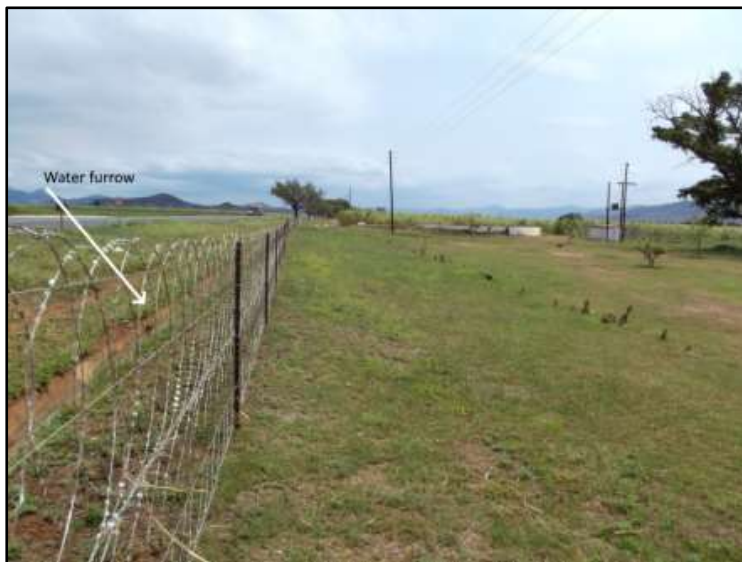
View west

5.1.10. Site MAL 10

Recommendation: The canal is 54 years old and therefore does not currently fall under the ambit of the Act (25 of 1999) which automatically protects structures and features older than 60 years (section 34 of the Act). It should however be noted that it is fast approaching the 60 year mark. Given its well documented origin and the drive behind its construction it is regarded as having high heritage value for the town and surrounding farming community. Current or imminent impacts should be kept minimal or avoided at best. A buffer zone is recommended to minimize impact. If the canal or a section thereof will be negatively impacted upon, pre-emptive mitigation is recommended.

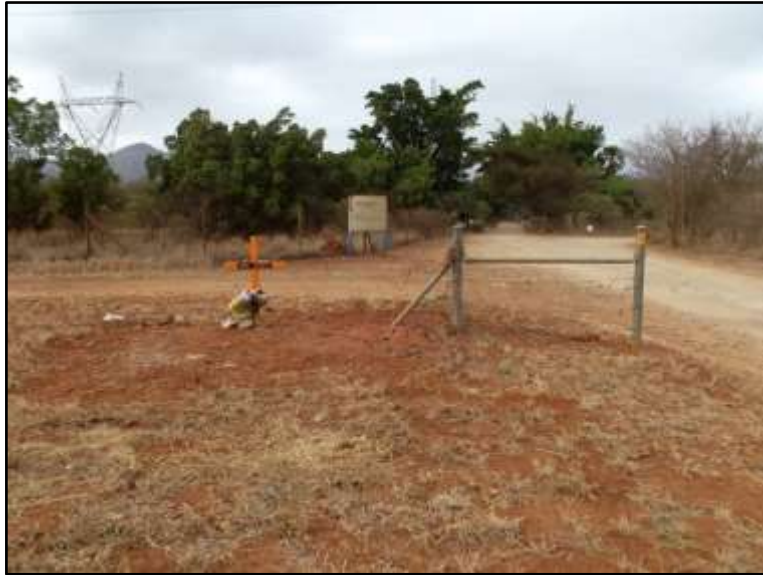
Fig. 1. Site MAL 1. Photo taken in a southern direction. A roadside marker probably indicating a road accident.

Location: See Appendix B and D (fig. 1)

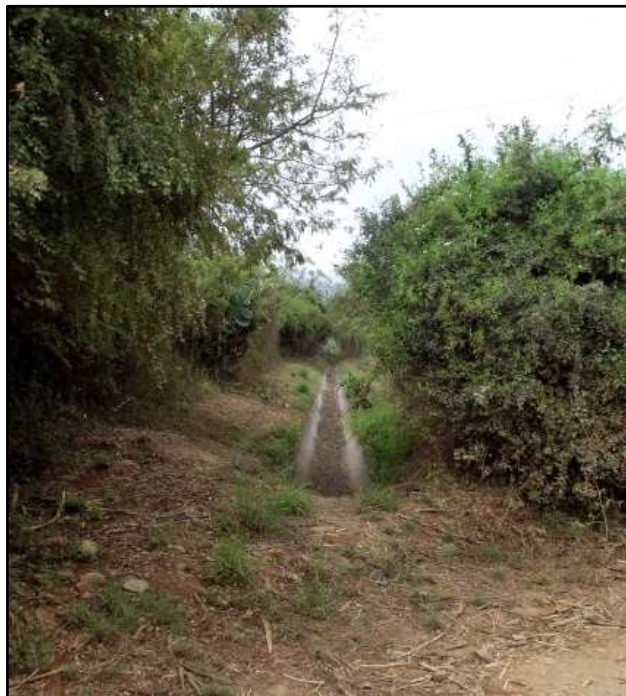
Fig. 2. Site MAL 2. Photo taken in a south-eastern direction. A section of the irrigation canal.

Location: See Appendix B and D (fig. 2)

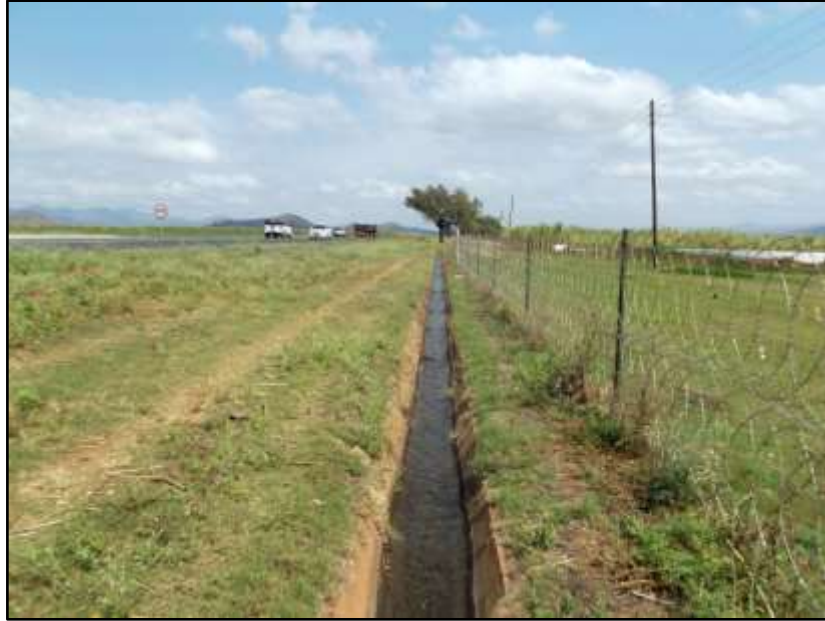
Fig. 3. Site MAL 3. A section of the irrigation canal. Photo taken in a south western direction.

Location: See Appendix B and D (fig. 3)

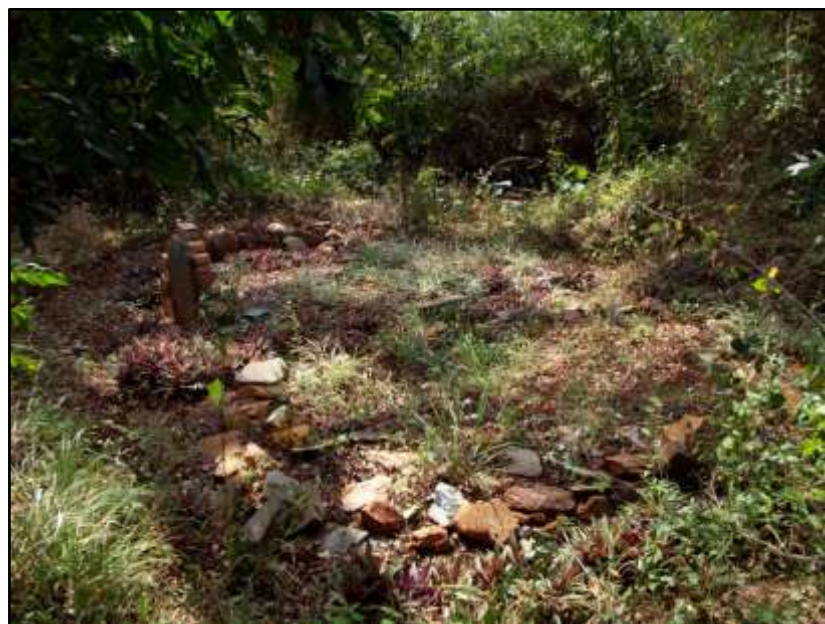
Fig. 4. Site MAL 4. Photo taken in a north-eastern direction. There are at least six graves located here. Only one has a headstone.

Location: See Appendix B and D (fig. 4, 5)

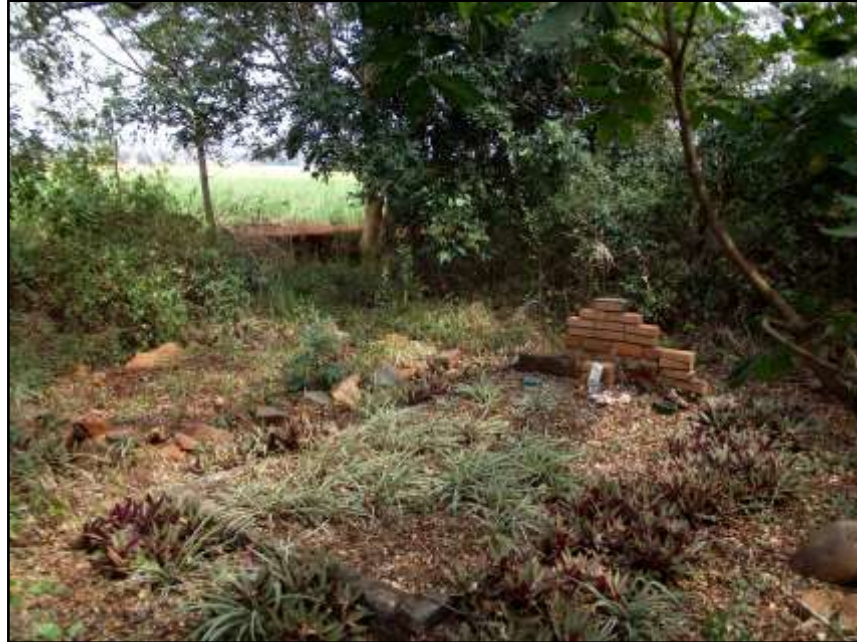
Fig. 5. Site MAL 4. Photo taken in a south western direction. There are at least six graves located here.

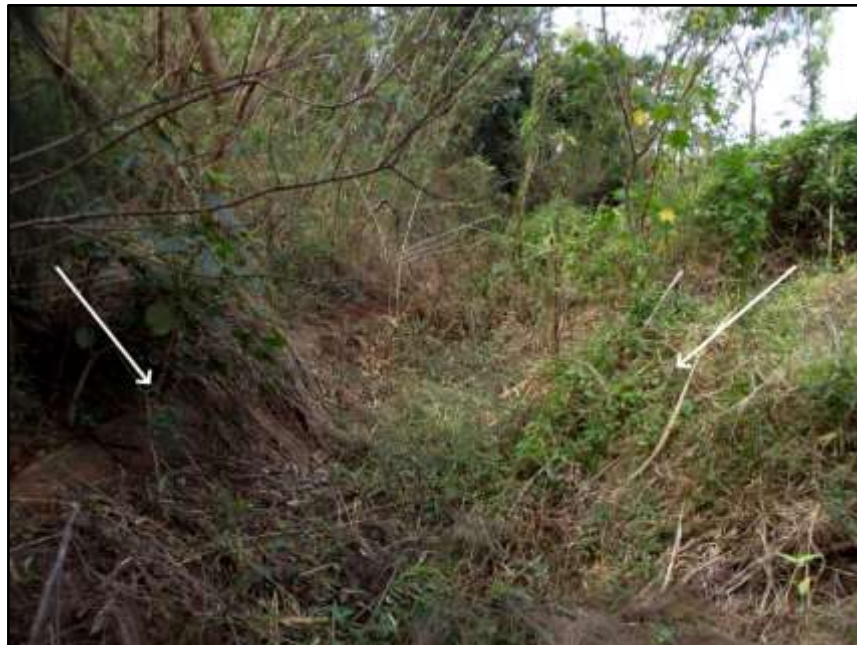
Fig. 6. Site MAL 5. Photo taken in an eastern direction. The white arrow shows the remains of the irrigation canal.

Location: See Appendix B and D (fig. 6)

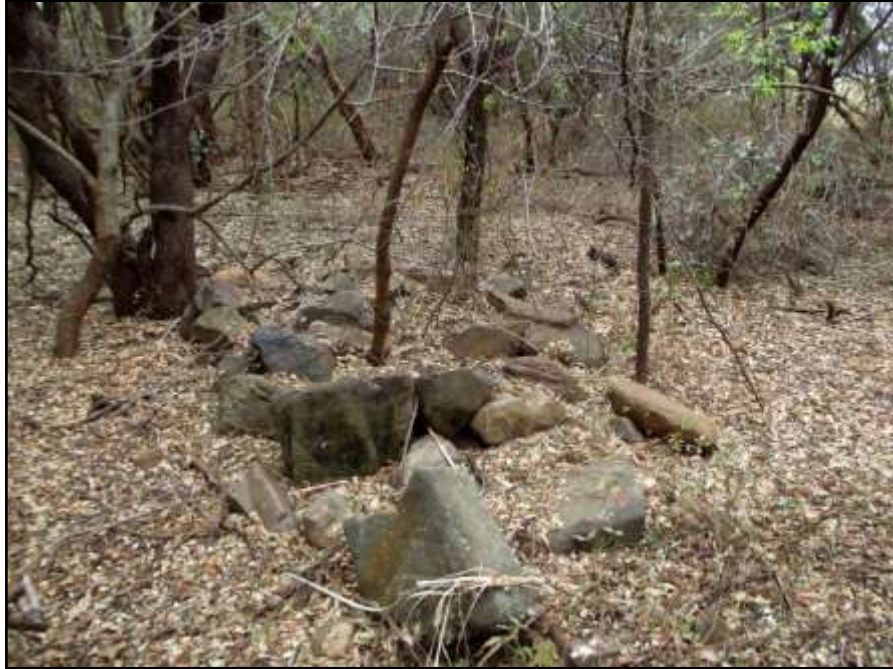
Fig. 7. Site MAL 6. Photo taken in a southern direction. Some of the rocks of a wall which collapsed.

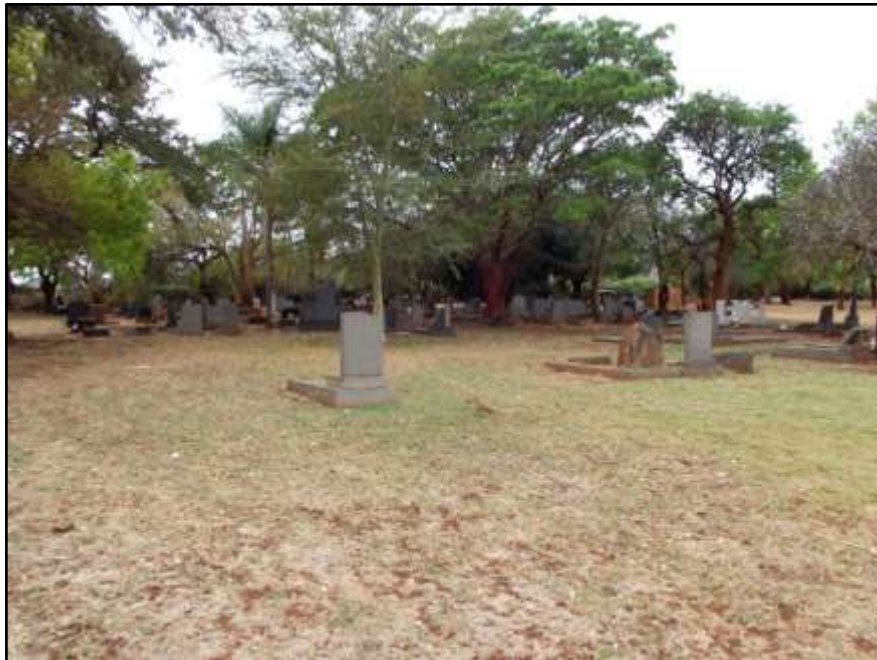
Fig. 8. Site MAL 7. Photo taken in a southern direction. The formal Malalane graveyard.

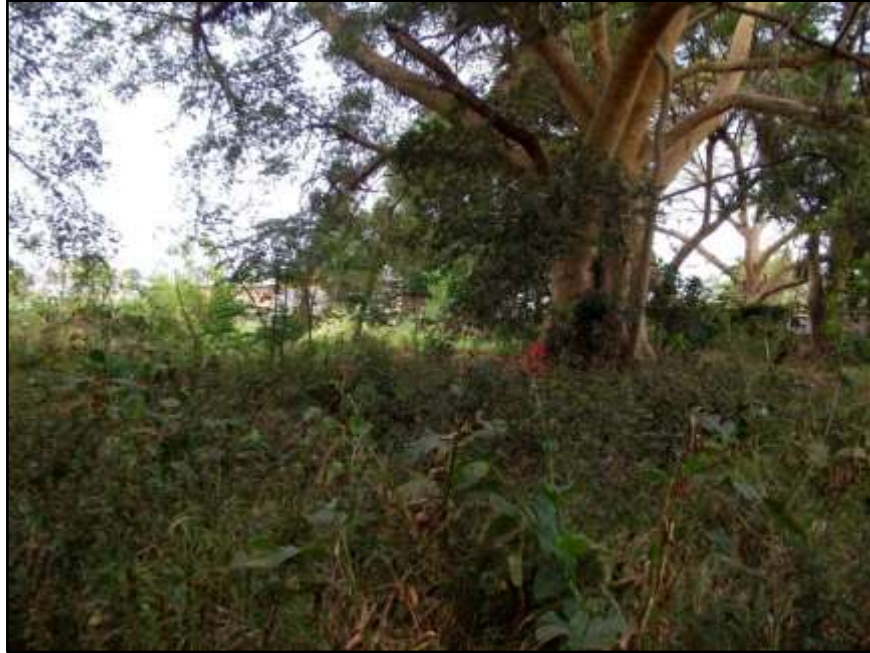
Fig. 9. Site MAL 8. Photo taken in a southern direction beneath a few large fig trees. No grave dressings could be located here but the informant Mr Botes, indicated that people were buried in this area.

Location: See Appendix B and D (fig. 9)

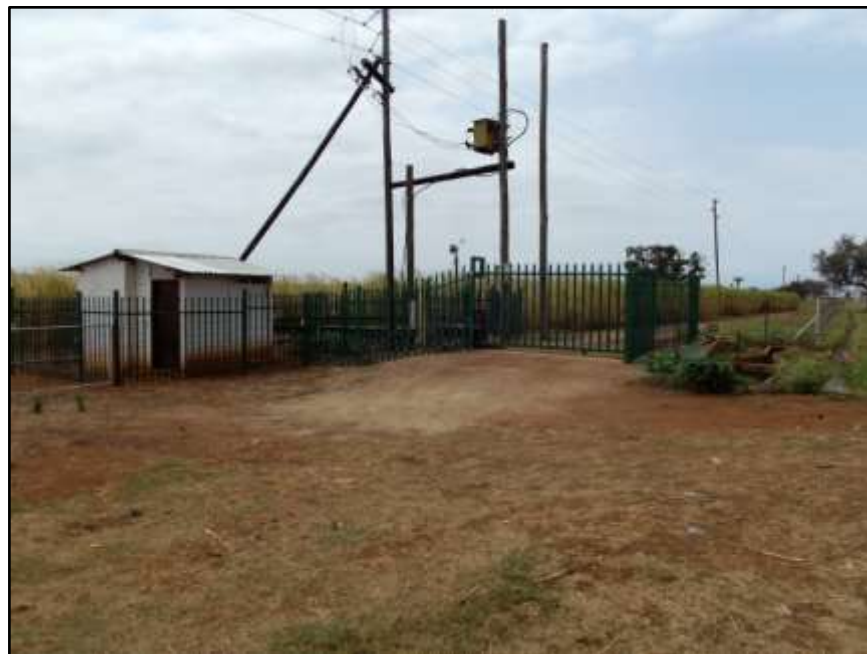
Fig. 10. Site MAL 9. Photo taken in a north eastern direction. The irrigation canal and a pump house is visible.

Location: See Appendix B and D (fig. 10)

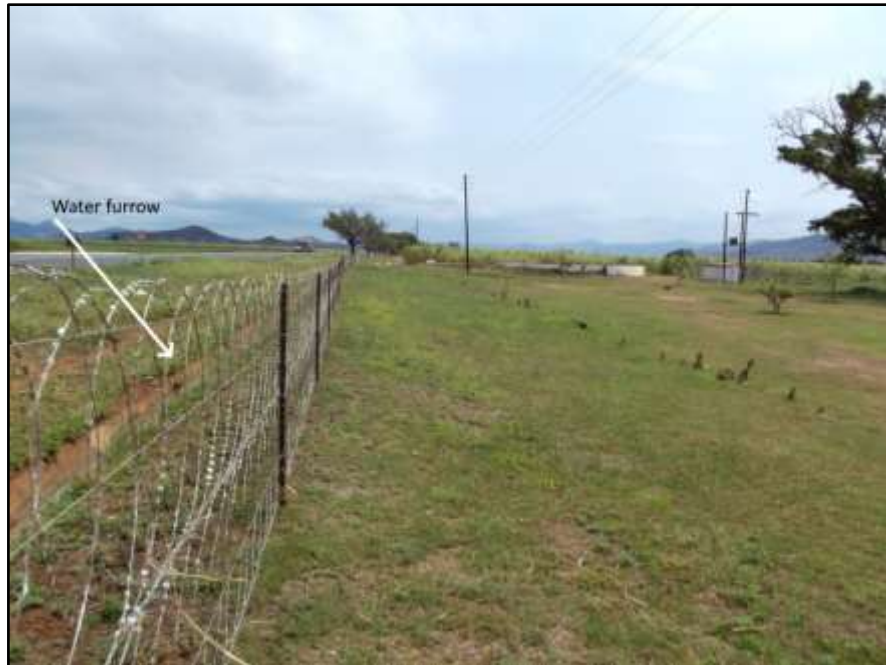
Fig. 11. Site MAL 10. Photo taken in a western direction. The arrow indicates the location of the water canal a few meters north of the N4 road.
