**MANDLAKAZI BULK WATER SUPPLY SCHEME –
PHASE 1, ZULULAND DISTRICT MUNICIPALITY,
KWAZULU-NATAL**

Phase 1 Heritage Impact Assessment

February 2022

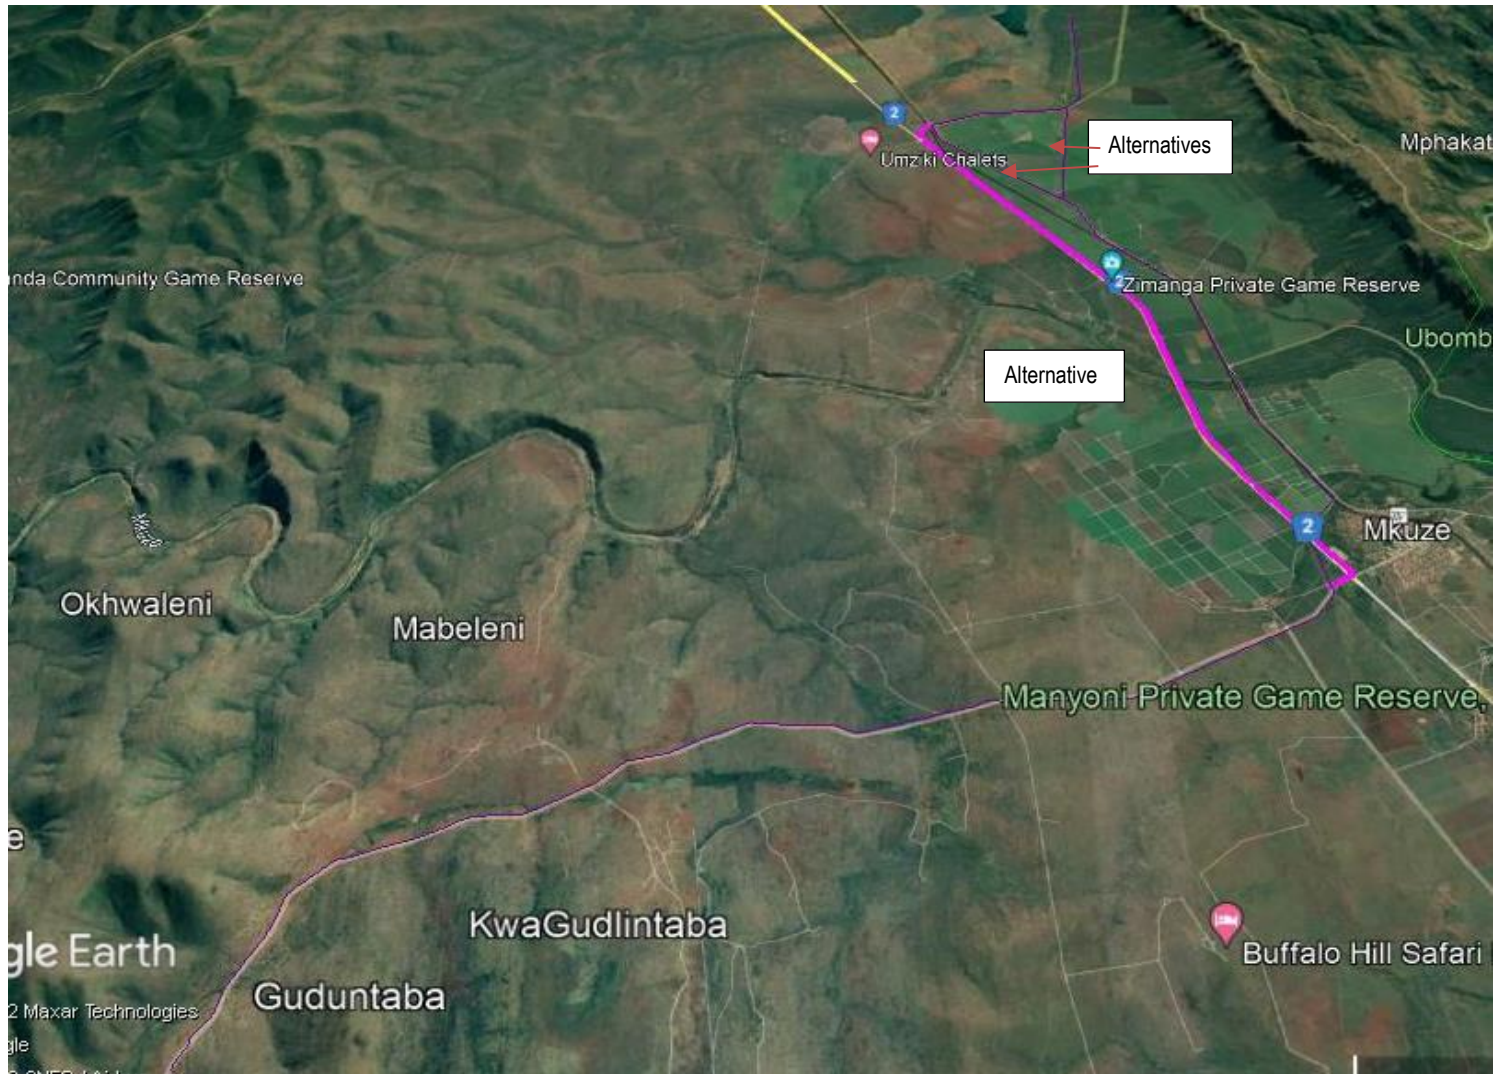
Figure 1: Bulk water pipeline indicated in purple with alternative route indicated in pink

The project is located in the Zululand District Municipality and is situated from the abstraction point on the south-eastern end of Pongolopoort (27°29'34.96" S; 32°00'08.86" E) to the Mandlakazi WTW (27°40'50.84" S; 31°55'01.56" E) which is located approximately 15km south-west of the town of Mkuze. There is a short alternative route for the pipeline that runs on the eastern side of the N2 highway (indicated in pink) as well as alternative routes immediately south of the Pongolo Nature Reserve (see **Figure 1**).

The 1963 aerial image of much of the route shows a largely uninhabited area with many dams, some cultivated land and roads. As depicted in Figure 1 above, just before the road to Jozini and the Pongolo Nature Reserve, the pipeline route splits with a direct line to the Nature Reserve and dam and a longer alternative running along an existing farm road that then crosses into the Nature Reserve before turning north-eastwards to join the pipeline route to the dam.

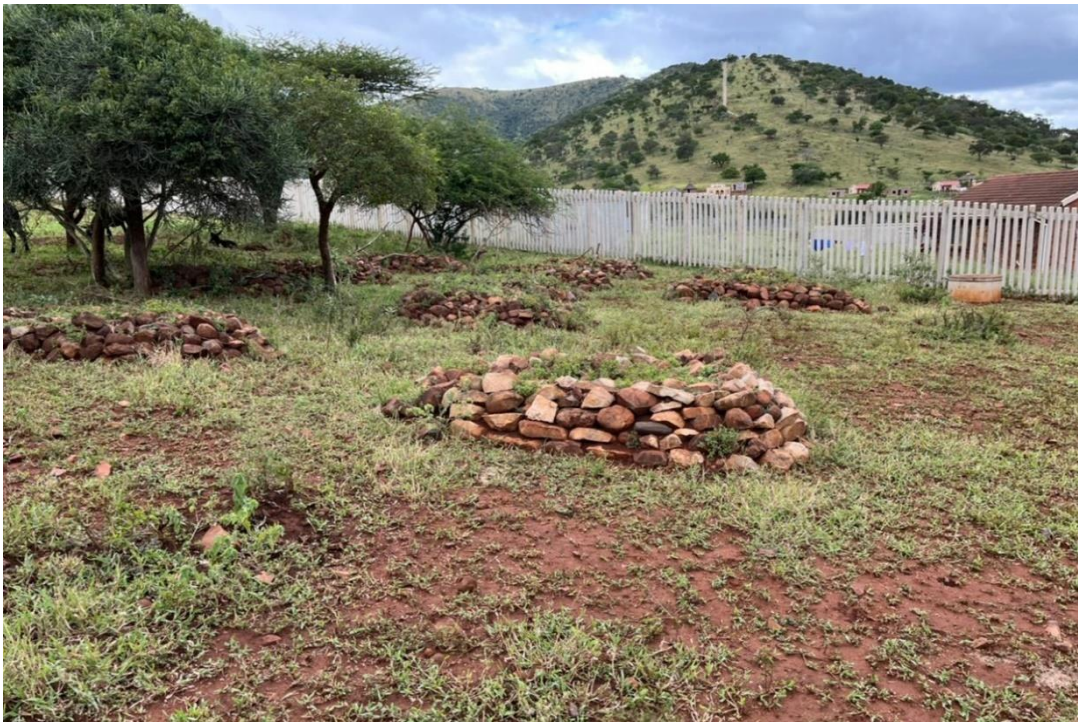
The inspection started from the Mandlakazi WTW with the pipeline route inspected largely on foot. There are several homesteads situated north/north-east and north-west of the pipeline route with many located over 20m from the proposed pipeline. At least 10 graves were found on the northern boundary of the WTW. The pipeline is located 13m south of the graves and within the boundary of the WTW.

Figure 3: Graves situated on northern boundary of WTW

- 12m fenced buffer around graves in which no construction activities may take place.
- The buffer area must be clearly demarcated and visible to construction crews

- If any of the graves are damaged during construction, then work must stop in the immediate vicinity and the graves must be rehabilitated to its previous condition. If the graves are >60 years, then the Institute must be informed and the necessary permits obtained from the Institute for the repair to the grave/s prior to work been undertaken on them.

During the site inspection, several heritage sites were found including a number of graves in an informal burial area. In terms of section 39 (1) of the KwaZulu-Natal Amafa and Research Institute Act, graves or burial grounds older than 60 years or deemed to be of heritage significance by a heritage authority- (a) not otherwise protected by the above Act and (b) not located in a formal cemetery managed or administered by a local authority, may not be damaged, altered, exhumed, inundated, removed from its original position, or otherwise disturbed without the prior written approval of the Institute having been obtained on written application to the Institute. Graves are highly significant to many people and there are many traditional, cultural and personal sensitivities and norms concerning damage to graves or the relocation of graves. It is recommended that graves are not moved and that they are fenced to avoid any damage to them during the installation of the proposed pipeline. If, for whatever reason, the graves will need to be altered or moved, the

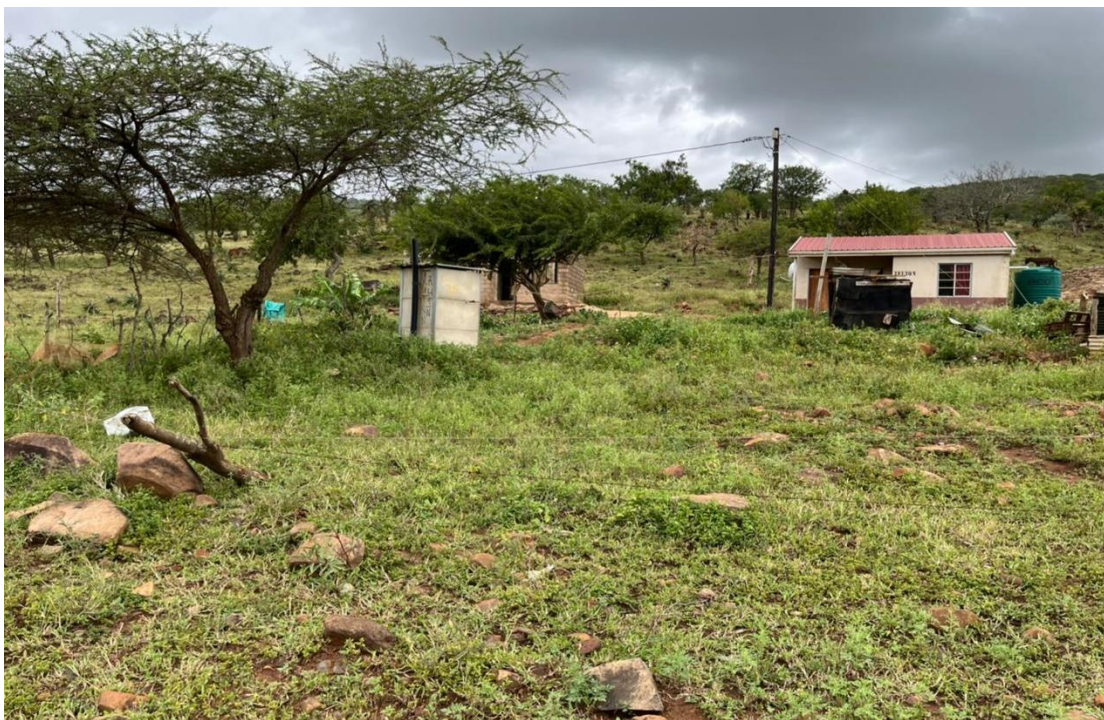
Figure 4: Pipeline route past houses situated north of Mandlakazi WTW

The specialist spoke to several residents (Doris Nxumalo, Amos Nkwanyana, Lindani Dlamini and Thokozile Myeza) along the pipeline route who said that most graves were found within homestead complexes with many at the rear of the homesteads or in the fenced fields which are mostly located away from the road and pipeline route. There is existing water infrastructure near the pipeline route, including manholes, as well as a power line.

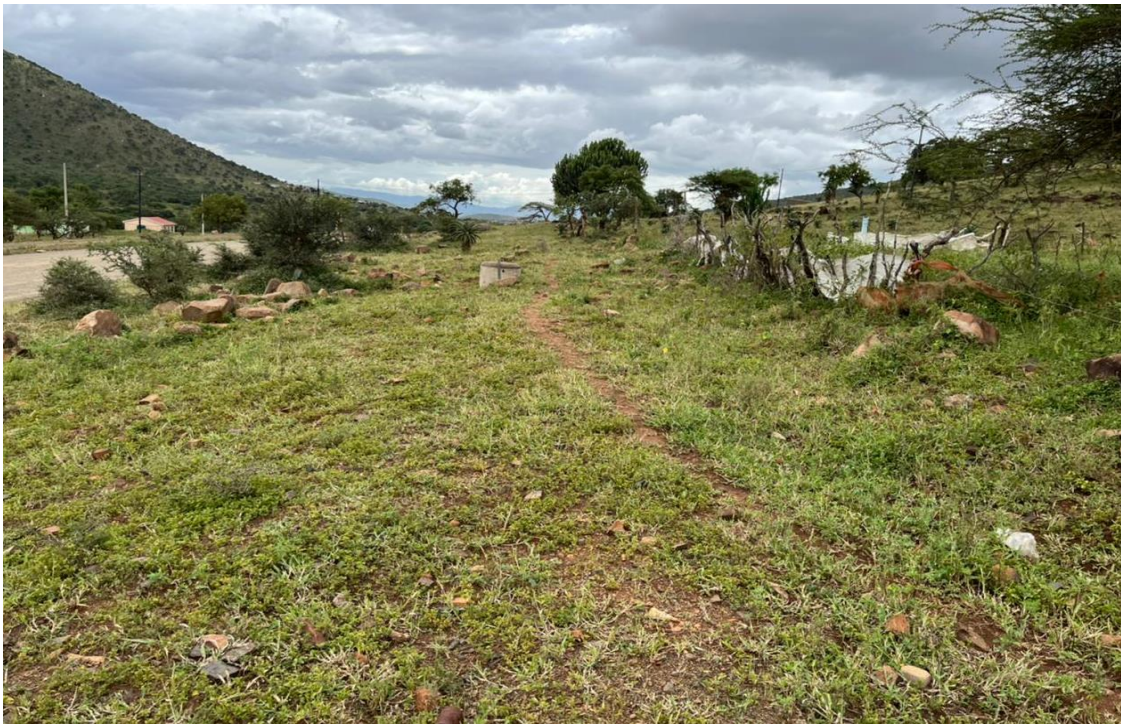
Figure 5: Pipeline route with existing manhole visible

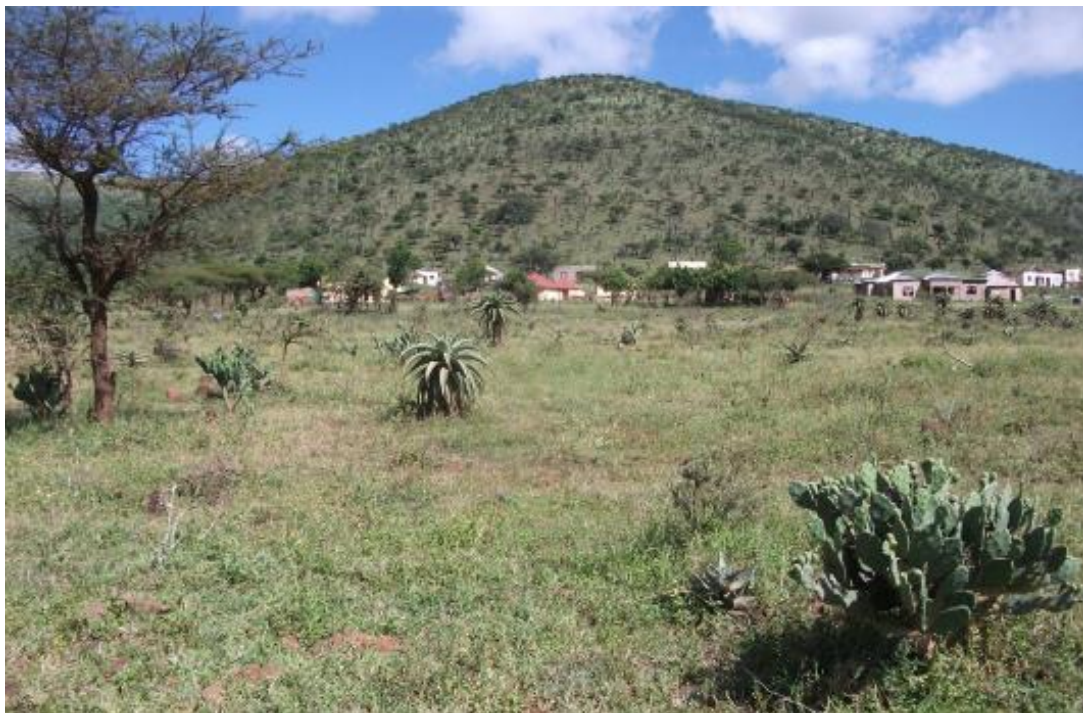
Figure 6: Distance between pipeline and homesteads

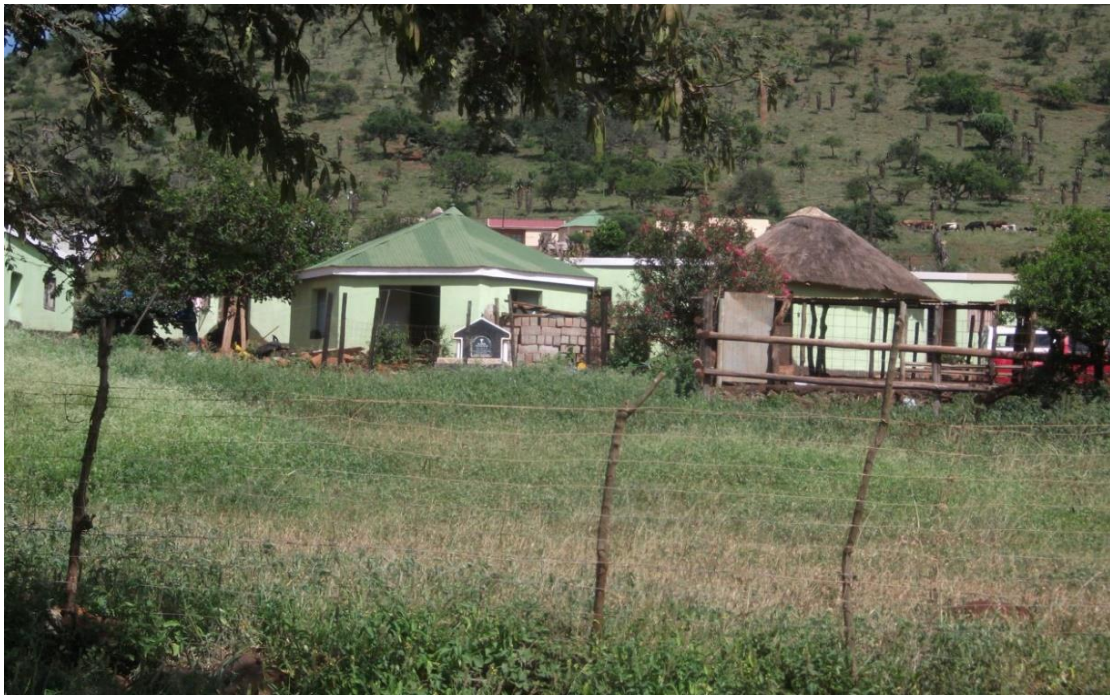
Figure 7: Headstone close to homestead and behind fenced fields

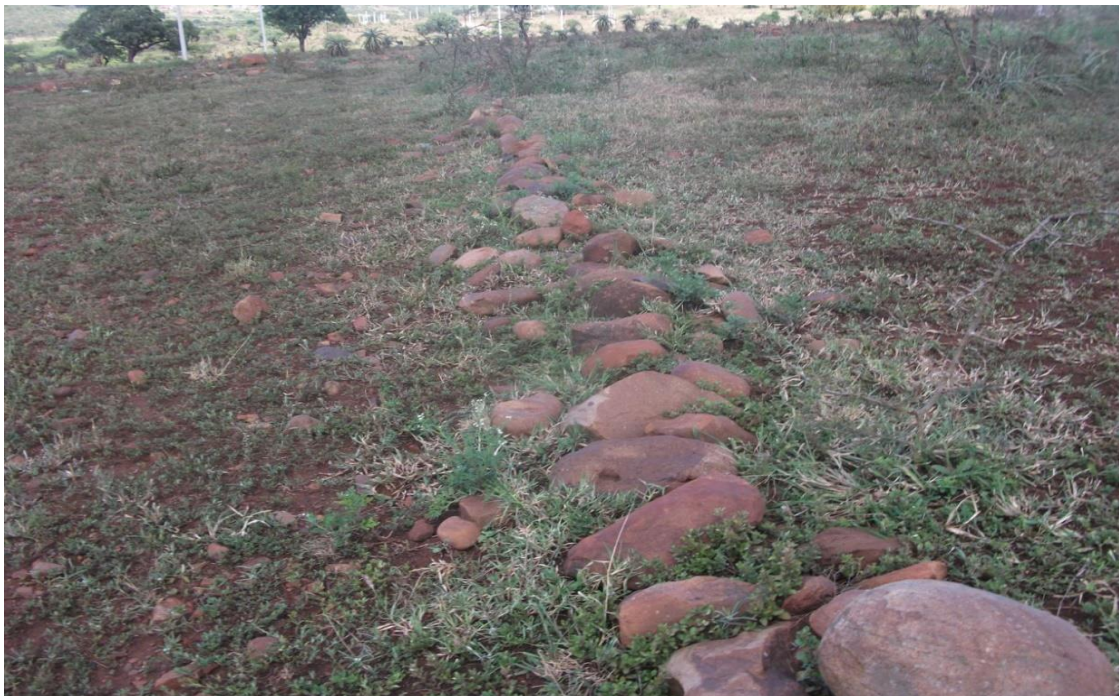
The remains of low stone walling in straight lines were found 20 metres north of the proposed pipeline route. The resident living close to the walling told the specialist that the walling had been used to demarcate fields / gardens.

Figure 8: Low stone walling

The low stone walling, which is found in the area and across the province, is of low heritage significance and should not be impacted by the installation of the pipeline. A 12m buffer must be placed around the walling to avoid construction activity impacts. If the walling is impacted, then application will need to be made to the Institute for permission to repair the damage as the walling is protected by section 40 (1) of the KwaZulu-Natal Amafa and Research Institute Act, 2018, no person may destroy, damage, excavate, alter, write or draw upon or otherwise disturbed any battlefield, archaeological site, rock art site, palaeontological site, historic fortification, meteorite or meteorite impact site without written permission of the Institute having been obtained on written application to the Institute.

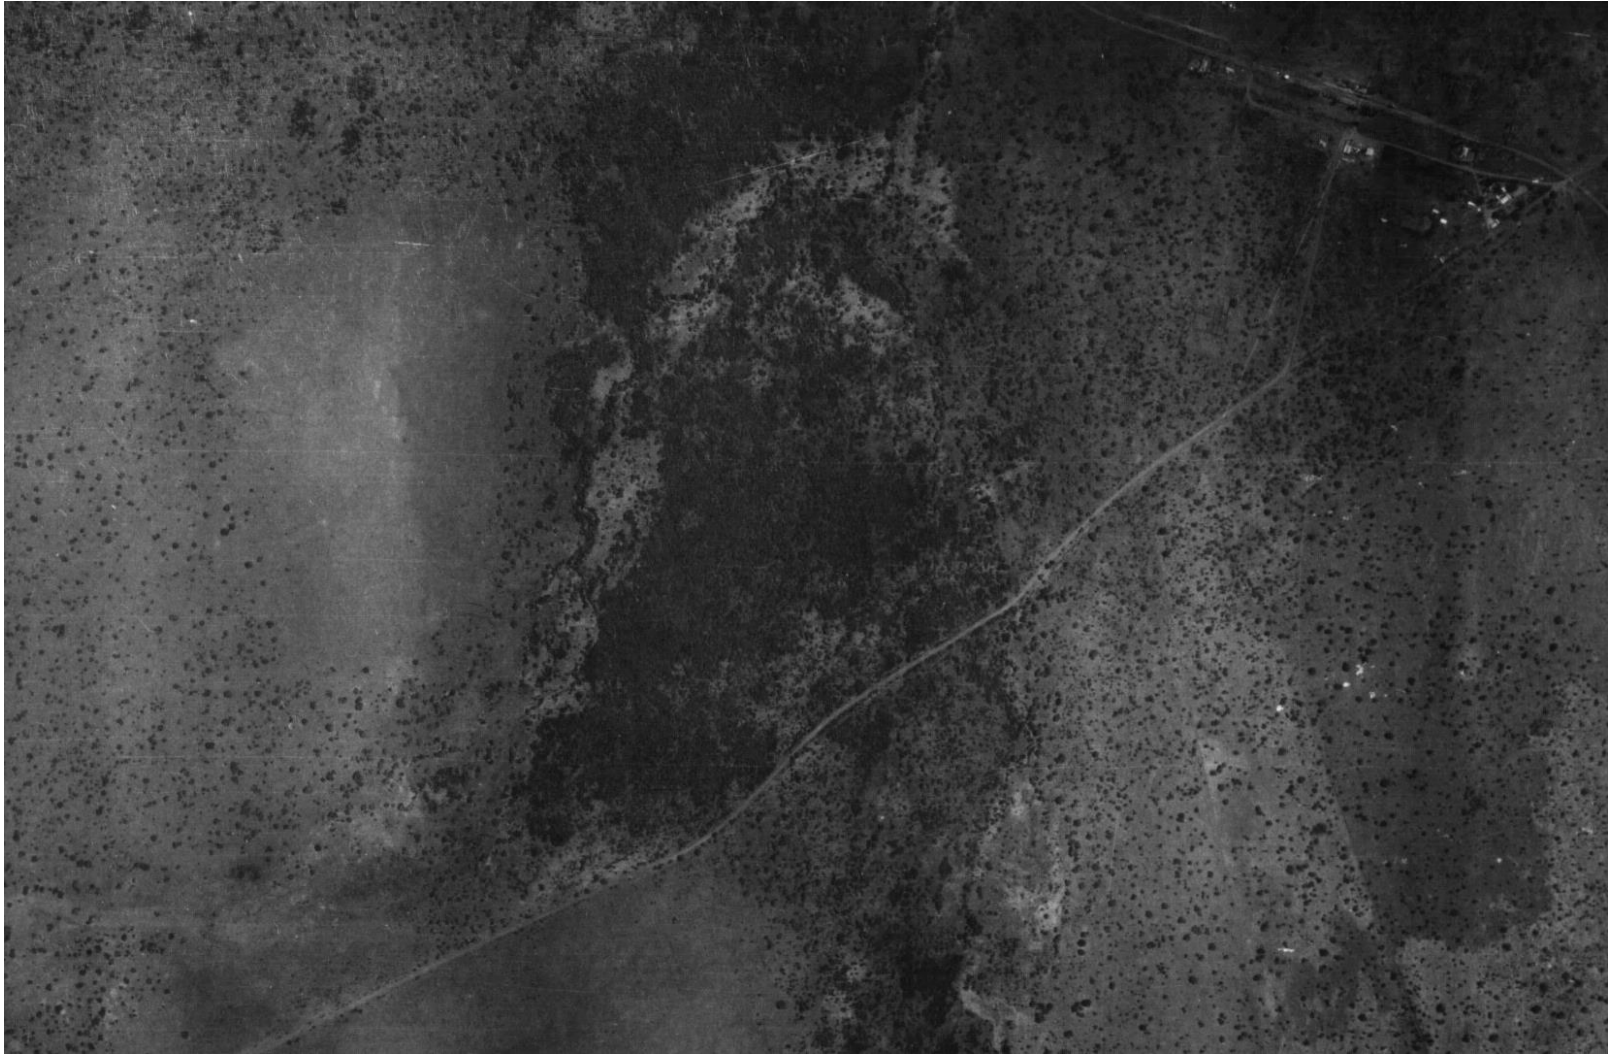
Figure 10: Section of project area immediately west of road and Mkuze

Figures 8 - 9 below show the 1943 aerial images of the section of pipeline up to and until the area of the N2 highway and town of Mkuze. The images show an area with almost no habitation until just before the road that was to become the N2 where there are some dwellings that formed part of the town of Mkuze. This area is still largely uninhabited with game farms prevalent for over 6km west of Mkuze. **Figures 10 – 11** depict the environment along which the area where it is proposed to install the pipeline. The inspection of this section of the pipeline route revealed no heritage resources.

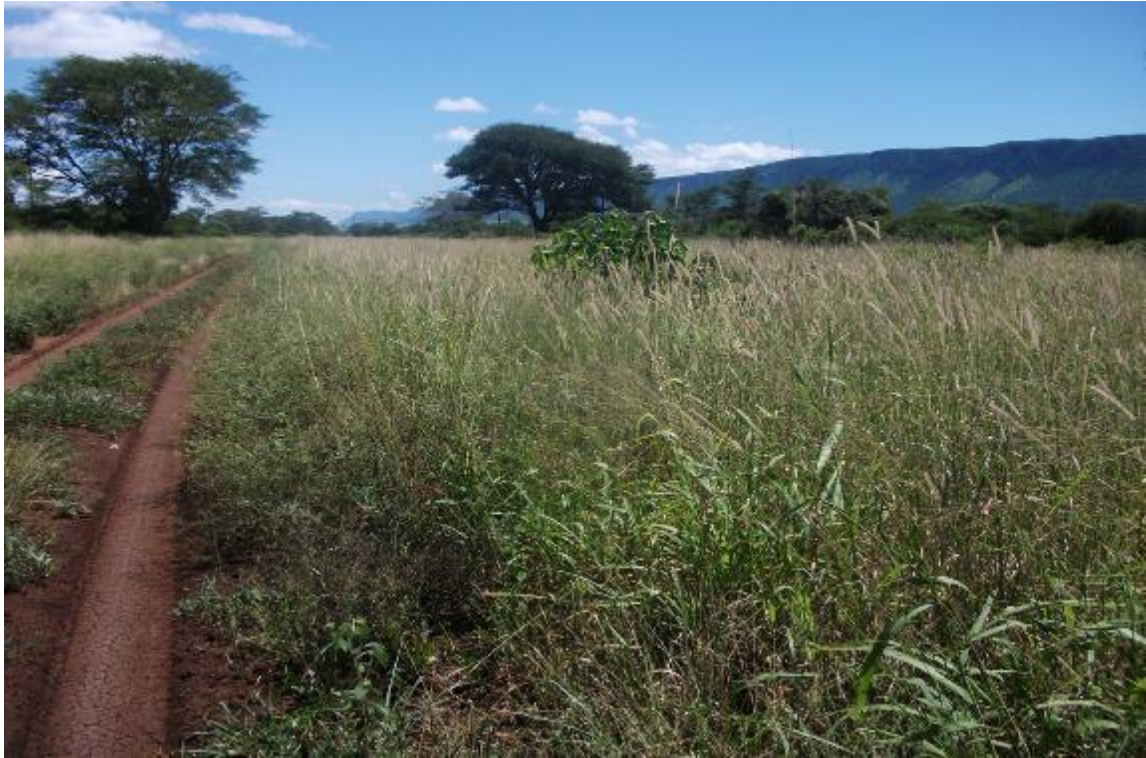
Figure 13: Pipeline route to right of vehicle track

During the inspection of the section of the pipeline that deviates to the north-east before crossing the highway, a fairly recently built pump station was found together with a reservoir (**Figures 12 - 13**). The reservoir is damaged on the one site and the pump station is no longer in use. This section of the pipeline route was heavily overgrown with vegetation.

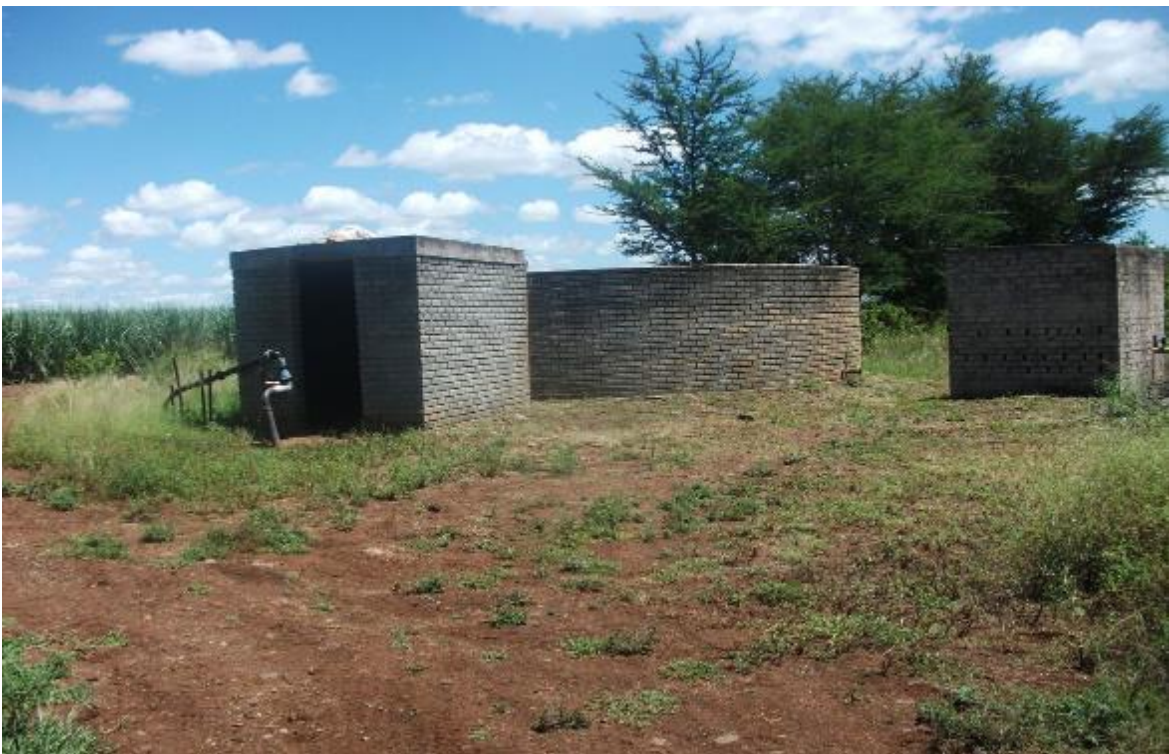
Figure 14: Pump station and reservoir

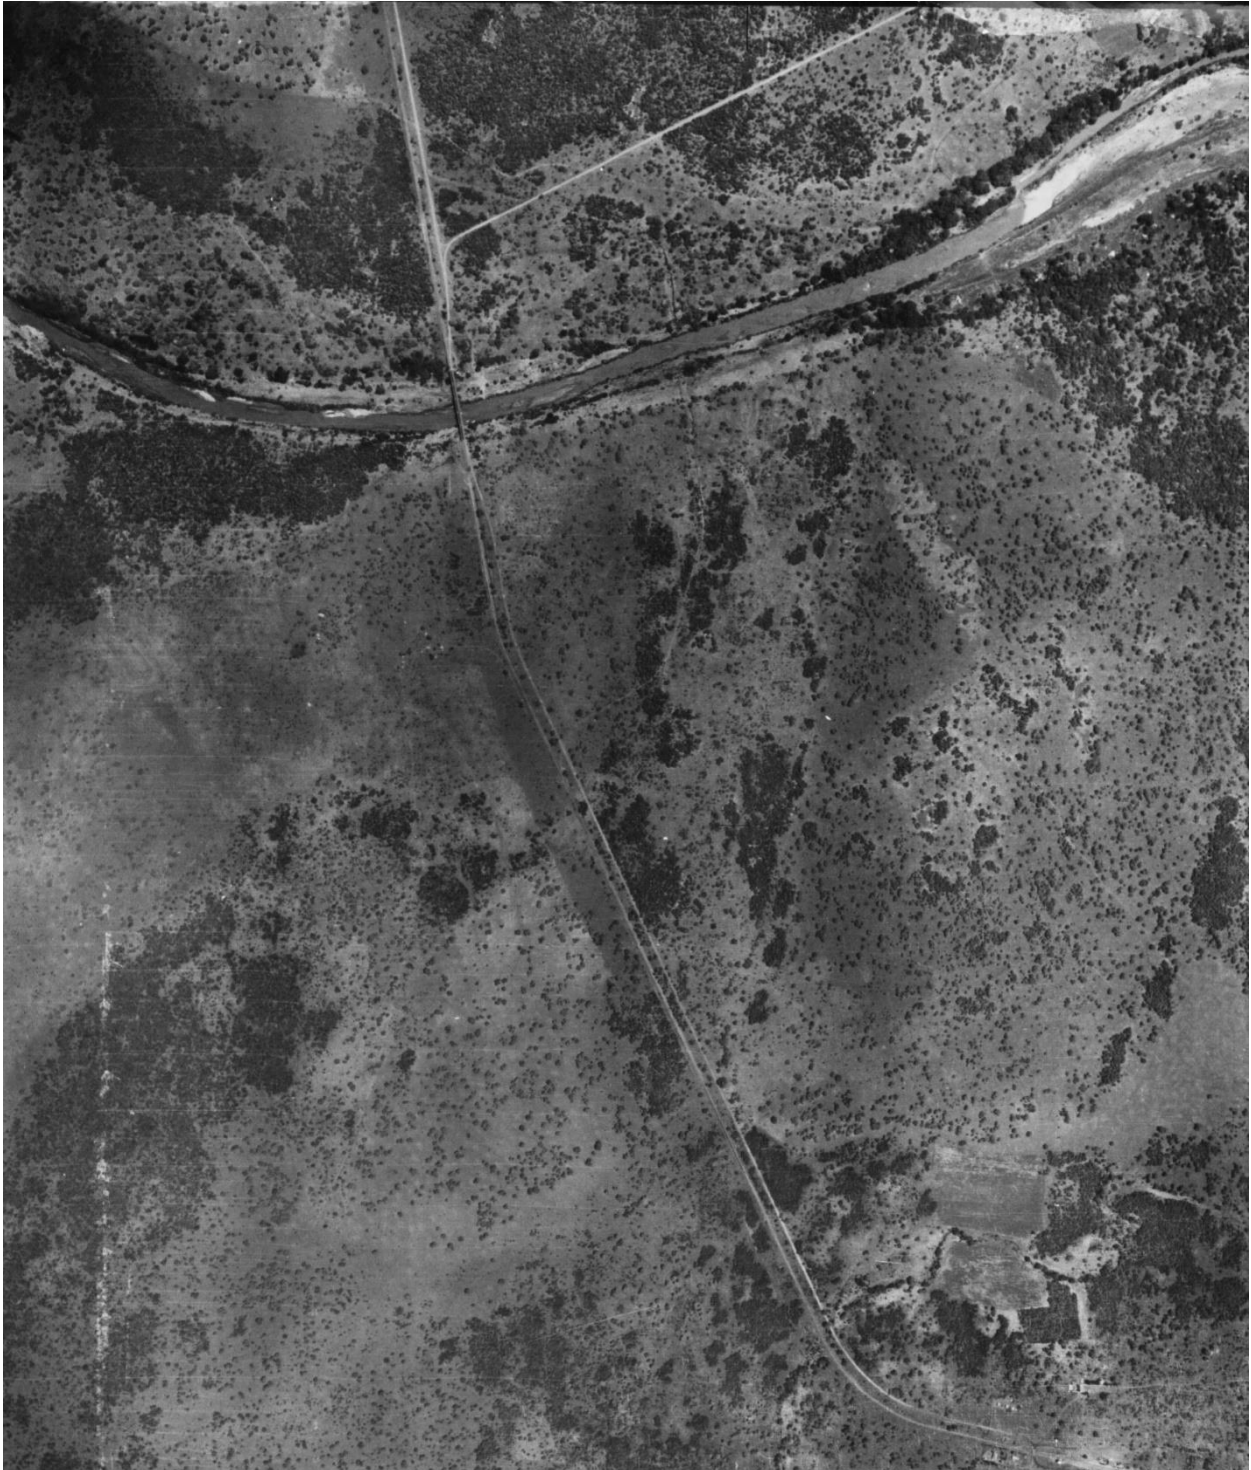
Figure 15: Aerial image showing road, railway line and Mkuze River

The pipeline route crosses the N2 highway and runs next to sugar cane fields before turning to the north to run between the road and railway line. The 1943 aerial image of this area shows the road and railway line with a bridge crossing the Mkuze River. There is very little habitation in the wider area.

Rail and vehicle bridges cross the Mkuze River. The rail bridge is a new addition; however, the age of the vehicle bridge could not be determined. A bridge is already in existence in 1943. Whether the existing bridge is the same bridge as depicted in 1943 aerial image (**Figure 14**) is unknown but it is possible. A structure that is older than 60 years is protected by section 37 (1)(a) of the KwaZulu-Natal Amafa and Research Institute Act, 2018, which refers to the protection of structures that are or that may reasonably be expected to be older than 60 years. The Environmental Assessment Practitioner (EAP) undertaking the environmental authorisation process for this project indicated that the Mkuze River crossing for the pipeline will involve the construction of a new stilted pipe bridge that will be located adjacent to the road.

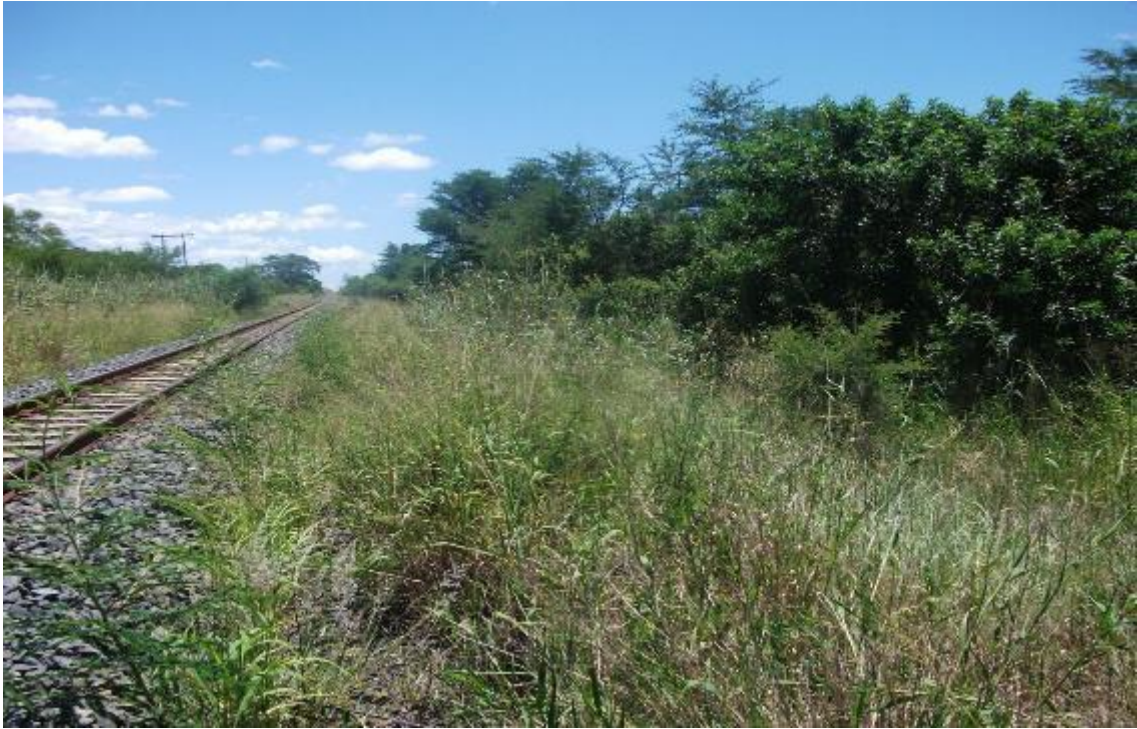
Figure 16: Pipeline route between railway line and road

Just before the Mkuze River, the pipeline route passes very close/through to what appears to be an abandoned water treatment works. The plant is a fairly recent structure and is below 60 years of age.

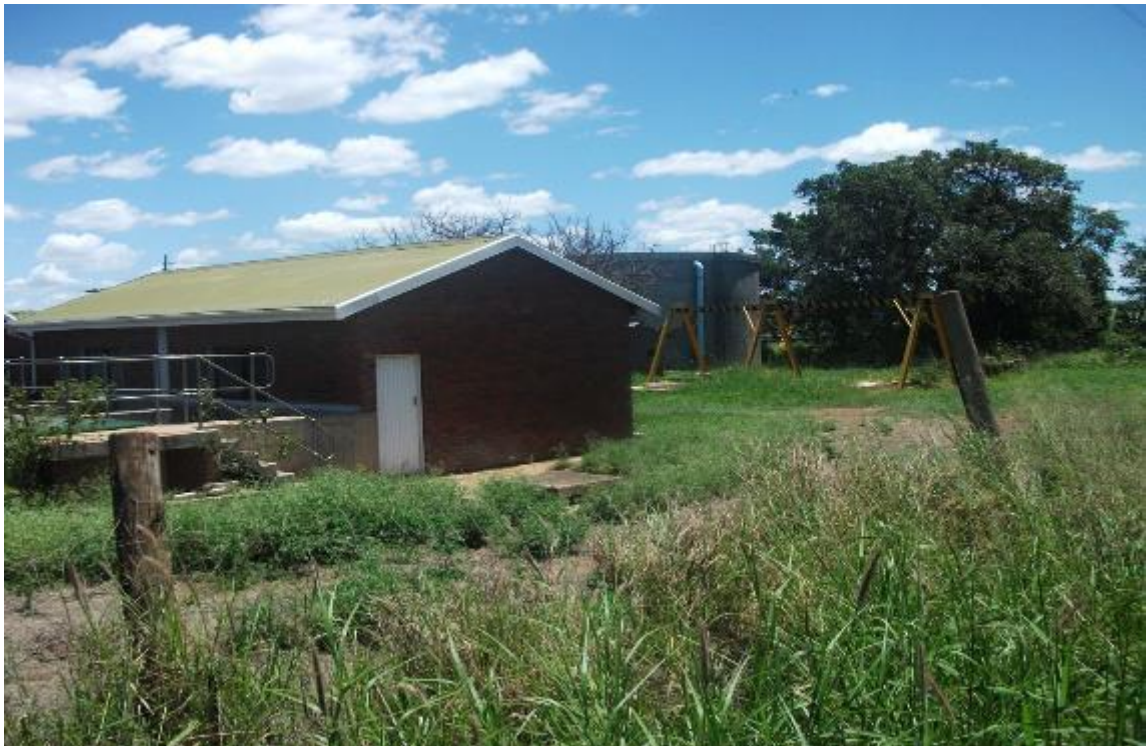
Figure 17: Water treatment plant

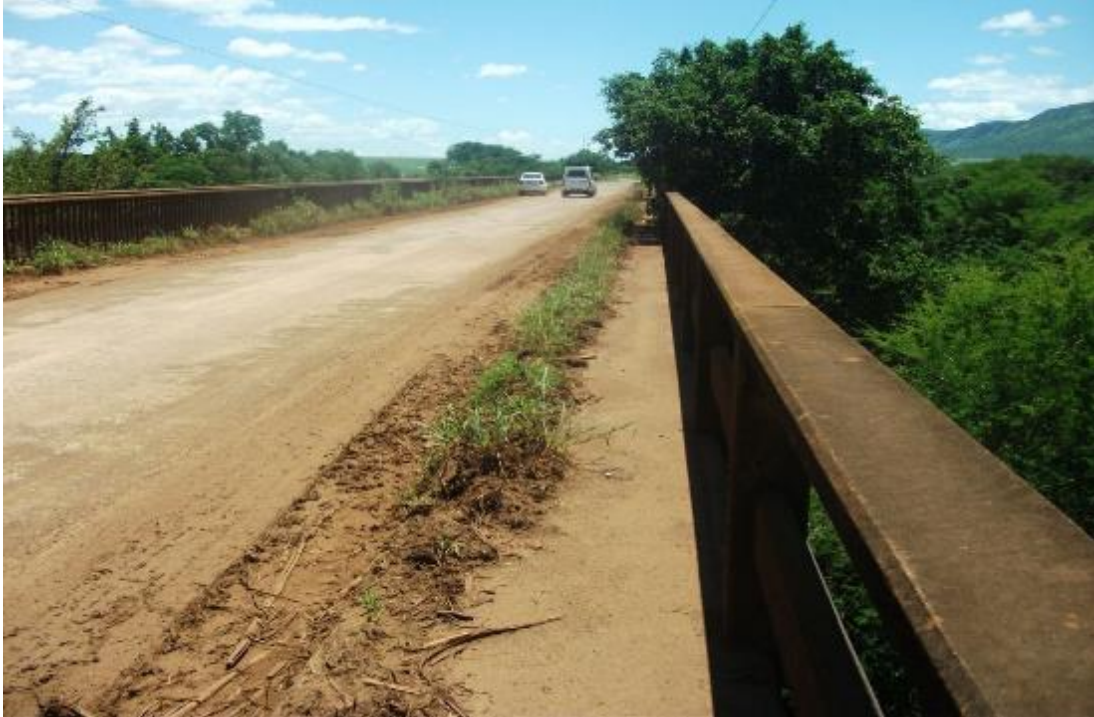
Figure 18: Road bridge over Mkuze River

The vehicular bridge that crosses the Mkuze River is probably over 60 years hence protected by section 37 (1)(a) of the KwaZulu-Natal Amafa and Research Institute Act, which refers to the protection of structures that are or that may reasonably be expected to be older than 60 years. It is recommended that the bridge is not impacted in any way by the project. However, if the bridge is to be impacted or is impacted in any way, then application must be made to the Institute in terms of the process described in section 3 of the draft KwaZulu-Natal & Research Institute Regulations, 2021 or section 2 of the KwaZulu-Natal Heritage Regulations 2012 if the 2021 regulations have not been officially promulgated by the time an application is made.

In terms of the alternatives, it is recommended that the alternative running alongside the N2 is utilised as no heritage resources will be impacted by this route. The original route that crosses the Mkuze River may impact the vehicular bridge which could be older than 60 years.

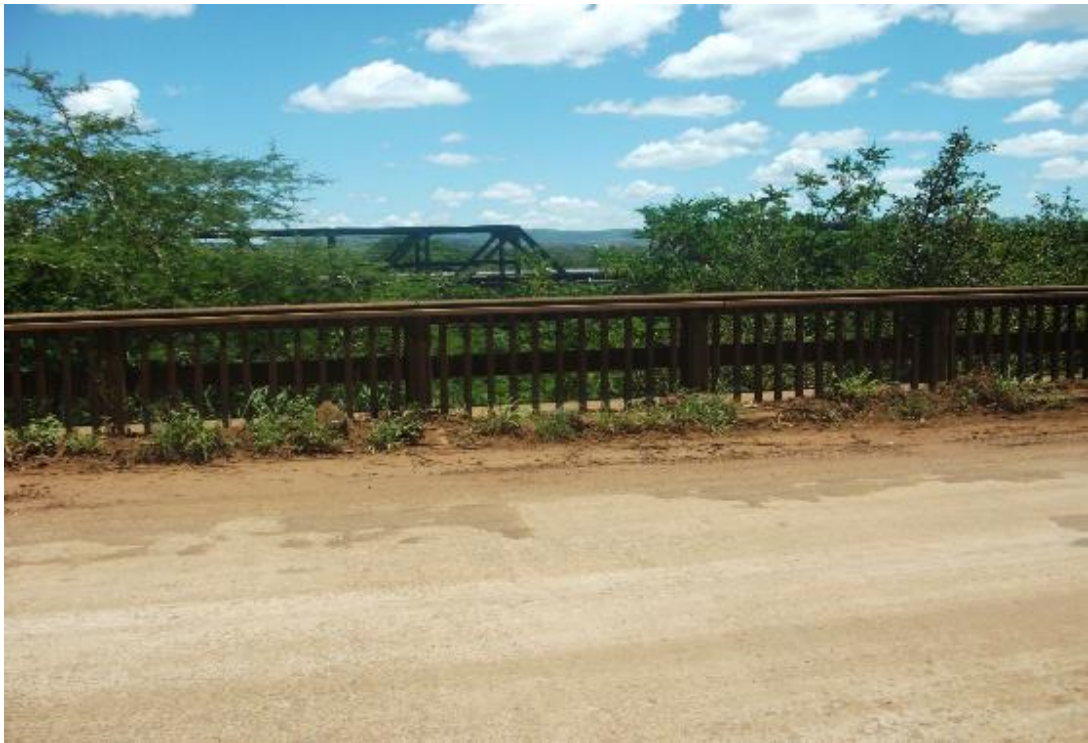
Figure 19: Road bridge with rail bridge in background

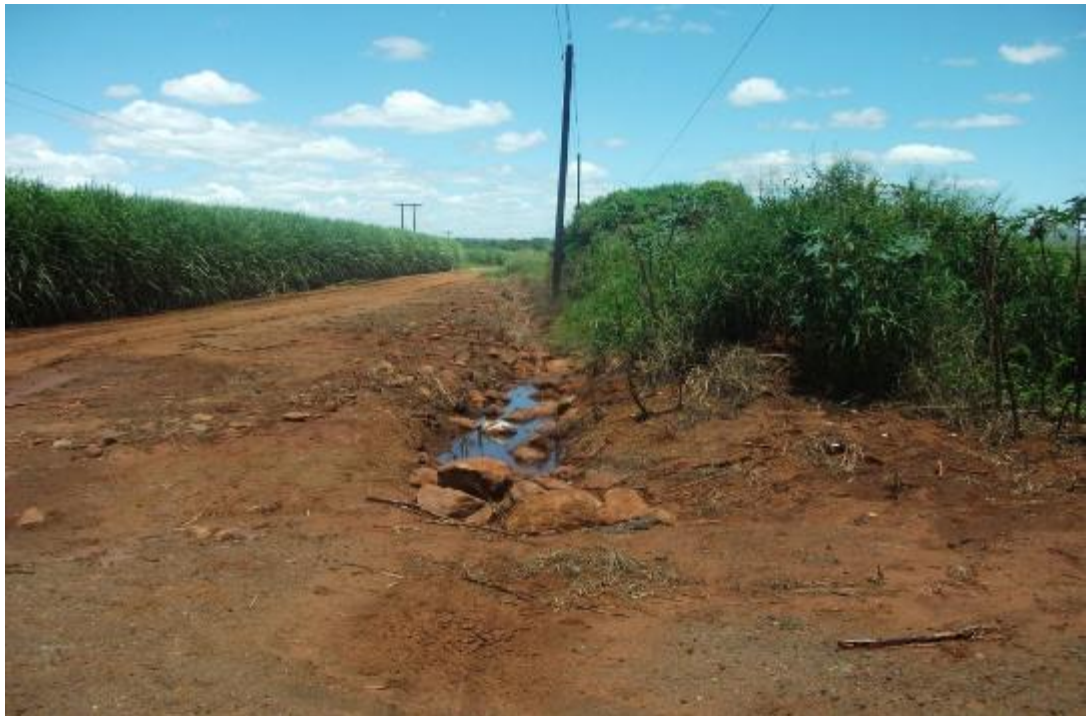
Figure 20: Pipeline route adjacent to road

The pipeline then runs adjacent to the gravel road and close to and through sugar cane fields in a highly disturbed environment that includes power lines and a borrow pit. No heritage sites were found.

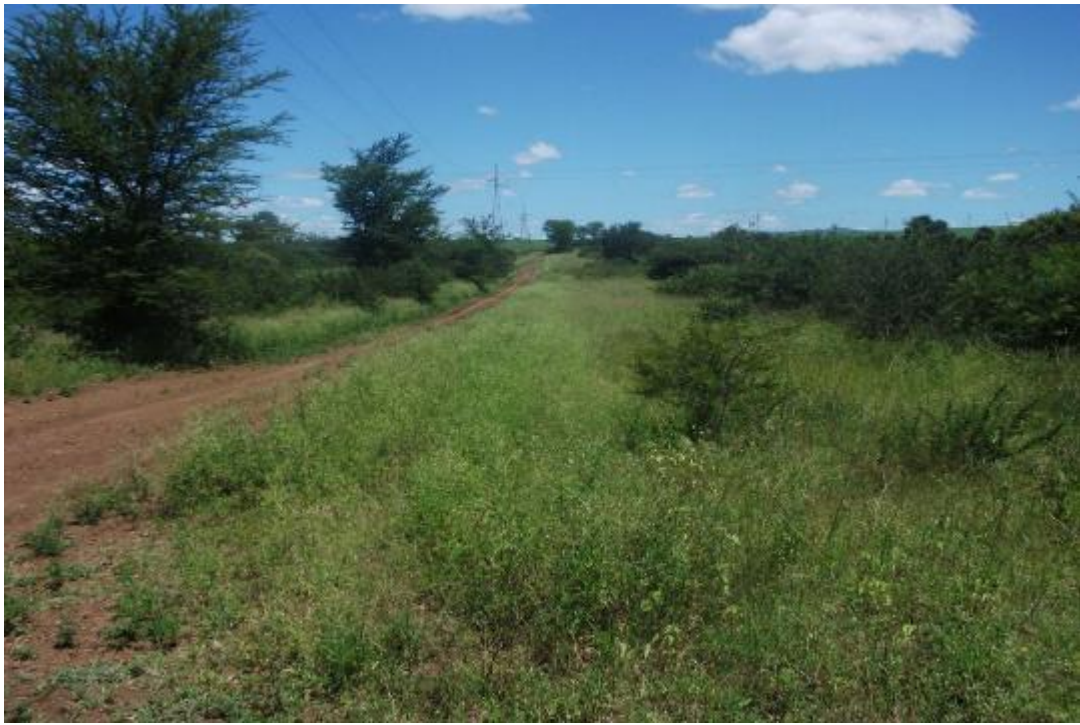
Figure 23: Pipeline route in nature reserve

The pipeline alignment then crosses the road to Jozini and enters the Pongolapoort Nature Reserve where it runs east of the gravel road. No heritage sites were found during the inspection.

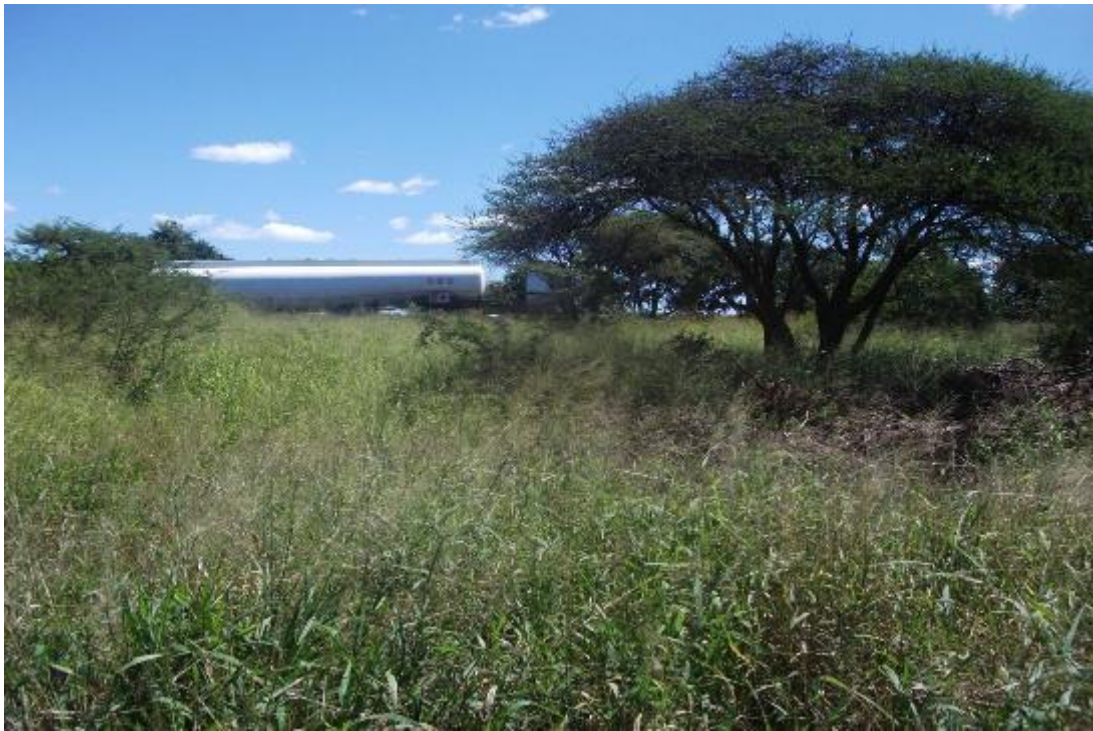
Figure 25: Pipeline route with highway in background

The other alternative pipeline route runs alongside and east of the N2 highway. This alternative was inspected. The area was densely overgrown with vegetation. No heritage resources were found.
