Basic Heritage Impact Assessment for the proposed upgrades to the Maropeng Interpretive Centre

Date: November 2014

Report Compiled by: Dr. Dominic Stratford

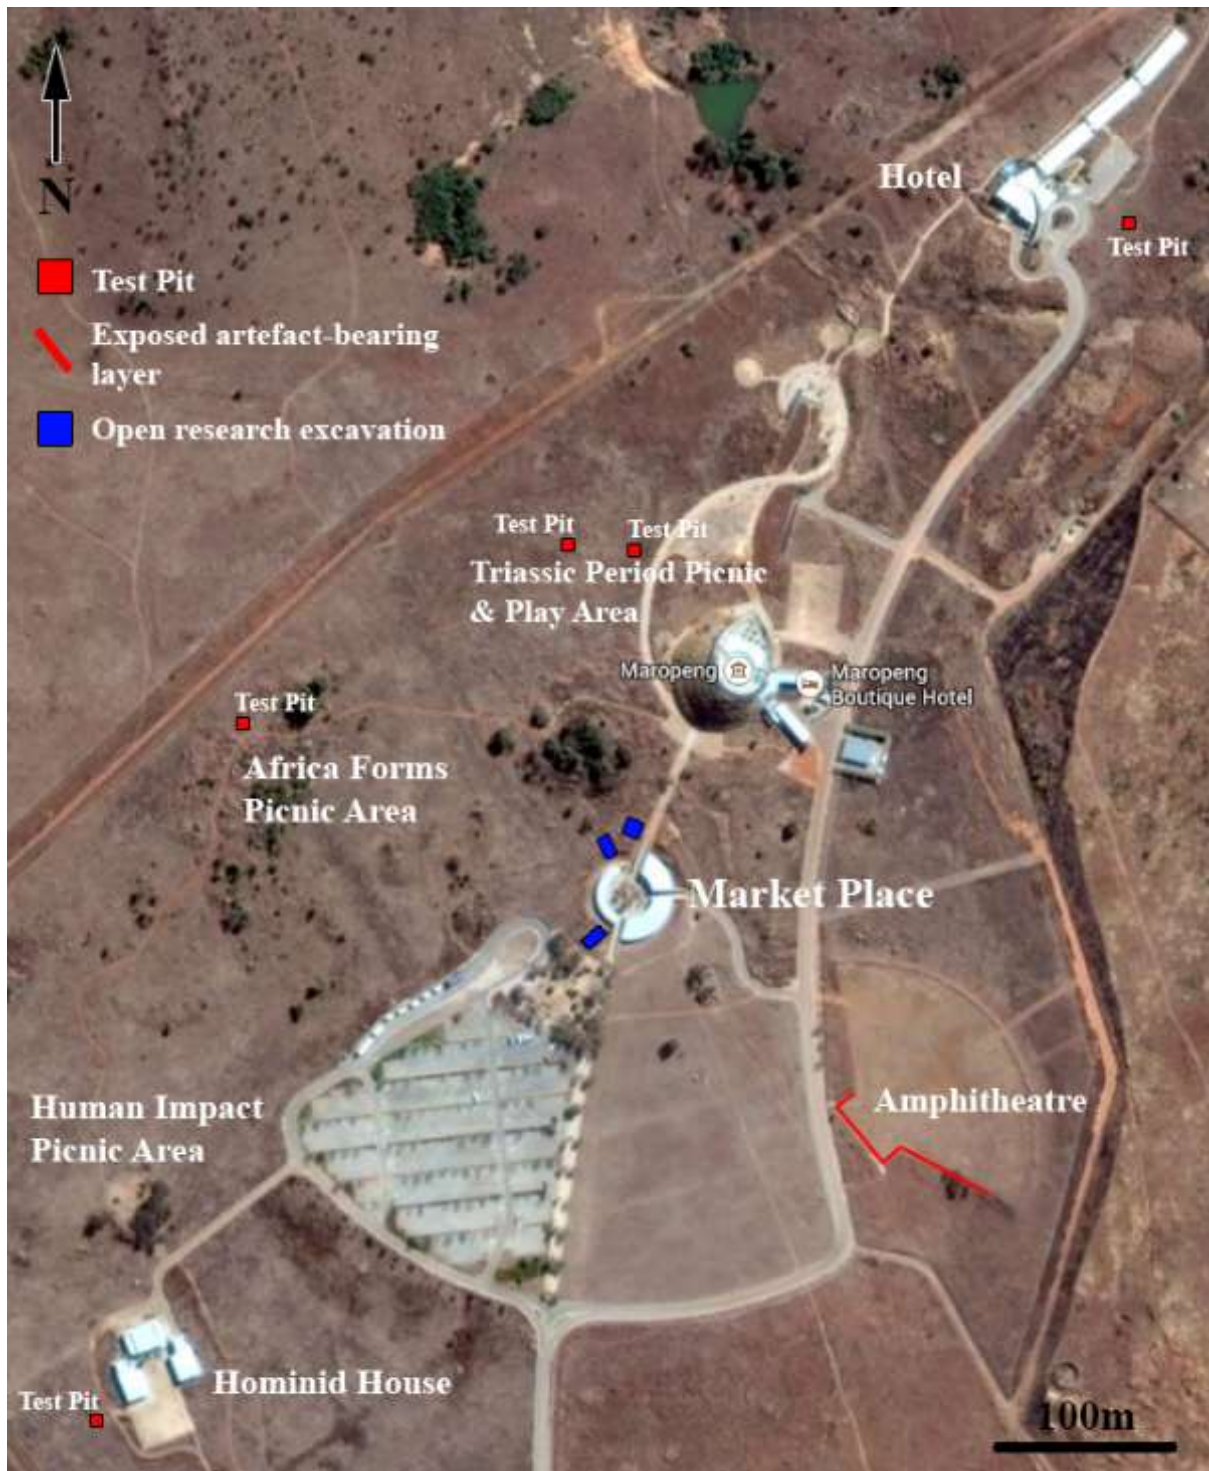
Figure 2. Plan view of the Maropeng site. Major areas for proposed upgrades are Human Impact Picnic Area, Africa Forms Picnic & Play Area, Triassic Period Picnic Area and Play Area, the Hotel and the Amphitheatre.

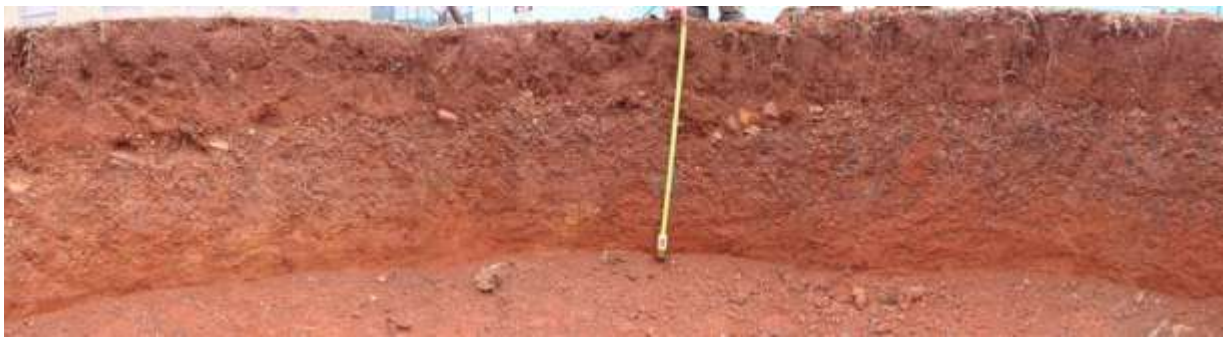
Most of the foundations for the construction had already been filled by the time the site was visited for initial inspection. Two excavations were still open. The first was for services and was located in the middle of the Hominid House construction site two meters to the west of the site office, the second was for a ‘Fire Pit’. The first service related excavation measured to a depth of 700mm. No artefacts or sedimentary features associated with the artefact-bearing layer could be seen in the excavation profiles. Ten meters to the north of the services excavation, was the 1200mm deep excavation for the ‘Fire Pit’. The large intricate excavation of several concentric circles exposed a gently easterly dipping artefact-bearing horizon with a

depth of 300mm below the ground surface at the westerly exposure and 350mm eastern extremity of the excavation. Here, larger clasts of quartz and quartzite were found in the upper levels of a well decayed and pelletised dolorite (Figure 3). Clast proportions were very low and generally restricted in size to <100mm. Although the sedimentary layer associated with the artefacts was relatively thick (200mm at thickest) in this exposure, only one artefact could be identified in situ (Figure 4). No artefacts were found when construction spoil heaps were inspected and I can, therefore, conclude that although a stratigraphically and sedimentologically continuation of the main artefact-bearing layer was exposed at Hominid House, this part of that layer has a **very low artefact density** and is therefore cannot be deemed a heritage high impact risk area.

Figure 3. Panoramic photograph of the artefact-bearing layer and associated sedimentary features exposed in the ‘Fire Pit’ excavation at the Hominid House Construction Site.

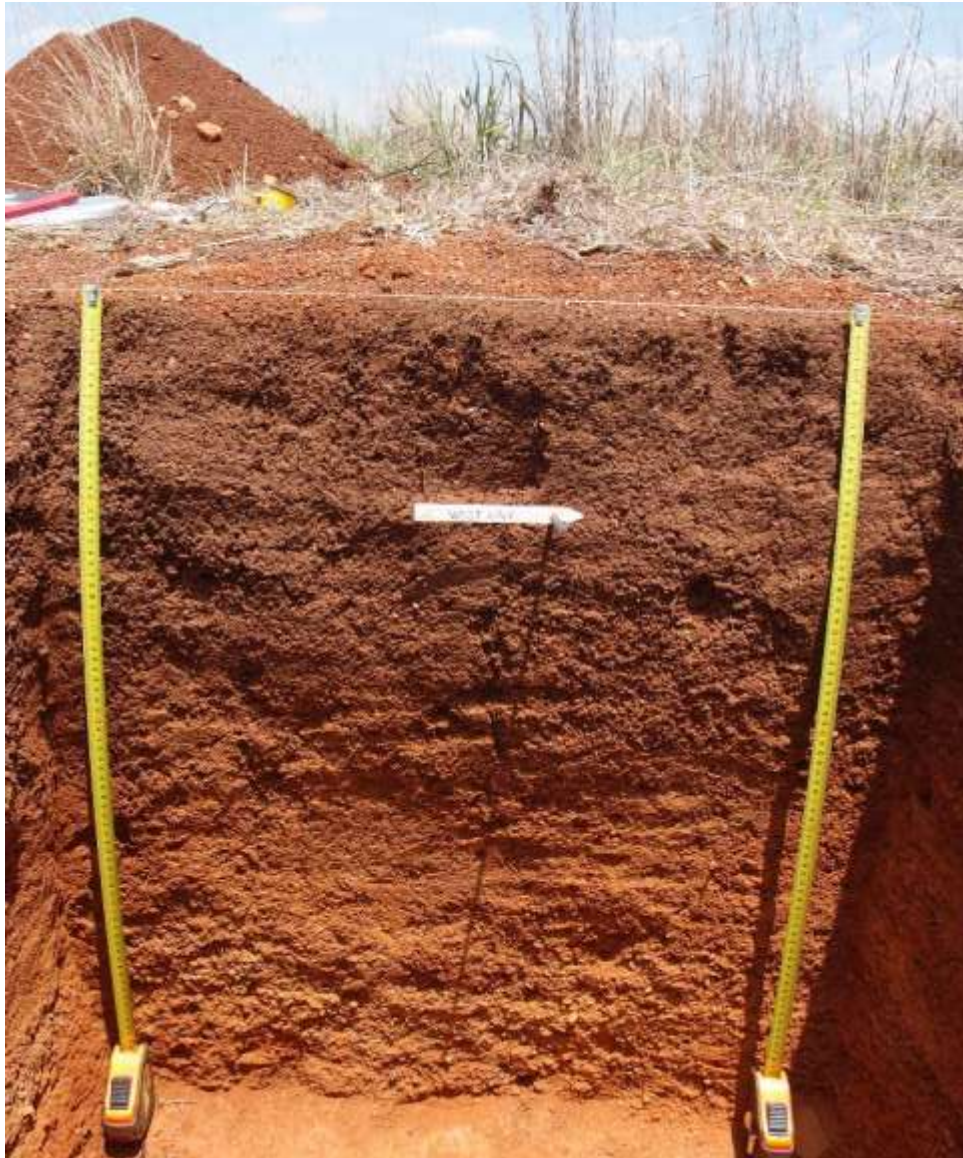
This 1 x 1m test pit was excavated to identify the westerly extent of the artefact-bearing layer identified in the Hominid House ‘Fire Pit’ excavations. Given the gentle westerly slope of the above described layer, it was unclear if this continued further west and was possibly closer to the landscape surface or terminated. The test pit was excavated to the dolomite bedrock which

was exposed at a depth of 90cm. Several artefacts matching the type and raw material found in the main excavations at the Market Place, were found at a depth of between 78-80cm and were associated with the same artefact-bearing layer as was exposed in the Market Place excavations and in Hominid House 'Fire Pit'. In this location, the layer thickness is highly variable and 120mm at its thickest. As in the 'Fire Pit' excavation, the larger clasts and artefacts were associated with the upper levels of the pelletised decayed dolorite layer, were of low density and generally restricted to <100mm in maximum dimension. The direct association of the lower surface of this artefact-bearing unit with the highly irregular upper decayed surface of the dolorite bedrock (Figure 5) suggests that the depth of the artefact-bearing layer is not uniform or predictable across the larger Maropeng property. This irregularity is demonstrated in the relatively shallow depth of the artefact-bearing layer found in the Hominid House 'Fire Pit'. Artefact density in this area is also low and has a low heritage impact risk.

Figure 5. The western wall of the Hominid House Test Pit. The same pelletised decayed dolomite level can be seen towards the base of the test pit at a depth of between 70cm and 90cm. On the western wall this layer is discontinuous. Both tape measures are extended 90cm.

Despite the low artefact density, as a mitigation process, I would recommend that services and foundations are not excavated to a depth of over 600mm in this area. This restriction includes the small pond, eco-friendly toilet facilities and the water pump which are proposed for the Human Impact Picnic Area to the north.

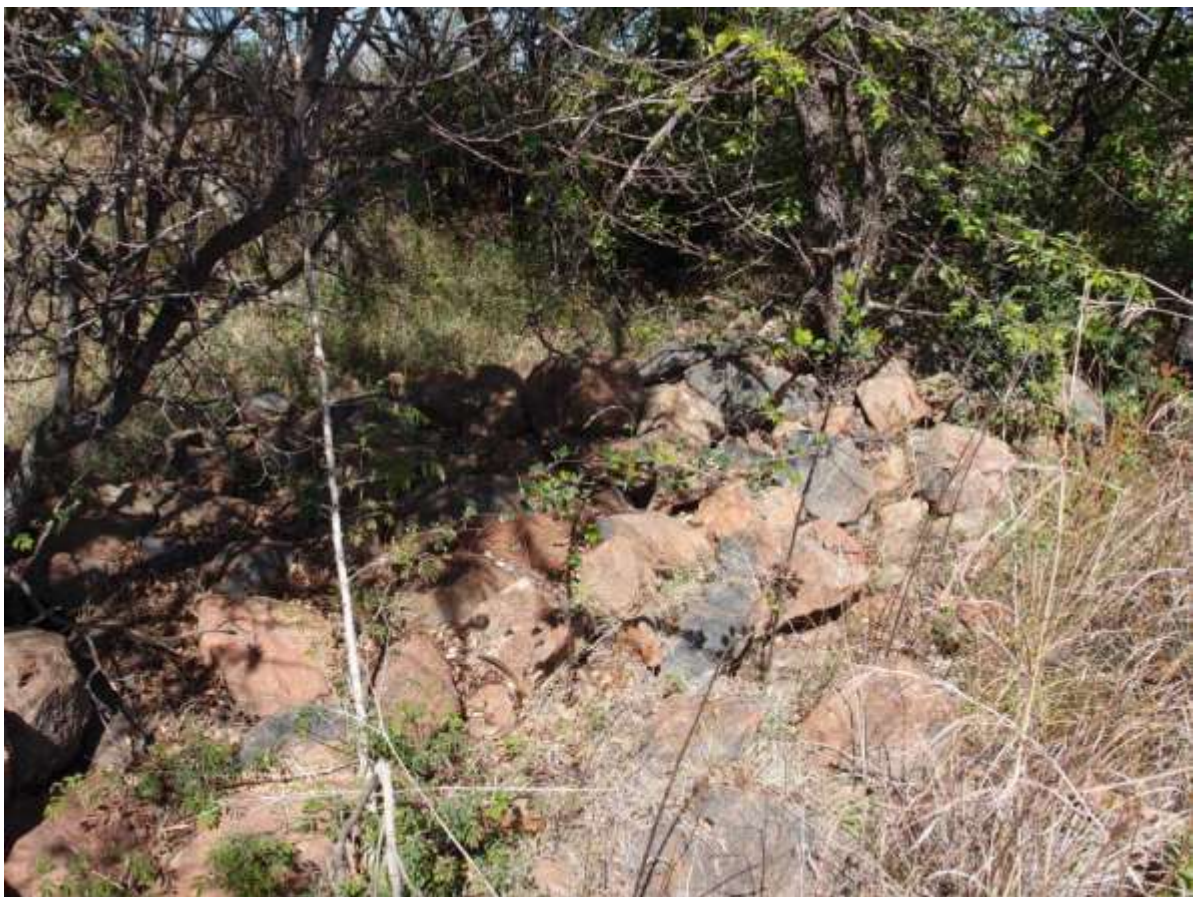
The stone wall structures (described as ‘packed stone wall kraals’ in the original EIA) found in this area cover an approximate area of 2000m² and are restricted in location to the dolorite outcrops in the western area of the site. The stone walling is of Early Iron Age style and take the form of large and small stone walled circles in varying states of preservation (Figure 6). The structures are not continuous and represent isolates structures of different sizes. In the cases of larger circles, natural dolorite outcrops are integrated into the wall. The walling is made up of large blocky quartzite clasts. This area was given a high conservation status and sensitive to development. It remains as such and this area should not be disturbed.

Figure 6. Stone walling structures preserved near the proposed African Forms picnic area.

The preservation of multiple archaeological contexts in this area contributes to a higher sensitivity. The higher integrity of the stone walling structures means that these should be prioritised for preservation and management. The poor integrity of the ESA and potentially MSA assemblages found buried in the area means that although artefacts should be recovered during any construction process, their analytical or interpretive value is limited to basic typological comparisons. These artefacts are, however, of some value and I recommend that given the relatively shallow nature of the artefacts, an archaeologist is present during the construction of infrastructure or the planting of trees (as planned for this site) to recover artefacts uncovered.

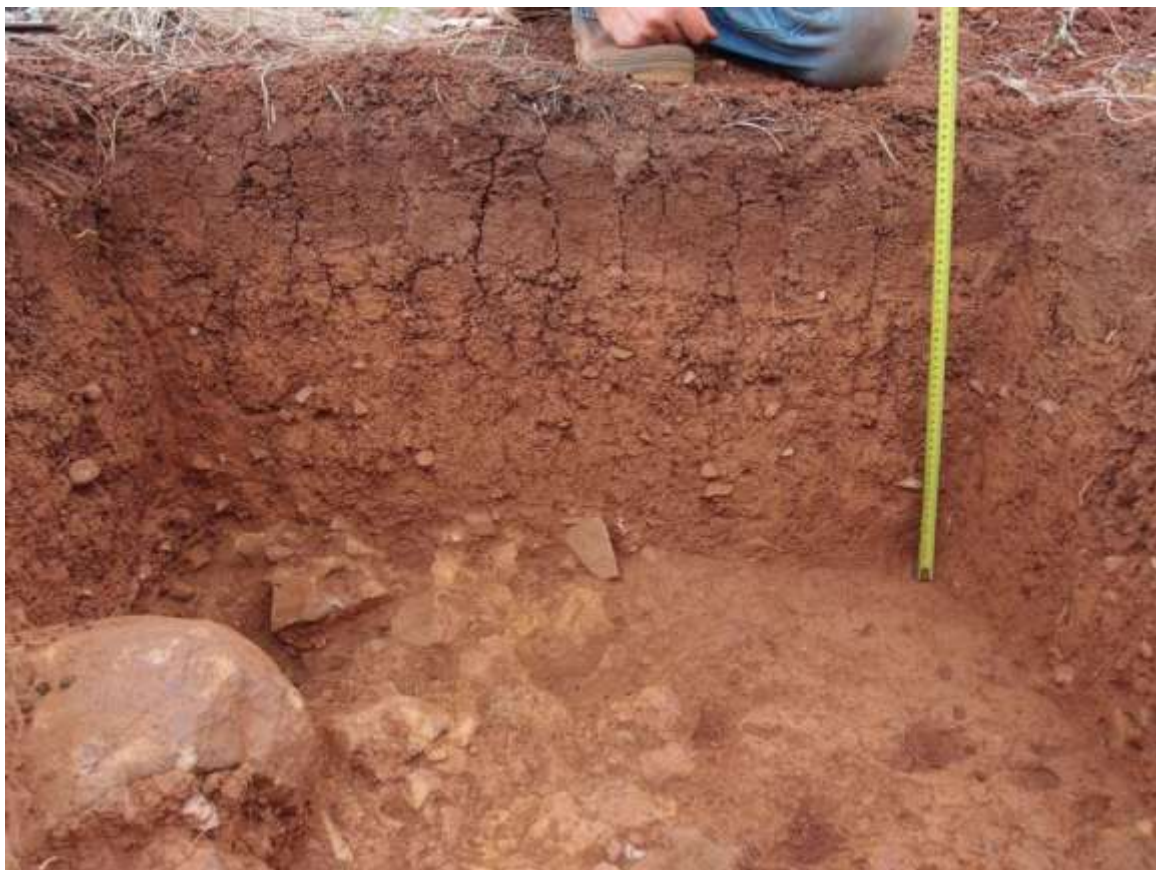
The 1 x 1m test pit was excavated until the dolorite bedrock was reached. The abundance and proximity of the nearby dolorite outcrops suggested that the dolorite would be shallow. This

has various implications for the preservation and integrity of buried archaeological artefacts. The test pit was excavated to a depth of 50cm before dolorite was exposed (Figure 7). No discrete artefact-bearing layer was present but several artefacts were recovered from all depths of the excavation. Diagnostic ESA artefacts, like a quartzite Acheulean handaxe, were recovered from close to the base of the excavation, and were directly associated with the irregular surface of the dolorite surface. Several quartz flakes were found from upper levels but were generally smaller in size (<50mm). The lithic artefacts cannot be associated with the stone walling and represent distinct archaeological phases on the Maropeng property. The shallow nature of the artefacts and the presence of roots, dessication cracks and animal burrows indicate that turbative processes have modified the archaeological context and limited the assemblage integrity in this area.

Figure 7. Western wall of the Africa Forms Picnic and Play Area Test Pit. Larger clasts and artefact are seen directly associated with the irregular surface of the dolorite, while smaller clasts can be seen throughout the profile and are often directly associated with root structures and dessication cracks indicating turbation processes. Tape measure is extended 50cm.

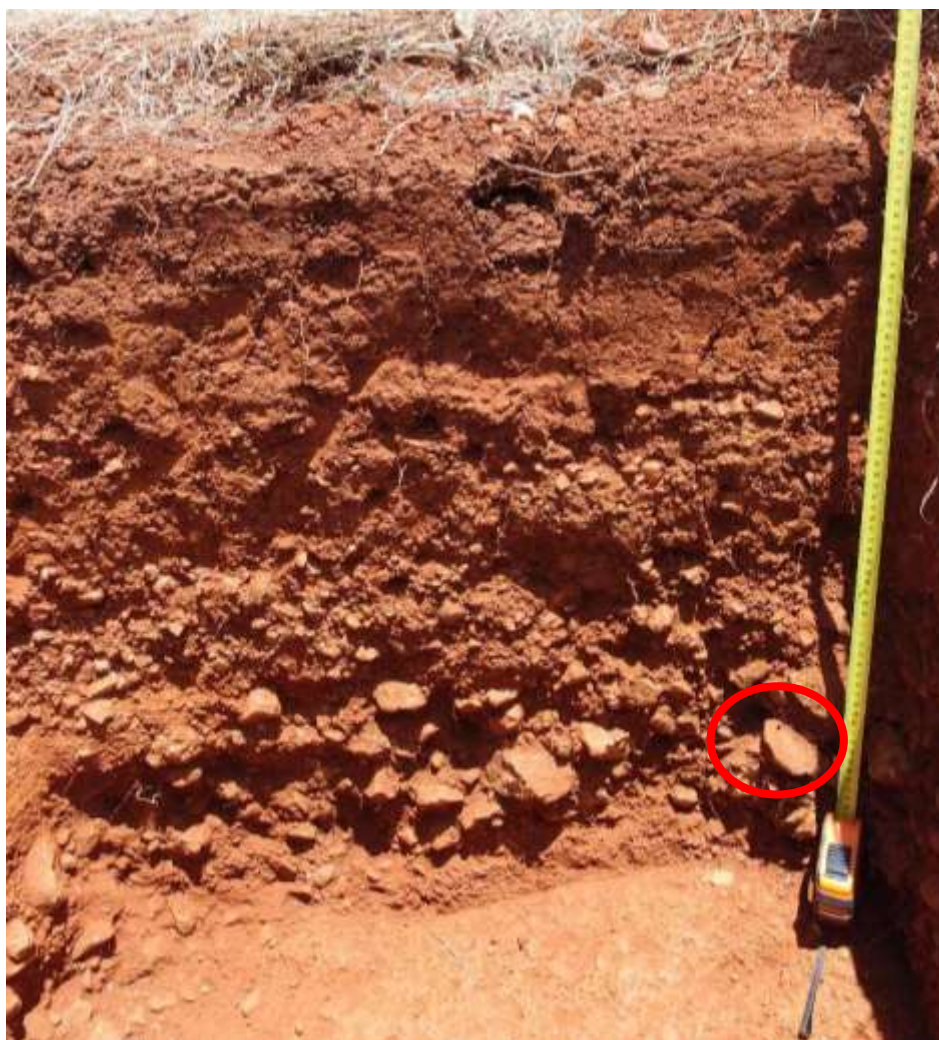
More artefacts were yielded from this test pit than any other in this assessment and I would describe the artefact density as medium. The artefact-bearing layer itself is thicker in this site than has been seen in any of the archaeological work at Maropeng, and although the clasts and artefacts are generally smaller than found at the Market Place excavations, the density, artefact type and raw material proportions are comparable.

Figure 8. Southern wall of the Triassic Period Picnic Area Test Pit. The west - east gradient of the exposed underlying dolomite can be seen. A single platform core can also be seen in situ (red circle). Tape measure is extended 90cm.

The increased thickness of the artefact-bearing layer in this location and the higher density of ESA-type artefacts mean that this area is more sensitive and efforts should be made not to excessively disturb this context. The nature of the proposed upgrades to this area should allow this preservation as only very limited excavations are planned. The exception to this is the proposed ‘Triassic Sculpture Lake’. If excavations are planned to reach beyond 50cm in depth then I recommend that an archaeologist be present to excavate a controlled sample of artefacts and ensure the recovery of artefacts and documentation of sediment features in this area during construction. This should include planting of trees – an activity that is in the current upgrade proposal.

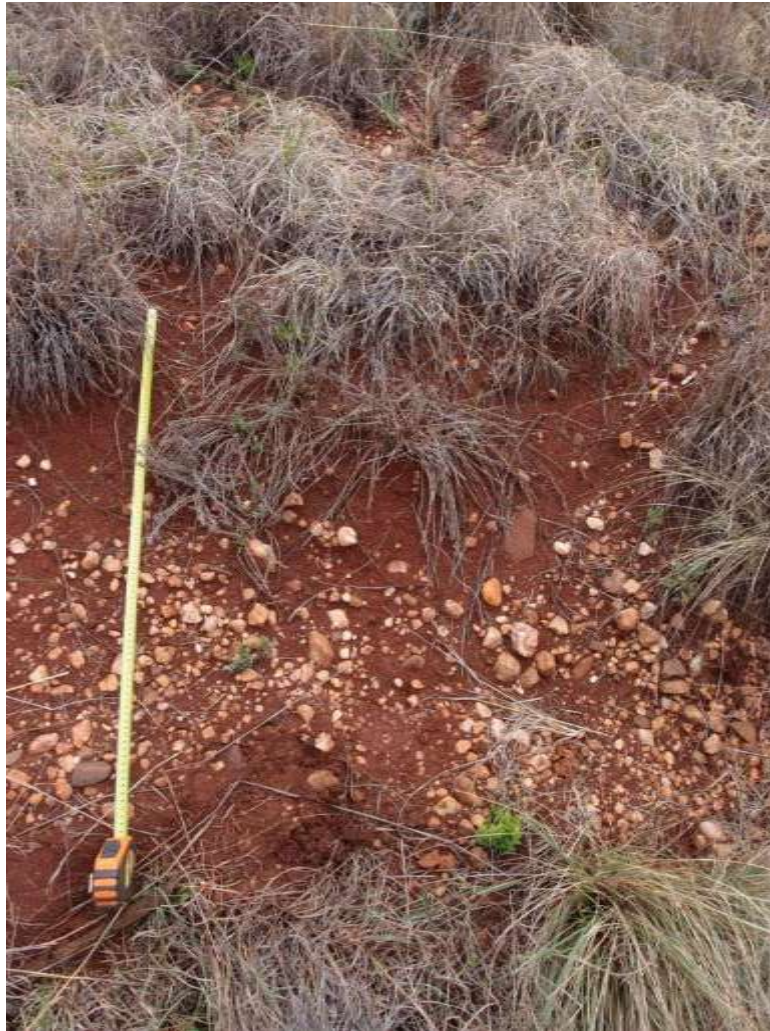
Testing the presence, density and thickness of an artefact-bearing layer was important in this area, given the findings of the Triassic Period Picnic Area Test Pit. Ground survey of the proposed location for the play area revealed a low density of small flake artefacts scattered on the landscape surface, undoubtedly a result of the earlier construction phases and subsequent landscaping. A diffuse artefact-bearing layer was also identified eroding from the walls of a shallow drainage ditch which runs north - south and is located about 10m west of the paved path which circumnavigates the Tumulus building (Figure 9). This layer was discontinuous and disappears 15m to the north of the thickest exposure. A geotrench-style test pit was excavated to clarify the nature of the layer.

Figure 9. Western slope of the drainage ditch in the vicinity of the proposed Triassic Period Play Area. The diffuse and eroding artefact-bearing layer can clearly be seen. Several quartzite artefacts were recovered from the surface prior to excavation.

The artefact-bearing layer in this area is close to the landscape surface (25cm), but discontinuous and is generally low in artefact density. It therefore has medium heritage sensitivity. I would, however, recommend that an archaeologist be present during any excavations for services so that artefacts can be recovered and added to the comparative assemblage for the whole Maropeng site. This recommendation is extended to the café play area to the north east.

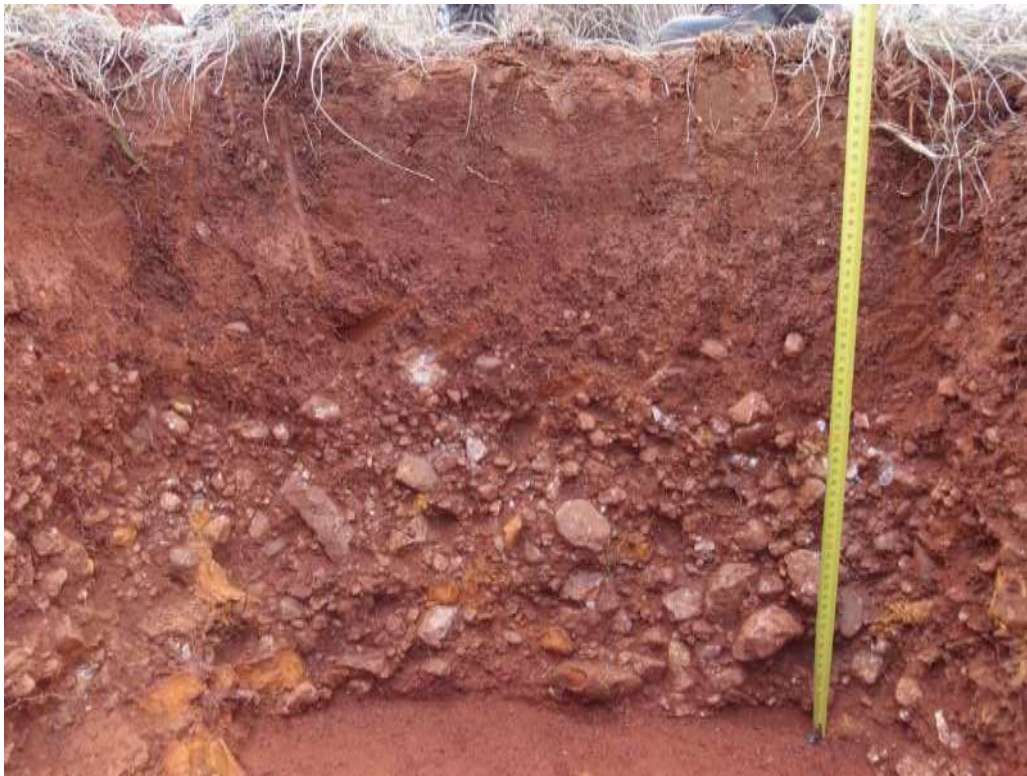
Upon excavation of the test pit, an artefact-bearing layer very similar to that found in the Triassic Period Picnic Area was exposed. The layer shares most of the sedimentological characteristics of the Period Picnic Area Test Pit but is generally thinner (maximum thickness 25cm) (Figure 10), has a lower density of smaller artefacts, and has a sharper upper deposit contact. The layer also partially directly overlies exfoliating dolorite and blocks can be seen incorporated into the artefact-bearing layer. An in situ irregular dolorite surface can be seen in the south western corner of the test pit. Artefacts and gravels have filled the irregular surface morphology. Away from the exfoliating dolorite, decayed dolorite pellets are found

and the artefact-bearing layer lies conformably on this. Clasts in the artefact-bearing layer are unorganised and poorly sorted.

Figure 10. Western wall of the Triassic Period Play Area Test Pit.

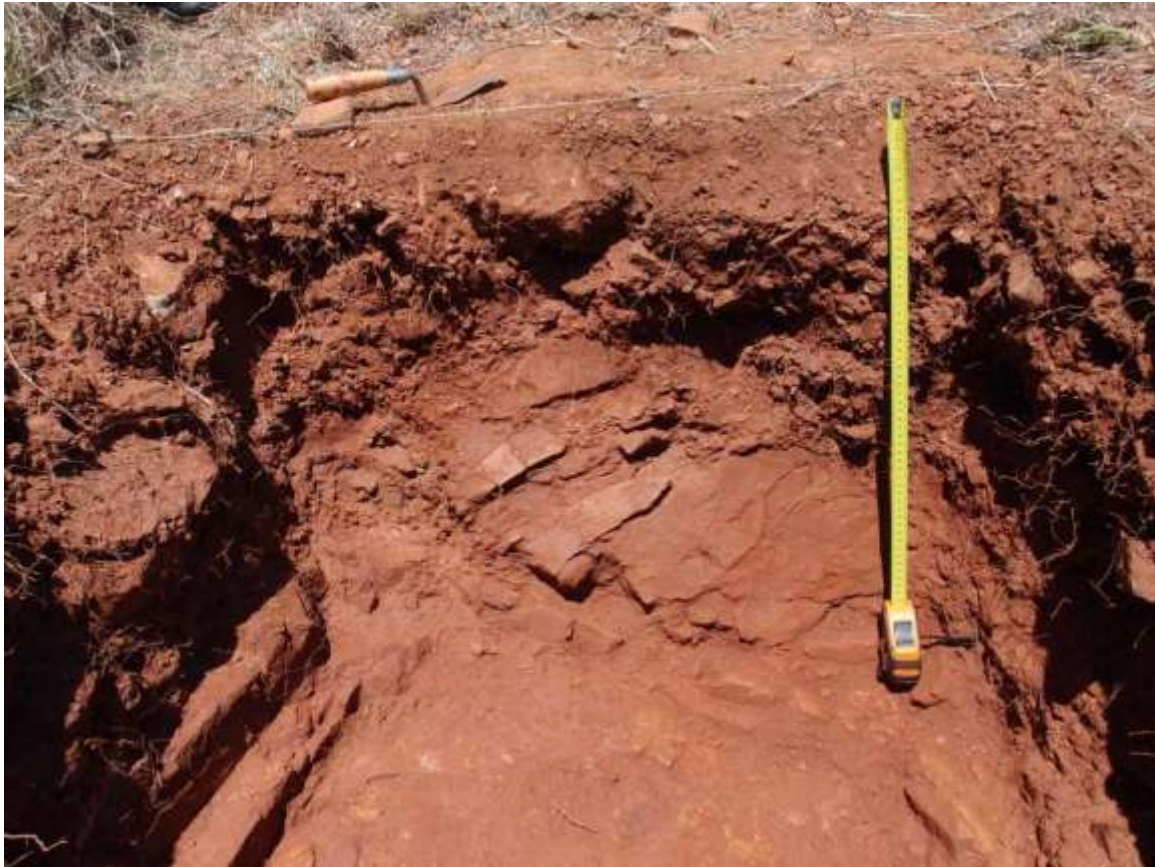
An in situ bedded and poorly metamorphosed quartzite with interbedded finely laminated sandstone strata was exposed approximately 50cm below the landscape surface. Overlying this was a clast-supported poorly organised colluvium consisting of large (up to 300mm), decaying blocks of the same stone (Figure 11). The organic horizon is thin and the land surface is dominated by eroding quartz, and dolorite pebble-sized clasts. Dolorite can be found outcropping 10m to the east of the test pit. Localised rivulets spread fine sediments and occasional artefacts from the very large construction spoil heap located 40m to the south east. This spoil heap consists of material relocated from the construction of the Market Place and Museum. It is rich in artefacts but the material has no remaining context and therefore has no scientific value beyond general ESA typological enquiries.

Figure 11. Southern wall of the Maropeng Hotel Test Pit. Tape measure is extended 60cm.

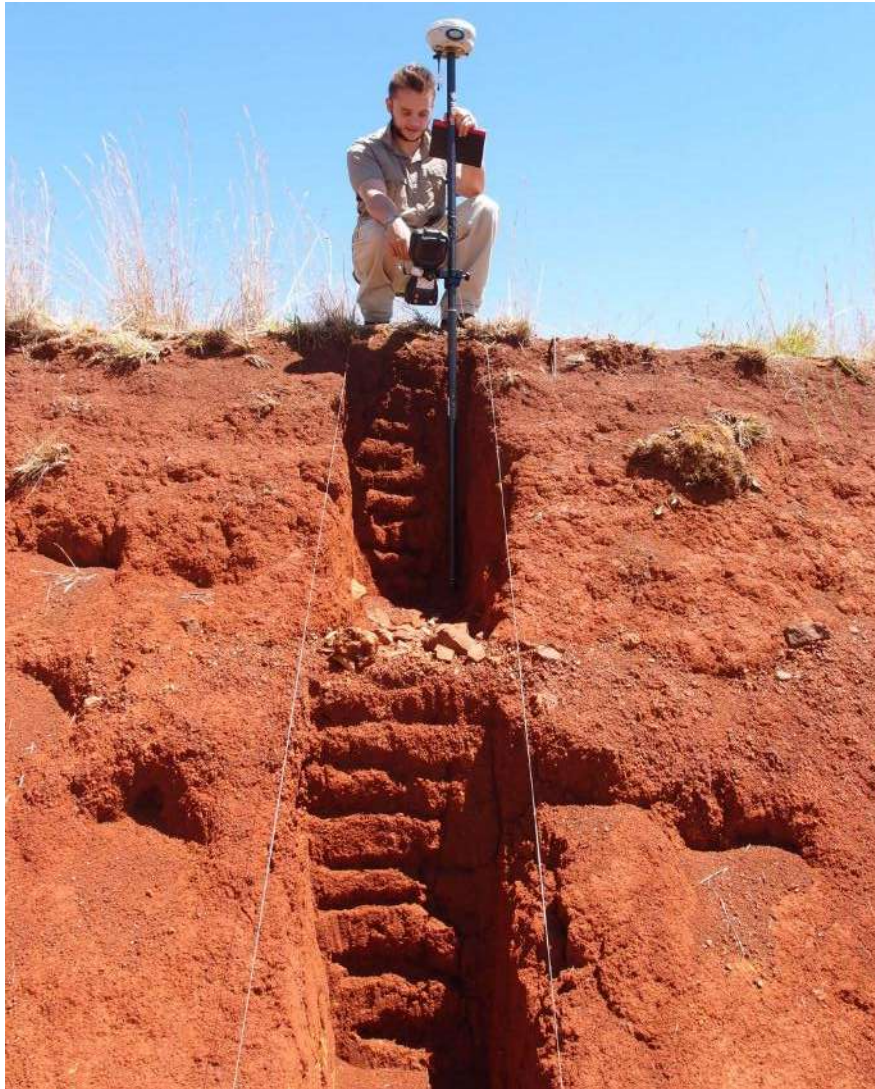
The amphitheatre artefact-bearing layer is of particular interest for the site formation history of this extensive deposit because it shares sedimentological characteristics with the Hominid House 'Fire Pit' site, and the artefactual density, type and abundance of the Market Place excavations. Figure 12 shows a geotrench-style test pit which was excavated into the southern wall of the amphitheatre. The layer, which is exposed at a depth of about 1m (1640 msl.) below the landscape surface across the entire southern wall (134m of sediments exposed to 1m depth), is continuous and associated with a relatively thin (<200mm) pelletised decayed dolorite layer that has been fluviially deposited (Figure 12). Large clasts and artefacts (>80mm) are found associated with the upper surface of this layer and are generally well preserved with cores and flaked showing sharp edges. The pellet layer lies conformably on the horizontal surface of a massive matrix-supported laterite layer which contains occasional medium sized (50-150mm) decayed dolorite clasts towards the base of the test pit. The maximum thickness of the artefact-bearing layer in the amphitheatre is 100mm, and the upper contact with the overlying massive laterite layer (with the same sedimentological characteristics as the basal layer) is sharp. Artefacts are of striking similarity in preservation, raw material proportions, type proportions, and size profile to the Market Place excavations.

Figure 12. Southern wall of the Amphitheatre Test Pit. Upper laterite layer is approximately 1m thick. Mr Aub is taking DGPS points from the exposed artefact-bearing layer to assess the relative elevation of this layer across the Maropeng property.

This area is of particular concern from a heritage management point of view. The exposure of an artefact-rich layer across an extensive space is rare and requires further study. The generally good preservation of the artefacts also warrants careful sampling and excavation. The artefacts are in a secondary context but represent one of the better preserved ESA assemblages in the Cradle of Humankind. I recommend that this exposed artefact-bearing layer is disturbed as little as possible and that discussions are held with the consulting architects to find ways to ensure minimal disturbance is caused. I also recommend the

supporting subterranean services (sewerage, water and electricity) are kept shallower than 1m and that an archaeologist is present during the excavation of service-related trenches. Given the irregular depth of this artefact-bearing layer, it is important to collect any artefacts that are accidentally excavated. If disturbance of the in situ artefact-bearing layer is unavoidable then I recommend that discussions are held to locate an area of least potential impact and that the area identified for disturbance is excavated by an archaeologist to ensure appropriate contextual preservation and access of the assemblage for analysis.
