**HERITAGE SURVEY OF THE PROPOSED MCWASA  
DAM, WILD COAST, EASTERN CAPE**

**FOR AURECON SOUTH AFRICA (PTY) LTD**

**DATE: APRIL 2009**

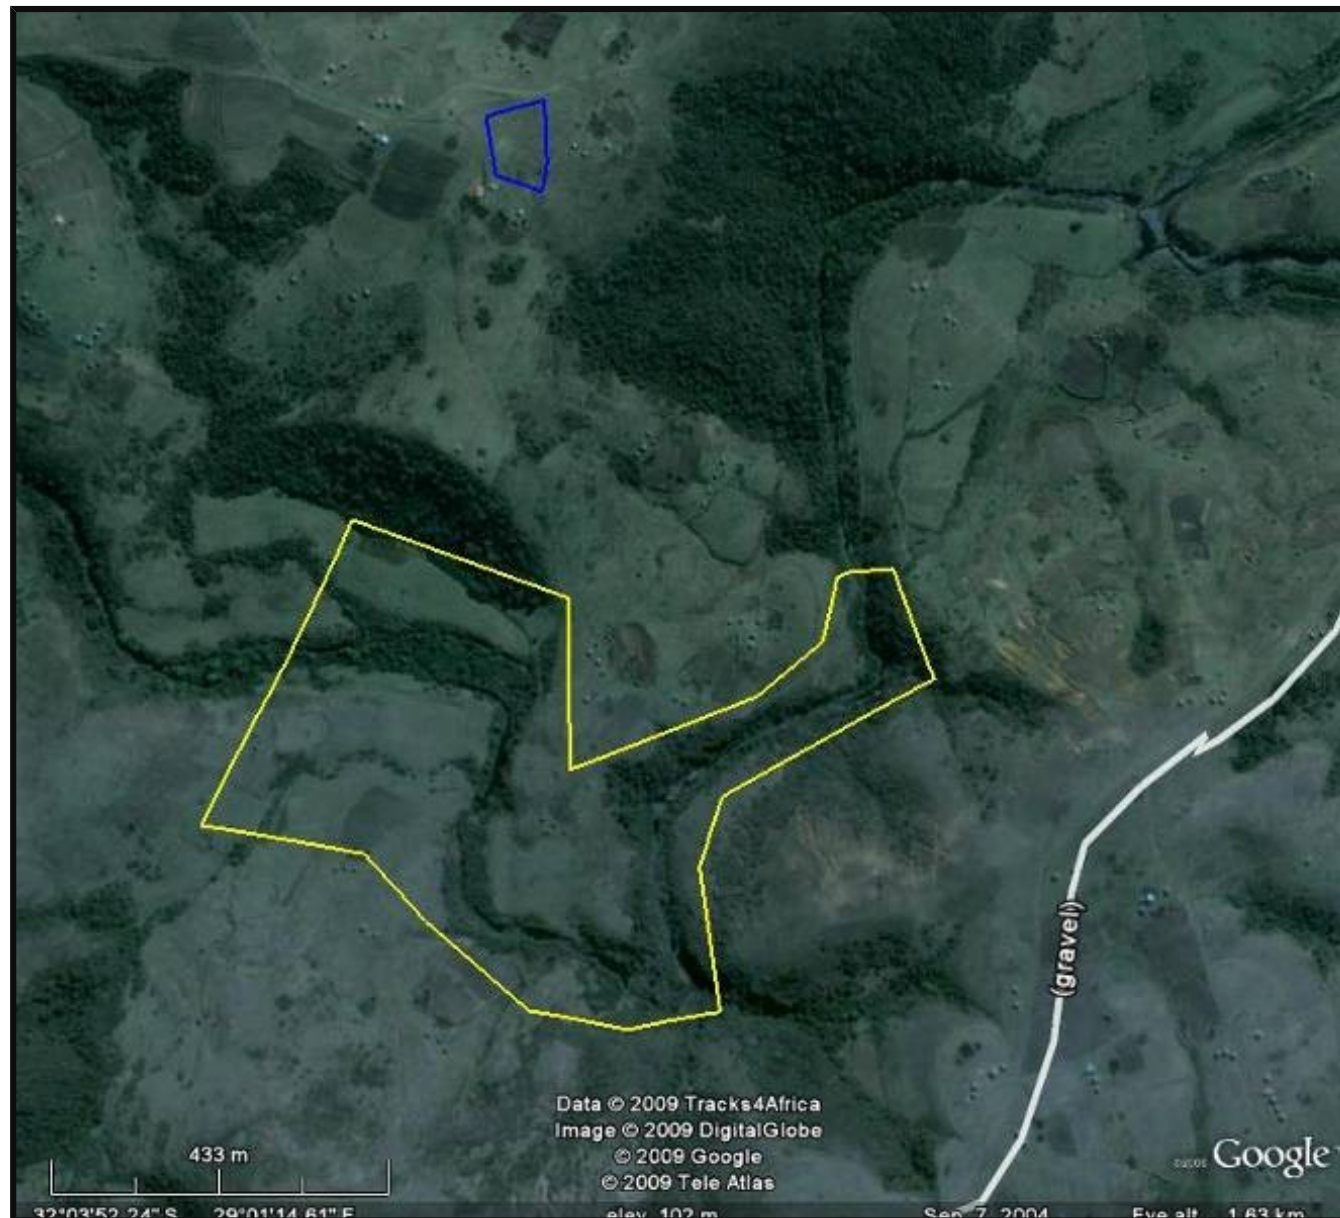
FIG. 2: LOCATION OF 100 YEAR FLOOD LEVEL AND WATER WORKS<sup>1</sup>

<sup>1</sup> Waterworks in blue; approx. 100 year flood level in yellow

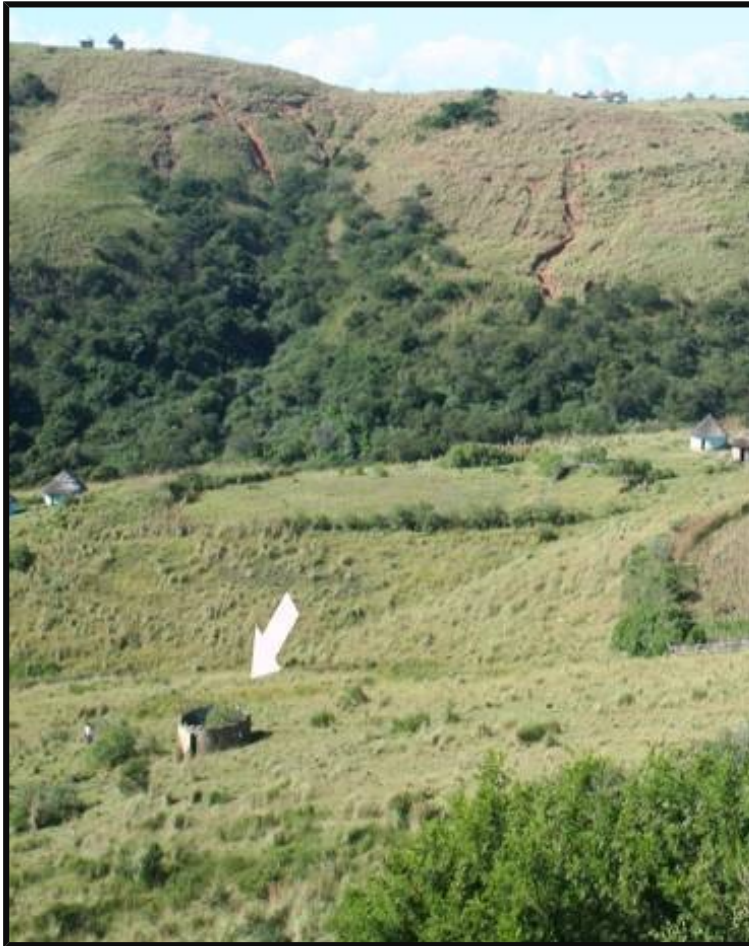
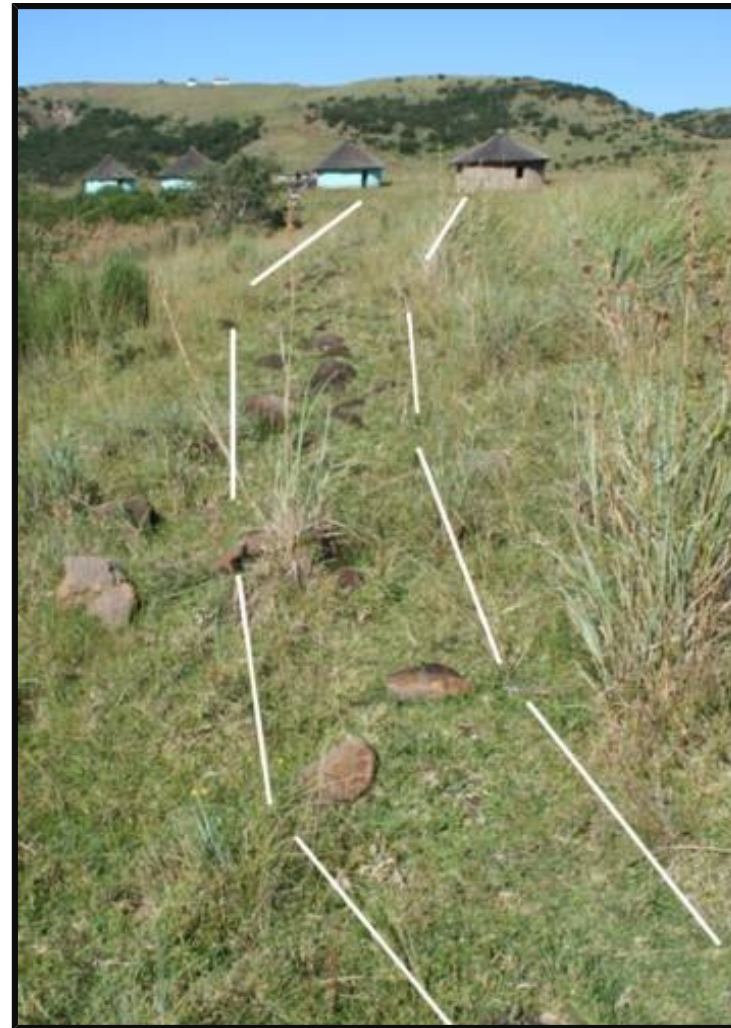
FIG. 4: RECENT HISTORICAL HOUSE AND WALLING

The site consists of three recent (modern historical) house foundations. Below this house is a long dolerite stone wall (or boundary wall) and a recently abandoned house (see fig. 4). The site is probably just above the 100 year flood line.

Significance: The site is of low significance

Mitigation: No further mitigation is required.

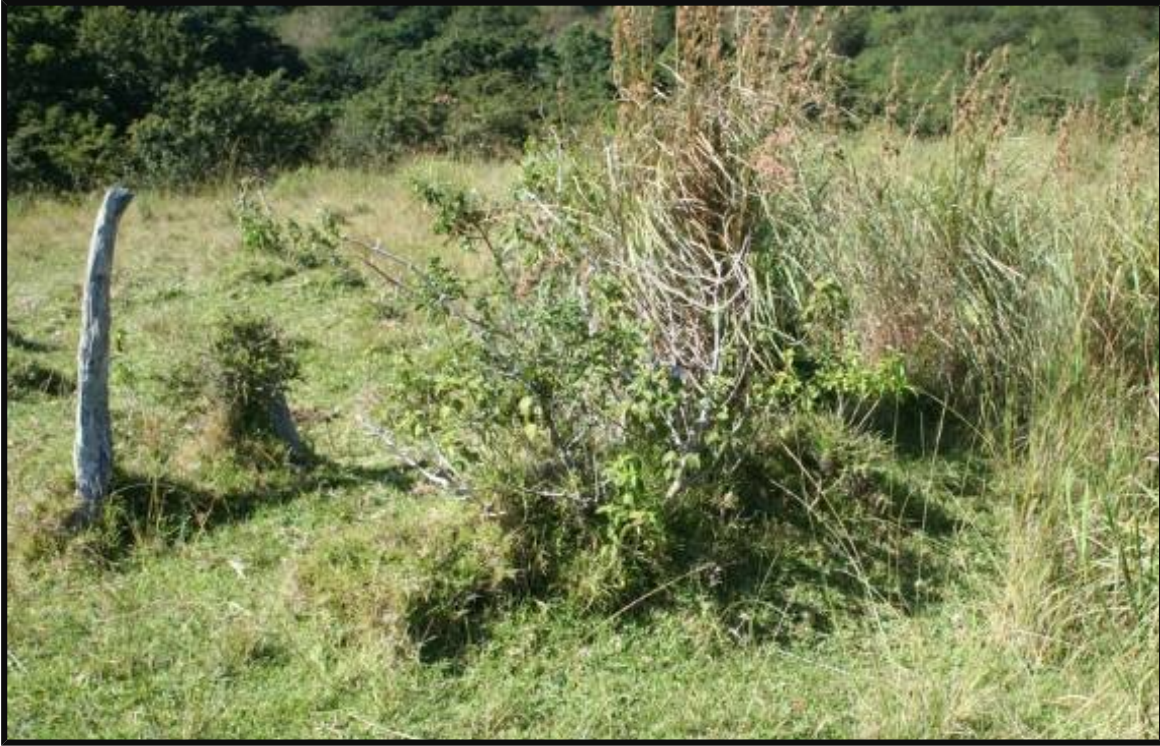
**FIG. 5: GRAVE AT MCW3**

The site consists of an ephemeral scatter of MSA stone tools exposed by presumed geological testing boreholes. These tools are in a secondary context. Slightly uphill from the flakes are two existing huts with a kraal. A grave occurs ~30m to the southeast of the house. The grave is a mound of sand and has two hard wooden (Sneeze wood?) poles beside it.

Significance: The grave is of high significance, while the rest of the site is of low significance.

Mitigation: The graves are on the edge of the 100 year flood line and human remains should be re-allocated. Since the graves are probably younger than 60 years they are not protected by SAHRA legislation and a local undertaker would be able to exhume the remains. Several permits from various government organisations are required for the exhumation.

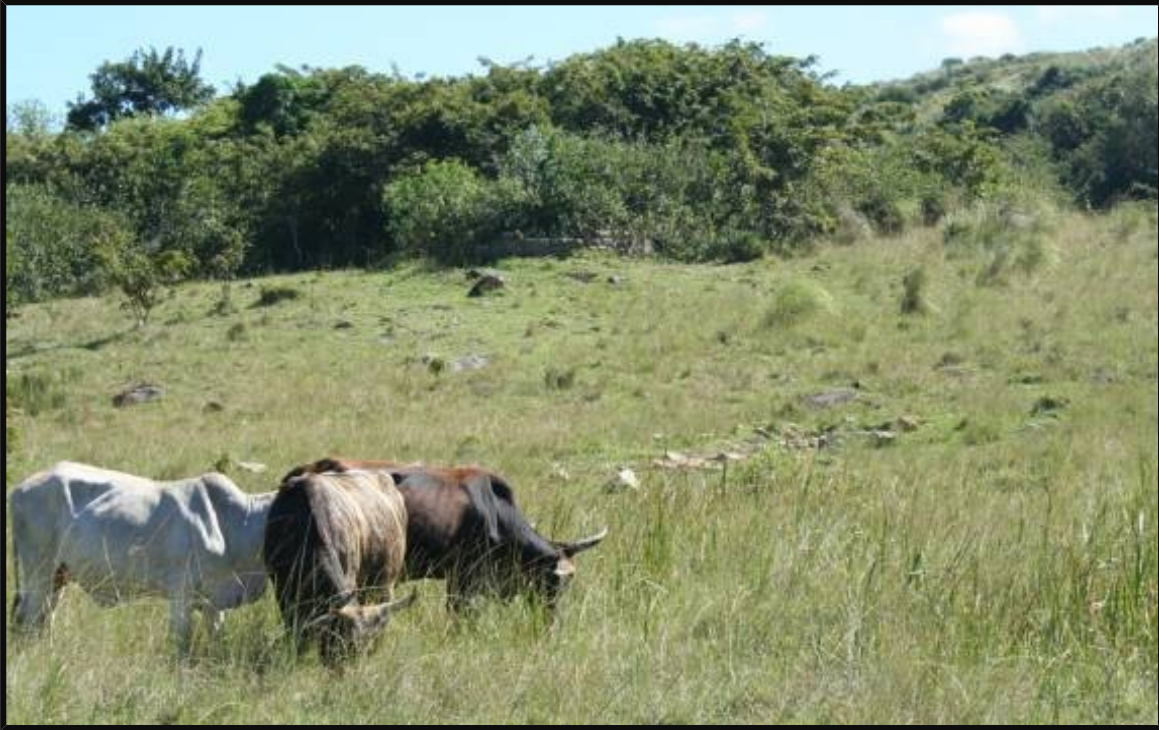
**FIG. 6: HOUSE REMAINS AT MCW9**

Site consists of three house foundations on a small hill, next to a thicket (fig. 6). The site may be related to MCW8 in that MCW8 is the kraal area while MCW9 is the domestic area.

Significance: The site is of low significance

Mitigation: No further mitigation is required.
