**HERITAGE IMPACT ASSESSMENT:
PART 2 AMENDMENT TO RELOCATE AN AUTHORISED
MAIN TRANSMISSION SUBSTATION ON PORTION 7 OF
HAMELKRAAL 16, LAINGSBURG MAGISTERIAL DISTRICT,
WESTERN CAPE**

HWC Case No.: 21052401

It is proposed to develop a Main Transmission Substation (MTS) within an already authorised grid connection corridor. Another location for the substation has previously been authorised some 1.3 km to the north but due to topographic constraints it is now desirable to move the MTS to a new location nearby. The project is undergoing a Part 2 Amendment to relocate the MTS. The application also seeks to lengthen the 132 kV powerline leading into the MTS from the north and shorten the 400 kV powerline leading out of the MTS towards the south so as to align with the new location.

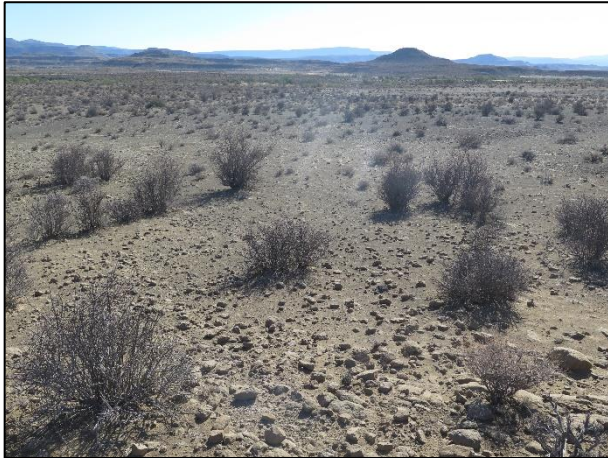
Figure 3: Looking westwards from the north-eastern corner of study area. Sandstone gravels on the alluvium in the foreground, finer gravels in the centre of the study area.

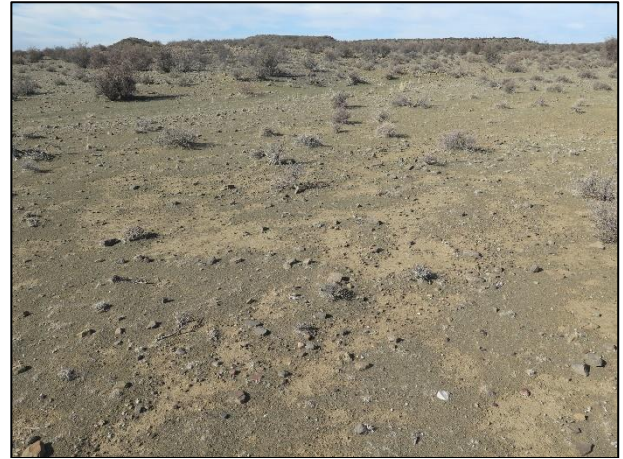
Figure 4: View from the north-eastern corner of the study area towards the east, across the alluvium and light gravels.

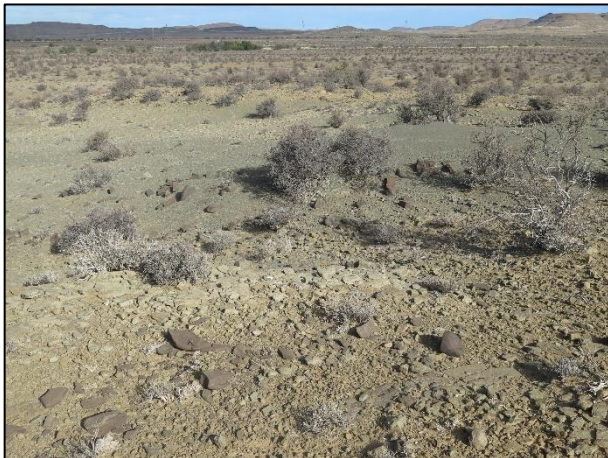
Figure 5: View to south from centre of study area. Sandstone and 'koffie klip' blocks are visible in the foreground with alluvium and gravels in the rest of the area.

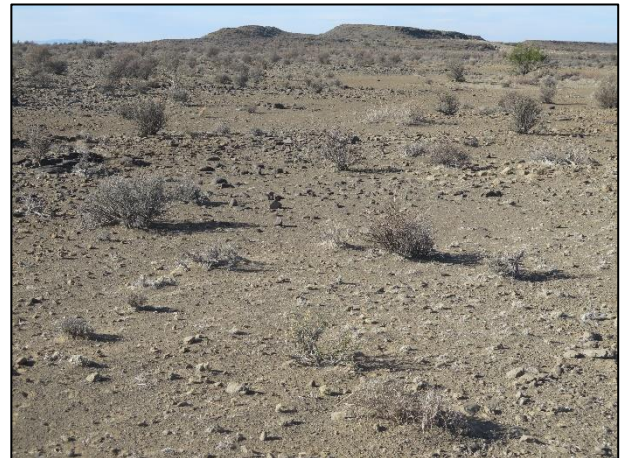
Figure 6: Looking towards the northeast from the south-western corner of the study area.

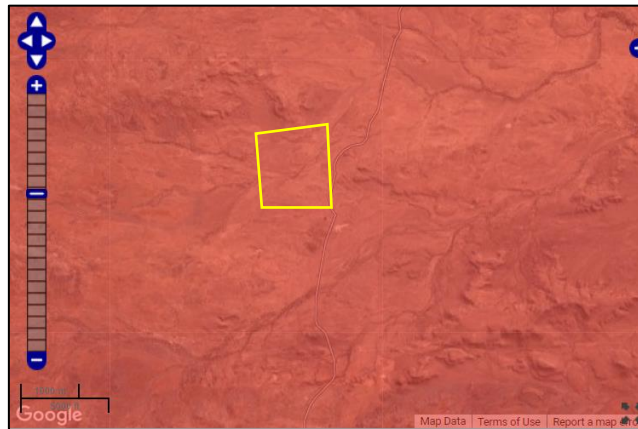
The SAHRIS Palaeosensitivity map shows the entire study area and surrounds to be of very high palaeontological sensitivity (Figure 7). Almond's (2021) field study revealed that the surface of the study area was coated in unconsolidated alluvial and downwasted gravels and other finer sediments. These are generally of low sensitivity. Rocky areas in other parts of the authorised grid

connection corridor (reported previously) as well as in an area just to the east of the site have produced fossils though. These include fragments of large bones, moulds of plant stems and some trace fossils. On contrast to the palaeosensitivity map, Almond (2021) finds the study area to be of low sensitivity.

Figure 7: Extract from the SAHRIS Palaeosensitivity map showing the study area (yellow polygon) to be of high palaeontological sensitivity (red shading).

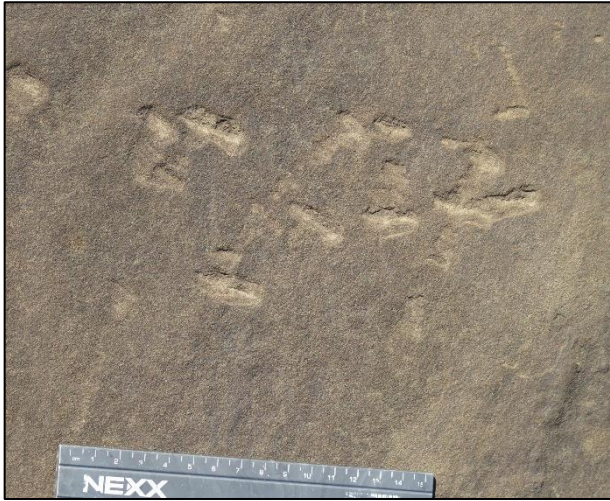
Most important within the study area are a number of engravings that are all assumed to be historical. None of them seems represent recognisable imagery and the markings at waypoint 497 may even simply be chop marks from somebody using the rock to chop firewood on (Figure 9). The remainder are all obviously deliberately incised and pecked though (Figures 10 to 15). Interestingly, the engravings have varying degrees of weathering suggesting variable age (but still all historical). These engravings lie along a low ridge capped with koffieklip rocks and slabs (Figure 16) and it is on this koffieklip that the engravings are made. John Almond (pers. comm.) describes this rock as “secondary (diagenetic/post-depositional) ferruginous carbonate within a channel sandstone matrix”. One further engraved rock was found right on the eastern edge of the study area (Figure 17). This one appeared to have the name “WICKUS DE WEE” incised on it. It is hard to know what these engraved rocks relate to and to know how important they are as heritage resources.

Figure 10: Historical engravings at waypoint 497. 15 cm ruler for scale.

- The engravings should be photographed and traced as necessary to produce a clear record. This should include moving the stones in order to achieve the best light for photography;

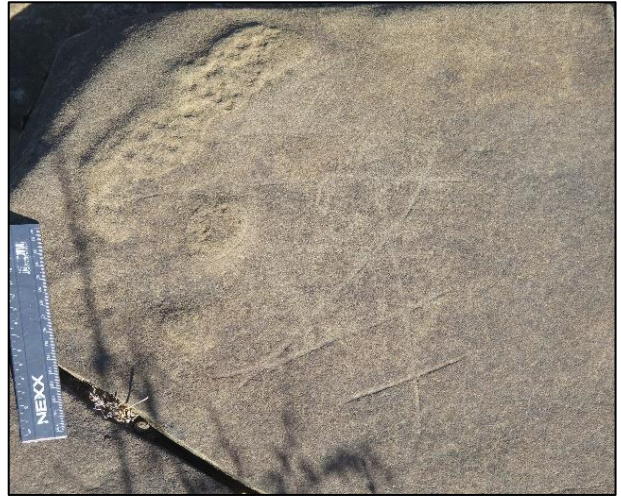
Figure 11: Historical engravings at waypoint 498. 15 cm ruler for scale.

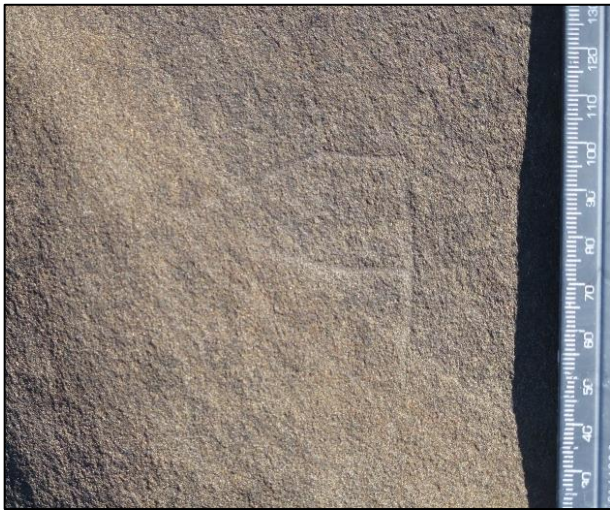
Figure 12: Historical engravings at waypoint 499. 15 cm ruler for scale.

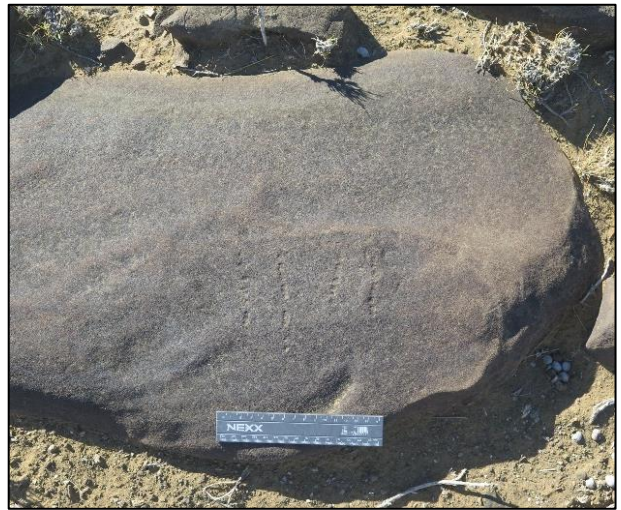
Figure 13: Historical engravings at waypoint 500. 15 cm ruler for scale.

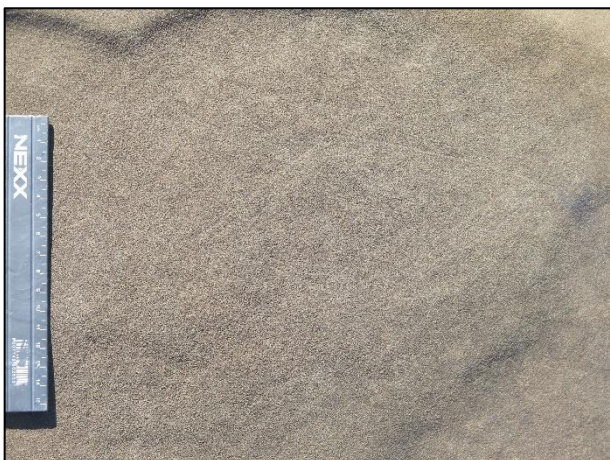
Figure 14: Historical engravings at waypoint 501. 15 cm ruler for scale.

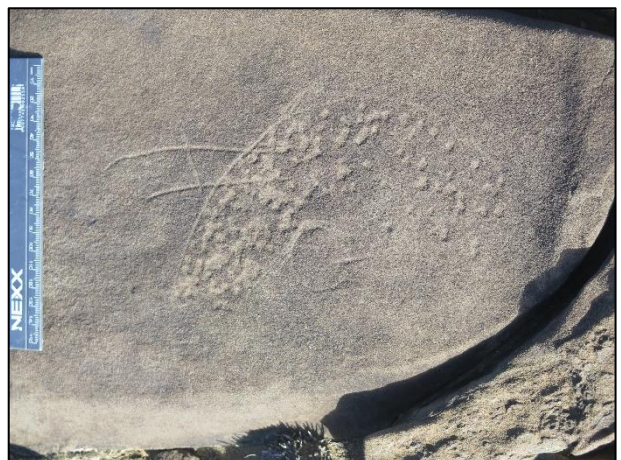
Figure 15: Historical engravings at waypoint 502. 15 cm ruler for scale.

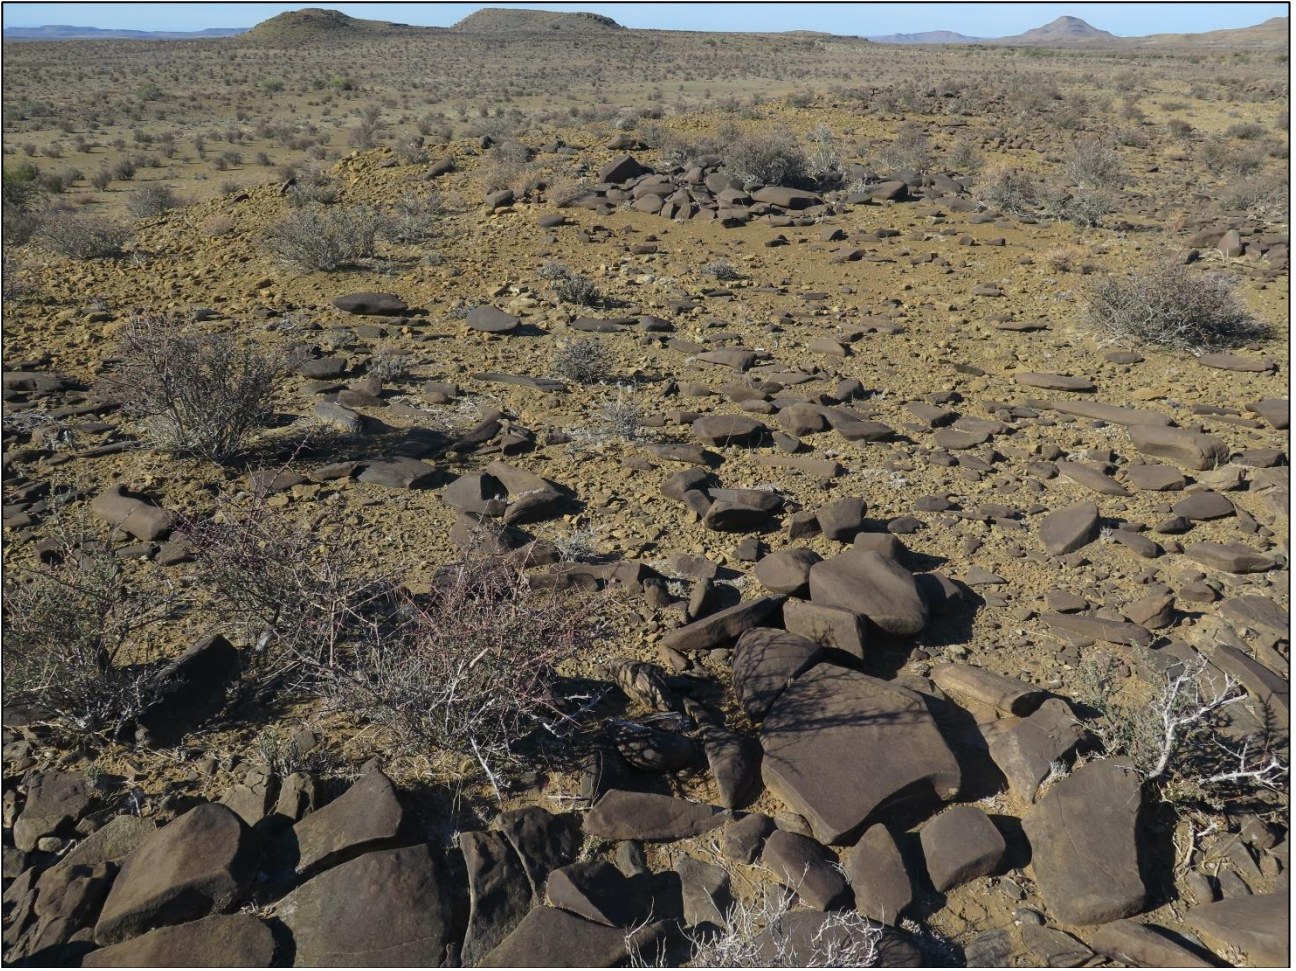
Figure 16: Looking NE along the low rise with koffiekliip where most of the rock engravings occur.

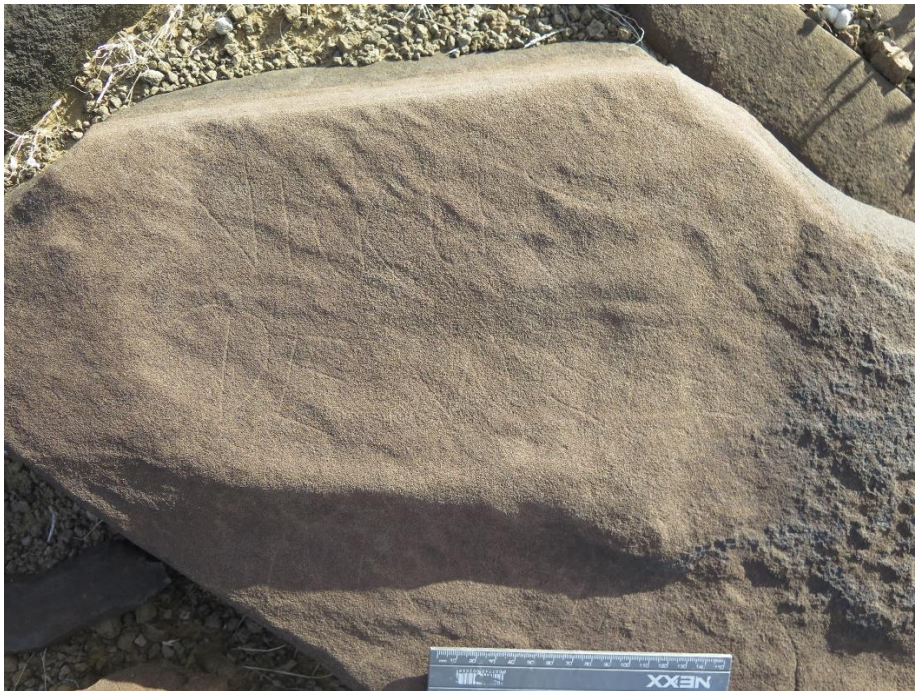
Figure 17: Historical engraving at waypoint 506. 15 cm ruler for scale.

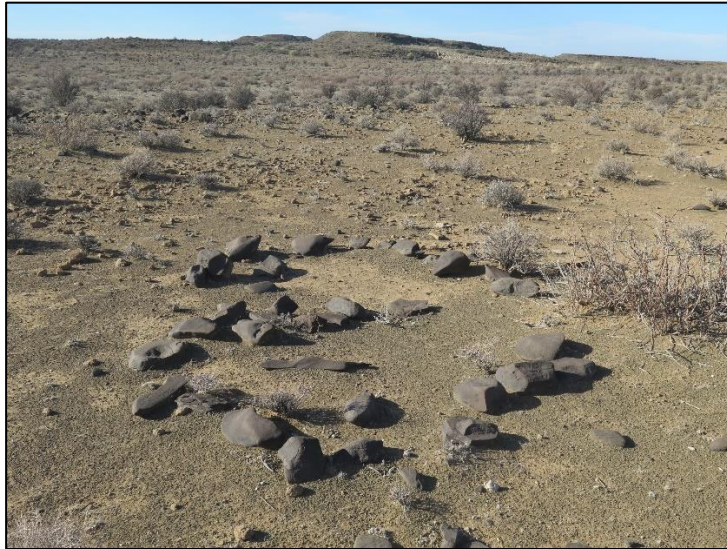
Some stone features were also found. One of these is a potential grave and is discussed under Section 6.3. The other is a set of rocks on a level area of alluvium and that appear to form two conjoined semi-circular shapes (Figure 18). They have no obvious function and there were no artefacts in the area.

Figure 18: Stone feature at waypoint 504.

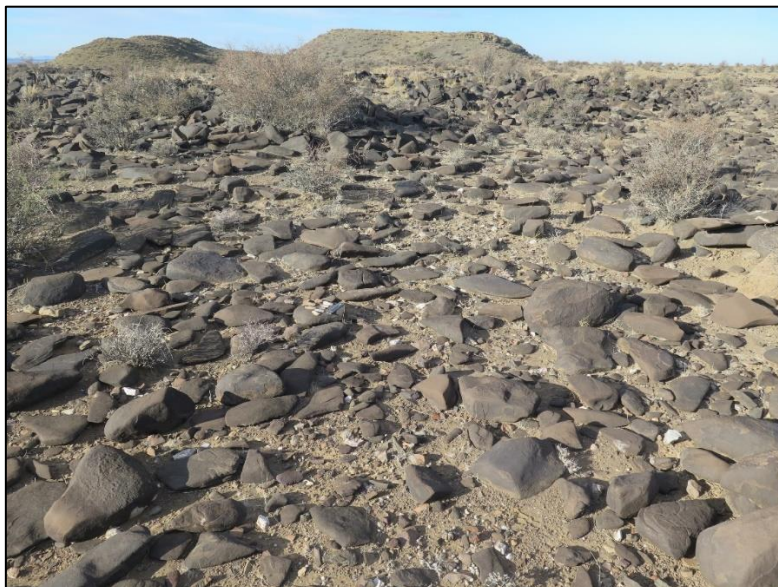
A number of archaeological finds were made on a small raised rocky area just outside the eastern edge of the study area (Figure 19). Most of these were spatially related (waypoints 507 to 512). In this area there were many stone artefacts dating from both the MSA and LSA, but with the former strongly dominating (Figures 20 to 23). Blades and points (pr fragments of these types) were quite common. The slightly elevated position of this area was obviously a favoured spot.

Figure 19: View towards the northeast over the area with the greatest concentration of MSA and LSA stone artefacts (waypoint 510).

- The potential grave cairn should be unpacked and the ground tested to determine the status of the feature;
- The cluster of Stone Age materials located just outside the eastern edge of the site should be avoided and protected from harm throughout the construction phase; and

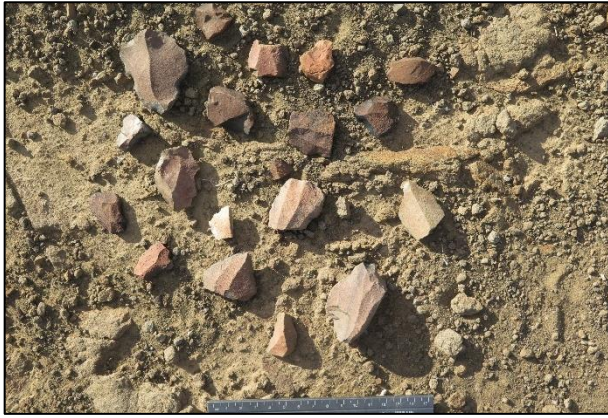
508	S32° 42' 40.8" E21° 15' 46.1"	Scatter of weathered and patinated fine-grained sandstone, hornfels and possibly Matjiesfontein chert MSA and LSA artefacts, including blades and points.	IIIC
510	S32° 42' 41.3" E21° 15' 46.4"	Spatially discrete scatter of MSA and LSA artefacts in an area of approximately 10 x 18 m. The greatest concentration of stone artefacts is in an area of about 2 to 3 m ² where there are probably 30-40 artefacts per m ² . The artefacts are made of fine-grained sandstone, hornfels and Matjiesfontein chert and consist of flakes, blades, points, cores. Also a few more crudely-flaked sandstone artefacts. The scatter tapers off in density quite quickly.	IIIC

Figure 20: Stone artefacts from waypoint 508. 15 cm ruler for scale.

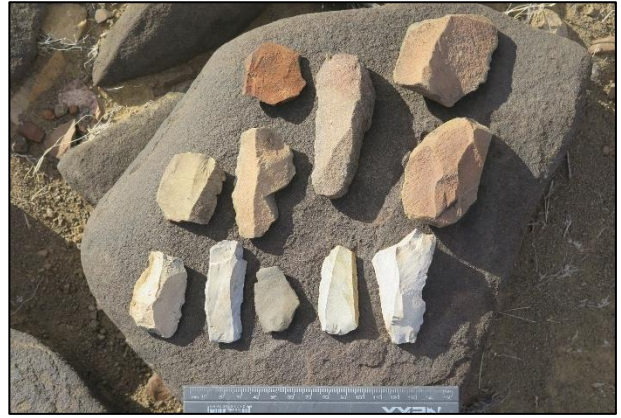
Figure 21: Stone artefacts from waypoint 509. 15 cm ruler for scale.

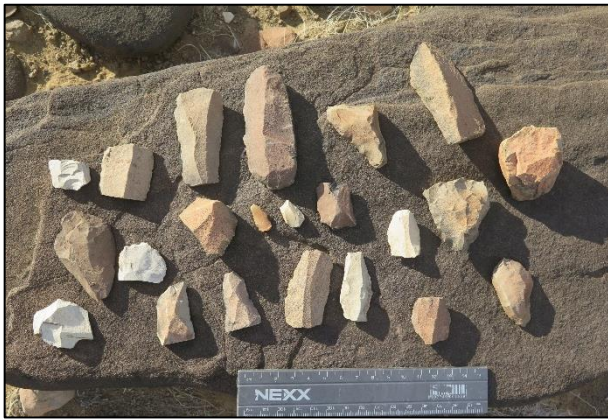
Figure 22: Stone artefacts from waypoint 510. 15 cm ruler for scale.

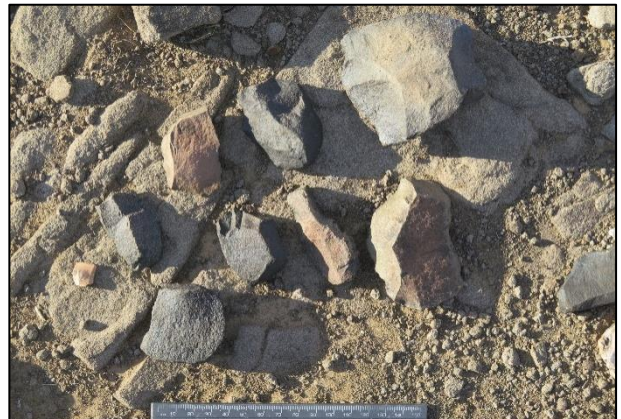
511	S32° 42' 40.4" E21° 15' 47.2"	Small cluster of several fine-grained sandstone flakes and chunks, one LSA flake possibly of Matjiesfontein chert.	IIIC
512	S32° 42' 41.7" E21° 15' 47.5"	Small cluster of several fine-grained sandstone flakes, blades and bladelet core, with one patinated hornfels blade.	IIIC
513	S32° 42' 40.9" E21° 15' 46.7"	Areas apparently cleared of koffieklip boulders. The boulders are heaped to one side forming a semi-circle to the west of the 3-4 cleared areas. These may be possible sleeping hollows. Fewer than 30 LSA artefacts of fine-grained chert and quartz, as well as pieces of OES occur in association with these areas.	IIIC

Figure 23: Stone artefacts from waypoint 511. 15 cm ruler for scale.

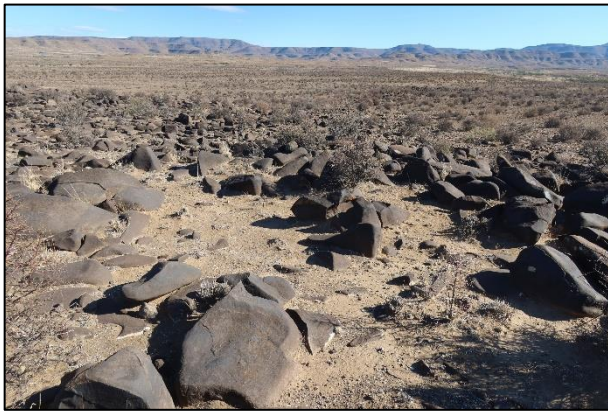
Also in this area were a number of sandier patches amongst the koffiekliip stones that might have been deliberately cleared (Figure 24). A light scattering of LSA flaked stone artefacts in CCS (chert) and quartz were found in these areas along with fragments of ostrich eggshell (Figure 25). If these areas were indeed deliberately cleared then they may represent sleeping hollows.

Figure 24: View towards the southwest across the sandy patches between koffiekliip boulders.

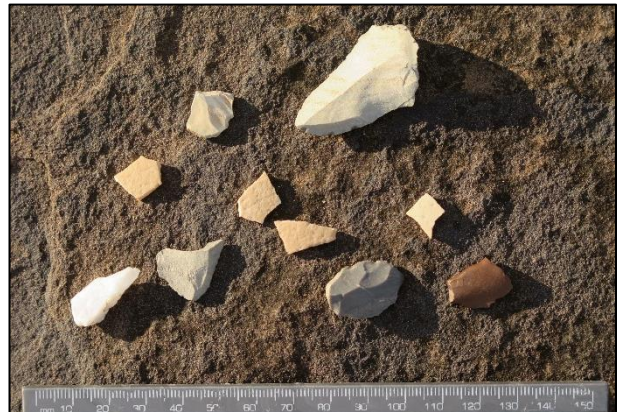
Figure 25: Stone artefacts from waypoint 513. 15 cm ruler for scale.

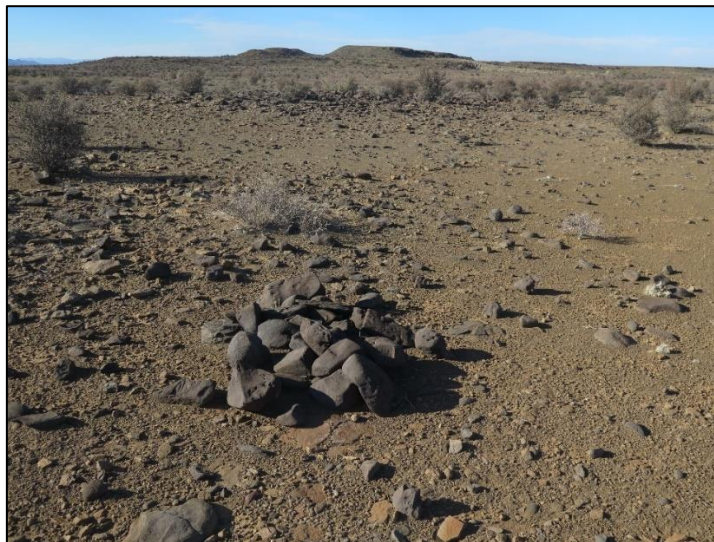
No graves were found, but one pile of stones seemed suggestive of a possible burial cairn (Figure 26). It is undoubtedly an anthropogenic feature but, although unlikely to be a grave, this cannot be ruled out.

Figure 26: Mound of koffjieklip stones.

Graves are deemed to have high cultural significance for their social value and are considered IIIA resources. One possible grave was found but should it turn out to not be a grave (which is likely) then the feature would be of very low cultural significance and be graded NCW.

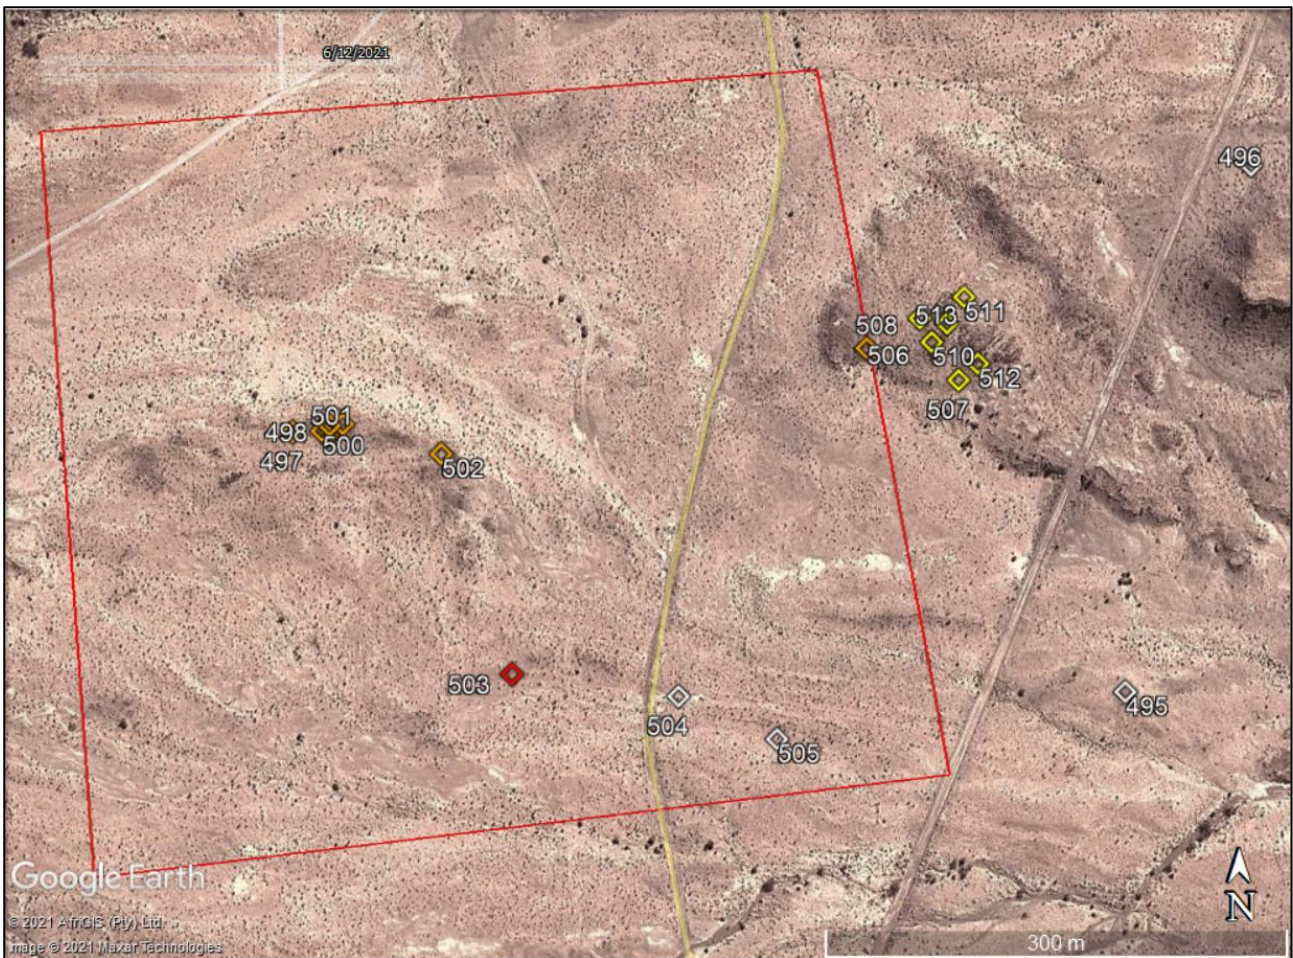
Figure 28: Map of archaeological heritage resources by grade. Red = IIIA, Orange = IIIB, Yellow = IIIC, White = NCW. Note that if waypoint 503 is not a grave then it would be NCW.

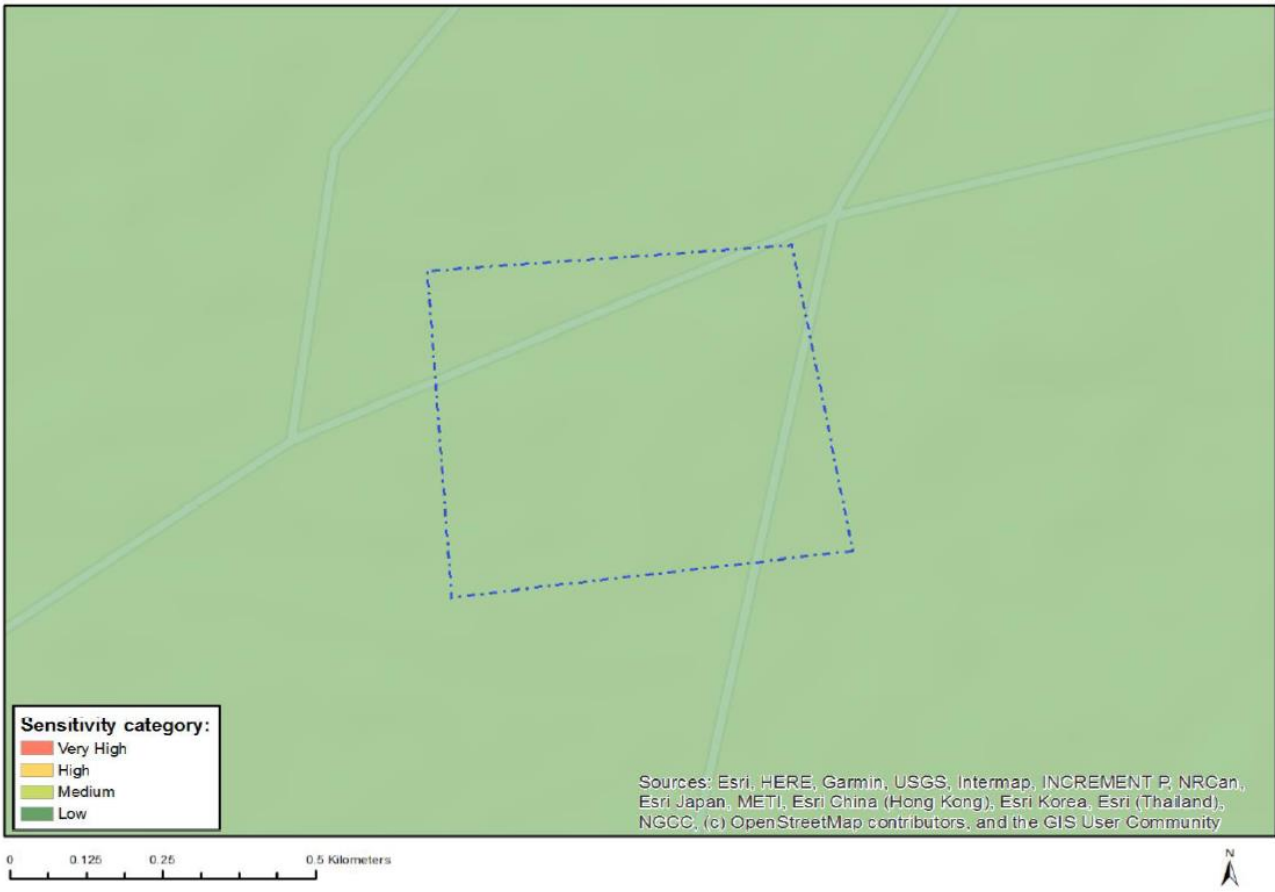
The map below is extracted from the screening tool report and shows the archaeological and heritage sensitivity to be low. The site visit showed that the majority of the site is indeed of low sensitivity but that a few small areas of higher sensitivity were present (where archaeological resources were found). Figure 2 in the report shows the areas considered to be archaeologically sensitive. Since the sites were not of high cultural significance, these areas can be considered as a medium sensitivity. A photographic record and description of the relevant heritage resources are contained within the impact assessment report. The specialist thus generally agrees with the screening tool sensitivity rating but noting that the low sensitivity is not uniform.
