**HIA OF THE PHASE 2 OF THE MHLABATSHANE
BWSS, KWAZULU-NATAL**

FOR TRIPLO4

DATE: 18 NOVEMBER 2015

**Umlando: Archaeological Surveys and Heritage
Management**

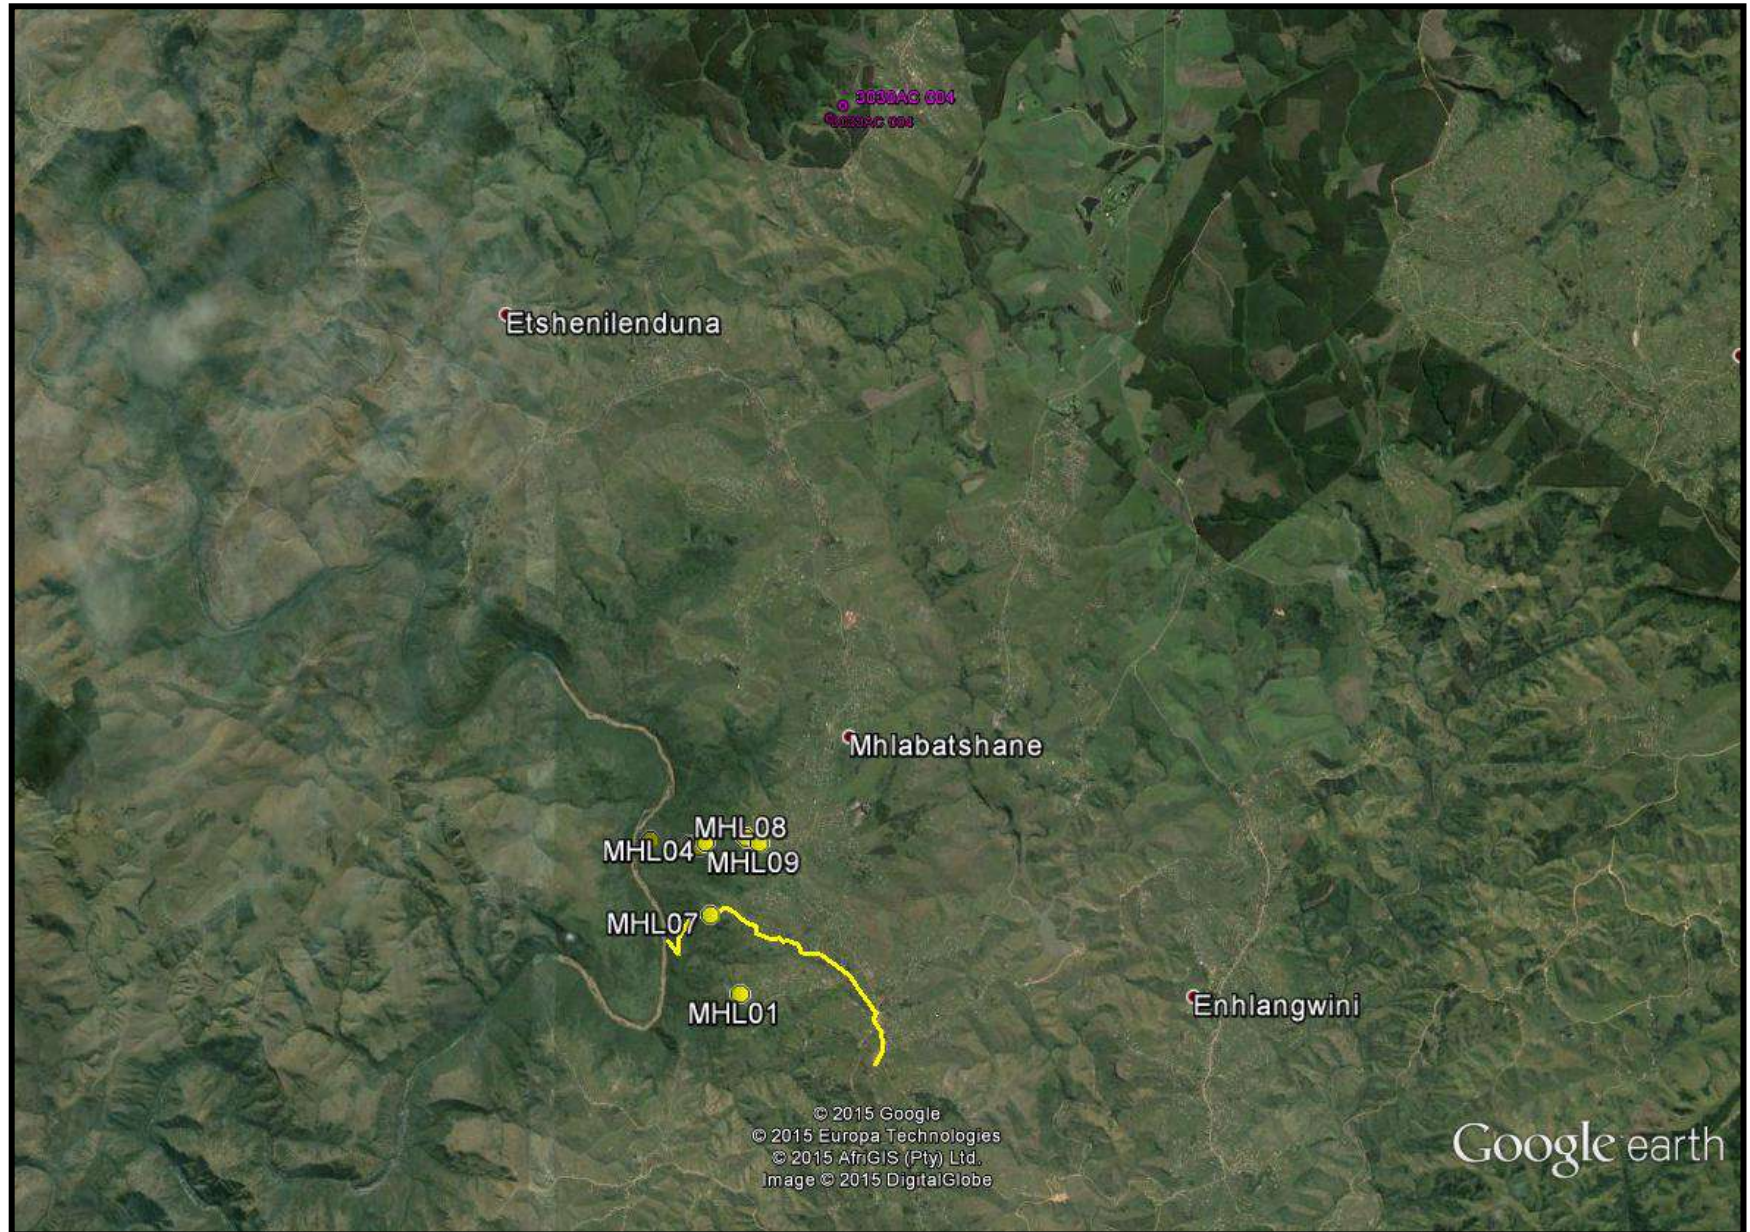
FIG. 4: LOCATION OF KNOWN HERITAGE SITES NEAR THE STUDY AREA

The desktop study consisted of analysing various maps for evidence of prior habitation in the study area, as well as for previous archaeological surveys. The archaeological database indicates that there are archaeological sites in the general area (fig. 4). These sites include all types of Stone Age and Iron Age sites. No sites occur in the study area.

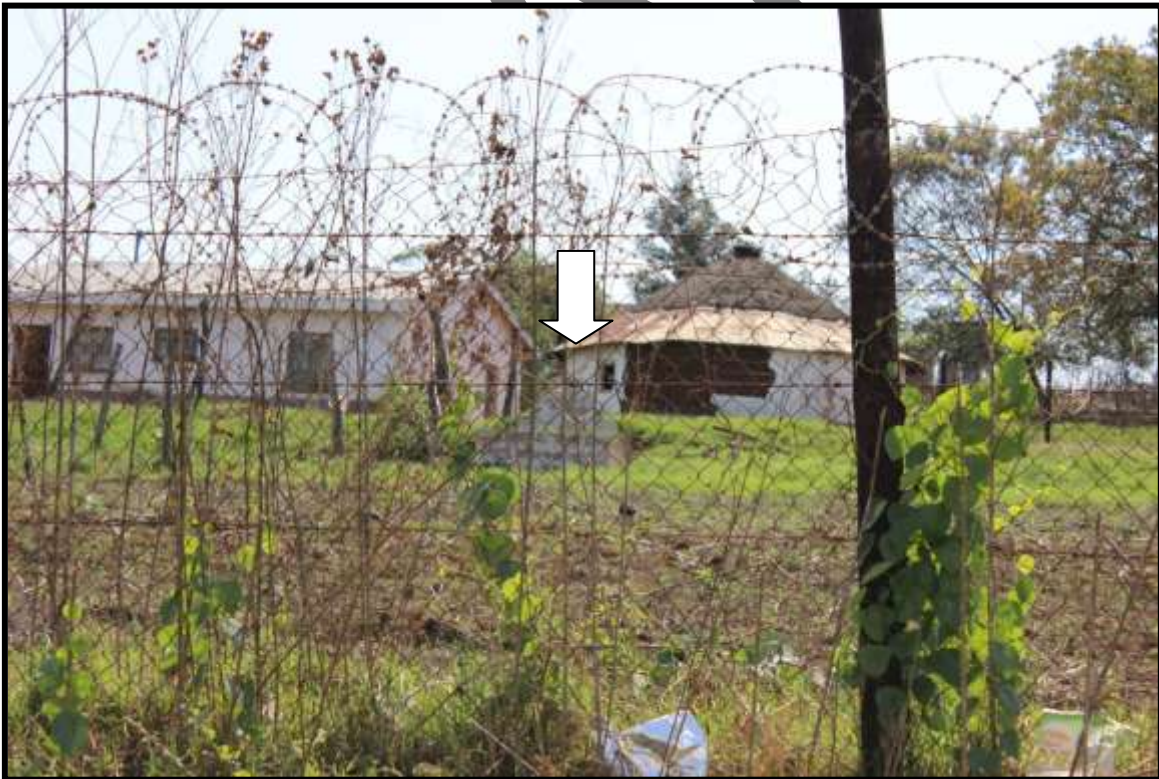
FIG. 9: SITE AT GRAVE 1

Grave 1 is located within a settlement that is fenced off from the road. There is a solitary recent grave in a northeast-southwest alignment (Fig. 9). This grave occurs ~28m from the line centre point.

Significance: The grave is of high significance.

SAHRA Rating: 3A

Mitigation: Normally a 20m buffer is required between a grave and a development. Either the line must move to the southern side of the road, the footprint be decreased to 8m, or permission would be required to impact on this buffer zone. I would suggest decreasing the footprint width.

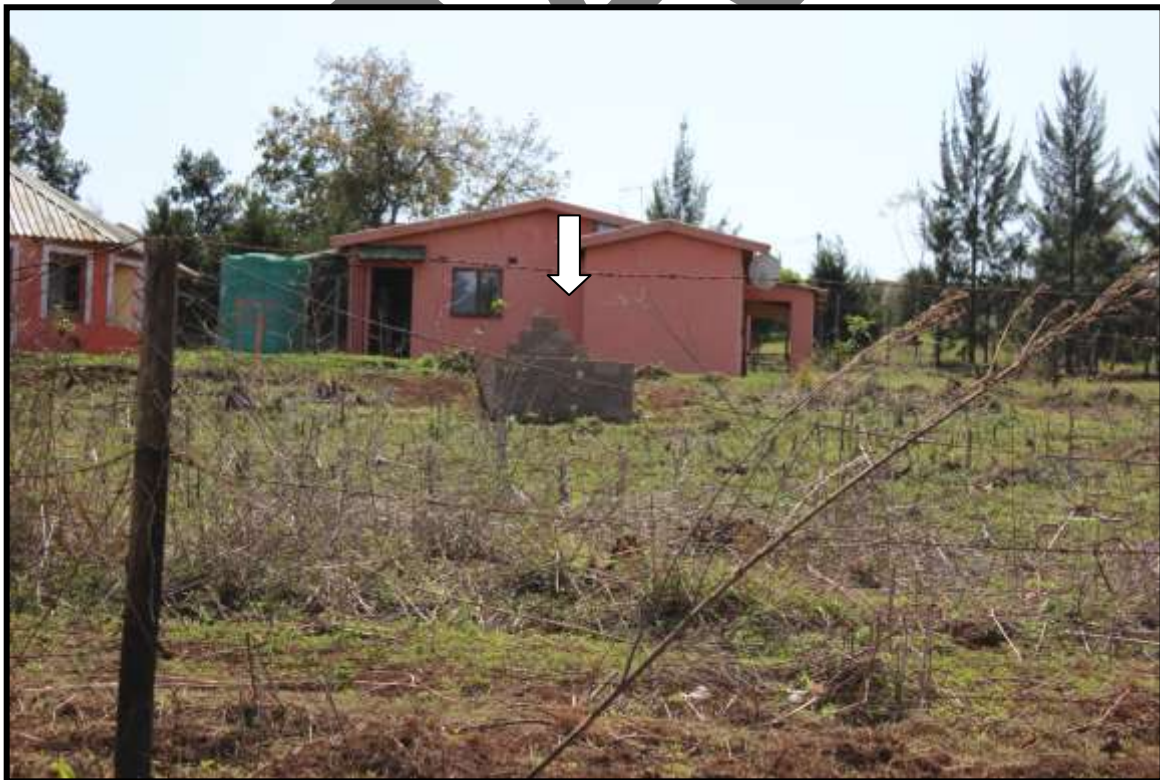
FIG. 10: SITE AT GRAVE 2

Grave 2 is located within a settlement that is fenced off from the road. There is a solitary recent grave in a northeast-southwest alignment located between the house and the maize field (Fig. 10). This grave occurs ~28m from the line centre point.

Significance: The grave is of high significance.

SAHRA Rating: 3A

Mitigation: Normally a 20m buffer is required between a grave and a development. Either the line must move to the southern side of the road, the footprint be decreased to 8m, or permission would be required to impact on this buffer zone. I would suggest decreasing the footprint width.

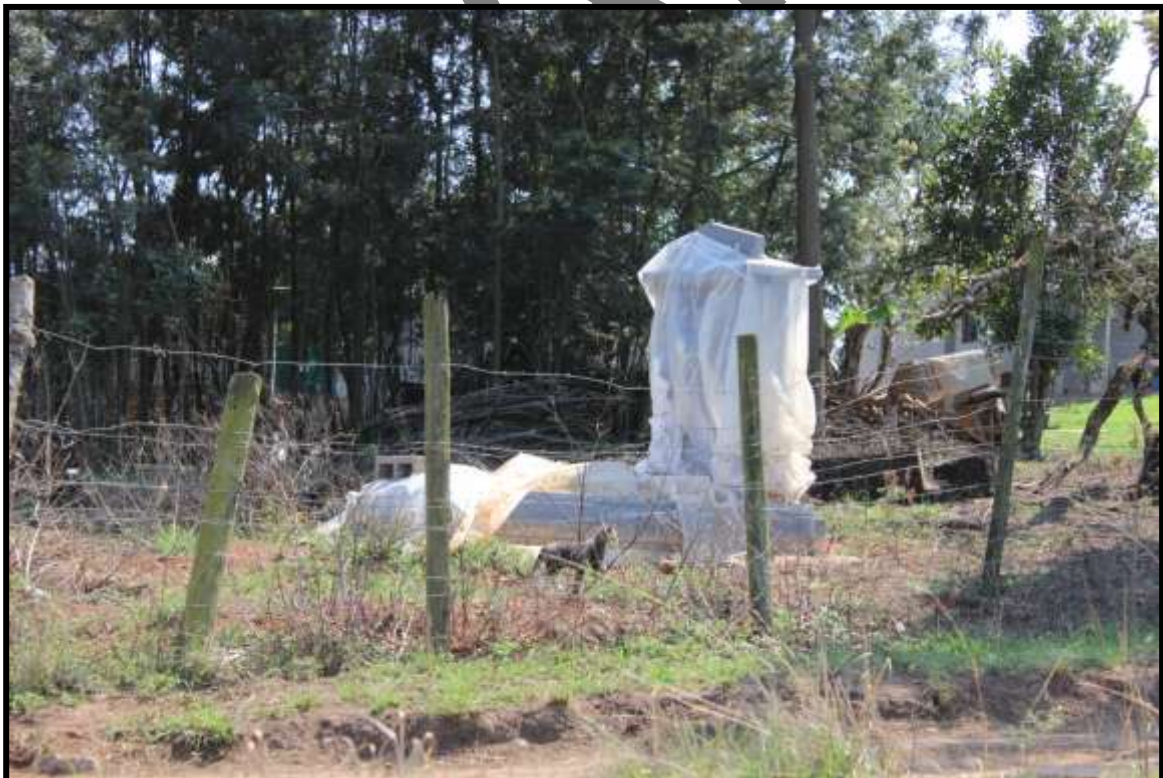
FIG. 11: SITE AT GRAVE 3

Grave 3 is located within a settlement that is fenced off from the road. There is a solitary recent grave in a northeast-southwest alignment (Fig. 11). This grave occurs ~21m from the line centre point; however, it is on the opposite side of the road.

Significance: The grave is of high significance.

SAHRA Rating: 3A

Mitigation: Normally a 20m buffer is required between a grave and a development. The road itself will act as a buffer, and thus the buffer zone should be partially omitted for this site.

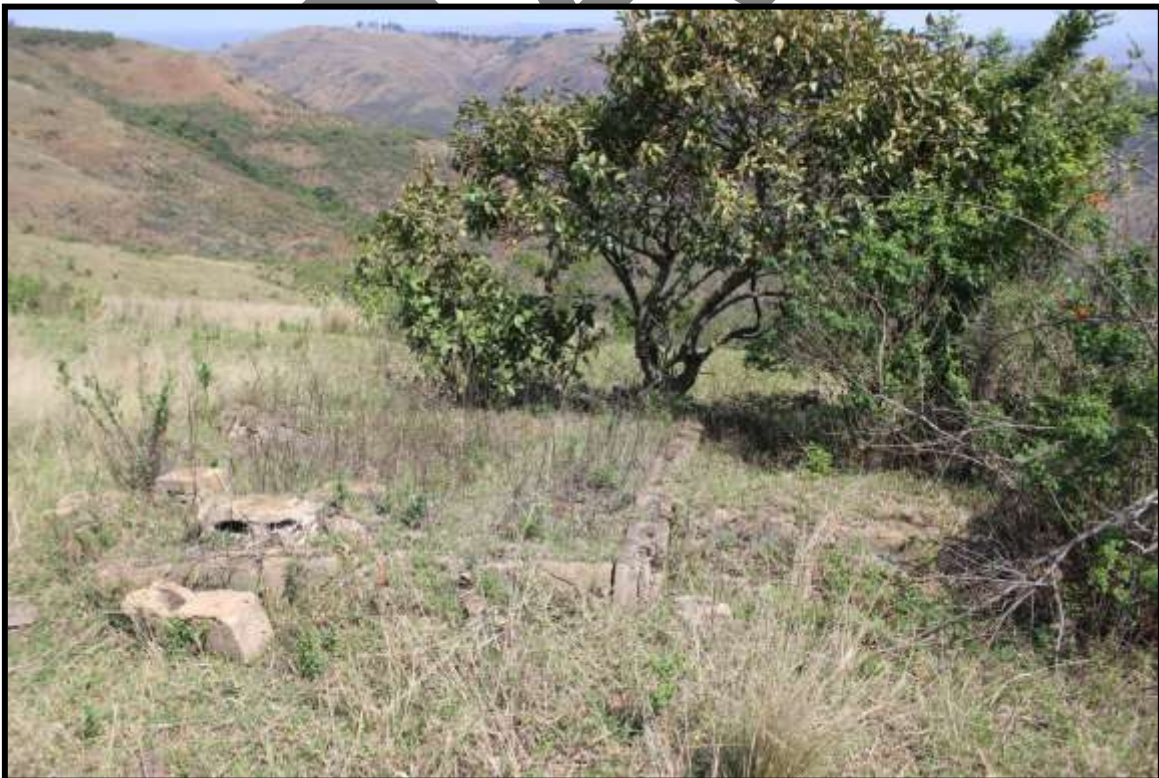
FIG. 12: SITE AT GRAVE 4

Grave 4 is located on the western side of the line and may be associated with HH6. The site consists of at least two graves underneath a bush on the slopes of the hill (Fig. 12). An informant from the nearby house stated that the graves might date to the 1980s and the descendants have moved nearby. There is another set of graves ~40m northeast of these graves. These latter graves are associated with the existing settlement.

Significance: The graves are of high significance.

SAHRA Rating: 3A

The line route has been moved >50m from the graves.

Mitigation: No mitigation is currently required.

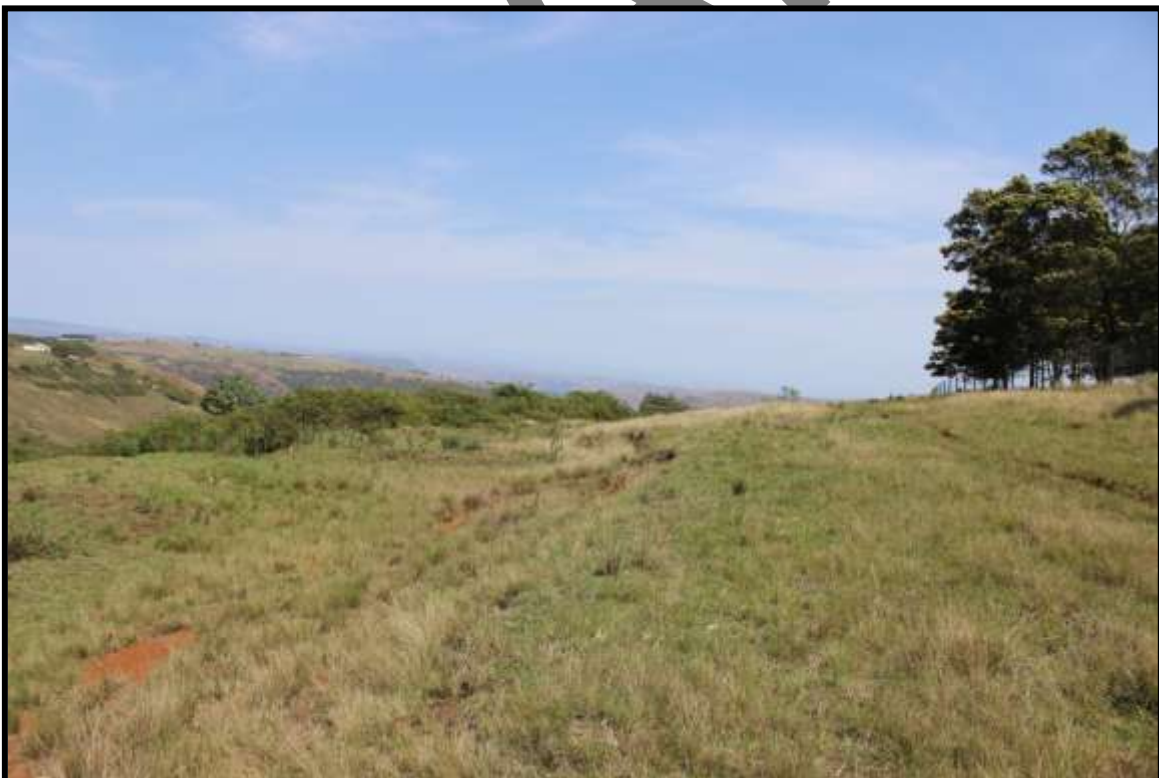
FIG. 13: SETTLEMENT AT HH1

HH1 occurs on the slopes of the hill. The site consists of an old settlement that is ~100m long and 20m wide (Fig. 13). Several raised house floors still occur, but nor graves were directly visible. The site occurs on the 1968 topographical map.

Significance: Site is of low significance unless graves occur.

SAHRA Rating: 3C

The line has been moved >50m uphill from the site

Mitigation: No mitigation is currently required.

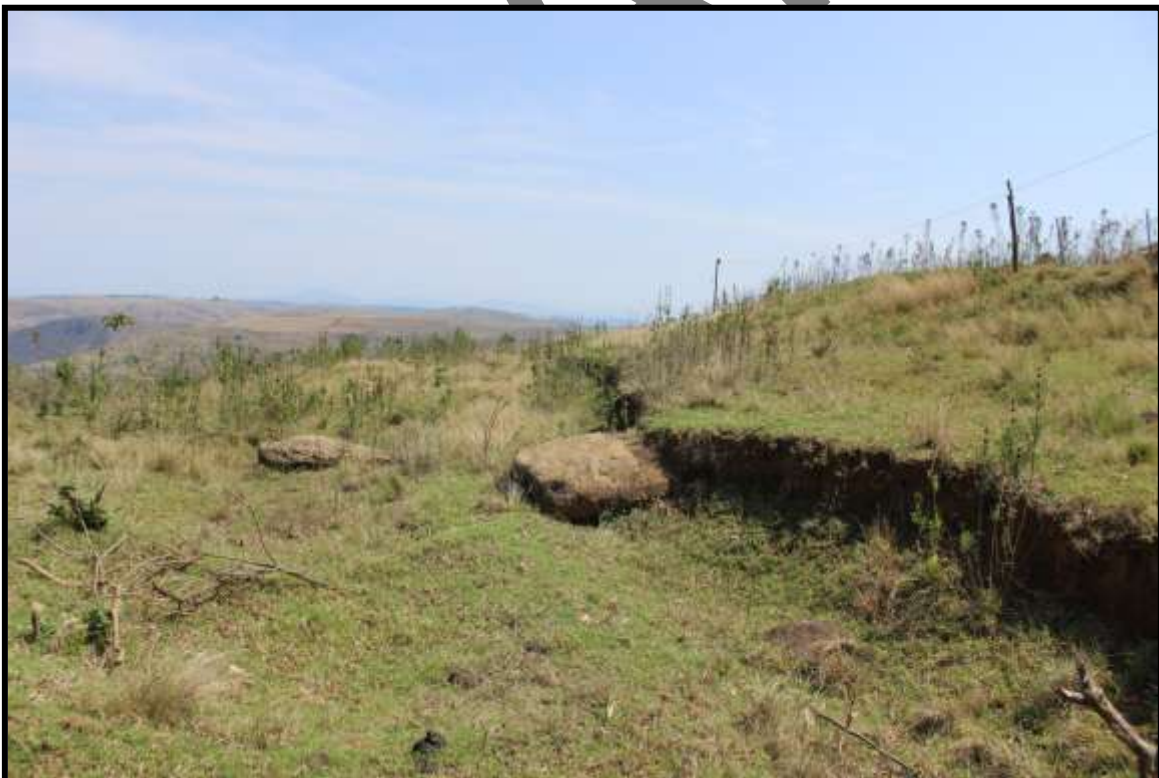
FIG. 14: SETTLEMENT AT HH2

HH2 occurs on the slopes of the hill. The site consists of an old settlement that is ~50m long and 20m wide (Fig. 14). Several raised house floors still occur, but nor graves were directly visible. The site occurs on the 1968 topographical map.

Significance: Site is of low significance unless graves occur.

SAHRA Rating: 3C

The line has been moved >50m uphill from the site

Mitigation: No mitigation is currently required.

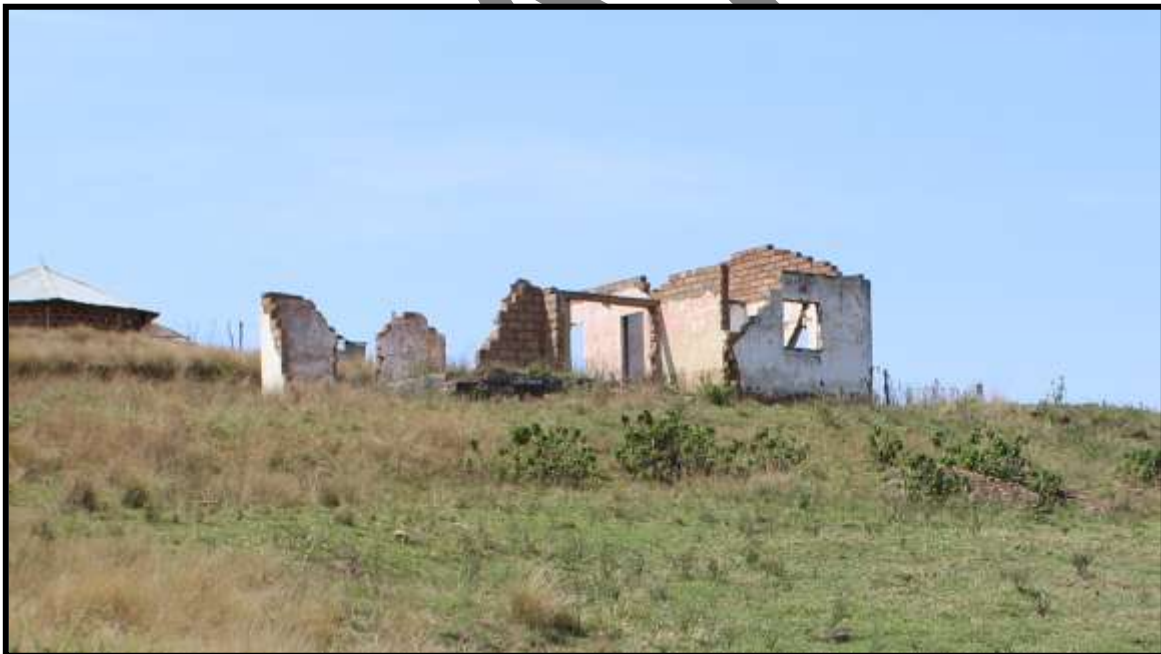
FIG. 15: BUILDING AT HH3

HH3 occurs on the slopes of the hill. The site consists of an old building that could have been a General Dealer (Fig. 15). The site occurs on the 1968 topographical map. No graves are directly associated with the building.

Significance: Site is of low significance unless graves occur.

SAHRA Rating: 3C

The line has been moved >50m uphill from the site

Mitigation: No mitigation is currently required.

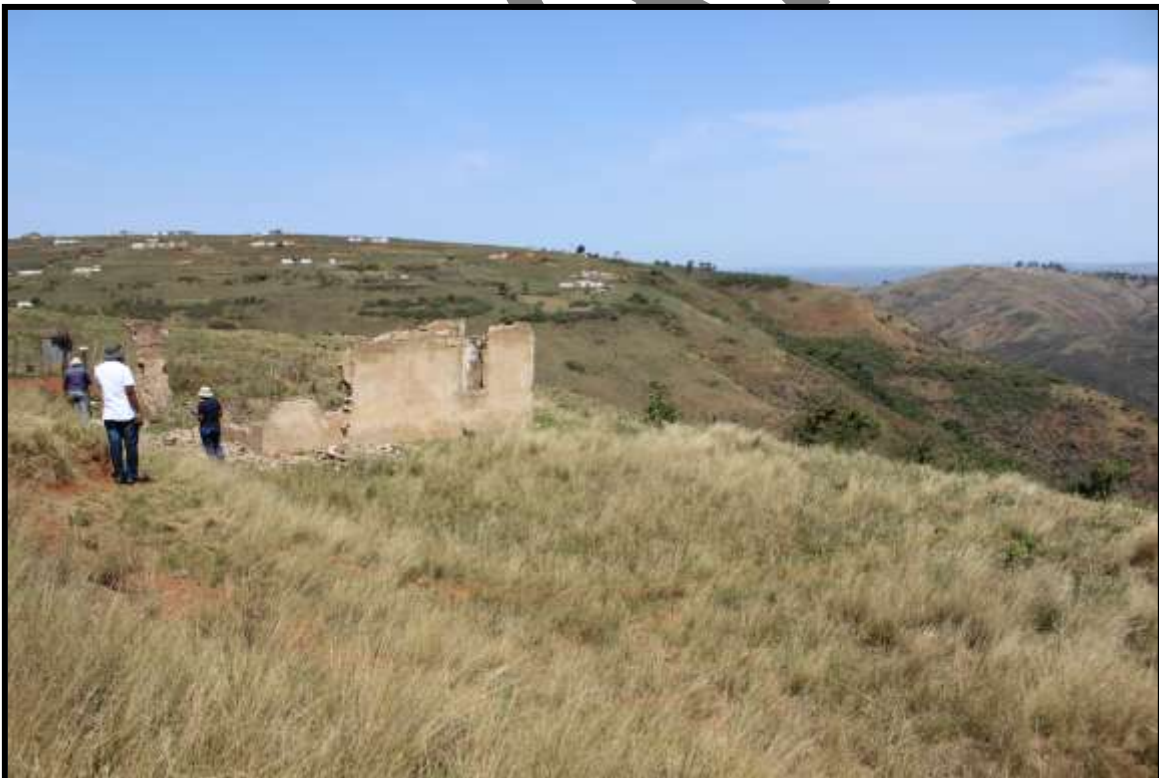
FIG. 16: SETTLEMENT AT HH2

HH4 occurs on the slopes of the hill on the western side of the line. The site consists of an old settlement that is ~50m long and 20m wide (Fig. 16). Two raised house floors still occur. No graves are directly associated with the building. The site occurs on the 1968 topographical map.

Significance: Site is of low significance unless graves occur.

SAHRA Rating: 3C

The line has been moved 150m uphill from the site

Mitigation: No mitigation is currently required.

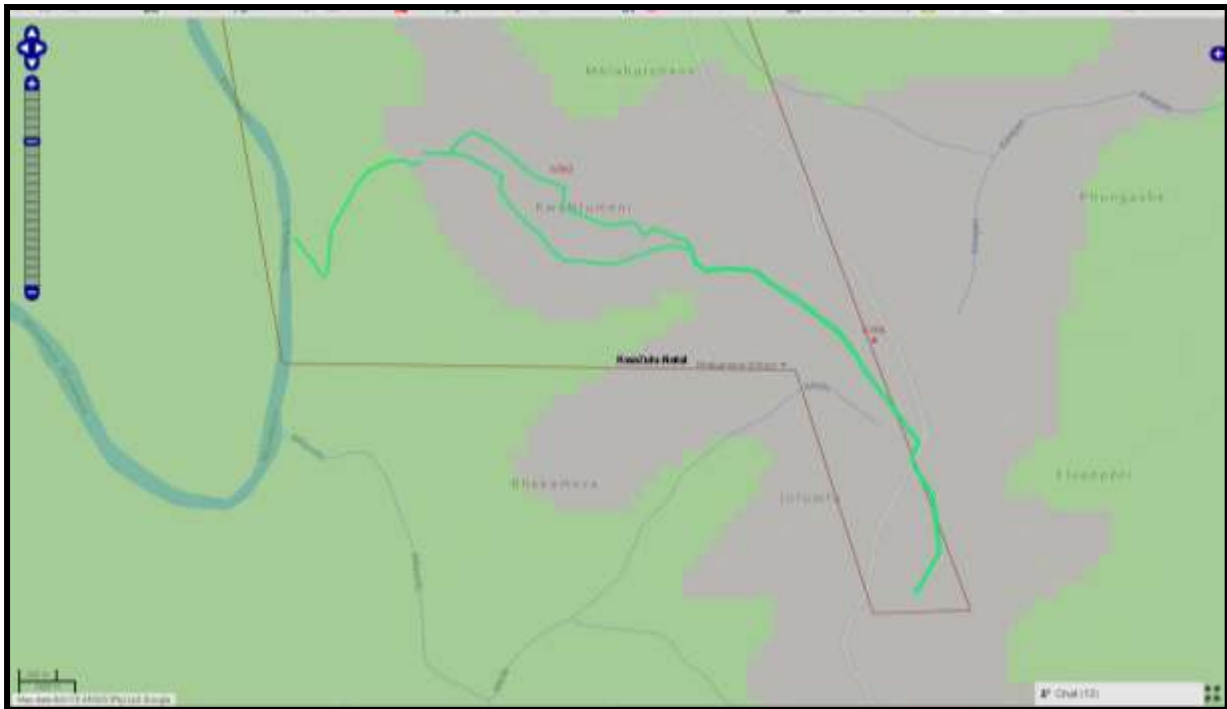
FIG. 18: PALAEOSENSITIVITY MAP OF THE LINE

Most of the line is in a non-palaeontological sensitive area. The last 800m occurs in the green area of the sensitivity map (Fig. 18). Along this latter section it follows the crest of the hill, and then down a steep hill into the flood plains. I would suggest that this part of the line be exempt from a PIA due to its short distance and that the pipeline will occur a maximum of 1.5m below the surface and thus only affect already disturbed and weathered deposits.
