HERITAGE IMPACT ASSESSMENT FOR THE PROPOSED UPGRADE AND REHABILITATION OF THE KOGMANSKLOOF PASS, MONTAGU MAGISTERIAL DISTRICT, WESTERN CAPE

(Assessment conducted under Section 38 (8) of the
National Heritage Resources Act (No. 25 of 1999) as part of an EIA)

Jayson Orton

Archaeology Contracts Office

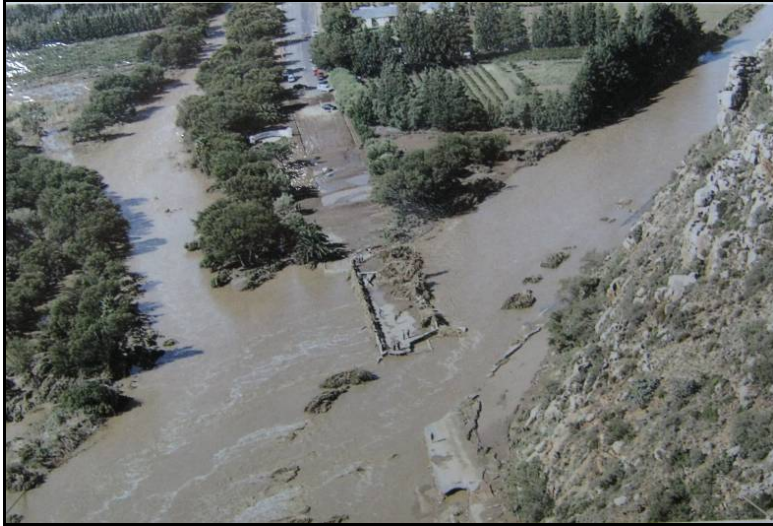
Figure 4: Aerial photo showing the eastern end of the Kogmanskloof Pass during the March 1981 flood event (Source: Montagu Museum).

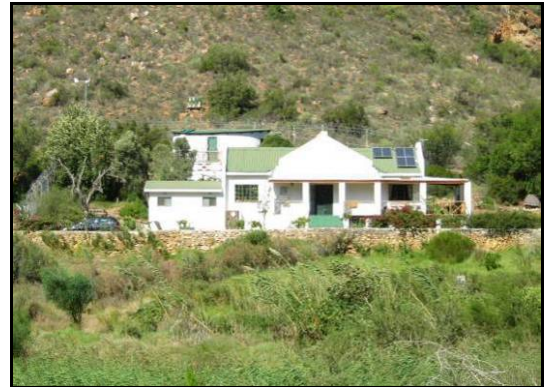
Figure 7: The recently renovated toll house in Kogmanskloof Pass.

Just south of the rock tunnel is a house that has undergone recent renovation (Figure 7). The house is labelled “Die Ou Tol” on the 1:50 000 topographic map (Figure 1) and this suggests that the building served as a toll house for Thomas Bain’s original road that passes immediately in front of its main entrance. Indeed, its modern name is “Die Tolhuis Guest Farm”. Given that the house is not part of the proposed project and will not be impacted in any way, no detailed research on it was conducted. Note that further discussion relating to this house is, however, contained under Section 6.2.3 below.

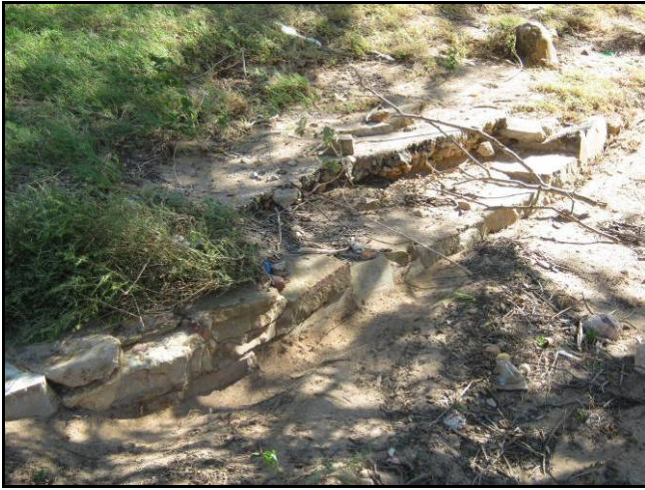
Figure 8: View of the edging of the old pass just east of the rock tunnel.

Archaeological resources relating to the historic pass were found in one rest area just east of the rock tunnel. They comprise of remaining drystone walling capped by early tar. While this resource could be damaged during remedial work, it is felt that with appropriate input from an archaeologist and landscape architect this fabric can be revealed and incorporated in a new design for this rest area. Again, this is discussed below. Archaeological resources in the form of historic stone walling may be preserved below the surface alongside the Boy Retief Bridge. Should destruction of any historical fabric be required then a permit may be required from HWC.

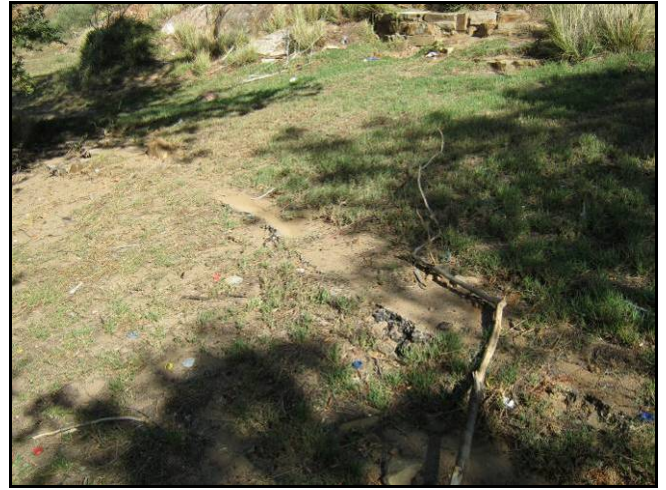
Figure 9: View of the old pass edging just east of the rock tunnel.

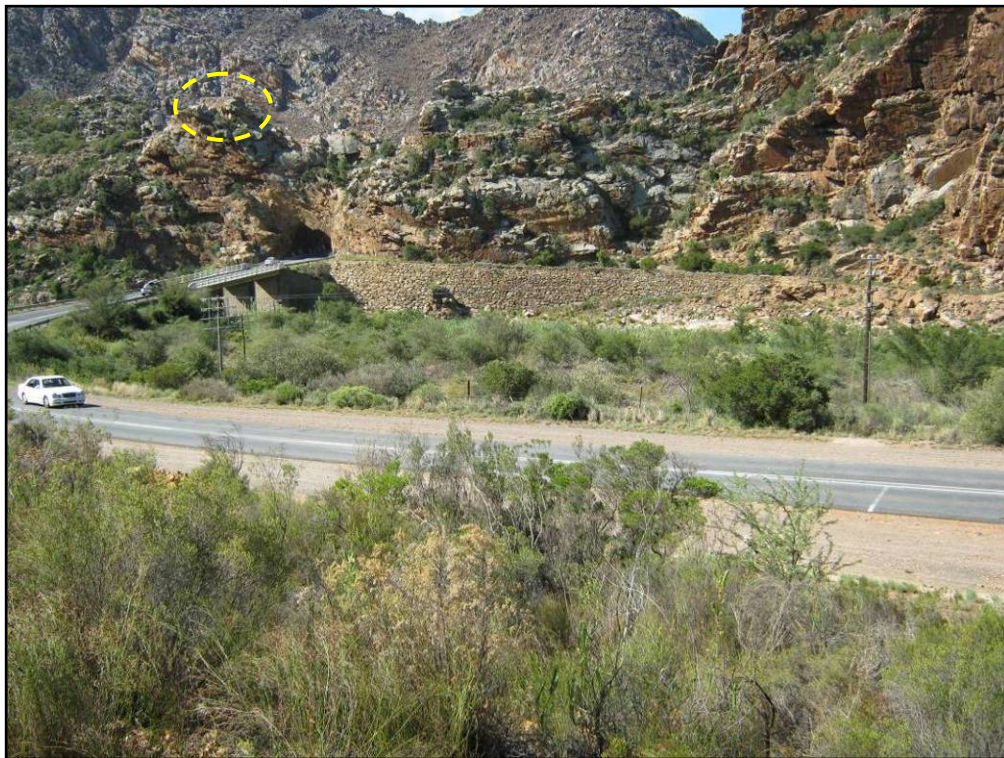
Figure 11: View eastwards towards the rock tunnel with the fort perched on the rocks above (yellow circle).

The most well-known is the old Anglo-Boer War fortification located above the rock tunnel midway along the pass, atop a rocky ridge known as Kalkoenkrans. The fort was built by Lieutenant-Colonel Sidney of the Royal Field Artillery and was garrisoned by the Gordon Highlanders (Coyne 2010). It is constructed from local stone with the result that it blends well with its surroundings (Figure 11). Tomlinson (1997) does not consider the structure to have been a proper blockhouse, since it bears no roof. However, one may once have been present. The degree of restoration that has taken place over the years is unknown and thus little can be said of its construction. Tomlinson (1997) assumes, however, that a screen wall must have protected the entrance, either just inside or just outside the current opening. It will not be directly affected by the proposed upgrade, although the opportunity to improve public access to this site will be afforded. Figures 11 to 13 illustrate this structure further.

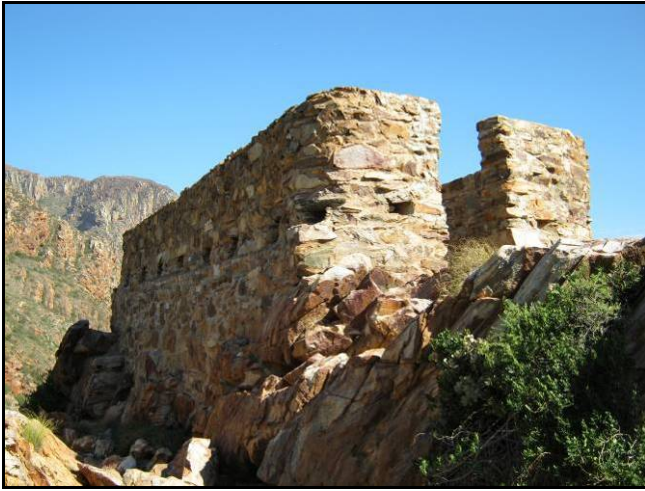
Figure 12: The northern aspect of the Boer War fort. The gun ports are clearly visible.

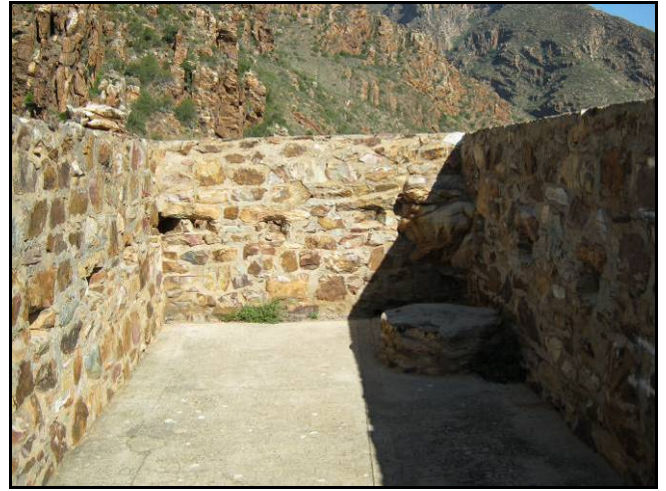
Figure 13: The interior of the fort. The circular structure is likely the base of a water tank.

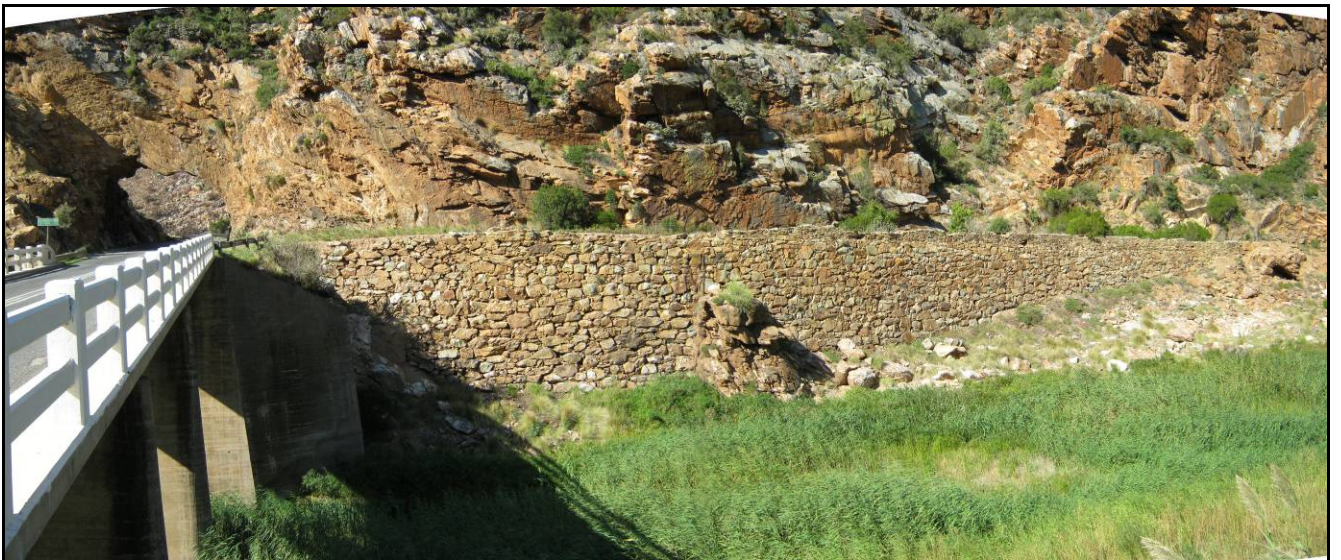
Figure 20: View of the old stone retaining walls built by Bain at the point where his pass turned eastwards through the rock tunnel, which is visible on the far left above the Billy Loftus Bridge.

- Sensitive treatment of the interface between the proposed new Boy Retief Bridge and any historical fabric that remains preserved beneath the vegetation cover may be required if it is found that Bain's dry stone wall extends towards the road beneath the current gravel area. Also, the landscaping should seek to reduce the degree to which the raised bridge will dominate the surroundings.

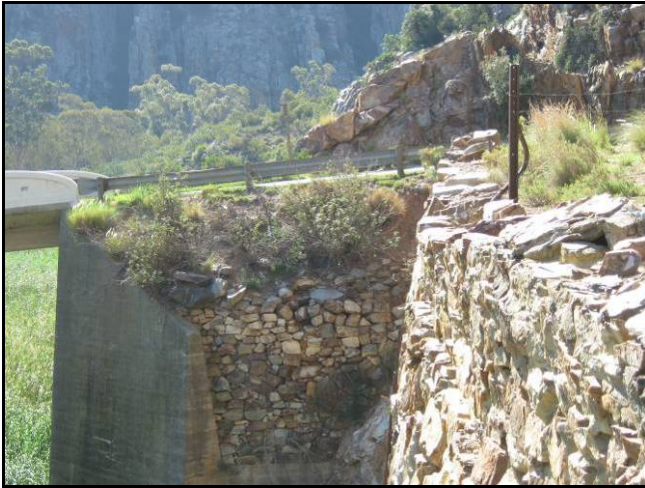
Figure 21: View of Bain's retaining wall (right) where the new bridge meets it and carries the road into the tunnel. Bain's wall is broken down to level with the old road surface.

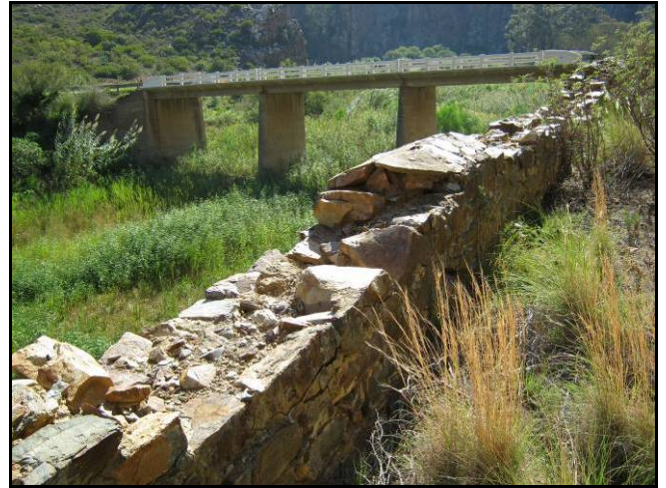
Figure 22: Slightly further from the new bridge Bain's walls are better preserved but still falling apart.

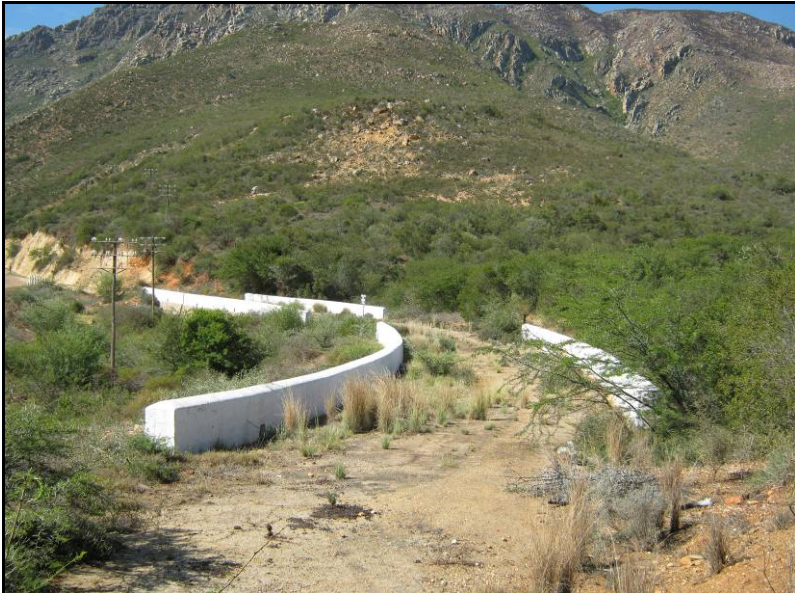
The original pass made use of two small neighbouring bridge structures together termed “Hodges Bridge” near the Ashton end of the pass (Figures 26 & 27). It seems likely that the upper parts were plastered and whitewashed more recently given that the rest of Bain’s walls were exposed stone.

Figure 26: View of Hodge’s Bridge looking towards the east. The two individual structures are visible.

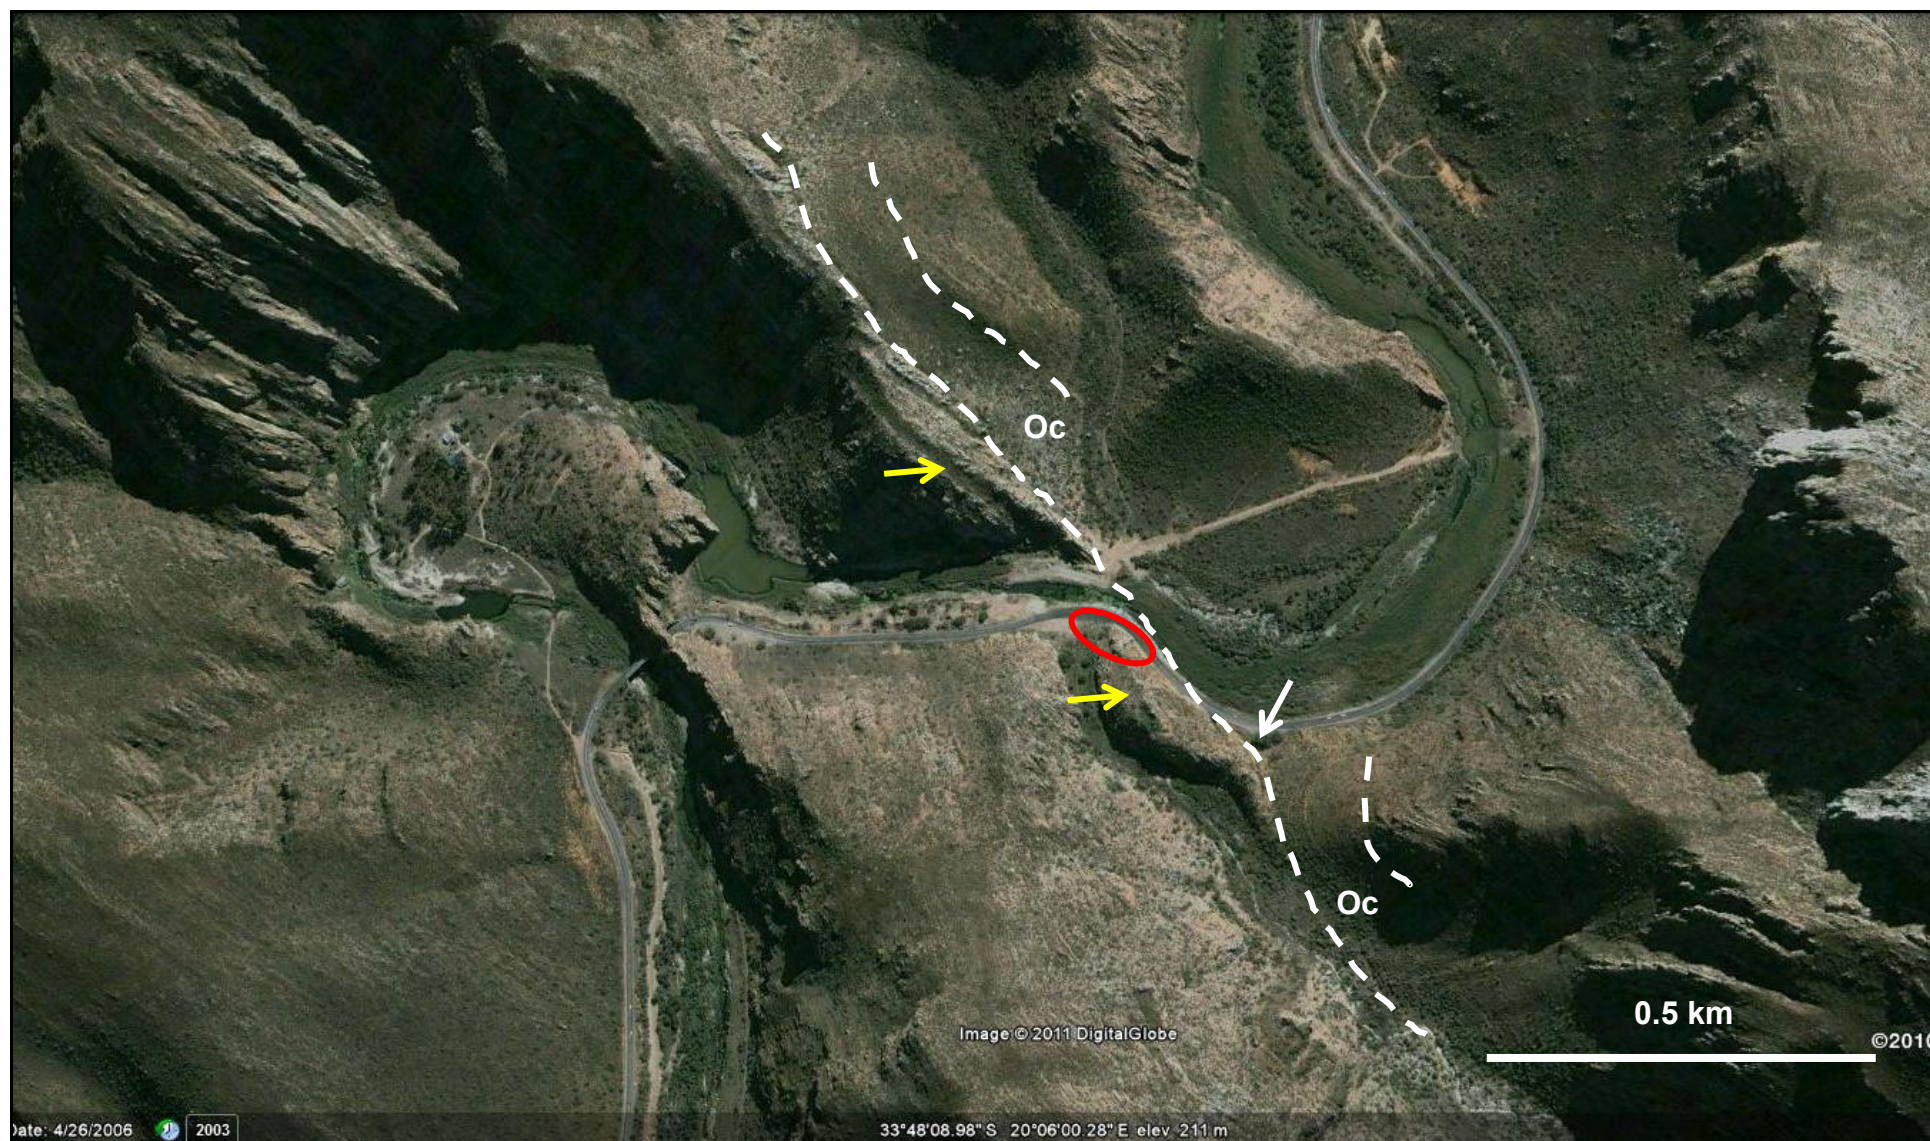
Figure 4. Satellite image of the central portion of Cogmanskloof showing inferred outcrop of the Cedarberg Formation (Oc, between white dashed lines), a laterally-persistent recessive weathering unit within the uppermost Peninsula Formation (yellow arrows), the likely position of an exposure of dark Cedarberg Formation mudrocks in the rest area at km 24.3 (white arrow) and the rocky section earmarked for blasting (red ellipse).

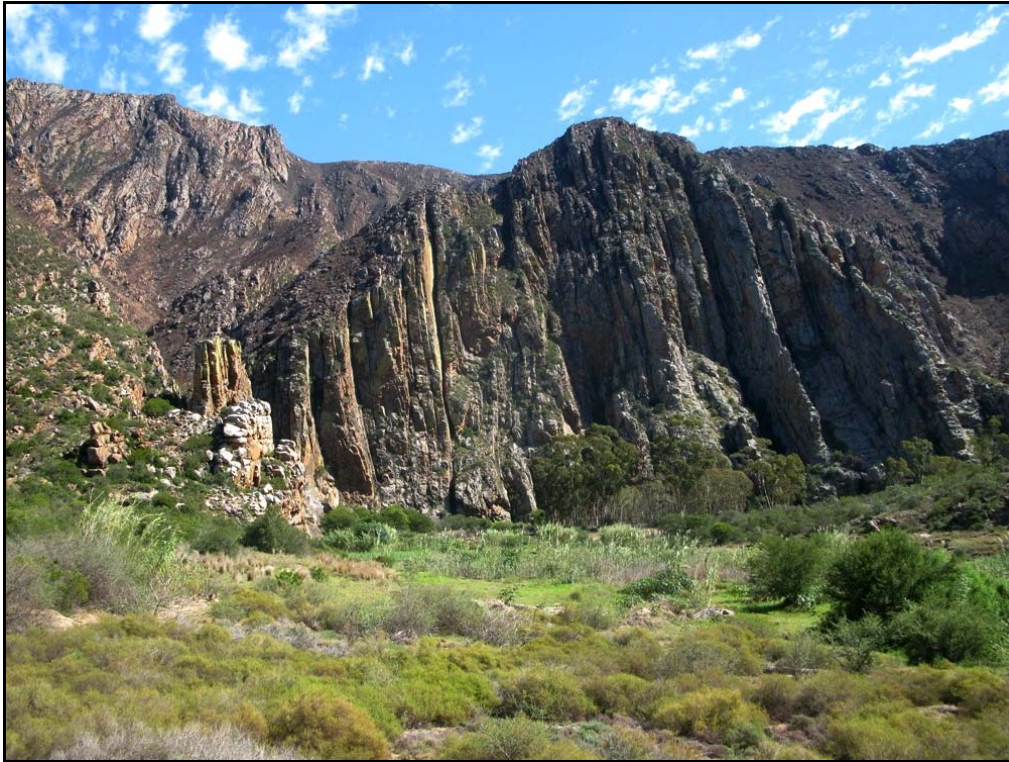
Fig. 6. View of the Kalkoennes area, Cogmanskloof, looking to the NW showing steeply dipping quartzites of the Peninsula Formation. Note elevated pediment surface truncating steeply-dipping TMG quartzites in background.

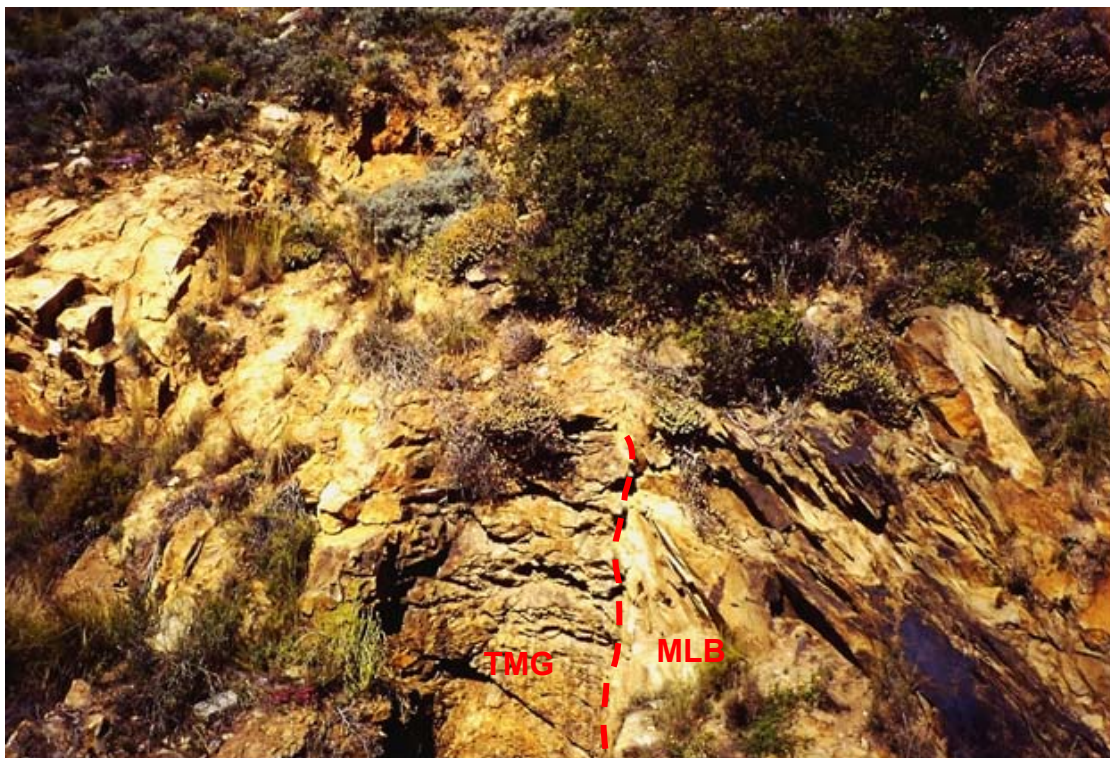
Fig. 7. Subvertical, unconformable contact between the basal breccio-conglomerates of the Table Mountain Group (TMG) and the highly cleaved phyllites of the Malmesbury Group (MLB), indicated by the red dashed line. This exposure is seen on the SE side of the tar road close to the southern entrance to Cogmanskloof.

Although the exposure of the TMG / Malmesbury contact in Cogmanskloof is an important geosite that has been visited by numerous geological groups in the past, it should be noted that the stratigraphic interpretation of the lowermost TMG succession here is equivocal and has not yet been described in detail. The basal breccio-conglomerates are overlain by several meters of thin- to medium-bedded quartzites of probable fluvial origin. There follows a 3 to 4m thick, thin-bedded, heterolithic interval comprising pale, cleaved and horizontally laminated quartzites interbedded with much darker laminated mudrocks containing striking horizons of pseudonodules (Figs. 8 & 9. N.B. The irregular rounded “blobs” seen here might alternatively represent the mineral ottrelite, a chlorite-

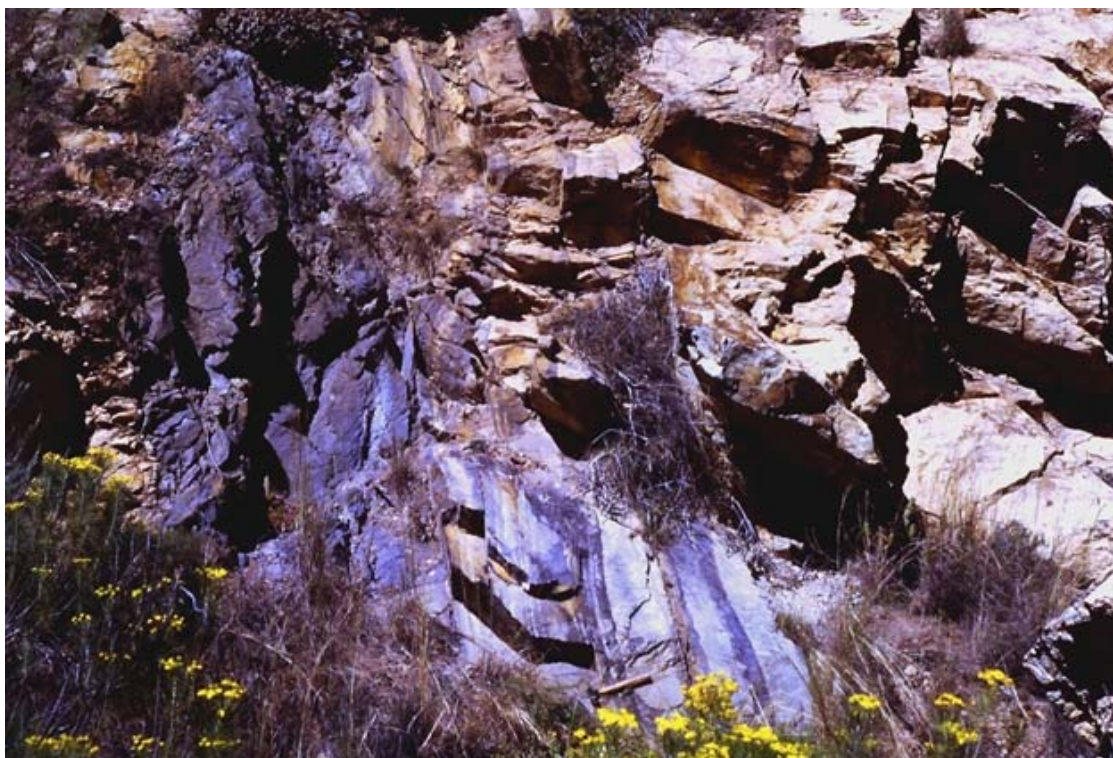
Fig. 8. Unusual rock succession within the lowermost Table Mountain Group showing thinly interbedded sandstones and mudrocks beneath hammer (c. 27cm long) overlain by lenticle of dark cleaved mudrocks. Southern entrance of Cogmanskloof, viewed towards the SE.

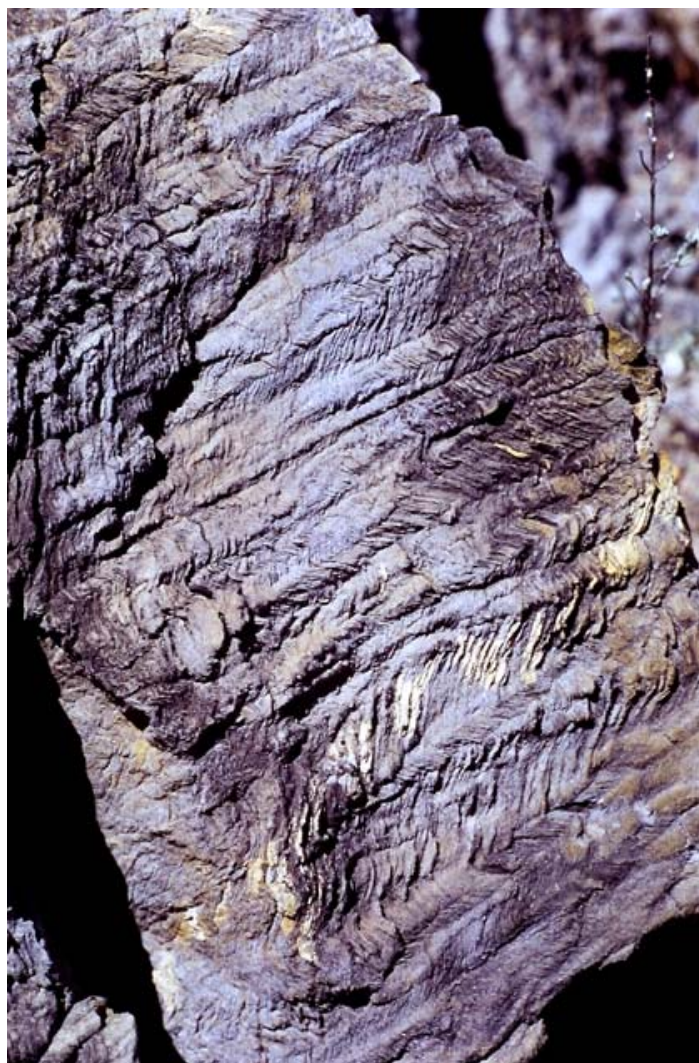
Fig. 10. Well-developed crenulation cleavage within lenticle of dark mudrocks seen in Fig. 8, implying two successive phases of intense deformation.

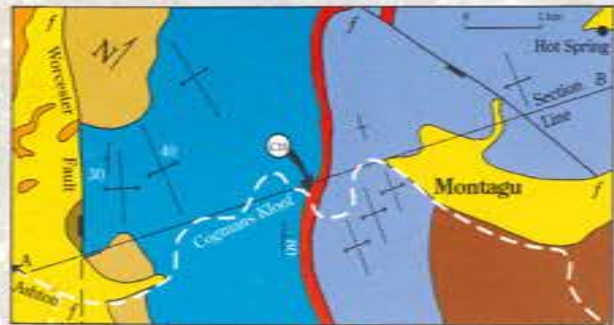
- Soil cover
- Enon Formation
- Witteberg Group
- Bokkeveld Group
- Nardouw Subgroup
- Pakhuis & Cedarberg Formations
- Peninsula Formation
- Malmesbury Group
- 40° strike and dip
- vertical beds
- anticline
- normal fault (tick on down-side)
- road

At the southern (Ashton) end of Cogmans Kloof, yellowish-brown phyllites (metamorphosed shales) of the Malmesbury Group underlie the steeply tilted and folded younger sandstones of the Table Mountain Group (TMG) that dominate the scenery of the kloof. In contrast to the horizontal contact between the Malmesbury and Table Mountain Groups at Cape Town, this plane (called an angular unconformity) at Cogmans Kloof is vertical, because it was folded along with the other strata.
