## Proposed construction of a low perimeter wall around the La Motte Cemetery, Franschhoek

Tim Hart

7 September 2015

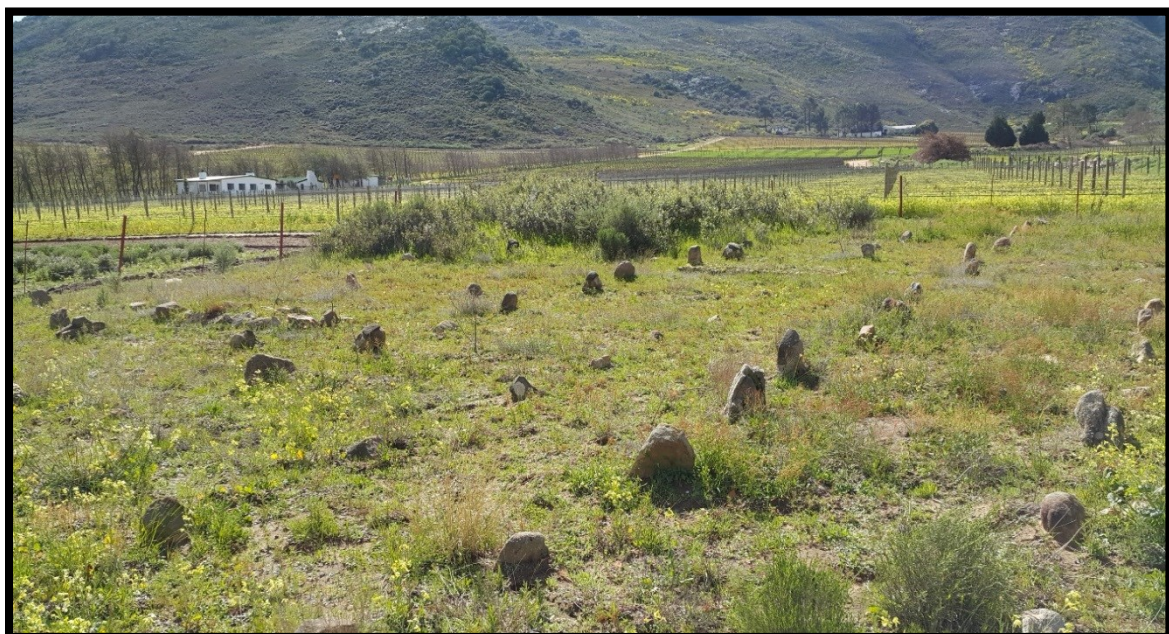
*Figure 2*

The site is recognisable as a 'graveyard' because of the cypress trees growing around it and because of the headstones. But the organisation of the headstones feels very artificial compared to other (historical, and more modern) informal and farm graveyards we have come across over the years. The alignment of the head and footstones is very regimental and uniform, and the 'graves' are sited very closely next to each other. (Fig. 2-3) The plastered soil mounds have disappeared and not all headstones are legible any more. Based on our experience, we would concur with the historical research that most likely there will be no human remains present under these 'graves'. An exception might be the two graves which are built in a different fashion: one has one line of stones put in the earth in a rough rectangular shape (Fig. 4), the other has a very formal stone and cement outline (Fig. 5). But these graves are not near the boundary of the site where the enclosing wall is proposed.

Currently the site is enclosed with barbed wire and galvanised steel rods. This is not in keeping with the historical buildings located on the same and adjacent erven.

Based on the history of the site, our visual assessment and our experience over the years, we deem the chance of uncovering human remains during the limited excavation work need to put a low boundary wall in place around the 'grave yard' very slight. However, as one can never completely discount the possibility of encountering human remains anywhere on the landscape, we suggest that monitoring by an archaeologist is facilitated during excavation work, or at the least, that the crew get a very thorough briefing that all work is to be halted immediately as soon as there is even the slightest suspicion that human bone is present. In the latter case, an archaeologist needs to be notified immediately and the find will have to be assessed.

It is our finding that the construction of a low perimeter wall is an acceptable solution to solving issues of erosion and giving this collection of important historical objects (and possibly some graves) some status as is fitting of its context. It is recommended that SAHRA approve the proposed actions.
