HERITAGE WALKDOWN REPORT

for the approved Msenge Emoyeni Wind Energy Facility and associated
infrastructure in the Eastern Cape

CTS HERITAGE

June 2022

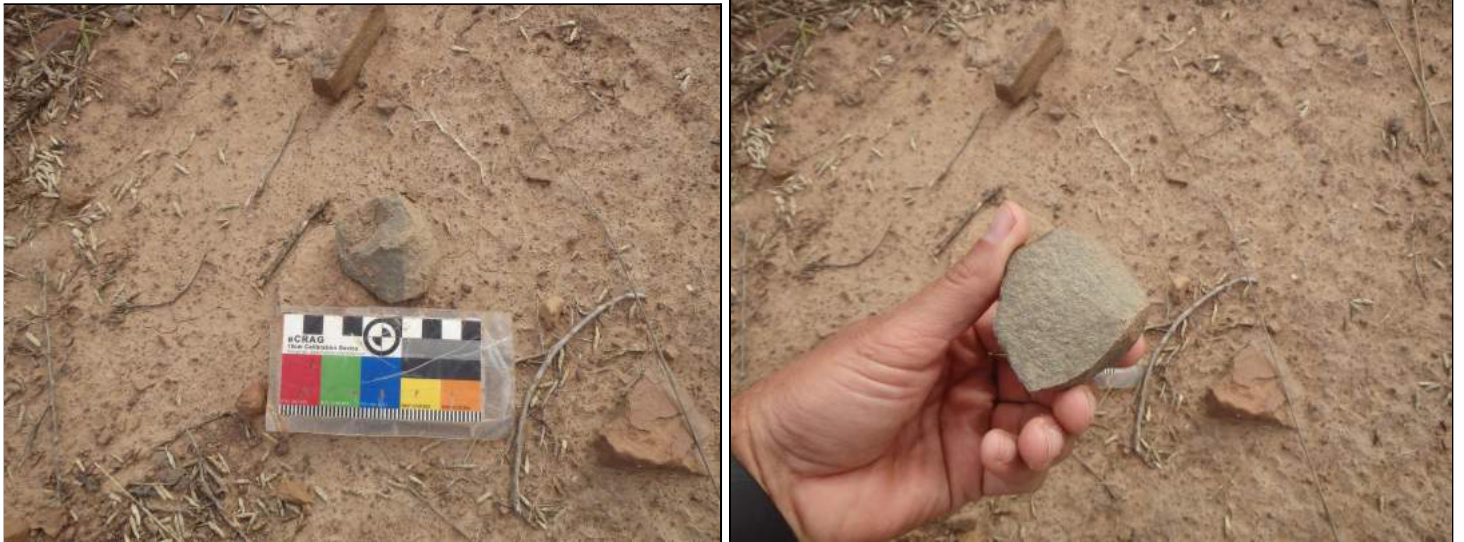
Figure 7.2: Observation 016

Around 20 observations were made primarily of weathered Middle Stone Age flakes and radial cores. The raw materials were locally sourced quartzites and siltstones which displayed very little evidence of large transport distances as access to the bedrock and river cobbles is readily available. Later Stone Age evidence was also present and higher grade hornfels cores and flakes were found that were most likely brought into the area from a number of possible karoo sources. All of the archaeological resources identified were low density, single incidence *ex situ* artefacts that have been determined to be Not Conservation-Worthy. One structure, a stone walled ruin (Observation 012), was identified outside of the area proposed for the Msenge Emoyeni WEF development area. This site has been Graded IIIB and no impact to this site is anticipated.

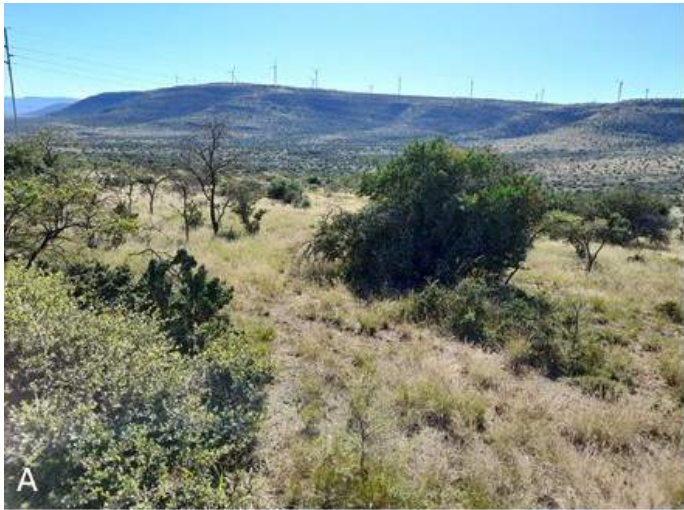
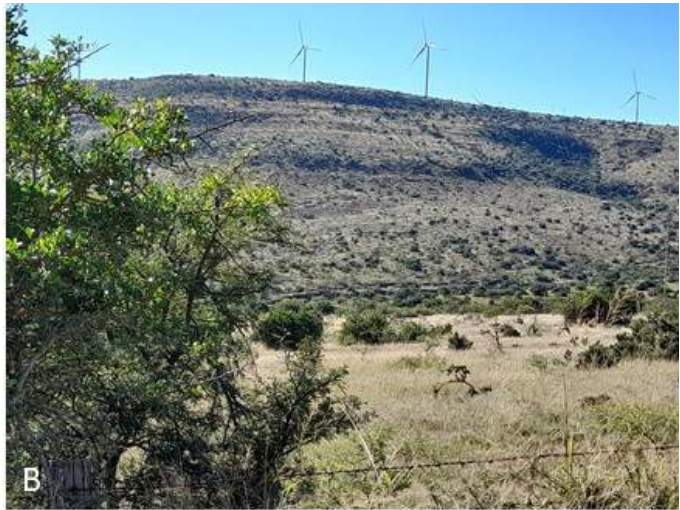
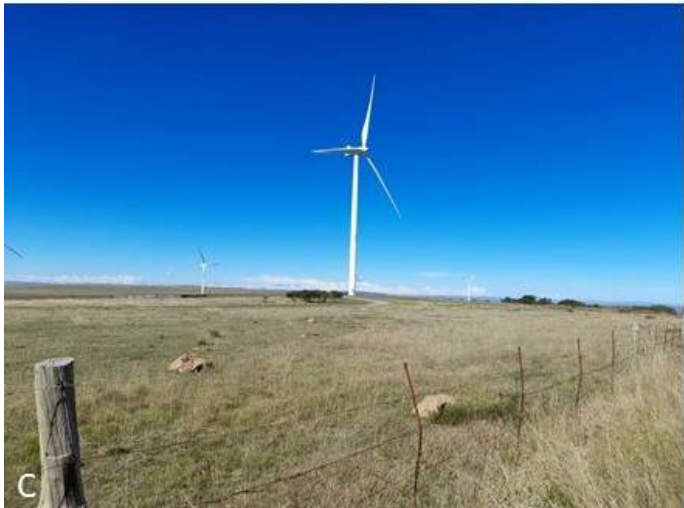
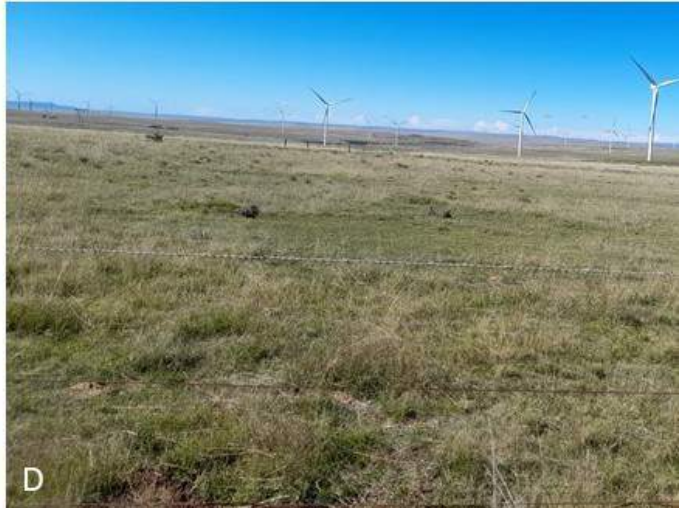
Figure 7

25° 54' 24.25"E		
MP-3 32° 56' 28.70"S 26° 07' 37.03"E	Beneath the powerlines from Poseidon Substation. There will be minor deviations from the existing powerline for the new powerline. Deep soils, no rocky outcrops and no fossils visible on the surface.	8A-C
MP-4 32° 46' 36.26"S 26° 01' 36.75"E	Road to Middleton from the Patryshoek Road (MR00635), border of Farm 260 with a view of the ridges to the south, en route to OHPL crossing. Open veld, short vegetation. No rocky outcrops and no fossils visible on the surface.	8D, 11A
MP-5 32° 48' 40.65"S 26° 00' 30.09"E	Middleton River cutting that exposes the sandstones and thin bands of mudstones of the Middleton Formation. No fossils and no signs of biotic activity in the rocks.	9B-D,
MP-6 32° 49' 12.82"S 25° 59' 55.90"E	Powerline crosses over the road here towards Poseidon Substation. Private property of Amakulu WEF on the east side. Borrow pit on the west side shows the coarse sandstone and calcrete capping of the exposed strata (probably recent). No laminated strata visible and no fossils.	10 A-D

MP-0 32° 55" 25.22"S 26° 05' 35.52"E	R350 from Bedford to Grahamstown, just north of the wide bend in the road, on Farm 225. Ridge has short vegetation, no rocky outcrops or surface fossils visible. This section overlaps with the Iziduli WEF.	11 A-D

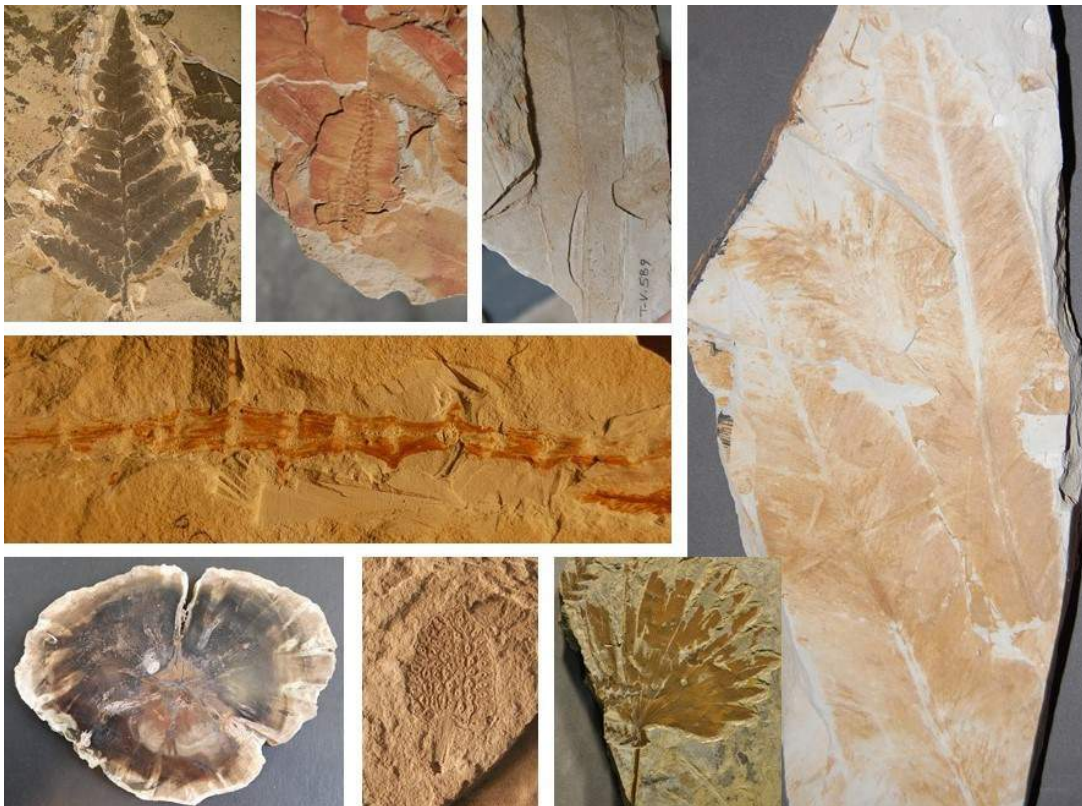
Figure 2: Photographs of fossil plants of the Beaufort Group.
