WALKDOWN REPORT FOR THE MULILO TOTAL HYDRA TRANSMISSION LINE OUTSIDE DE AAR, NORTHERN CAPE

Draft for Comment: 29 September 2021

Revised Draft for Comment: 27 October 2021

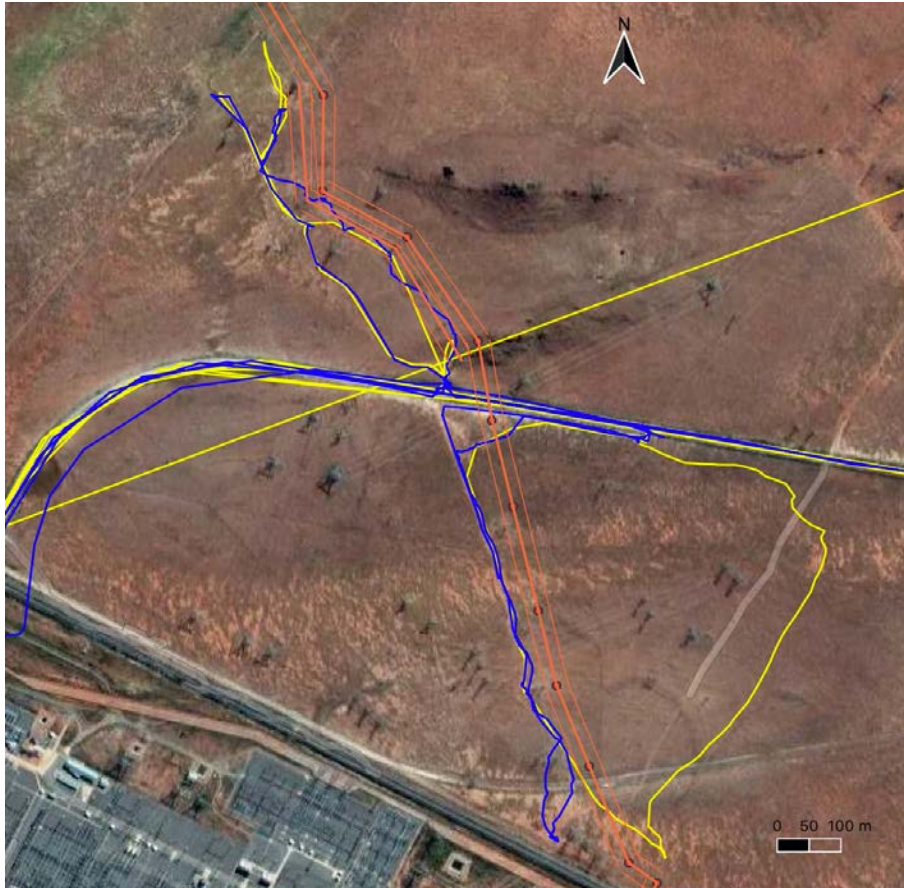
In 2020 Gribble and Euston-Brown (2020) surveyed the area of the transmission line within the boundary of the Hydra substation and over the road on the farms Wag 'n Bietjie 3/5 and 1/137 as part of the assessment of the grid connection line for the De Aar 2 South Wind Energy Facility (Figure 4). No sites were reported in this area of that survey.

Figure 4: 2020 Gribble & Euston-Brown survey tracks (yellow and dark blue) in the vicinity of the Hydra substation (bottom left) for the De Aar 2 South WEF grid connection. The current transmission route is shown in orange (Source: Google Earth)

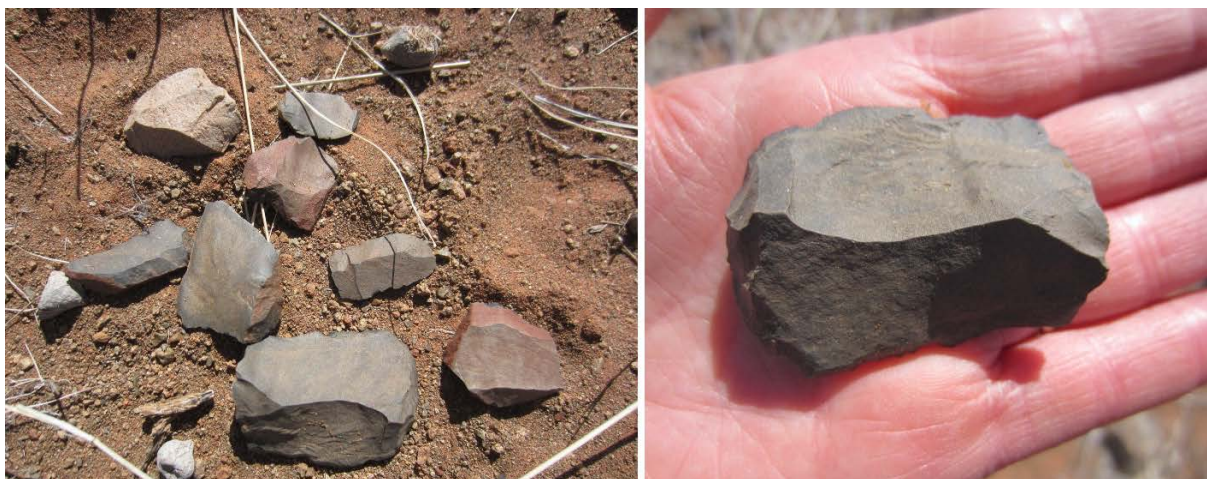
A scatter of fresh, unpatinated flaked stone was recorded (G021) in the lee of a dolerite dyke near the Hydra substation terminus of the transmission line. Made mainly on hornfels the scatter includes at least two scrapers (one quite large) and a silcrete flake and appears to be Later Stone Age (LSA), possibly of the Lockshoek industry. This site was graded as III C and although not directly on the transmission line route must be avoided in during its construction (Figure 6 and Plate 1).

Plate 1: Examples of the possible Lockshoek lithics recorded at G021, with one of the scrapers shown on the right (Photos: G Euston-Brown).

It is recommended therefore that the stone scatter G021 and the possible grave cairn J043 are avoided and treated as no-go areas during the construction and operation of the transmission line. It is recommended that a no-go buffer of 20 m is established around the co-ordinates of G021, and that J043 is simply cordoned off and avoided during construction activities.

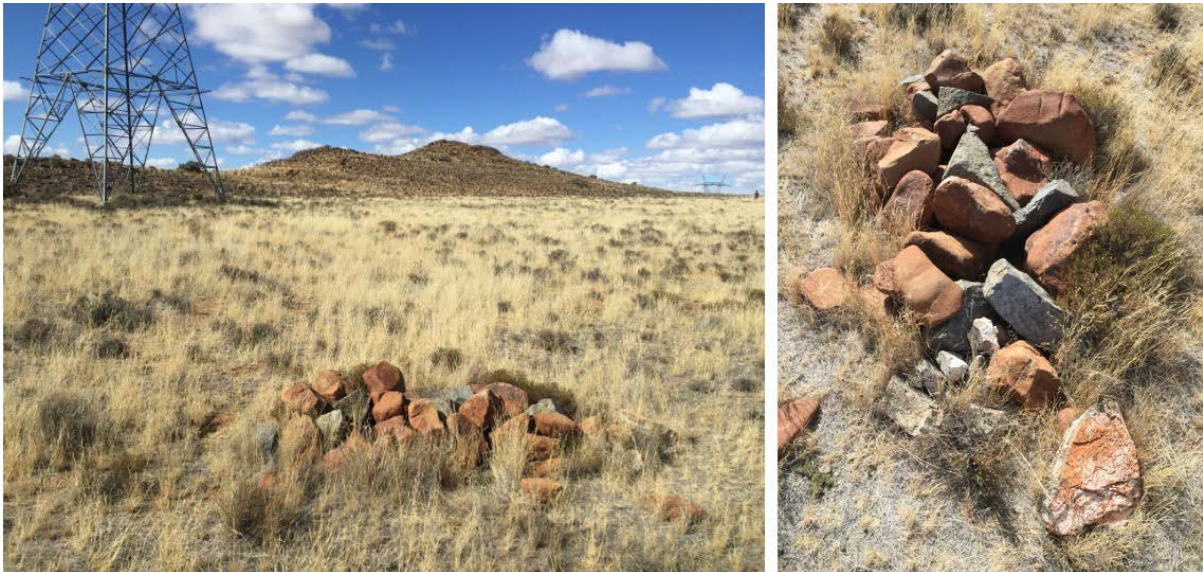
Lastly, also near the Hydra end of the transmission line, a pile of dolerite boulders mixed with chunks of grey granite and smaller pieces of grey slate was recorded (J043). Approximately 1.5 x 0.7 m in size, this pile could represent a grave cairn, although from the location and setting this appears unlikely. However, if this is a grave, its significance will be

high and as a precaution it has been graded IIIC and it is recommended that it is avoided during the construction and operation of the transmission line (Figure 6 and Plate 2).

Plate 2: Boulder pile (J043) recorded near the Hydra substation end of the transmission line (Photos: J Gribble).

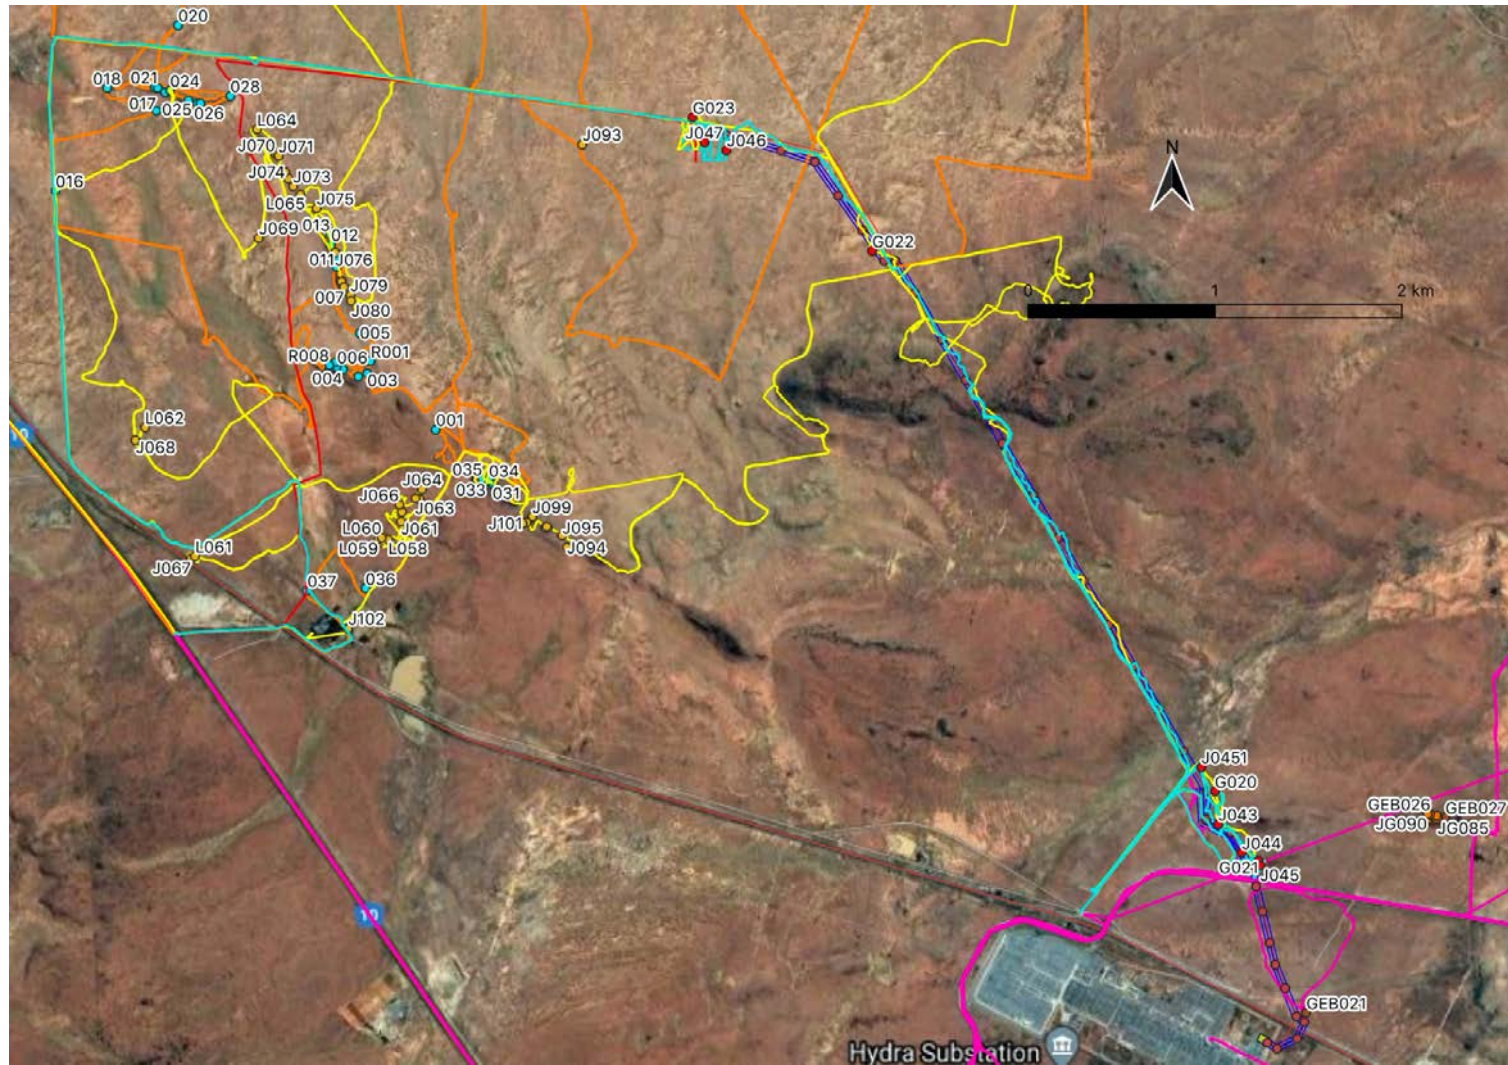
Figure 5: ACO survey track plots (2021 = pale blue; 2019 = pink; 2013 = yellow; 2011 = orange), overlaid on the project elements. All findspots recorded are shown as numbered items.(Source: Google Earth).

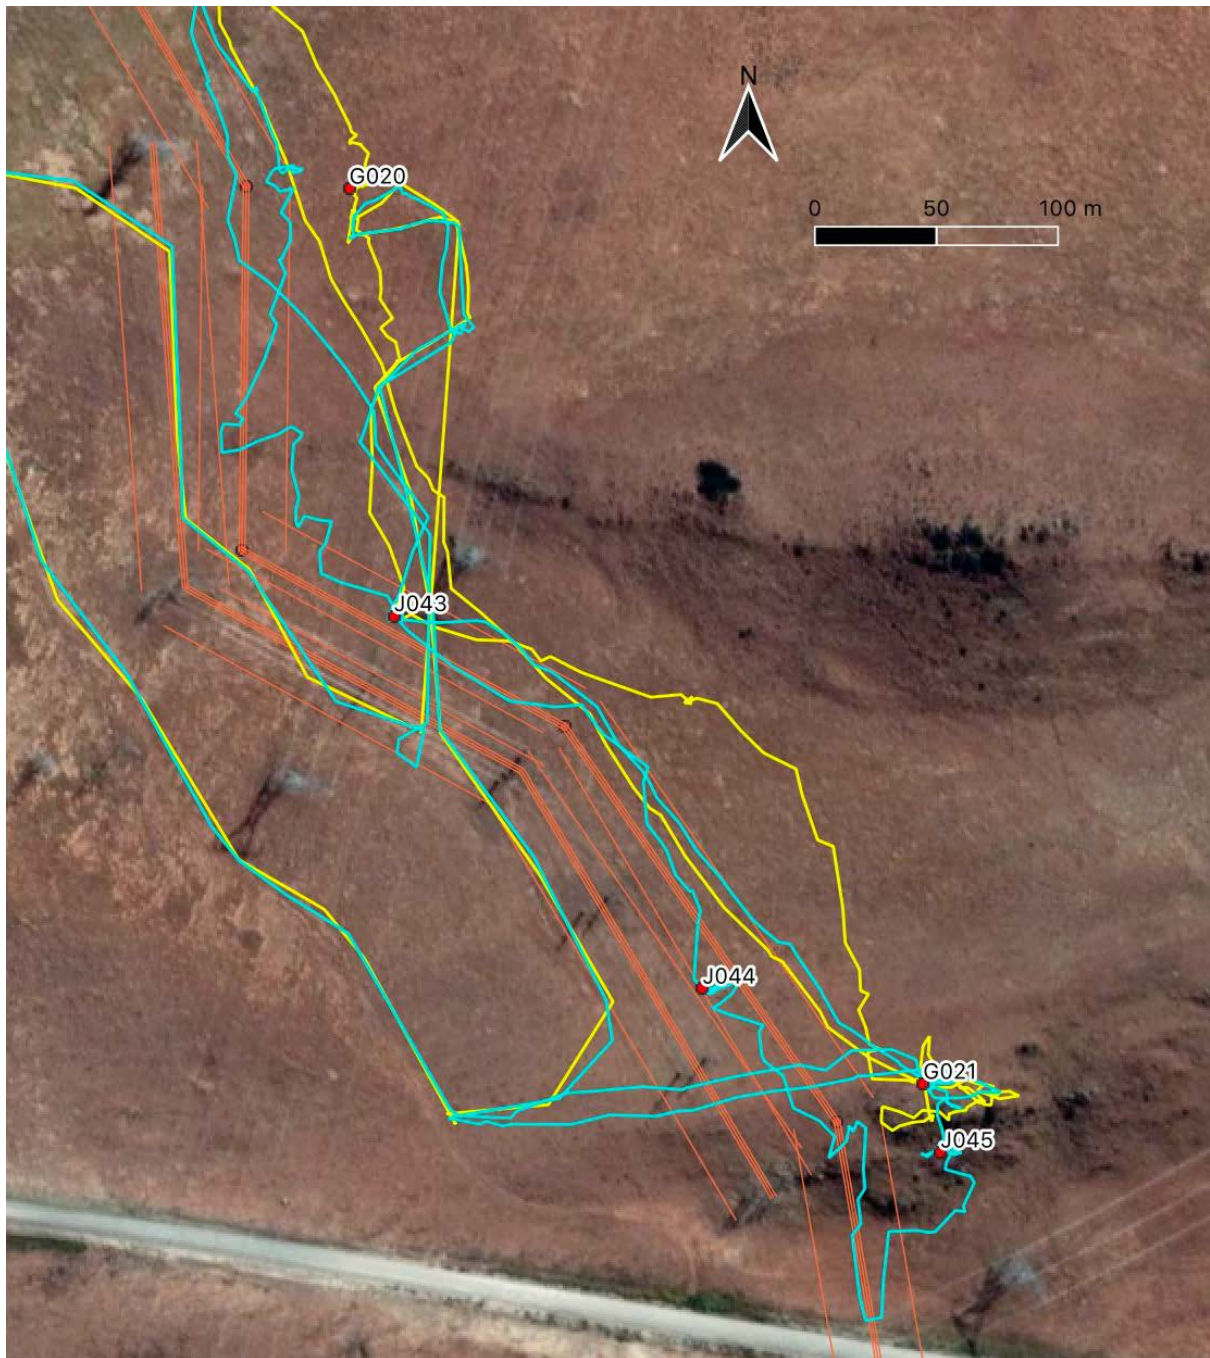
The bulk of this material (J044, J045, G020, G022 and G023) (Figure 6) consisted of heavily patinated Middle Stone Age (MSA) lithics which were assessed not to be conservation-worthy. Since these occurrences are considered not conservation-worthy, they need not be conserved should they be impacted by the construction of the transmission line, on-site substation or access road.

Figure 6: Sites recorded during the 2021 walkdown survey near the Hydra terminus of the transmission line (Google Earth).

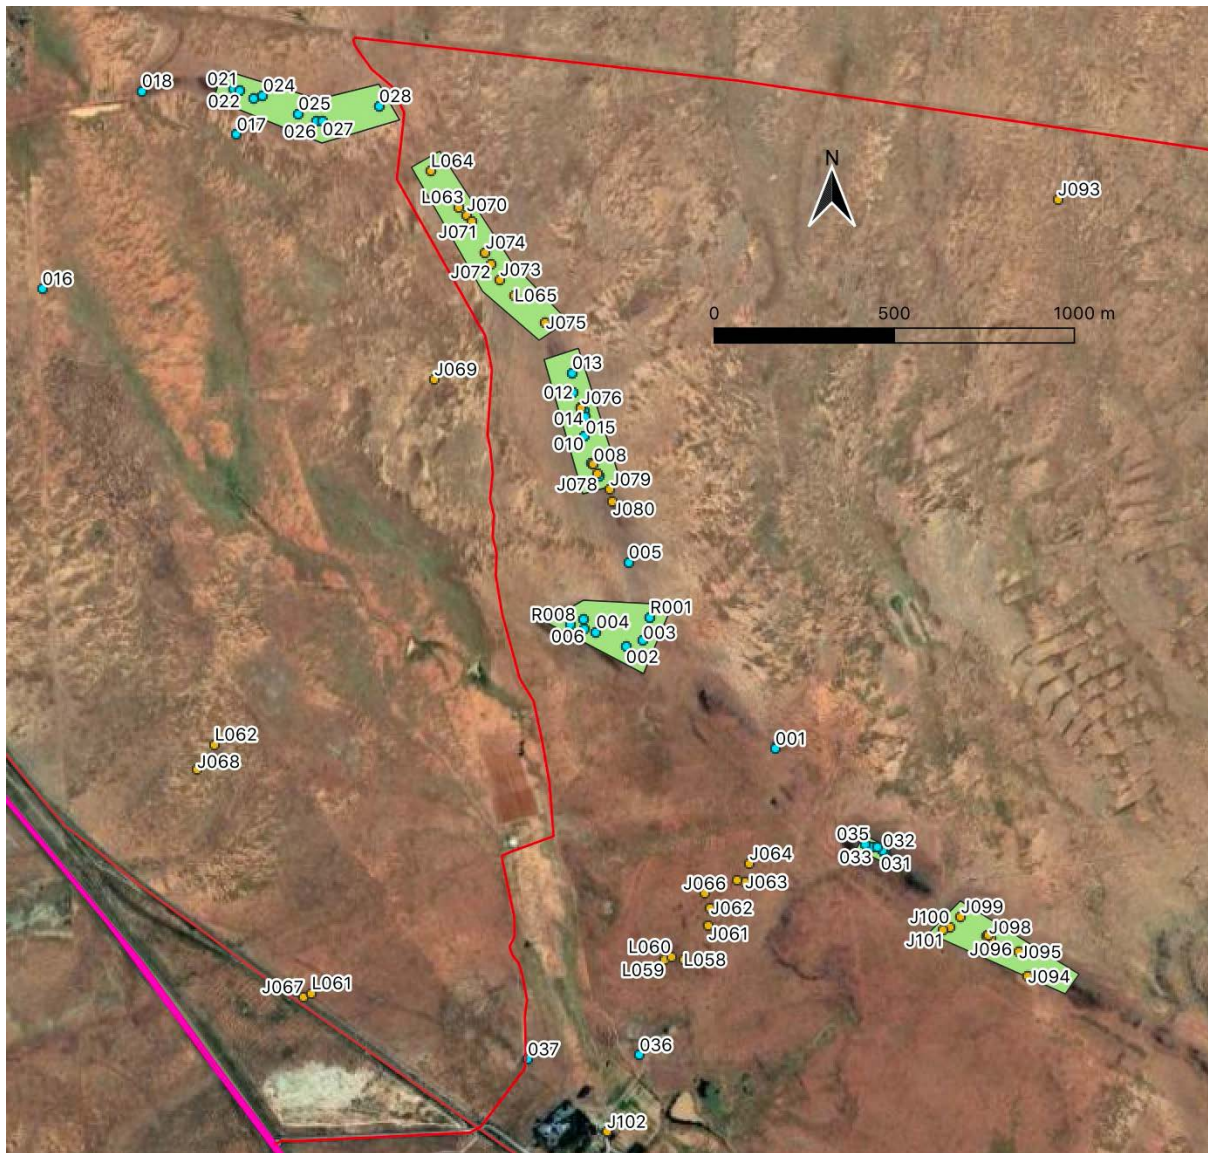
Figure 7: Heritage no-go areas (green polygons) demarcated by Mulilo around the archaeological sites on the dolerite ridges adjacent to the proposed access road (red line) (Source: Google Earth).

Mitigation recommended by both Orton (2011) and Webley and Orton (2013) included the avoidance of the dolerite ridge with all its archaeological features and, where avoidance of sites is not possible, archaeological mitigation in the form of excavation and collection of artefacts. This recommendation has been acted on by Mulilo and they have created heritage no-go areas around most of the sites on the dolerite ridge that are in any way proximate to the proposed access road (Figure 7). It is recommended that these no-go areas are implemented during the construction of the access road and remain in force in future during the operation of the transmission line.
