## HERITAGE SURVEY OF THE UPGRADE OF SERVICES FOR THE N11 SECTION 11 BETWEEN GROBLERSDAL AND MARBLE HALL

# FOR DELTA BUILT ENVIRONMENT CONSULTANTS (PTY) LTD

DATE: 15 SEPTEMBER 2022

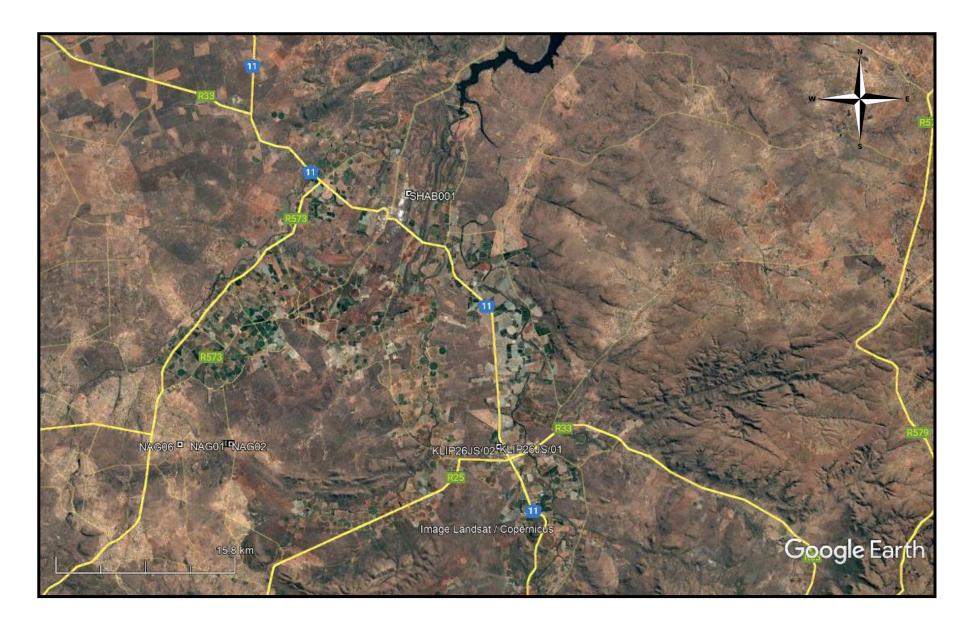
FIG. 5: LOCATION OF KNOWN HERITAGE SITES IN THE GENERAL AREA

The desktop study consisted of analysing various maps for evidence of prior habitation in the study area, as well as for previous archaeological surveys (fig. 5). No surveys have occurred near the study area, except for two at the southern culvert, Groblersdal. There have been no systematic heritage surveys near the proposed Borrow Pits. Kusel (2012) recorded several Middle Stone Age artefacts at the Groblersdal Airfield. Van Der Walt (2011) noted several historical buildings at southern Groblersdal

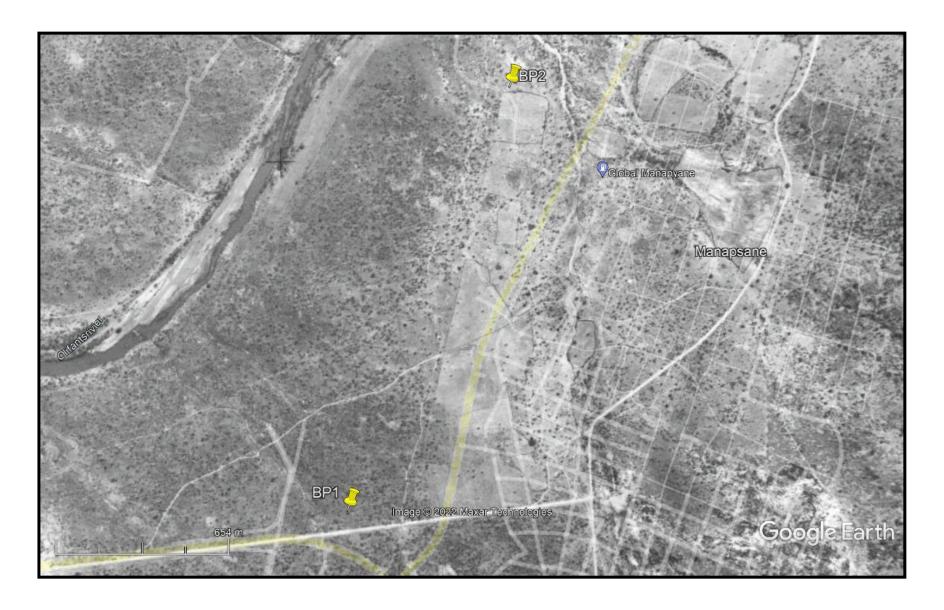
FIG. 6: LOCATION OF THE BORROW PITS IN 1951

The 1951 aerial photograph indicates that both Borrow Pits are n the edge of cultivated land (fig. 6). No houses or other structures are visible around the Borrow Pits.

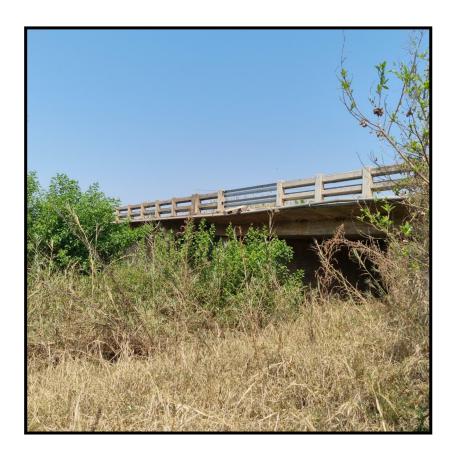
FIG. 8: MOSES RIVER BRIDGE

The bridge over the Moses River is undated and appears to be less than 60 years in age (fig. 8).

The built structures are less than 60 years in age and require no further mitigation.

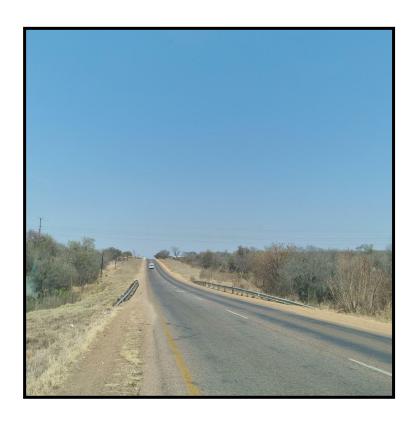
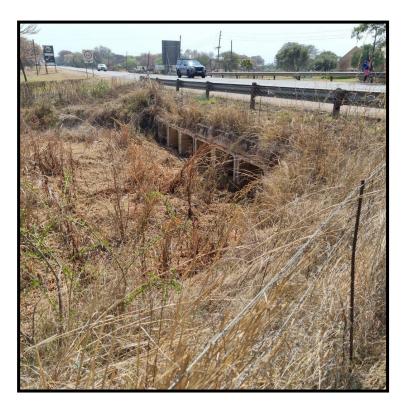
FIG. 9: CULVERTS ON THE N11

Similarly, the two culverts are undated, but less than 60 years in age (fig. 9).

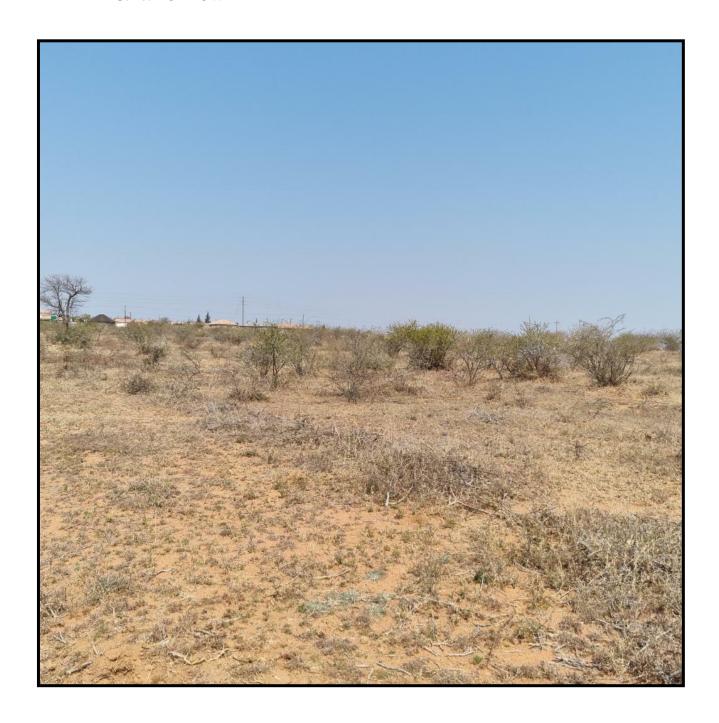
FIG. 10: BORROW PIT 1

**Borrow Pit 1** is located next to rubbish dumping area. The area consists of low scrub and thorn trees (fig. 10). No artefacts or built structures were noted within a hectare of the proposed Borrow Pit.

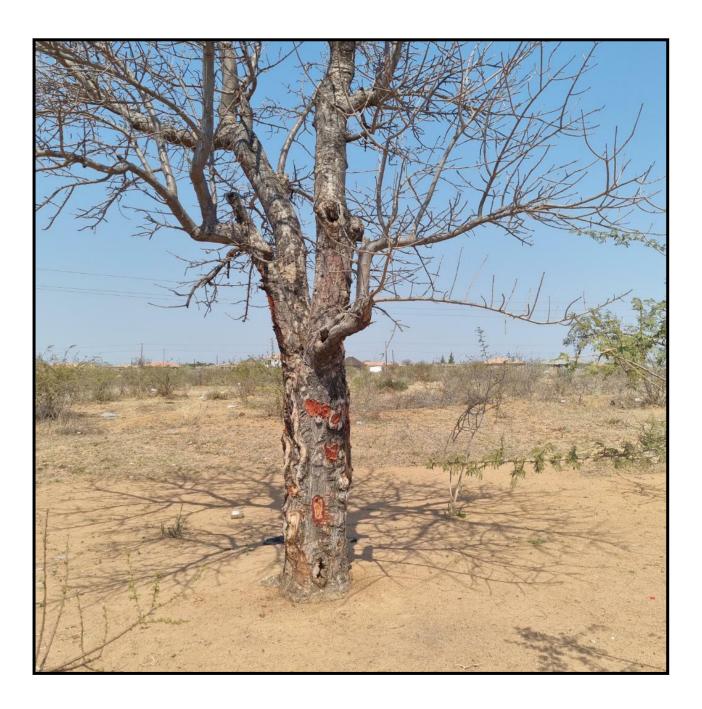
FIG. 11: MARULA TREE AT BORROW PIT 1

There is a Marula tree that is being used for traditional medicine purposes: parts of the bark are being systematically cut (fig. 11). The tree is not protected however it does carry cultural status. The tree is located at S24.985539, E29.389366. The tree is probably on the edge of the Borrow it footprint.

Significance: The tree is of low significance; however it is of medium cultural significance.

Mitigation: The tree should be kept out of the footprint of the borrow pit and be made accessible to the public.

The two borrow pits are in areas of disturbed land and require no further mitigation, apart from BP1. A Marula tree occurs on the edge of the Borrow Pit footprint. The bark from the tree has been used for traditional medicine and the tree is thus a cultural resource. The tree should be left outside of the footprint with community access to it.

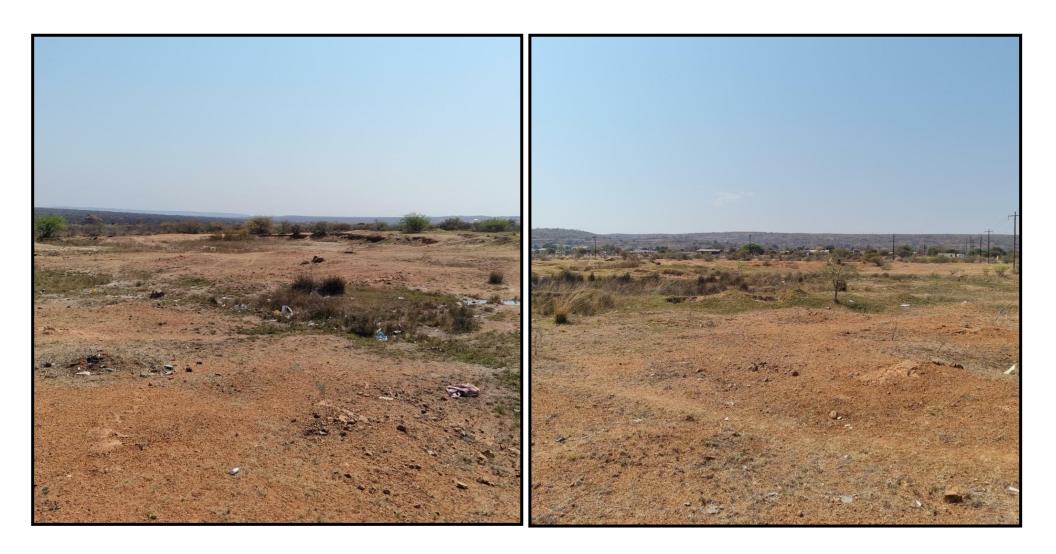
FIG. 12: BORROW PIT 2

**Borrow Pit 2** is located in an area that has already been "mined" for sand. There are many excavations of various sizes. The area is highly disturbed.

No artefacts or features were noted within the hectare footprint.
