- **Subsection 7.2: From the Ntlavukazi Interchange to the Msikaba River Bridge**

3.4.2.4 Section 8: From the Msikaba River Bridge up to and including the Mtentu River Bridge

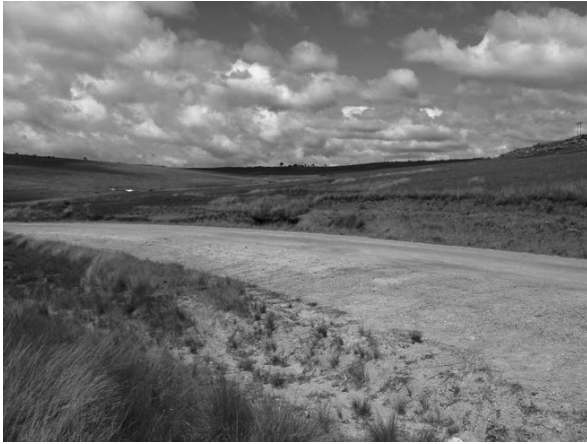
Photo: SAS DSC00205, October 2011. Viewed towards the south-west. Photographed at 31°19'58.9"S; 29°45'11.6"E.

Figure 151. Subsection 7.2: Spot check (labelled SC7.2.1 in the SAS report) on the site of the Ntlavukazi Interchange and on the existing gravel road, close to a road cutting (also see Figures 152 and 153). No evidence was observed of archaeological sites or artefacts.

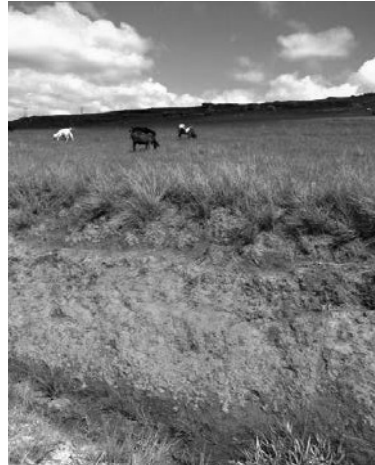
Photo: SAS DSC00202, October 2011. Viewed towards the south-west. Photographed at 31°19'58.5"S; 29°45'11.3"E.

Figure 152. Subsection 7.2: Spot check, labelled SC7.2.1, at the road cutting on the site of the Ntlavukazi Interchange, showing the shallow soil and the dense grassveld, which is used as grazing for cattle and goats (also see Figure 153).

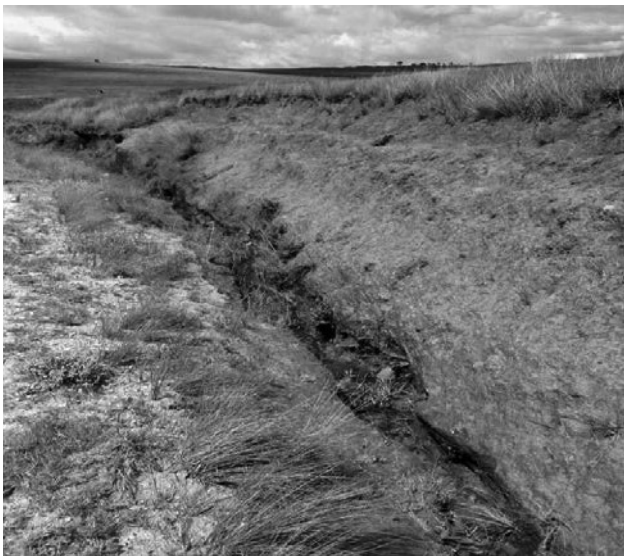
Photo: SAS DSC00211, October 2011. Viewed towards the south-west. Photographed at 31°19'59.2"S; 29°45'11.0"E.

Figure 153. Subsection 7.2: Spot check, labelled SC7.2.1, at the road cutting on the site of the Ntlavukazi Interchange, showing typical shallow soil with some water seepage on the Msikaba sandstone in a roadside gully.

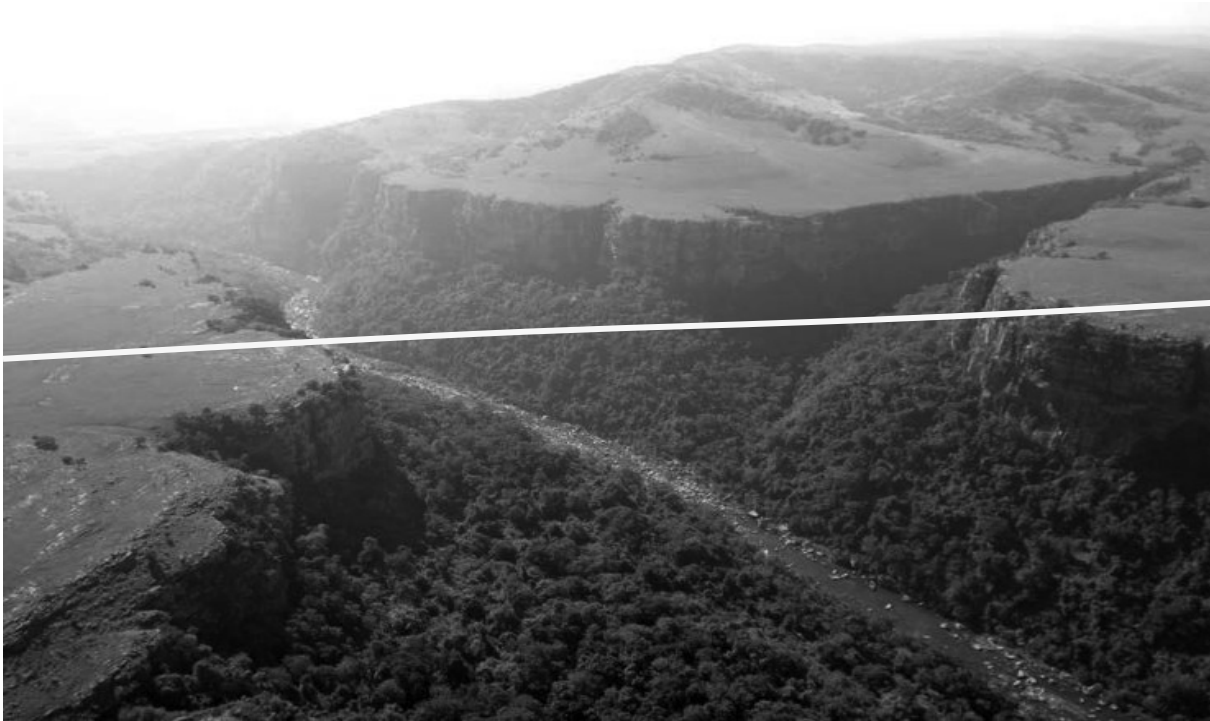
Photo: SANRAL Heli IMG_4406. Viewed towards the north-west.

Figure 154. Subsection 7.2: The site of the approved Msikaba River Bridge is dominated by the grass-covered sandstone plateau flanking the deeply eroded ravine of the Msikaba River. For long stretches it is impossible to access the river from the top of the cliffs. The bridge and its support structure will be constructed across the ravine with no impact on the slopes and vegetation in the ravine. The yellow line indicates the approximate position of the future bridge. No evidence of human occupation is visible on the site.

Road reserve Subsection 7.2 diverges from the existing road network as a greenfields section, entering the rugged terrain of the Msikaba Sandstone plateau (see Figures 149 and 150) from the Ntlavukazi Interchange towards the site of the approved Msikaba River Bridge. A spot check (labelled SC7.2.1 in the SAS report) on the site of the Ntlavukazi Interchange revealed the dense grass cover typical of the Pondoland-UGU sandstone Coastal Sourveld and shallow, moist soil on Msikaba sandstone (see Figures 148 and 151 to 153). The Msikaba River Bridge will be constructed on the approved construction site across the Msikaba ravine, with no impact on the vegetation and ravine channel (see Figure 154).

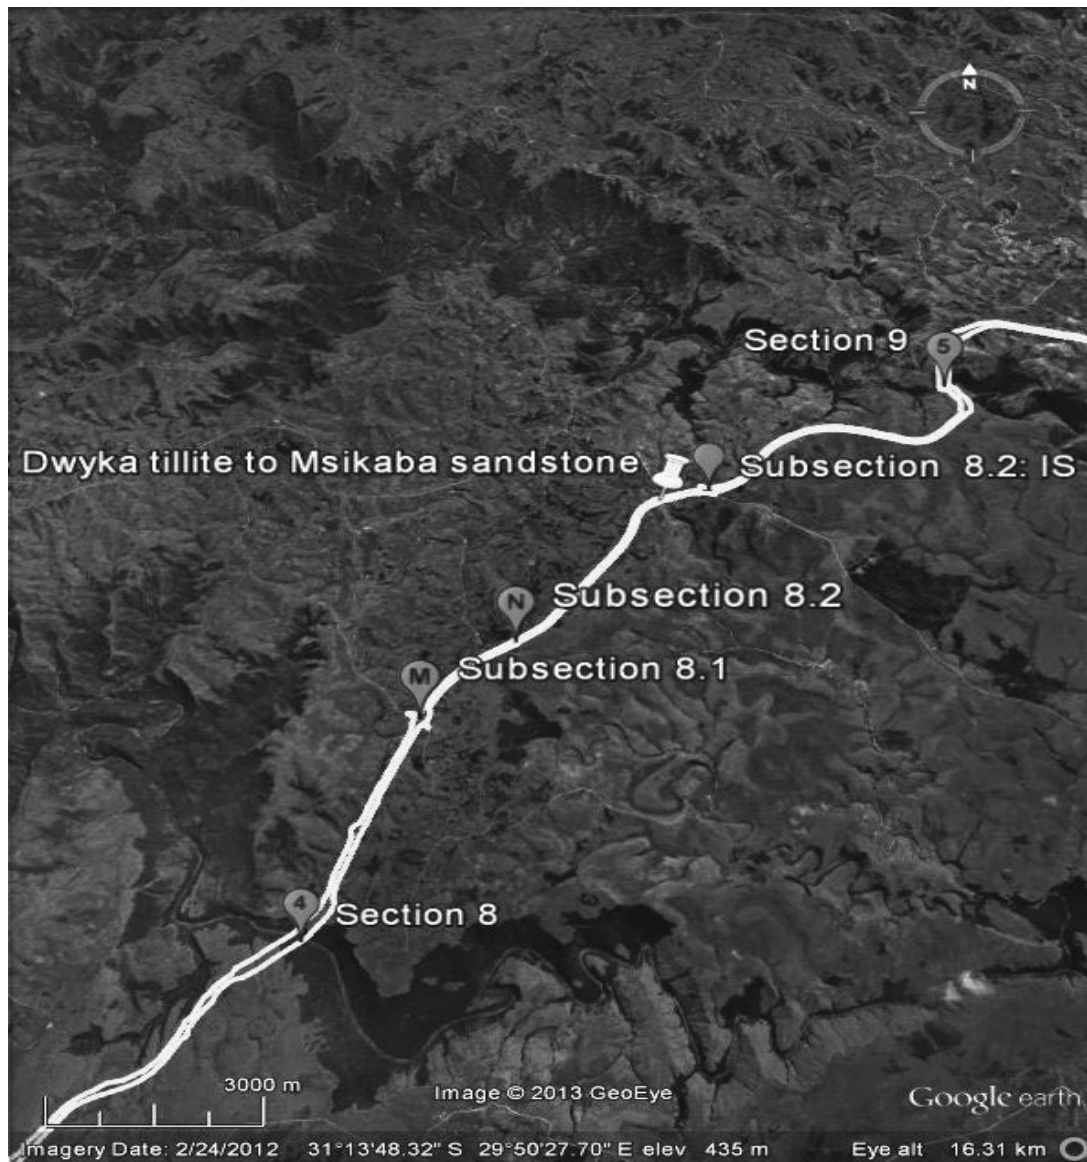
Figure 155. Section 8, Subsections 8.1 to 8.2: Alignment of Section 8 of the N2WCTH road reserve. The eroded surface of the Msikaba sandstone slopes in the ravine runs downwards in an easterly direction towards the coast, causing run-off towards the ocean.

Transition from Dwyka tillite to Msikaba sandstone around 31°12'38.40"S; 29°51'45.53"E (see Figures 156 and 157 below).

For the purposes of the SAS report, Section 8 is subdivided into two subsections (see Figures 155, 158 and 162), as follows:

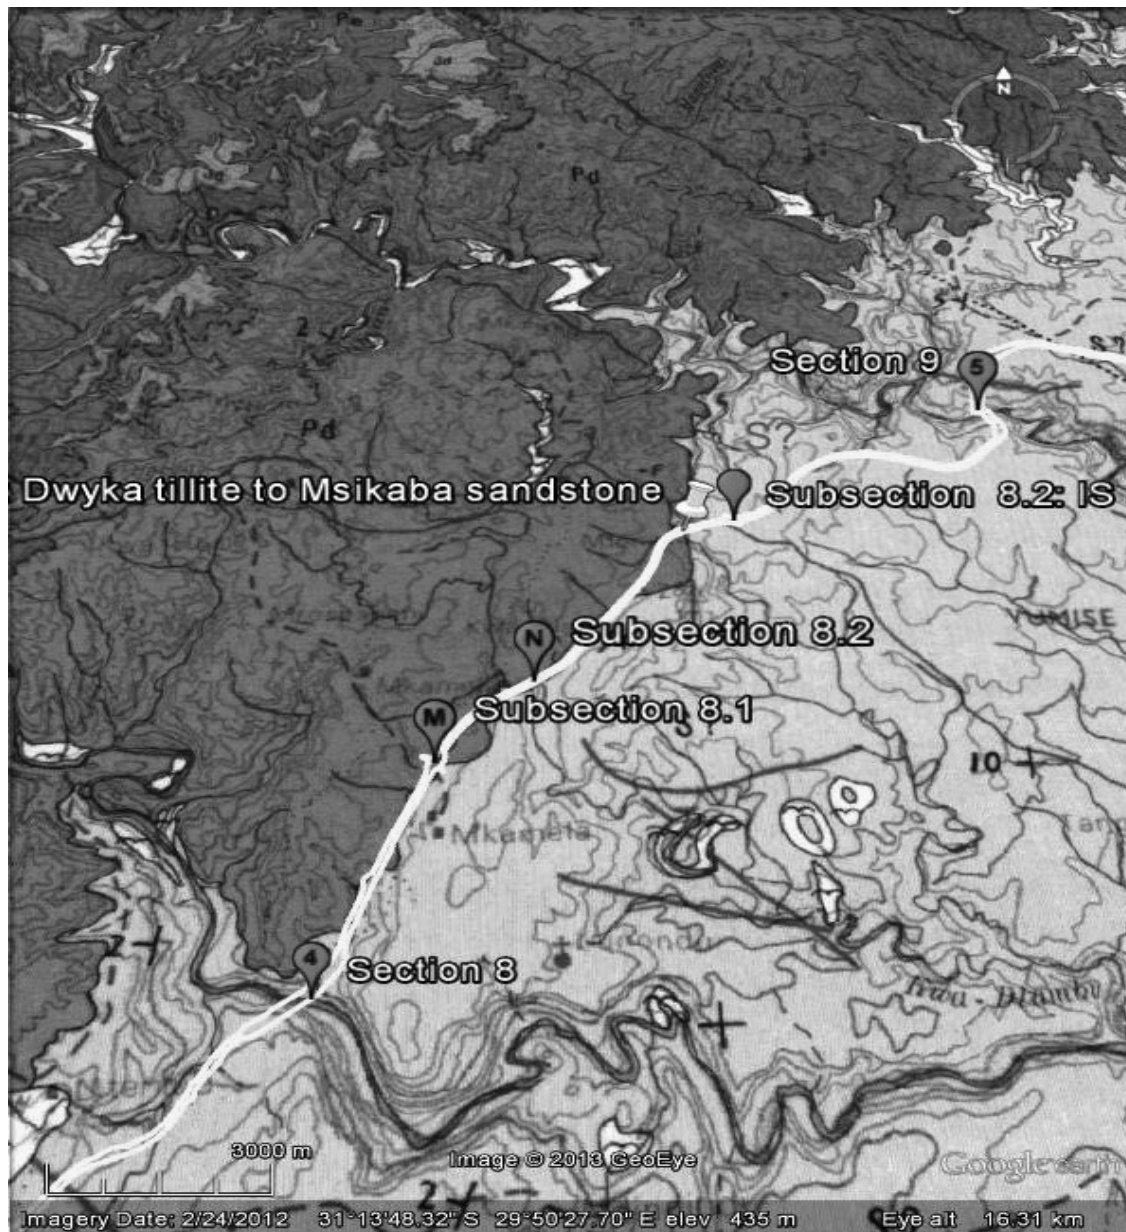
Figure 156. Section 8: The N2 WCTH road reserve alignment across the geological landscape. Where the road reserve mostly follows the transition line between the Dwyka tillite and the Msikaba sandstone between the Msikaba River Bridge (4), Mkamela (M), and the Kwadlambu River Bridge (N), the rural landscape is more densely populated than the Msikaba sandstone landscape around the Mtentu River Bridge (5) (also see Figure 157, below).

- 4 Section 8: Msikaba River Bridge, 31°17'35.09"S; 29°47'52.83"E.
- M Subsection 8.1: Mkamela Interchange, 31°15'21.14"S; 29°49'0.16"E.
- N Subsection 8.2: Kwadlambu River Bridge, 31°14'28.56"S; 29°50'1.32"E.
- 5 Section 9: Mtentu River Bridge, 31°10'43.59"S; 29°55'42.67"E.
- Transition from Dwyka tillite to Msikaba sandstone, around 31°12'38.40"S; 29°51'45.53"E.

Subsection 8.1 of the road reserve runs between the Msikaba River Bridge, Mkamela and the Kwadlambu River Bridge, more or less along a transition between the Dwyka tillite to the north-west and the Msikaba sandstone to the north-east of the road reserve (see Figures 155 and 156). A notable feature of the landscape is the fairly dense human settlement and intensive agriculture on the Dwyka tillite soil deposits, for example, on the site of the interchange near Mkamela and in the vicinity of the Kwadlambu River Bridge (see Figures 156 to 159).

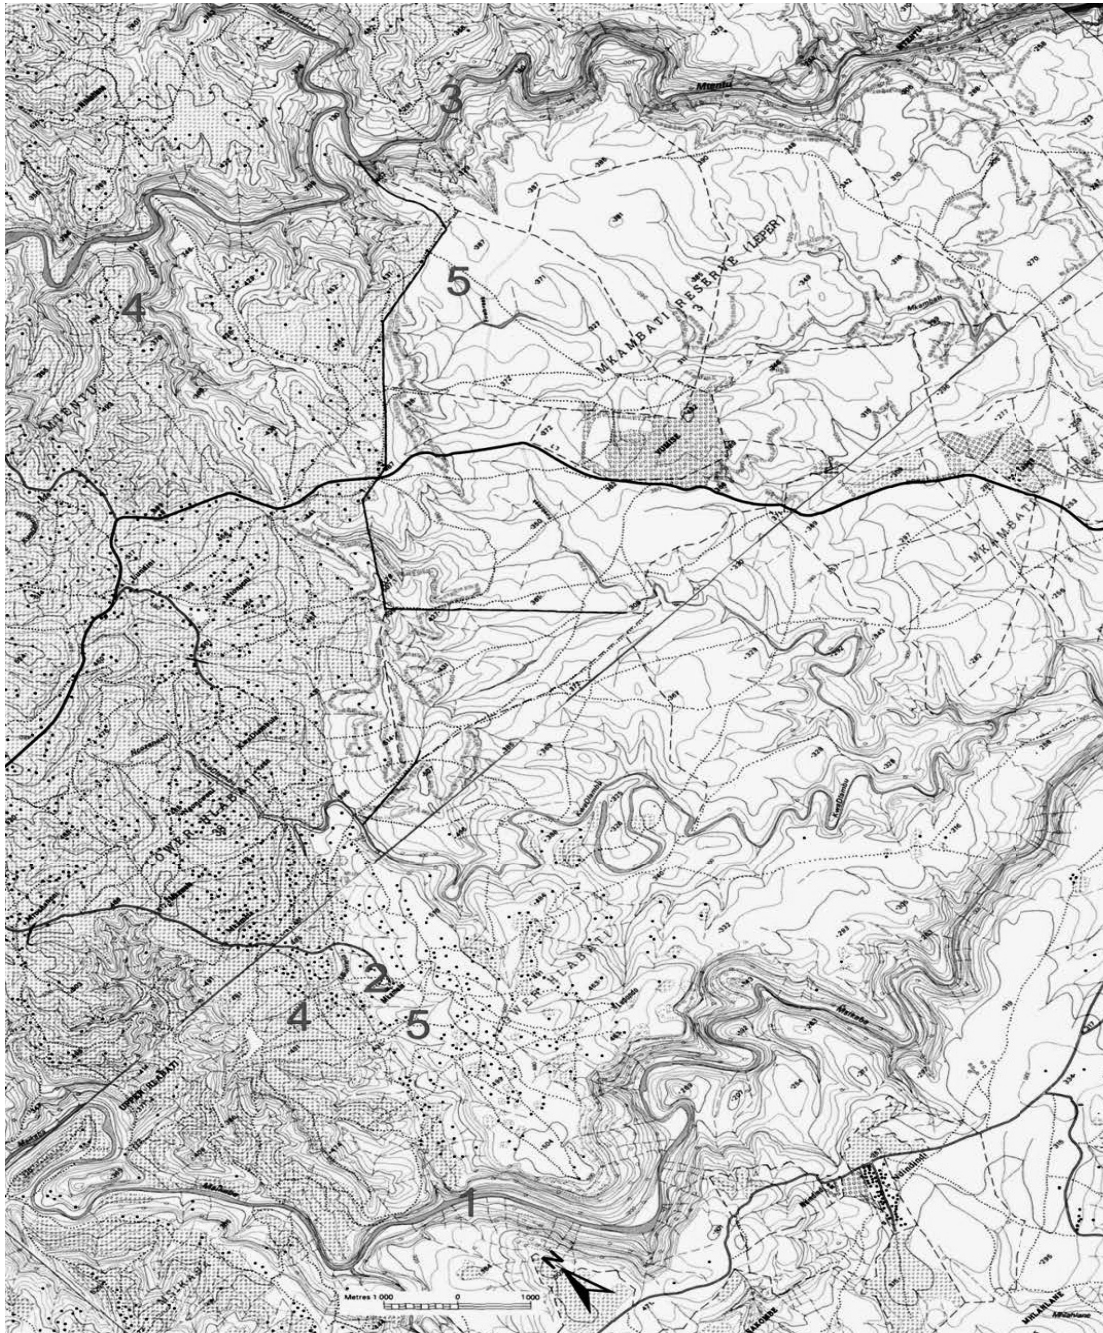
Figure 157. Section 8: Landscape features and human settlement density between the approved Msikaba River Bridge and Mtentu River Bridge (also see Figures 149, 150 and 156 above).

- 1 Msikaba River Bridge, 31°17'35.09"S; 29°47'52.83"E.
- 2 Mkamela, 31°16'12.01"S; 29°49'2.99"E.
- 3 Mtentu River Bridge, 31°10'43.59"S; 29°55'42.67"E.
- 4 Dwyka tillite.
- 5 Msikaba sandstone.

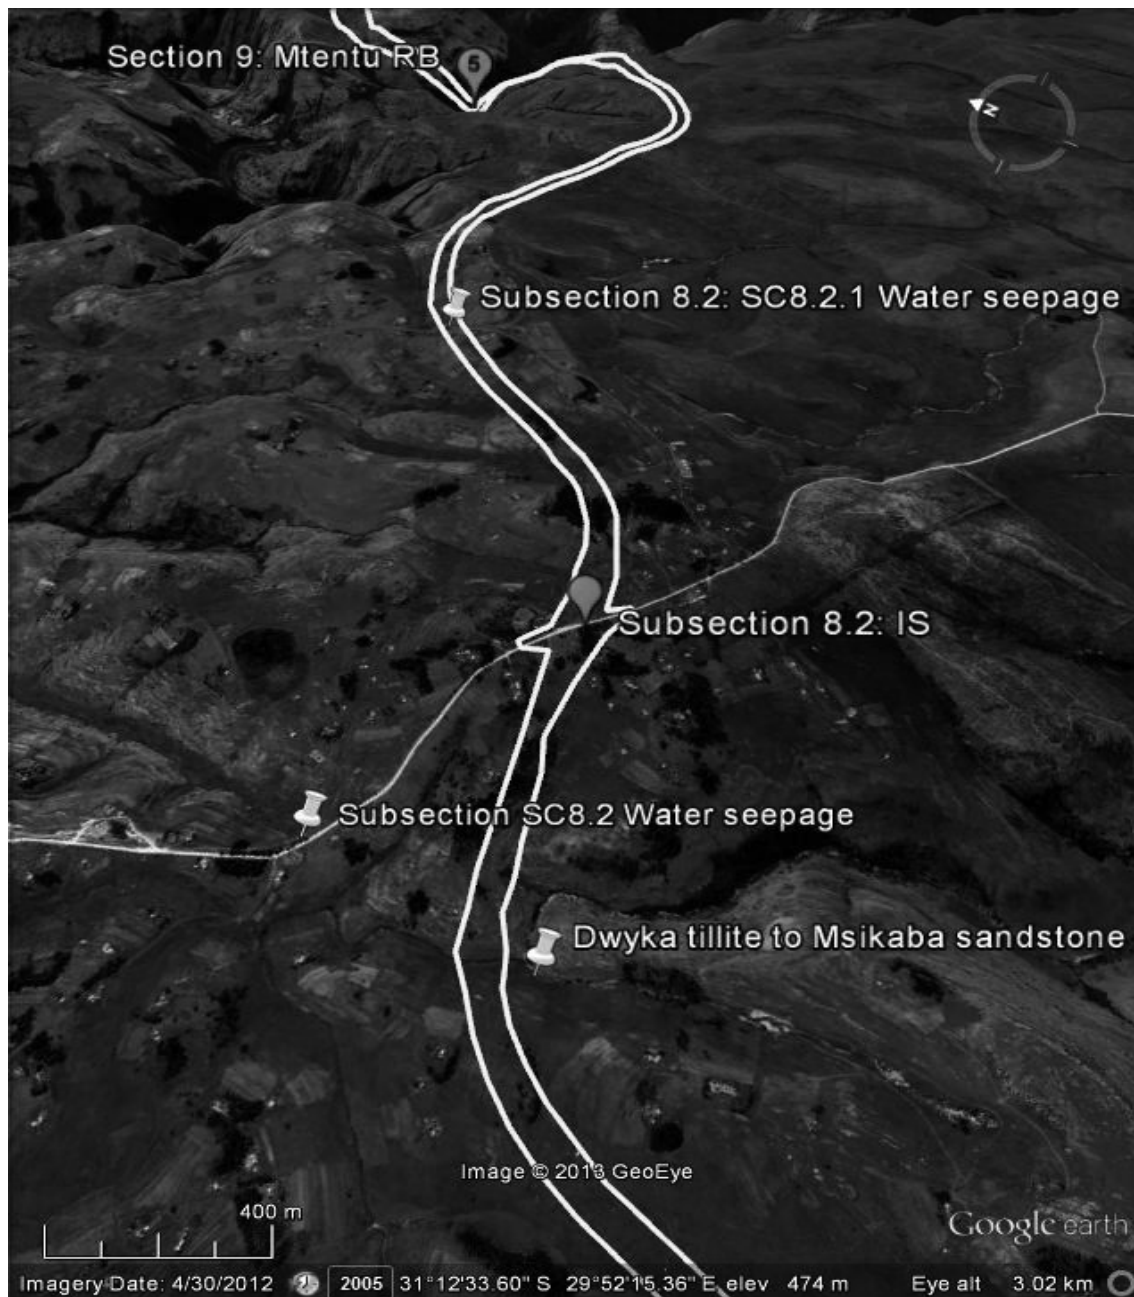
Figure 162. Subsection 8.2: The road reserve alignment across the Msikaba sandstone plateau landscape to the south-west of the Mtentu River Bridge. Spot checks SC8.2 and SC8.2.1 on local access roads or tracks revealed no evidence of archaeological sites (see Figure 166).

- Subsection 8.2 IS: N2WCTH/Holy Cross-Mkambati Road Intersection at 31°12'32.47"S; 29°52'20.28"E.
- Subsection 8.2: Spot check SC8.2 at 31°12'21.50"S; 29°51'45.10"E.
- Subsection 8.2: Spot check SC8.2. at 31°11'52.8"S; 29°53'11.6"E.
- 5 Section 9: Mtentu River Bridge at 31°10'43.59"S; 29°55'42.67"E.

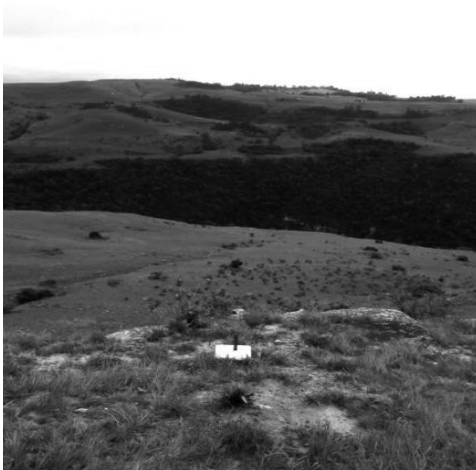
Photo: SAS DSC00157, October 2011.
Photographed at 31°11'05.1"S; 29°55'45.6"E.

Figure 170. Subsection 8.2: SANRAL markers on the Mtentu River Bridge site (see detail in Figure 171).

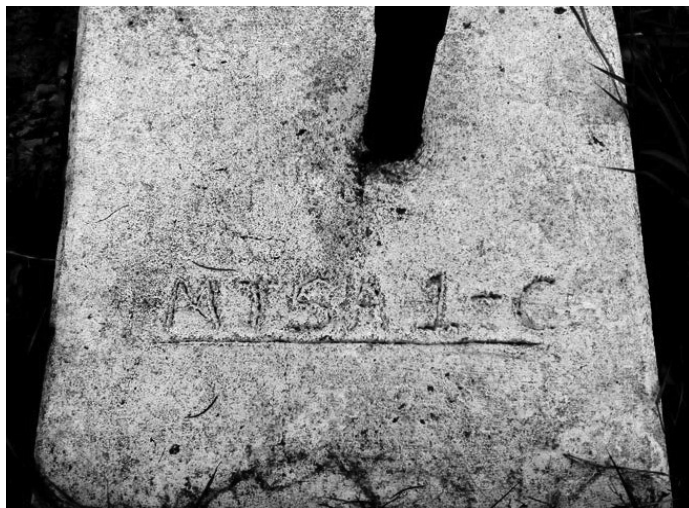
Photo: SAS DSC00163, October 2011. Photographed at 31°11'04.9"S; 29°55'45.6"E.

Figure 171. Subsection 8.2: Detail of the Mtentu River Bridge marker MTSA 1-C.

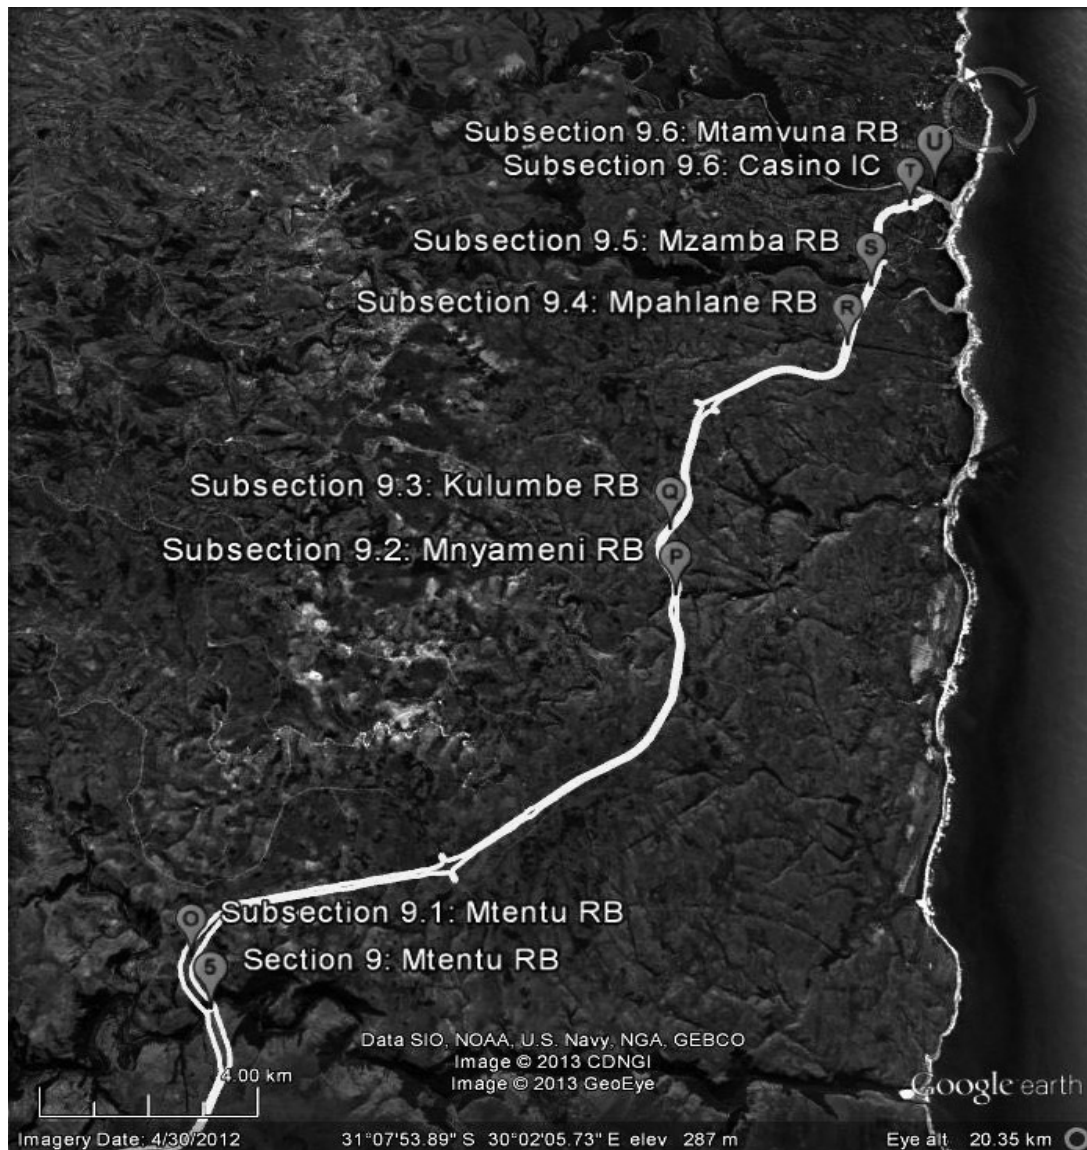
Figure 172. Section 9: Subsections 9.1 to 9.6, from the Mtentu River Bridge up to the Mtamvuna River Bridge. A noteworthy feature is the surface of the terrain and the sharply edged coastline of Msikaba sandstone.

Section 9 of the N2WCTH road reserve runs from the Mtentu River Bridge north-westwards up to the Mtamvuna River Bridge, which is located on the coastline just south of Port Edward. This road reserve section includes the construction sites of six large bridges, most of which will cross deep river ravines (see Figure 172).

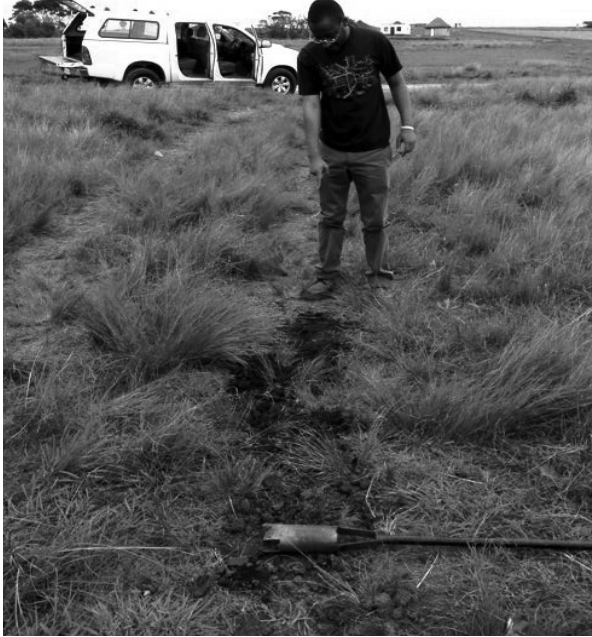
**Figure 194. Subsection 9.3
Interchange: Spot check
SC9.3.1, an auger test.**

- In and around the interchange in Subsection 9.3, occupied and recently abandoned rural homesteads surrounded by gardens and agricultural fields near available water sources were observed (see Figures 193 to 198, spot checks labelled SC9.3.1 to SC9.3.5 in the SAS report). An auger test at spot check SC9.3.1 at the site of the interchange (see Figure 194) revealed no evidence of archaeological or cultural heritage material.
