Phase I Heritage Assessment of P22071 SANRAL Worcester to Glen Heatlie Project

Including Palaeontology and Built Heritage Reports

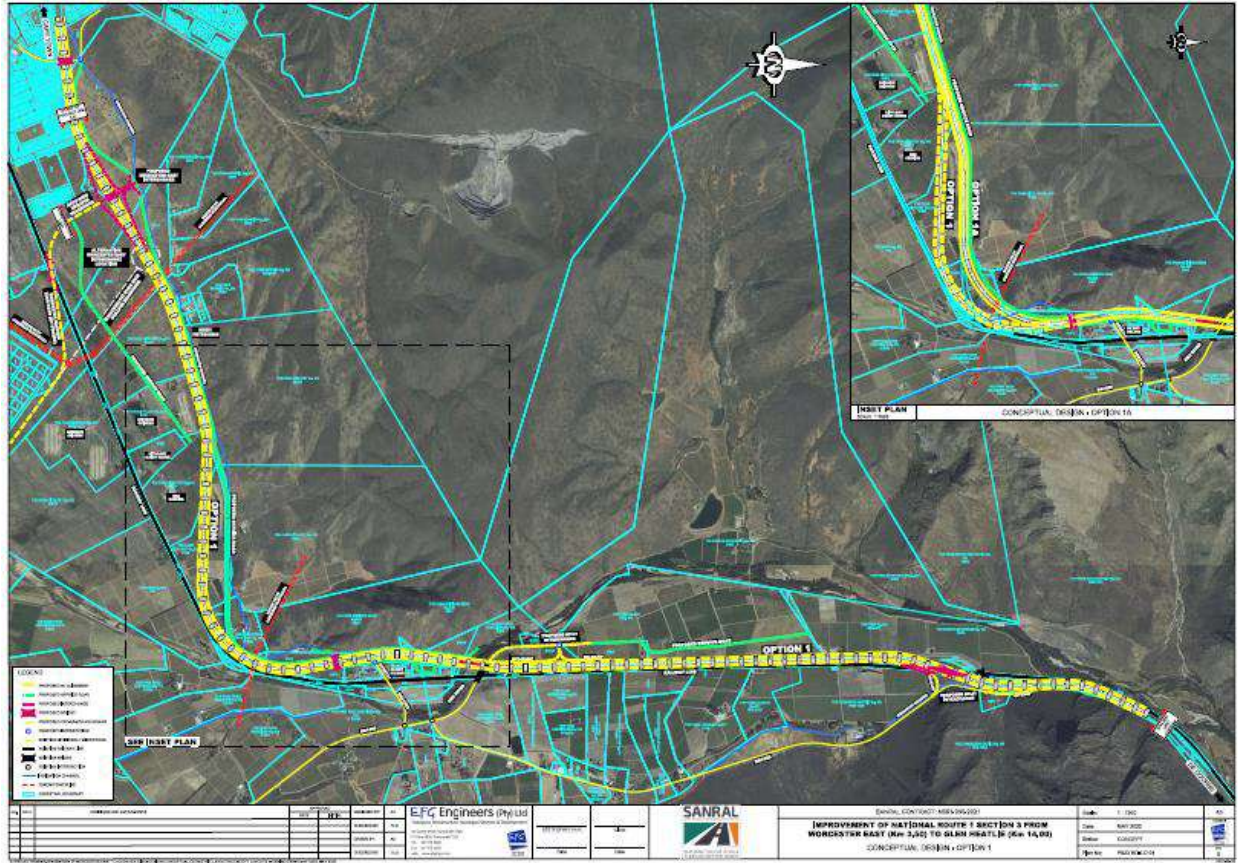
Figure 2. Option 1 and Option 1A. Option 1 will follow the existing road alignment, except for a short alignment at just before kilometer 7. Option 1A focuses on a proposed 90 degree bend at km 7.5. This will require a 60 meter radius which will mean cutting through an existing mountain on the west side of the road. Source: Delta BEC, BID.

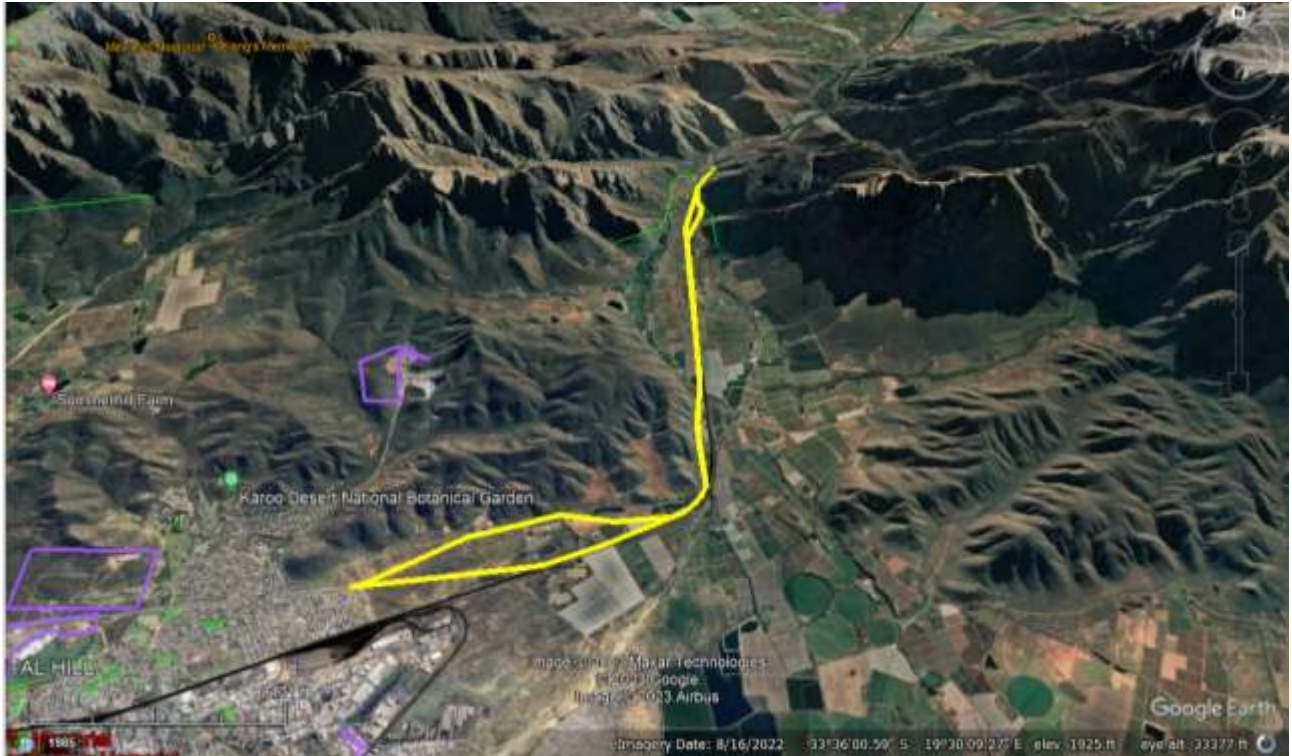
Figure 3. Option 2. A new alignment will run through existing farmlands, parallel to the existing railway until km 7. In the last section of the road a tie-in with the existing road will take place. Google Earth.

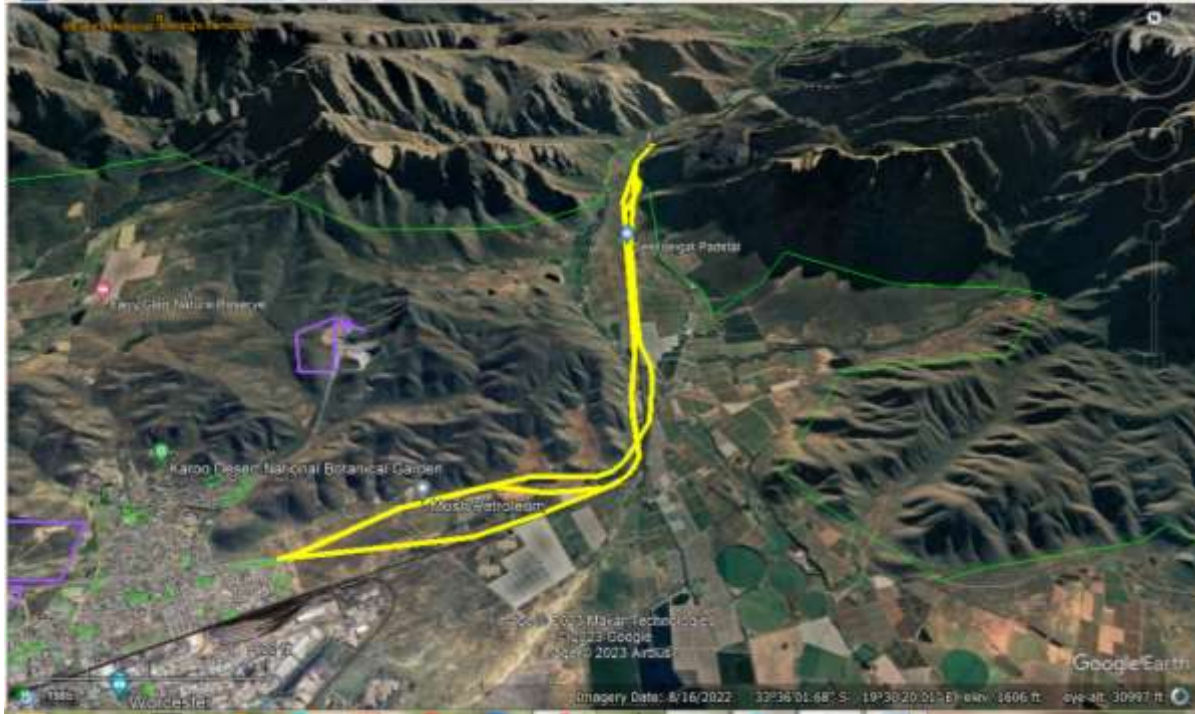
Figure 5. Option 3. From km 7 the road will deviate to the east side of the existing railway line. A full inter-change is also planned at the De Wet Bridge. Google Earth.

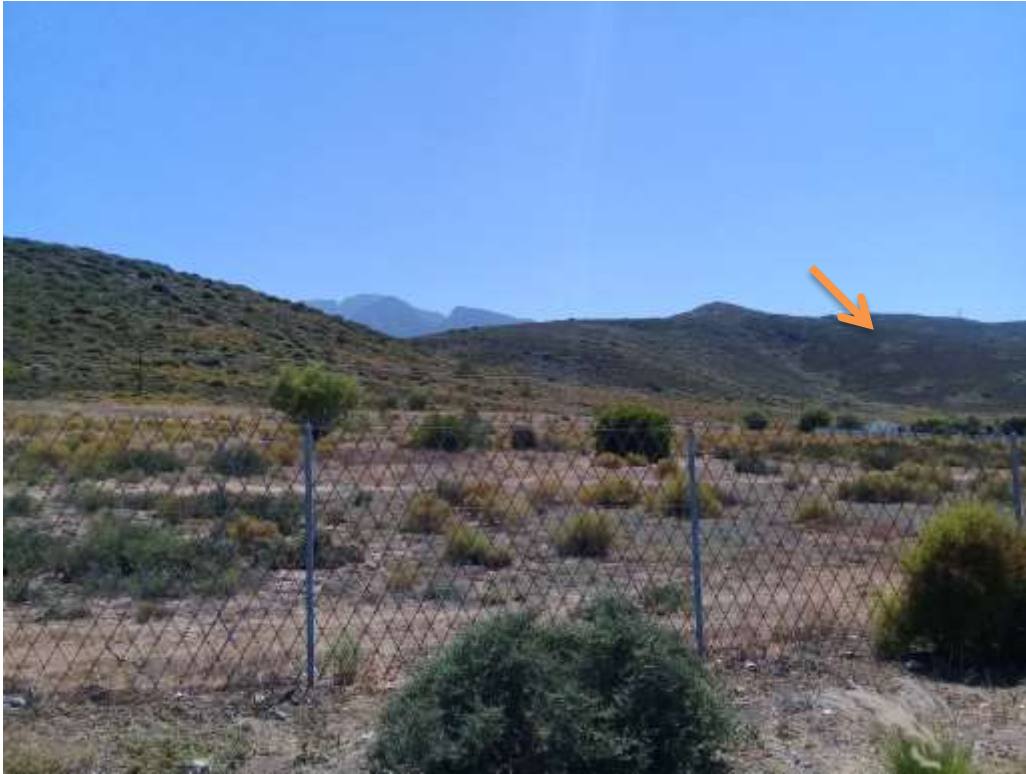
Photo 8. Farmland lying to the west of the N1, at the initiation of the project route, 27th March, 2023. This lies opposite the intersection of the R60 with the N1. The road was very quiet. On the hill to the right of the photo were some curious marks on the southern side of the hill (orange arrow), most likely caused by a die-off in indigenous “Fynbos” and “Protea” vegetation. Photo: Sian Hall.

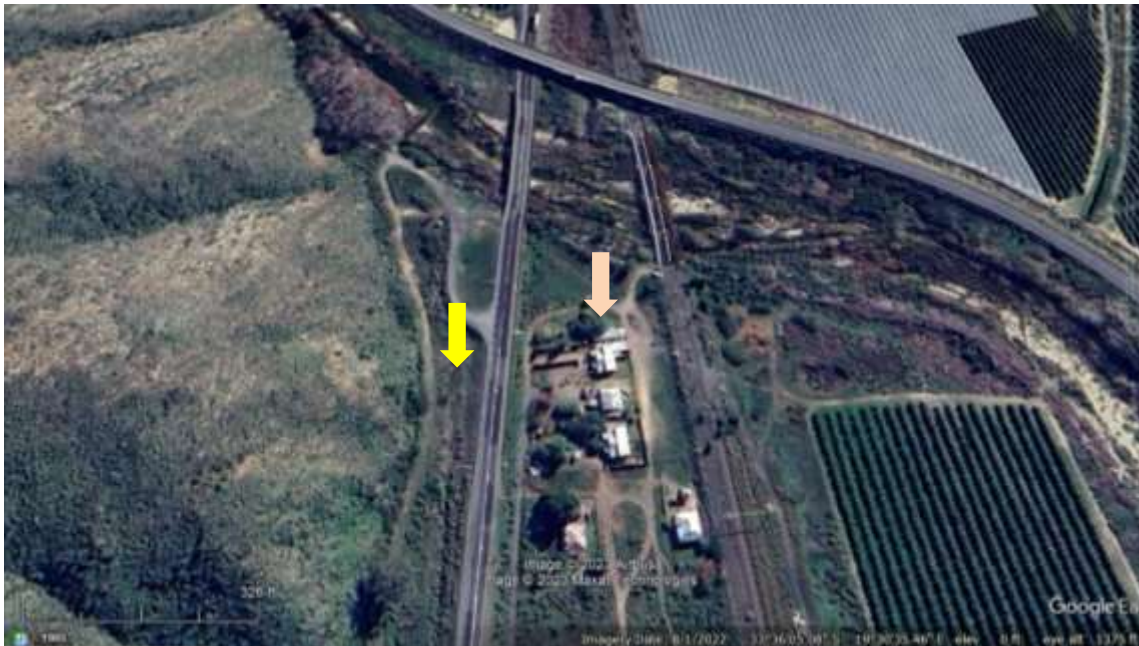
Figure 16. The location of the apparent cobblestone terrace, amongst which there appear to be Early Stone Age lithic artefacts. This is the site from which the photographed tools had come. There must be many more such terraces alongside the N1, but obscured by the vegetation and the impracticability of walking up, and then down, the entire length of the linear development. The Stone Age site is indicated by the yellow arrow. It is situated just opposite the cluster of corrugated iron sheet, and brick, buildings that are discussed further down in this report, and indicated by the light orange arrow. Google Earth.

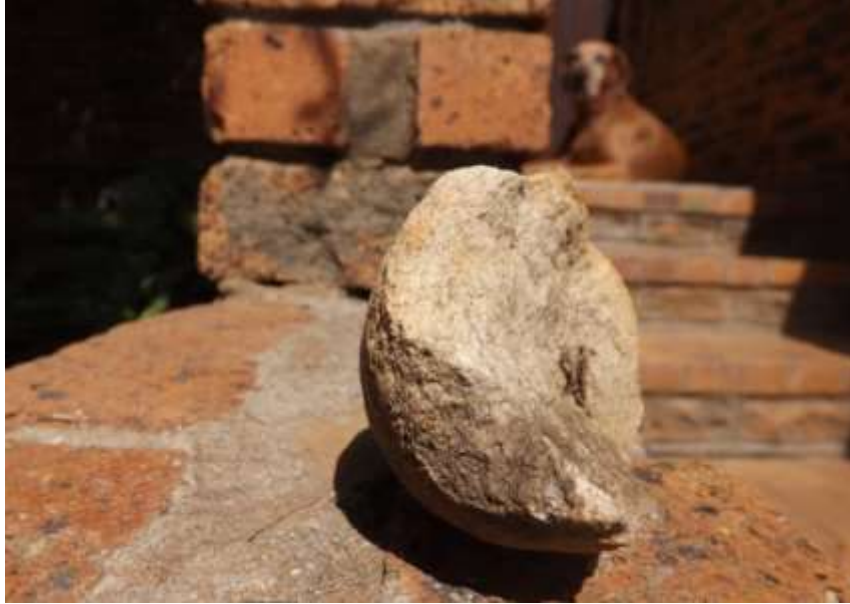
Photo 22. Most probably a core from which large cutting tool was struck. Photo: Sian Hall.

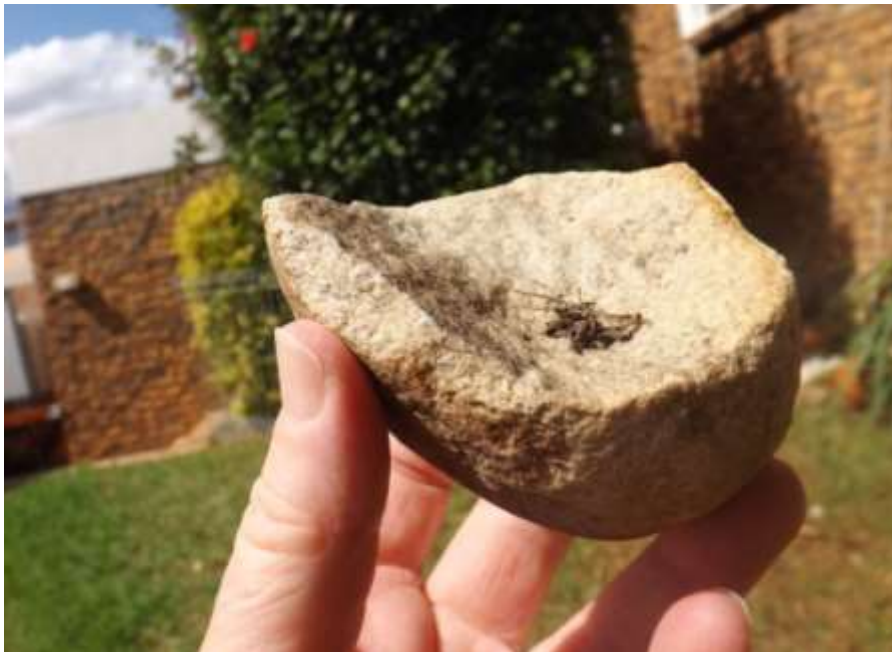
Photo 23. The core is very weathered and this is a result of it having shifted with alluvium, and the accompanying action of rock on rock, and abrasion by soil. Photo: Sian Hall.

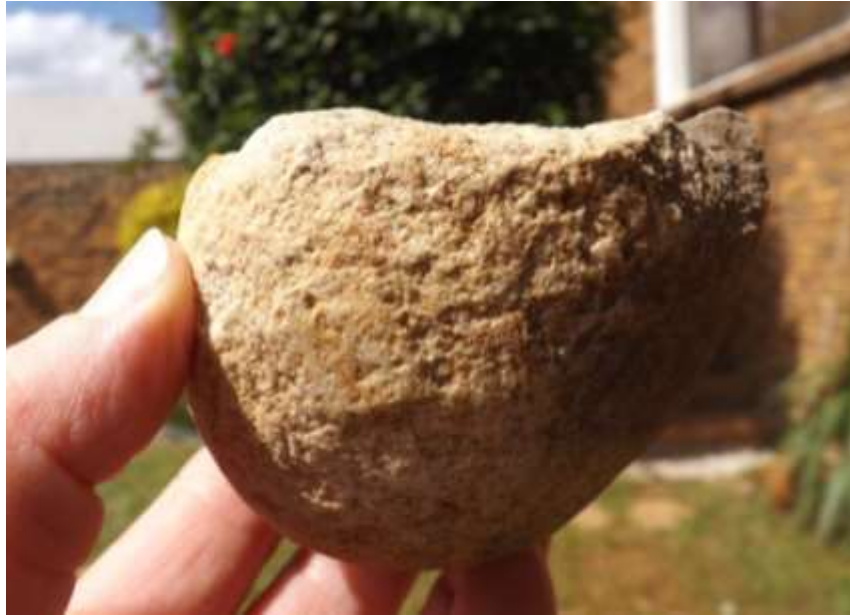
Photo 24. The effect of extreme weathering by running water, but mostly from the rolling action of rock on rock, and abrasion by soil, during movement in alluvium, or colluvium, is very obvious in this photograph. Photo: Sian Hall.

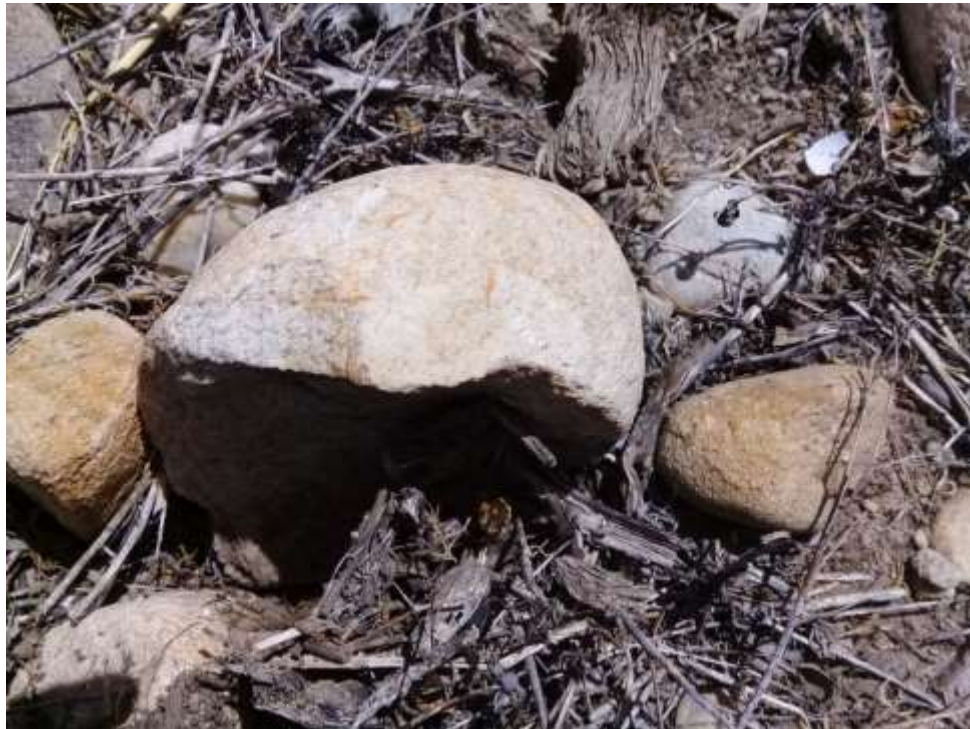
Photo 25. Another example of a cobbled core, or chunk from the Early Stone Age (Acheulian) terrace. This core / chunk was photographed in situ. Photo: Sian Hall.

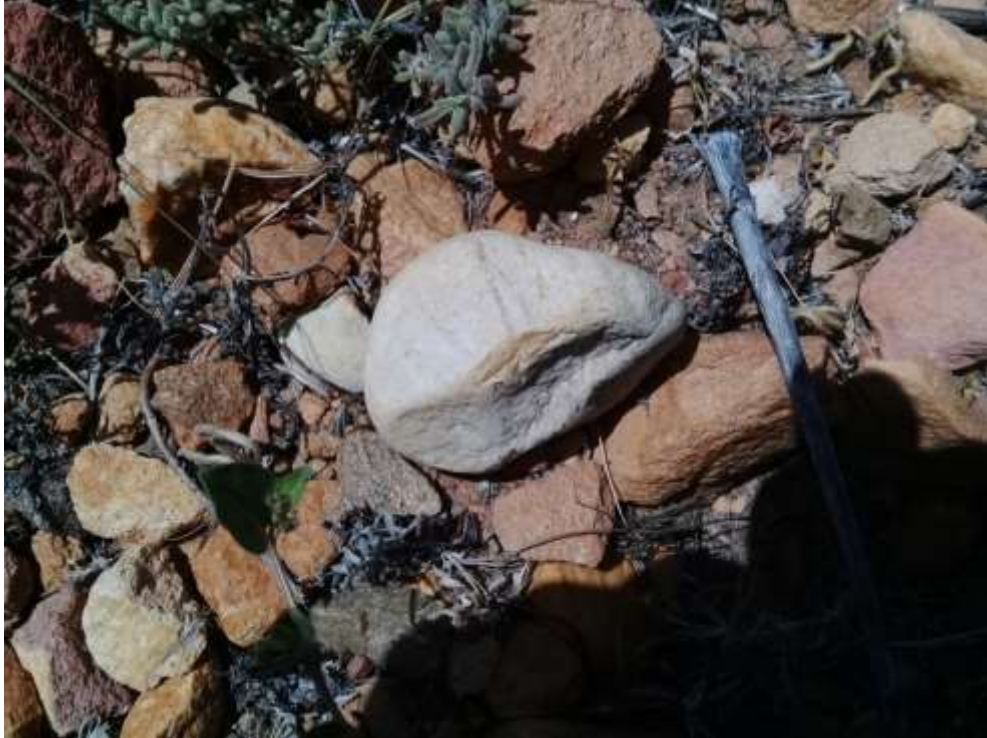
Photo 26 . A chunk / core Early Stone Age artefact, the result of industrial waste, photographed on site, in situ. Photo: Sian Hall

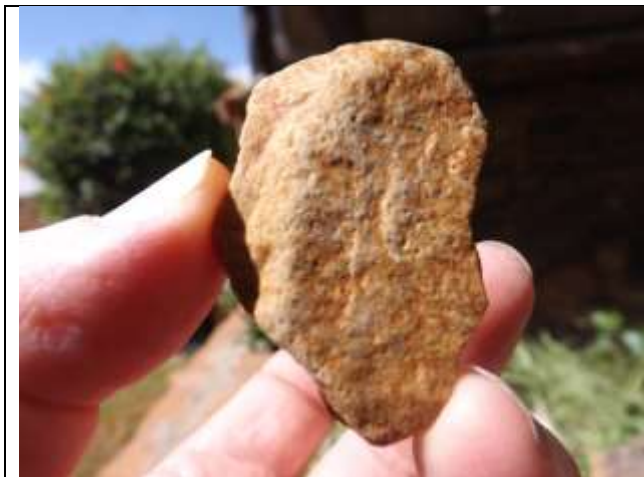
Photo 27. Quartzite EIA Industrial waste from the EIA site. Probably a discarded production flake. Photo: Sian

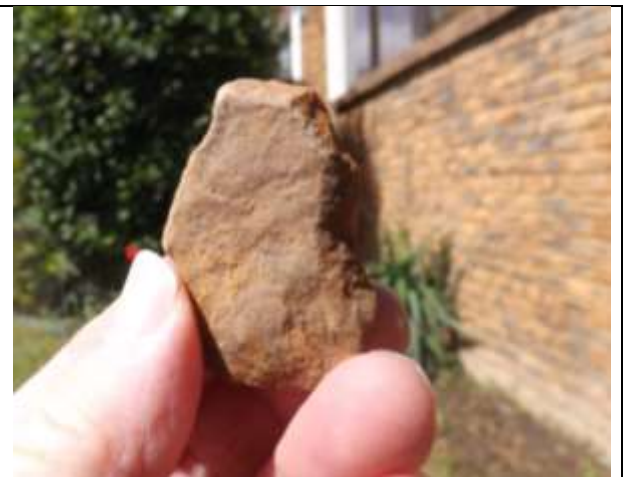
Photo 28. Another view from the same artefact. Photo: Sian Hall.

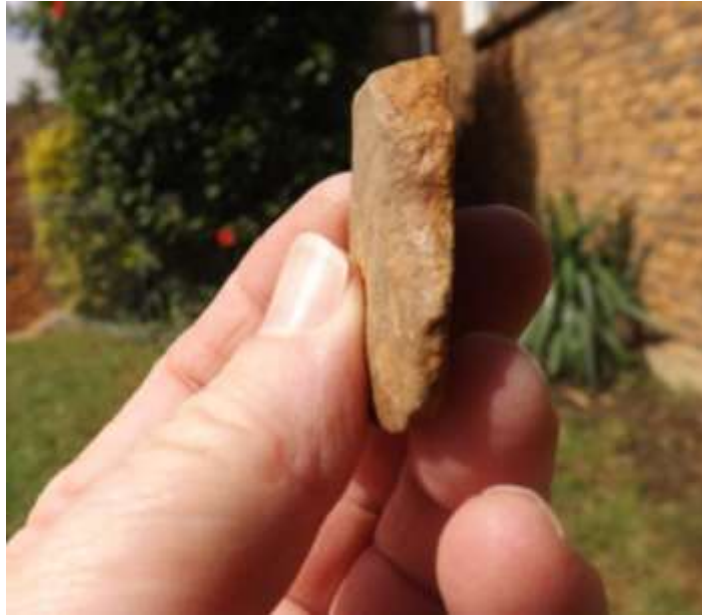
Photo 29. A side view of the above lithic. Photo: Sian Hall. .

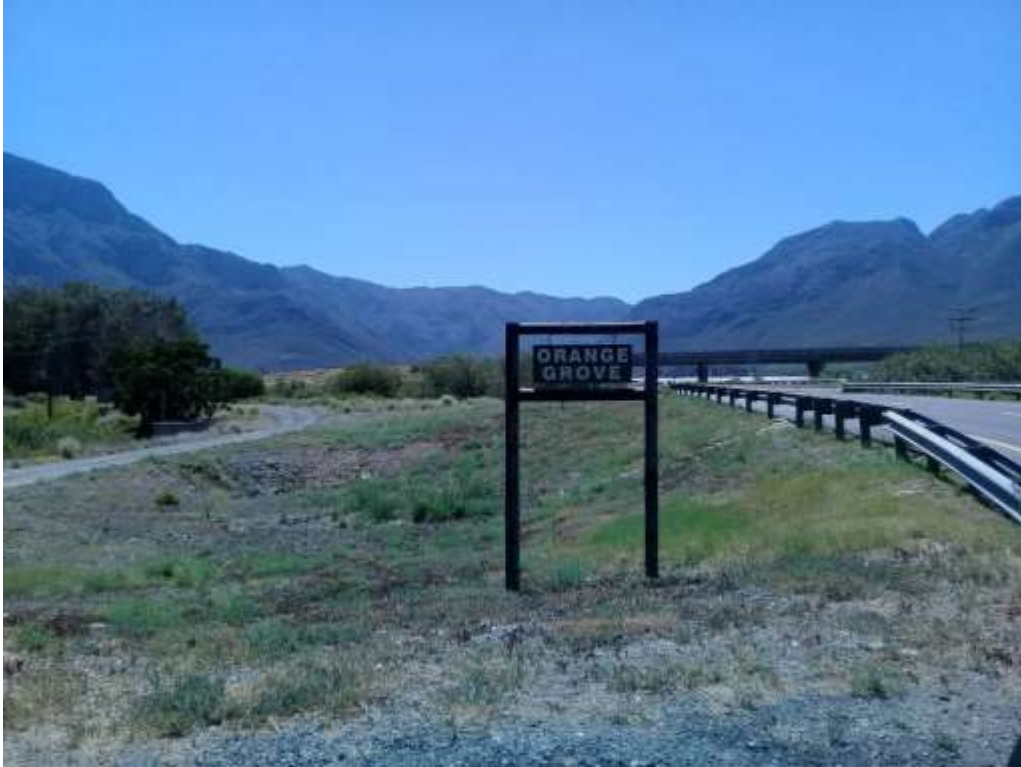
Photo 30. The northern extent of the cobbled terrace from which the EIA artefacts came. Photo: Sian Hall.

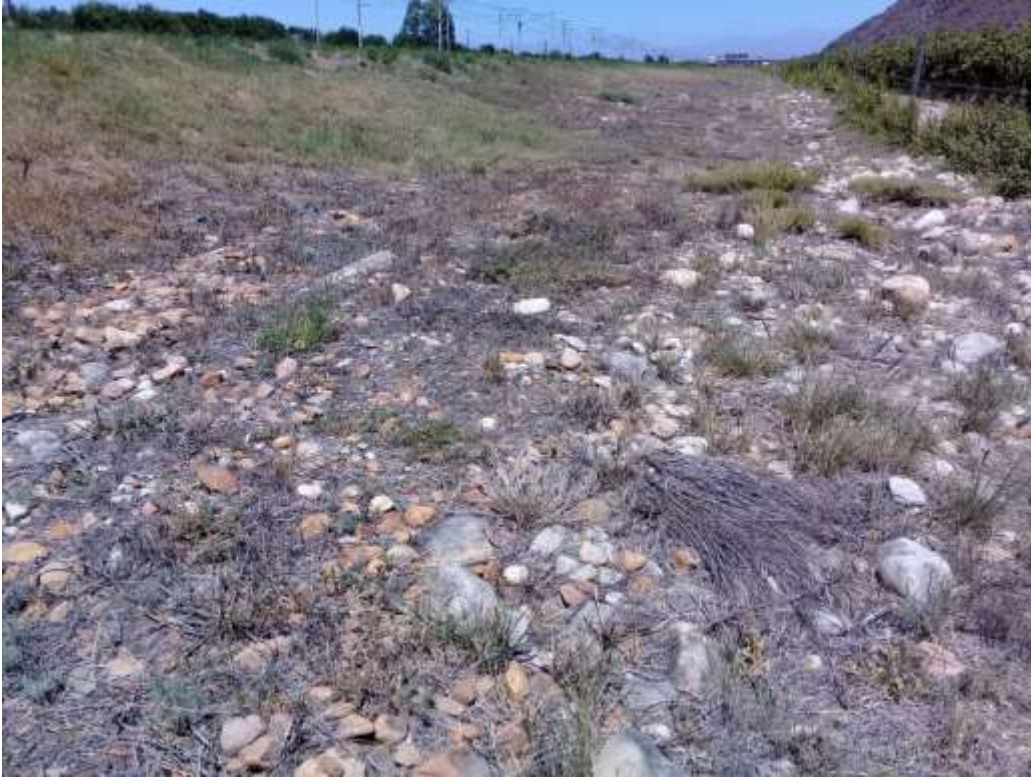
Photo 31. A good visual of the cobble stone terrace, looking southwards, on the west side of the N1, and in the northern section of the proposed project. It shows how prolific these rocks and cobbles are and how extensive the site is. Photo: Sian Hall.

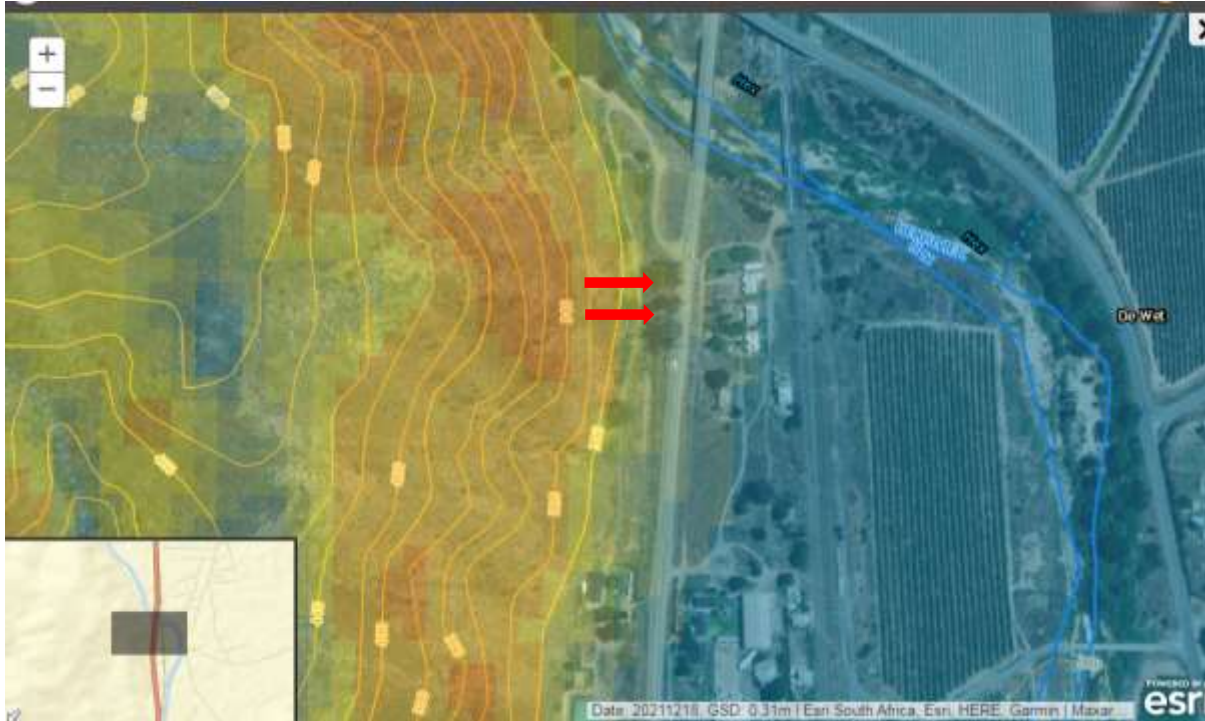
Figure 17 . This image illustrates a number of things. The first is the very steep topography of the mountain to the west of the archaeological site. This is illustrated by the yellow colour. The blue colour depicts the flat area below. The site is at the meeting point of the two (indicated by the red arrows). The dotted blue lines show the flow of rivulets down the mountains sides. The contours clearly show the palaeo-flow line and down slope drainage <https://gis.elsenburg.com/apps/cfm/>

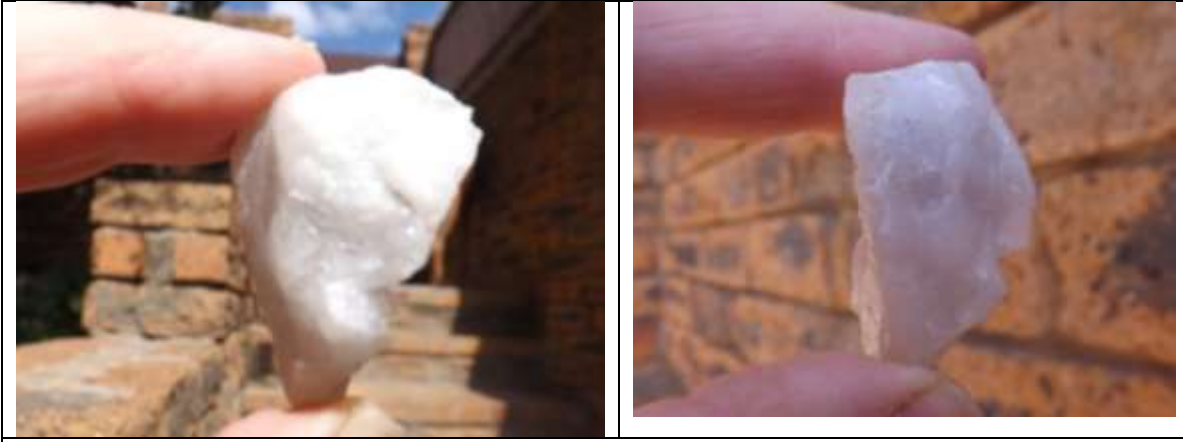
Photos 34 and 35. Another view of the same lithic. Photo: Sian Hall.

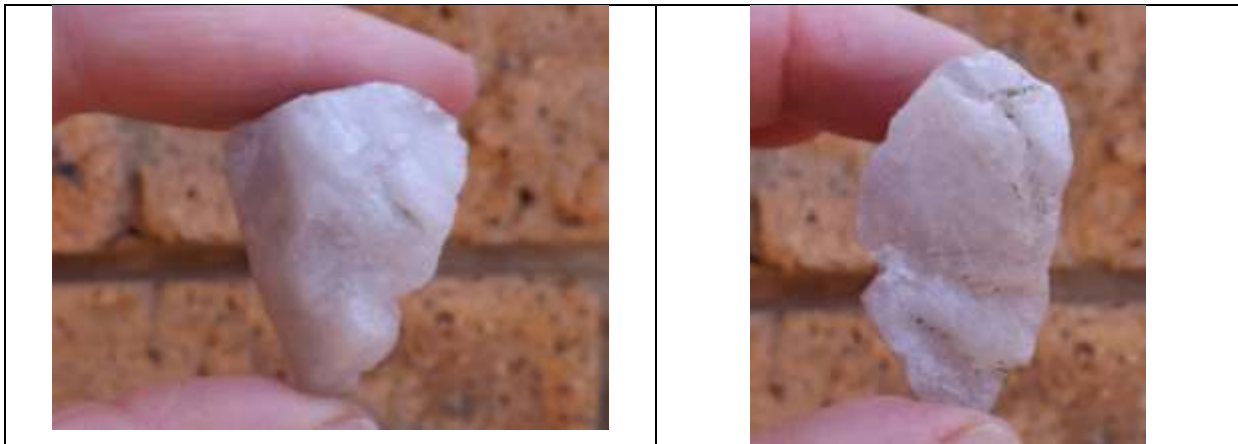
Photos 36 and 37. Show the bulb of percussion, and the sharp edges of the lithic. Photo: Sian Hall.

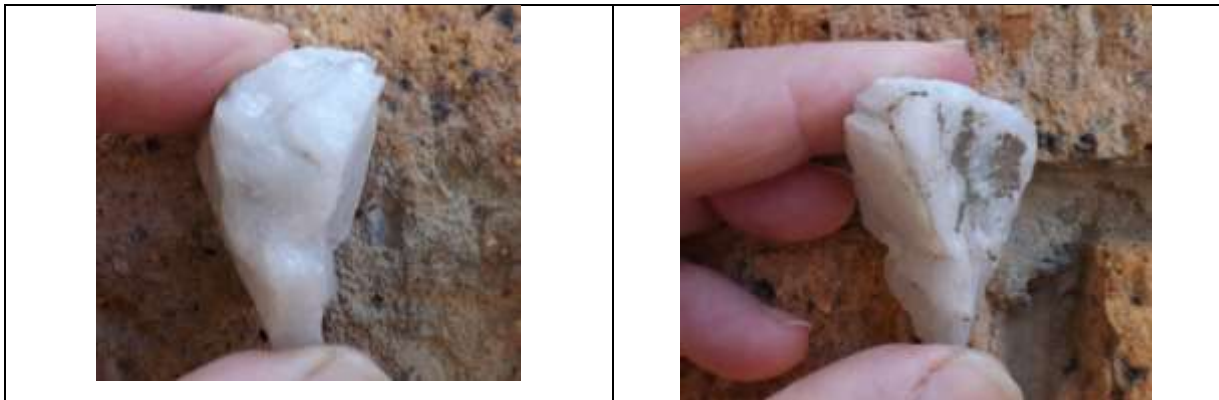
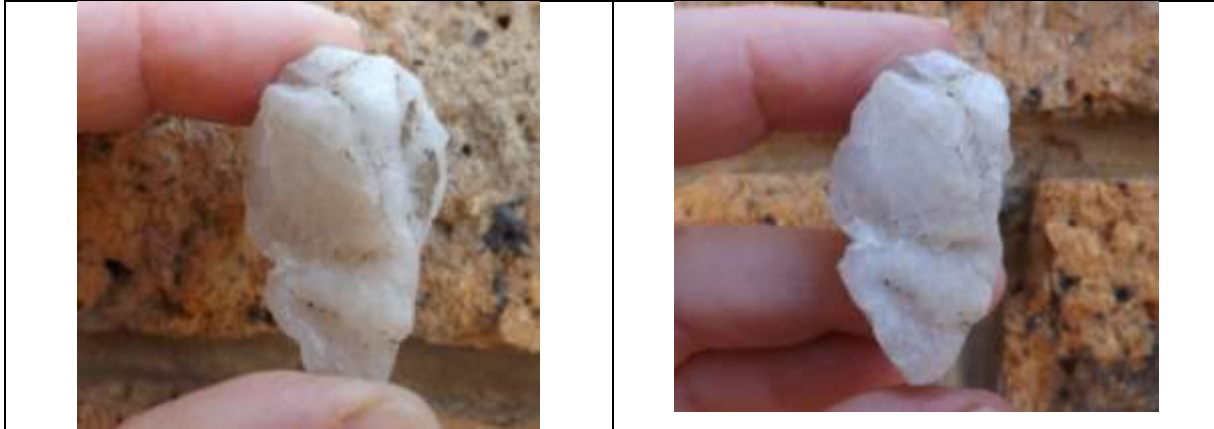
Photos 38 and 39. This was the only clear quartz lithic observed on the site, and the only lithic probably attributed to the LSA. Photo: Sian Hall.

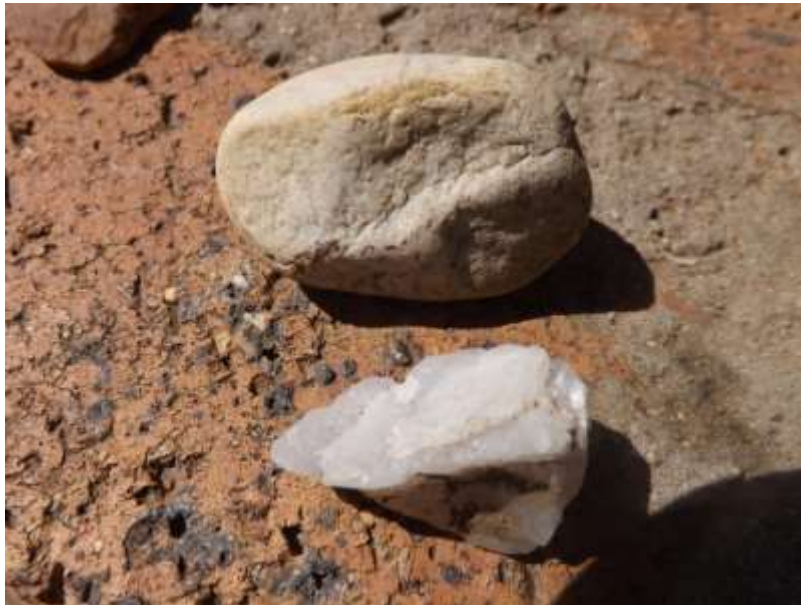
Photo 40. Here the tool is shown with another lithic/pebble from the same site. Photo: Sian Hall.

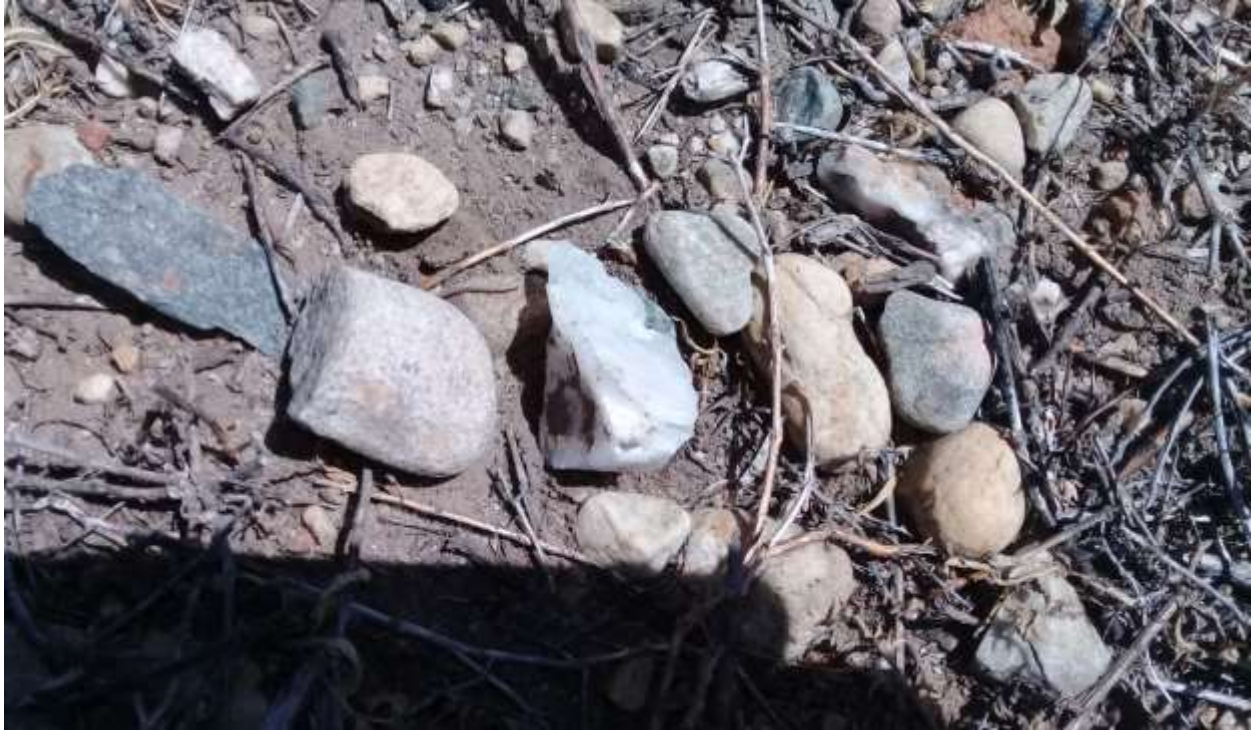
Photo 41. The clear crystal LSA lithic photographed in situ on site. Photo: Sian Hall.

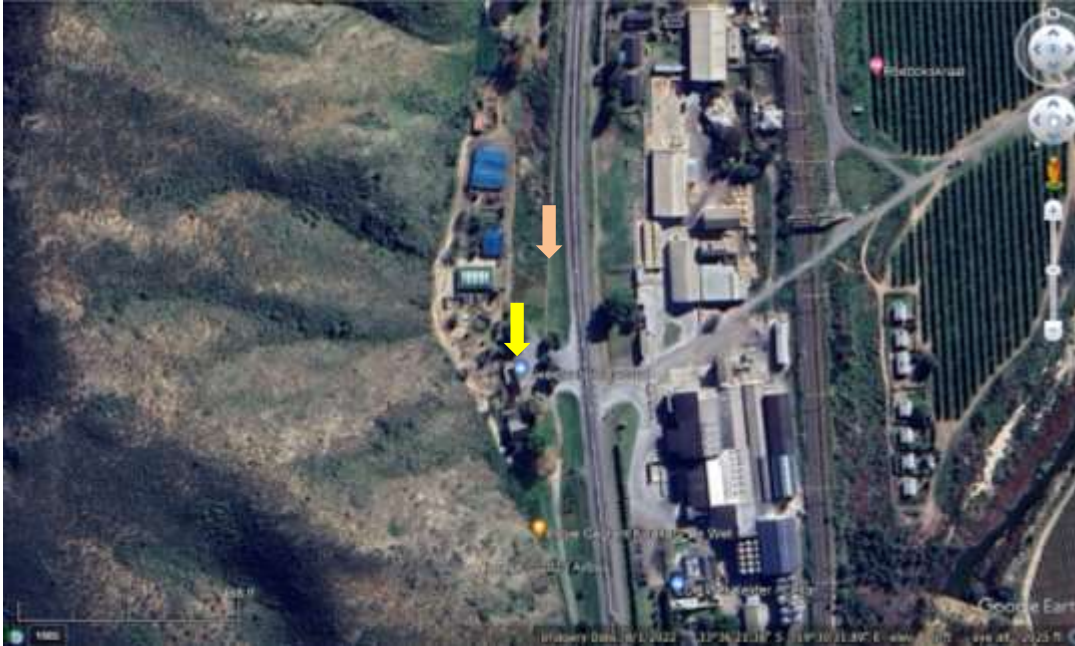
Furthermore, further to the front (east) of the store (approximately 10 metres from the store, and 23 metres from the N1) is a small canal along which fresh, clean and clear water runs. It is obvious that this is an old feature, certainly more than 60 years of age that may have been modified over the years. It would appear that it formed part of the original farm, most likely serving as an irrigation ditch. This is a heritage feature, and together with the farm stall, these

Figure 19. Tweefontein Padstal is set right up against the dramatic backdrop of mountains. The store is indicated by the yellow arrow, while the irrigation ditch line is indicated by the light orange arrow. Google Earth.

two features, and the space they occupy, should be afforded the high grading of Local Grade IIIA. They are of high significance locally, and should be retained as a Cultural and Living Heritage site. The implementation of the proposed development, as Options 1 or 2, will destroy the irrigation ditch, and also alter the essence of the store, if not lead to its ruin / demication. If the development, as Options 1 and 2, is to proceed, as planned, then some sort of mitigation should be made to retain this section of the road as it is at present. Certainly, if the proposed development, as these options, is to proceed then a Phase II Built Heritage Assessment is advised.

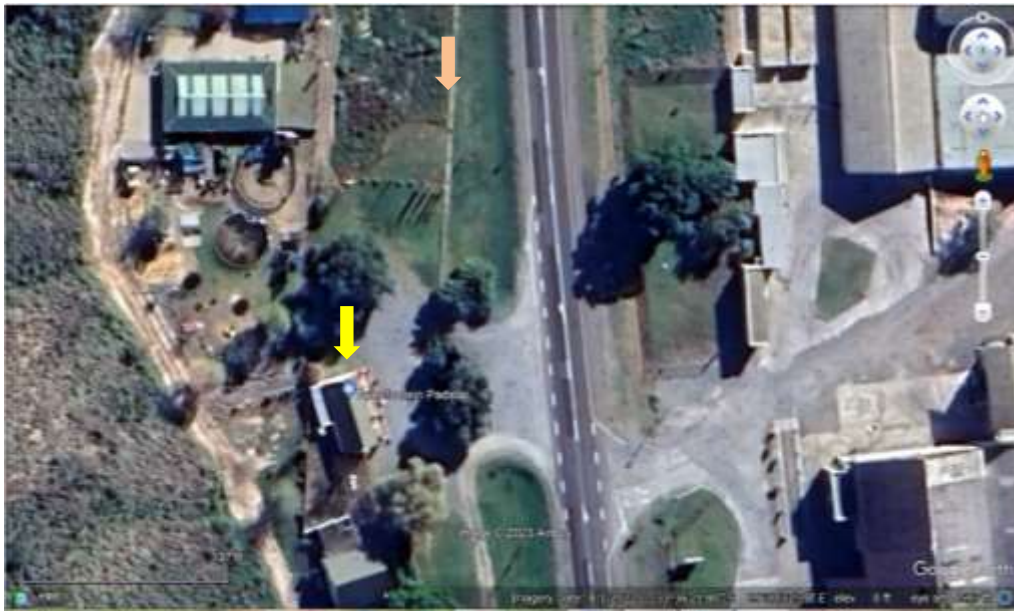
Figure 20. This Google Earth imagery provides detail on the form of the building, and a clear view of the irrigation ditch. The store is indicated by the yellow arrow, while the irrigation ditch line is indicated by the light orange arrow. Google Earth.

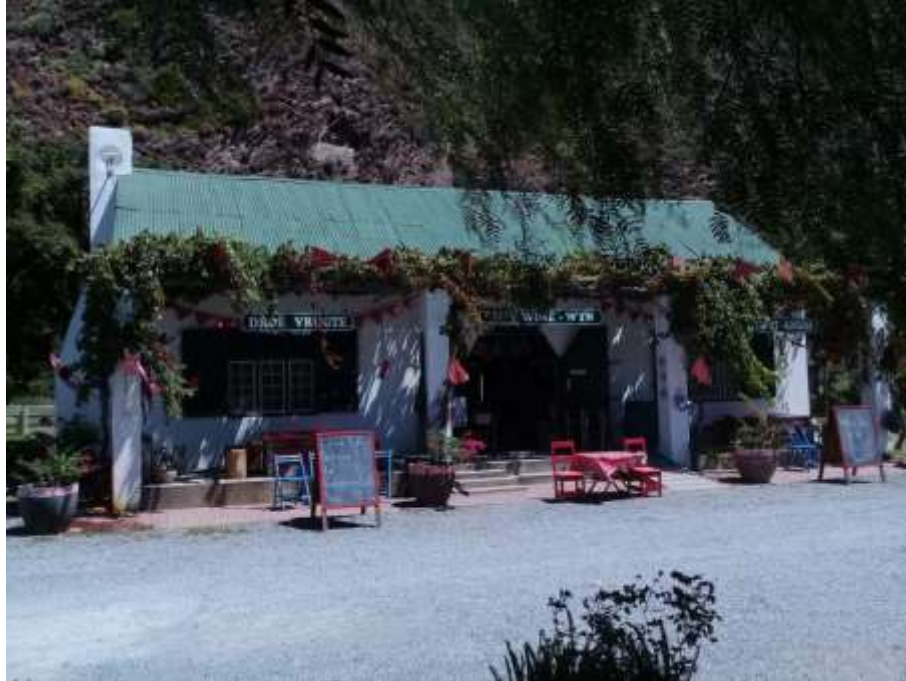
Photo 42. Tweefontein Padstal, lying about 30 metres to the west of the N1, has much charm and atmosphere. Photo: Sian Hall.

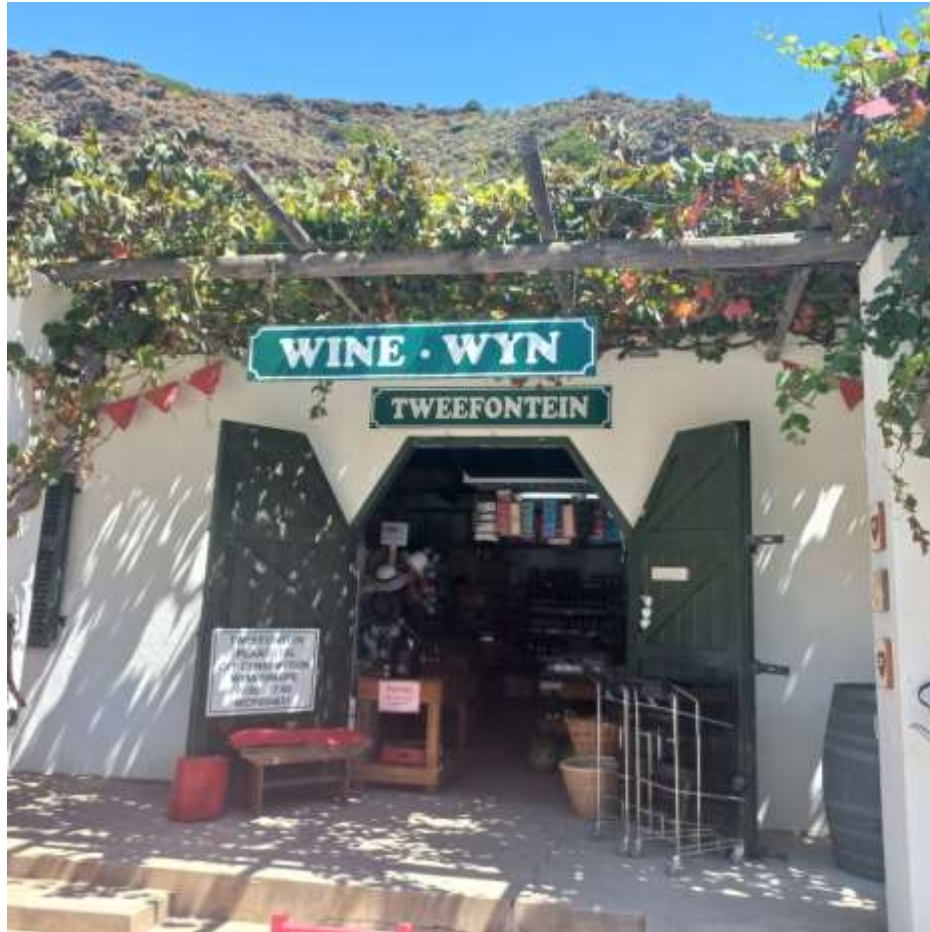
Photo 45. The doors of the store may be a later addition to the building. They are, however, in line with the type of doors typically seen on stable buildings. Photo: Adolfo Linares.

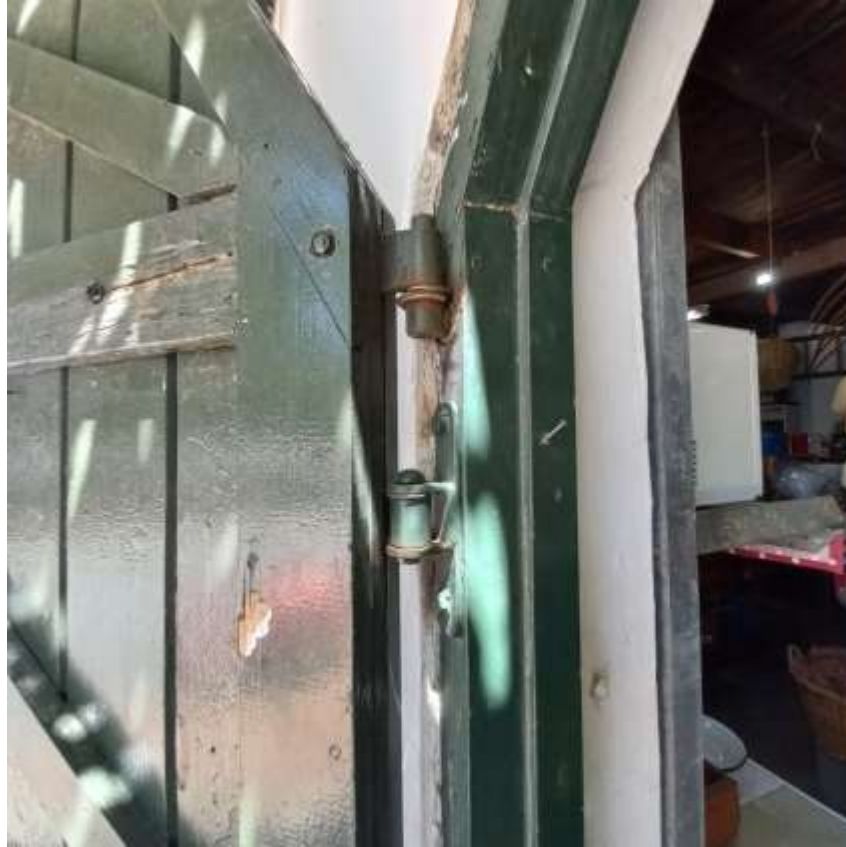
Photo 46. The hinges of the padstal door appear to be relatively recent. Photo: Adolfo Linares.

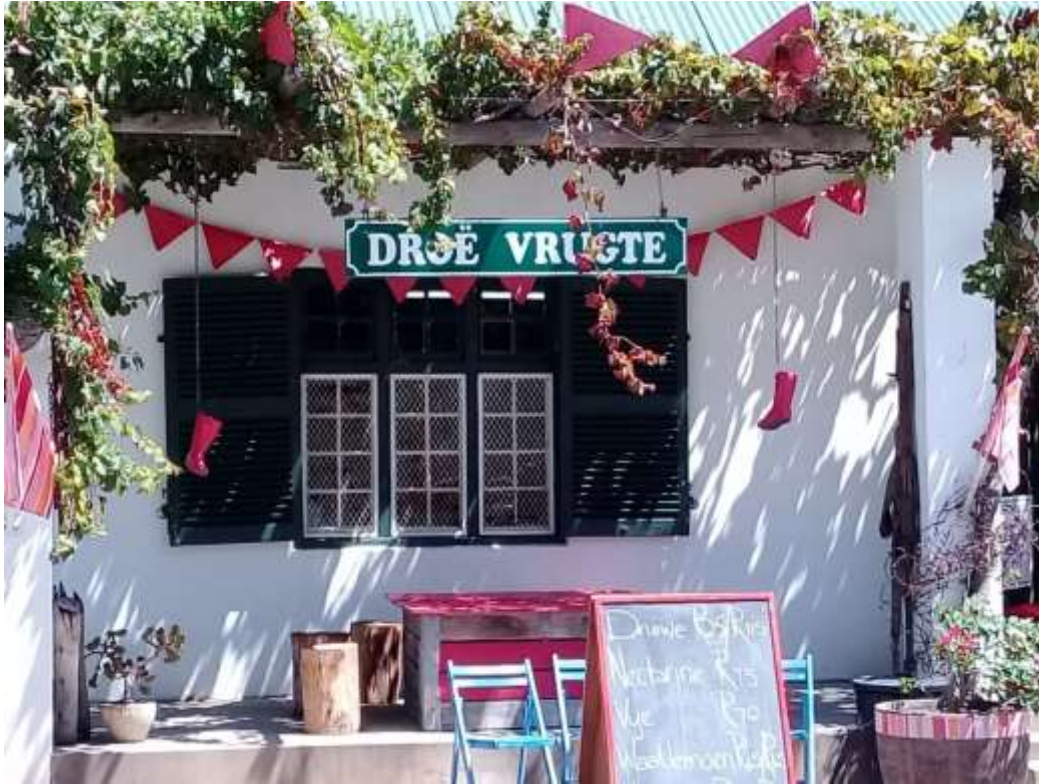
Photo 47. The windows of the building are original. They date to the mid-1800's, or before. Photo: Adolfo Linares.

The old wood ceiling could very well be part of the original ceiling of the building. It is stained and weathered in certain sections. The windows appear to be the original windows of the building, most likely dating to the mid-1800's, or before. The pergola at the front of the building is a new addition, and this falls in line with the history of the building having been, at certain points, a stable and a cellar, when it would have been without the pergola. The double door at the front of the building is also possibly a new addition, but the doors are in line with those that are typical of a stable. The door hinges, however, appear to be more recent. The screed floor appears to have been laid on top of an older original floor.

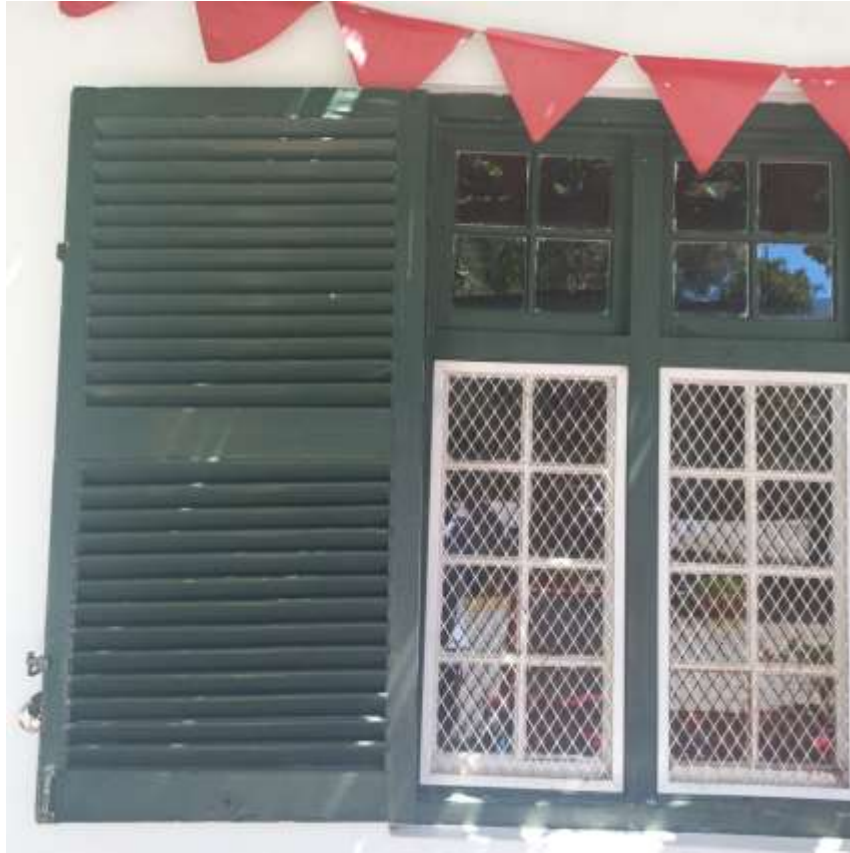
Photo 48. A closer view of the windows the building, and their shutters. These are most likely the original windows. Photo: Adolfo Linares.

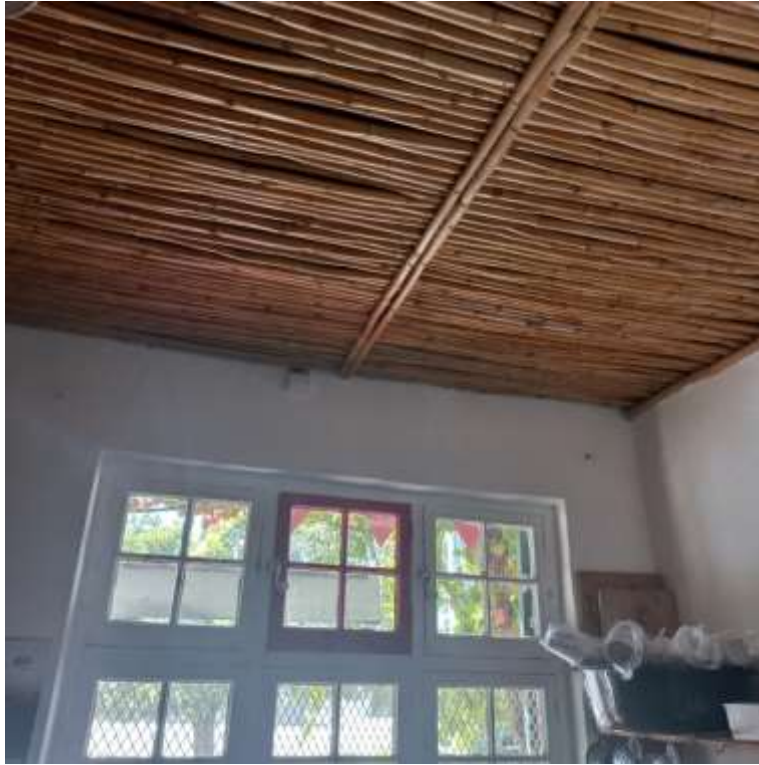
Photo 49. An interior view of the original windows, and of the reed ceiling. Photo: Adolfo Linares.

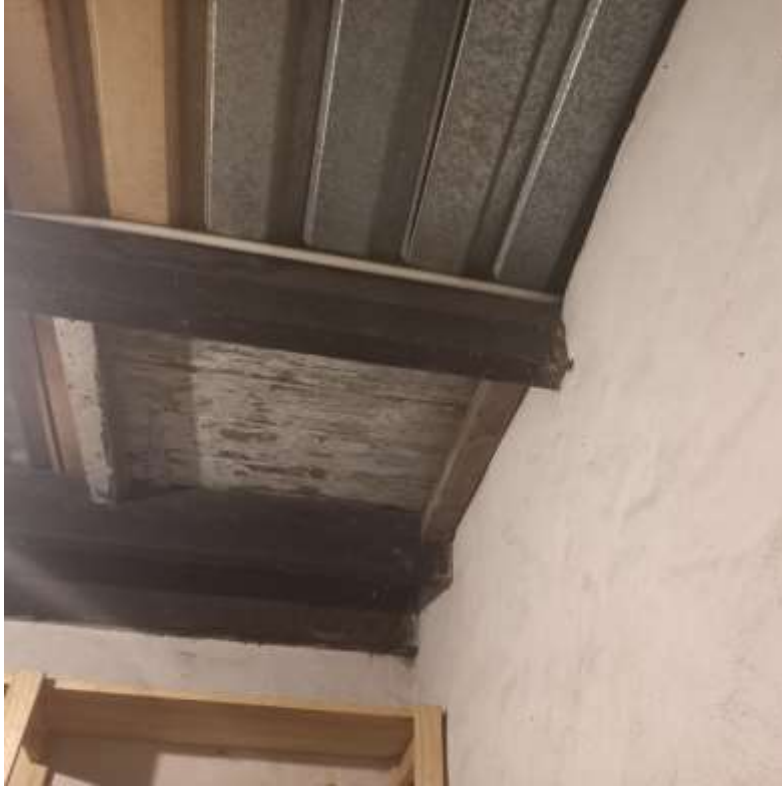
Photo 50. A section of the original wooden ceiling, which is quite probably made from Oak. Photo: Adolfo Linares.
