Phase I Heritage Assessment of P22071 SANRAL Worcester to Glen Heatlie Project

Including Palaeontology and Built Heritage Reports

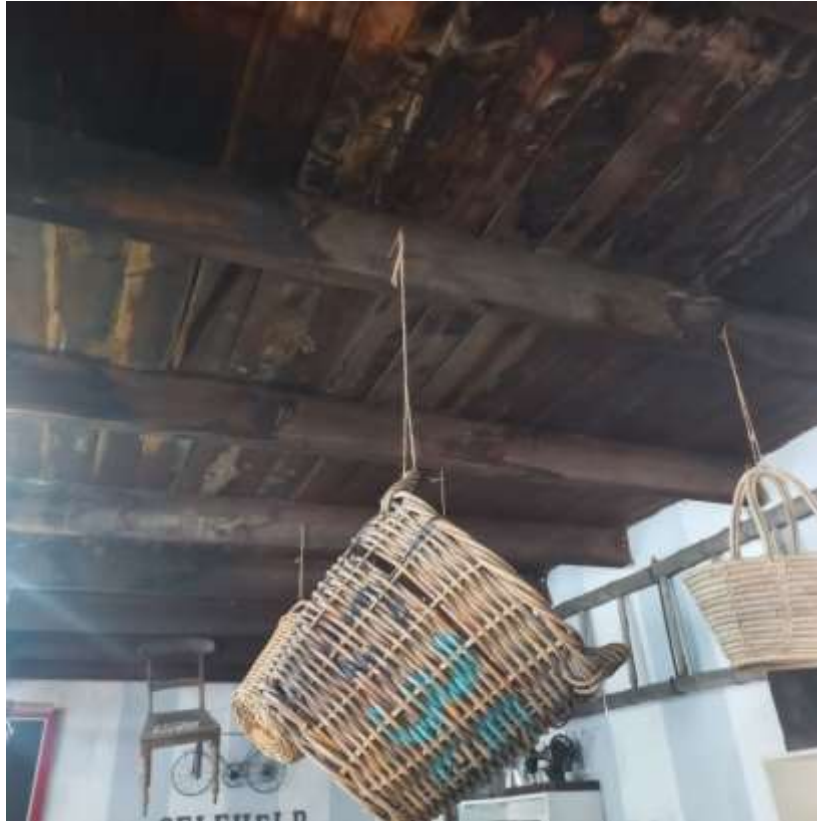
Photo 51. The original wooden ceiling of the building is clearly very old, and is much stained and weathered. Photo: Adolfo Linares.

The old wood ceiling could very well be part of the original ceiling of the building. It is stained and weathered in certain sections. The windows appear to be the original windows of the building, most likely dating to the mid-1800's, or before. The pergola at the front of the building is a new addition, and this falls in line with the history of the building having been, at certain points, a stable and a cellar, when it would have been without the pergola. The double door at the front of the building is also possibly a new addition, but the doors are in line with those that are typical of a stable. The door hinges, however, appear to be more recent. The screed floor appears to have been laid on top of an older original floor.

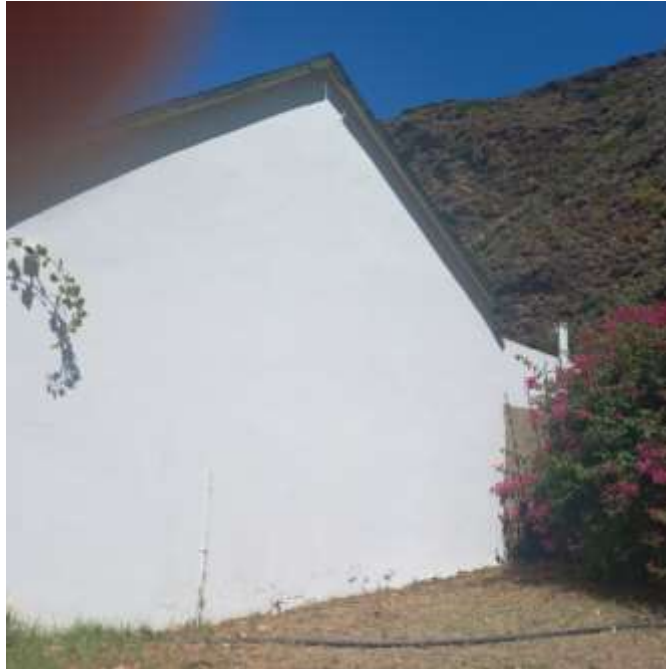
Photo 52. The north wall of the building. Photo: Adolfo Linares.

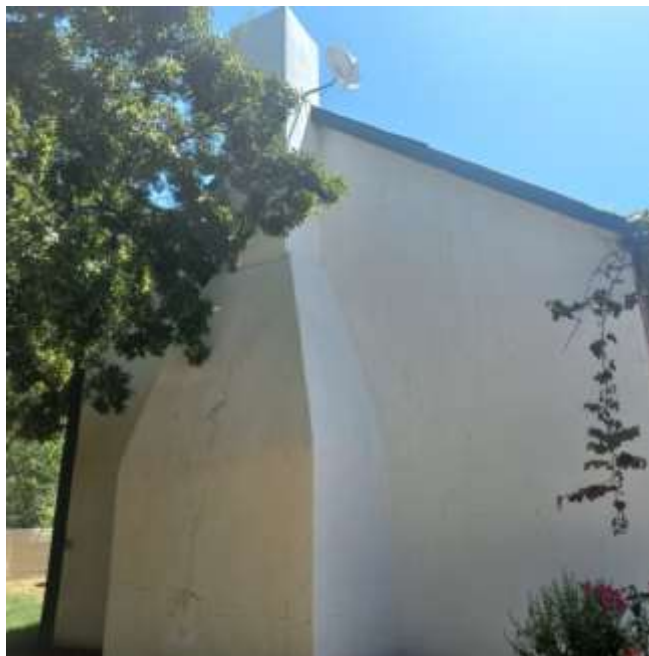
Photo 53. The southern wall of the building. Photo: Adolfo Linares.

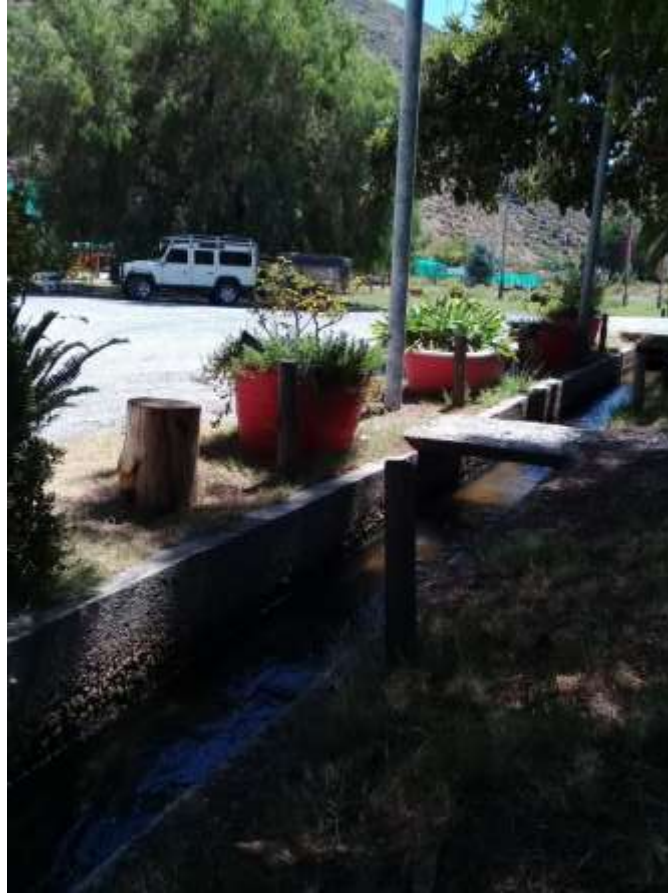
Photo 54. The probable irrigation canal, which is just some 10 metres from the padstal, is clearly an original (irrigation) canal of the working farm to which the farm store is associated. It is only 23 metres from the edge of the road, and as such, it would be obliterated by the proposed development, should Option 1 or 2 go ahead. The ditch must date to the 1800's, if not before, and it should be retained as a heritage feature. Photo: Sian Hall.

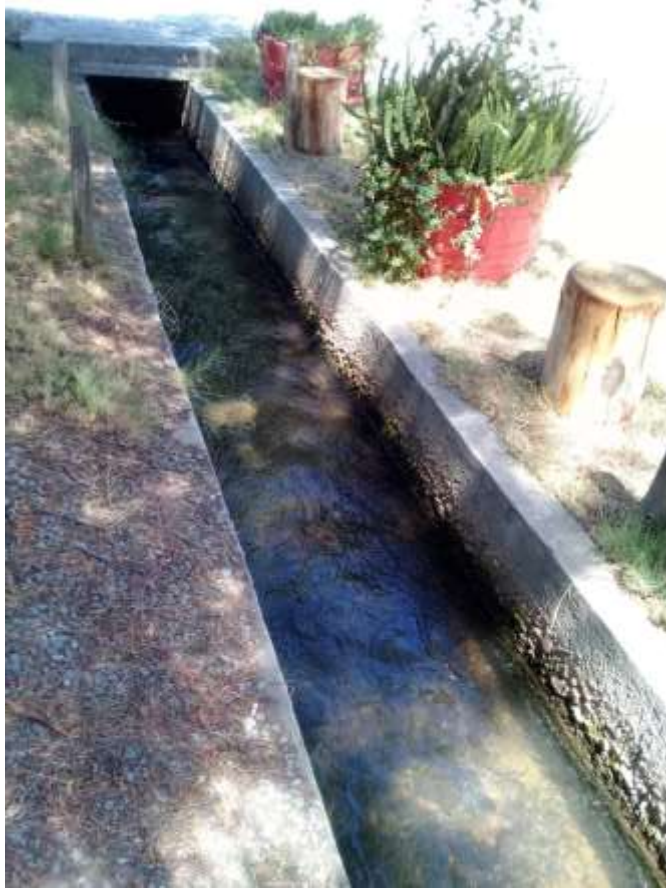
Photo 55. Clear water runs along the irrigation canal, and it has been made into a charming feature for visitors to cross before approaching the padstal. This entire space has become something of a cultural experience. Photo: Sian Hall.

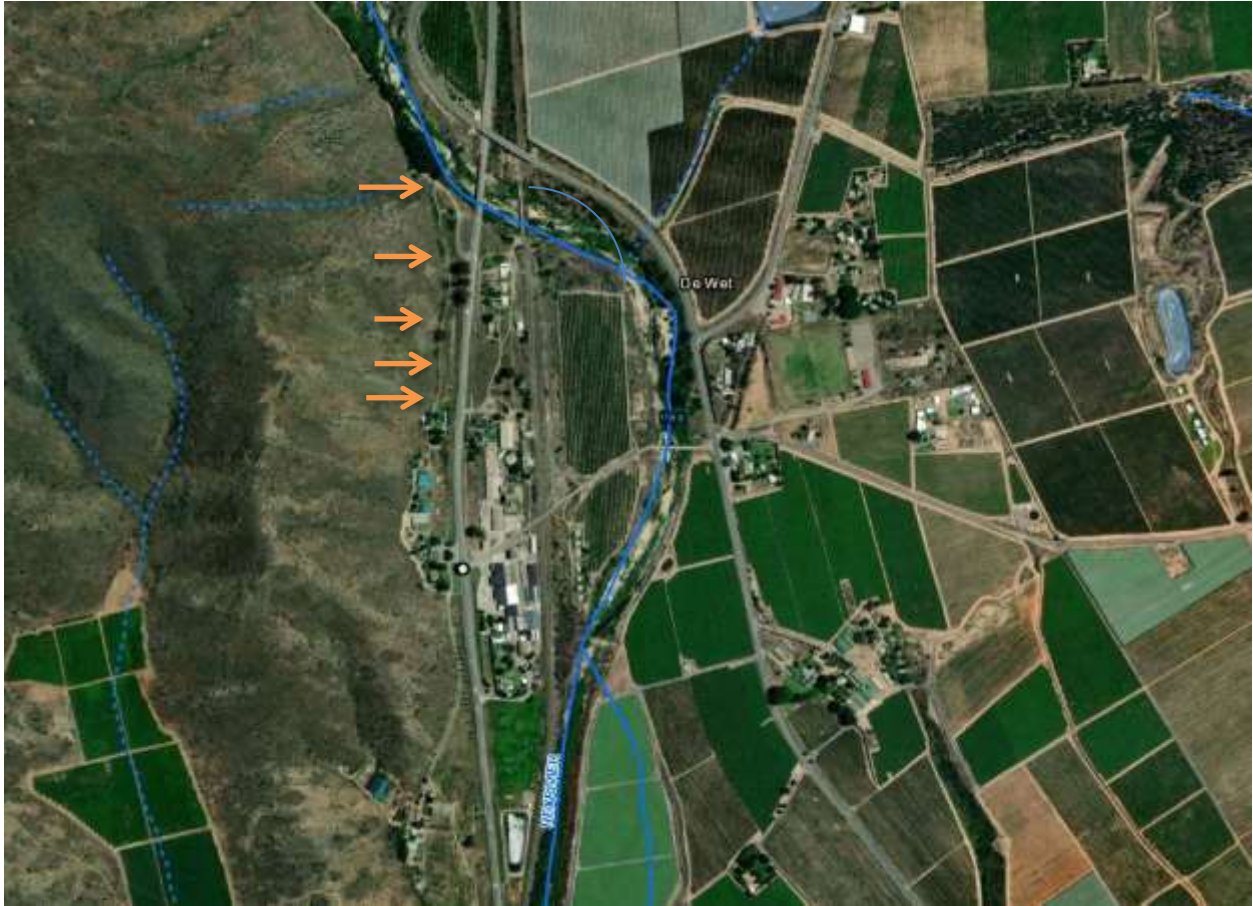
Figure 21. This figure shows the flow of water from the high mountains, down the valleys and into the Hex River. The pale orange arrows indicate the possible source of the water which drains into the irrigation ditch, and the path of flow of the irrigation ditch. The water may also originate from the close-by Hex River via an underground source. Source: Google Earth.

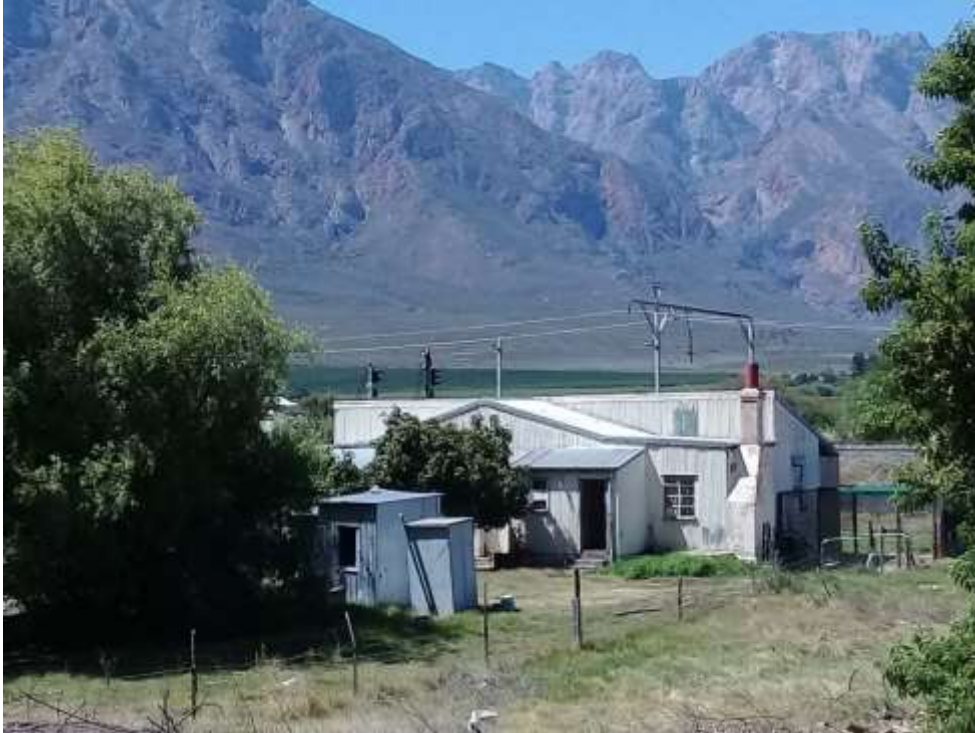
Photo 56. These buildings are built from corrugated Iron sheeting. The length of the sheets, from a distance, appears to be long, but this can only be confirmed on a closer inspection, during a more detailed Built Heritage study. It is quite possible that the material has been reused from an older structure, to build this one. The dates of the buildings are unknown, and can only be discovered during a more detailed study. Photo: Sian Hall.

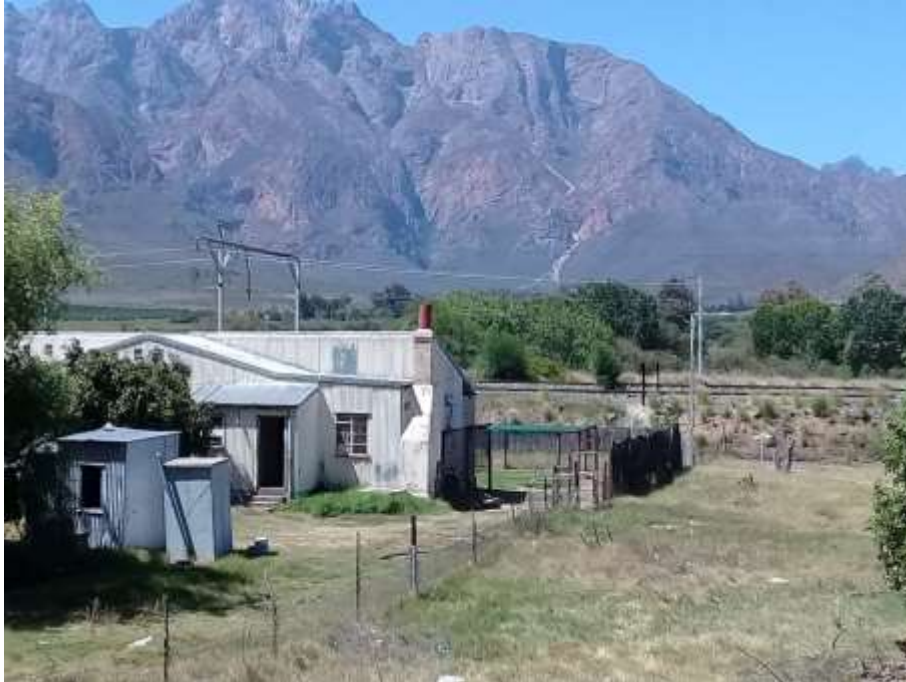
Photo 57. The structures in the foreground are only 7 meters from the N1 freeway. They are built from corrugated sheeting. The structures would be obliterated by the proposed development. The steel windows of the building appear to be a later feature, having been available in South Africa during the 1970's. This photo, taken a little further to the south of the property show, in the background, the valleys and wide open avenues along which colluvium could move down with high velocity water. Photo: Sian Hall.

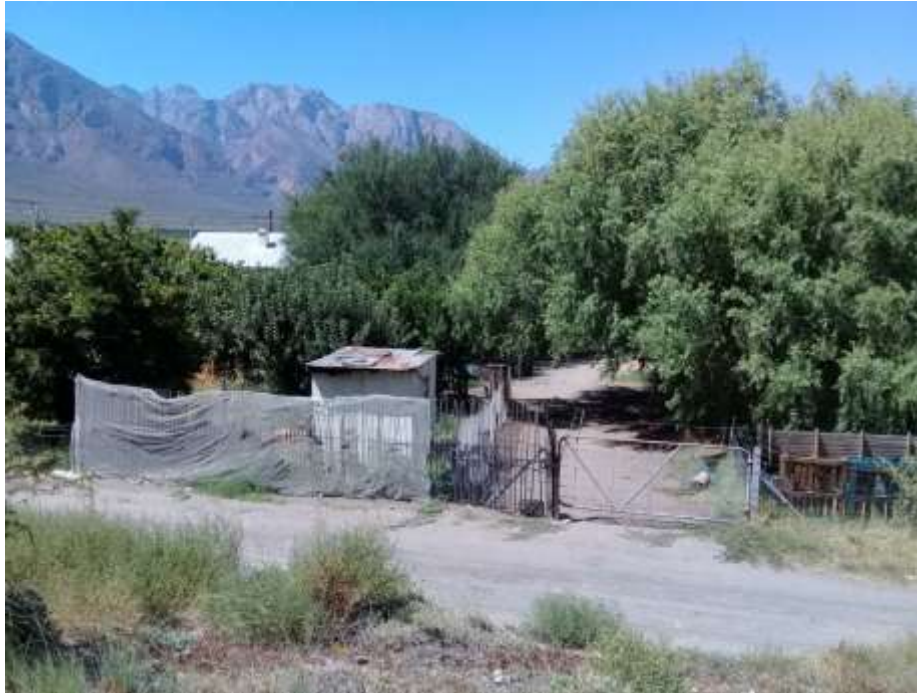
Photo 58. A closer look at the structure that lays closest to the verge of the N1, at a distance of about 7 meters. Photos: Sian Hall.

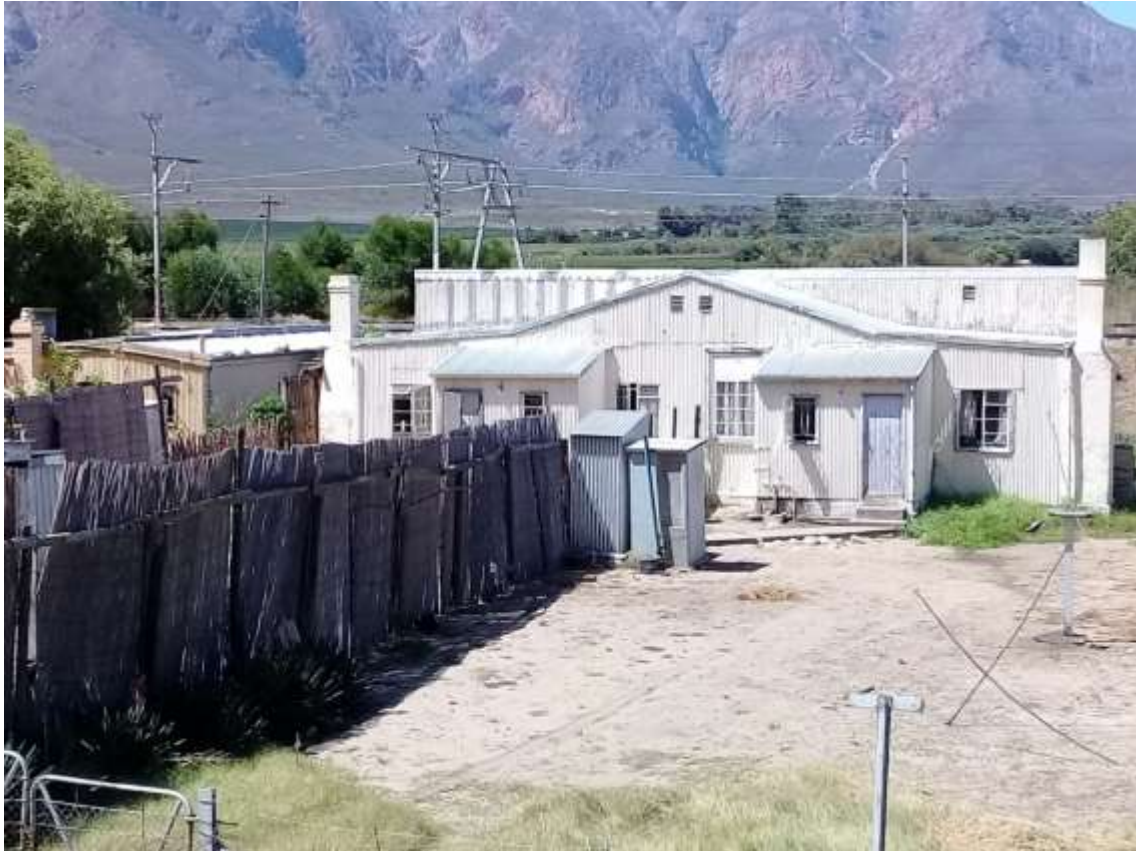
Photo 60. A closer look at the same house reveals, that it too, is built from corrugated iron sheeting. There appear to be a good number of people living in this cluster of dwellings, as some of the houses have been sub-divided to accommodate additional families. Photo: Sian Hall.

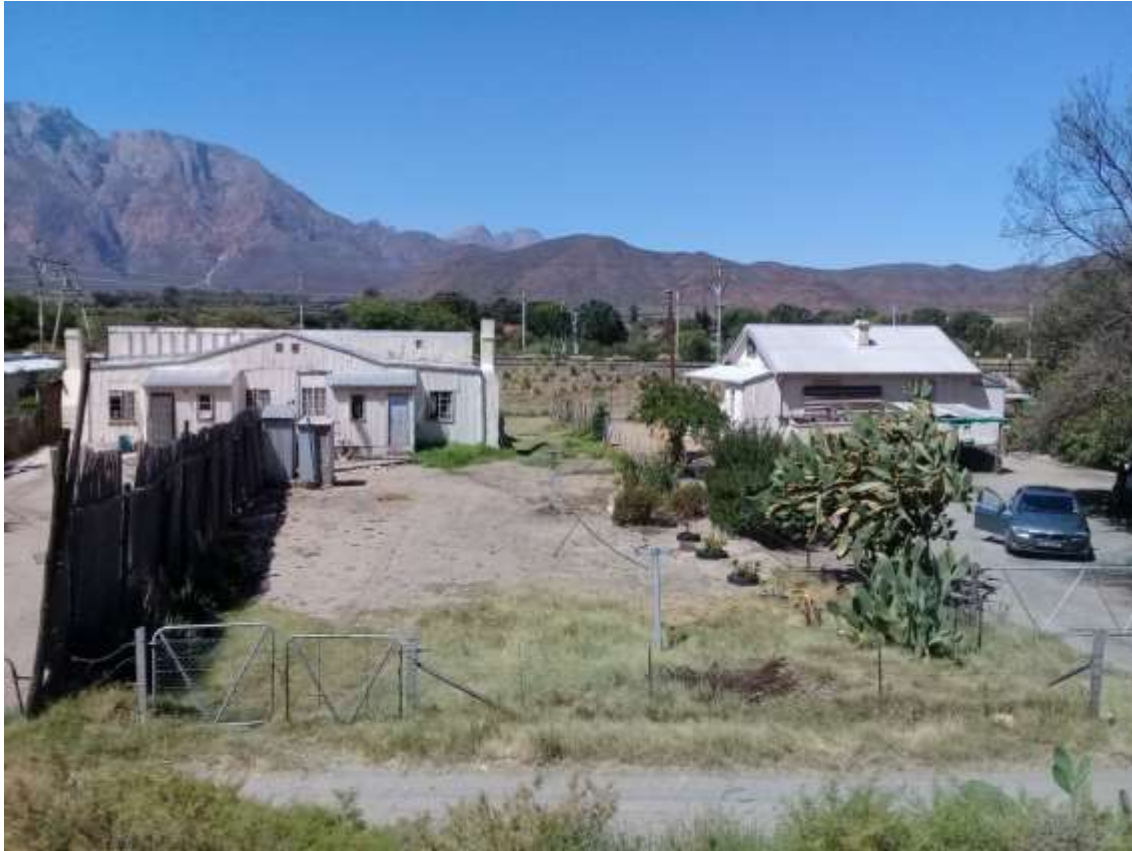
Photo 61. The date of these structures is unknown. A detailed study would be required to ascertain their date and their significance. It is obvious though, that this cluster of houses form a community, and that the proposed freeway (as Options 1 and 2) would be very disruptive, as the residents would lose their houses and would have to be accommodated elsewhere. What they would be paid-out for their houses may not be sufficient for them to purchase something as well-suited to their individual requirements. In addition, their community networks of mutual dependence may also be impacted. It could be that extended families live in these houses. Photo: Sian Hall.

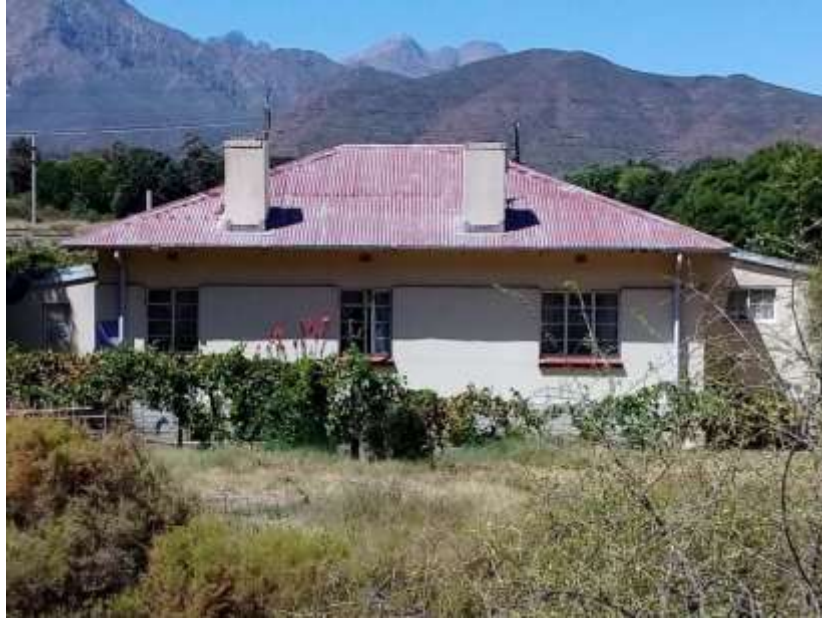
Photo 62. A brick house, further to the south of the houses in the previous photos, but still tightly grouped with the cluster of buildings. The date of the house is uncertain. It is possible that it is over 60 years of age, but it is possibly built in the 1970's. Photo: Sian Hall.

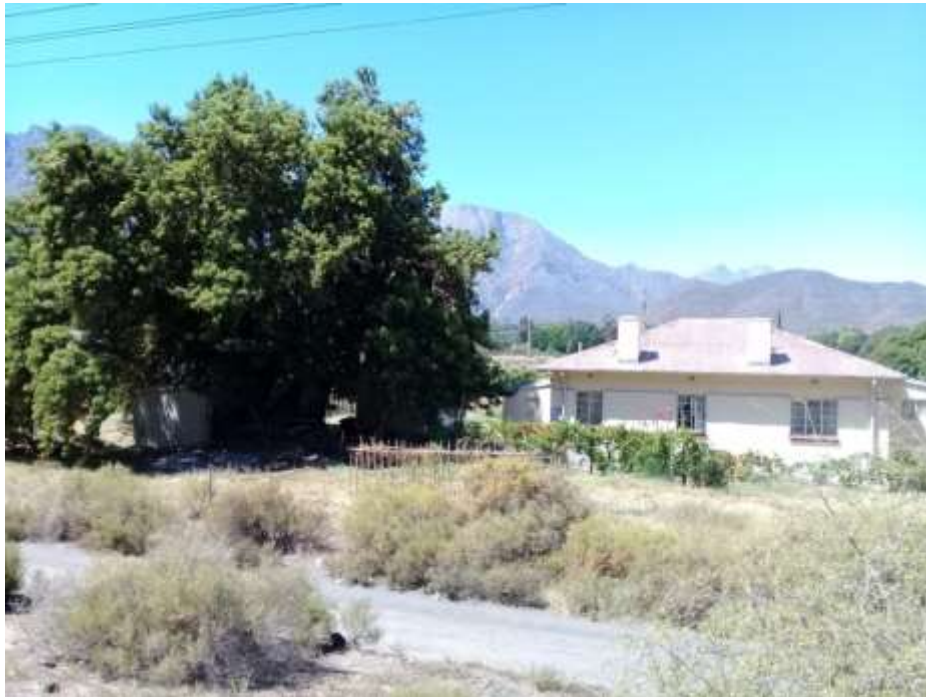
Photo 63. This same house (one of the furthest from the N1) is still very close to it at just over 12 meters. The author is standing on the N1 shoulder to take the photograph. Photo: Sian Hall.

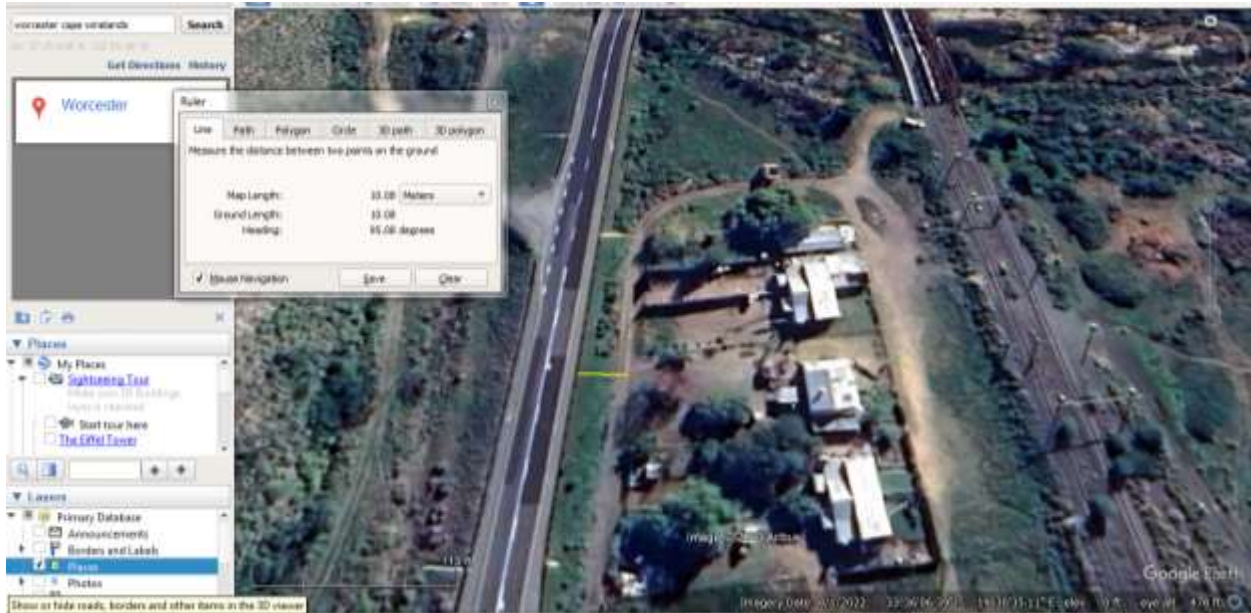
Figure 24. Google Earth imagery of the above house. Its yard boundary still lies very close to the N1, just 10 meters from it. Photo: Sian Hall.

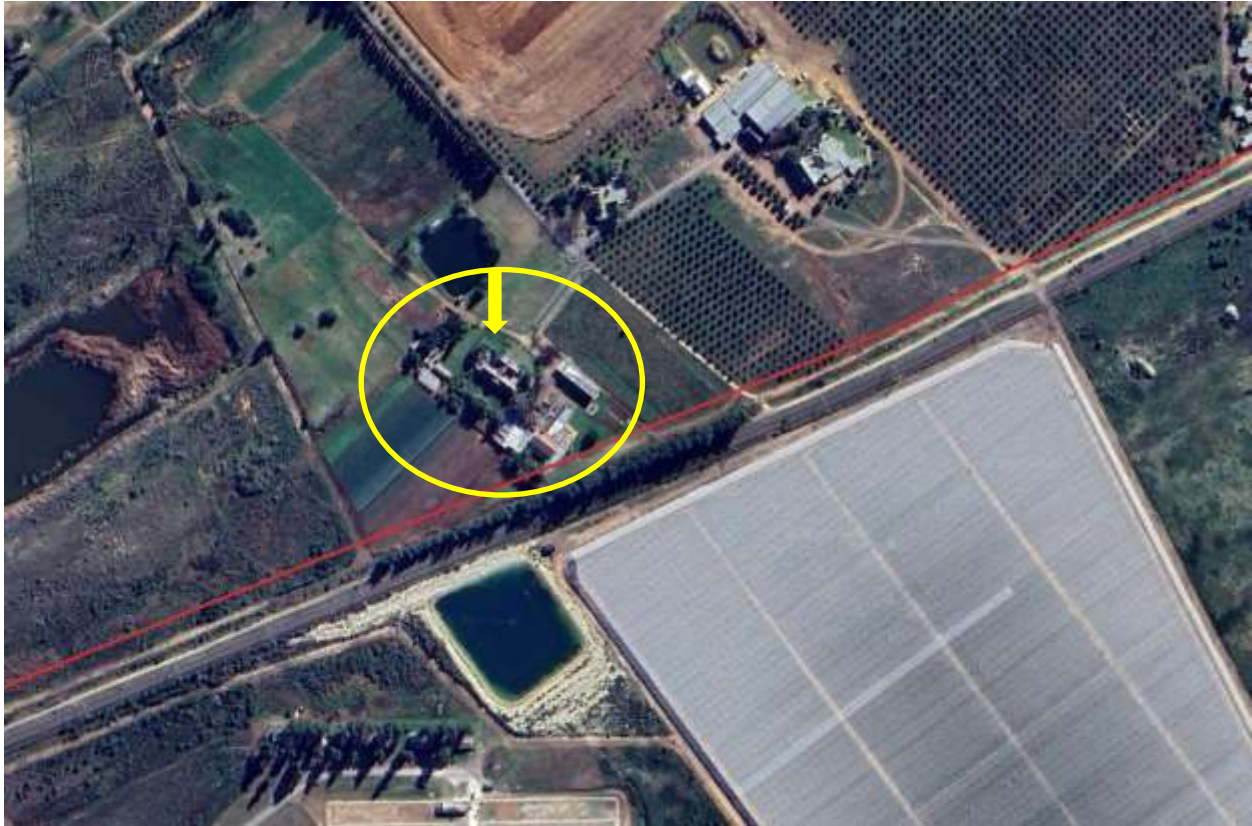
Figure 25. The proximity of Uitvlucht Guest House to the Proposed Option 2. The road would impact upon the established property of the National Monument. The main building of the National Monument is indicated by the yellow arrow, while the various buildings associated with it are encircled by the yellow polygon. Google Earth.

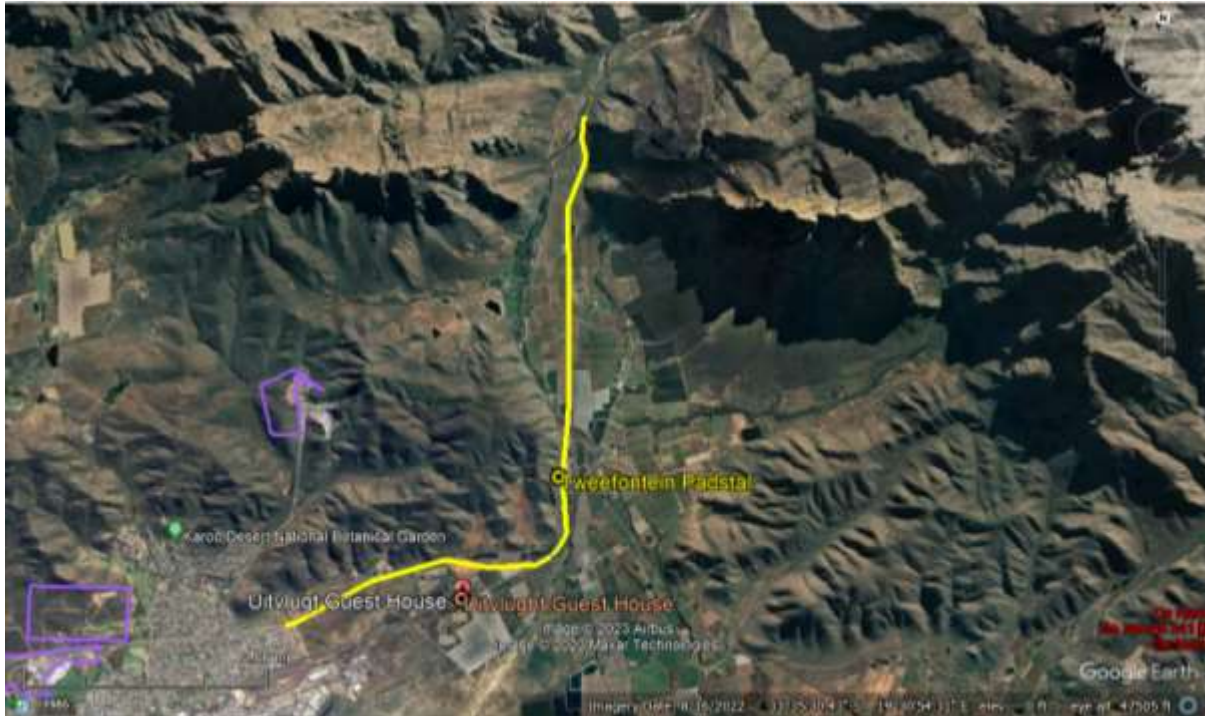
Figure 27. The route proposed by Option 1. The location of Twefontein Padstal is clearly visible in yellow. It is clear that the 50 meter (minimum) width of the proposed dual carriageway will obliterate this heritage space. The location of Uitvlugt Guest House is also visible, indicated by light orange colour. The guest house is not impacted by Option 1. Google Earth.

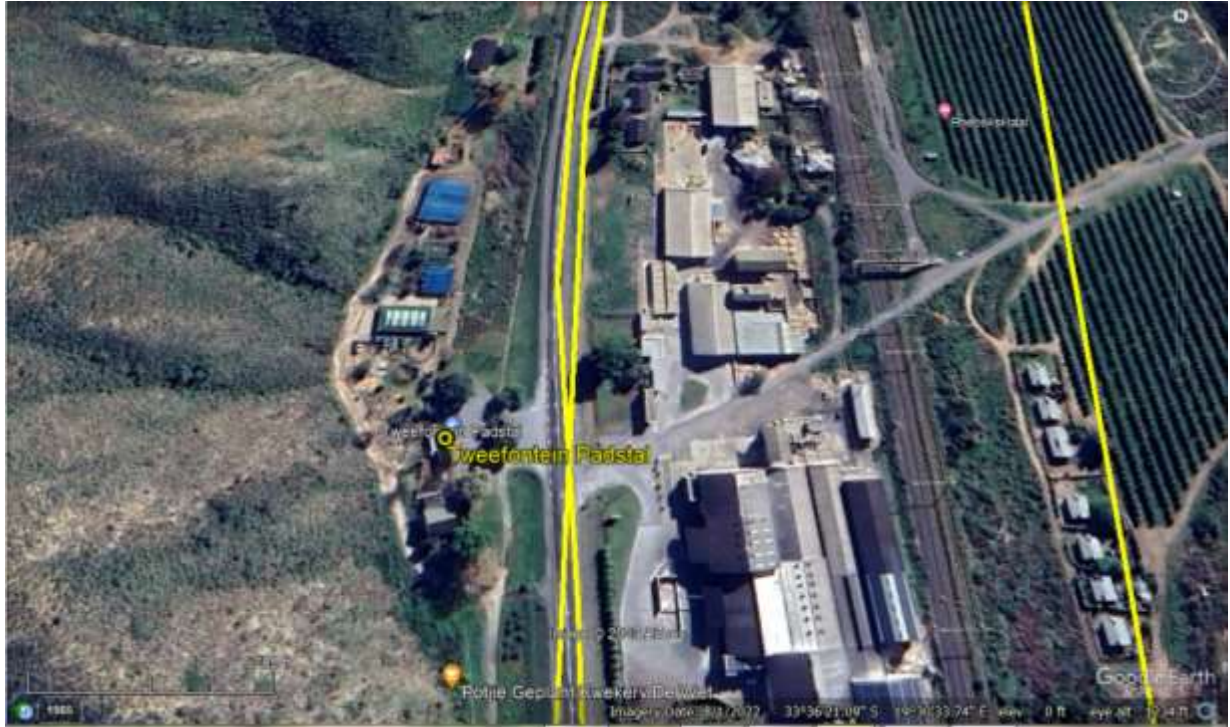
Figure 28. It is obvious that Twefontein Padstal area will be directly and negatively impacted by both Options 1 and 2, but not by Option 3. Google Earth.

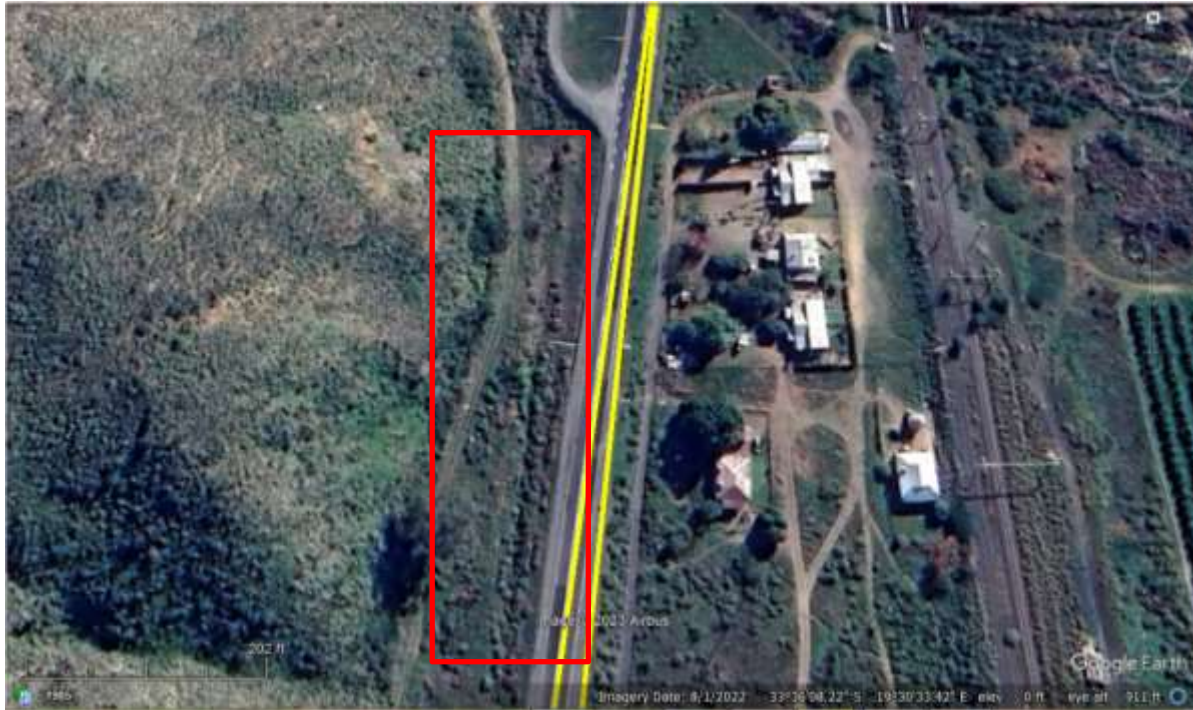
Figure 29. Both the Early Stone Age cobble terrace archaeological site, to the west of the freeway, and the cluster of houses of uncertain date, located to the east of the freeway, will be severely negatively affected by both proposed Options 1 and 2. Google Earth.

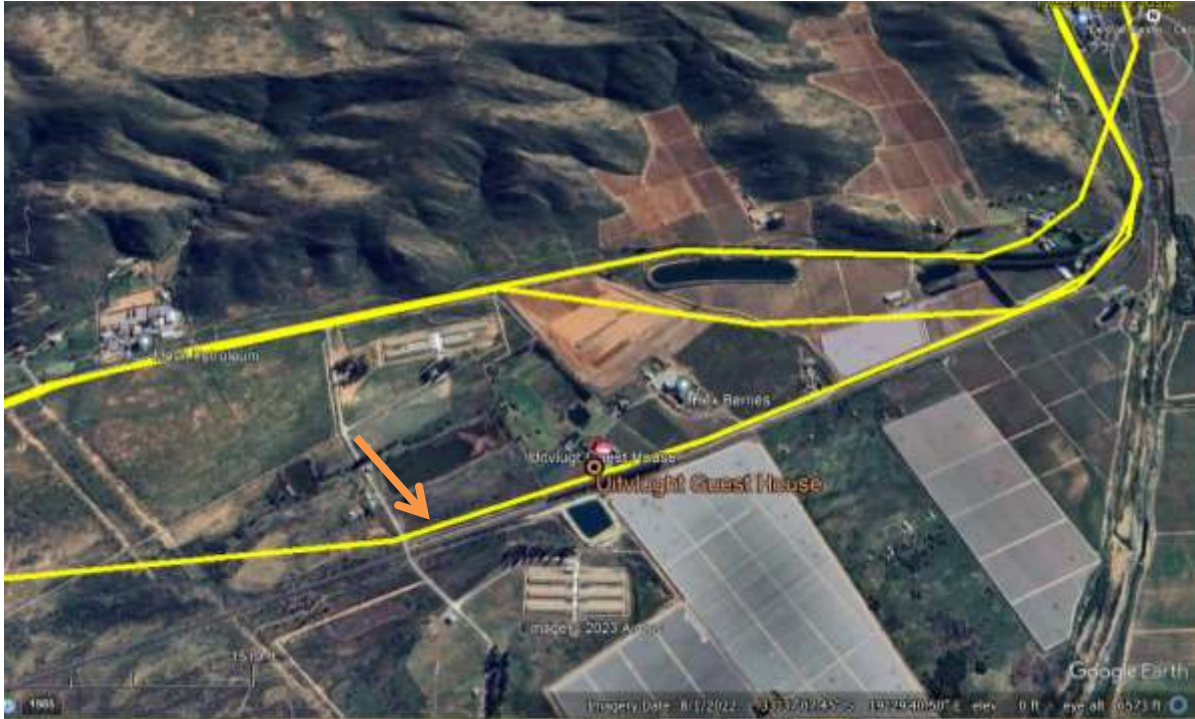
Figure 30. Option 2 (indicated by the light orange arrow) will pass too closely to the boundaries of the Provincial Heritage Site of Uitvlugt Guest House. It is not recommended that this Option be implemented, for this reason, and because it also compromises, Tweefontein Padstal, the Early Iron Age Site, and the cluster of six houses of uncertain date. Google Earth.

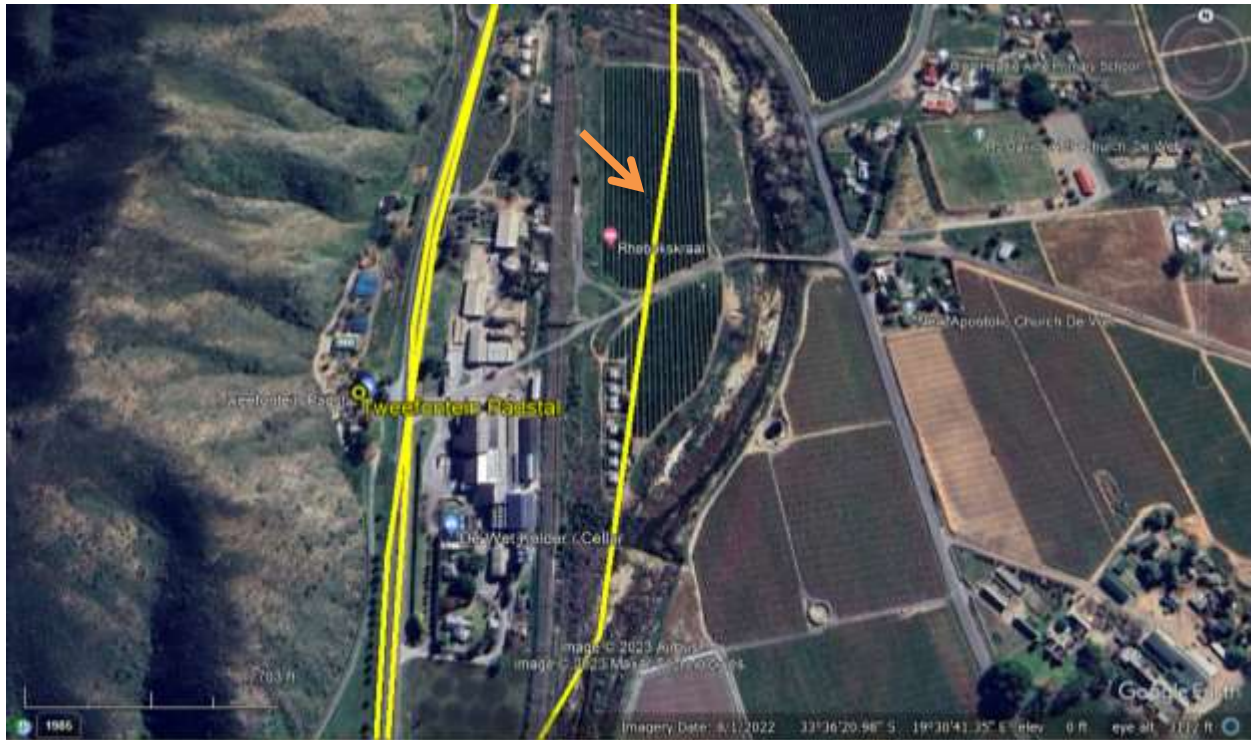
Figure 31. Tweefontein Padstal will not be affected at all by Option 3 (yellow line), as indicated by the light orange arrow. Google Earth.

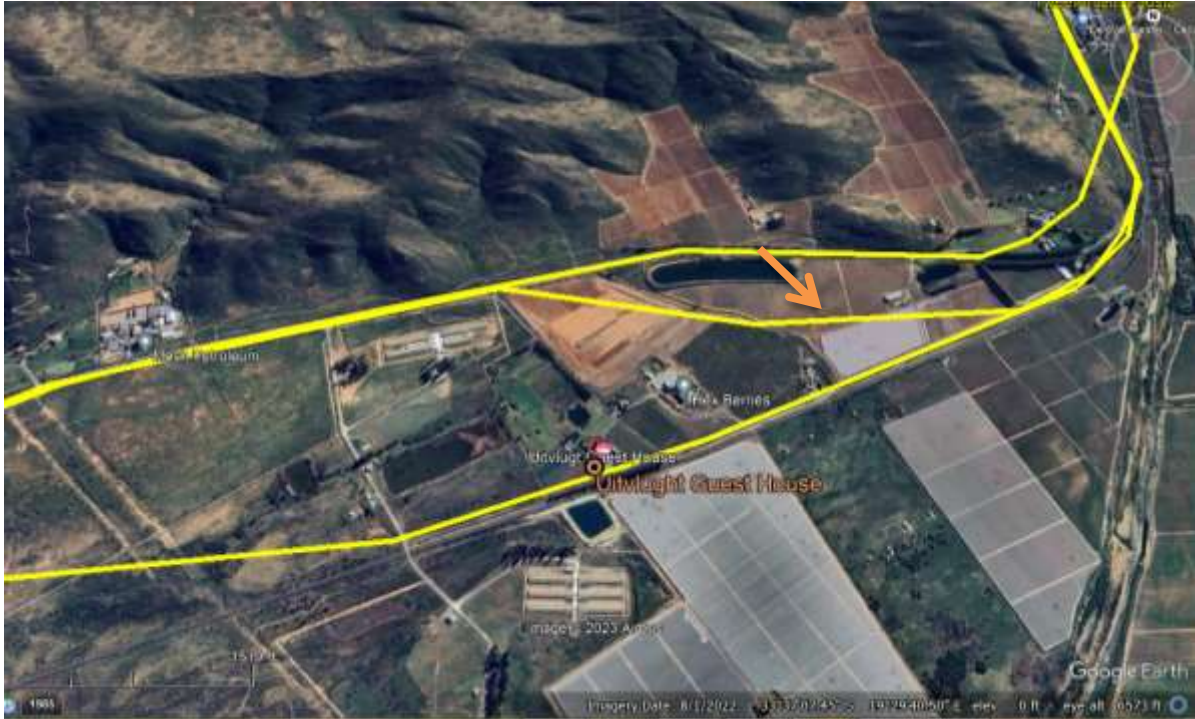
Figure 33. Uitvlught Guest House will not be affected by Option 3, indicated by the orange arrow. Google Earth.
